**Testimony of LANDMARK WEST!
Certificate of Appropriateness Committee
Before the Landmarks Preservation Commission
7 West 82nd Street
TBD, 2009**

The Certificate of Appropriateness Committee wishes to comment on the application to legalize work performed at the primary façade and areaway without Landmarks Preservation Commission permits at 7 West 82nd Street, a Renaissance Revival style rowhouse designed by Thom & Wilson and built in 1886-87.

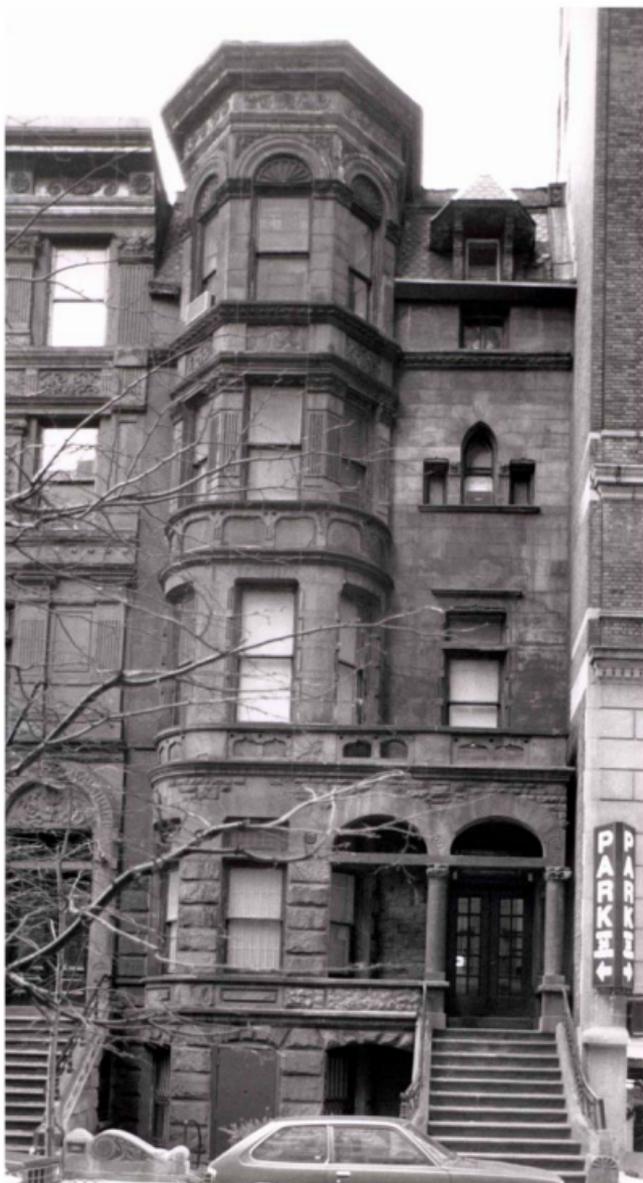
1

Designation photo:
Taken in 1990 at the
time of the designation
of the Upper West
Side-Central Park West
Historic District.

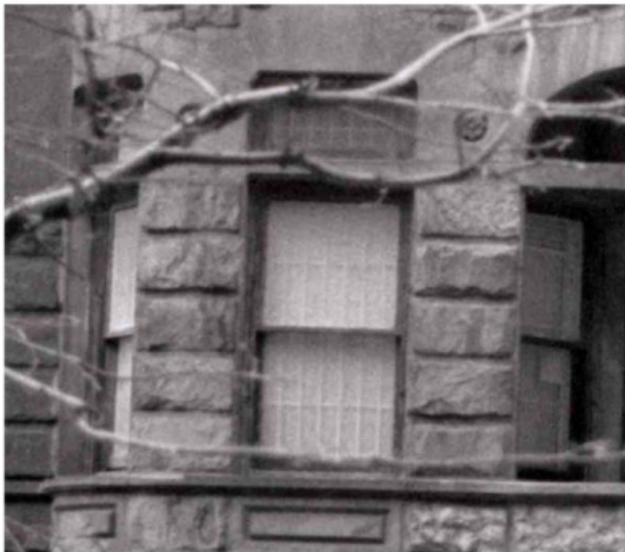
2

First floor window (see handout page 2): Via conversation with the applicant, it is our understanding that the transom window at the parlor floor level was thought to possess a stained glass, "special" window at the time of historic district designation (1990). By zooming in on the designation photo, it appears that what may look like window leading is more likely security gating installed on the inside of the window.

Top: Zooming in on the 1990 designation photo, we observe that the lines in the parlor floor window are likely security gates installed on the interior of the window.

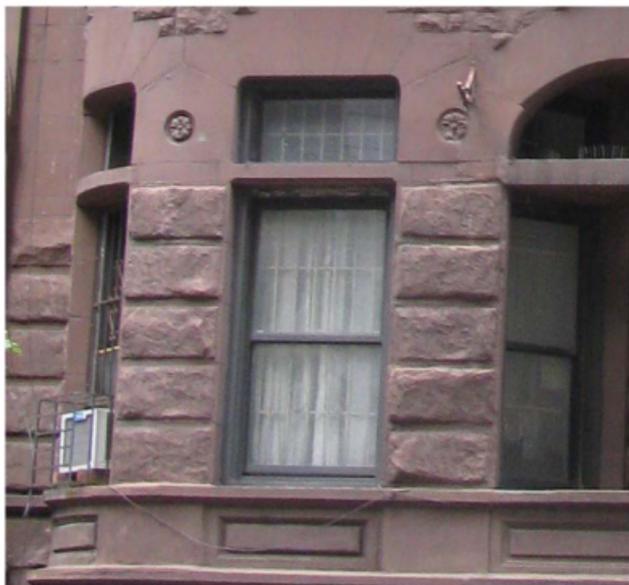
Bottom: Existing conditions photo of the parlor floor window.

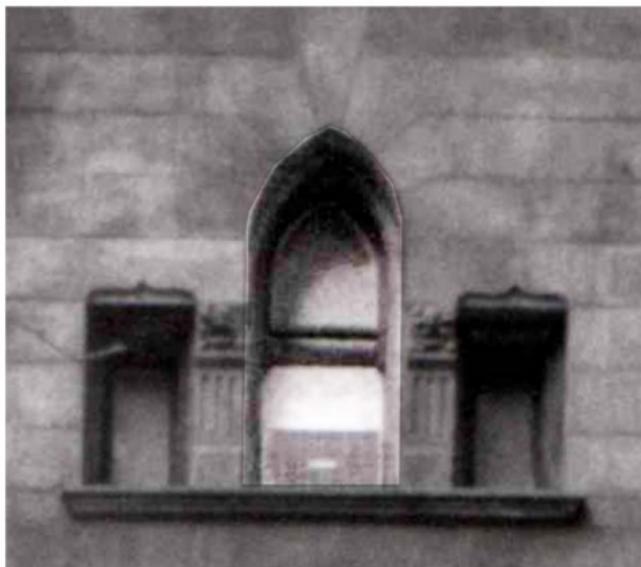
3

Third floor special window (see handout page 3): As with the first floor window, zooming in on the designation photo to inspect this arched window proved essential in determining that inappropriate modifications have been made to this "special" window. The designation photo (1990) depicts the curving window frame. Looking then to photos of the existing conditions, we can see that inappropriate aluminum panning has been installed in front of the window—and the window itself seems to have been replaced following designation. Both of these were done without LPC permits and should be folded into the portfolio of noncompliance issues being addressed at 7 West 82nd Street.

Top: Using Photoshop to lighten the shading created by this special window's arched stone surround, the curvature of the window at the time of designation (1990) is visible.

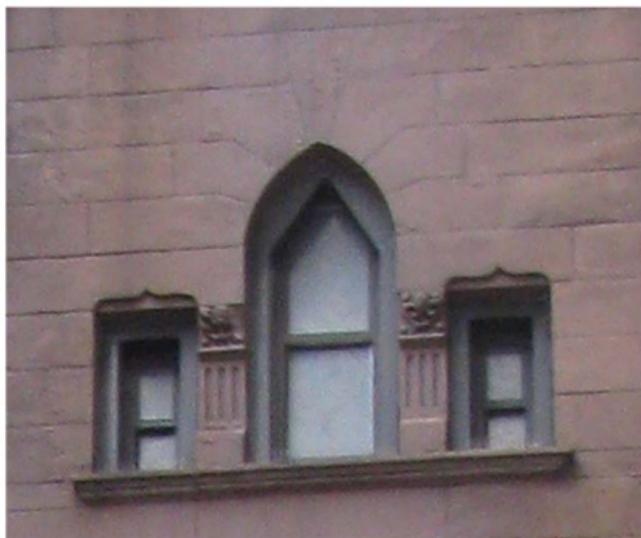
Bottom: Existing conditions photo of the special arched window, showing that in addition to replacing the window (without LPC permits), inappropriate aluminum panning has been installed.

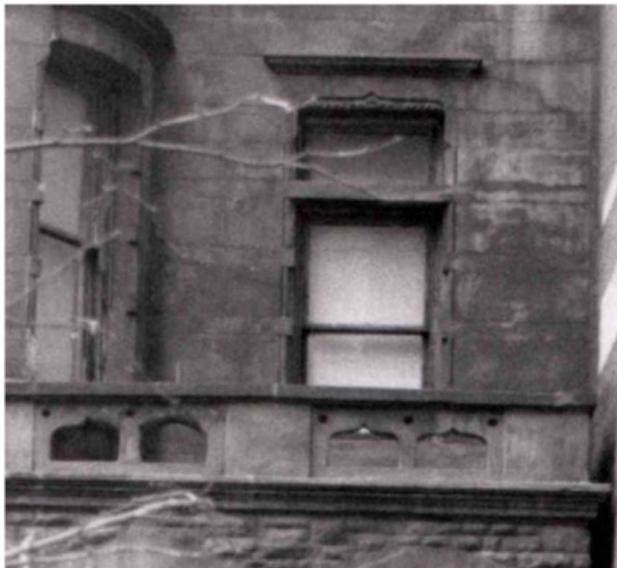
4

Second floor converted window-to-door; balcony railing (see handout page 4): The enlargement of a window opening to become a door without Commission permits is most distressing. Such an enlargement resulted in the loss of historic brownstone material, a modification on a principal façade that the Commission would have surely found to be inappropriate. The metal railing installed to accommodate this altered balcony space exacerbates the second floor noncompliance issues. If in fact such a railing is required for insurance purposes, we are certain that an appropriate design solution is possible. This is not it.

Top: Designation photo (1990) depicts second floor balcony and window conditions: Stone parapet and one-over-one window.

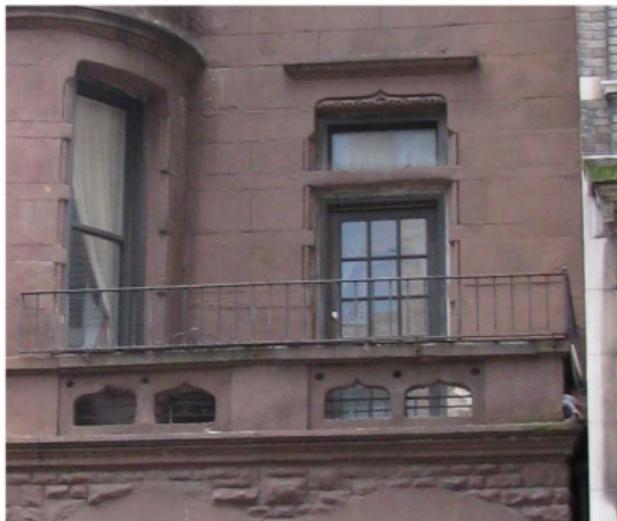
Bottom: Existing conditions photo shows that the window has been converted to a door and railing has been installed atop the historic brownstone parapet.

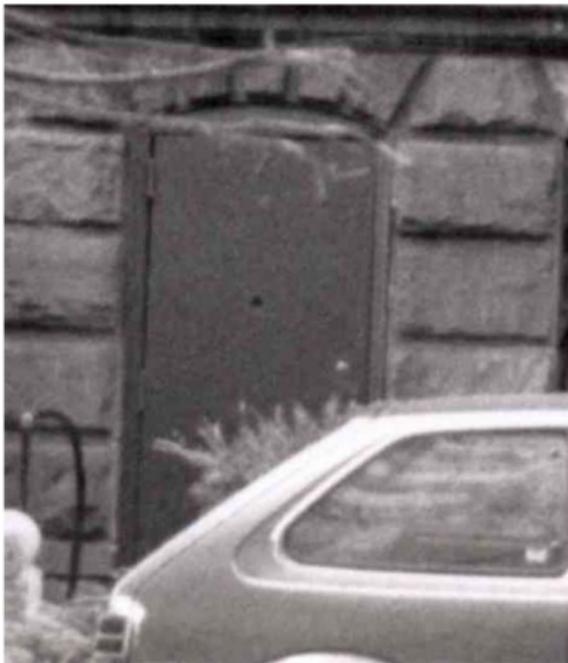
5

Window (see handout page 5): Since the time of the designation of the Upper West Side-Central Park West Historic District in 1990, this window has been installed, replacing a rudimentary wooden panel. The white vinyl windows currently in place is inappropriate, as is the metal grillwork. To get a sense of what would be appropriate metalwork for this Thom & Wilson rowhouse, LANDMARK WEST! advised the homeowner to complete a survey of other residences by this firm. To that end, we provided the full listing of the nearly 300 buildings in the UWS-CPW Historic District attributed to Thom & Wilson in the designation report along with a map of these addresses.

Top: Designation photo (1990) shows that a crude wood door stood in place of a window at the areaway level.
