The Children's Museum of Manhattan

361 Central Park West

Special Windows Conditions Assessment
6 December 2019

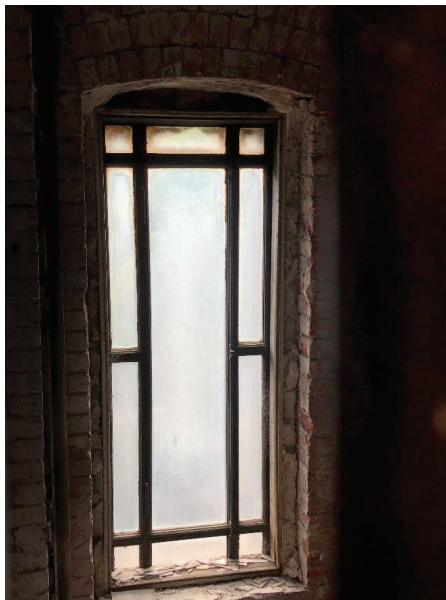
Picture 14

WINDOW REF #: **20** (picture # 13)
 SIZE: 7'-6 3/8"
 LOCATION: North Façade, Second floor
 OPERATION: Pivots
 QTY OF LITES : (16) lites of clear glass
 CONDITIONS ASSESSMENT: Frame is in good conditions window is not locked
 Glass sealant looks dry
 Build up verdigris metal corrosion at interior finish. (Picture 14)

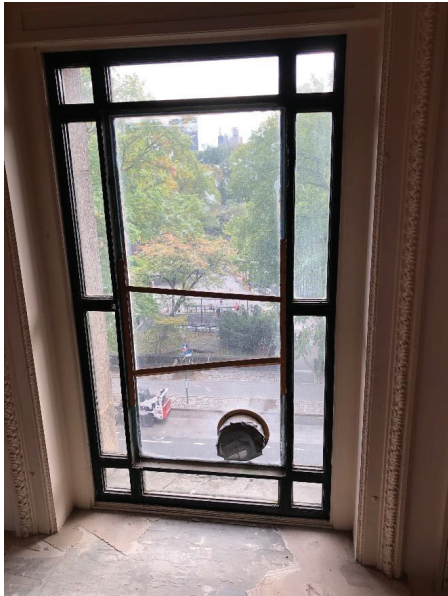
Picture 15

WINDOW REF #: **17** (picture # 15)
 SIZE: 5'-2"x 2'-2"
 LOCATION: East facade, second floor
 OPERATION: Fixed
 QTY OF LITES : (12) glass lites
 CONDITIONS ASSESSMENT: No access, Could not be reviewed
 No access lack of do to shaft
 We notice shattered glass at the seal but not missing glass

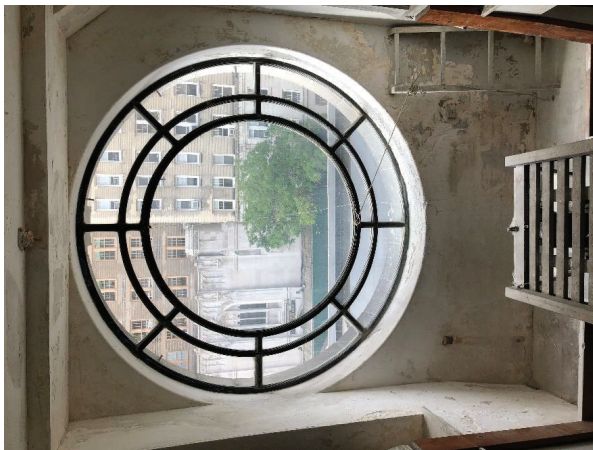
Picture 30

WINDOW REF #:	1 (picture #30)
SIZE:	Diameter 7'-6 3/8"
LOCATION:	South façade, second floor
OPERATION:	Pivoting panel
QTY OF LITES :	(16) lites of clear glass
CONDITIONS ASSESSMENT:	Window is generally in a fair condition and glass is not damaged. Frame is cracked at some joins locations and internal corrosion develops Abnormal build up of verdigris can be noticed at interior perimeter Glass is improperly cut, and edges are visible (picture 32) Pivoting windows cannot be closed and is maintained with a rope. (picture 31) Missing latching hardware
WINDOW REF #:	2 (picture # 29)
SIZE:	7'-6 3/8"
LOCATION:	South façade, second floor
OPERATION:	Pivoting panel
QTY OF LITES :	(16) lites of clear glass
CONDITIONS ASSESSMENT:	Window is generally in a fair condition (2) pieces of glass are damaged (dents) No apparent cracks on the frames Pivot is broken Abnormal build up of verdigris can be noticed at interior perimeter Corrosion develops on the outside, closed to the stone

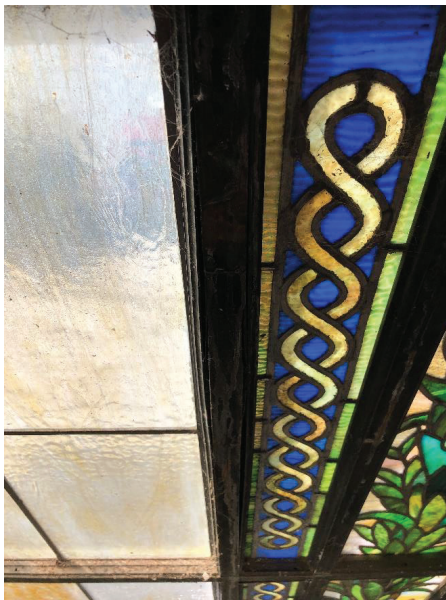
Picture 44

WINDOW REF #: 6 (picture 61)
 SIZE: 23'-3 5/8" X 7'-6"
 LOCATION: South façade, first floor
 OPERATION: (2) pivot panels
 QTY OF LITES : (60) lites of stained glass
 CONDITIONS ASSESSMENT: Window is generally in a poor condition
 window operates but does not close properly
 Latch is broken.
 Missing glass top (picture 41)
 Window is subject to deflection
 Operable window was silicone to prevent leaks (picture 43)
 Mullions are cracked at several locations. (picture 44,45,46)

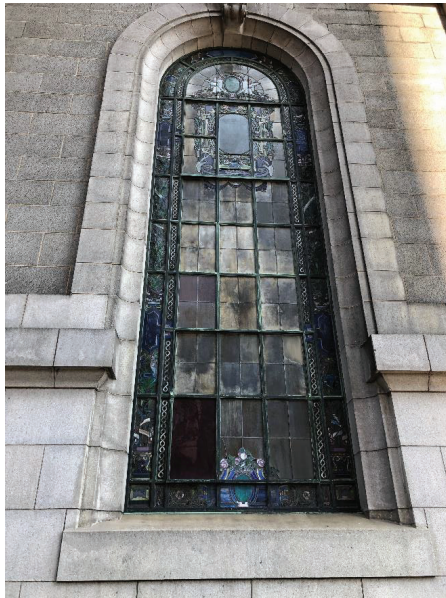
Picture 60

WINDOW REF #: 5 (picture 60)
 SIZE: 23'-3 5/8" X 7'-6"
 LOCATION: South façade, first floor
 OPERATION: (2) pivot panels
 QTY OF LITES : (60) lites of stained glass
 CONDITIONS ASSESSMENT: Window is generally in a poor condition
 Upper window does not close properly. Frame is not squared.
 Temporary brackets were installed to maintain the window locked
 Window is subject to deflection
 Missing screws at several location, especially at glass stops
 Abnormal build up of verdigris can be noticed at interior perimeter

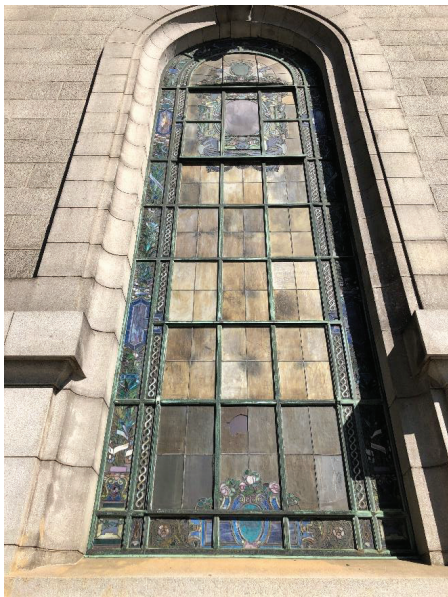
Picture 62

WINDOW REF #: 7 (picture # 62)
 SIZE: 23'-3 5/8" X 7'-6"
 LOCATION: South façade, first floor
 OPERATION: (2) pivot panels
 QTY OF LITES : (60) lites of stained glass
 CONDITIONS ASSESSMENT: Window is generally in a poor condition
 Operable window does not close entirely and is not locking
 Missing casement stay
 Window is subject to deflection
 Mullions are cracked at several locations

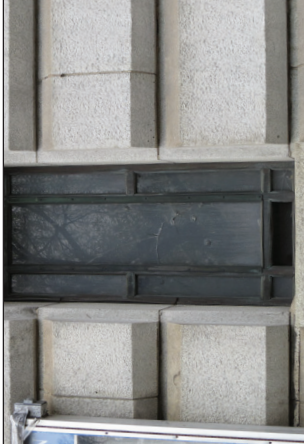
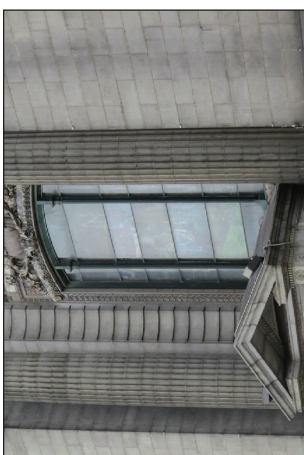
Broken glass at window 11

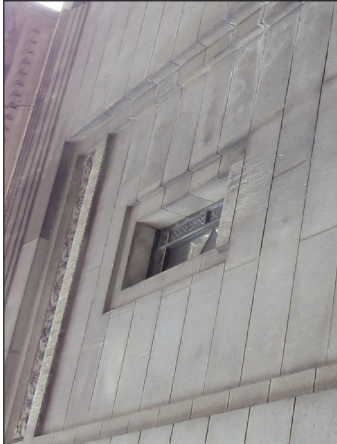
Broken glass at window 21

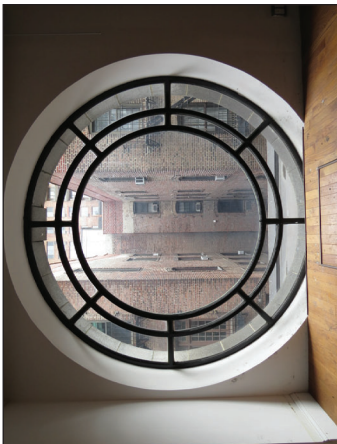
Typical window condition from inside (window 18 shown)

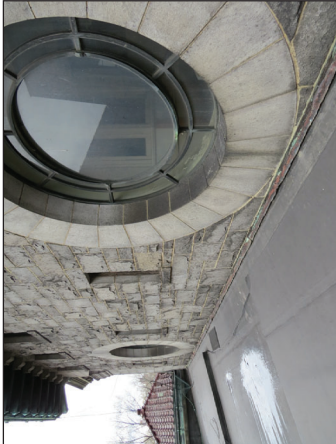
Typical overall window condition (window 19 shown)

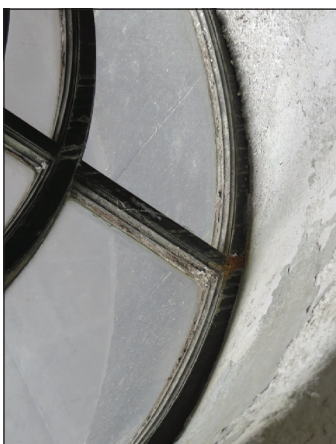
Rust & staining on bronze from inside (window 20 shown)

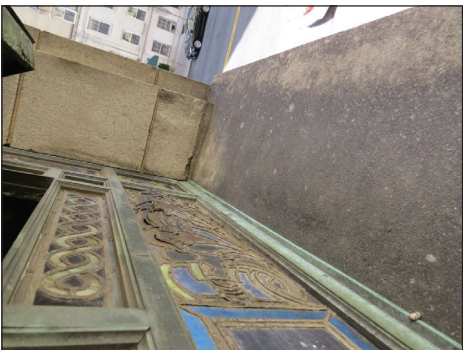
Typical bowing stained glass (window 25)

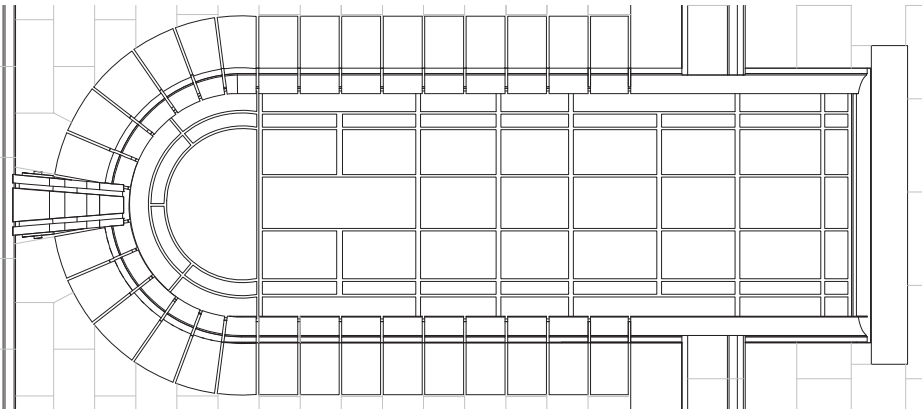
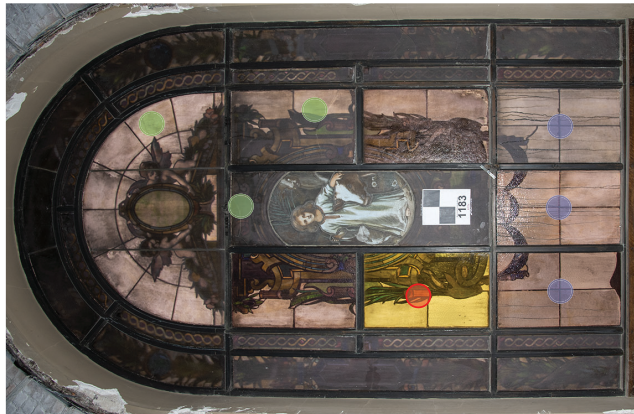
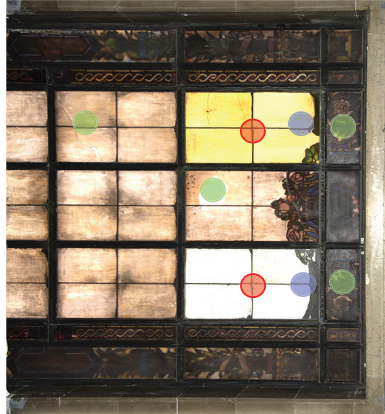
WINDOW 5 - BRONZE WITH STAINED GLASS

- Area of severe dirt and debris accretions. This accretion is hygroscopic, attracting water. Standing water adversely affects the lead comes, the framing, and in the long term, contributes to the corrosion of the glass.
- Area where the original glass is missing (interior plate) has been replaced with a poor color match.
- Area of broken glass.

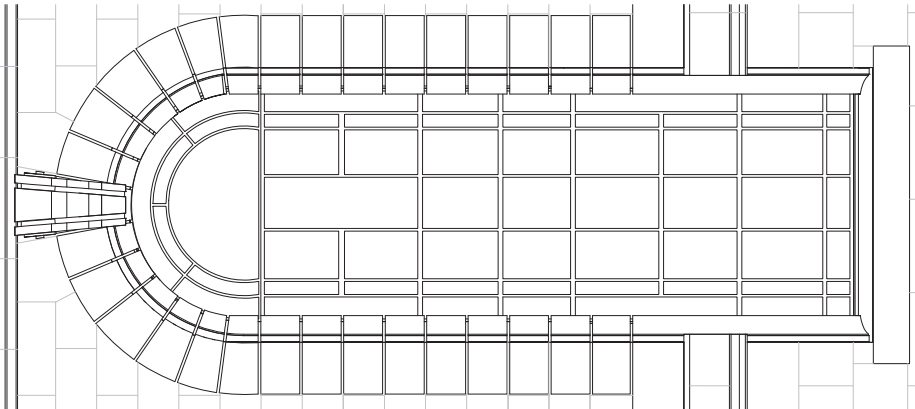
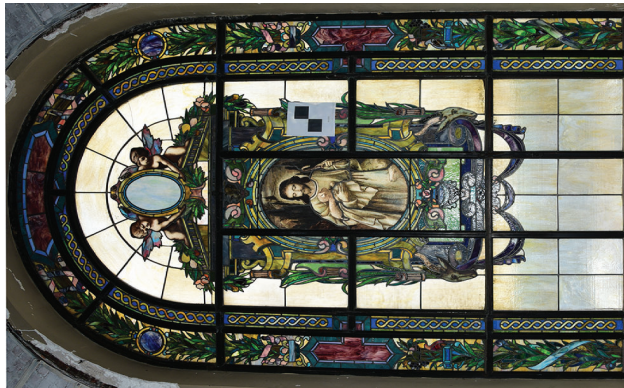
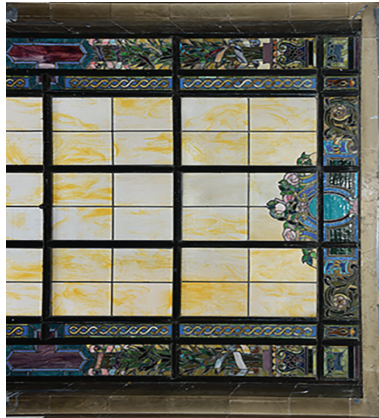
WINDOW 6 - BRONZE WITH STAINED GLASS

Area of broken glass.

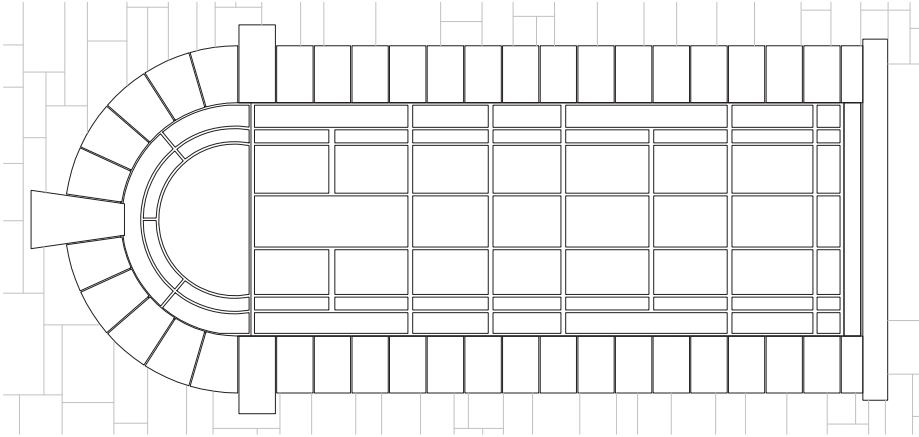
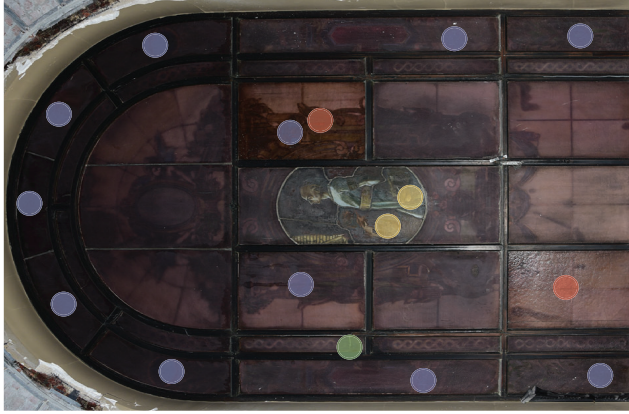
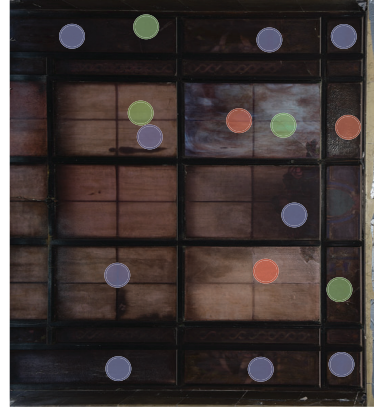
WINDOW 24 - BRONZE WITH STAINED GLASS

- Area of severe dirt and debris accretions. This accretion is hygroscopic, attracting water. Standing water adversely affects the lead comes, the framing, and in the long term, contributes to the corrosion of the glass.
- Area where the original glass is missing (interior plate) has been replaced with a poor color match.
- Area of broken glass.
- Area of paint loss.
