THE APTHORP APARTMENTS

2211 BROADWAY NEW YORK, NY 10021

PROPOSED SIDEWALK VAULT LIGHTS AND CONCRETE BENCH REMOVAL AT WEST 79TH STREET

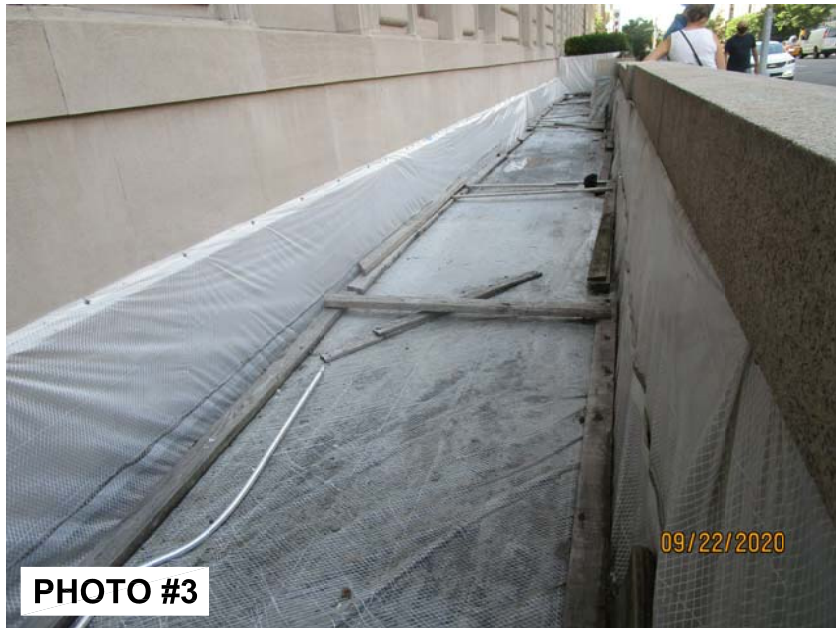
3 | VIEW OF THE TEMPORARY PROTECTION INSTALLED OVER AREAWAY WATERPROOFING
VIDARIS PHOTO, SEPTEMBER 2020

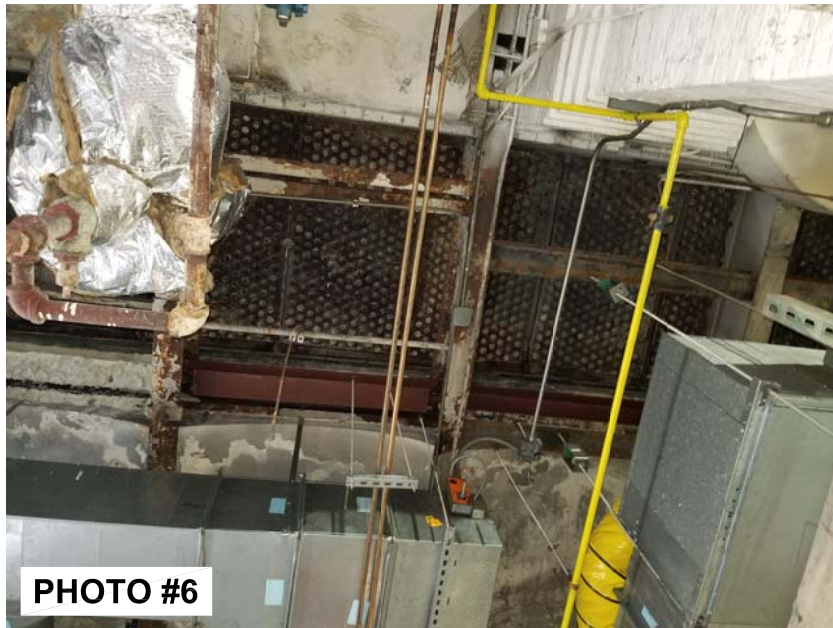
6 | VIEW OF THE CAST IRON GRATING WITH CONCRETE TOPPING BENEATH AREAWAY
VIDARIS PHOTO, DECEMBER 2018

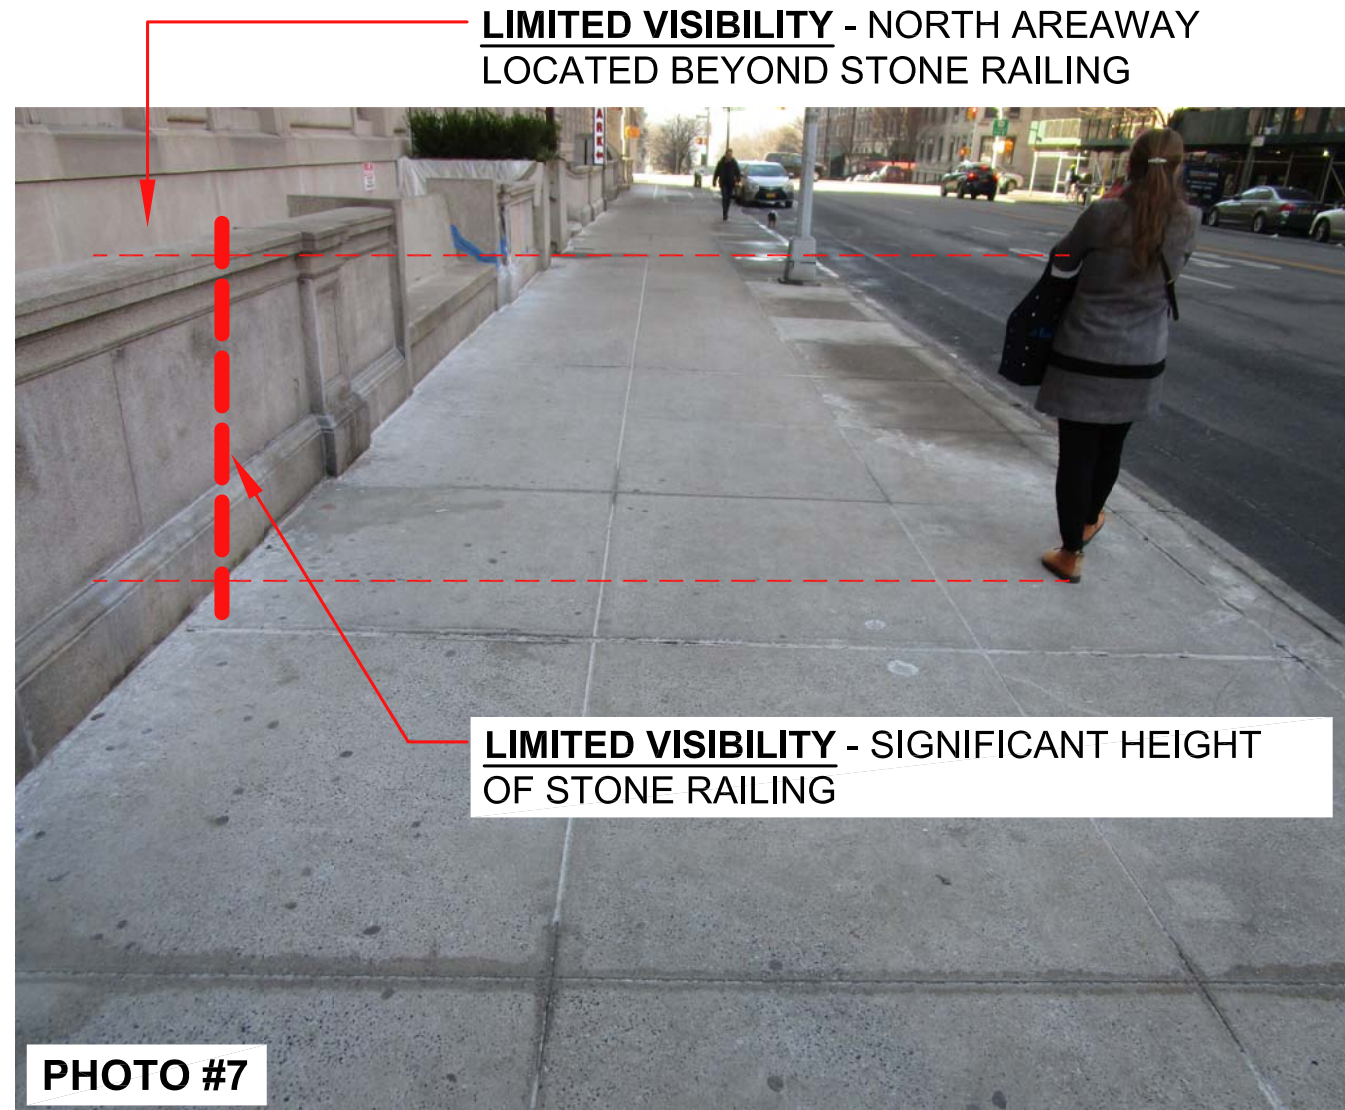
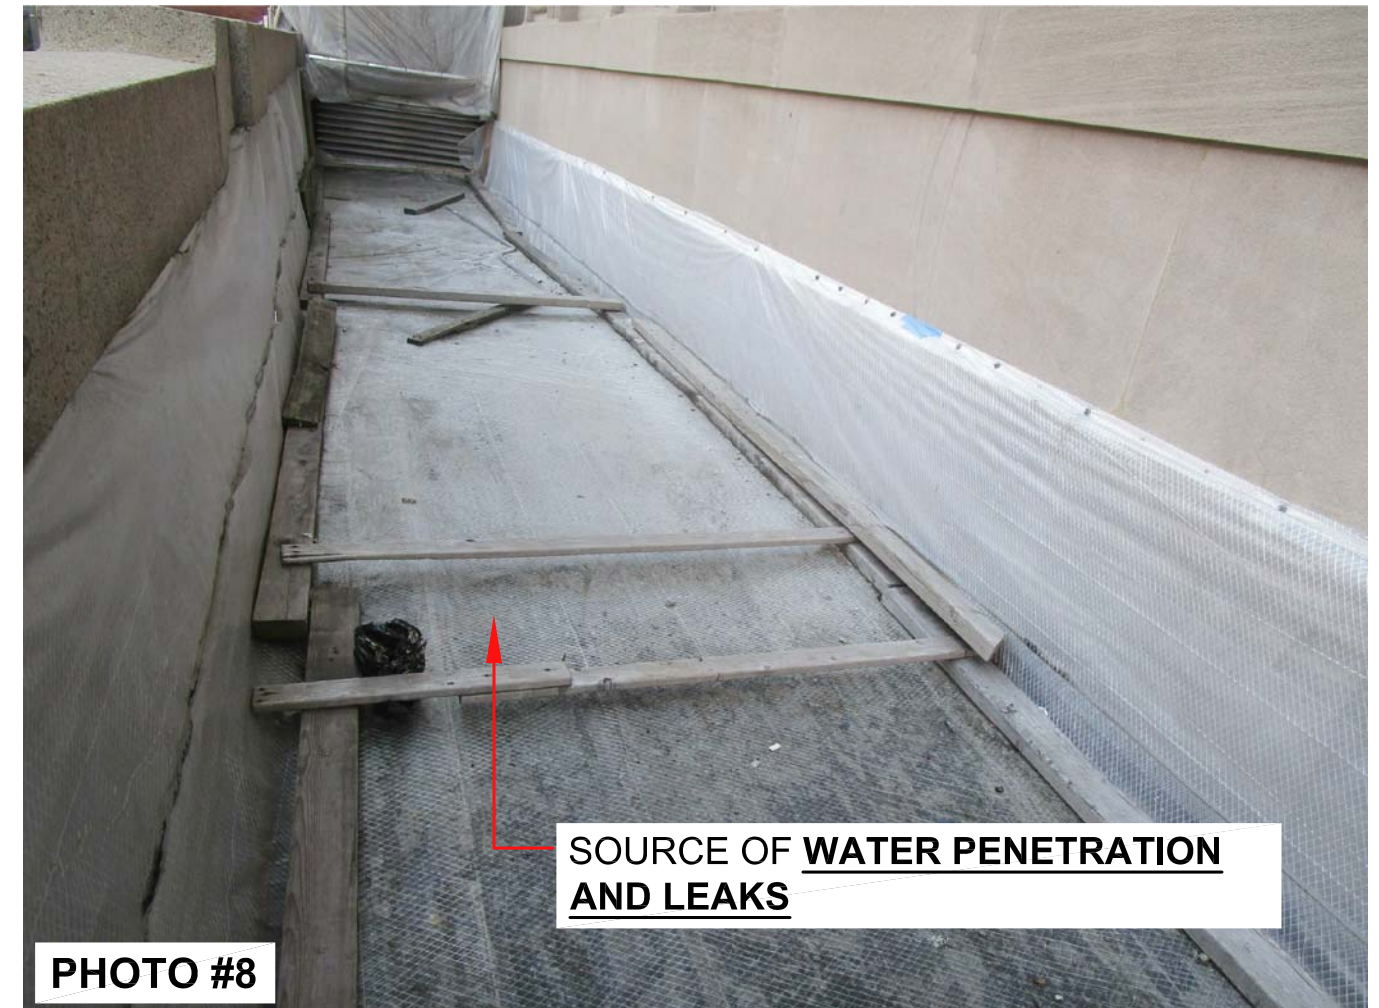
- HISTORIC CAST IRON VAULT LIGHTS IN THE AREAWAY ARE COVERED WITH CONCRETE TOPPING/ WATERPROOFING MEMBRANE AND WERE OBSERVED FROM THE UNOCCUPIED CELLAR LEVEL BELOW.
- THE AREAWAY VISIBILITY IS LIMITED FROM THE PUBLIC THOROUGHFARE DUE TO THE PRESENCE OF GRANITE RAILING SEPARATING THE AREAWAY FROM SIDEWALK.

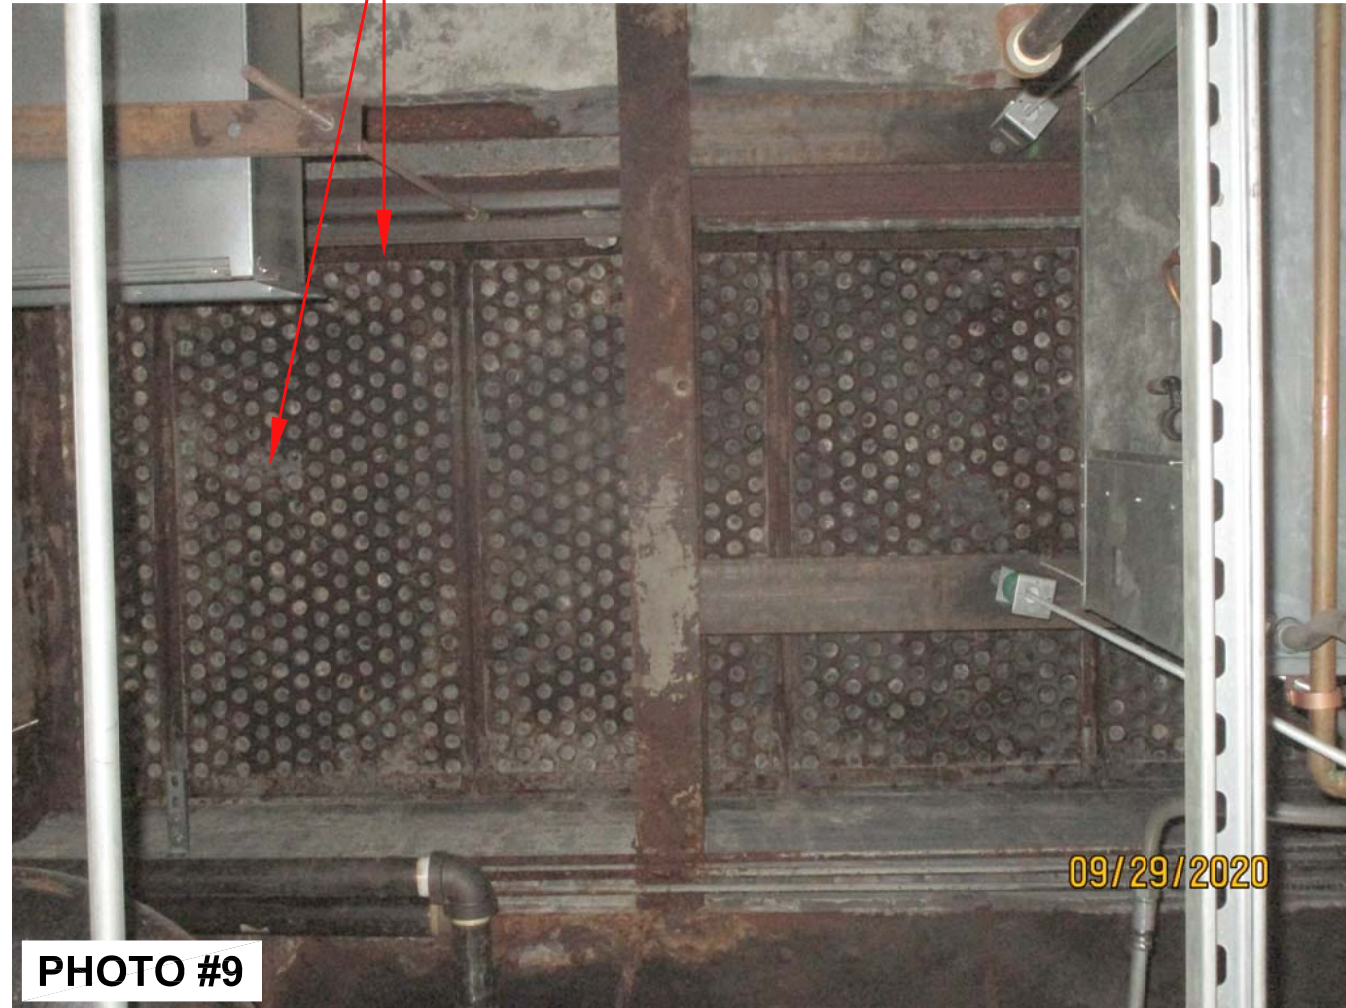
VISIBLE DETERIORATION AND CORROSION.
BROKEN/ MISSING GLASS LITES

- HISTORIC CAST IRON VAULT LIGHTS IN THE AREAWAY ARE COVERED WITH CONCRETE TOPPING/ WATERPROOFING MEMBRANE AND WERE OBSERVED FROM THE UNOCCUPIED CELLAR LEVEL BELOW.
- DELETERIOUS CONDITIONS OF CAST IRON VAULT LIGHTS, WATER PENETRATION RESULTING IN LEAKS AND LIMITED VISIBILITY OF THE AREAWAY FROM THE PUBLIC THOROUGHFARE WERE THE THREE MAIN OBJECTIVES FOR THE PROPOSED WORK ESTABLISHMENT.

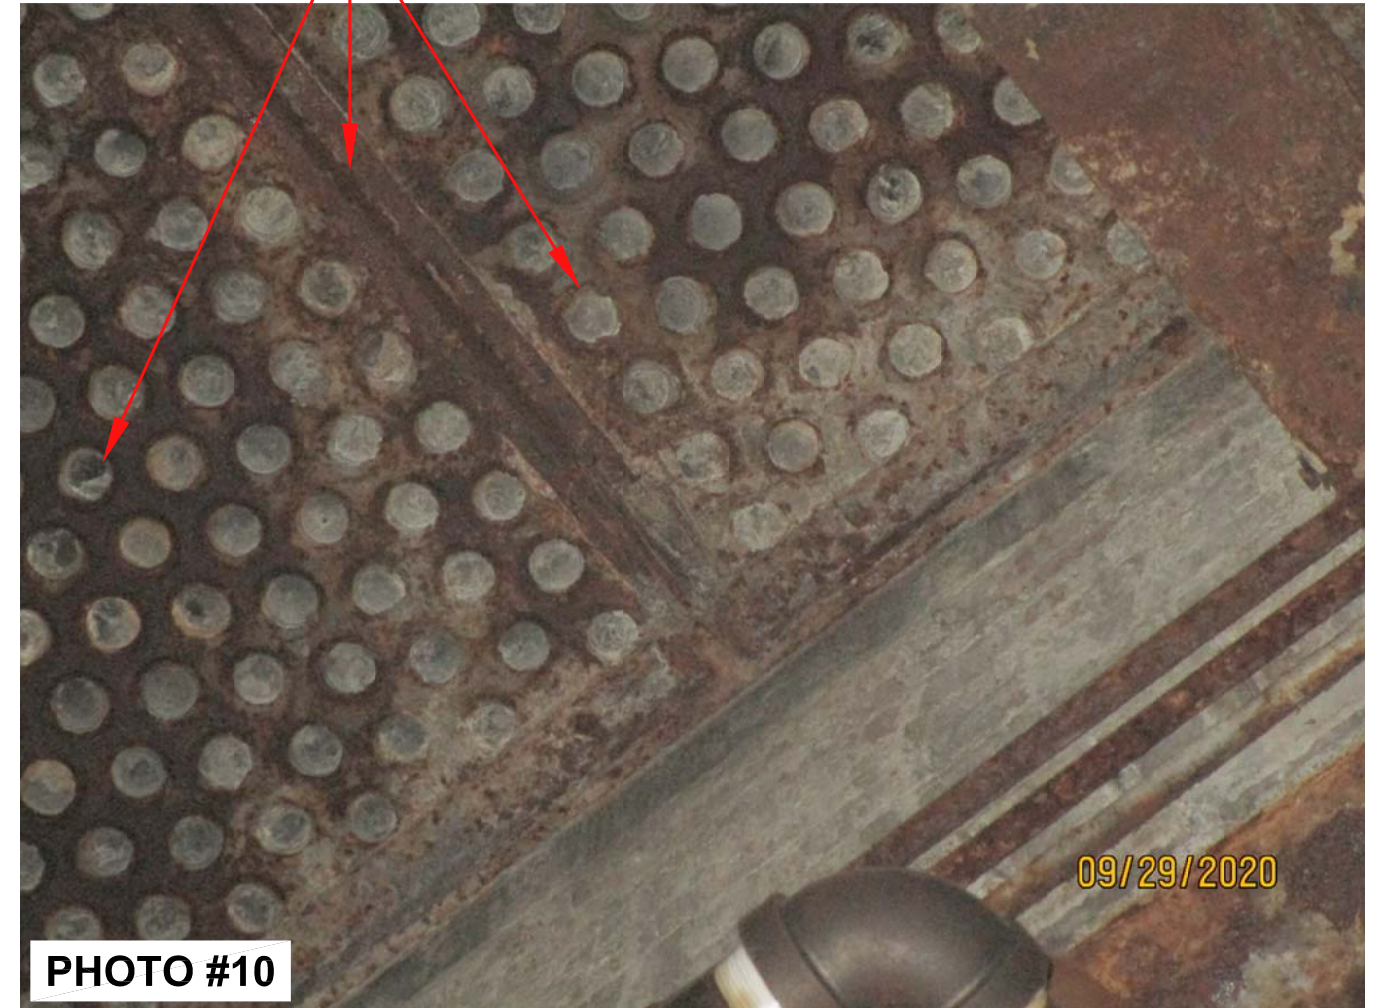
VISIBLE DETERIORATION AND CORROSION
BROKEN/ MISSING GLASS LITES

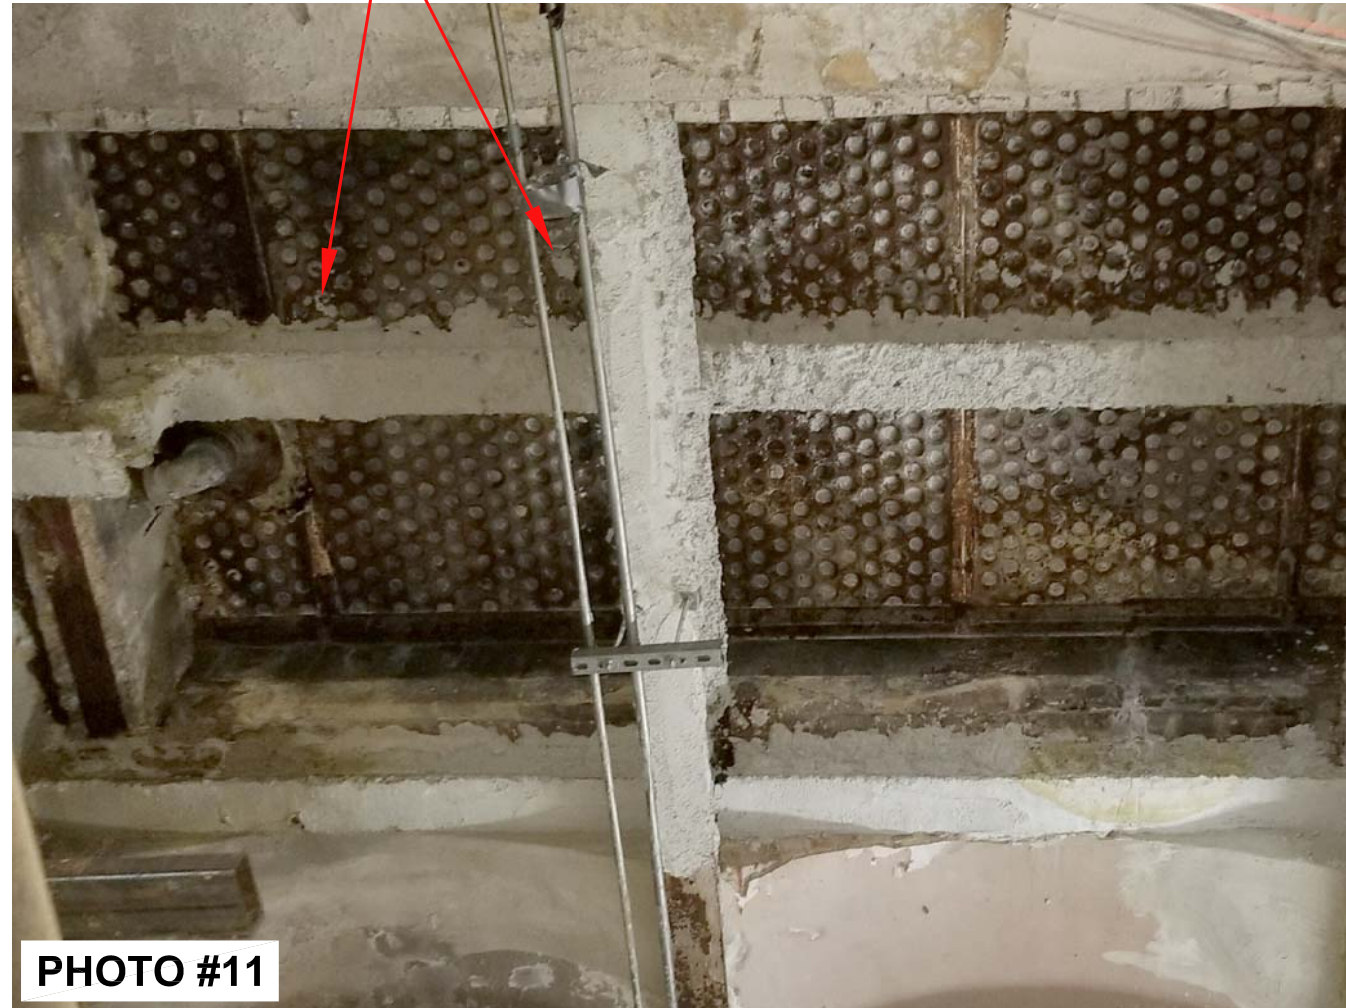
VISIBLE SECTION LOSS, DETERIORATION AND
CORROSION. BROKEN/ MISSING GLASS LITES

- HISTORIC CAST IRON VAULT LIGHTS IN THE AREAWAY ARE COVERED WITH CONCRETE TOPPING/ WATERPROOFING MEMBRANE AND WERE OBSERVED FROM THE UNOCCUPIED CELLAR LEVEL BELOW.
- DELETERIOUS CONDITIONS OF CAST IRON VAULT LIGHTS, WATER PENETRATION RESULTING IN LEAKS AND LIMITED VISIBILITY OF THE AREAWAY FROM THE PUBLIC THOROUGHFARE WERE THE THREE MAIN OBJECTIVES FOR THE PROPOSED WORK ESTABLISHMENT.

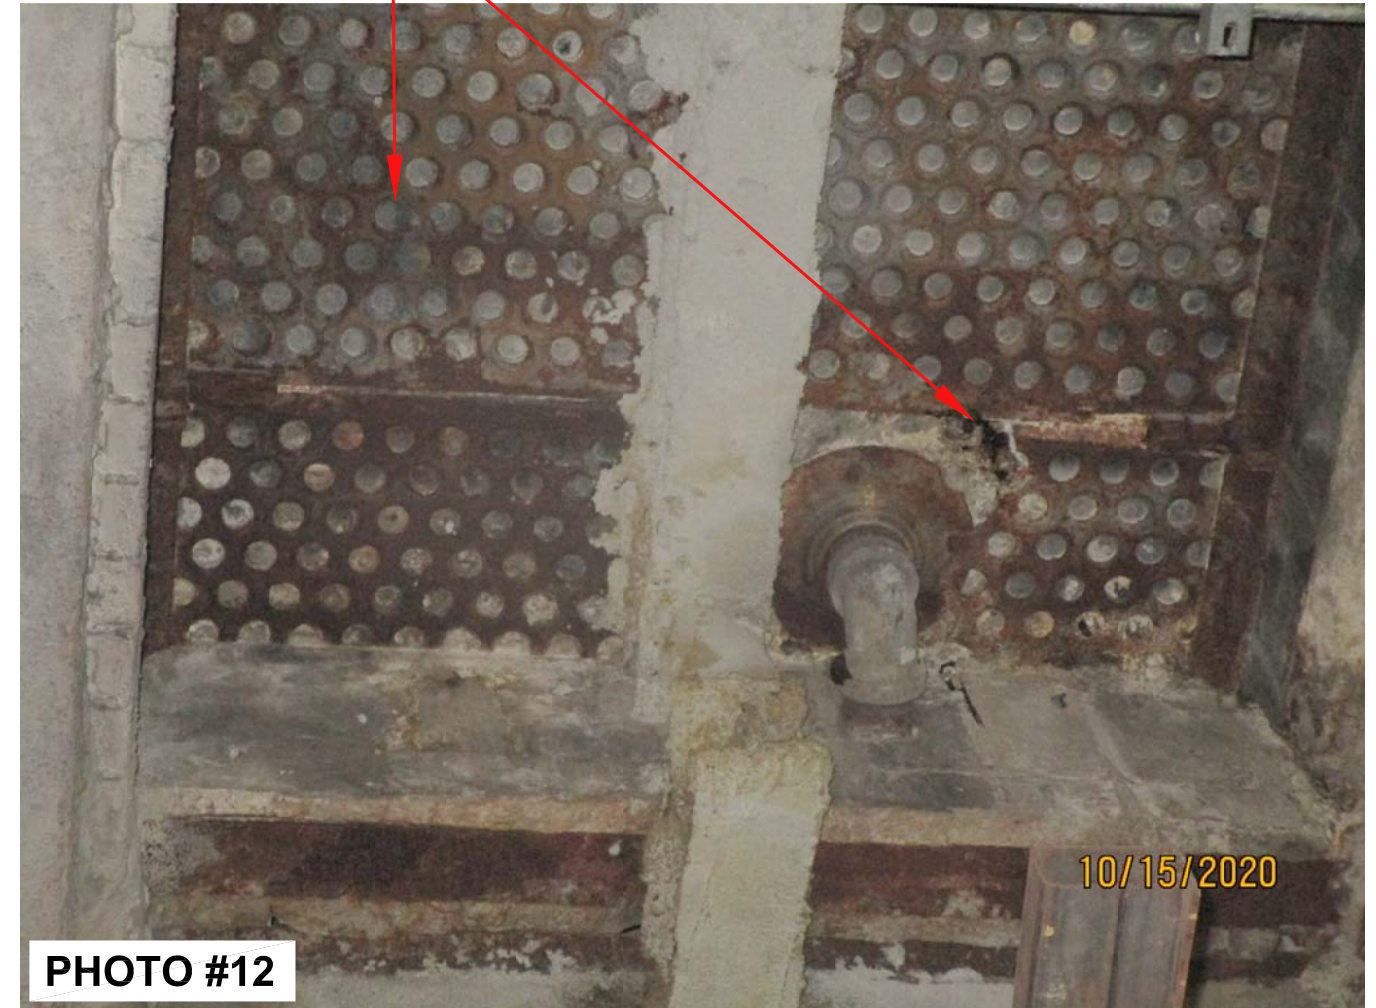
VISIBLE SECTION LOSS, DETERIORATION AND
CORROSION. BROKEN/ MISSING GLASS LITES

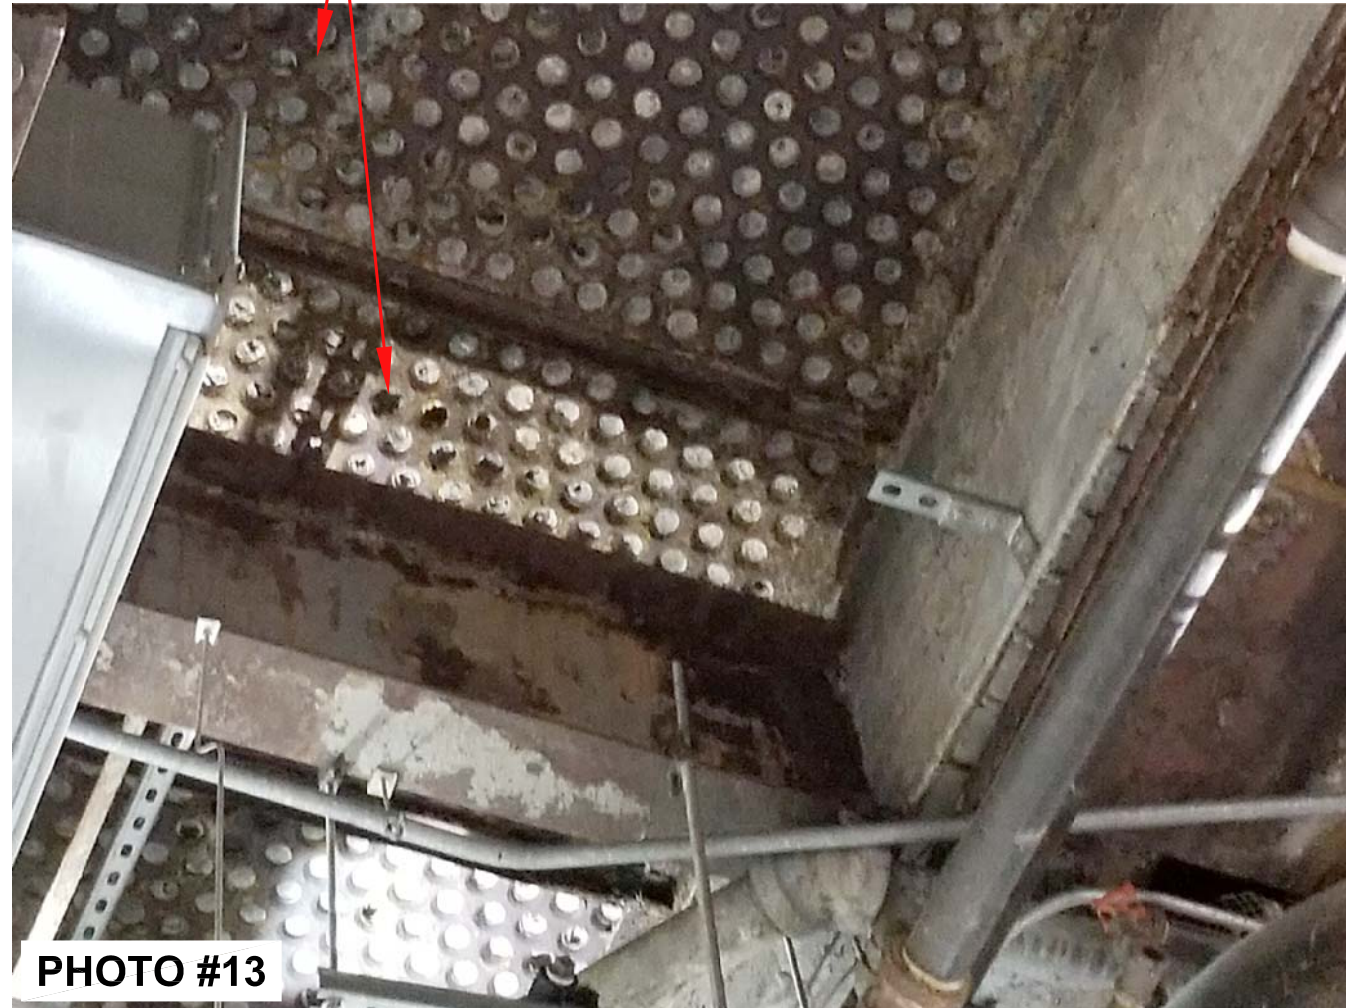
VISIBLE **DETERIORATION** AND **CORROSION**.
BROKEN/ MISSING GLASS LITES

- HISTORIC CAST IRON VAULT LIGHTS IN THE AREAWAY ARE COVERED WITH CONCRETE TOPPING/ WATERPROOFING MEMBRANE AND WERE OBSERVED FROM THE UNOCCUPIED CELLAR LEVEL BELOW.
- DELETERIOUS CONDITIONS OF CAST IRON VAULT LIGHTS, WATER PENETRATION RESULTING IN LEAKS AND LIMITED VISIBILITY OF THE AREAWAY FROM THE PUBLIC THOROUGHFARE WERE THE THREE MAIN OBJECTIVES FOR THE PROPOSED WORK ESTABLISHMENT.

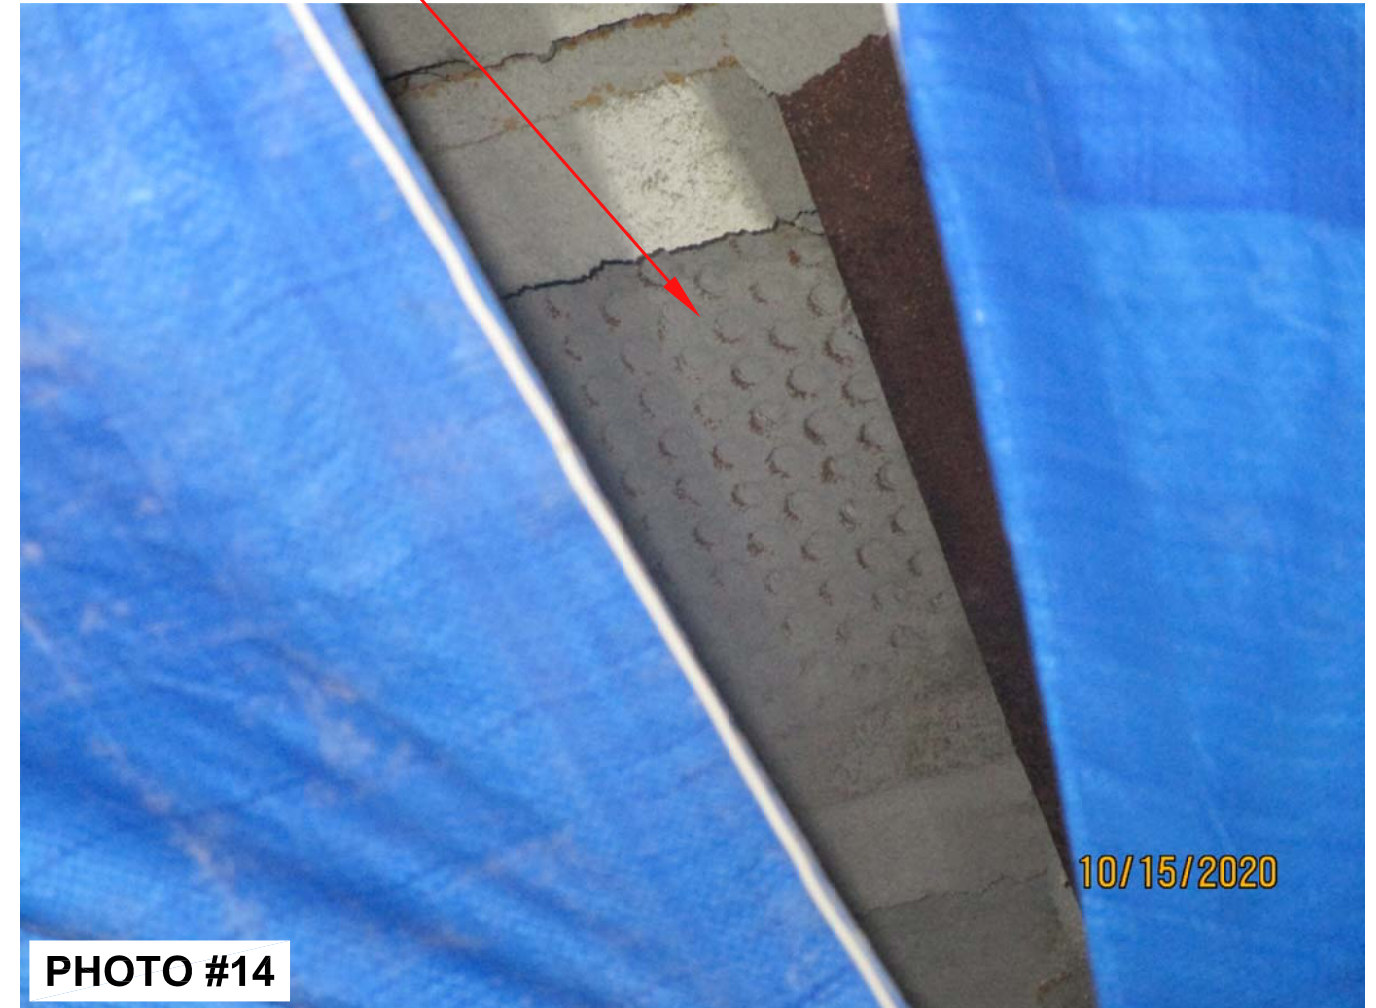
VAULT LIGHTS ABOVE TANK OIL AREA
WITH THE FIREPROOFING PRESENT
AT THE UNDERSIDE

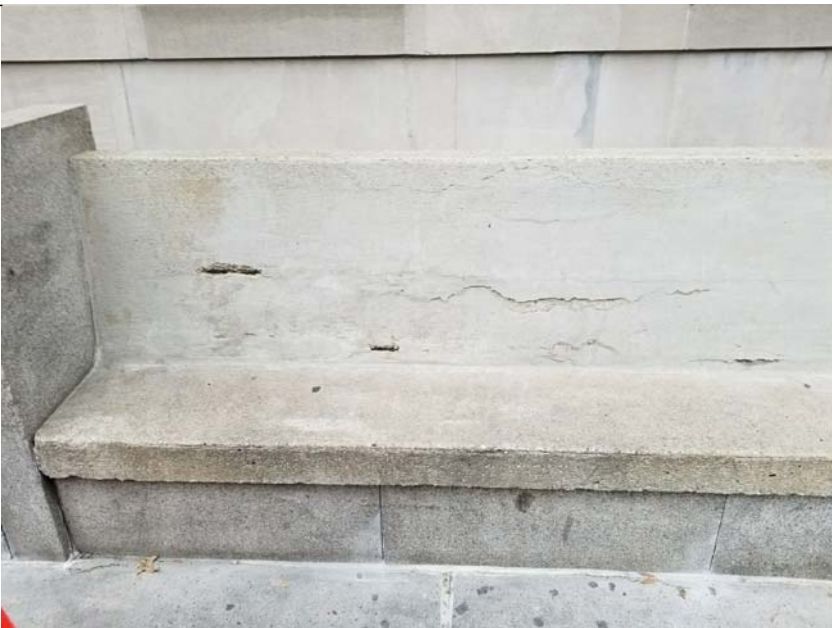
4 | CLOSE-UP VIEW OF EXISTING CONCRETE BENCH
TO BE REPLACED WITH GRANITE RAILING

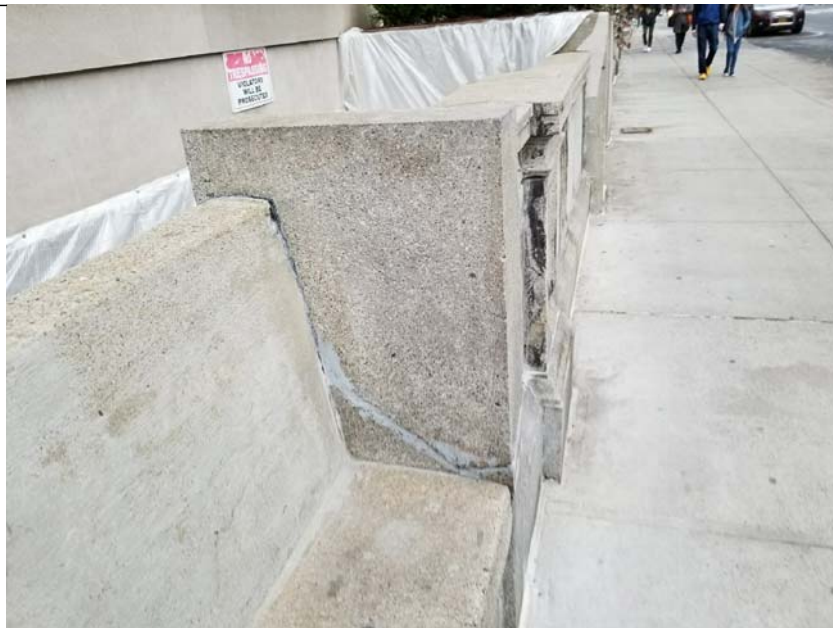
5 | CLOSE-UP VIEW OF EXISTING CONCRETE BENCH
TO BE REPLACED WITH GRANITE RAILING
