Preservation Department – Item 4, LPC-21-01073

**2211 Broadway – The Apthorp Apartments,
Borough of Manhattan**

PROPOSED SIDEWALK VAULT LIGHTS REMOVAL AT WEST 79TH STREET

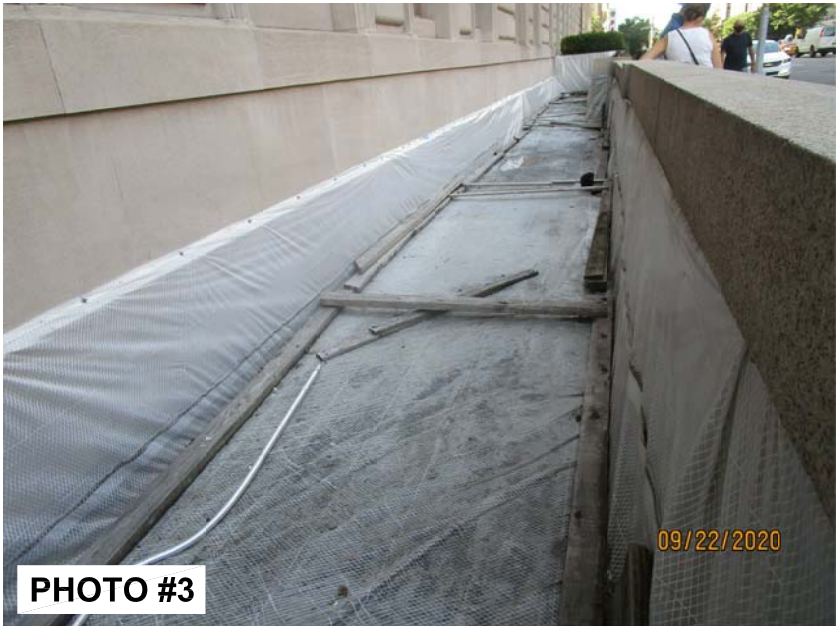
3 | VIEW OF THE TEMPORARY PROTECTION INSTALLED OVER AREAWAY WATERPROOFING
VIDARIS PHOTO, SEPTEMBER 2020

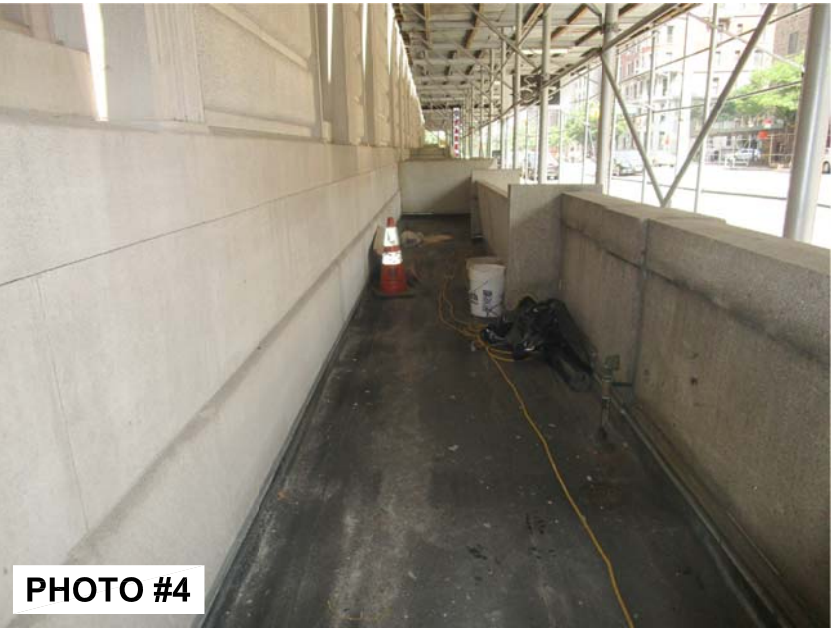
PHOTO #4

4 | VIEW OF AREAWAY WITH WATERPROOFING
VIDARIS PHOTO, JULY 2018

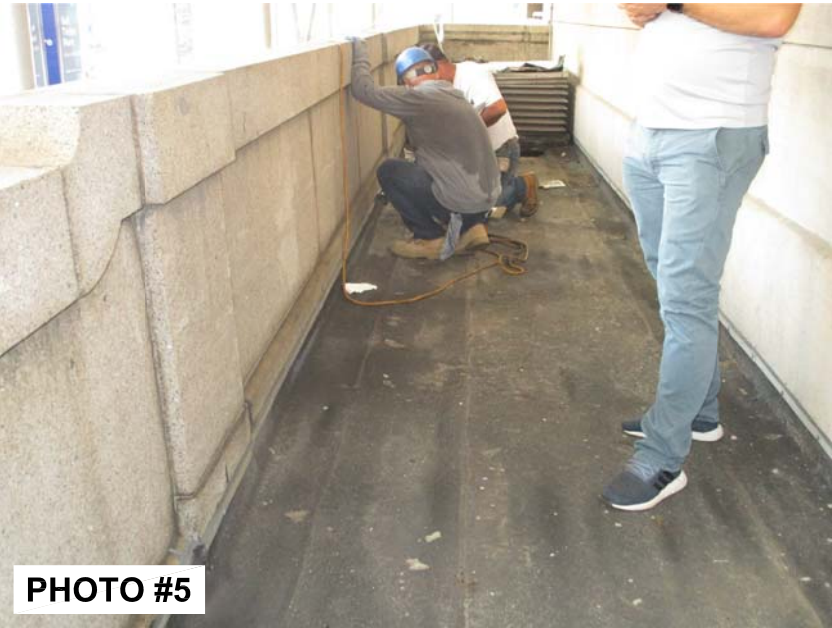
PHOTO #5

5 | VIEW OF AREAWAY WITH WATERPROOFING
VIDARIS PHOTO, JULY 2018

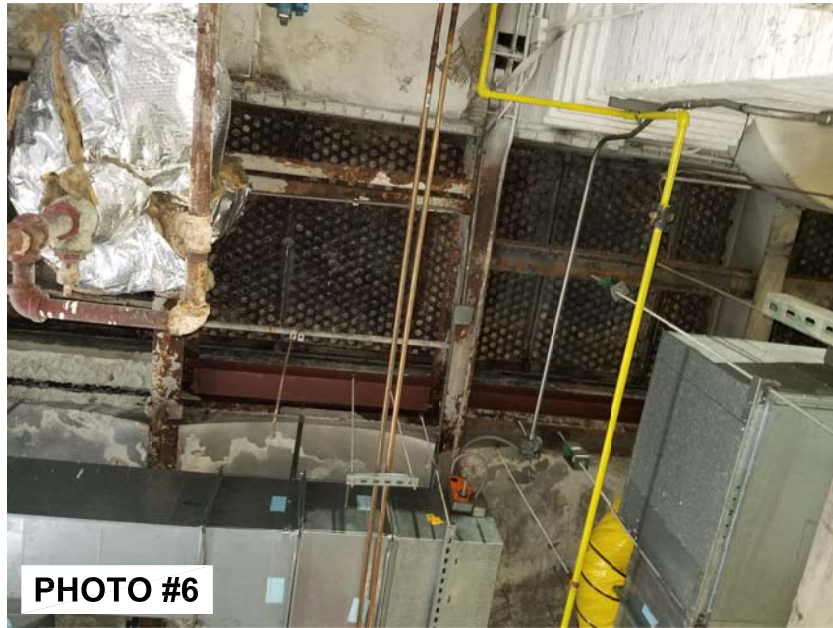
PHOTO #6

6 | VIEW OF THE CAST IRON GRATING WITH CONCRETE TOPPING BENEATH AREAWAY
VIDARIS PHOTO, DECEMBER 2018

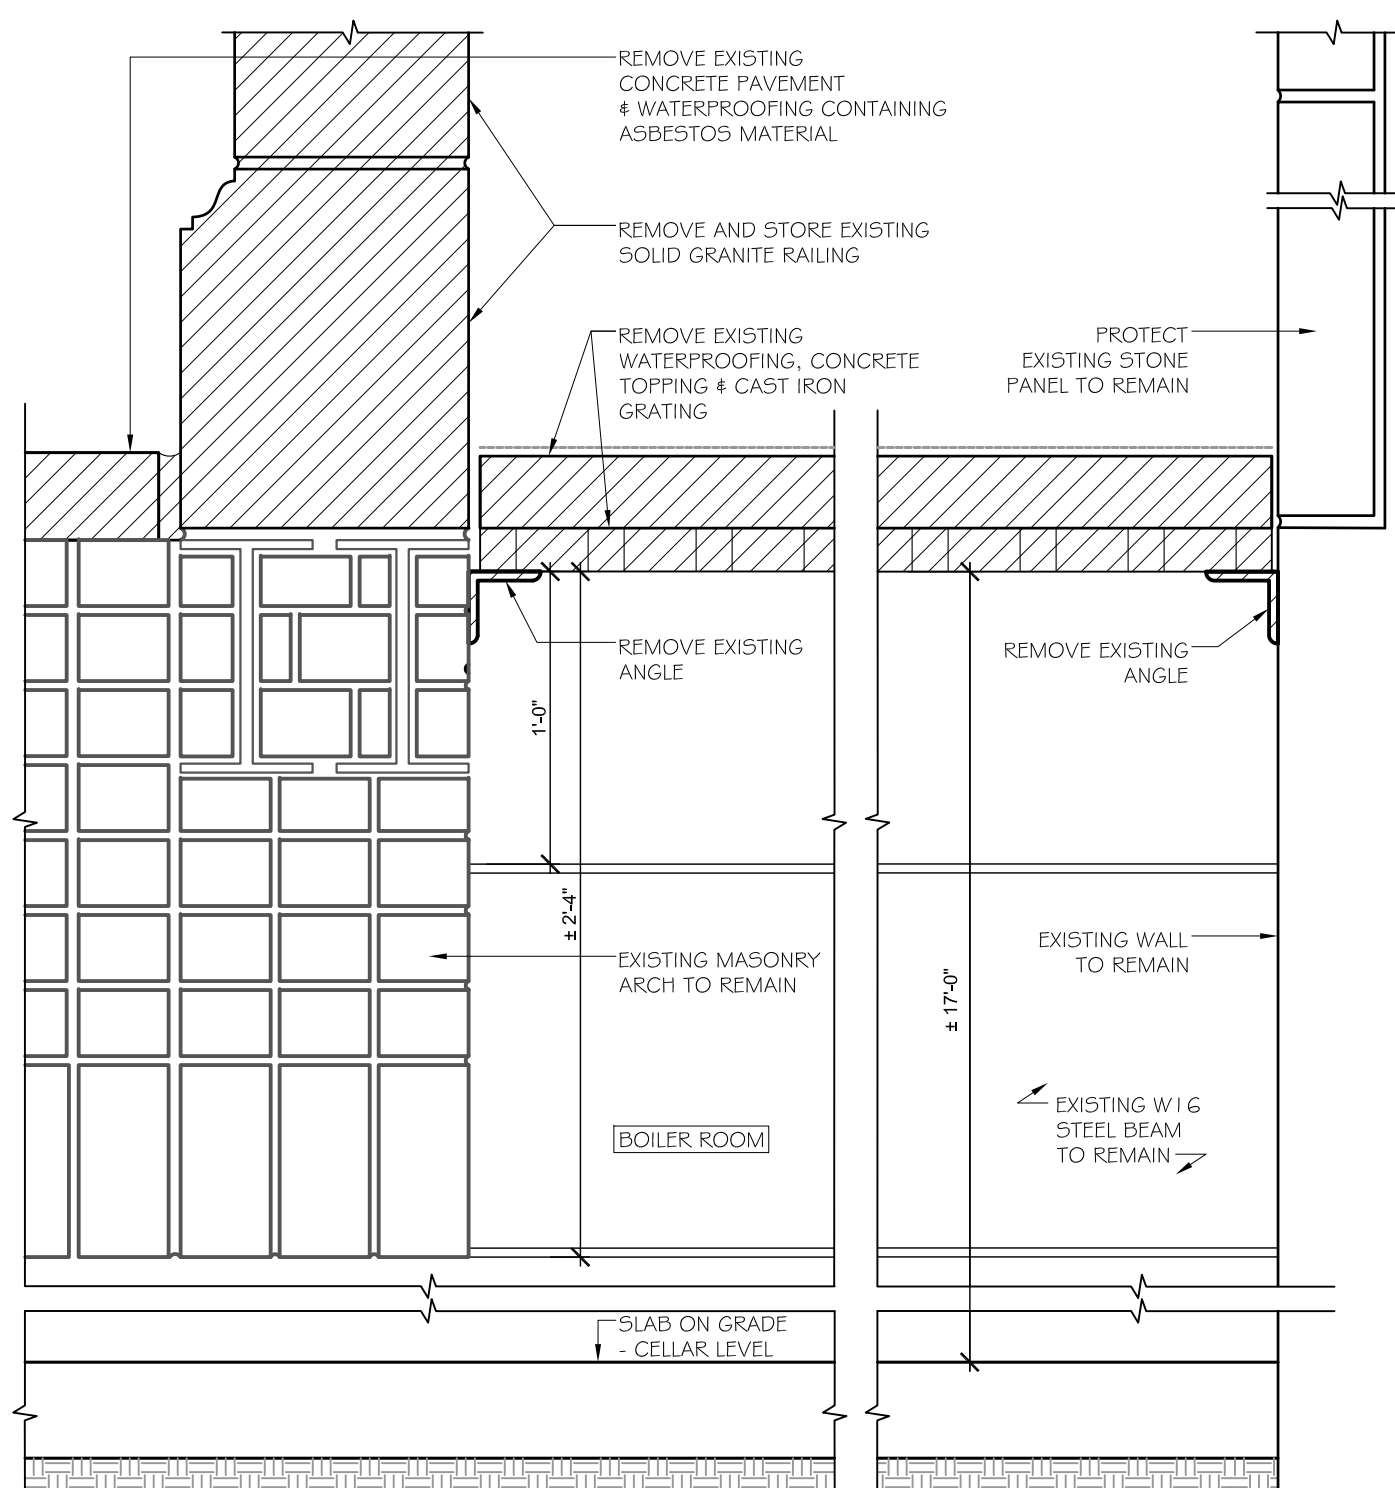
1 | EXISTING SECTION THROUGH NORTH AREAWAY EASTERN SIDE
SCALE: 1-1/2" = 1'-0"

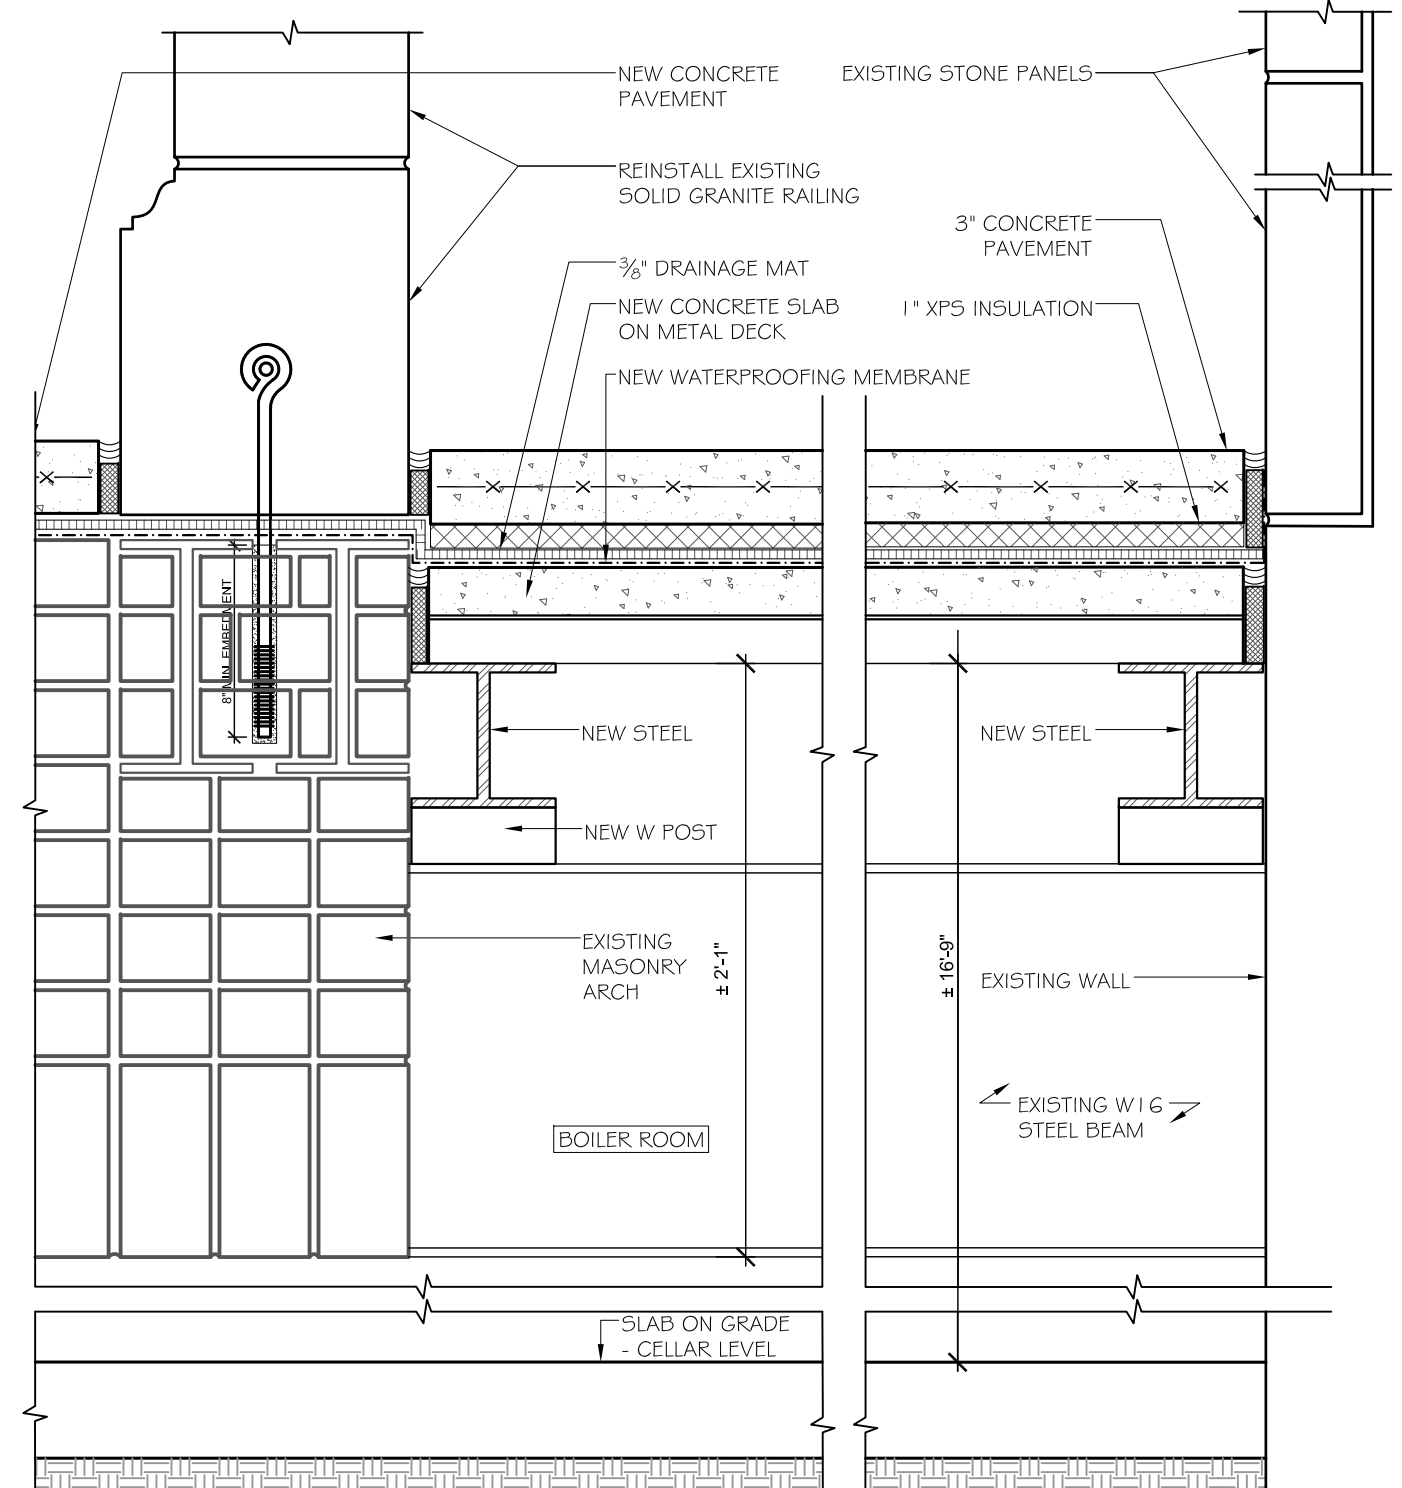
2 | PROPOSED SECTION THROUGH NORTH AREAWAY EASTERN SIDE
SCALE: 1-1/2" = 1'-0"

- WE HAVE PROPOSED THE REMOVAL OF EXISTING WATERPROOFING, CONCRETE AND CAST IRON VAULT LIGHTS WITH THE SUBSEQUENT POURING OF NEW CONCRETE SLAB ON METAL DECK, NEW WATERPROOFING MEMBRANE, DRAINAGE MAT AND CONCRETE PAVEMENT AT THE TOP.

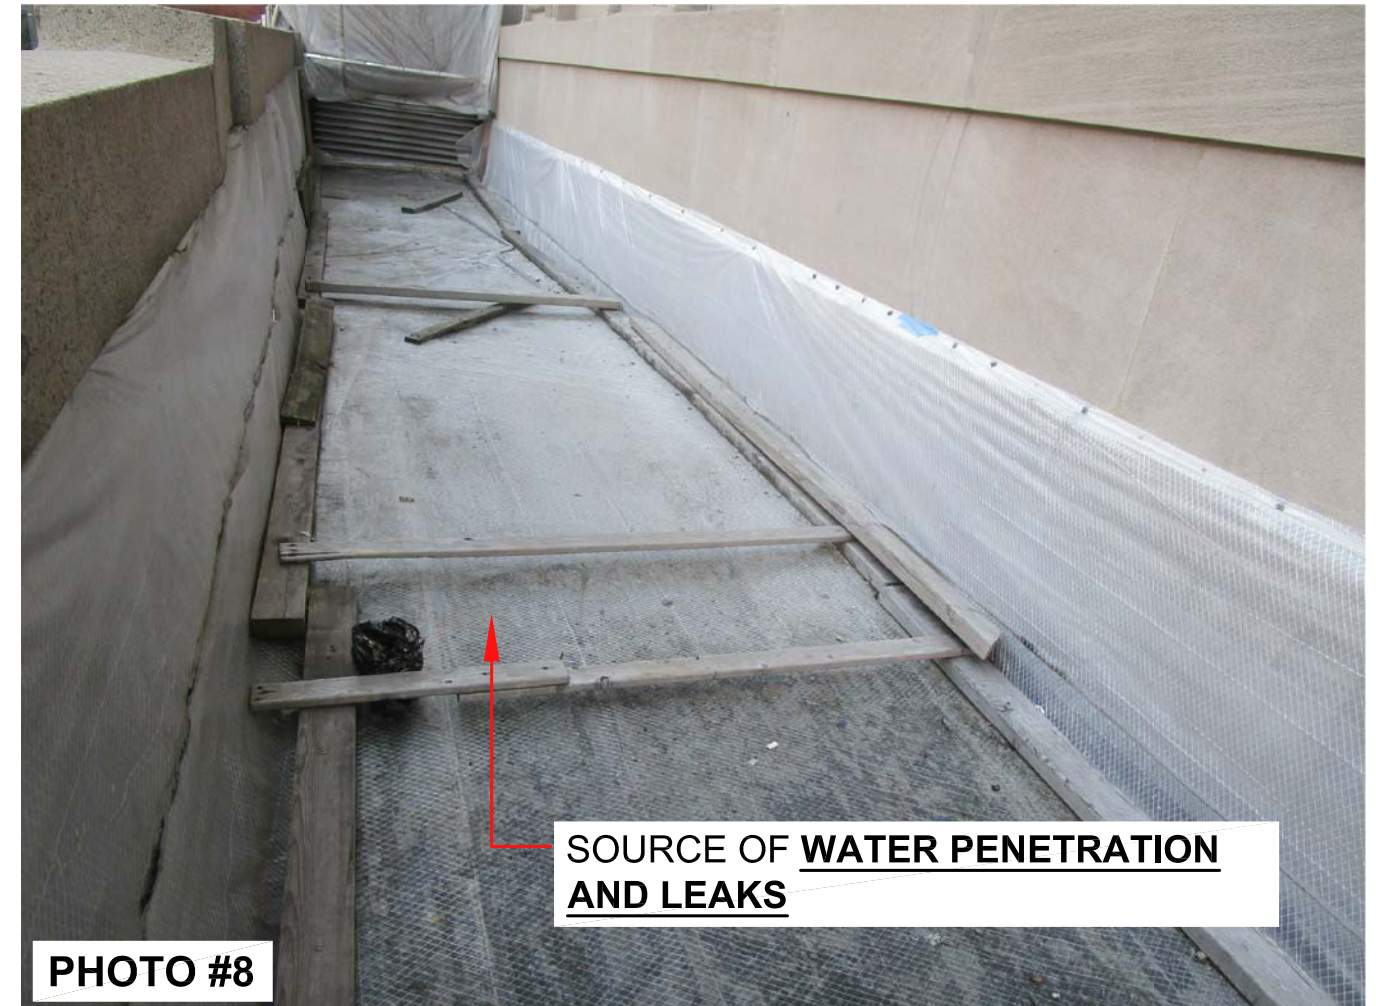
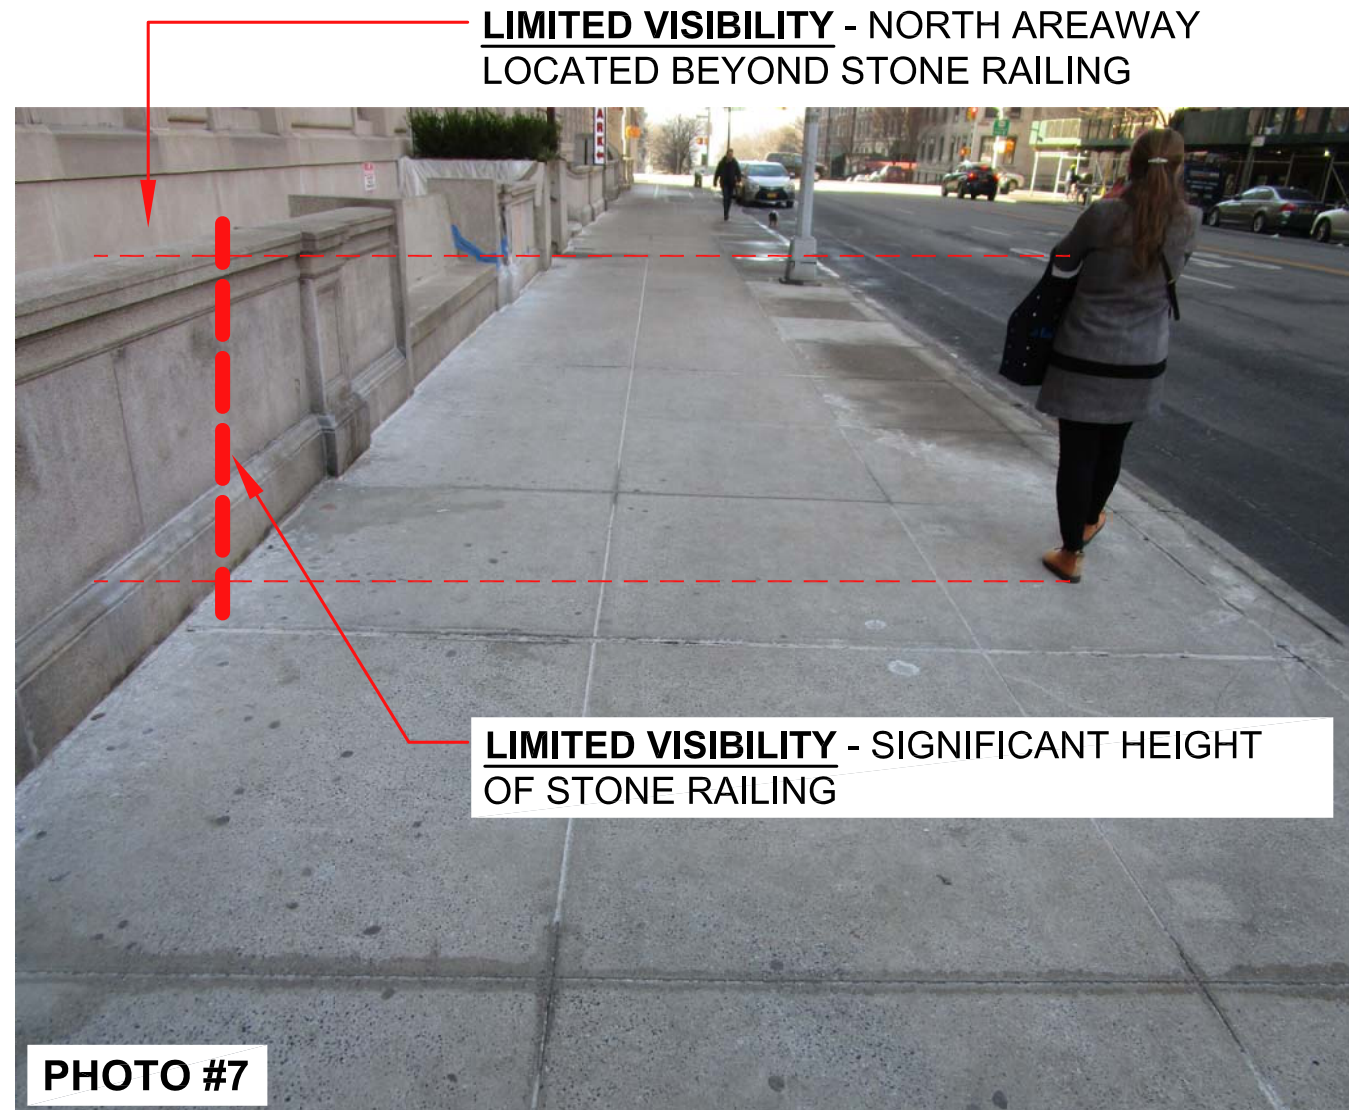
- HISTORIC CAST IRON VAULT LIGHTS IN THE AREAWAY ARE COVERED WITH CONCRETE TOPPING/ WATERPROOFING MEMBRANE AND WERE OBSERVED FROM THE UNOCCUPIED CELLAR LEVEL BELOW.
- THE AREAWAY VISIBILITY IS LIMITED FROM THE PUBLIC THOROUGHFARE DUE TO THE PRESENCE OF GRANITE RAILING SEPARATING THE AREAWAY FROM SIDEWALK.

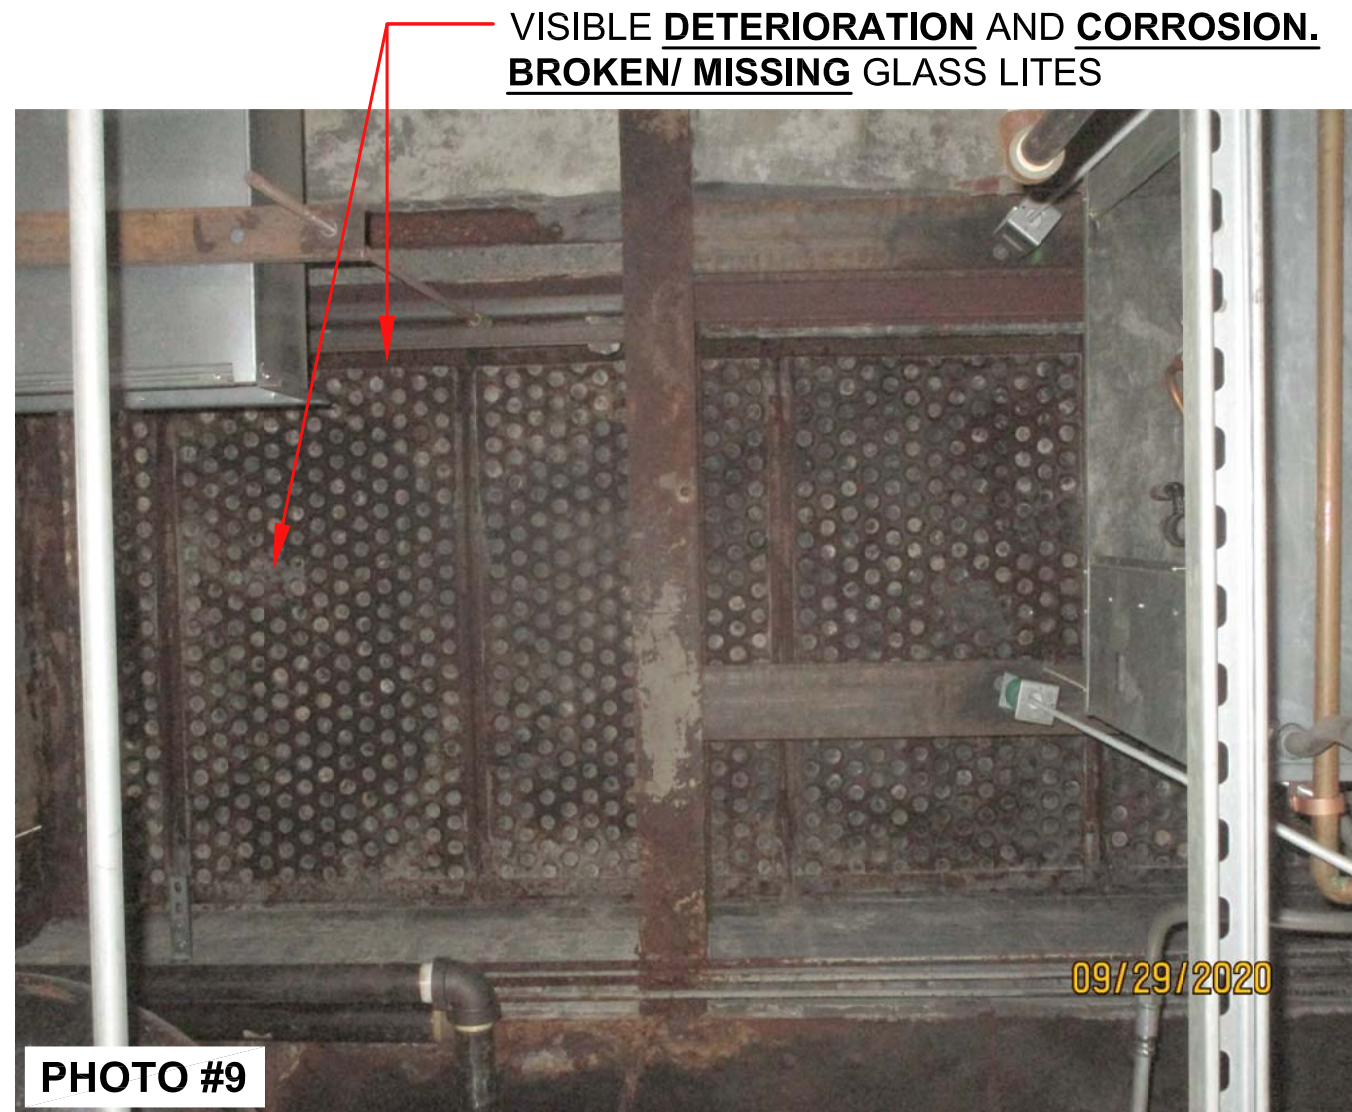
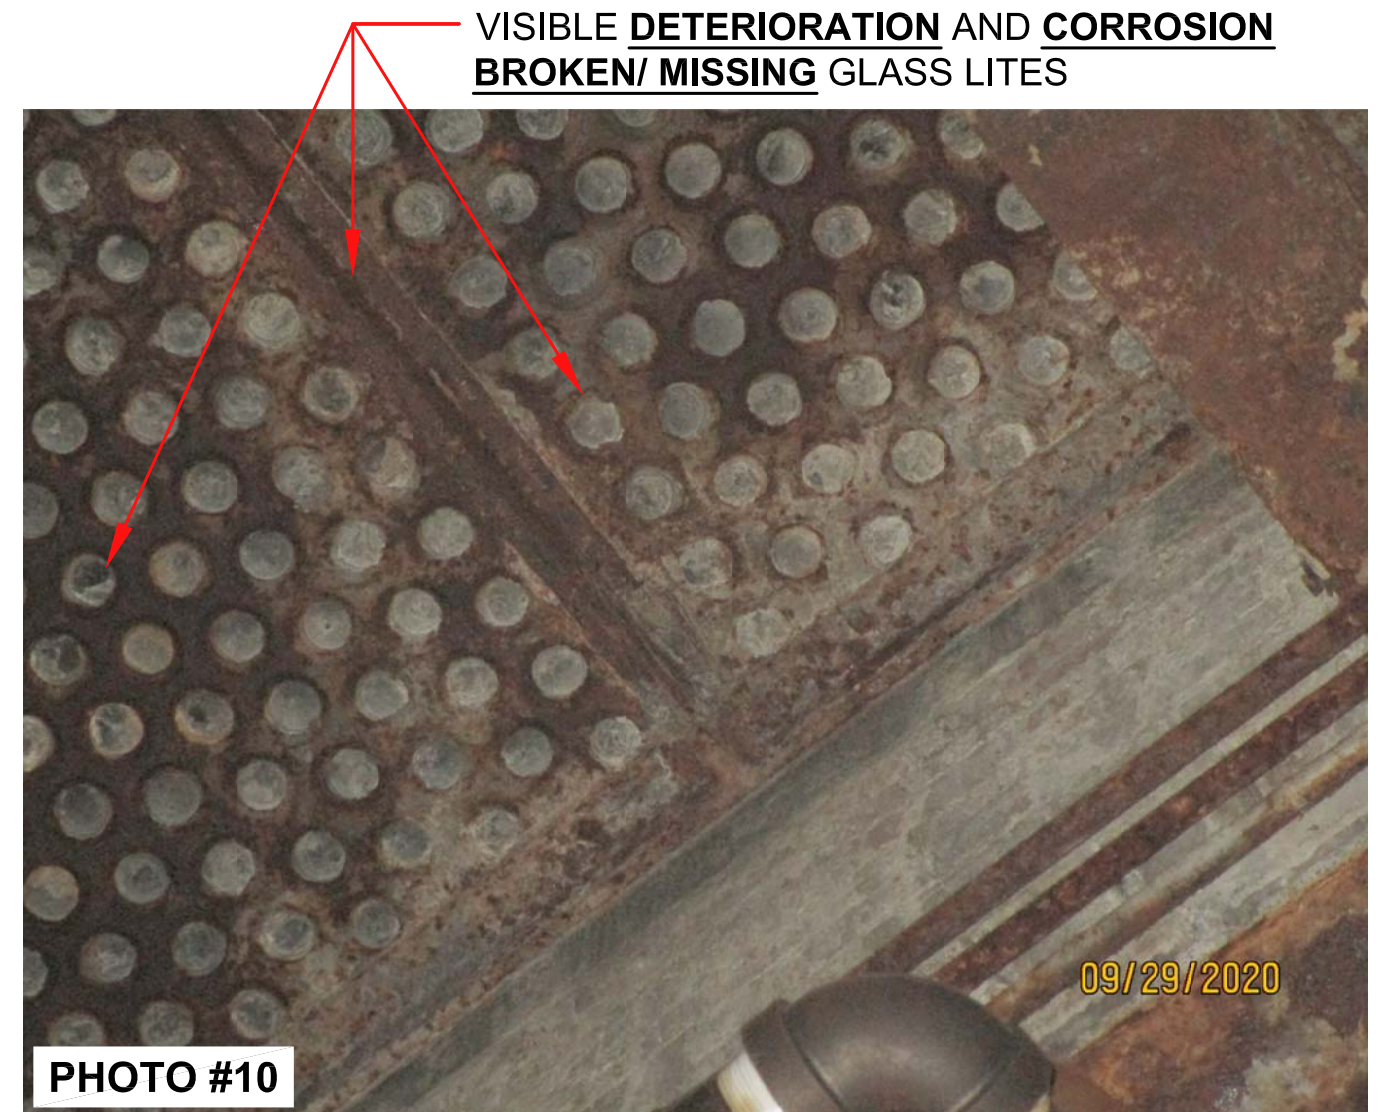
- HISTORIC CAST IRON VAULT LIGHTS IN THE AREAWAY ARE COVERED WITH CONCRETE TOPPING/ WATERPROOFING MEMBRANE AND WERE OBSERVED FROM THE UNOCCUPIED CELLAR LEVEL BELOW.
- DELETERIOUS CONDITIONS OF CAST IRON VAULT LIGHTS, WATER PENETRATION RESULTING IN LEAKS AND LIMITED VISIBILITY OF THE AREAWAY FROM THE PUBLIC THOROUGHFARE WERE THE THREE MAIN OBJECTIVES FOR THE PROPOSED WORK ESTABLISHMENT.

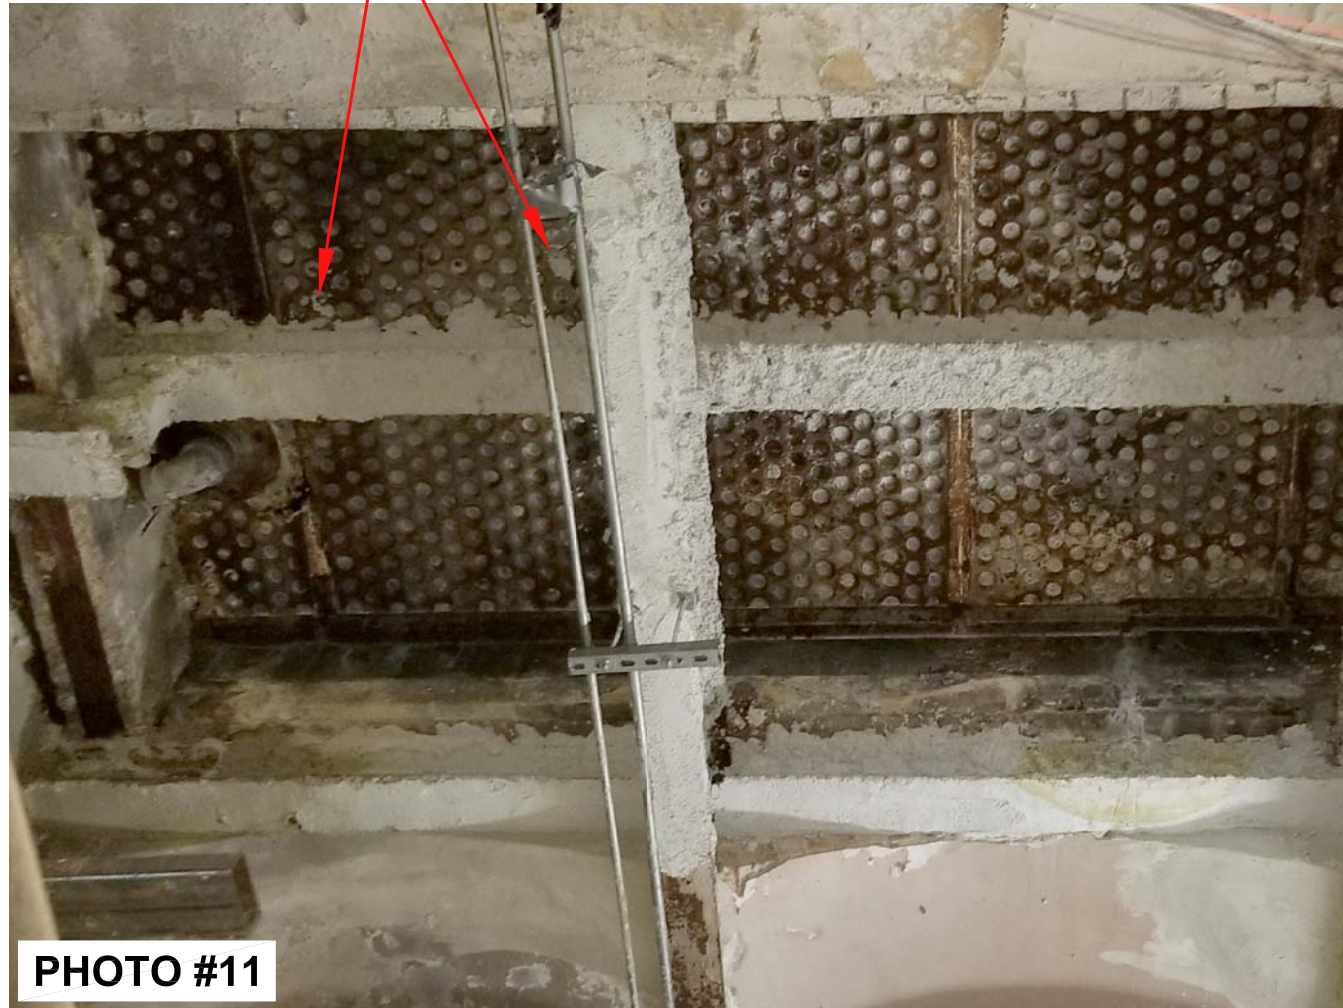
VISIBLE SECTION LOSS, DETERIORATION AND CORROSION. BROKEN/ MISSING GLASS LITES

- HISTORIC CAST IRON VAULT LIGHTS IN THE AREAWAY ARE COVERED WITH CONCRETE TOPPING/ WATERPROOFING MEMBRANE AND WERE OBSERVED FROM THE UNOCCUPIED CELLAR LEVEL BELOW.
- DELETERIOUS CONDITIONS OF CAST IRON VAULT LIGHTS, WATER PENETRATION RESULTING IN LEAKS AND LIMITED VISIBILITY OF THE AREAWAY FROM THE PUBLIC THOROUGHFARE WERE THE THREE MAIN OBJECTIVES FOR THE PROPOSED WORK ESTABLISHMENT.

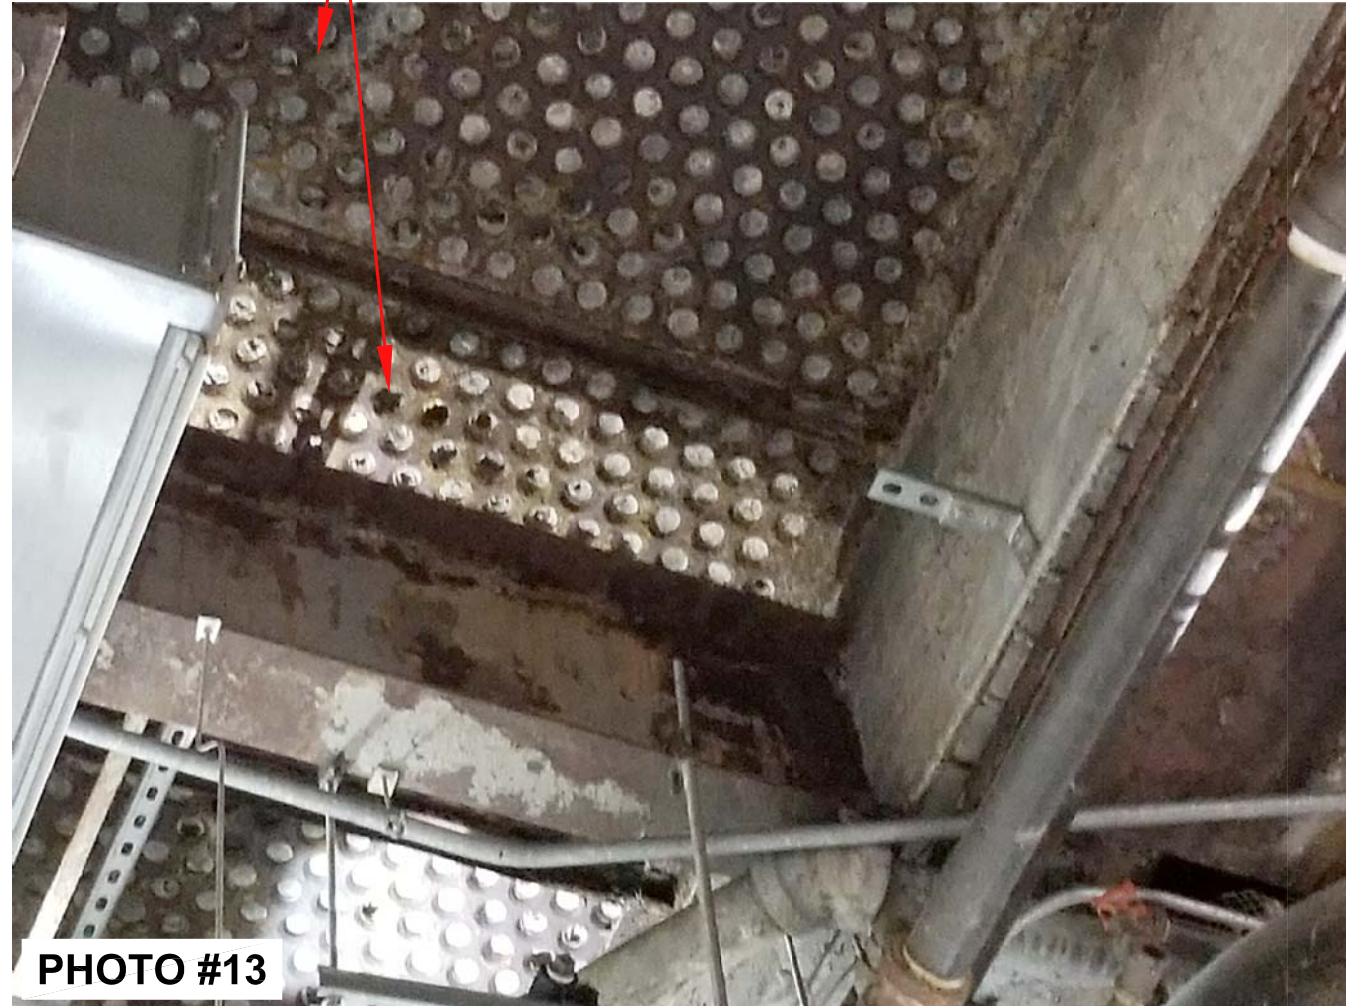
VISIBLE **DETERIORATION** AND **CORROSION**.
BROKEN/ MISSING GLASS LITES

- HISTORIC CAST IRON VAULT LIGHTS IN THE AREAWAY ARE COVERED WITH CONCRETE TOPPING/ WATERPROOFING MEMBRANE AND WERE OBSERVED FROM THE UNOCCUPIED CELLAR LEVEL BELOW.
- DELETERIOUS CONDITIONS OF CAST IRON VAULT LIGHTS, WATER PENETRATION RESULTING IN LEAKS AND LIMITED VISIBILITY OF THE AREAWAY FROM THE PUBLIC THOROUGHFARE WERE THE THREE MAIN OBJECTIVES FOR THE PROPOSED WORK ESTABLISHMENT.

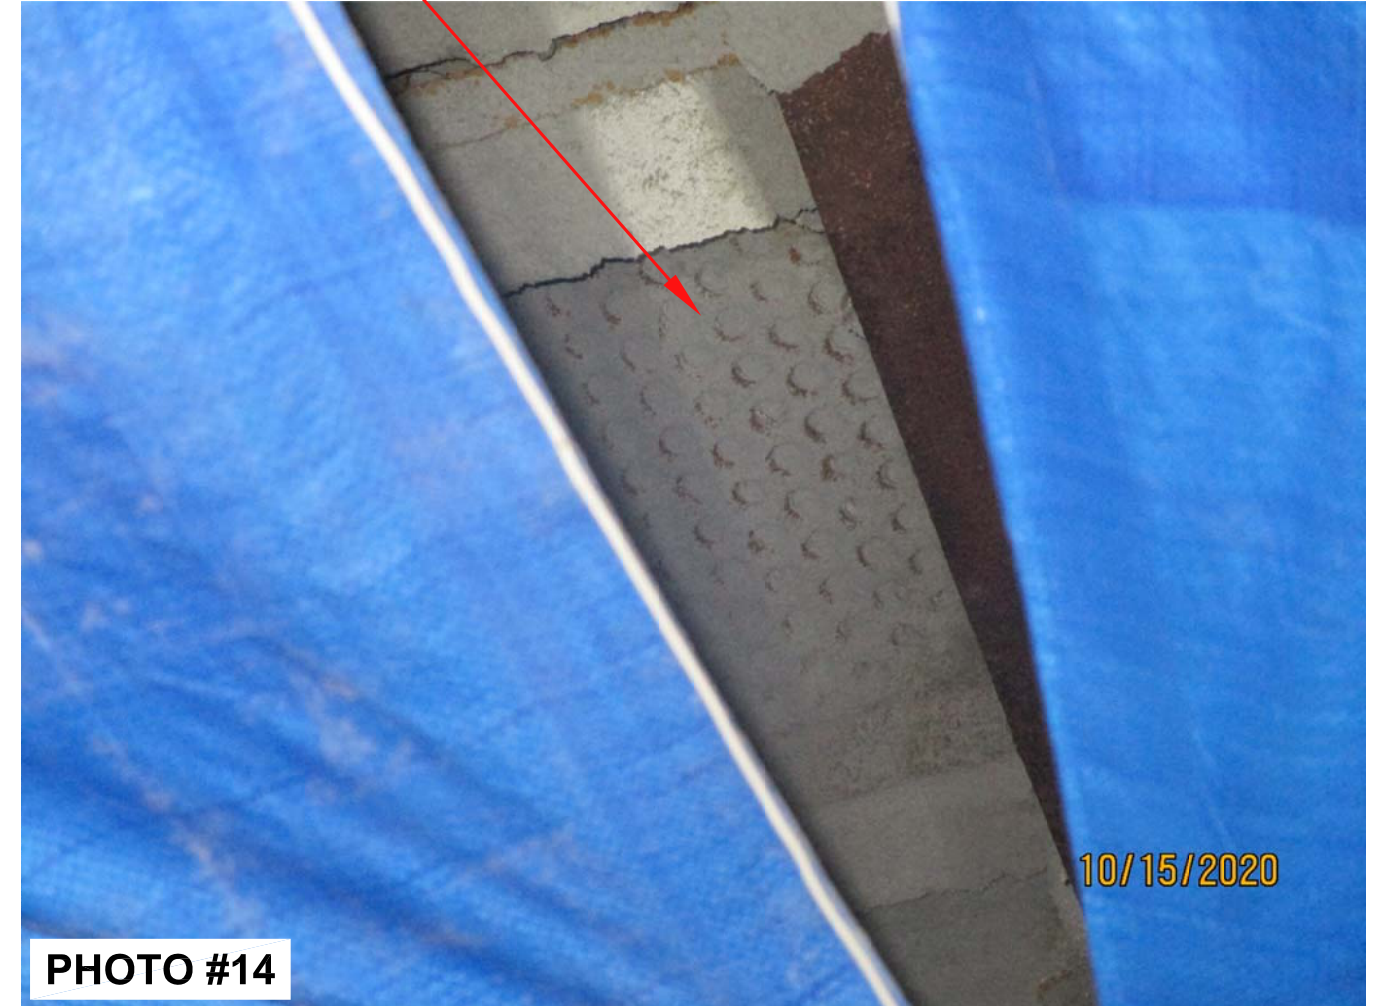
VAULT LIGHTS ABOVE TANK OIL AREA
WITH THE FIREPROOFING PRESENT
AT THE UNDERSIDE

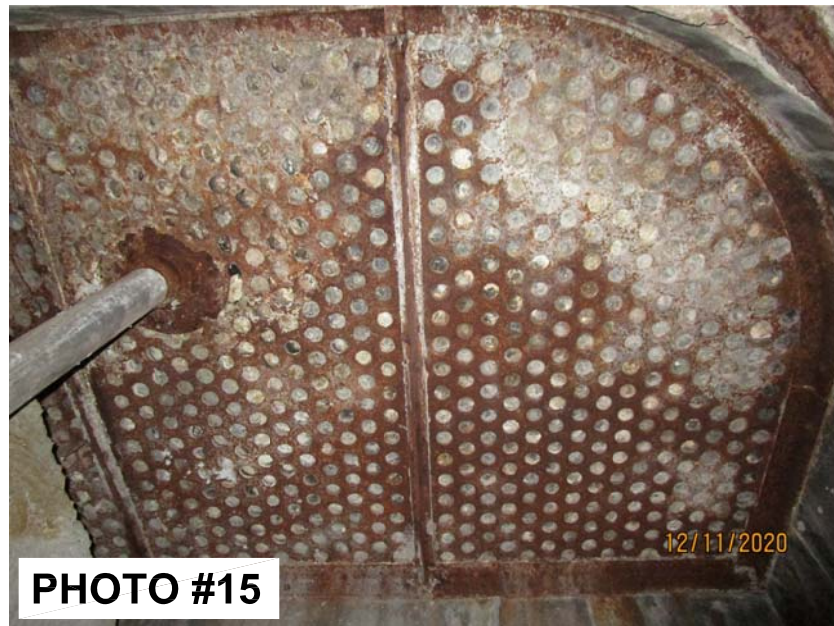
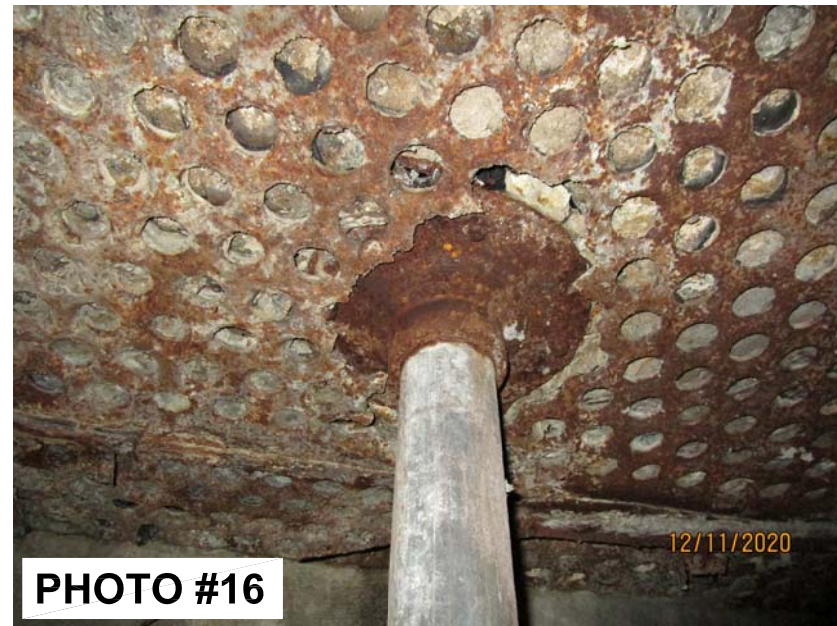
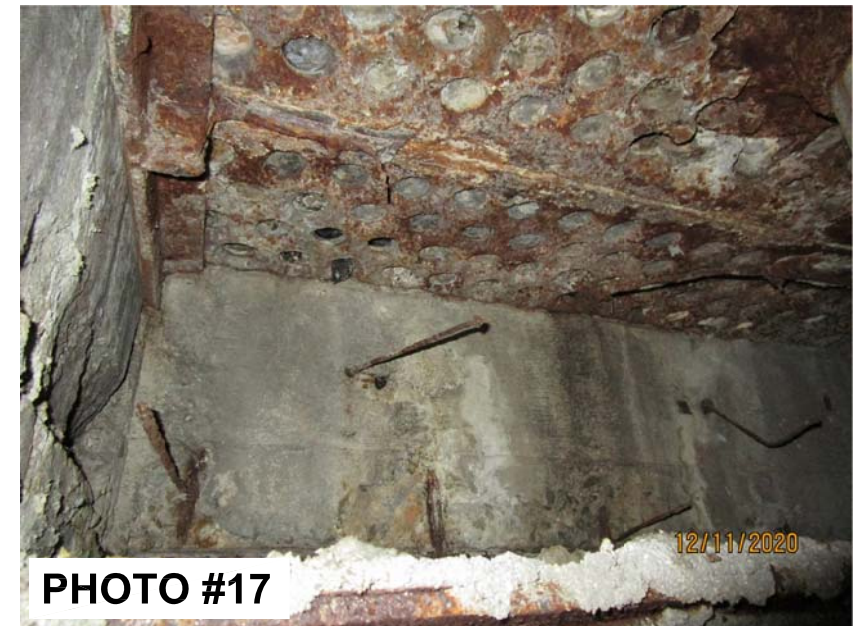
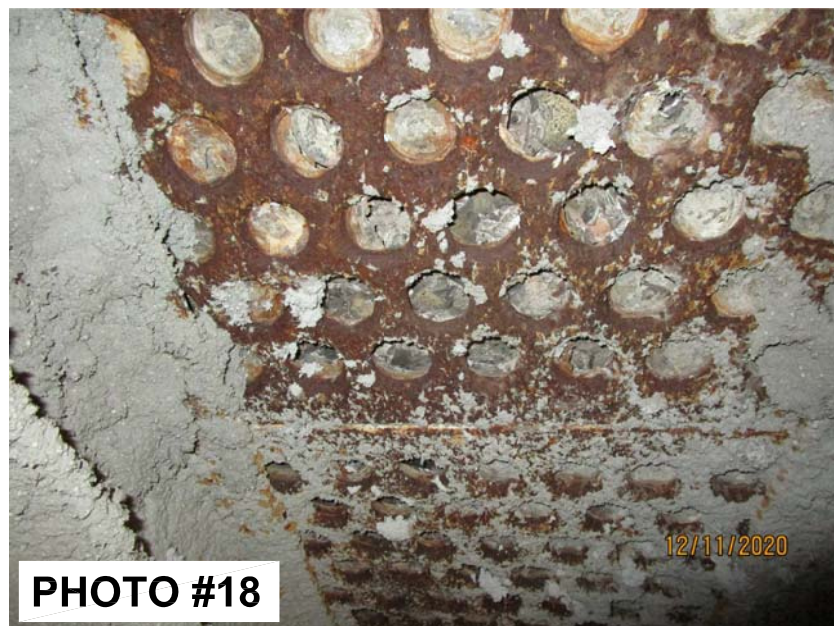
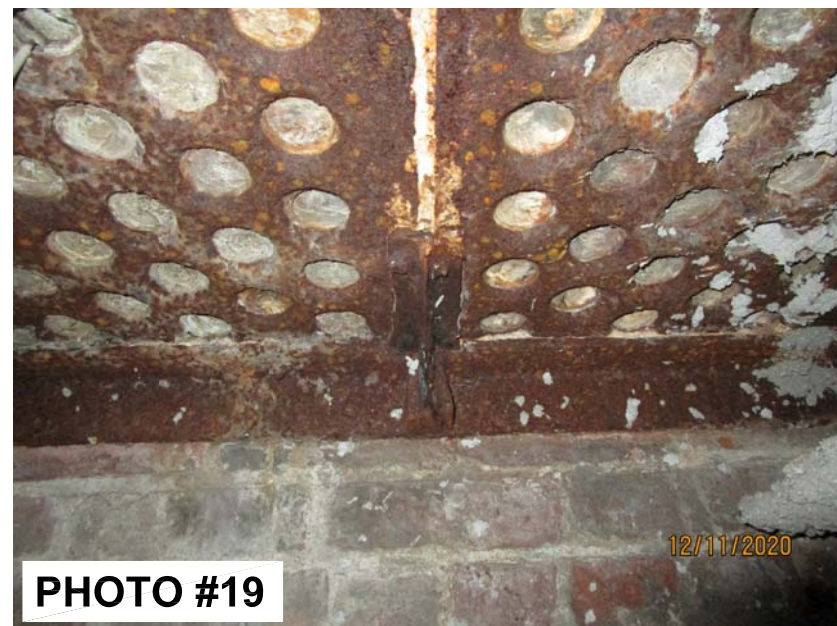
DETERIORATED AND CORRODED CAST IRON VAULT LIGHTS WITH BROKEN AND MISSING GLASS LITES - NORTH FACADE

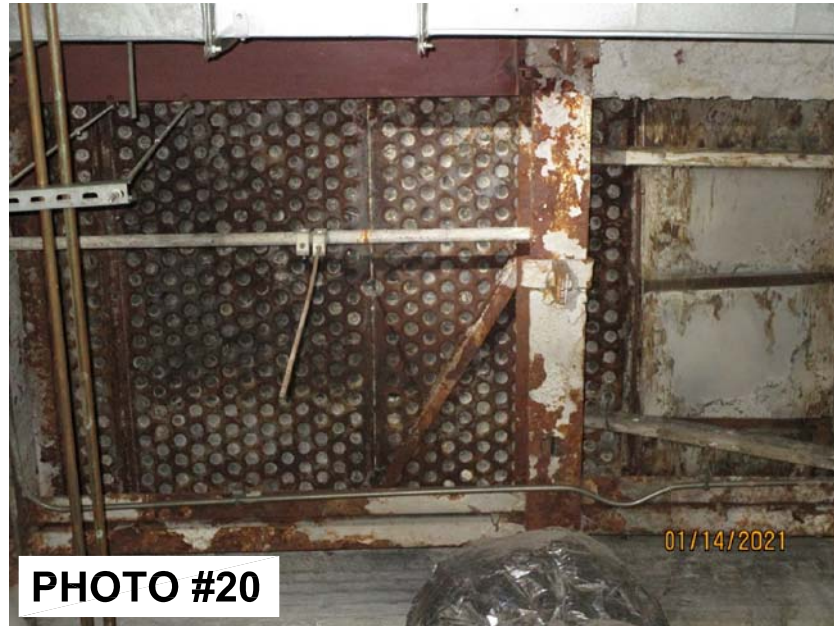
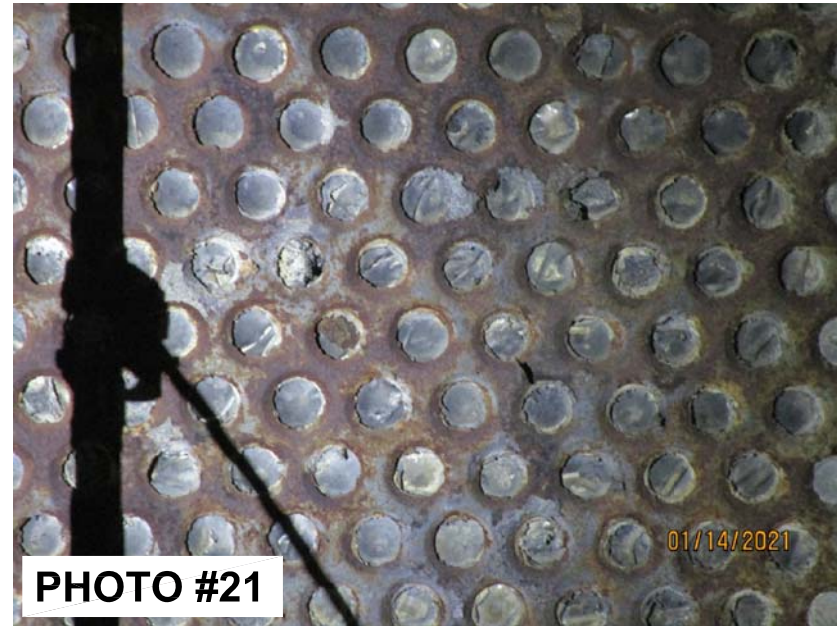
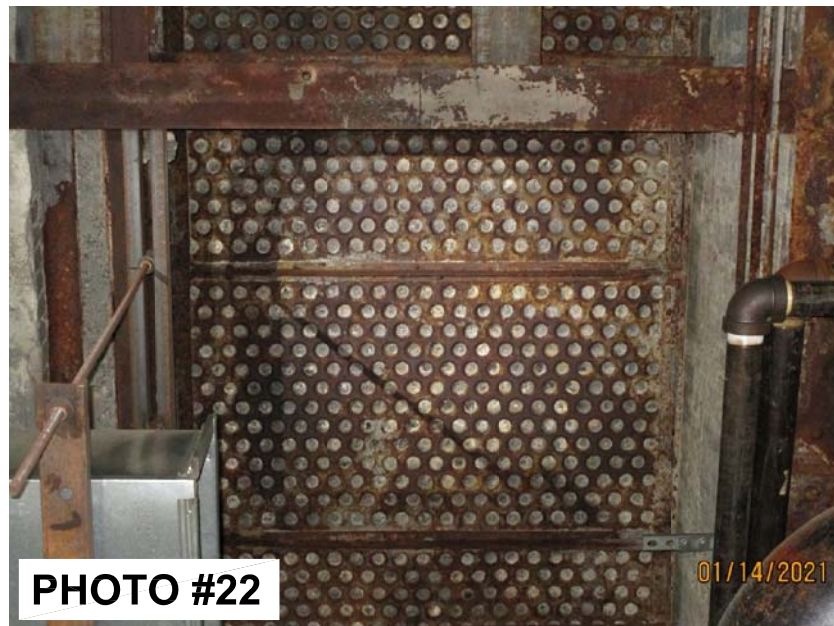
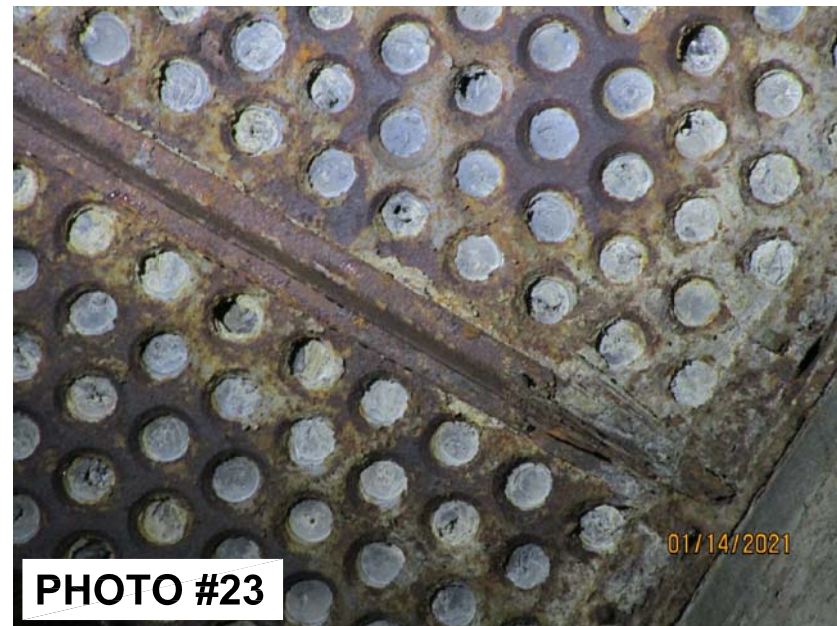
DETERIORATED AND CORRODED CAST IRON VAULT LIGHTS WITH BROKEN AND MISSING GLASS LITES - NORTH FACADE
