Preservation Department – Item 4, LPC-21-01073

**2211 Broadway – The Apthorp Apartments,
Borough of Manhattan**

PROPOSED SIDEWALK VAULT LIGHTS REMOVAL AT WEST 79TH STREET

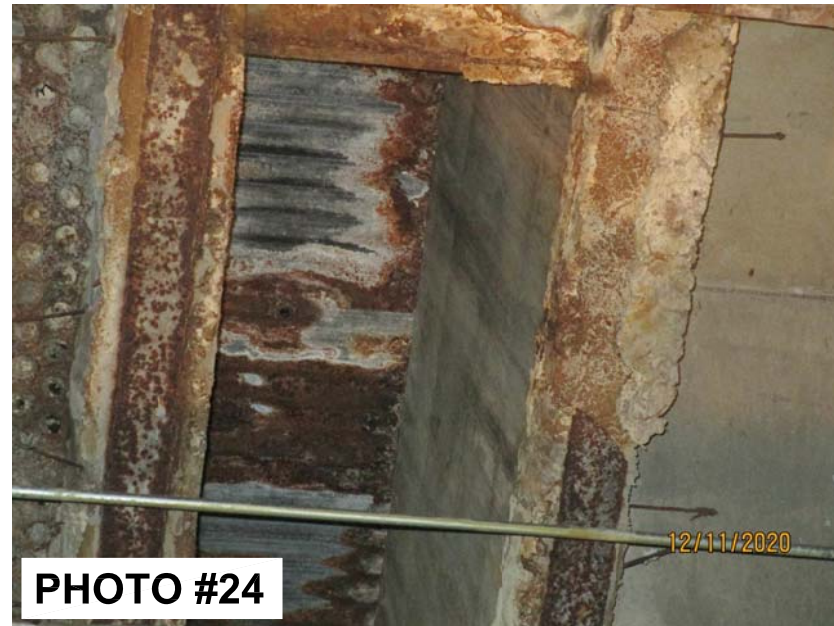
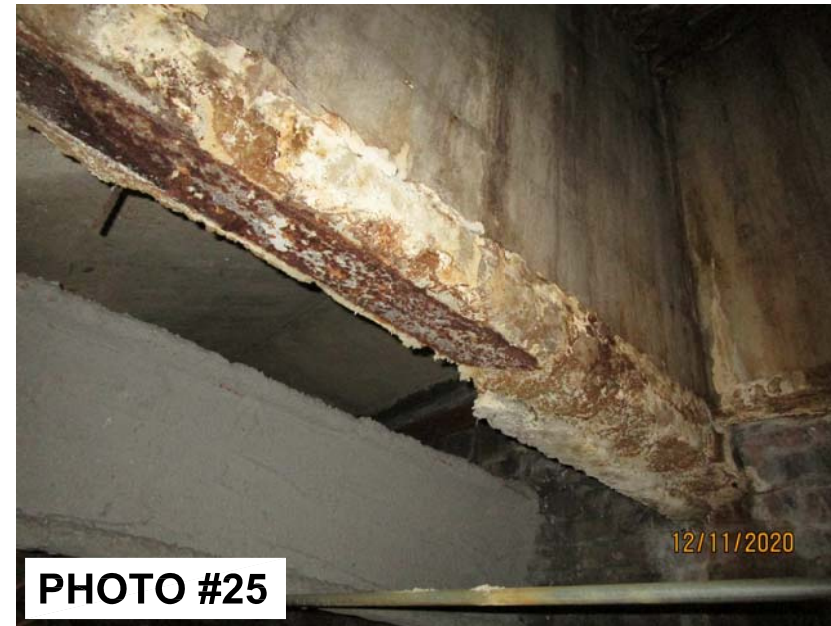
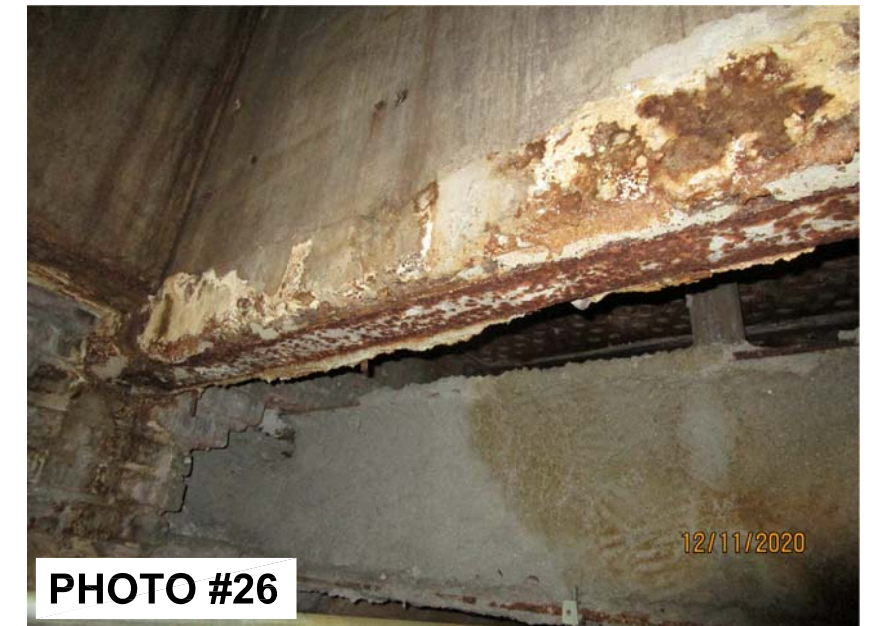
VIEW OF THE CORRODED STEEL BEAMS AND STRUCTURAL DECK WITHIN THE VAULTED AREA - NORTH FACADE

- DELETERIOUS CONDITIONS OF CAST IRON VAULT LIGHTS, STRUCTURAL STEEL AND WATER PENETRATION ARE RESULTING IN LEAKS.
- THE NORTH ELEVATION IS THE ONLY ELEVATION THAT HAS A VAULTED INTERIOR SPACE AND THE EXISTING VAULT LIGHTS WERE ORIGINALLY DESIGNED AS A UTILITARIAN FEATURE ALLOWING LIGHT INTO THE BOILER ROOM.
