B'NAI JESHURUN COMMUNITY HOUSE FIRE-RATED AND LOT-LINE WINDOW REPLACEMENT

REVISION#2 September 12th, 2022

Re: **DOCKET: #LPC-22-07597
WOOD WINDOW RESTORATION AND FIRE-RATED WINDOW REPLACEMENT
270 WEST 89TH STREET
MANHATTAN, NEW YORK 10024
BLOCK: 1236 LOT: 58**

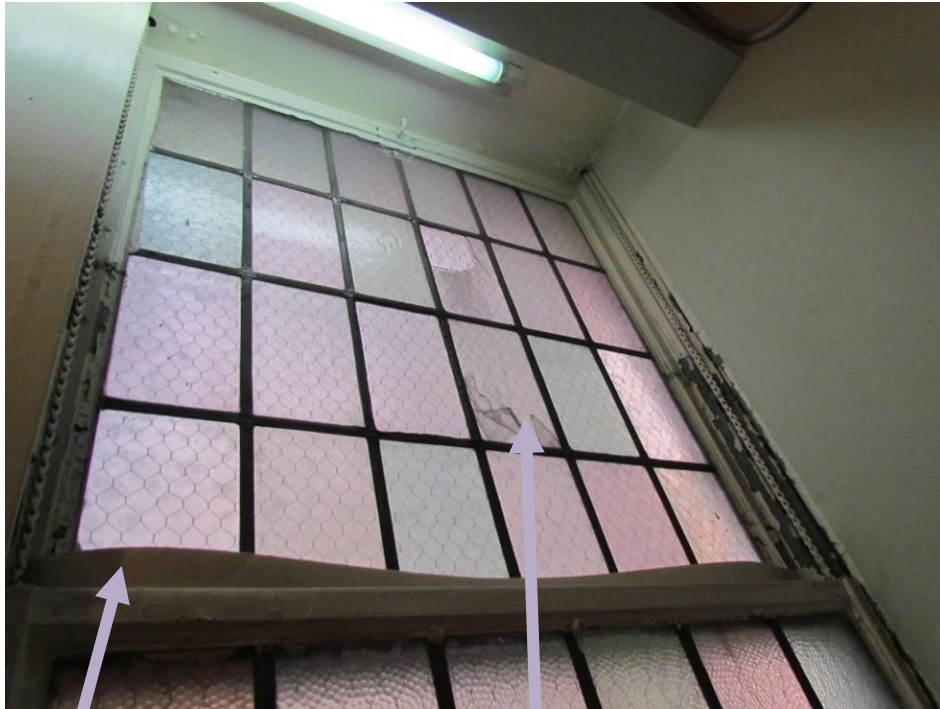
TEMPORARY INSULATION,
GAPS PRESENT

CRACKED GLAZING

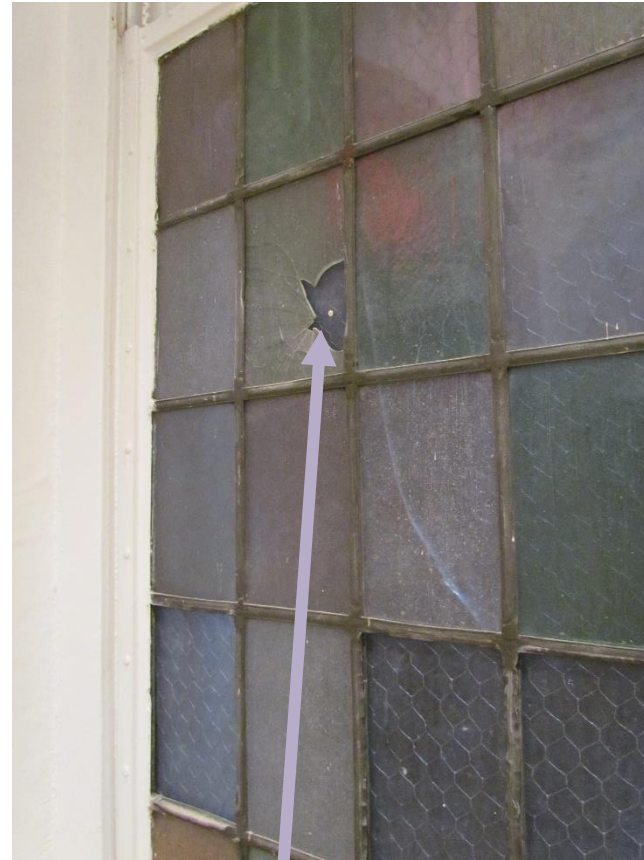
CRACKED GLAZING

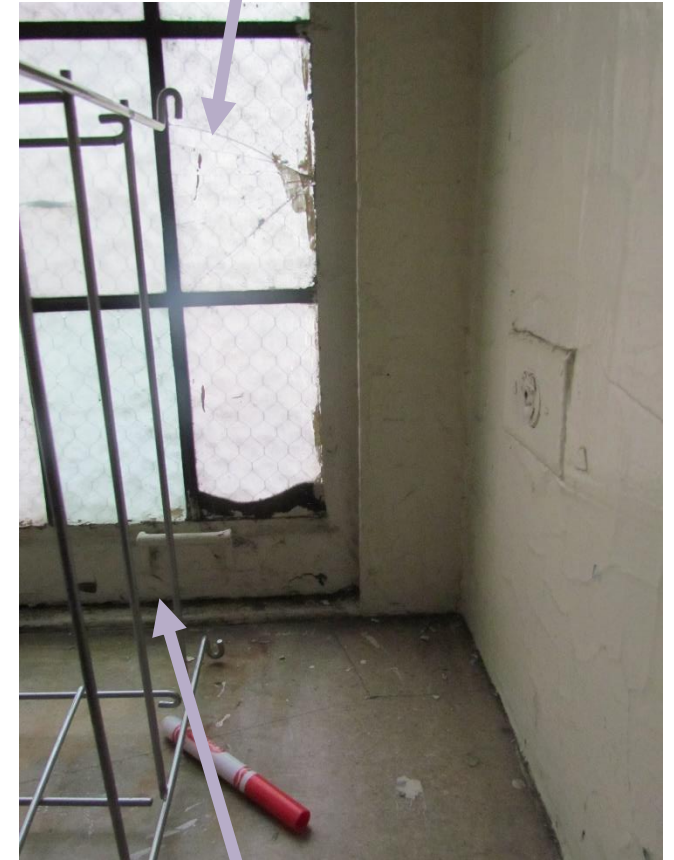
CRACKED GLAZING

INOPERABLE UNIT

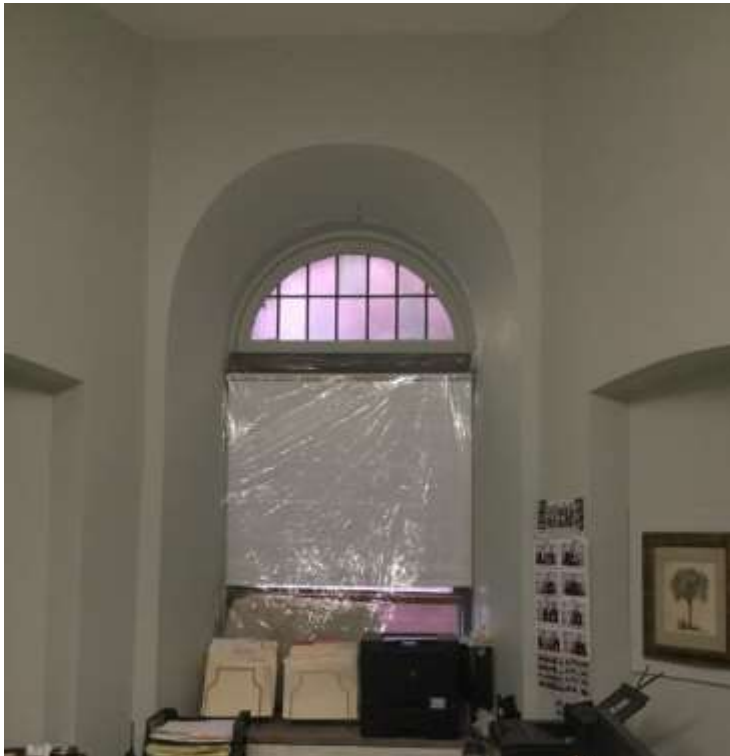
Photo 18:

ST30-1 existing conditions, interior:
Deteriorated sash, gaps present
between frame and sash (plastic
adhered to mitigate draft)

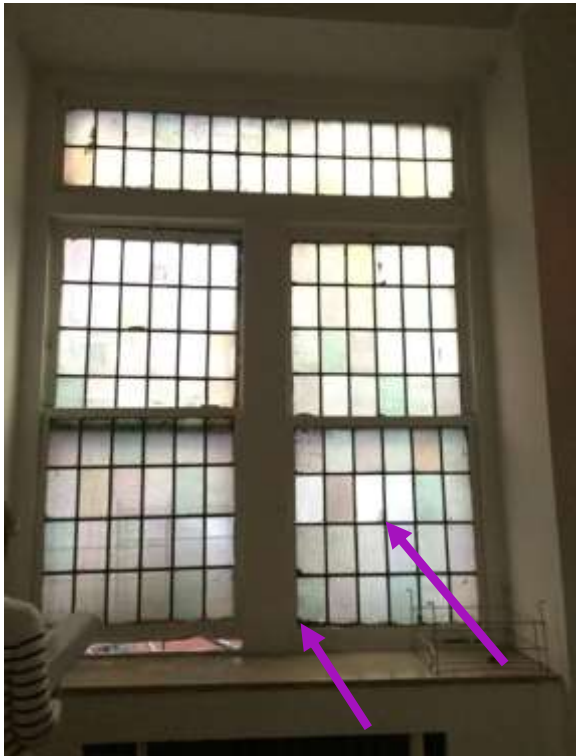
Photo 22:

ST9-1 existing conditions, interior:
Deteriorated frames and sash,
cracked colored lites, sash does not
close properly.

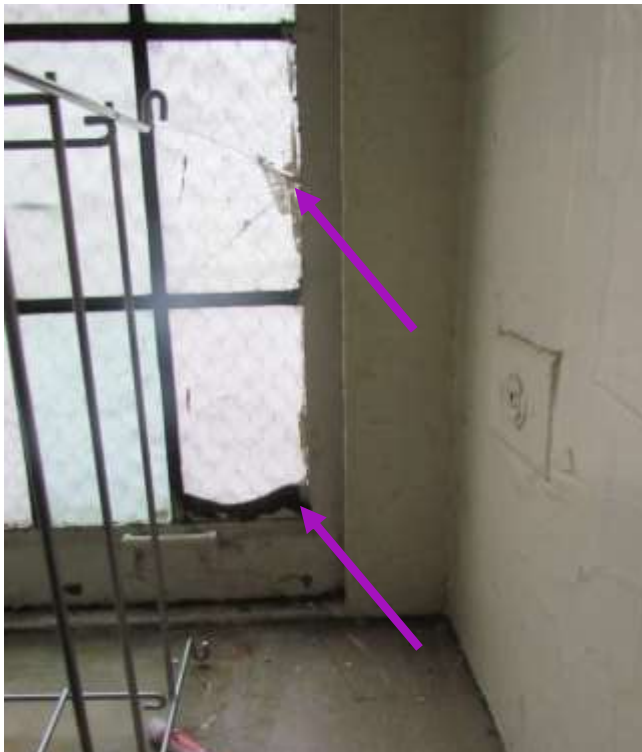
Photo 23:

ST9-1 existing conditions, interior:
Cracked glass lites at lower sash,
deformed caming

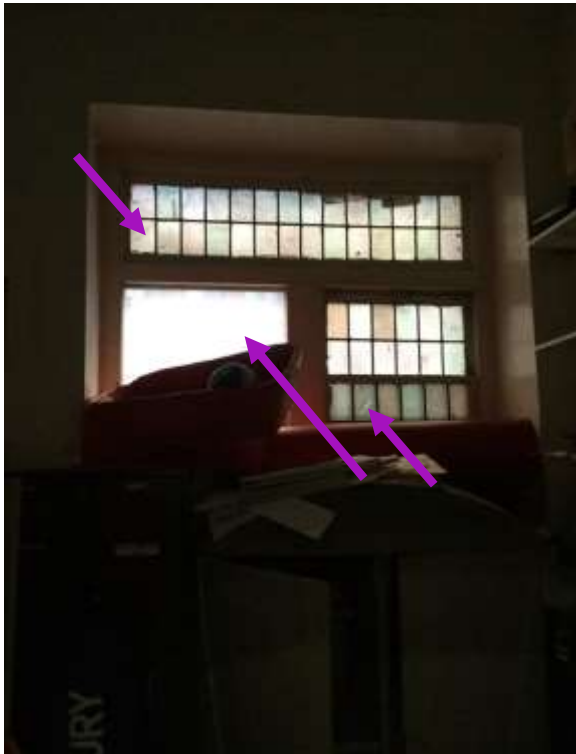
Photo 24:

ST9-2 existing conditions, interior:
Deteriorated frames and sash, clear
replacement sash, cracked colored
lites.

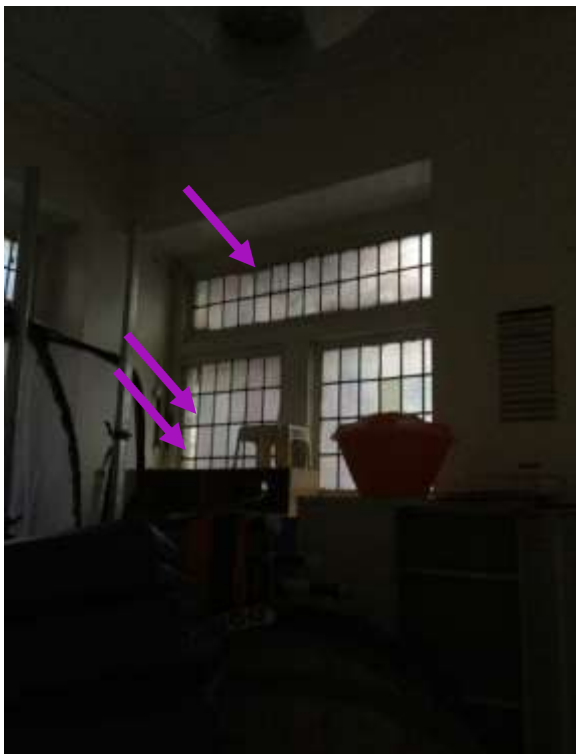
Photo 25:

ST9-3 existing conditions, interior:
Deteriorated frames and sash,
cracked colored lites.

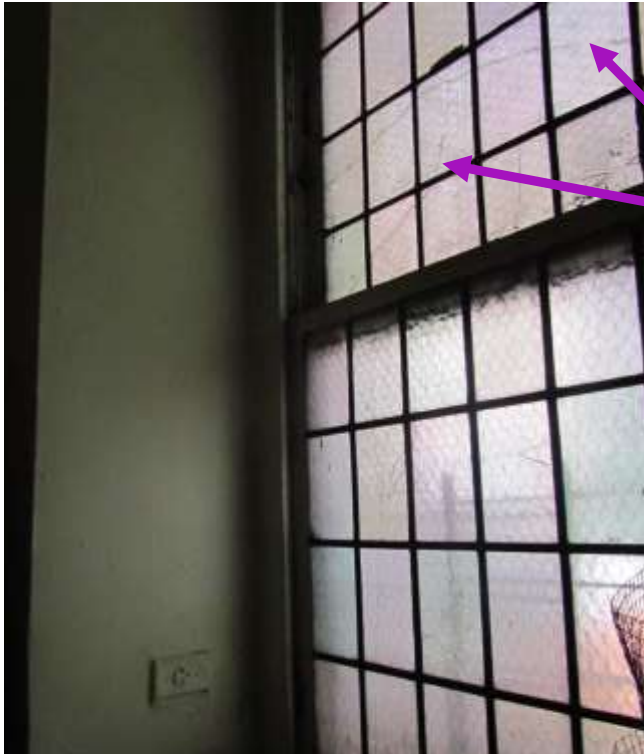
Photo 26:

ST9-3 existing conditions, interior:
Cracked glass lites at upper sash.

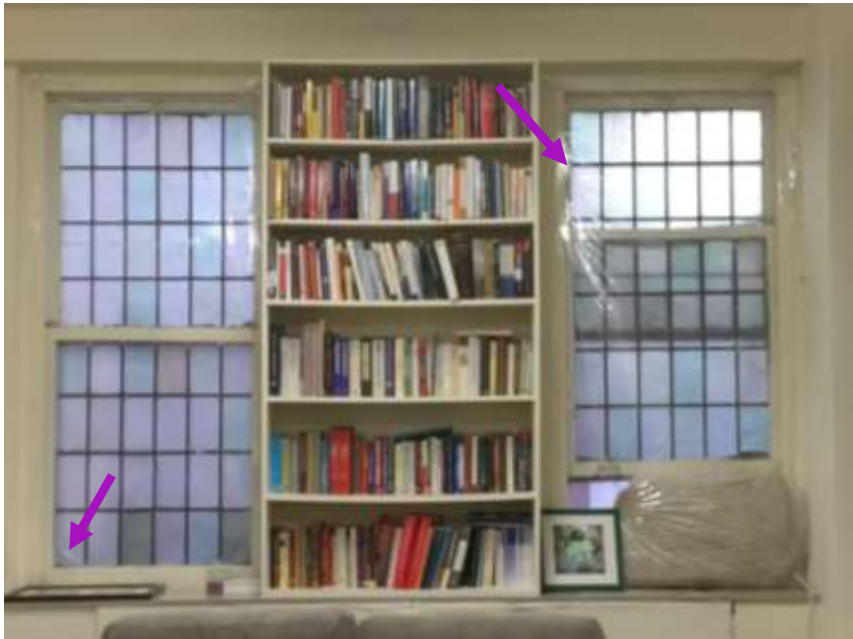
Photo 27:

ST28-1 existing conditions, interior:
Cracked colored lites, gaps present
between frame and sash (plastic
adhered to mitigate draft)

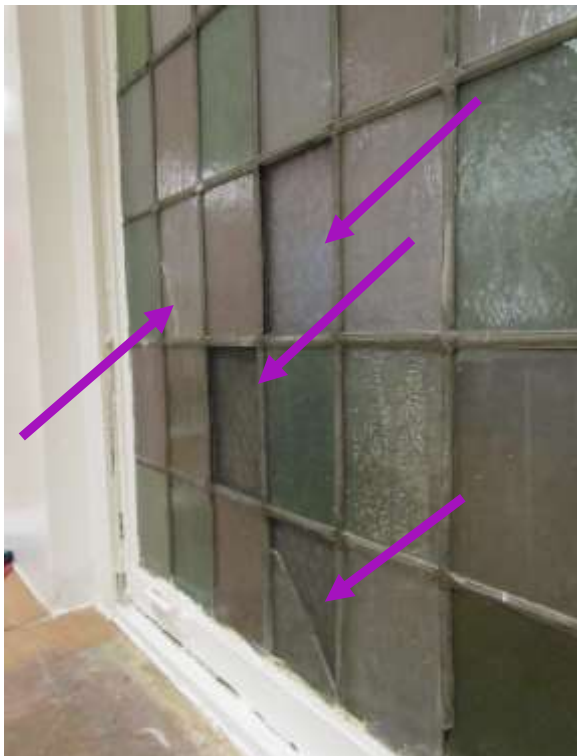
Photo 33:

ST1-1 existing conditions, interior:
Cracked glass lites, some missing
completely.

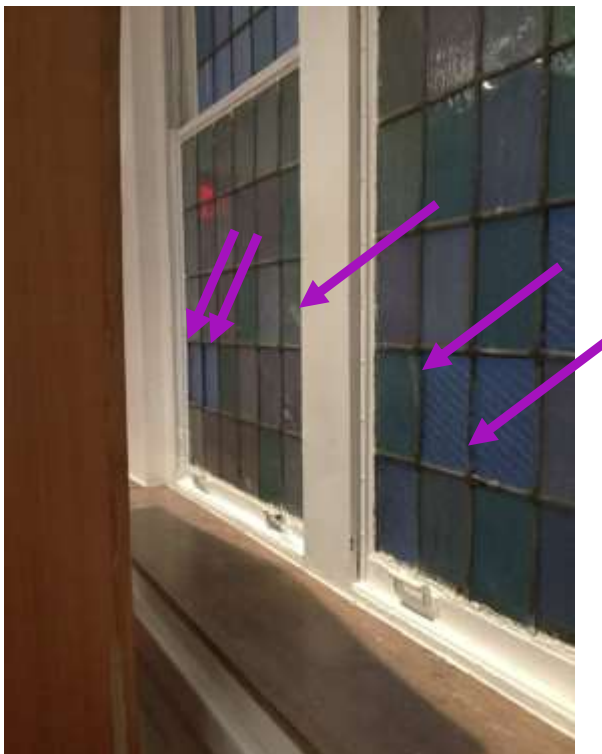
Photo 34:

ST1-2 existing conditions, interior:
Cracked glass lites, some missing
completely, warped casing.

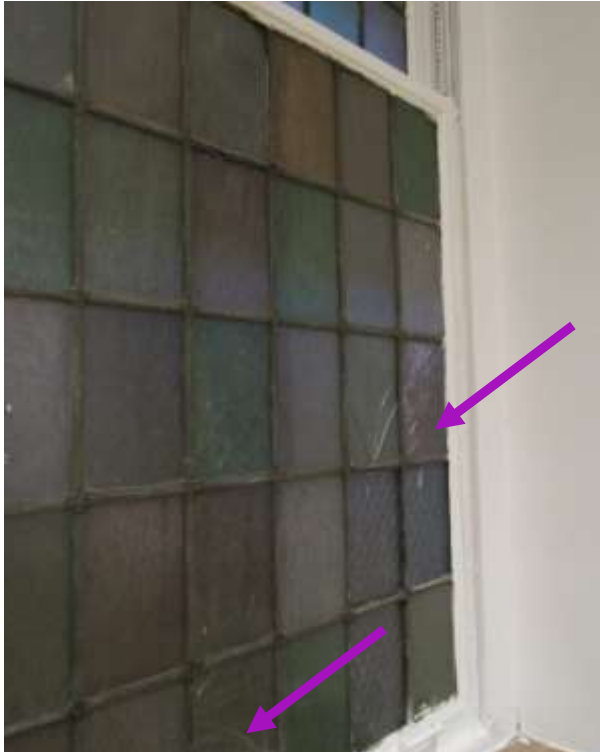
Photo 35:

ST1-3 existing conditions, interior:
Cracked glass lites, some missing
completely.

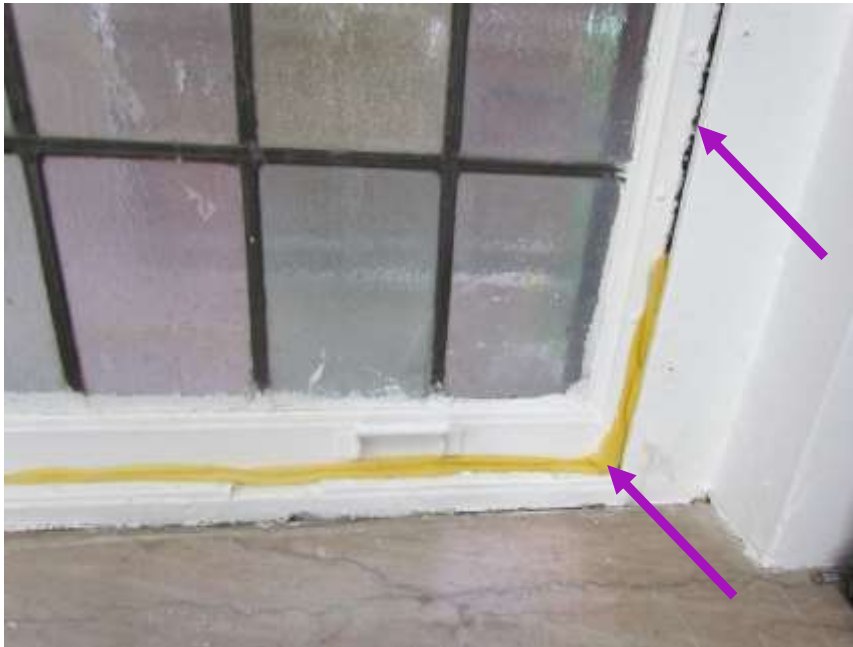
Photo 38:

ST3-1 existing conditions, interior:
Temporary insulation installed at
sash perimeter due to gaps, drafts
present.

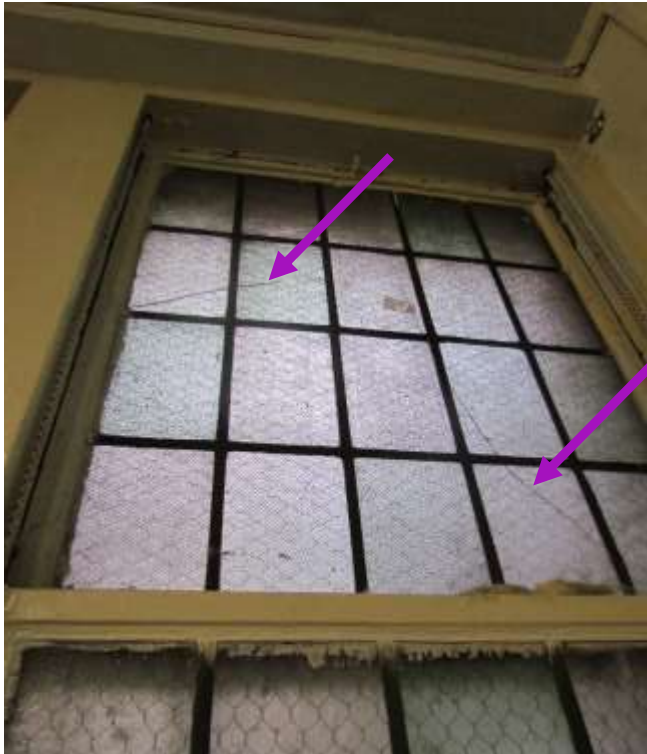
Photo 42:

ST4 existing conditions, interior:
Cracked glass lites upper sash.

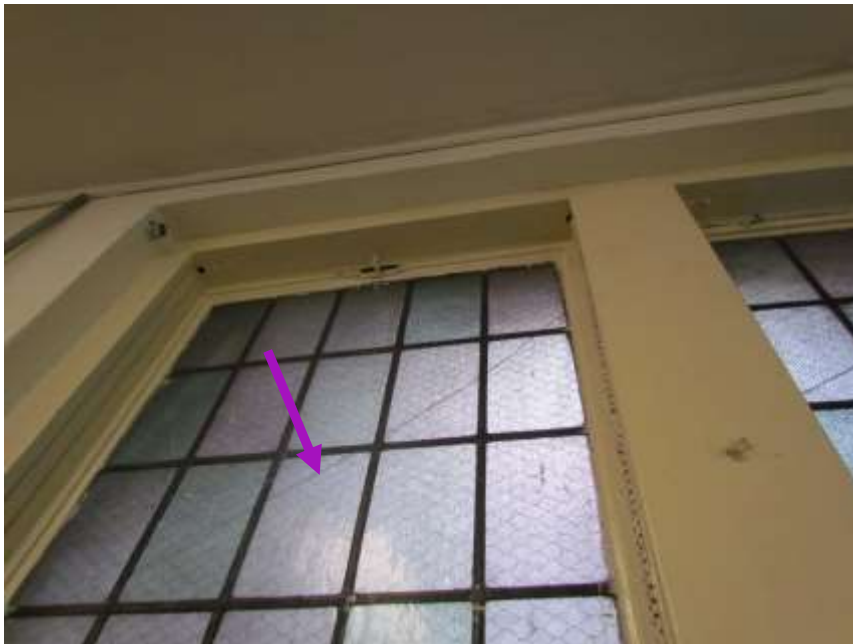
Photo 43:

ST4 existing conditions, interior.
Cracked glass lites upper sash.

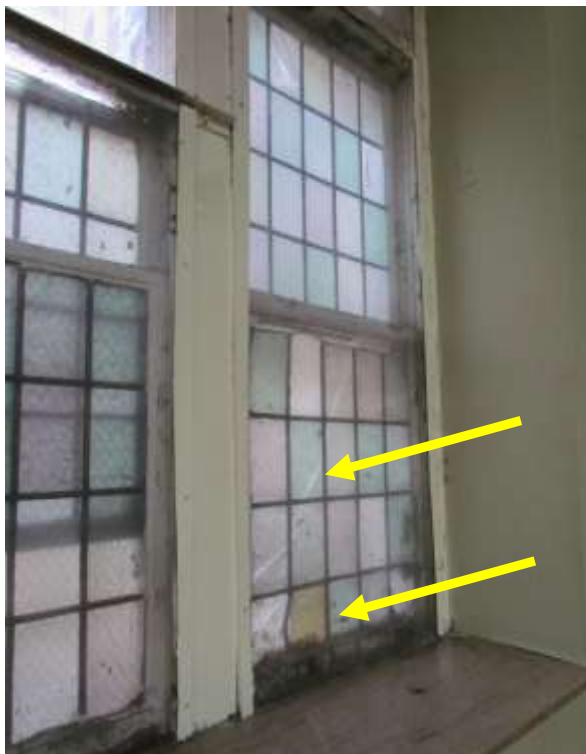
Photo 49:

ST7-1 existing conditions, interior:
Deteriorated frames and sashes,
cracked glass lites and bulging lites
at lower sash.

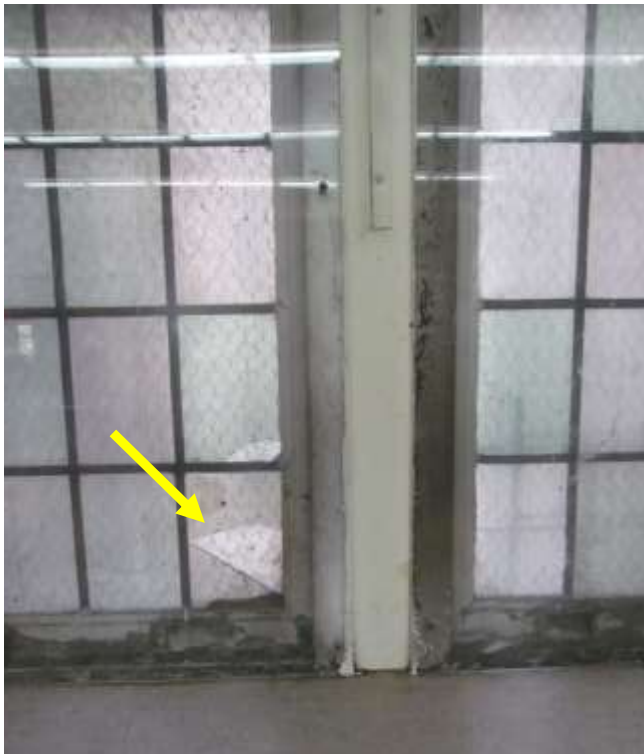
Photo 53:

ST8-1 existing conditions, interior:
Deteriorated frames and sashes,
cracked glass lites, some missing
completely.

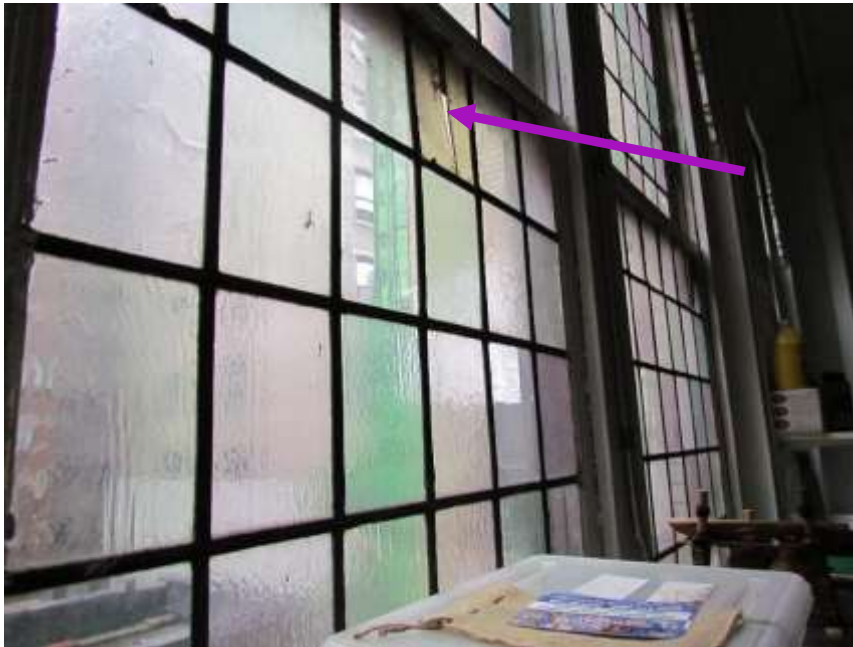
Photo 56:

ST11 existing conditions, interior:
Cracked glass lites at lower sash.

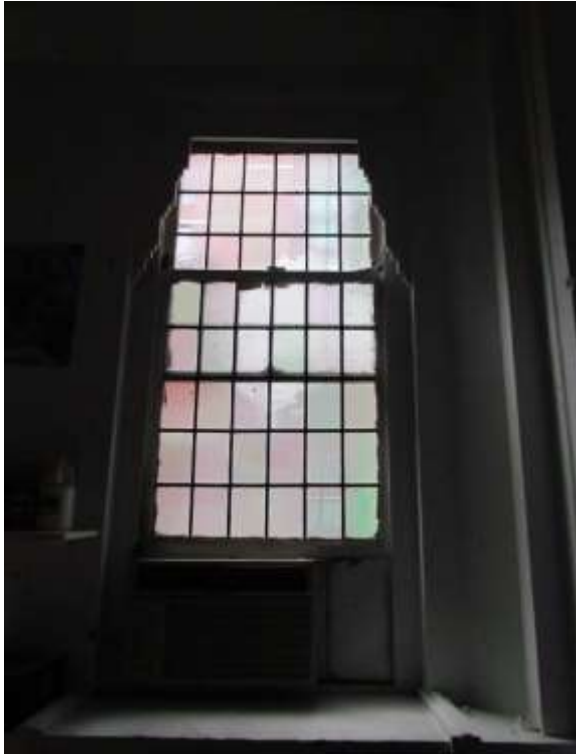
Photo 58:

ST12 existing conditions, interior:
Deteriorated frames and sashes.

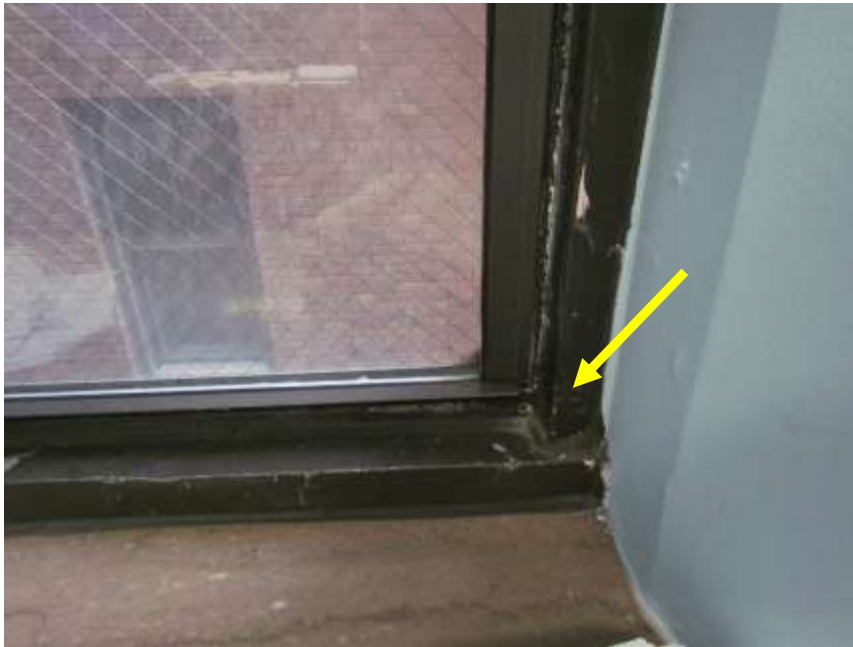
Photo 61:

ST30-2 existing conditions, interior.
Deteriorated snap trim at jamb.

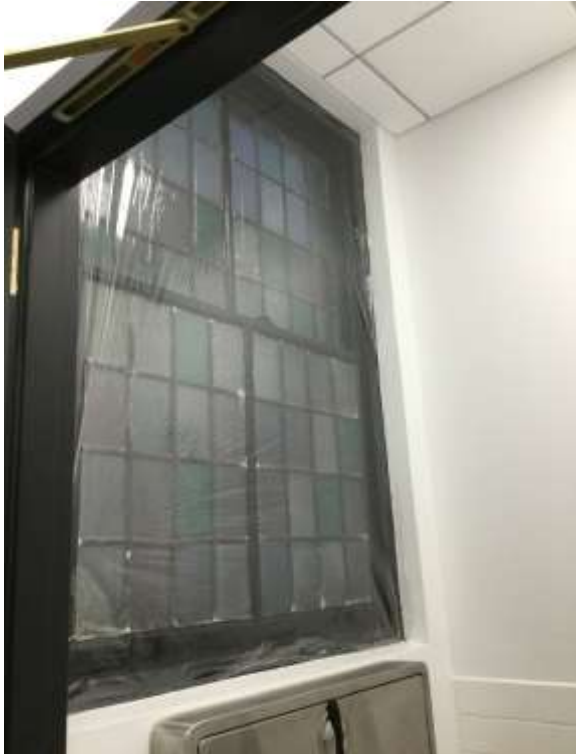
Photo 62:

ST28-1 existing conditions, interior:
Cracked colored lites, gaps present
between frame and sash (plastic
adhered to mitigate draft)

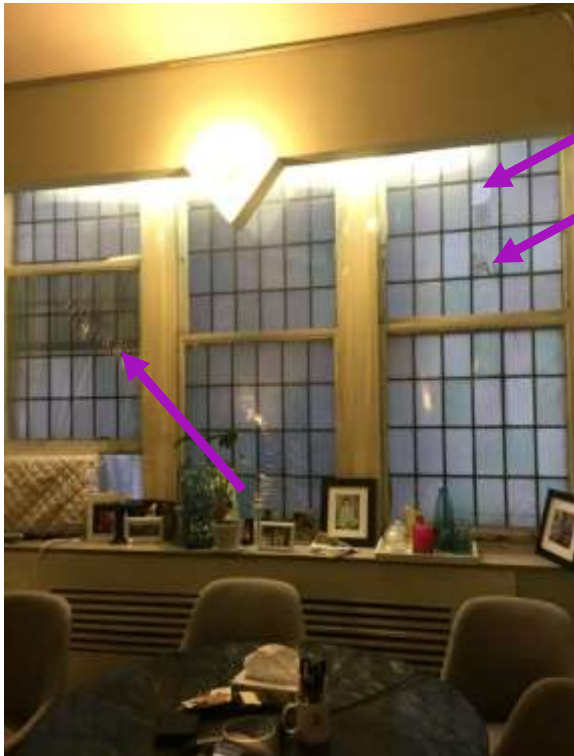
Photo 65:

ST27-3 existing conditions, interior:
Cracked colored lites, gaps present
between frame and sash (plastic
adhered to mitigate draft).

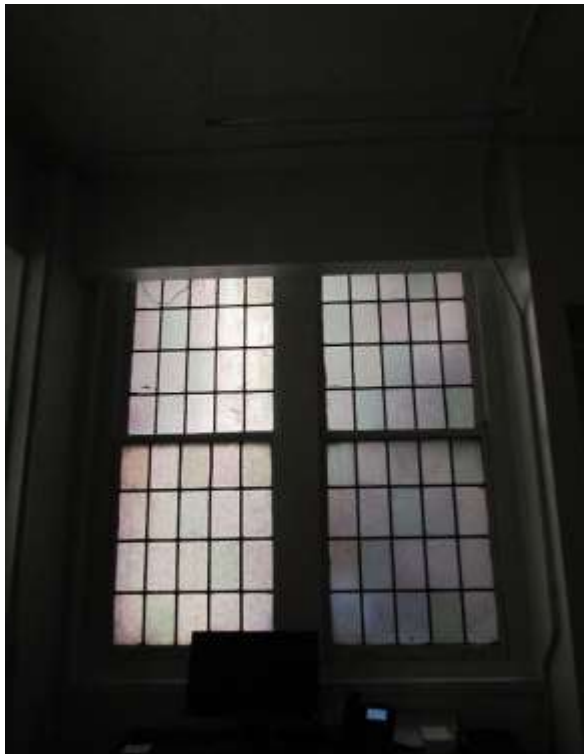
Photo 68:

ST27-1 existing conditions, interior:
Deteriorated frames and sashes.

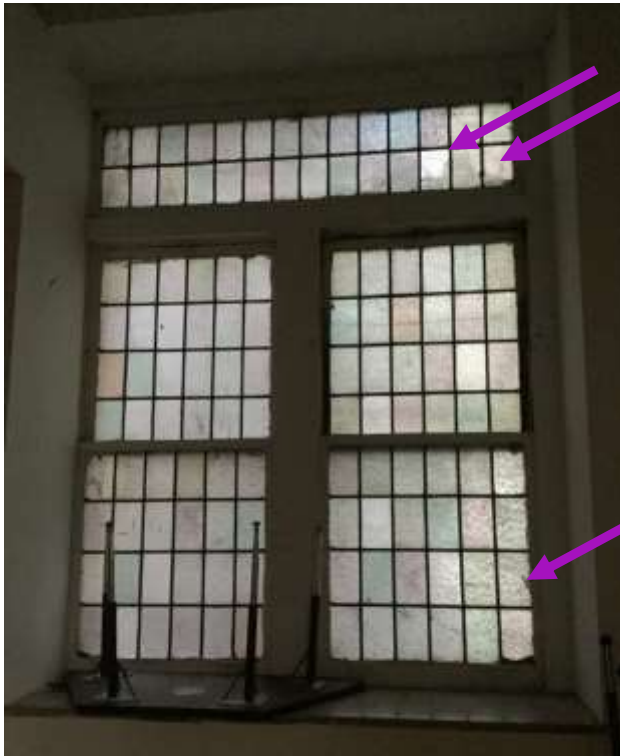
Photo 69:

ST27-2 existing conditions, interior:
Deteriorated frames and sashes,
cracked and broken colored glass
lites.

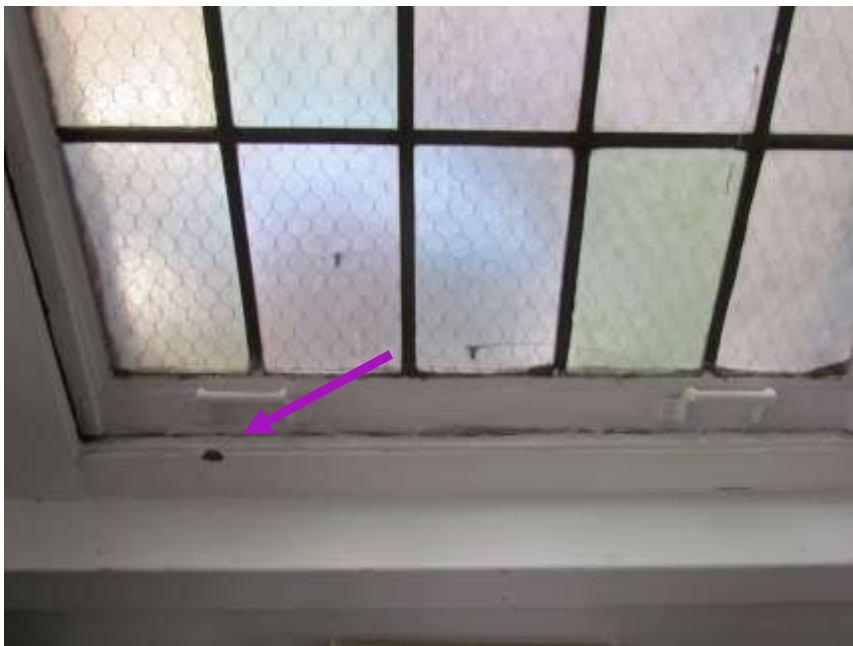
Photo 70:

ST27-3 existing conditions, interior.
Deteriorated interior frame.

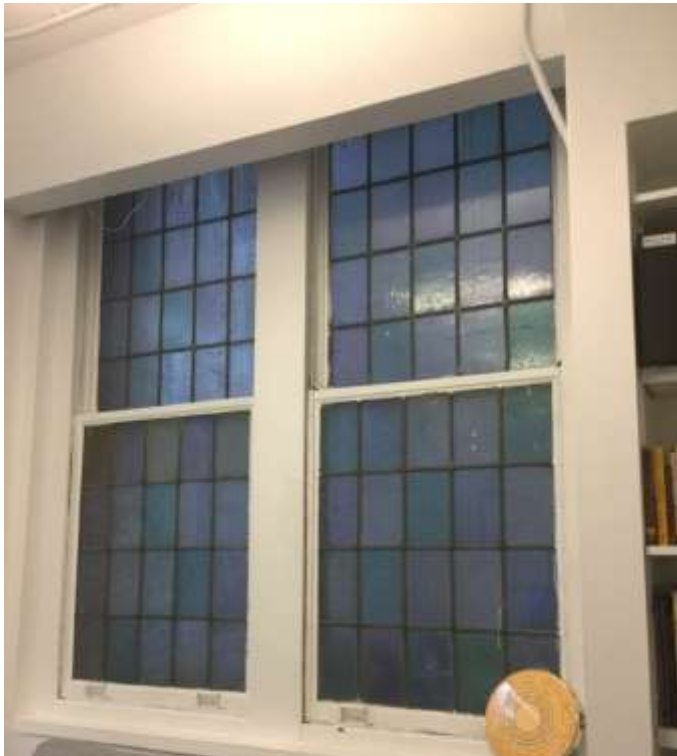
Photo 71:

ST6-2 existing conditions, interior:
Some windows inoperable (transom
behind drop ceiling).

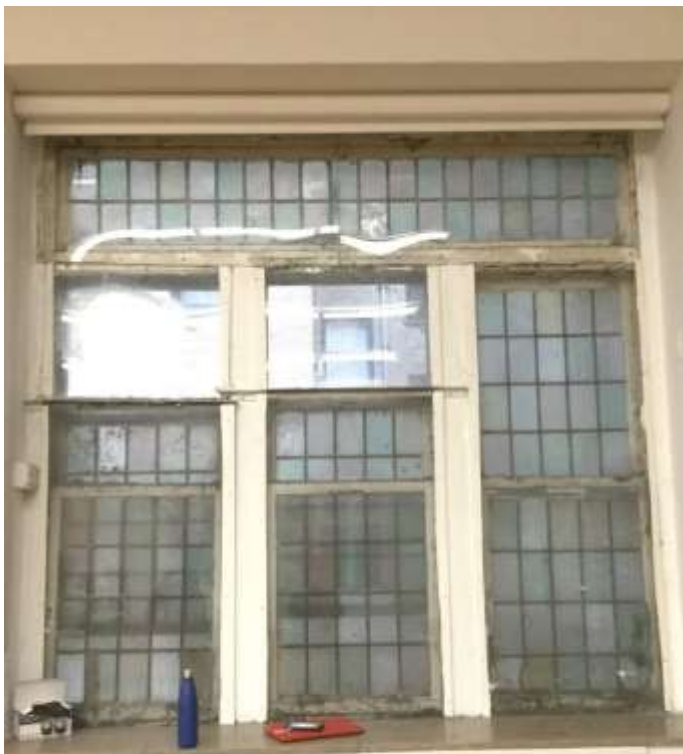
Photo 72:

ST7-2 existing conditions, interior:
Deteriorated frames and sashes,
cracked glass lites, some missing
completely.

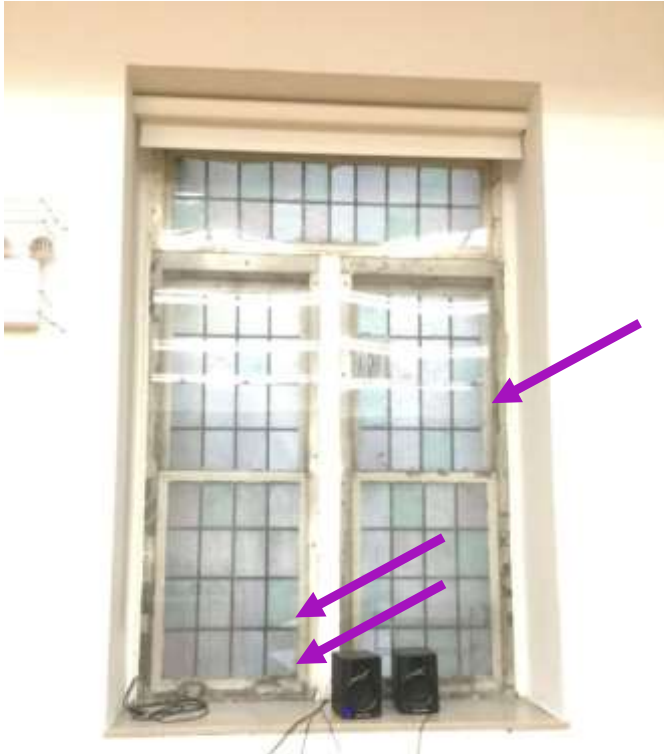
Photo 73:

ST8-2 existing conditions, interior:
Deteriorated frames and sashes,
cracked glass lites, some missing
completely.

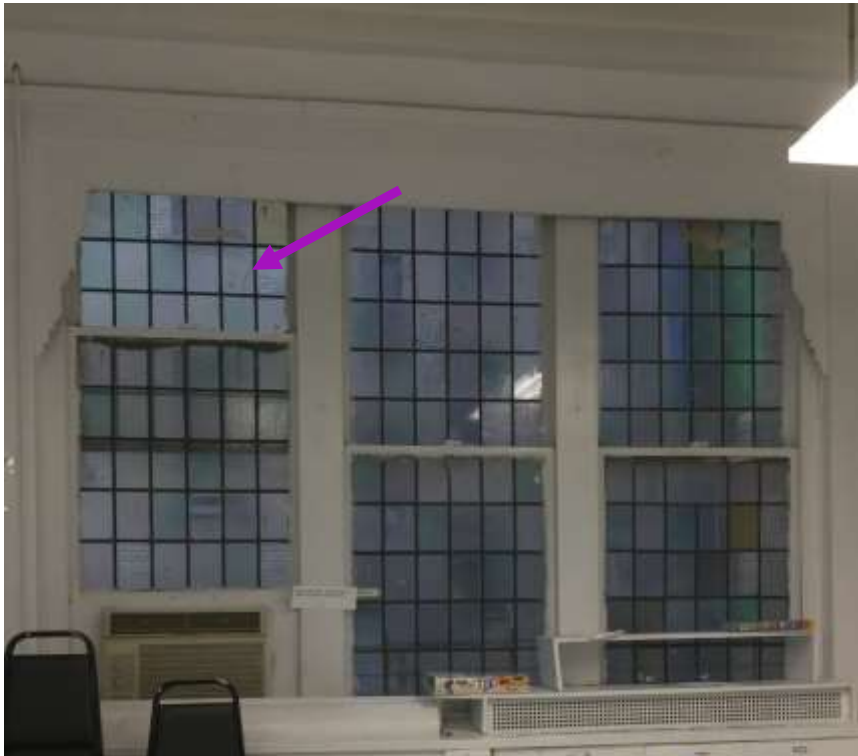
Photo 74:

ST11 existing conditions, interior:
Deteriorated frames and sashes,
cracked glass lites, some missing
completely.

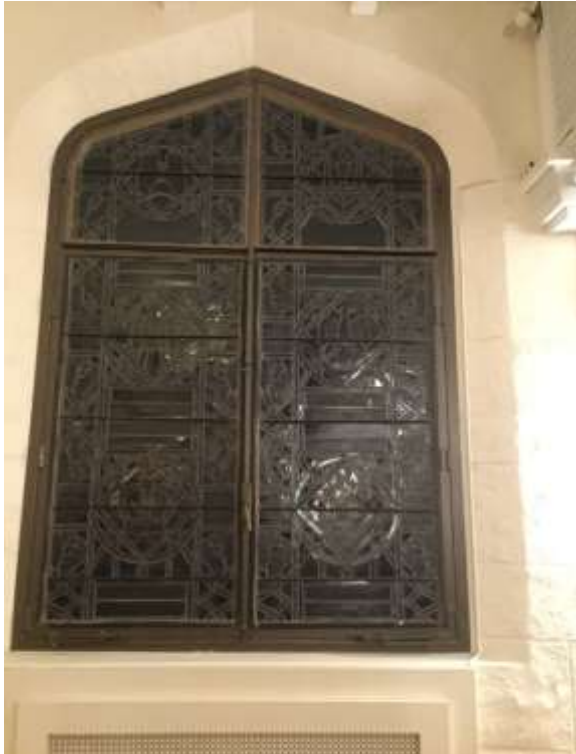
Photo 76:

ST51-2 existing conditions, interior:
Deteriorated exterior frame,
corrosion present.

Note: exterior window covered by
metal louver, to be removed during
current façade repair campaign.

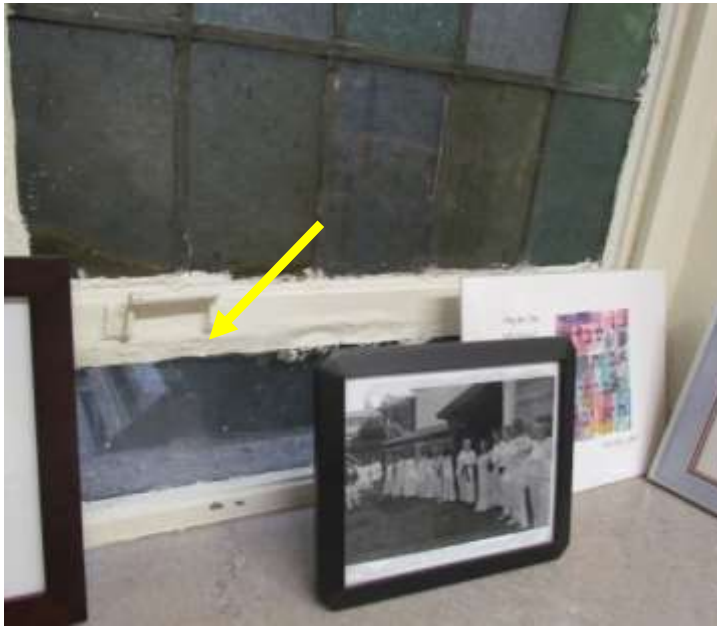
Photo 80:

SC1 existing conditions, interior.
Plexiglass installed at lower sash,
making it inoperable.
