Façade Reconstruction 231 & 233 West 74th Streets

This presentation seeks to demonstrate that the deterioration of the primary (south) facades of the above buildings is so advanced that restoration work is not be possible to perform safely or effectively. MVN therefore seeks permission from LPC to perform reconstruction of the primary facades using salvaged original masonry brick and stone units to the greatest extent possible, and new materials to match the existing, where existing materials are not able to be salvaged.

MVN Architect LLC
Public Hearing 10/3/2022

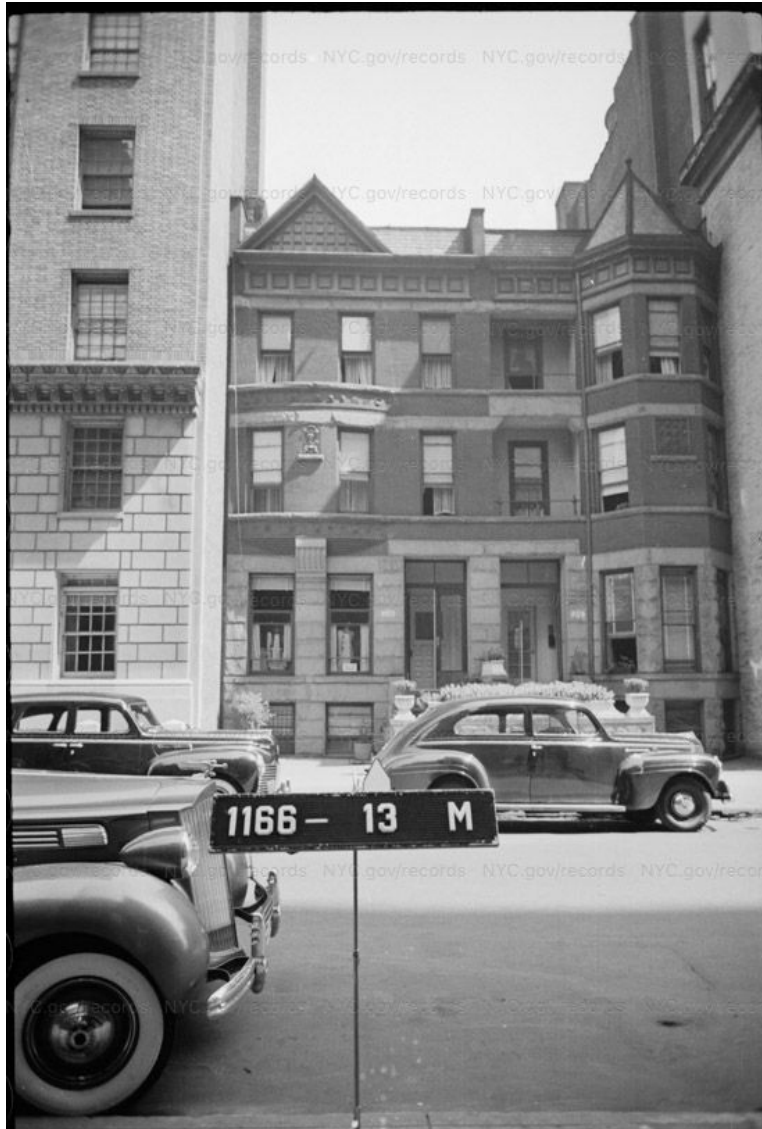
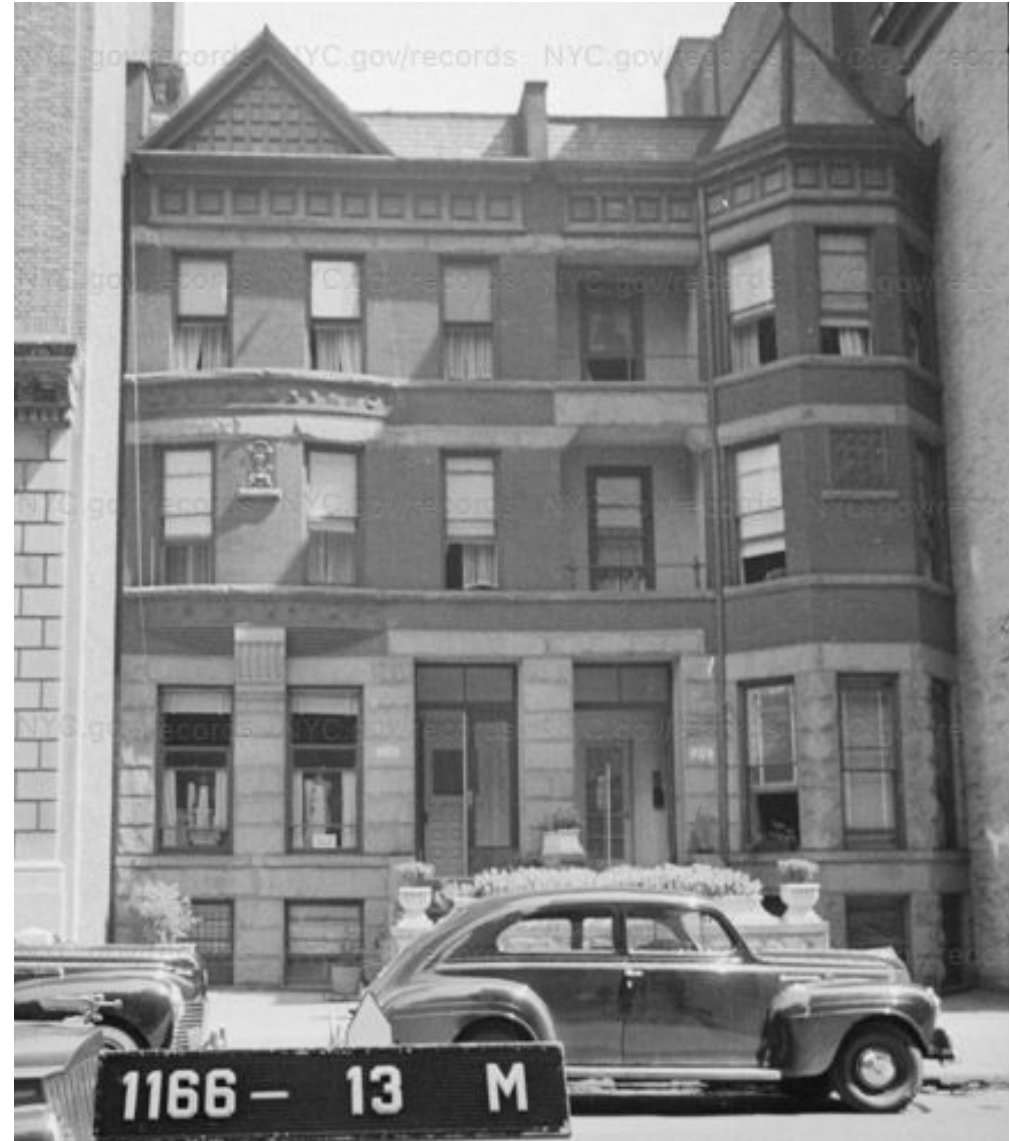
1940'S TAX PHOTO - shows little or no displacement

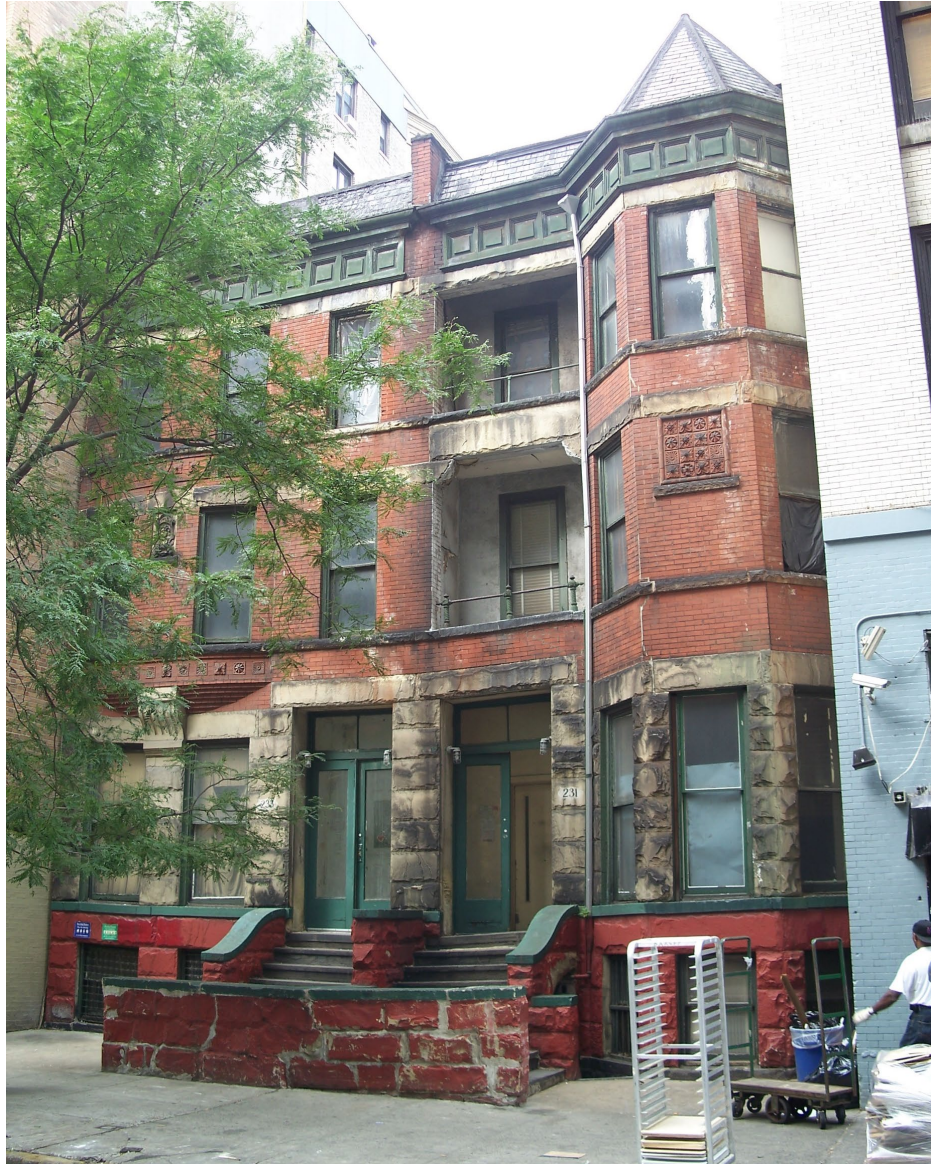
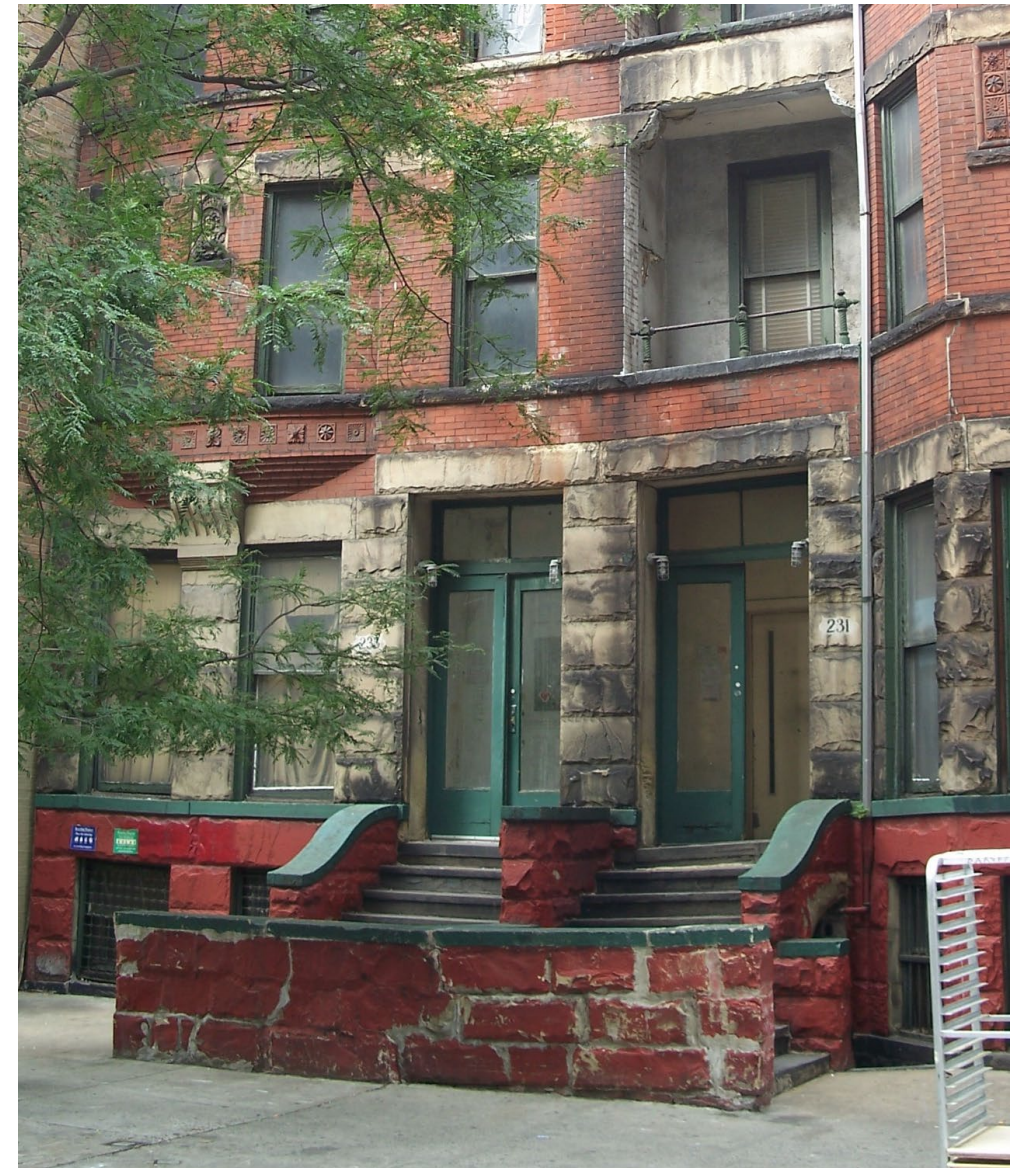
PHOTOS-2007 – displacement is evident

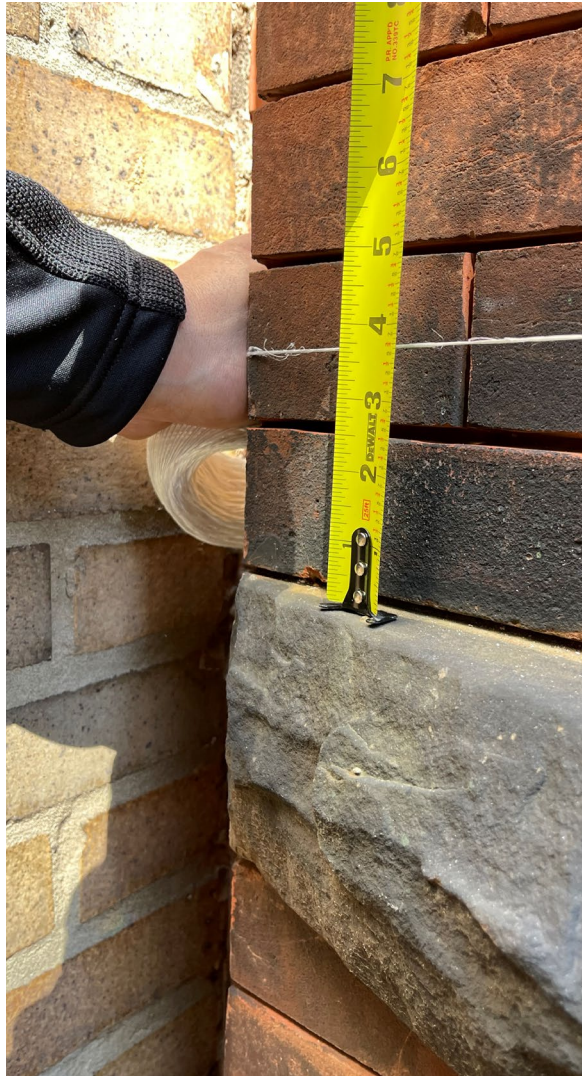
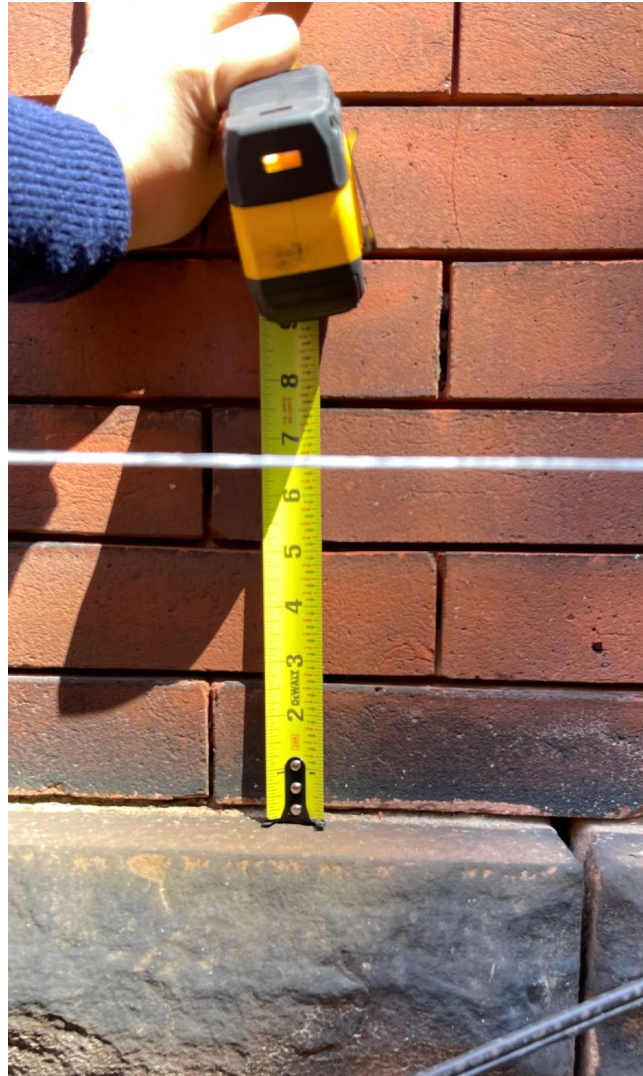
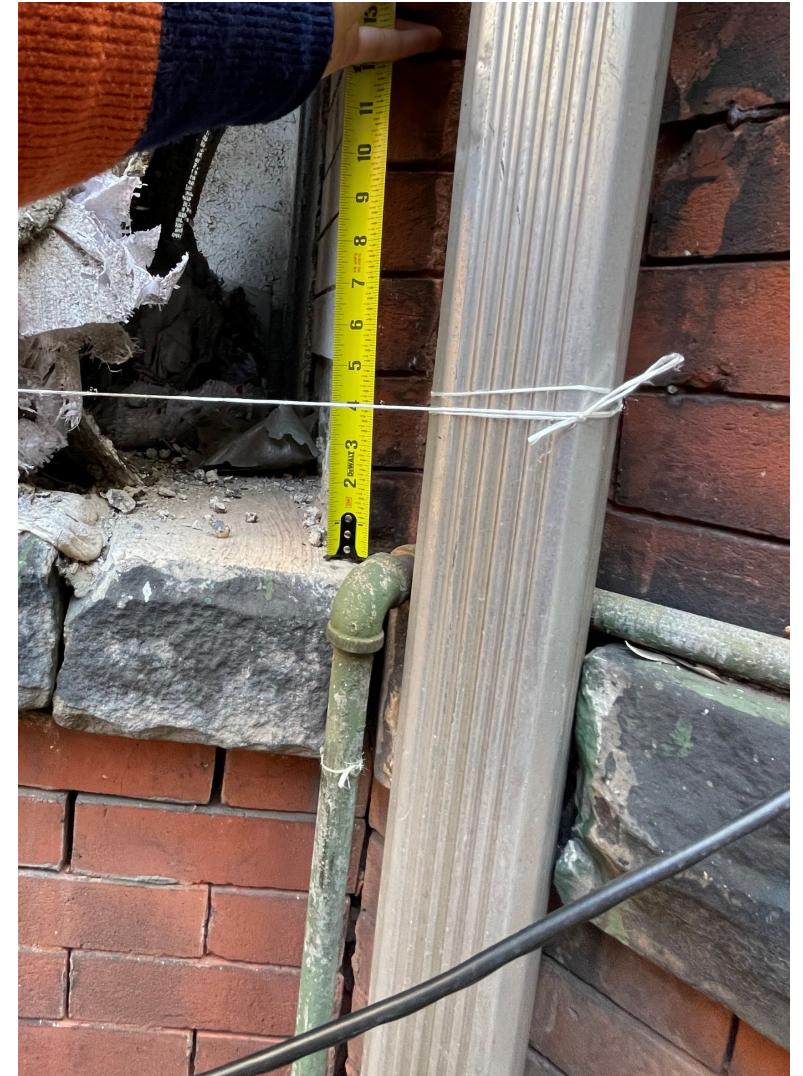
String Level indicates that portion of building adjacent to party wall between (2) buildings has settled close to 3 inches relative to West end of 233 and East end of 231.) Photos taken 2022

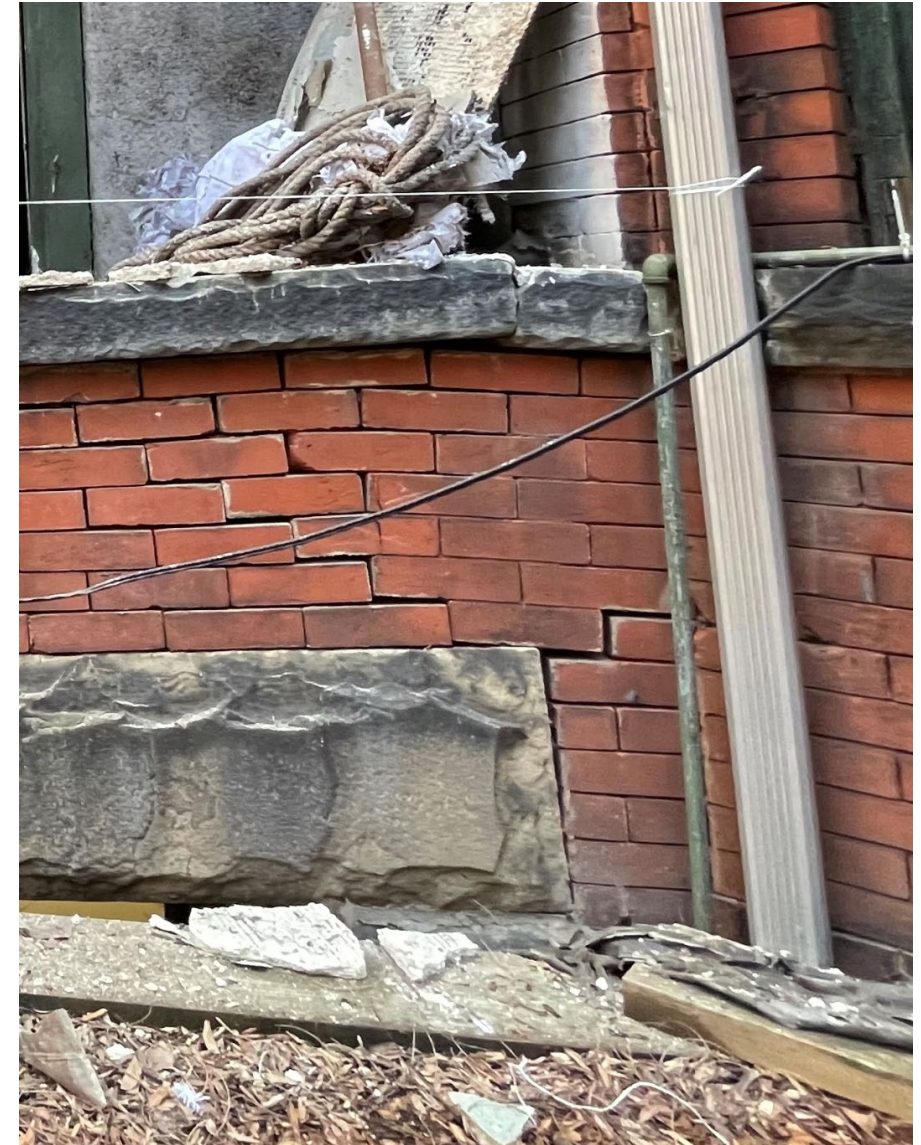
231 West 74th Street (Lintel above main Entrance severely deformed from façade settlement) 2022

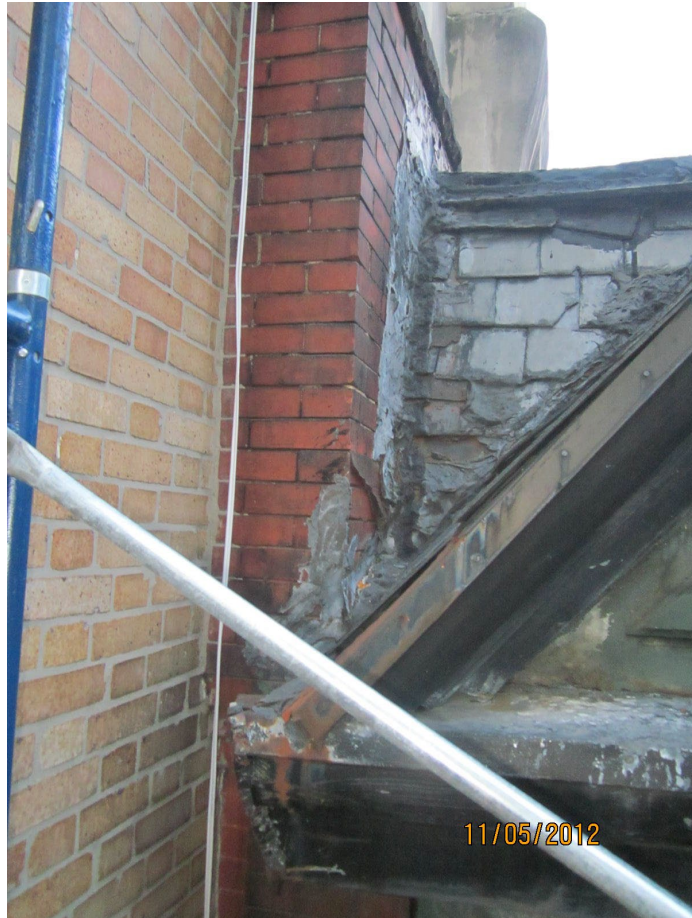
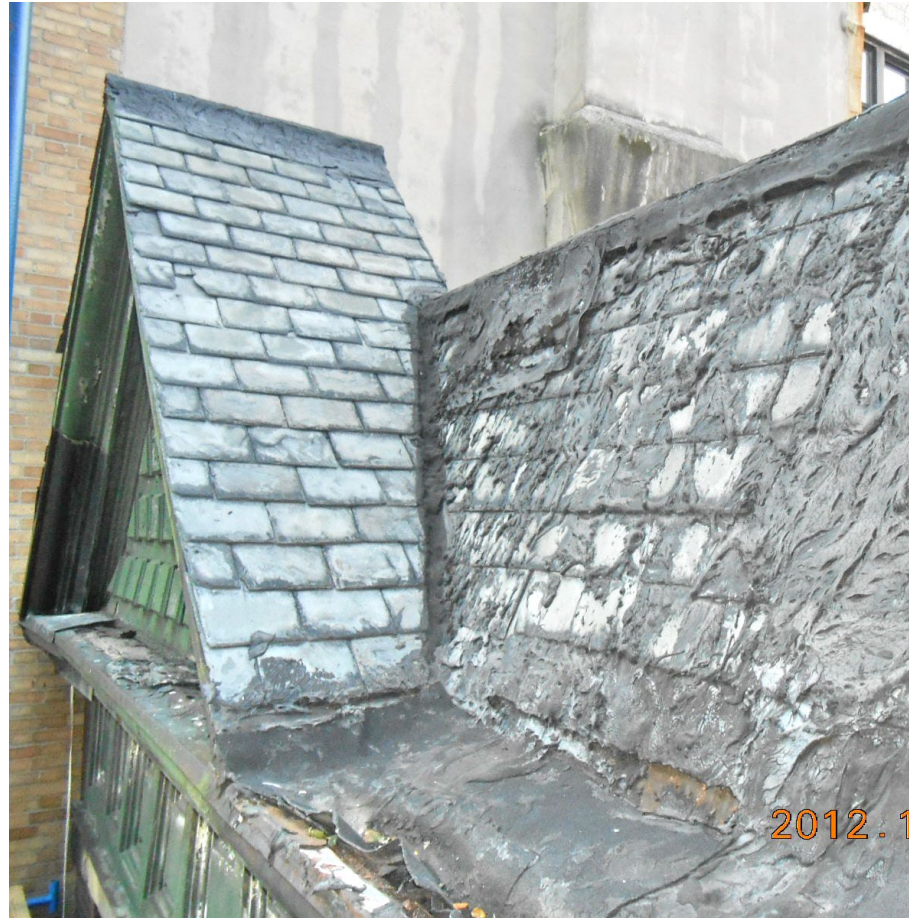
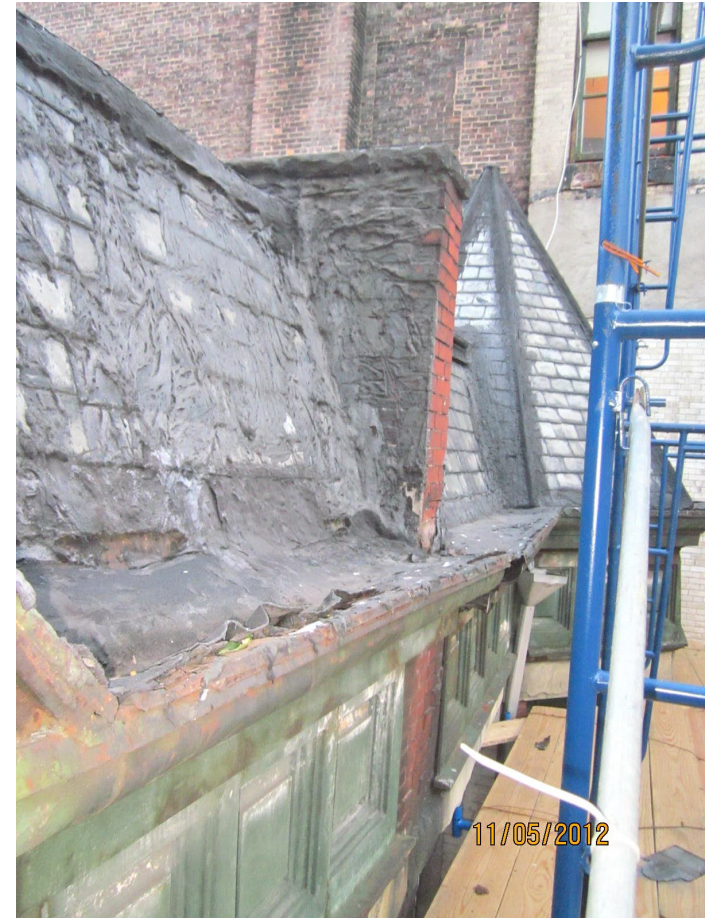
233 West 75th Street (Severe deterioration of Mansard and Gable Roofs and Integral gutter)
Photos taken 2012

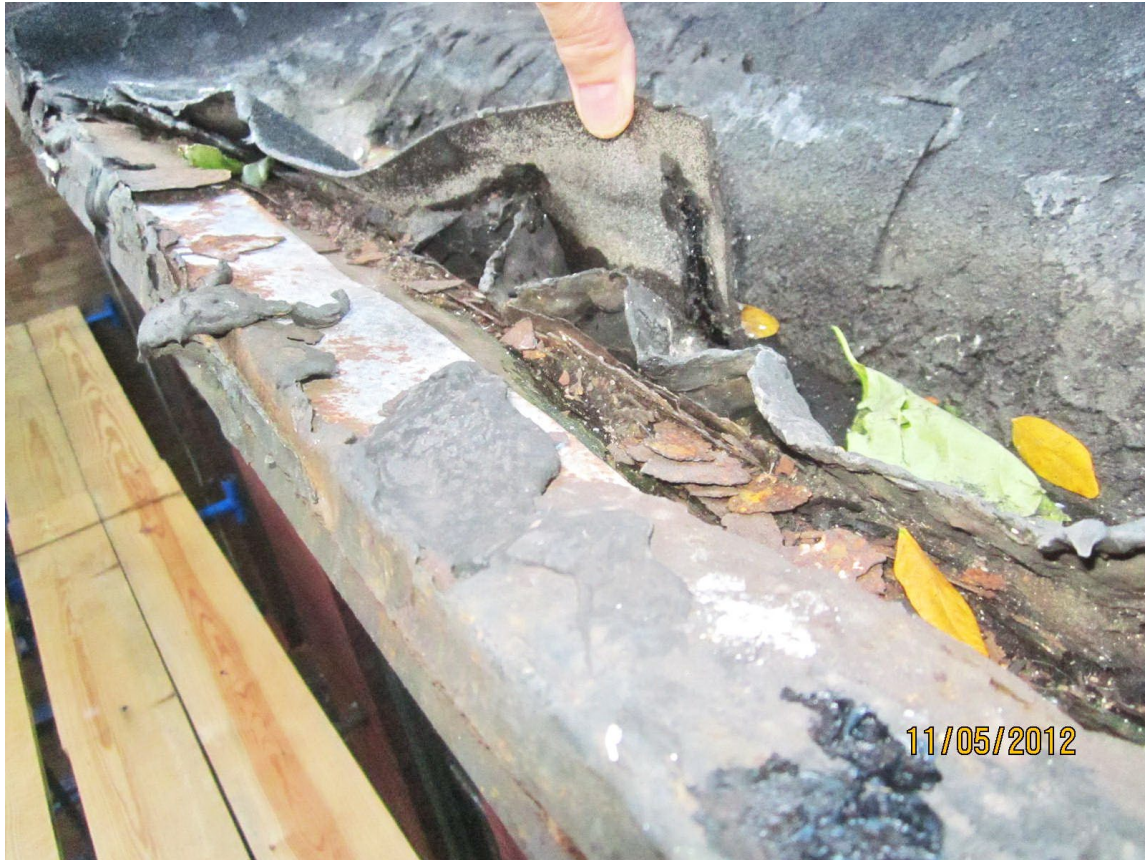
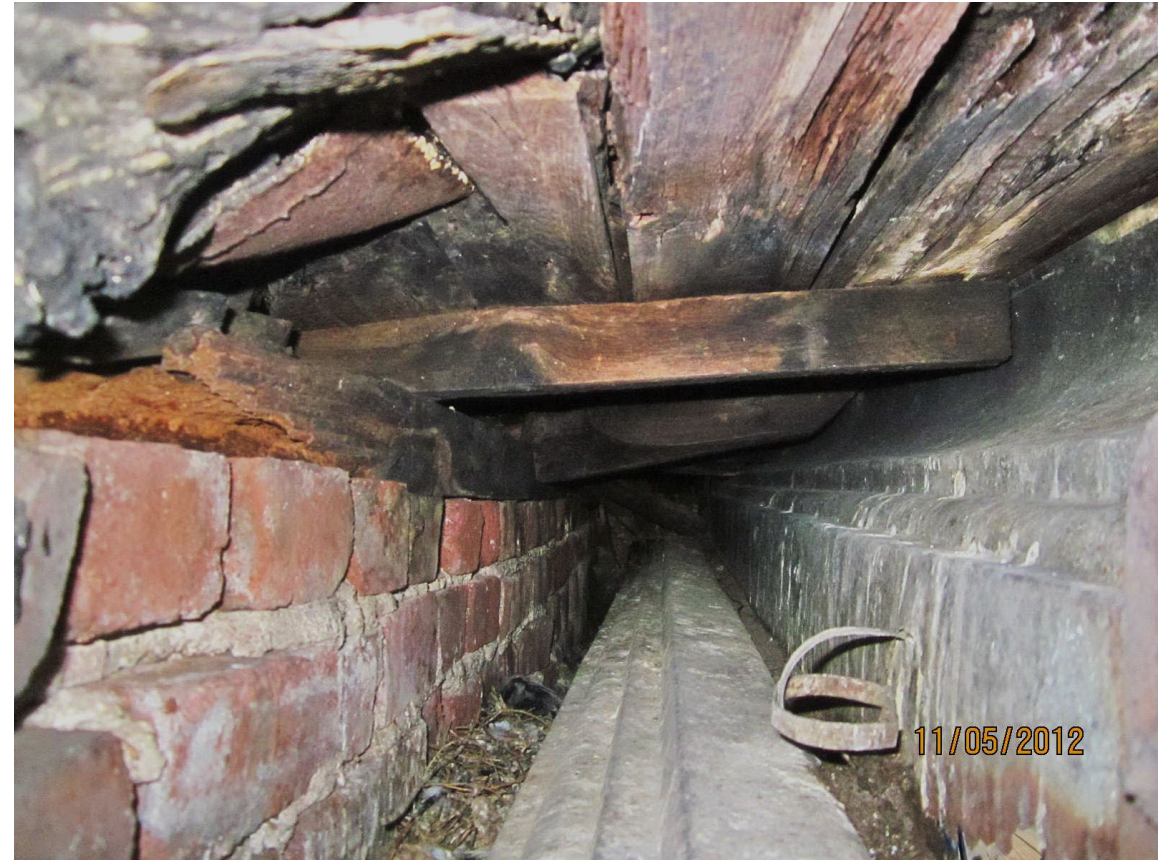
Photos Taken 2012

233 West 75th Street (Severe deterioration at Mansard Roof and underlying brick masonry)

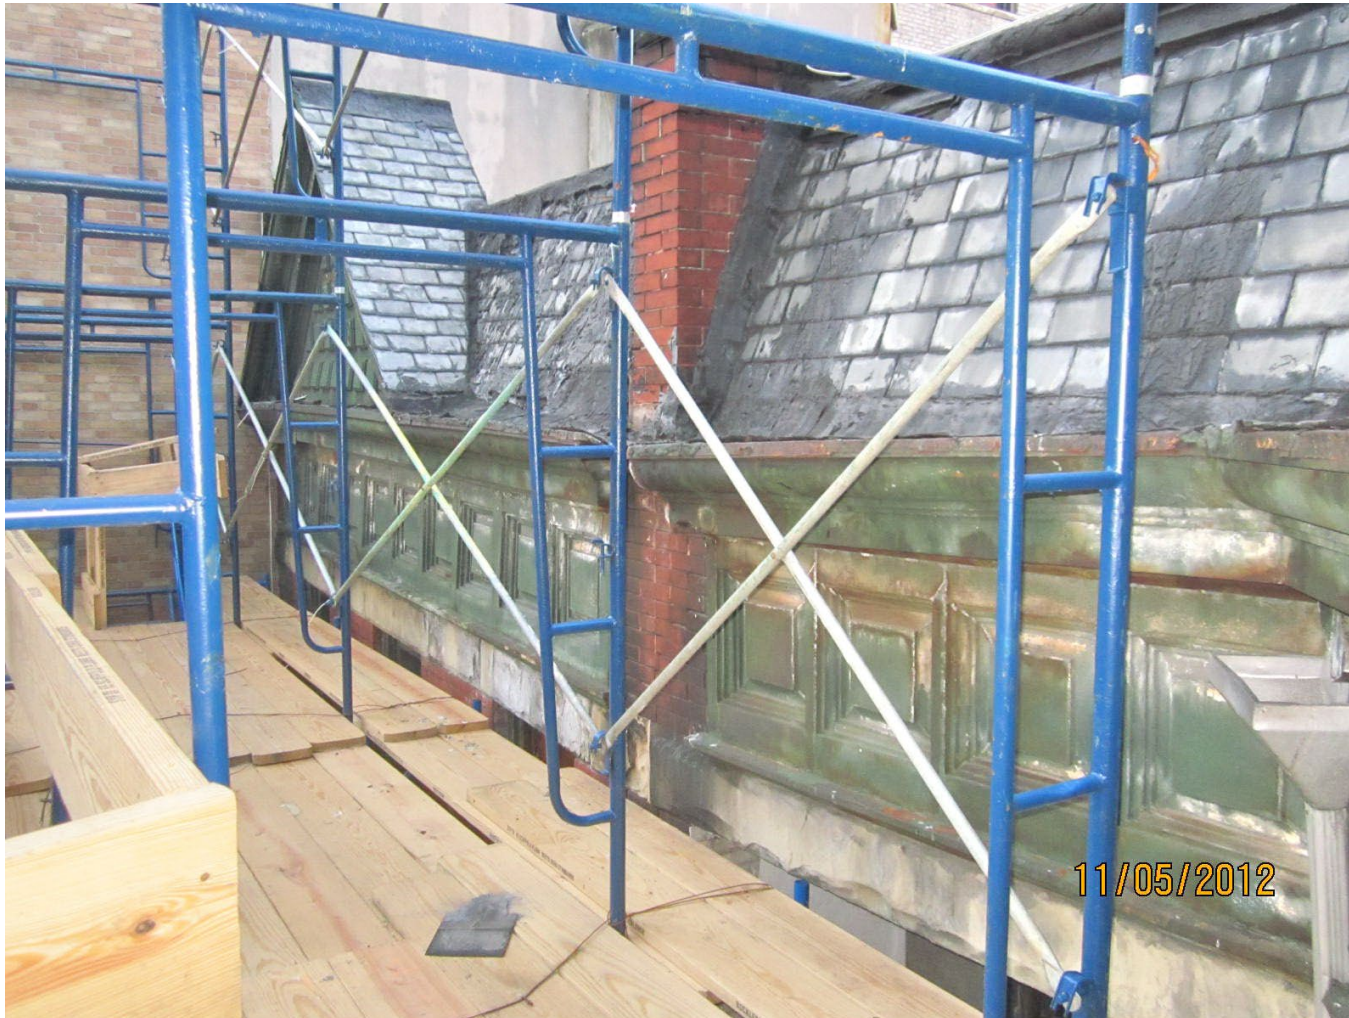
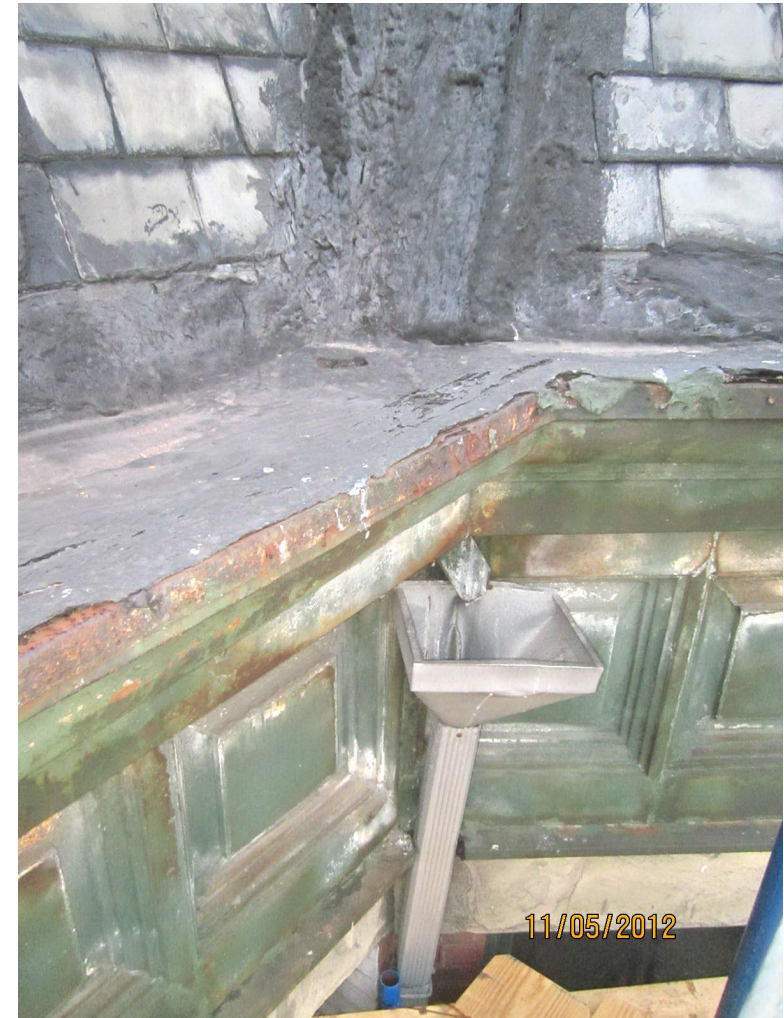
231 West 75th Street (Mansard and Turret Roof)

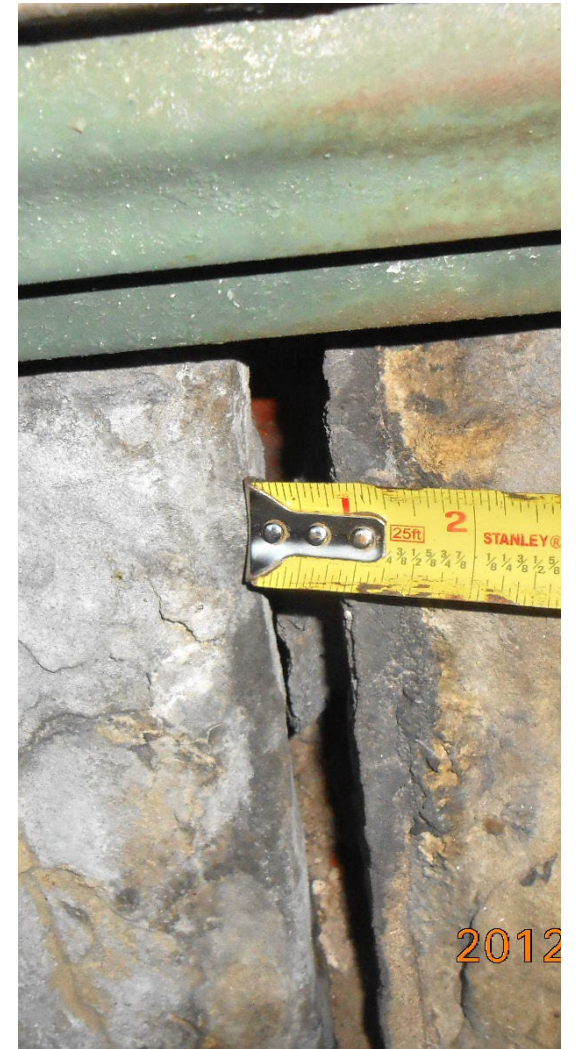
Photos Taken 2012

231 / 233 West 75th Street (Differential Façade Settlement visible at misaligned gutters and mortar joint widths)
