Re: 711 West End Avenue/Fraud, Pervasive Hazardous Conditions

RE: 711 West End Avenue Exterior Walls

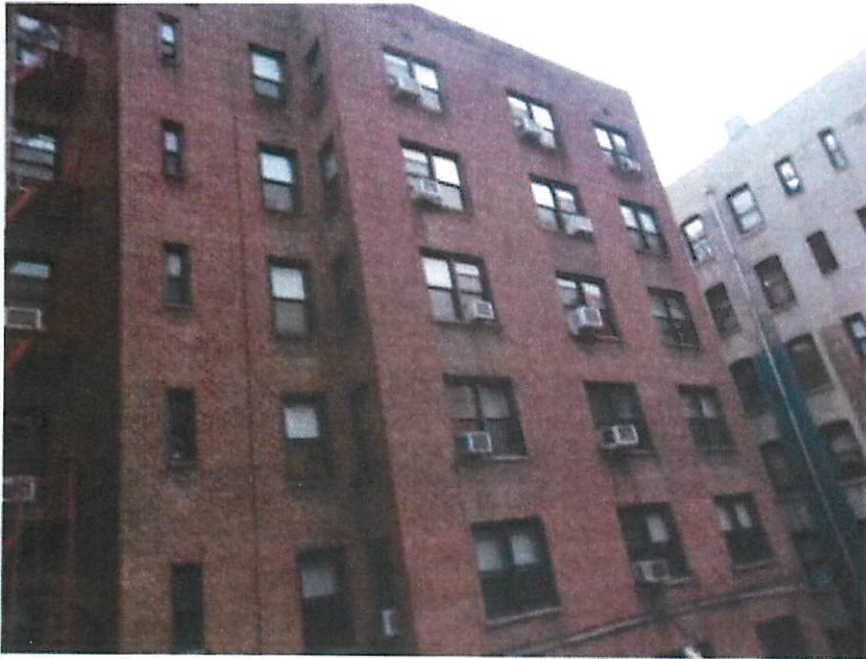
Like the exterior walls facing the street, the walls facing the garage roof are brick and date back to about 1950. These walls exhibit moderately to severely deteriorated brick joints concentrated primarily below window sills. There is also similar deterioration visible along a portion of the parapet wall. These locations are as follows.

All observed mortar deterioration is severe enough to allow water penetration. Much of this water penetration has been corroborated by observable damage along the interior of the wall. As this was a visual inspection, direct probing is necessary to determine if any of the mortar deterioration is severe enough to allow bricks to fall.

Exterior walls at south side of garage roof (facing north).

It is strongly recommended that the additional defects discussed within this report be thoroughly repaired as soon as possible. Once exterior wall repairs are complete, the exterior walls in general should be tested for representative vibration levels prior to any proposed construction that might cause the type of disturbance described herein. Furthermore, it is recommended that all city agencies responsible for enforcing applicable codes be informed of these findings and that the full force of the law be applied to protect both tenants and neighbors from these potential hazards.

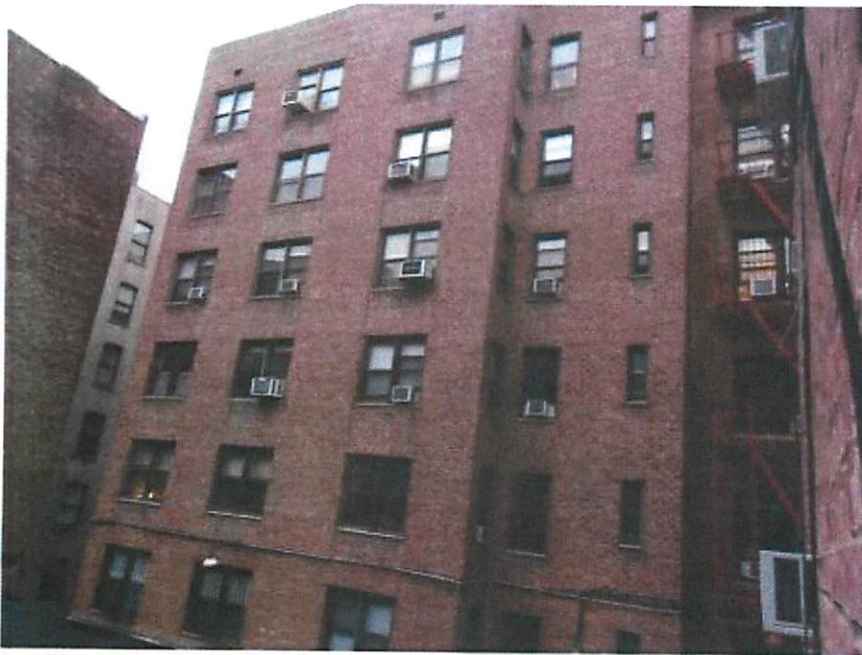
These walls exhibit moderately to severely deteriorated brick joints concentrated primarily below window sills. These locations are as follows.

All observed mortar deterioration is severe enough to allow water penetration. Much of this water penetration has been corroborated by observable damage along the interior of the wall. As this was a visual inspection, direct probing is necessary to determine if any of the mortar deterioration is severe enough to allow bricks to fall.

Exterior walls at north side of garage roof (facing south).

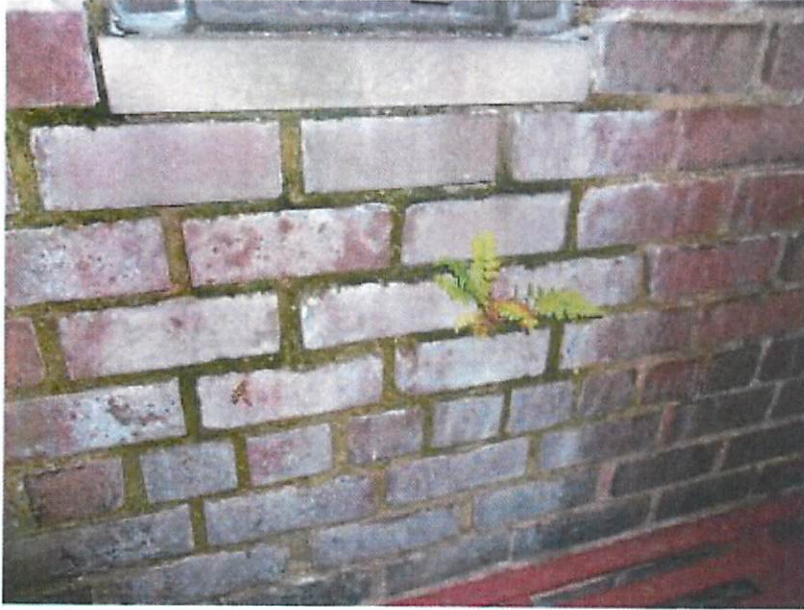
Most notable is the damage beneath the 5<sup>th</sup> story bathroom window (Area J1), noted originally during my inspection this past January. At this location, mortar has deteriorated virtually completely and plant growth in the joints is clearly visible. There is pronounced water damage along the inside of the wall. This condition is hazardous and has been allowed to deteriorate over many years.

Beneath 5th story window, exterior wall facing west at south wing.

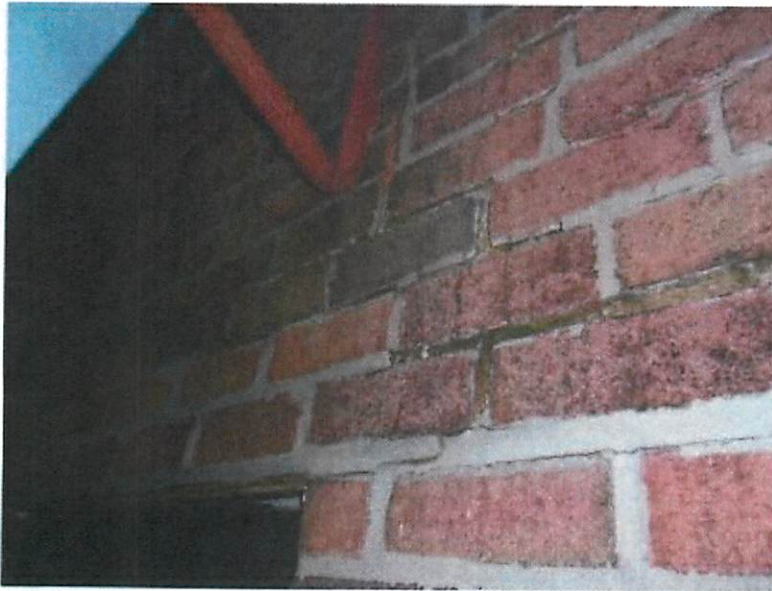
These walls exhibit moderately to severely deteriorated brick joints concentrated primarily below window sills. There is also similar deterioration visible along a portion of the parapet wall. These locations are as follows.

Along parapet, exterior wall facing west at south wing.

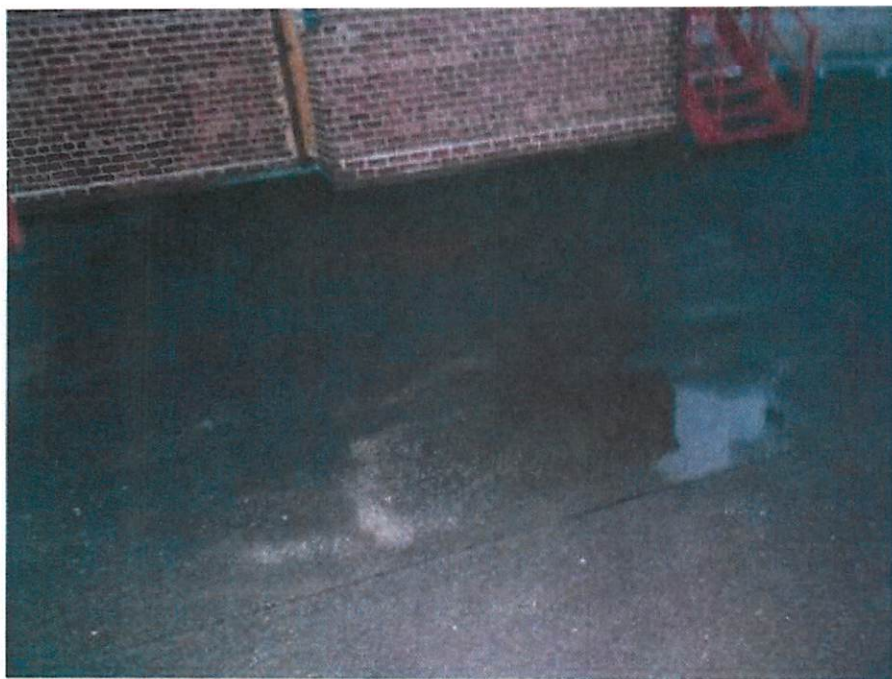
The inspection was performed the day after a heavy rain. The day of inspection, a significant amount of water was still impounded immediately west of the south bulkhead. The surrounding roofing membrane was saturated as well. These defects correspond to long term visible water damage along the hallway ceiling and walls below.

Roof, immediately west of the south bulkhead.

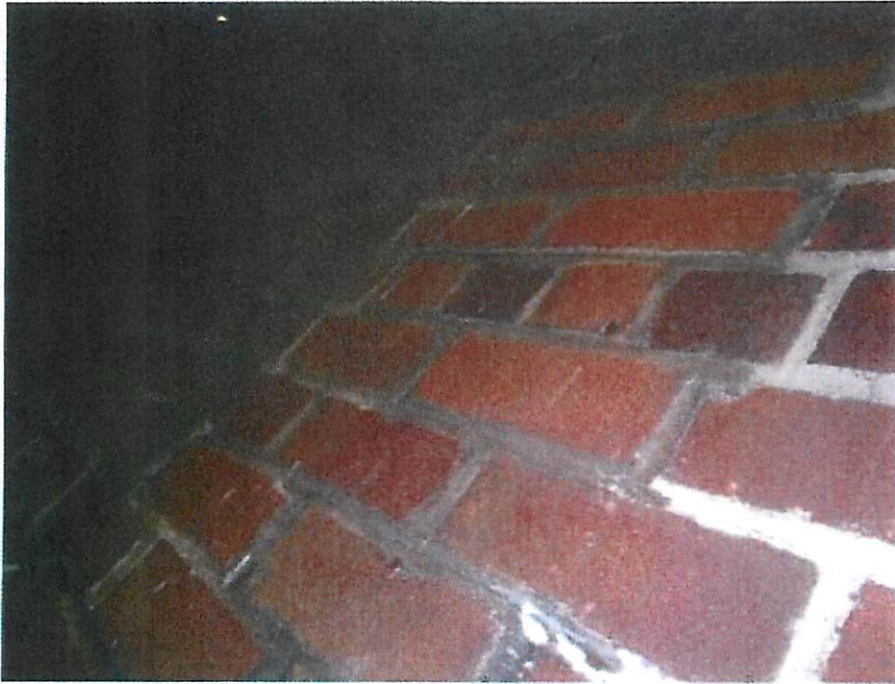
However, there are definite flaws in the work as well as additional potential flaws. New pointing, like the old, should be beveled rather than flat, to promote proper drainage. The joints observed look more like a patch.

The joints gave a bit of a hollow sound when tapped. This may indicate that scoring of the old loose mortar was not complete and/or that the new pointing was not thoroughly packed. This cannot be known with certainty without permission to perform an invasive probe of the joints.

The new mortar was very hard when subjected to tapping and scratching. This result is not necessarily positive. The pointing material may, in fact, be too hard which, counter-intuitively,

may cause damage to the brick over multiple freeze-thaw cycles. We cannot determine this for sure without lab testing.

Pointing outside apartment 4-HS.

My understanding is that under the permit issued, this job was not required to engage a special inspector to verify the quality of pointing and related work under controlled conditions. We might want to arrange for such testing independently of the project, but we would nonetheless require cooperation from building management.

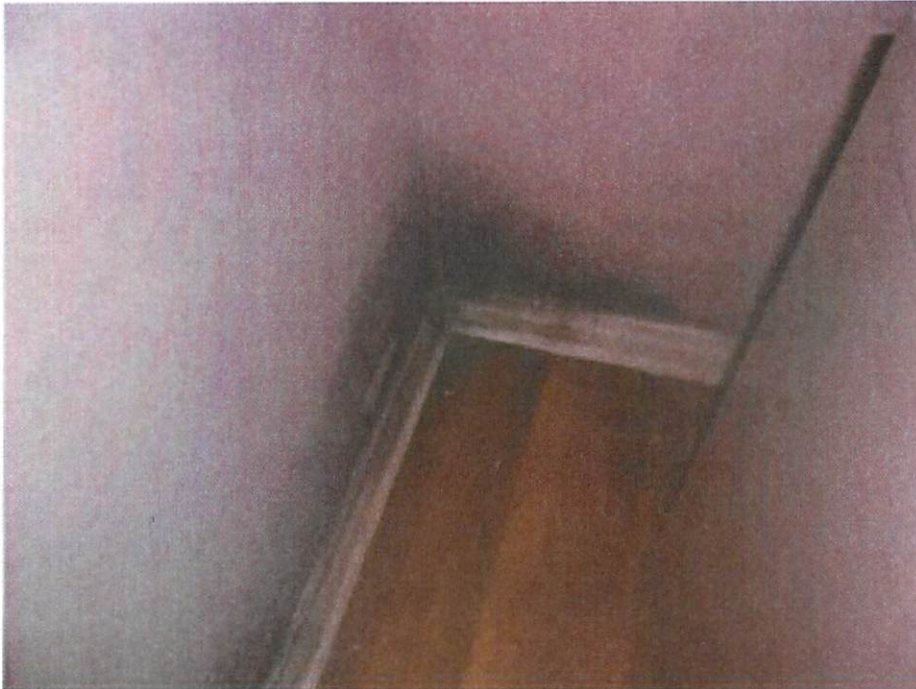
Mold was found at the southwest corner of the southwest bedroom. As observable in the photograph below, dark discoloration of the walls at the bottom corner, along with the spotty pattern are highly indicative of mold growth. The apparent source is water from the exterior side of the wall. Numerous areas of deteriorated pointing have been observed along the rear façade of the building and have led to similar problems throughout the building.

This is a serious issue. Once mold gets in to the gypsum wallboard, particularly the paper, it can grow unchecked. Mold will tend to become more pervasive and dangerous to the health of tenants over time. I recommend a professional mold test be performed. There are many types of mold, ranging from relatively harmless to highly hazardous. Effective treatment includes eliminating the source, ripping out the drywall or equivalent, applying fungicide thoroughly to the brick, and restoring the finish work. A superficial approach will be a waste of time and money. Therefore, professional mold remediation is recommended, both for this apartment and for the others in the building similarly affected.

Mold at southwest corner of southwest bedroom, Apartment 3M-S.
