CURRENT SCHOOL BUILDING

BUILDING ENTRY MODIFICATION for ADA ACCESS

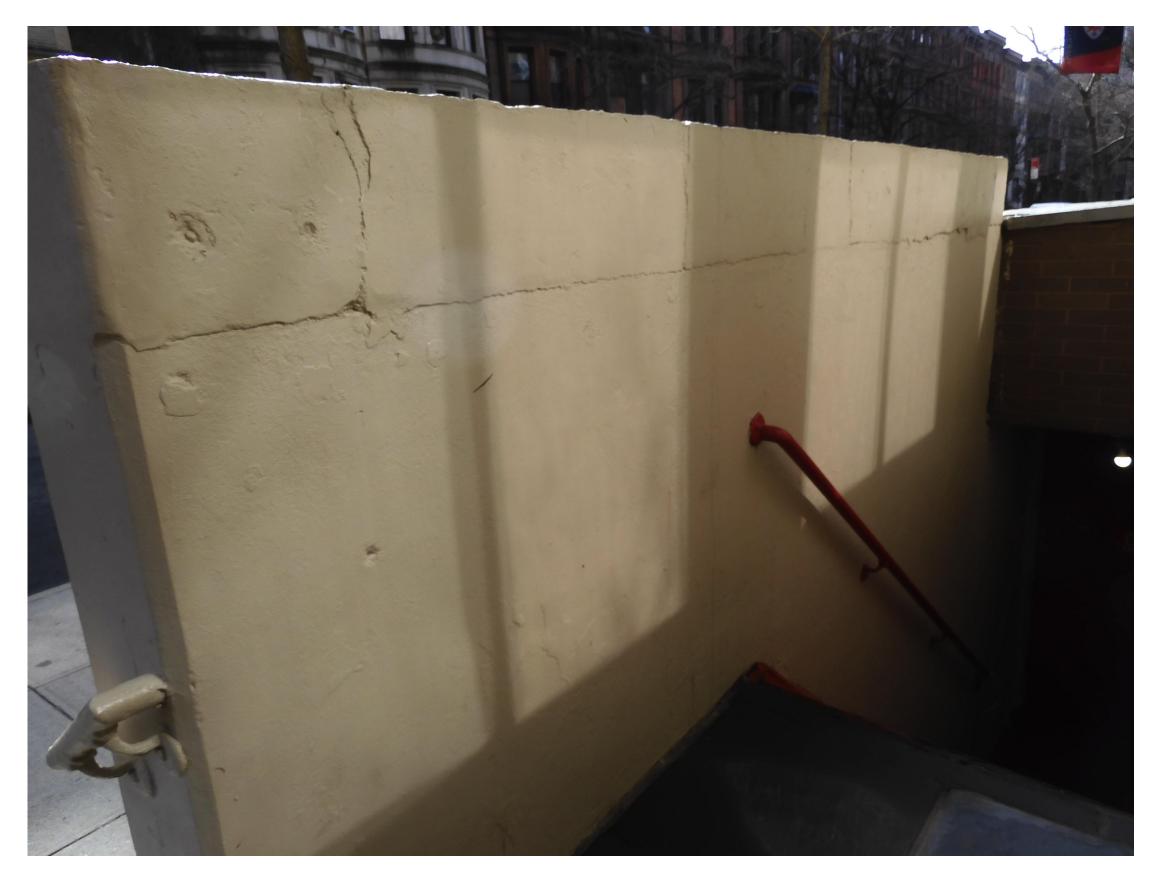
DETERIORATING CONCRETE WALL

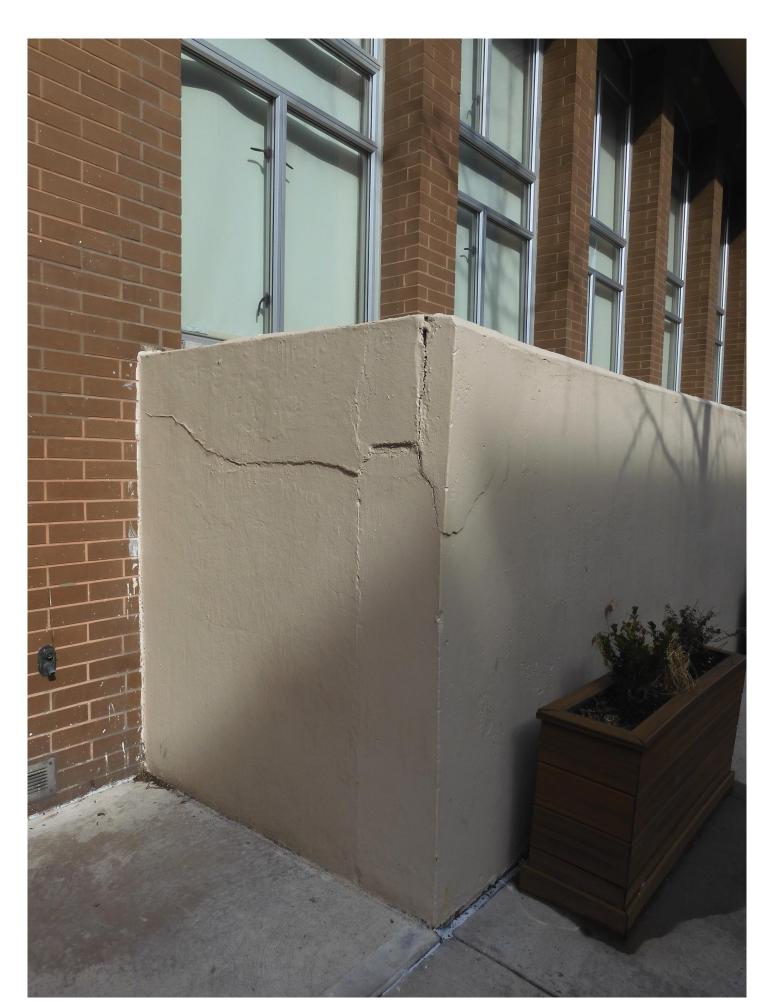
SPALLED CONCRETE WALL

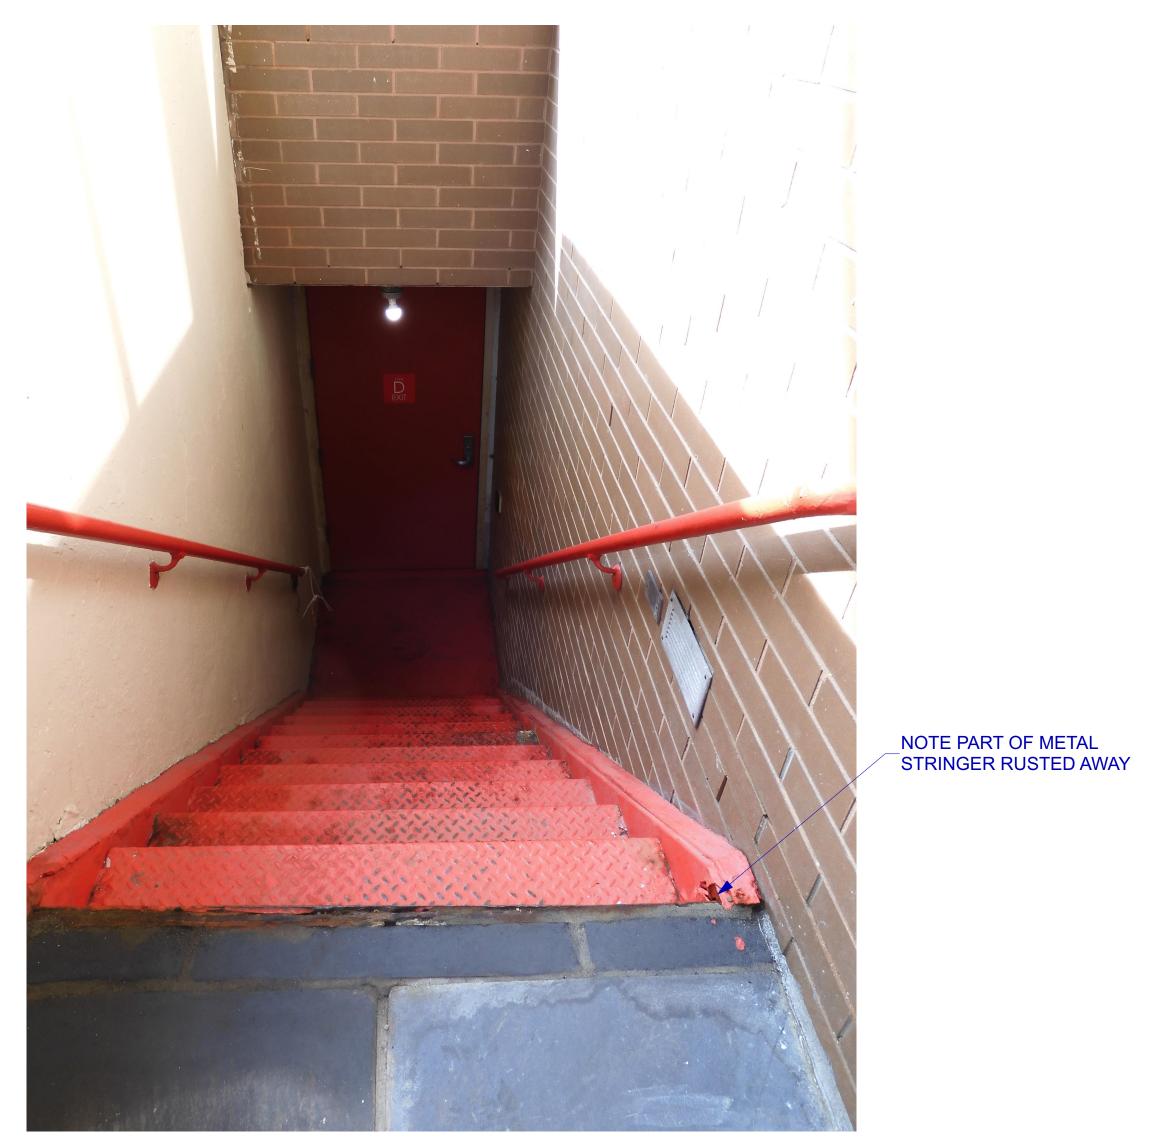
VIEW OF RUSTING METAL STAIR

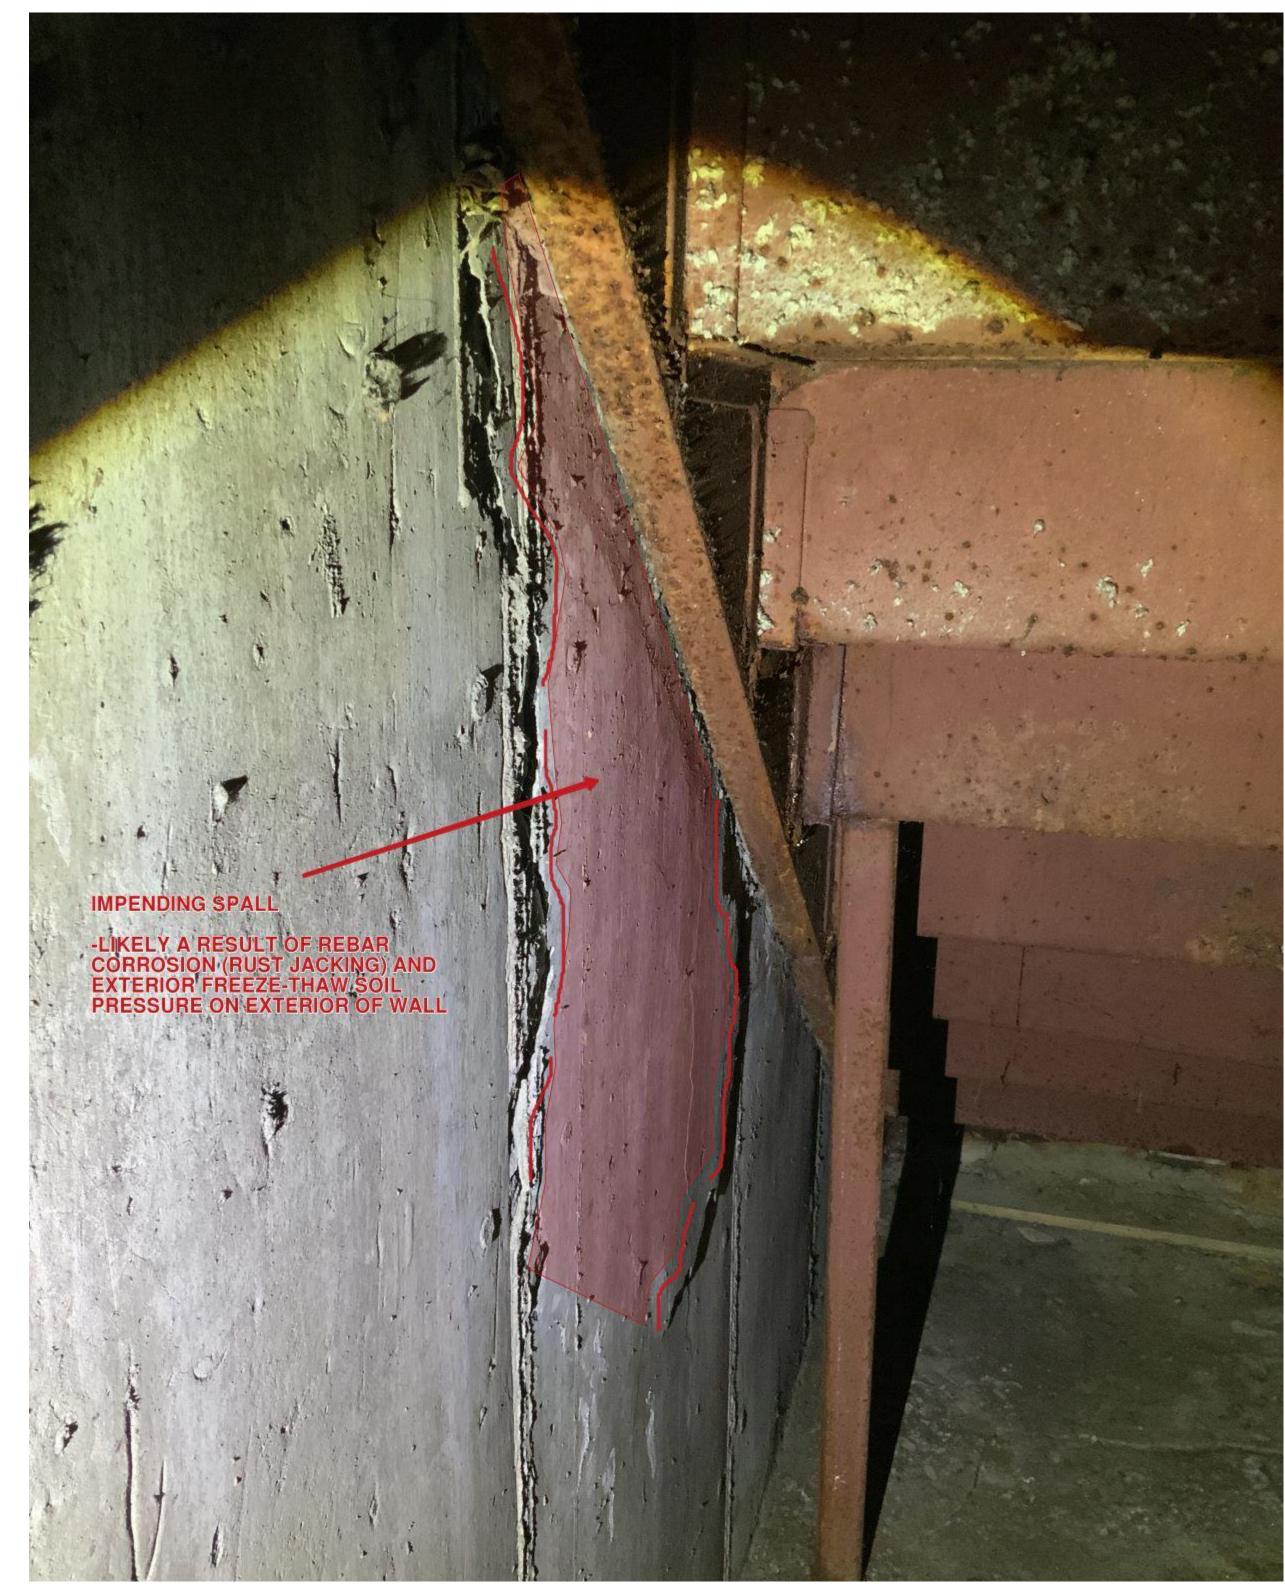
WALL DETERIORATION

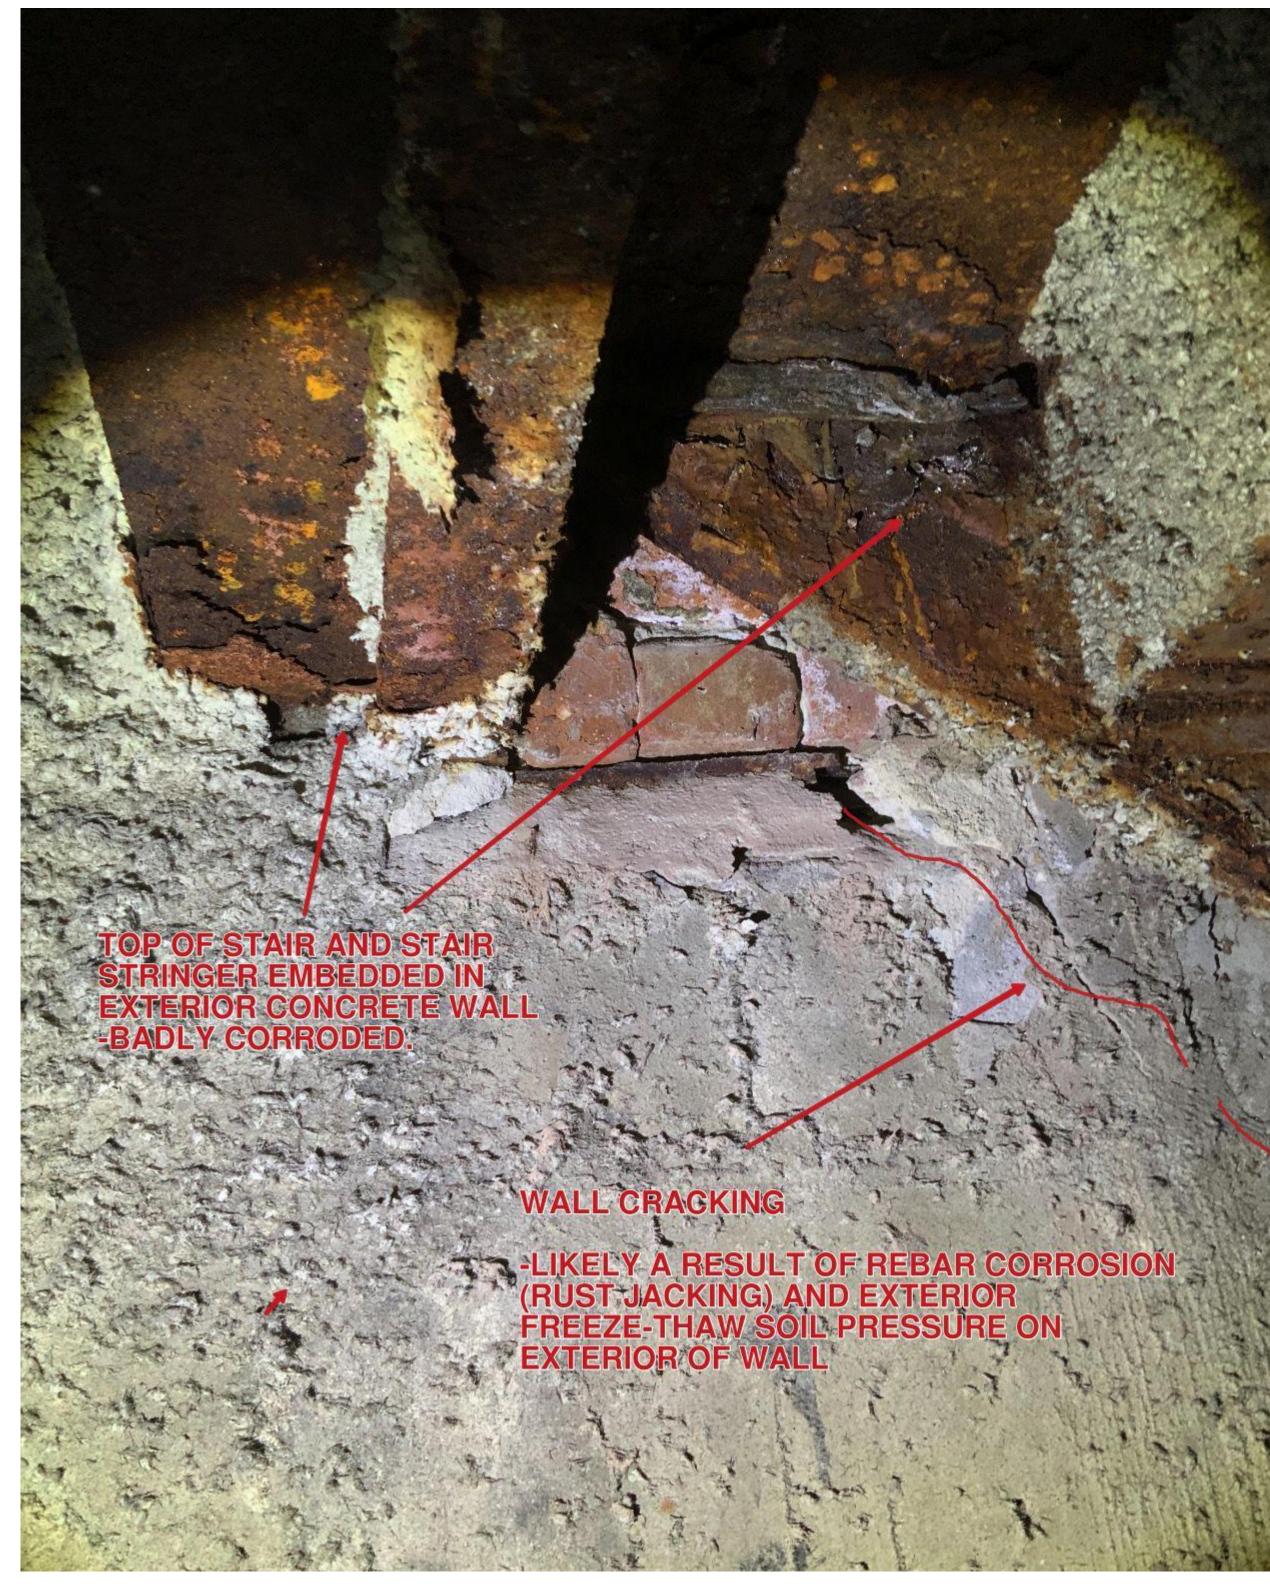
LANDING BEAM & STAIR CONDITION
