I <Heart> Brownstones: Not Just a Pretty Façade

LANDMARK WEST! March 3, 2017

Master Craftsman. J. Pontes, Inc.

Common Causes of Stone Deterioration

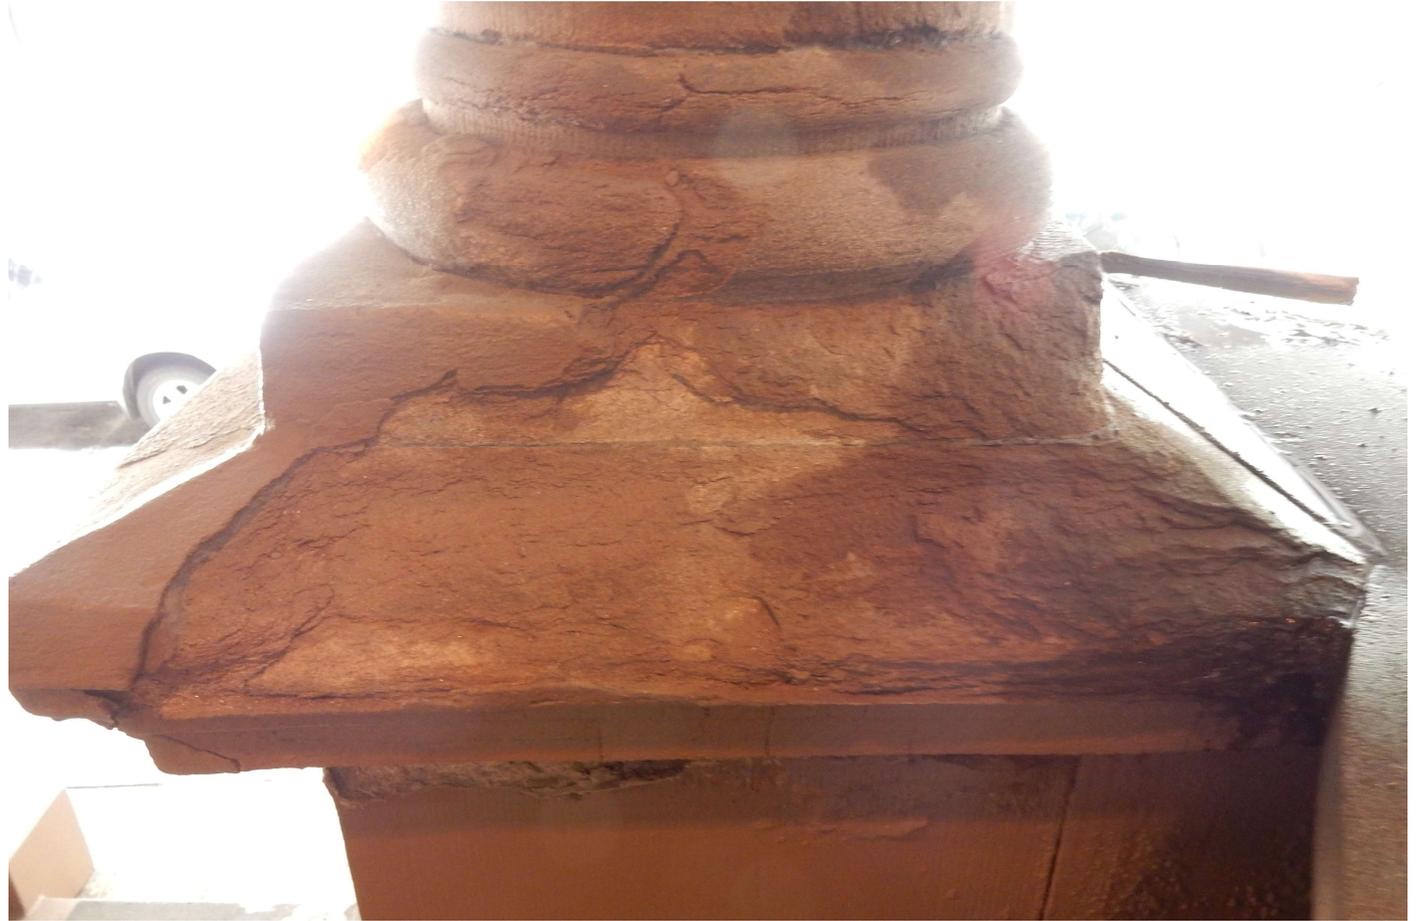
Chemicals

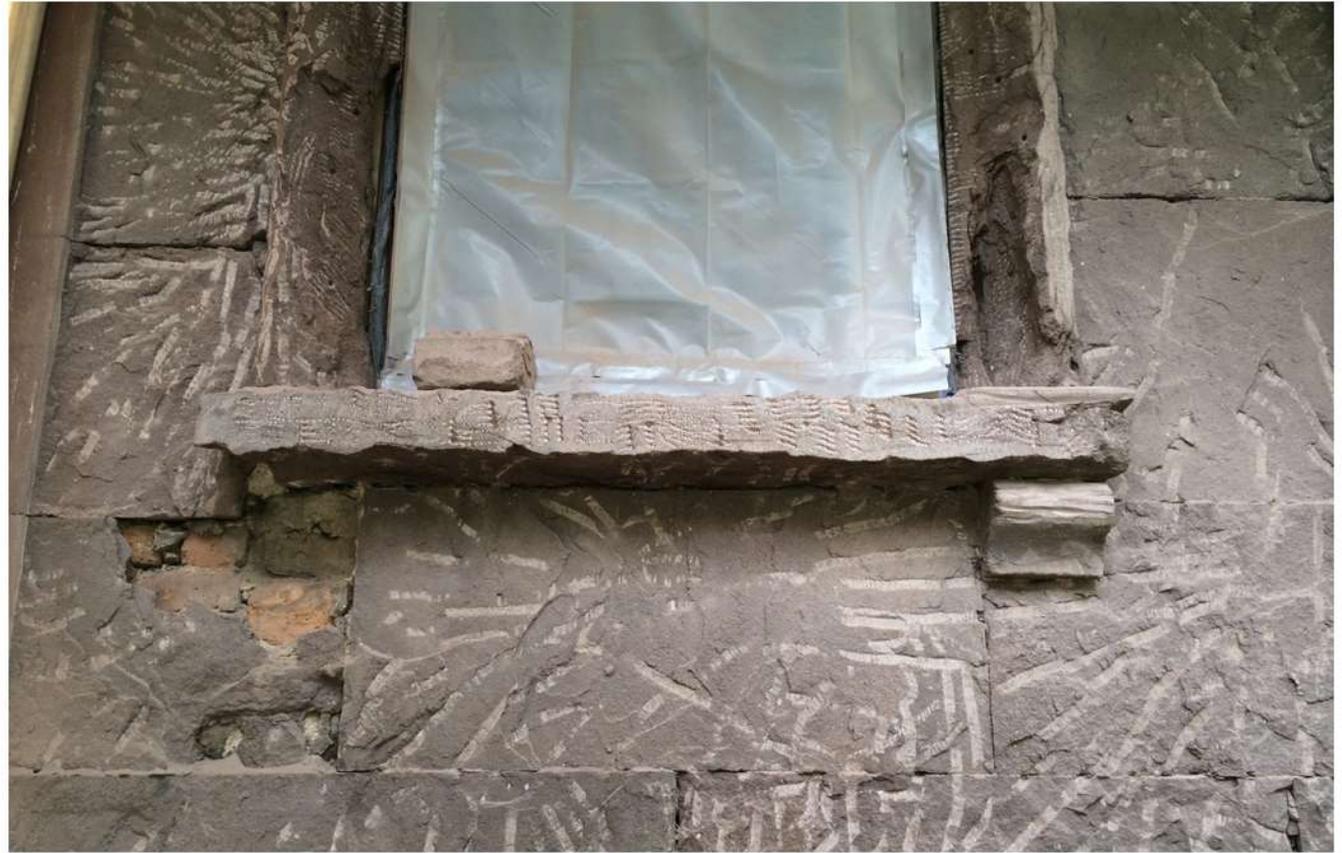
Deterioration

Water damage --
note interior
structural wall visible

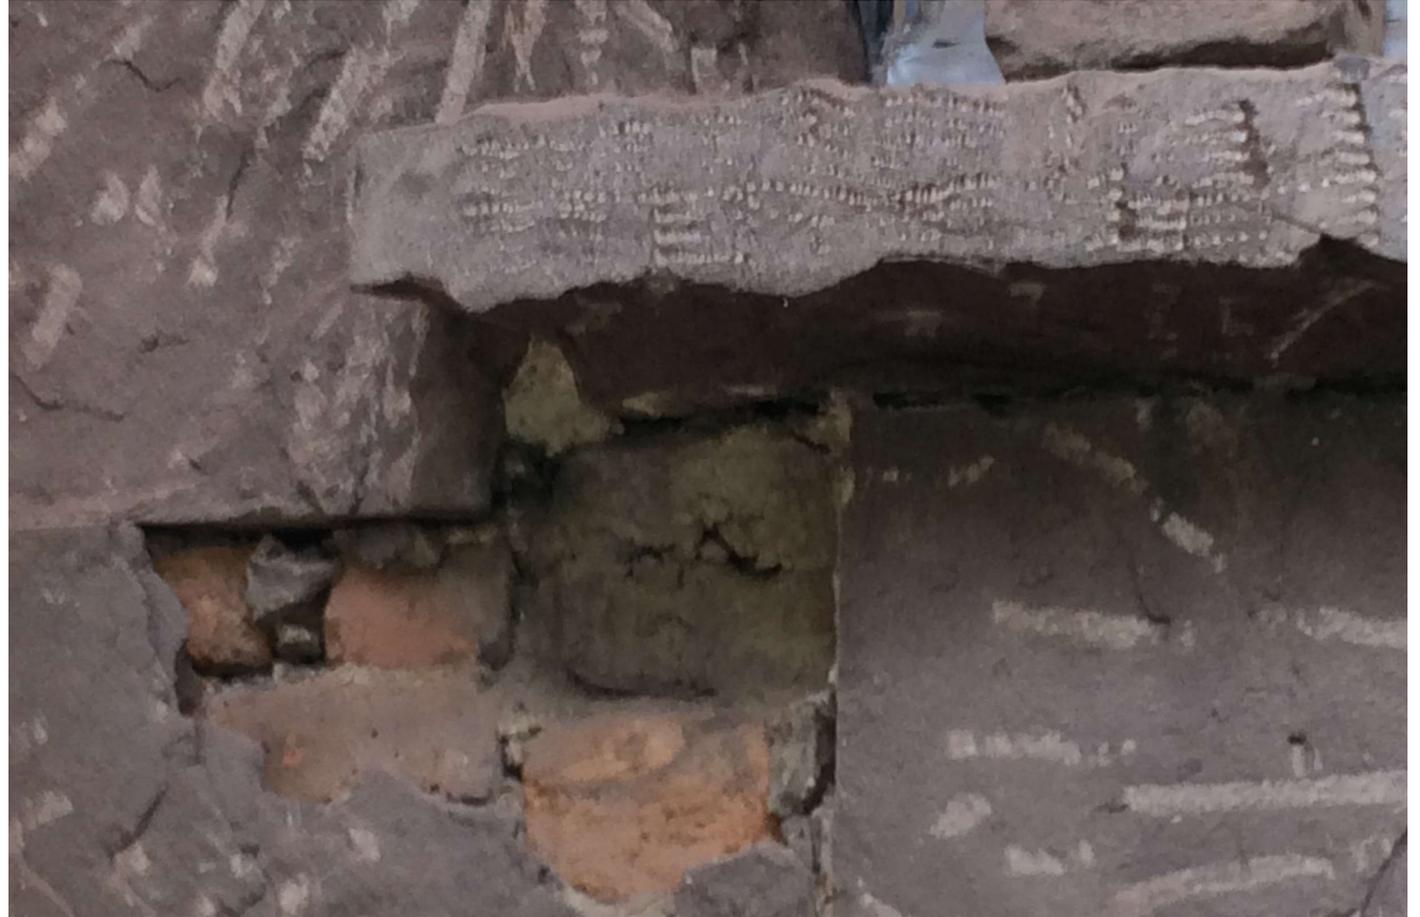
Stone Deterioration
Missing keystone

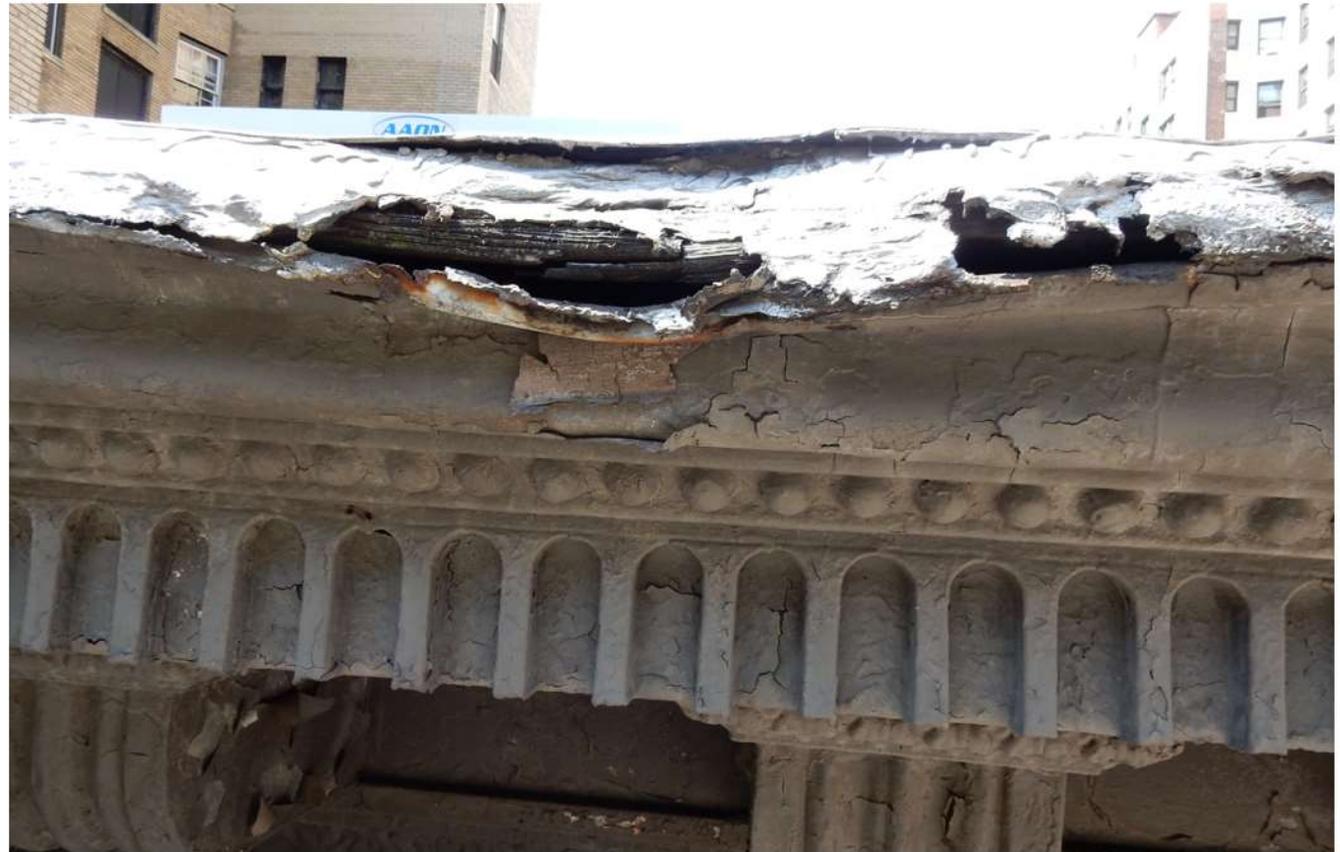
Owners may not realize they have serious roof damage

Allows water seepage into the façade

Neglect leads to significant future problems for the entire façade

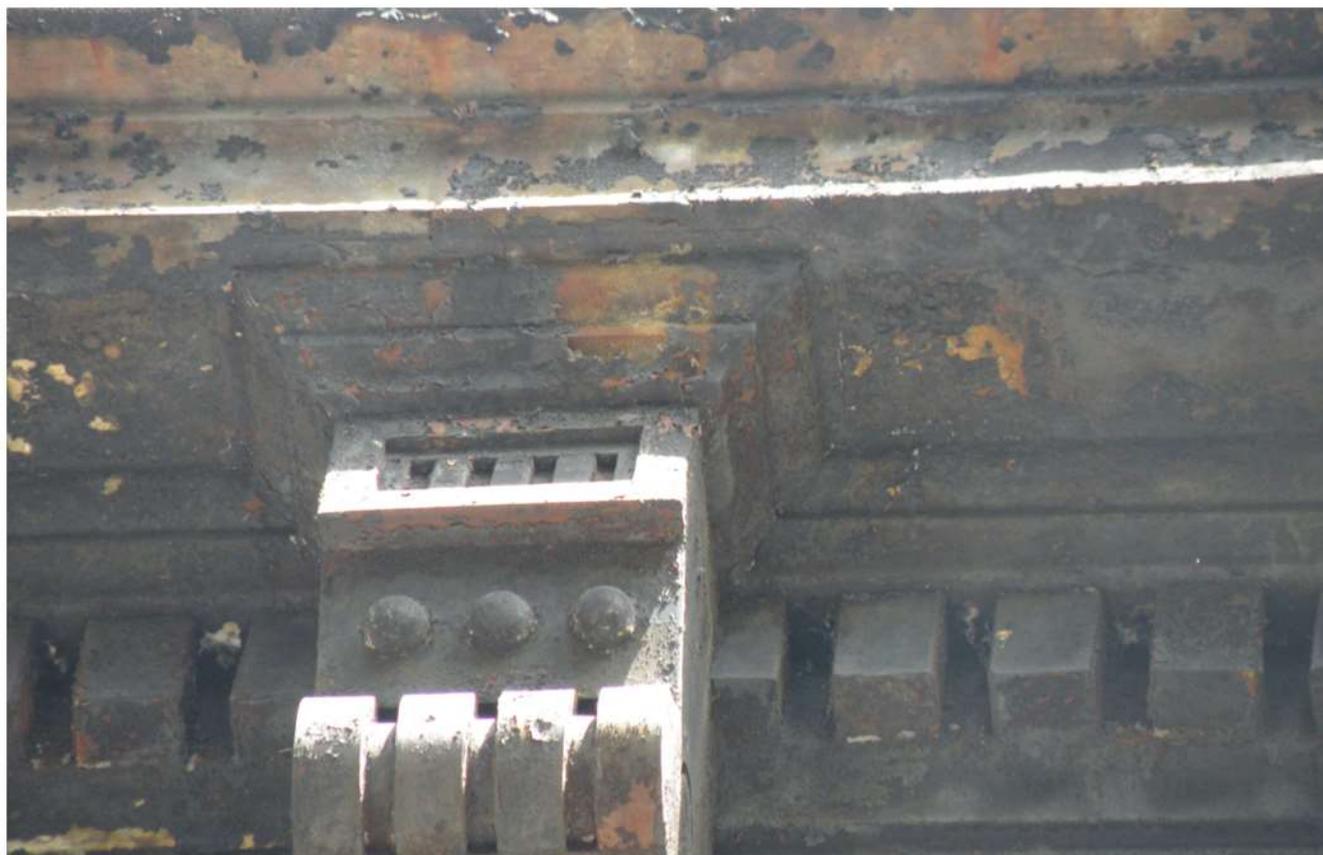
Cornice Deterioration

Heavy duty rust
starting

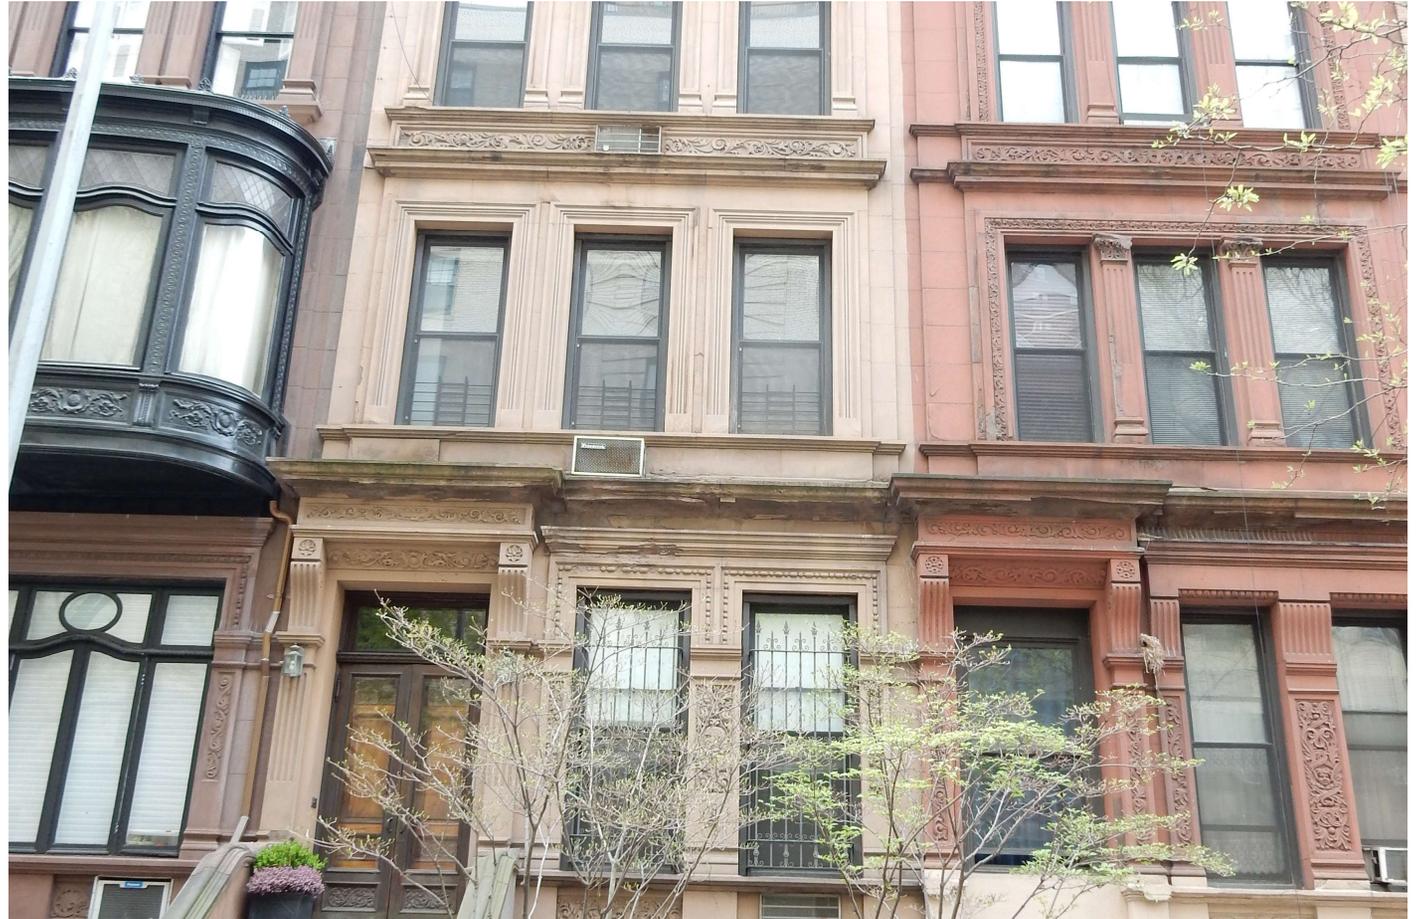
Façade Before
restoration

Stone deterioration

Air Conditioner
Openings

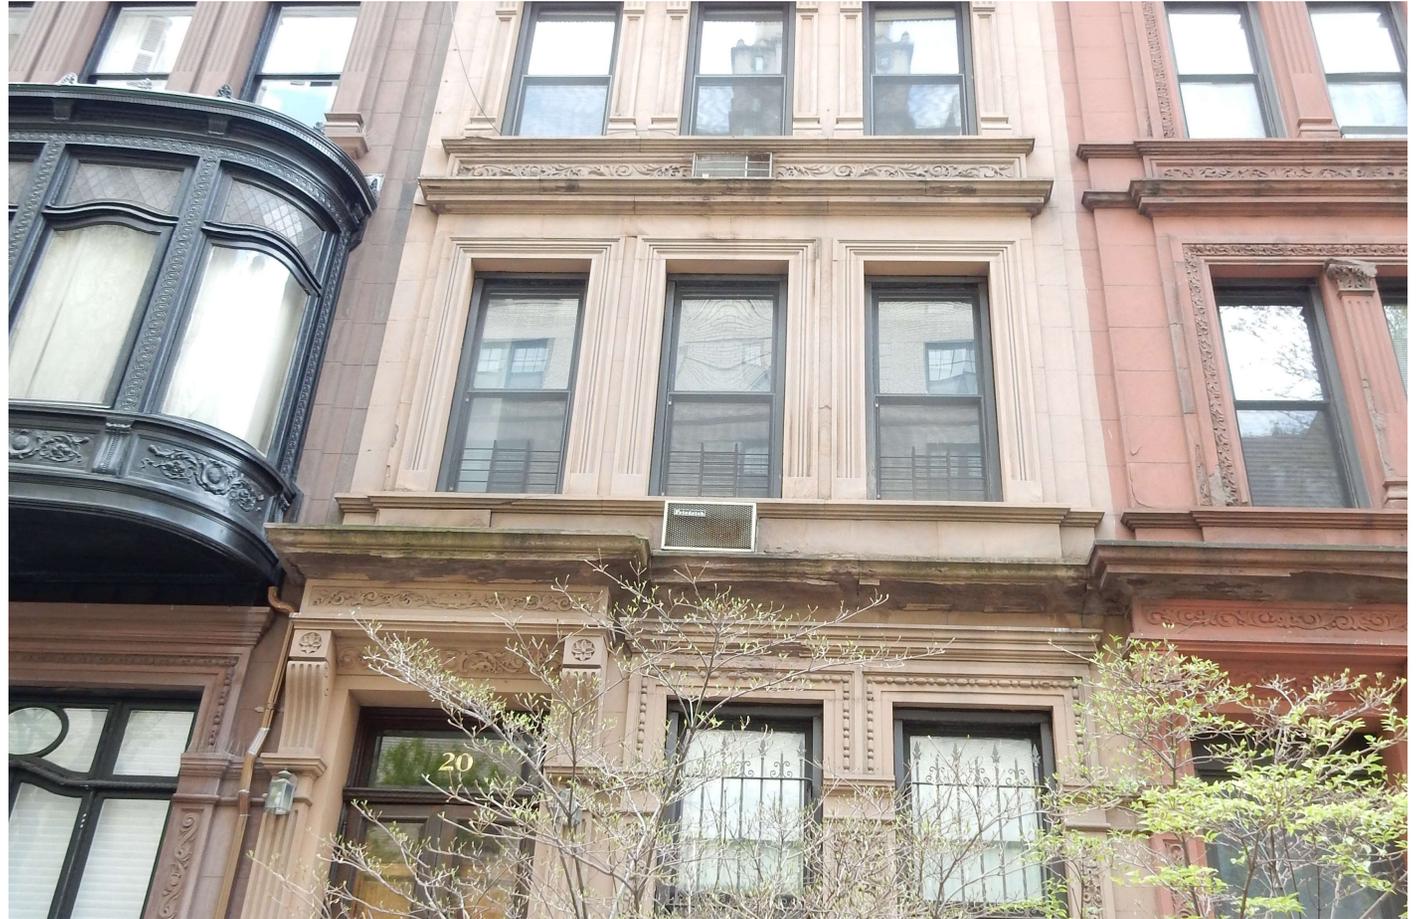
Façade Before Restoration

Deterioration

Air Conditioner
window sleeves

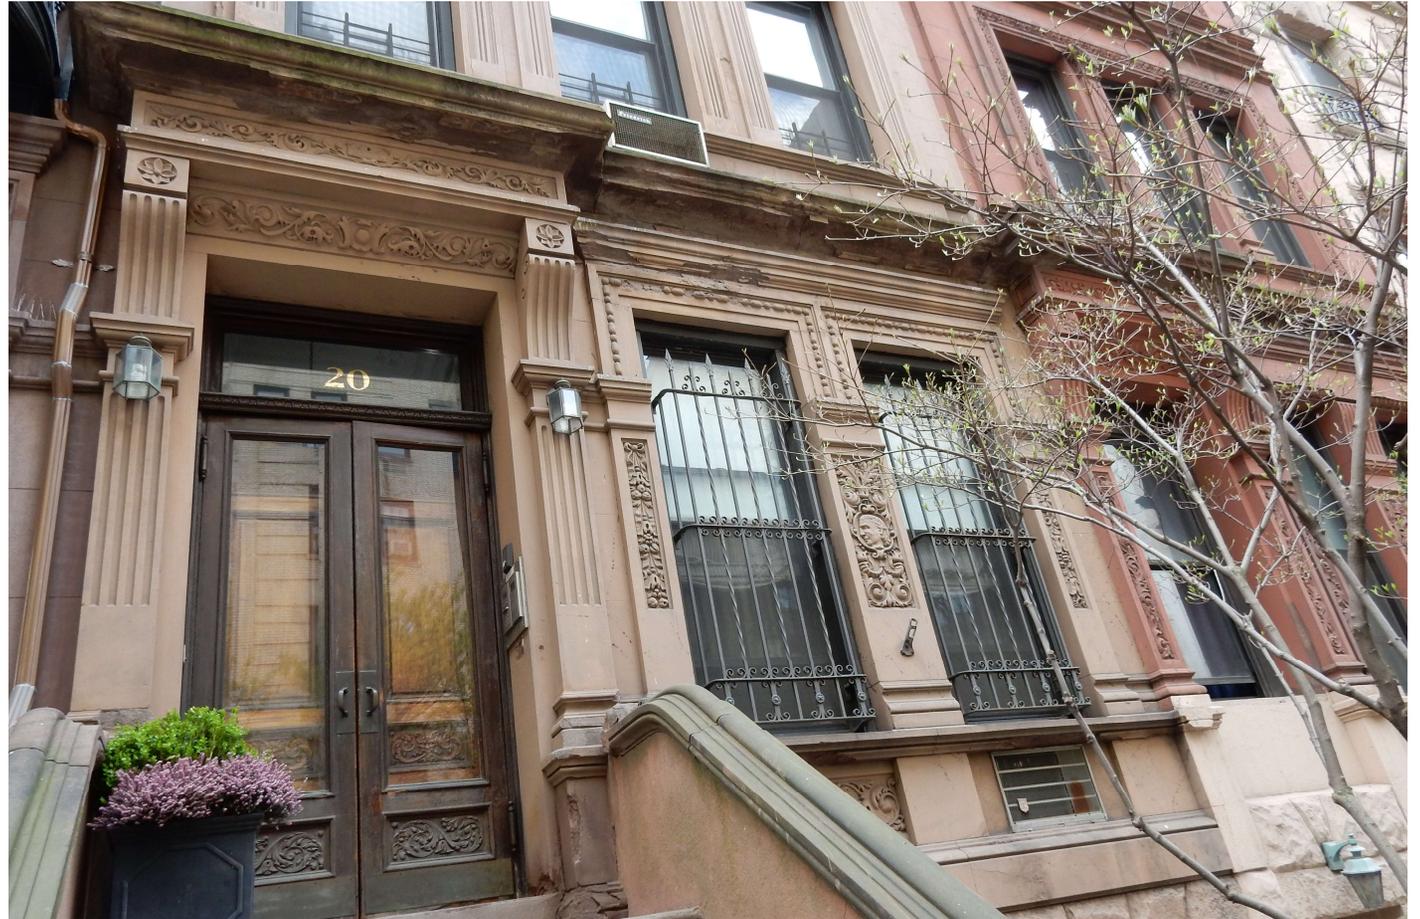
Before:

Front Door
Stoop railing
without
Balustrade

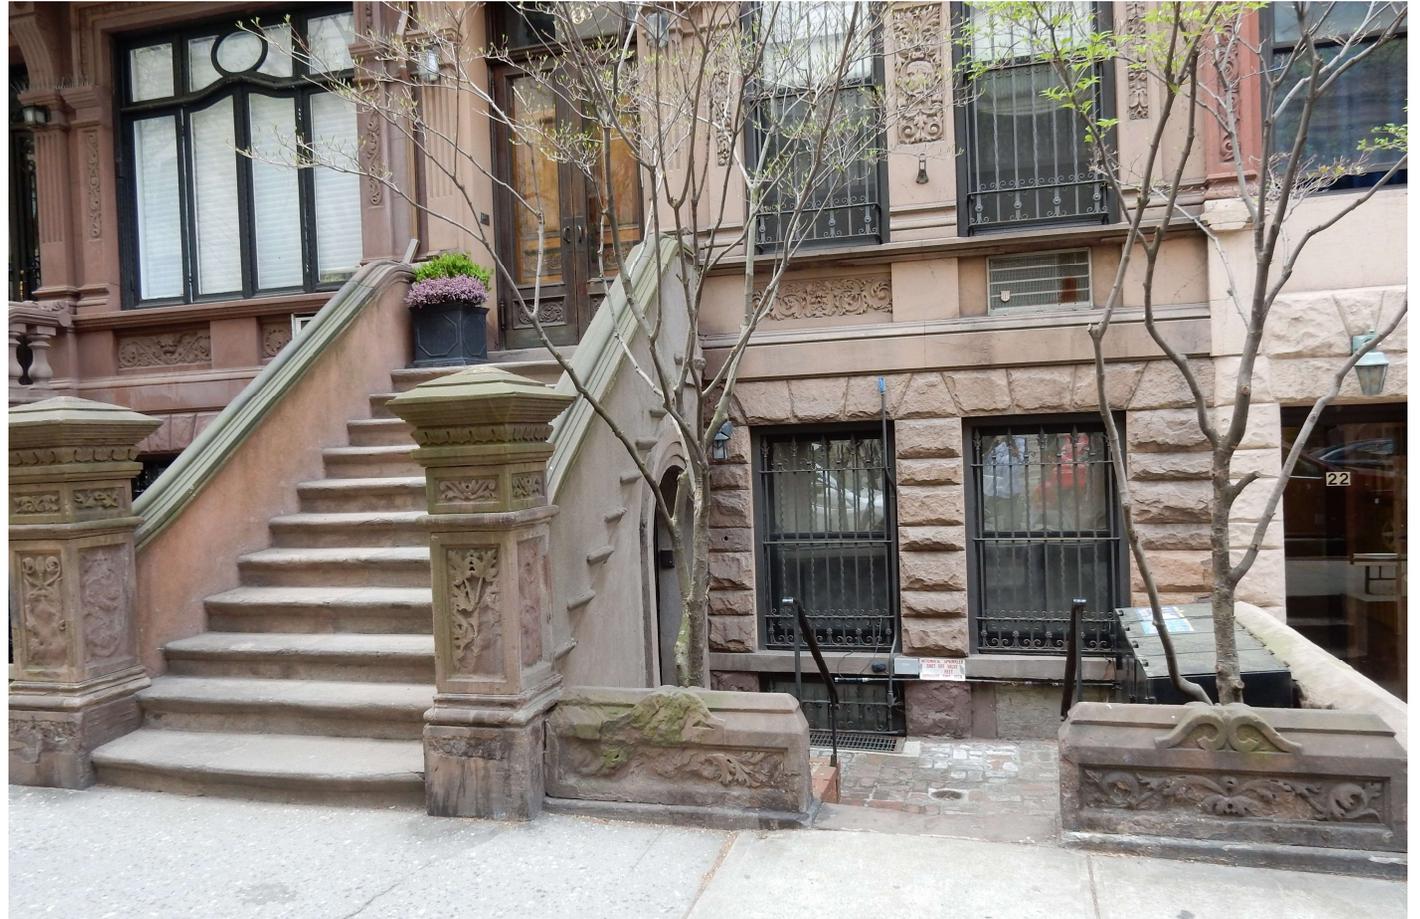
Lower façade
pre-restoration

Knee walls and
columns

Missing original
details

Lower areas
more susceptible
to salt damage

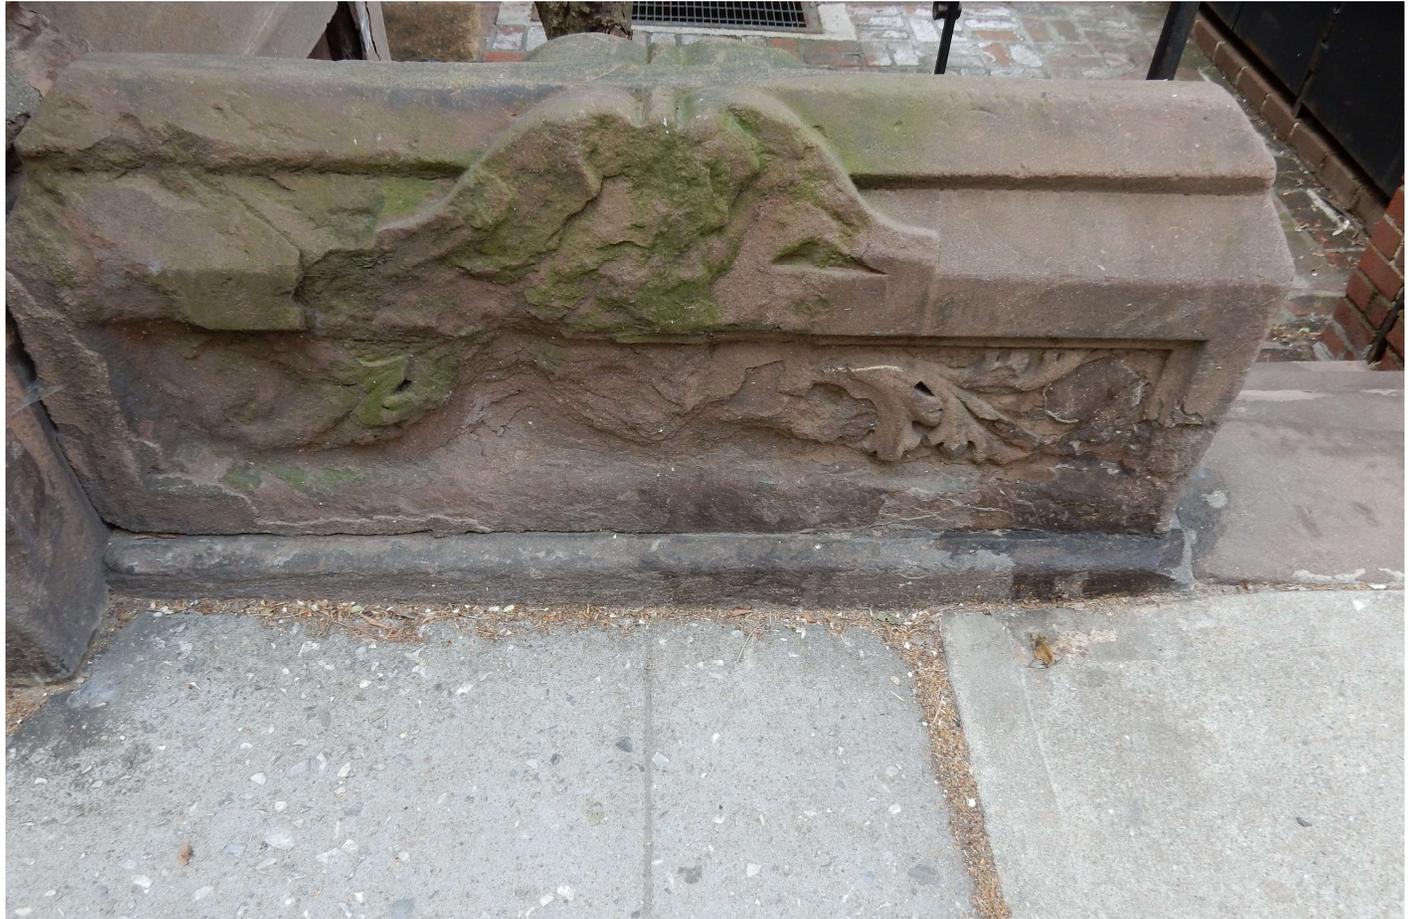
Before

Salt damage and
Deterioration

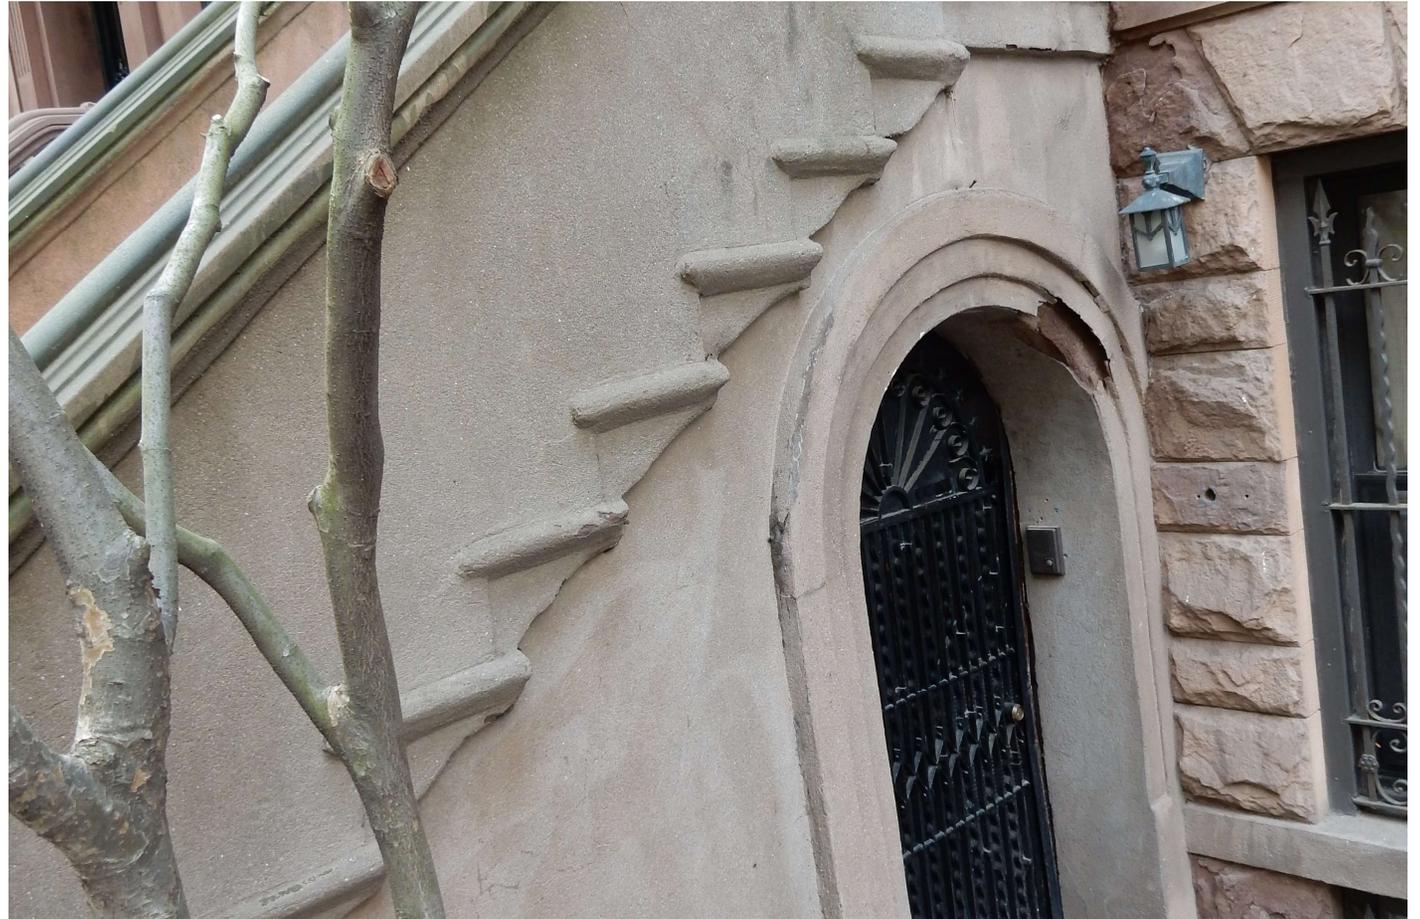
West side stoop
is missing
original details

Door surround
missing details

Stucco wall
replaced
balustrades

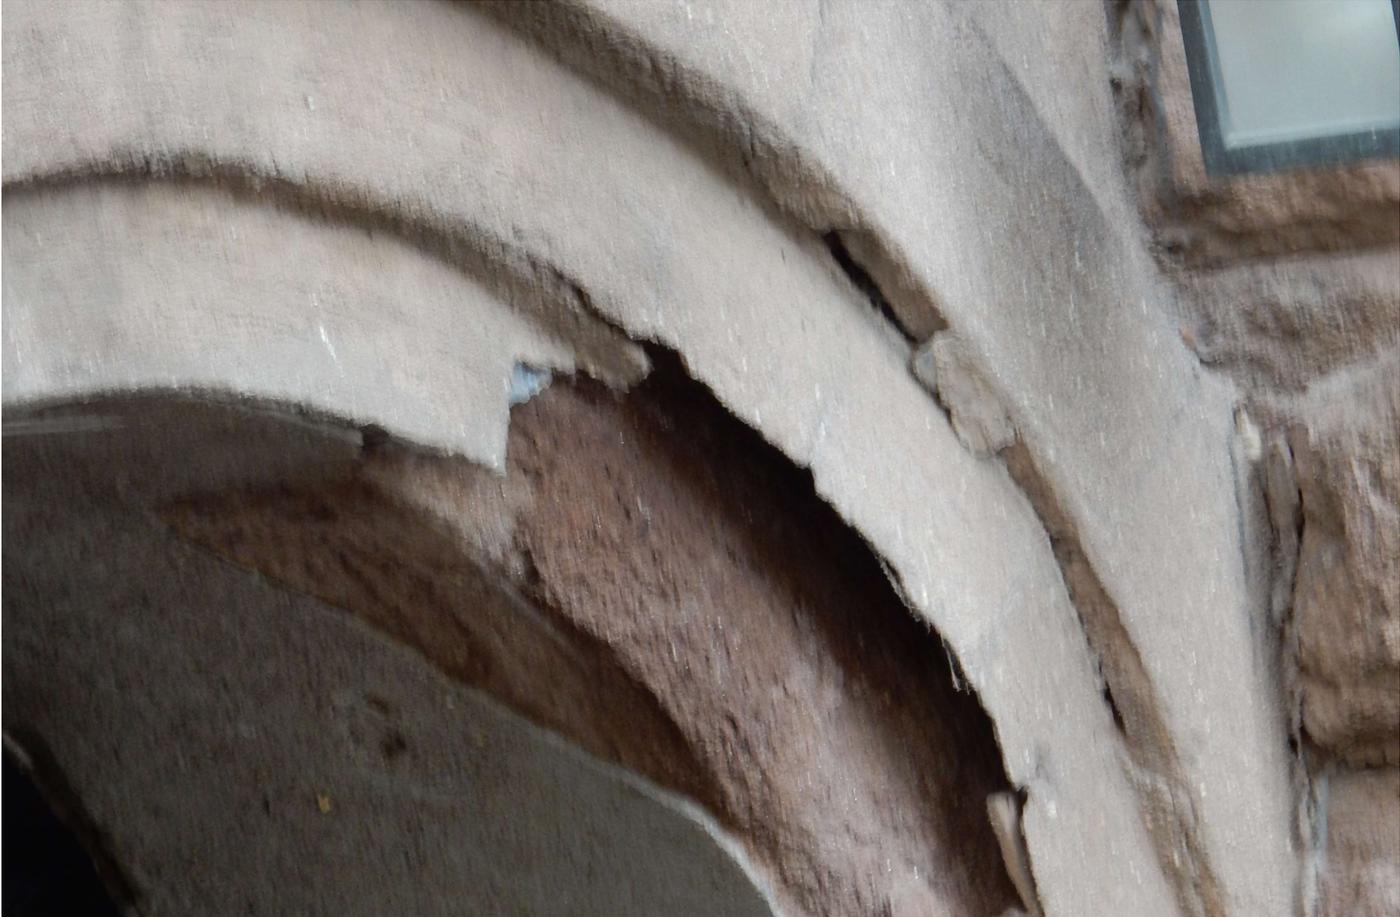
Door surround
damage

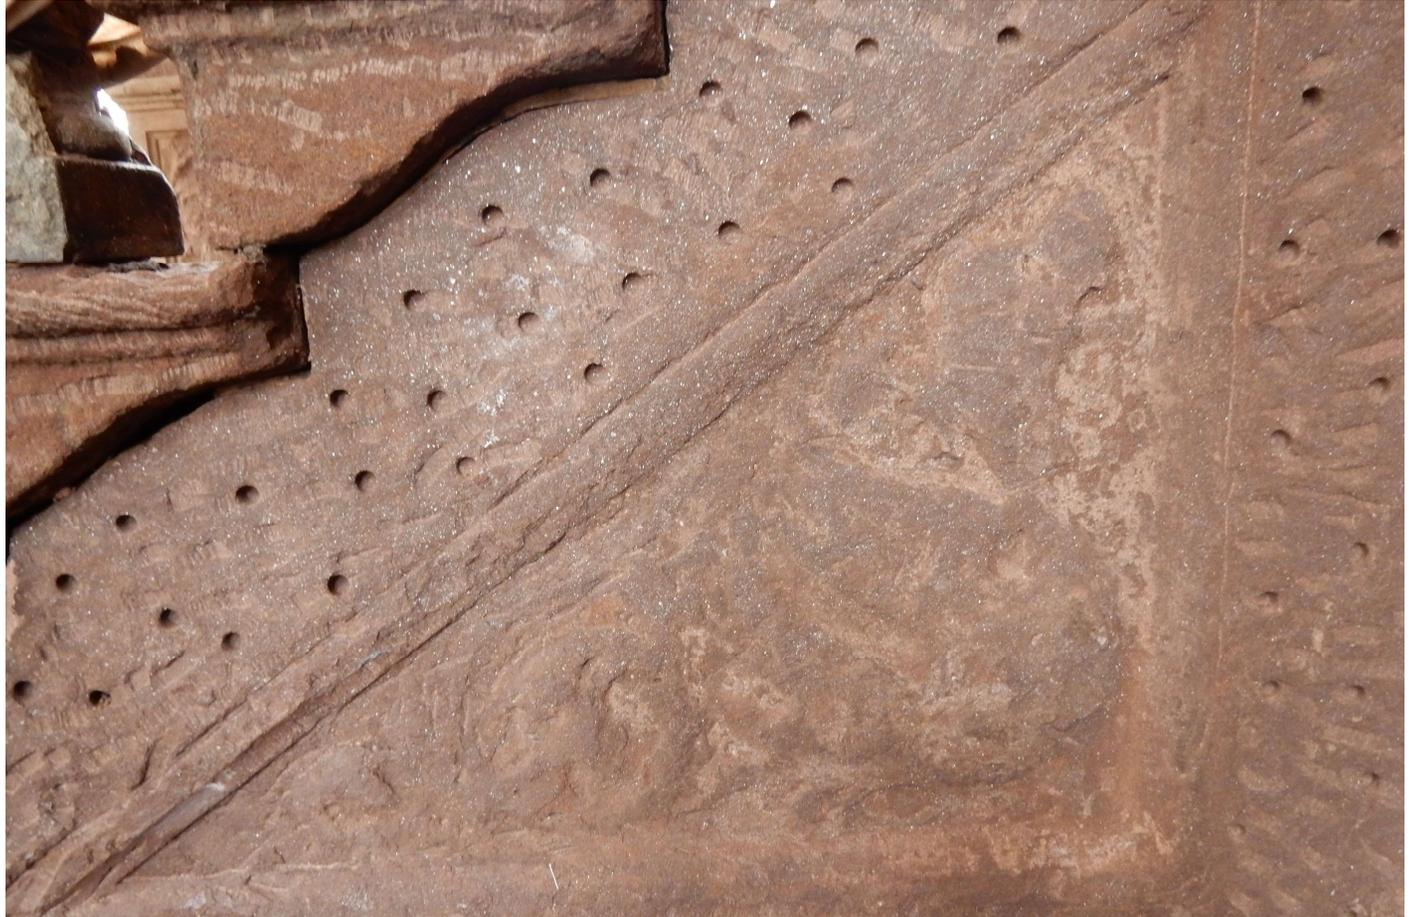
After removal
of stucco,
evidence
found of
original scroll
detail

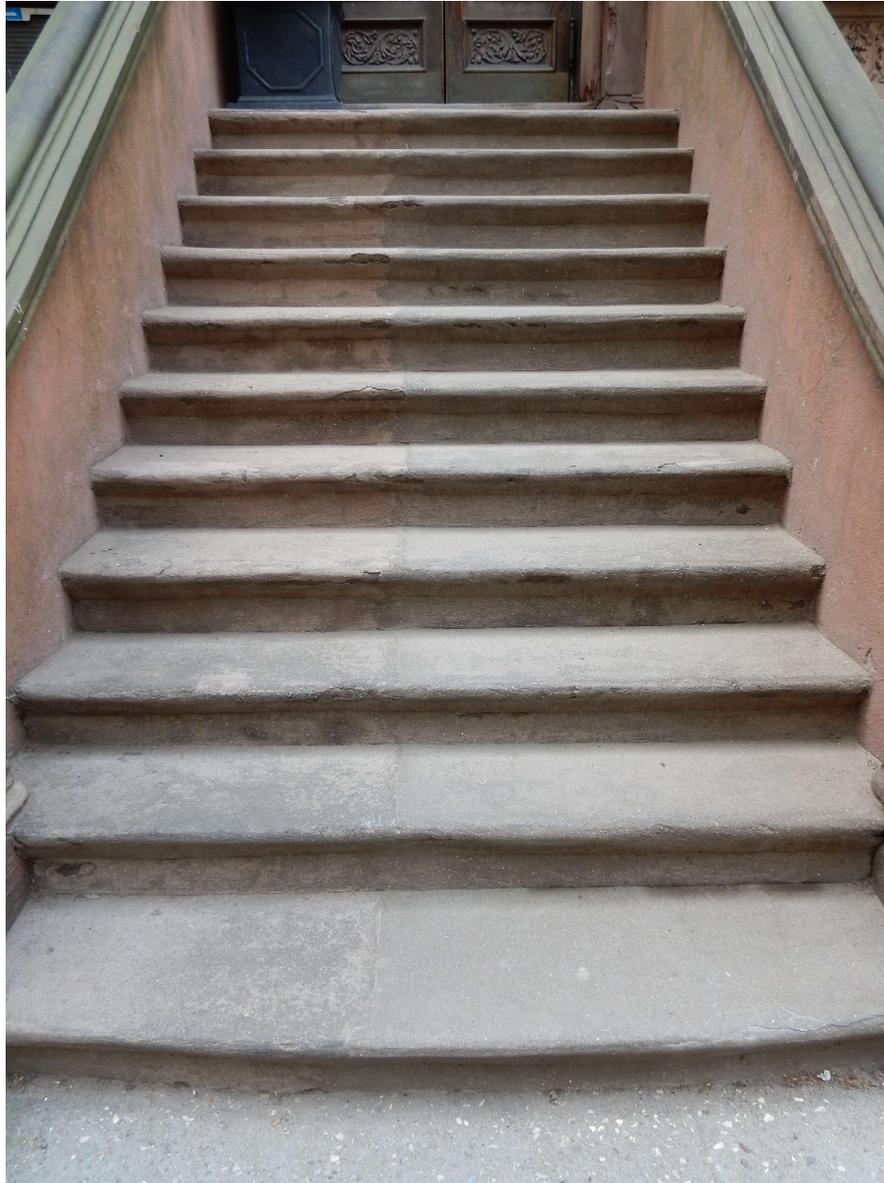
Before:
Walls along
stoop sides

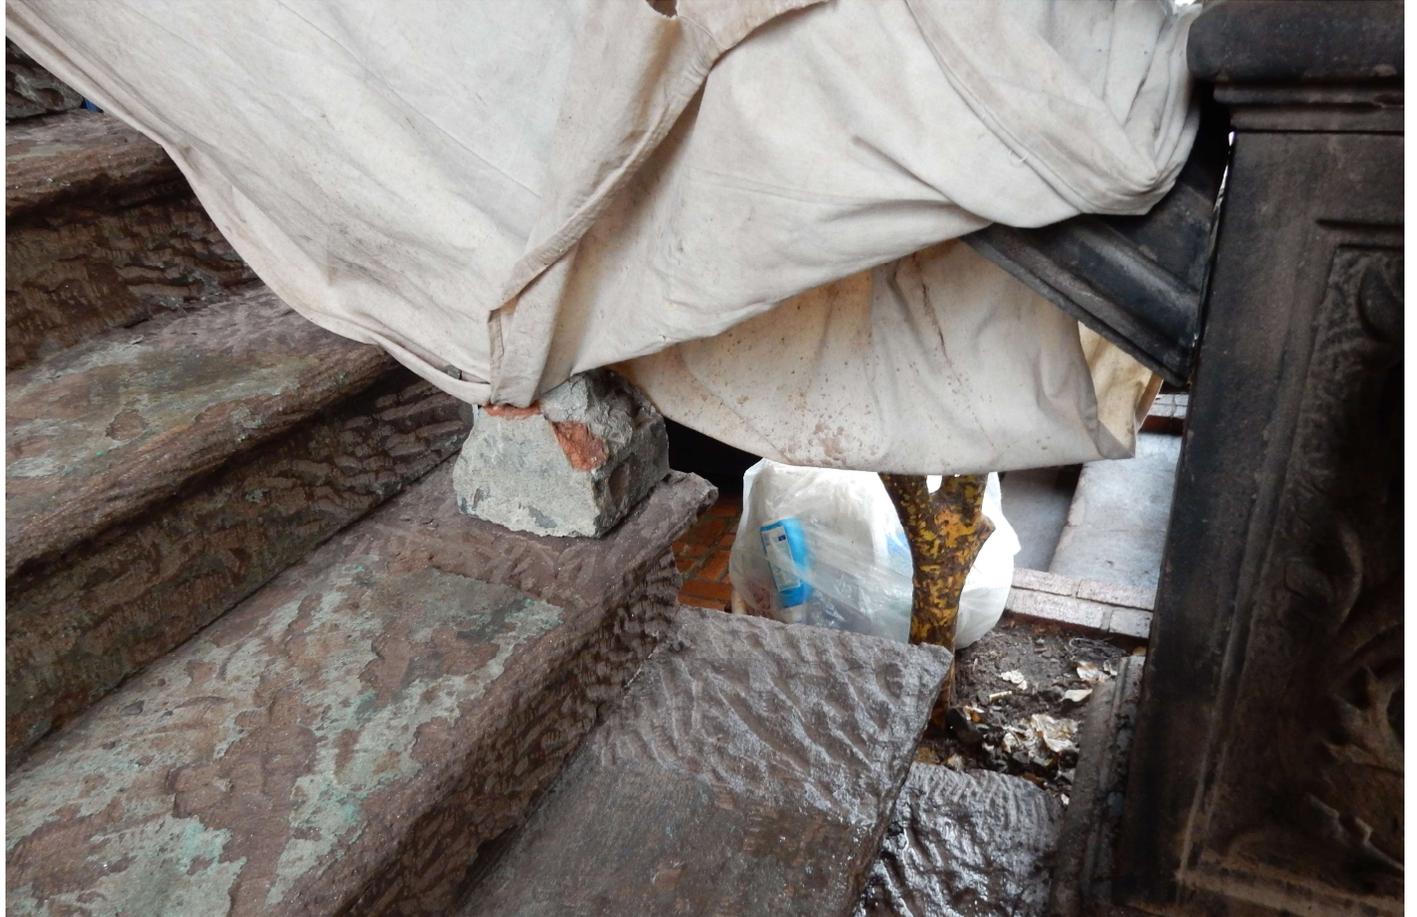
During:
Walls
Removed

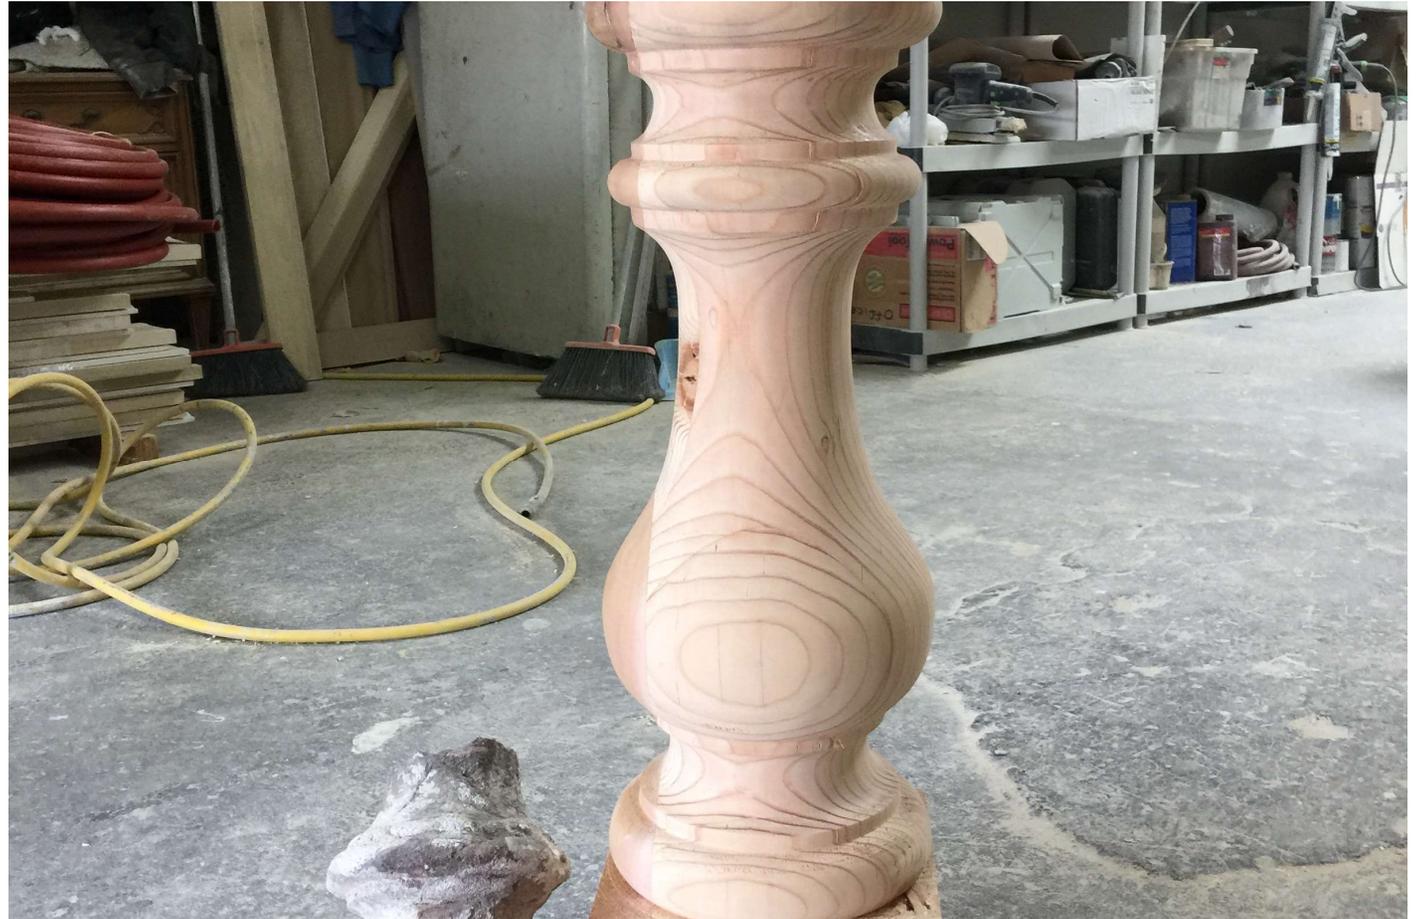
Balustrade:
Wood mold
created from
original piece
found in the
wall

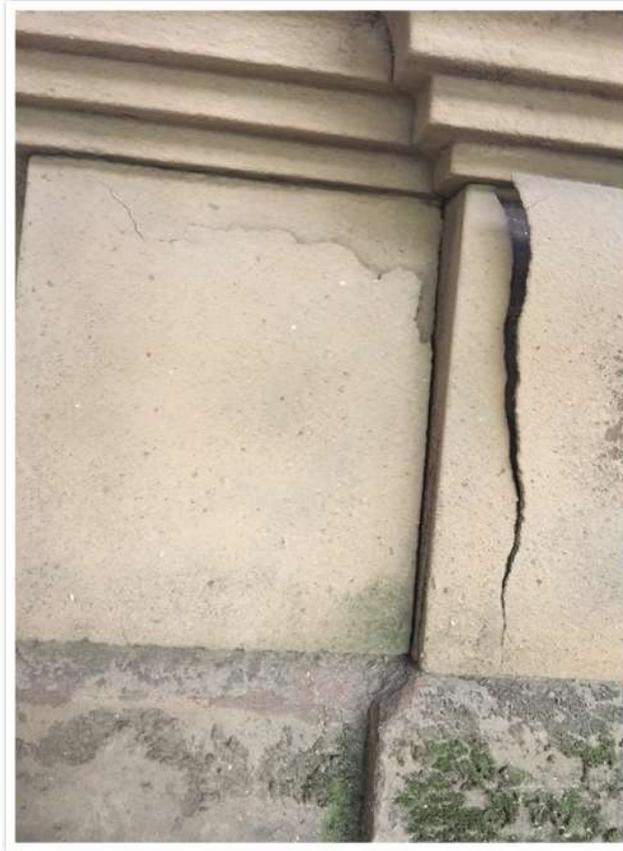
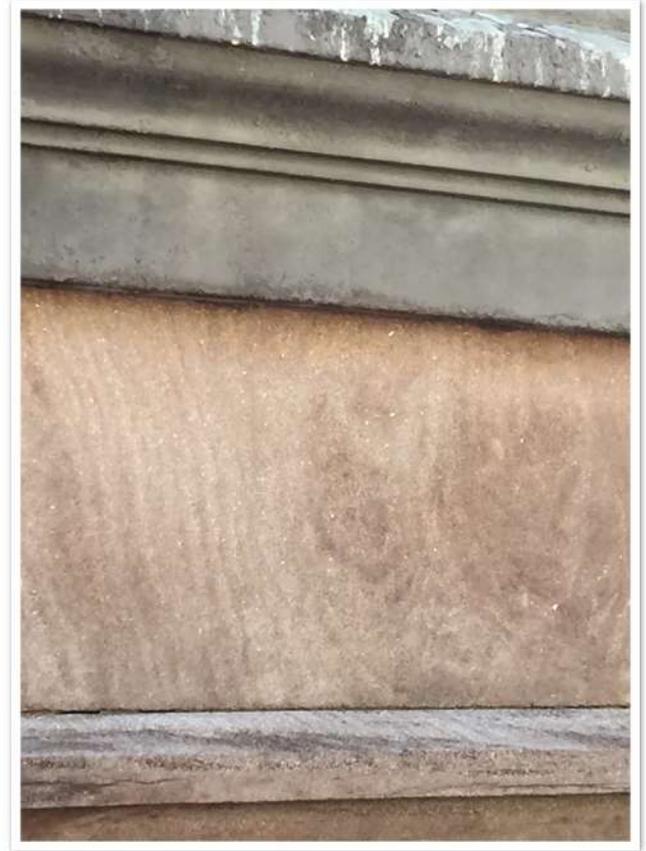
Condition of Stone

Stone pulling away

Mold

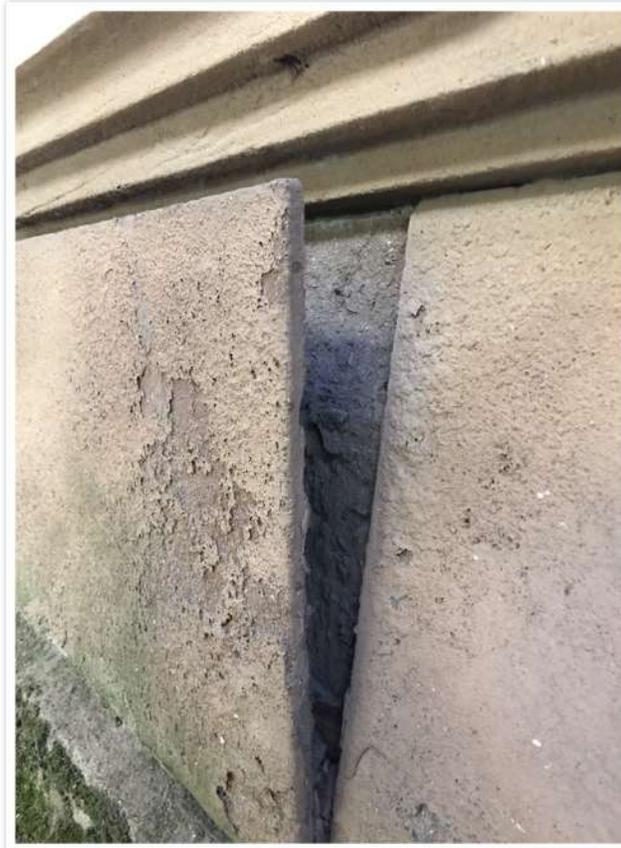
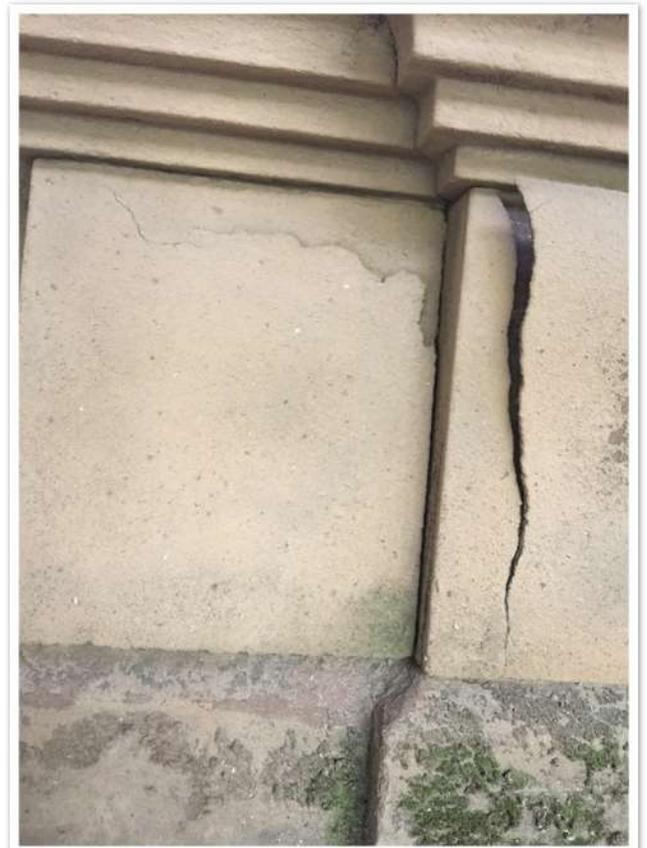
Condition of Stone

Other examples of significant deterioration
