I <Heart> Brownstones: Not Just a Pretty Façade

LANDMARK WEST! March 3, 2017

Master Craftsman. J. Pontes, Inc.

Common Causes of Stone Deterioration

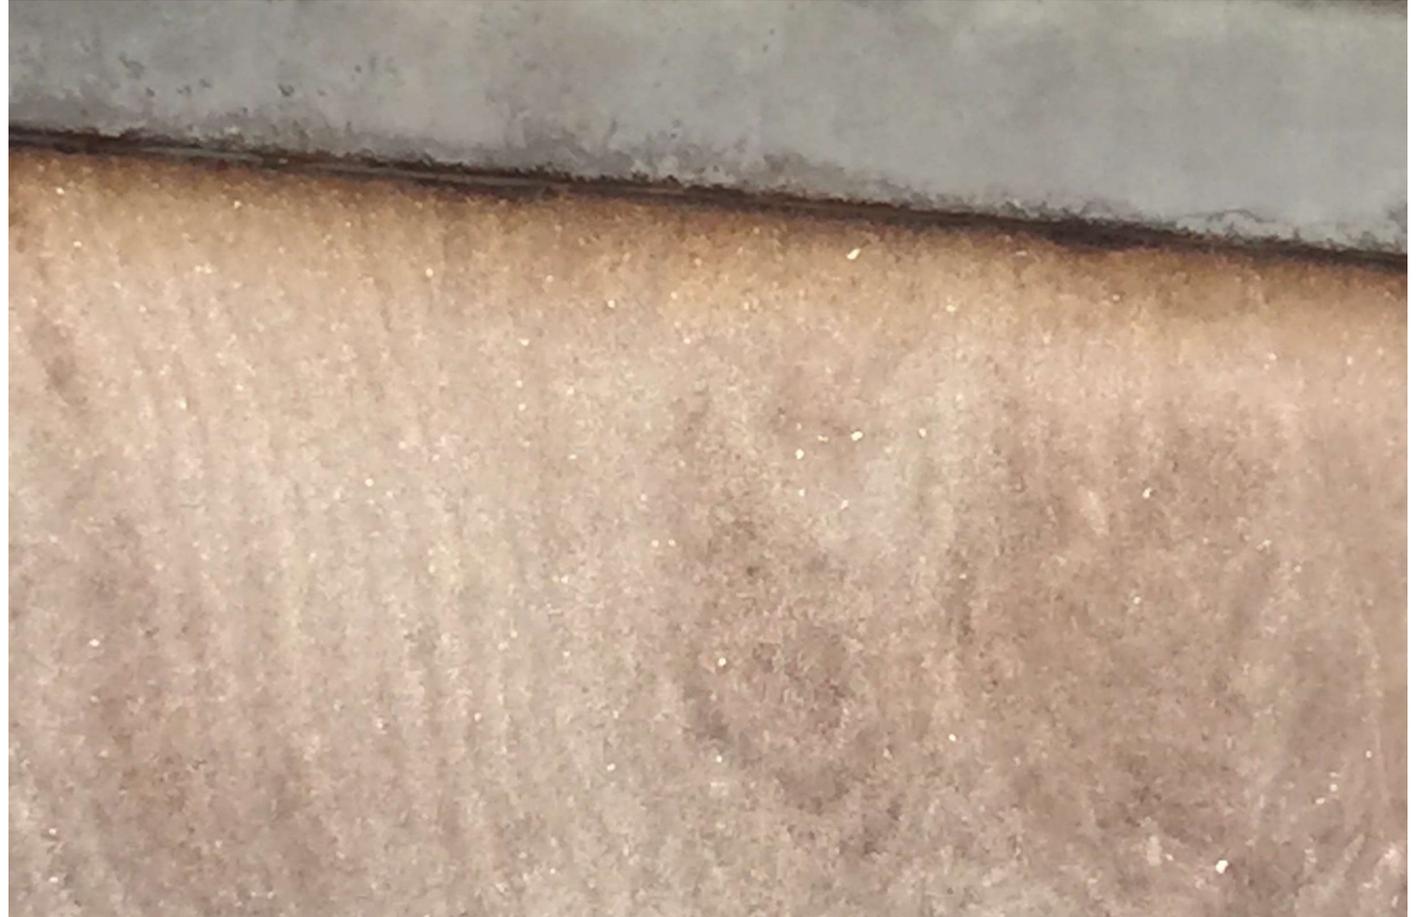
Part-way
through the
Cleaning
Progress

Original stone

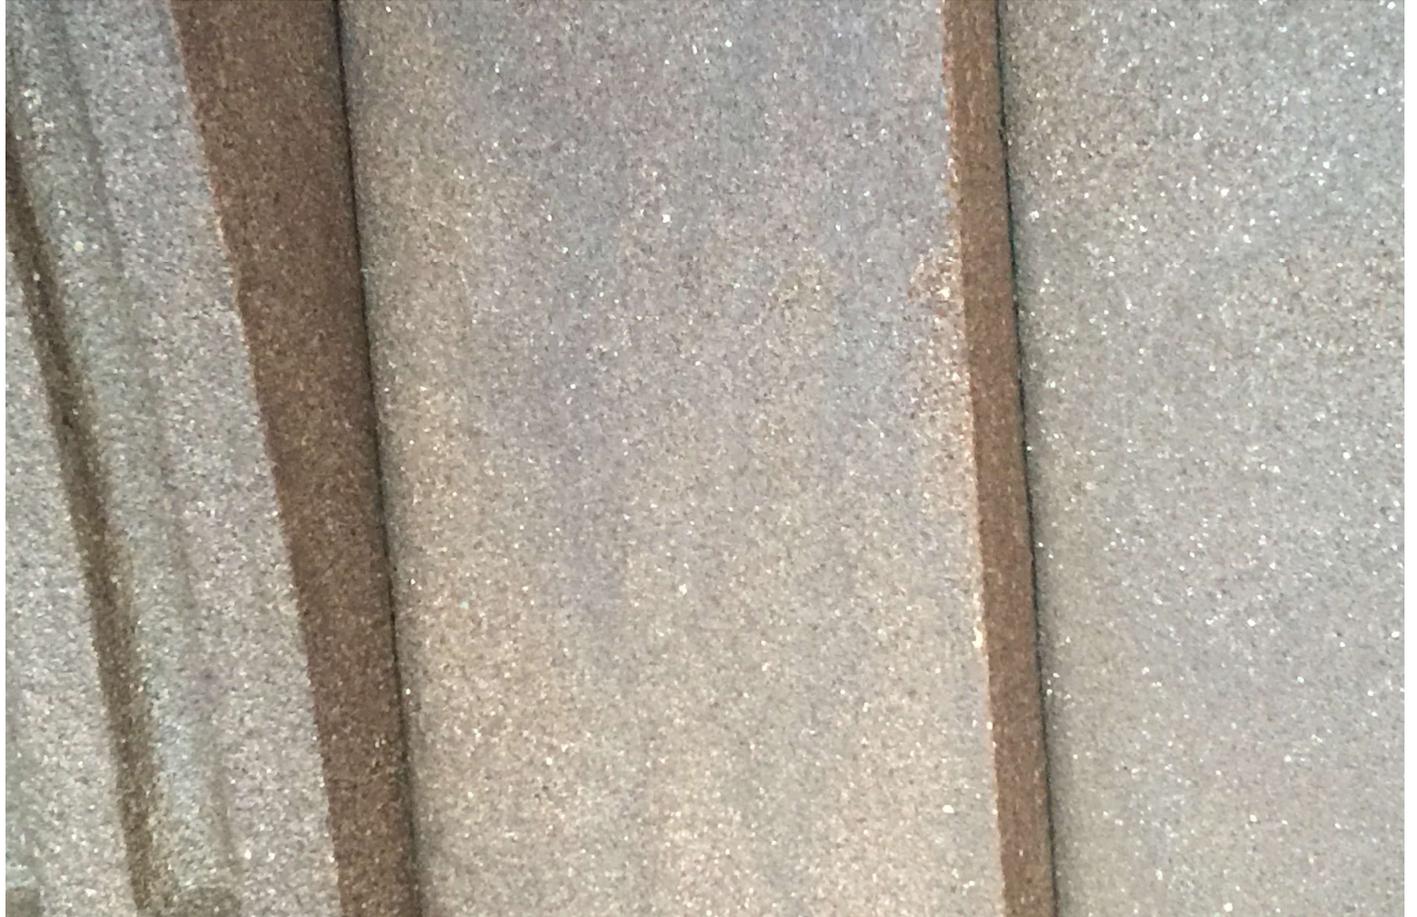
Original
brownstone
after paint
removal

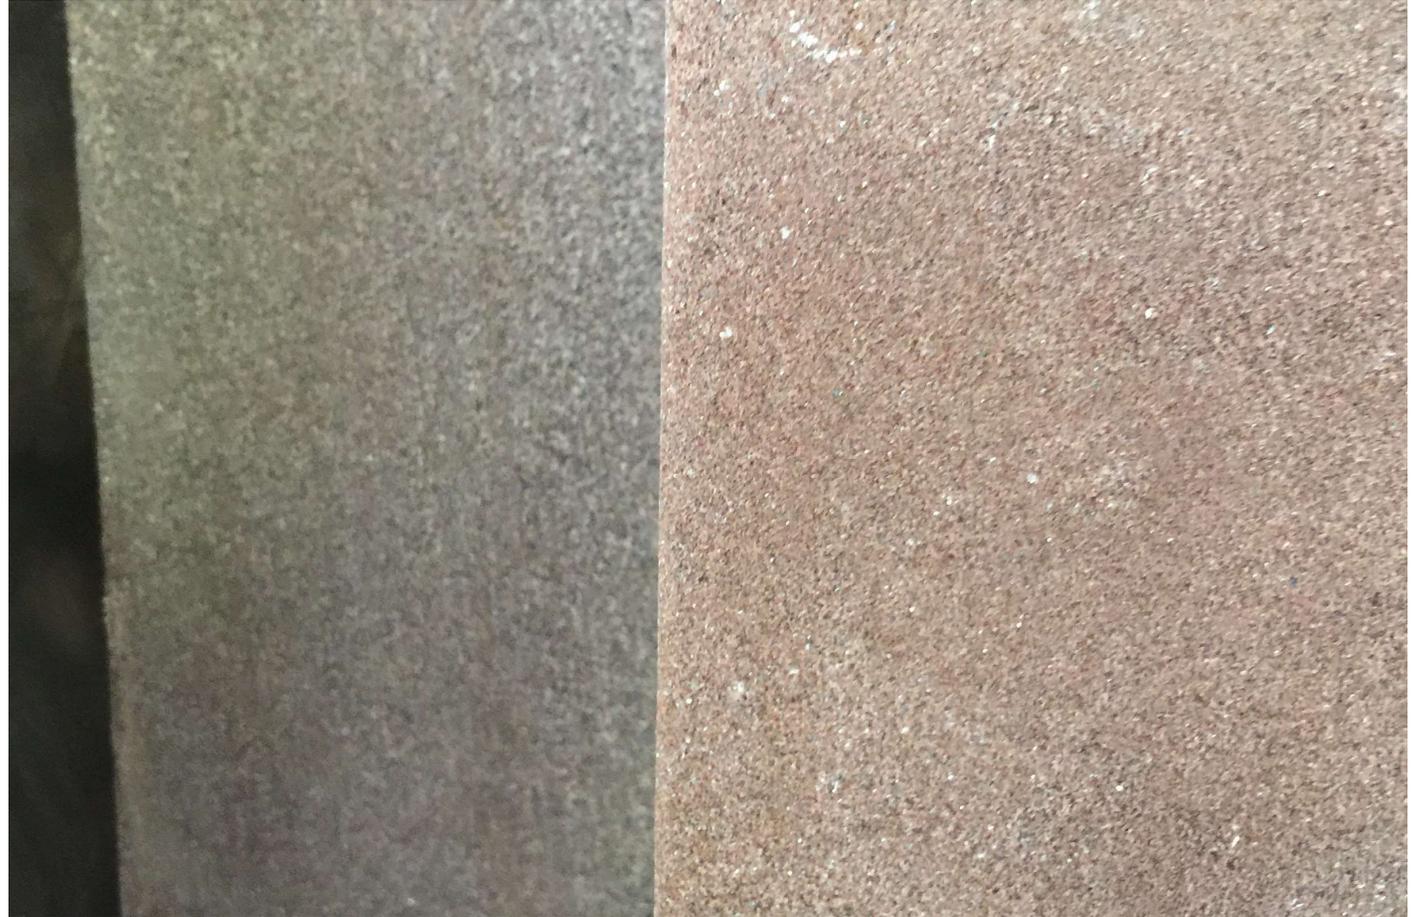
Different Colors of Stone & Considerations When Matching

Stone colors vary,
even in the
original stones
used on a building

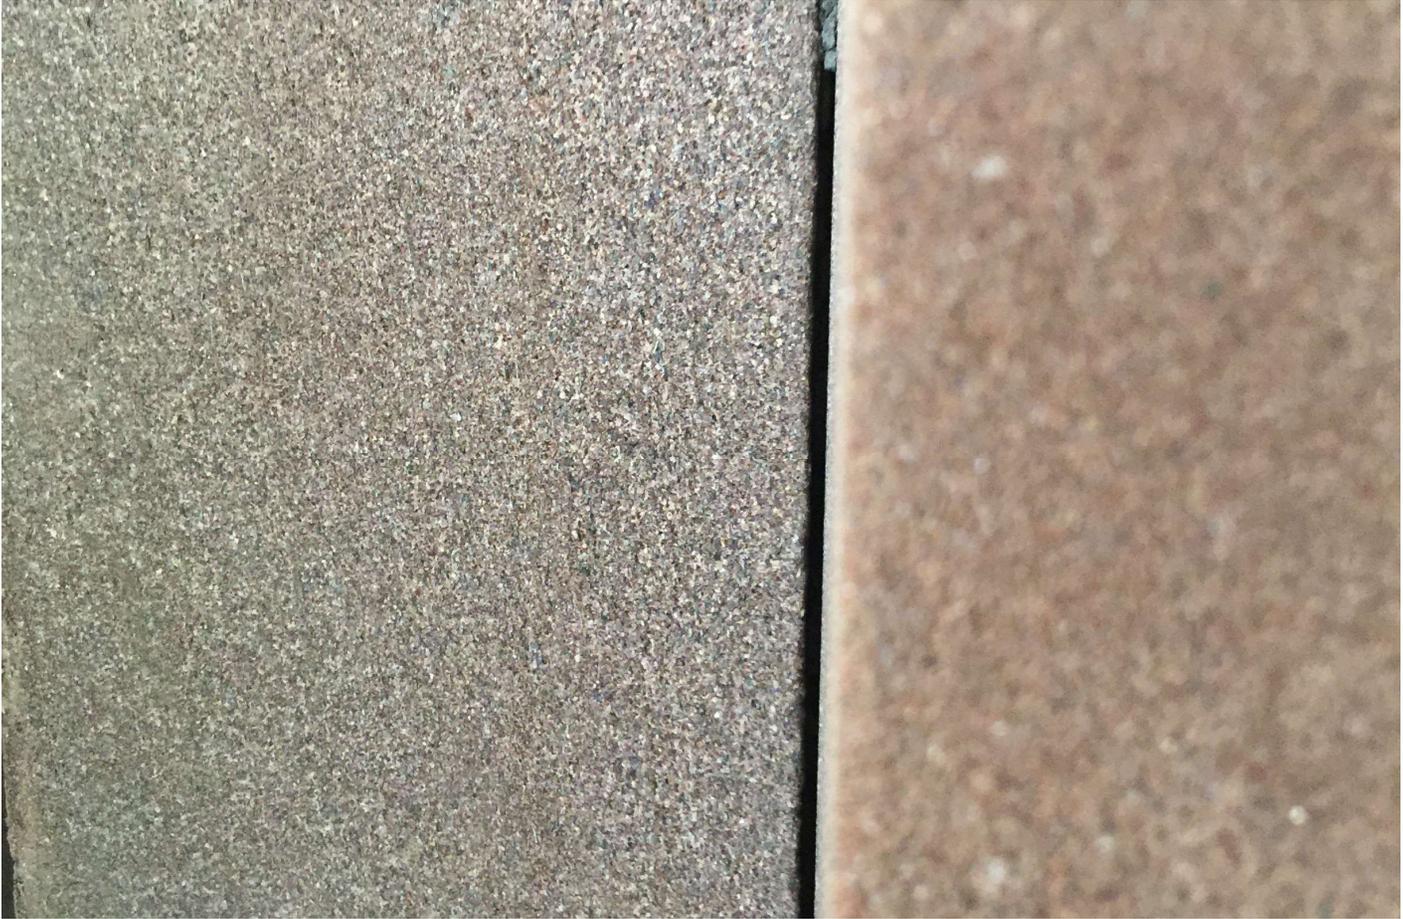
Missing
pointing

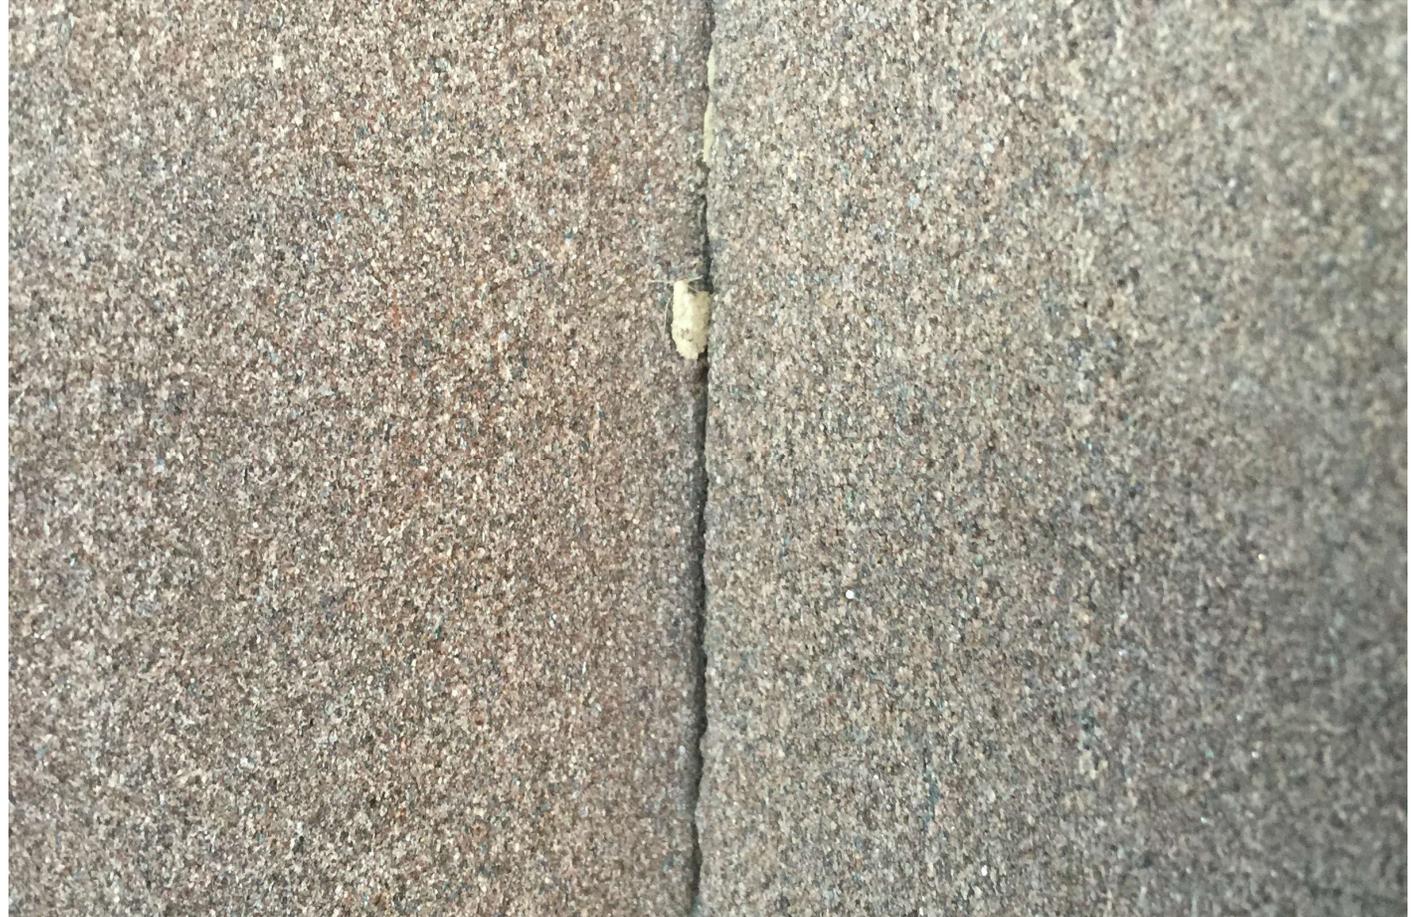
Similar color,
but missing
pointing

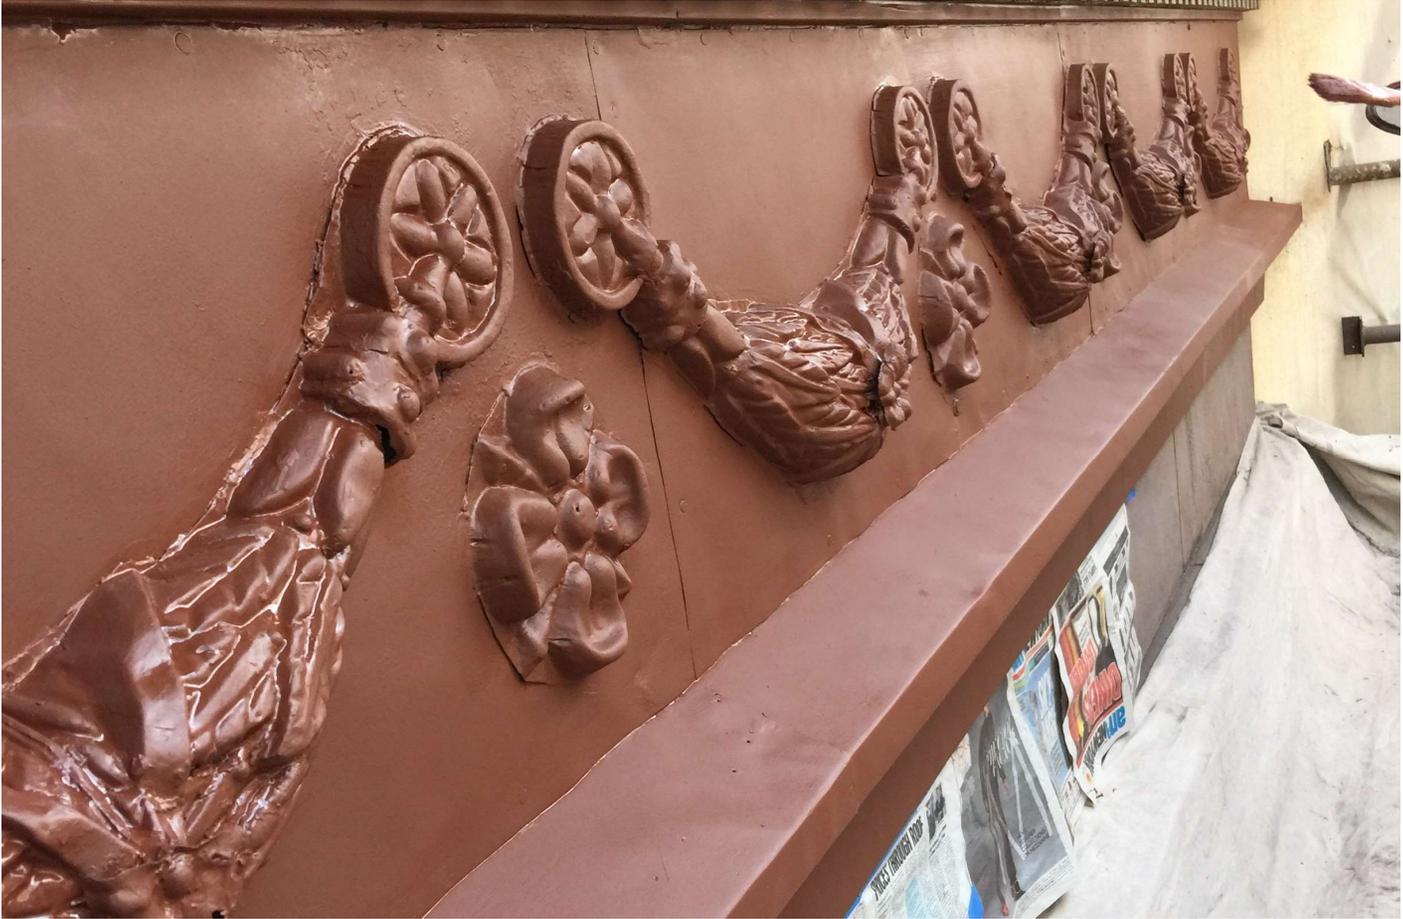
Cornice In Progress

Primer

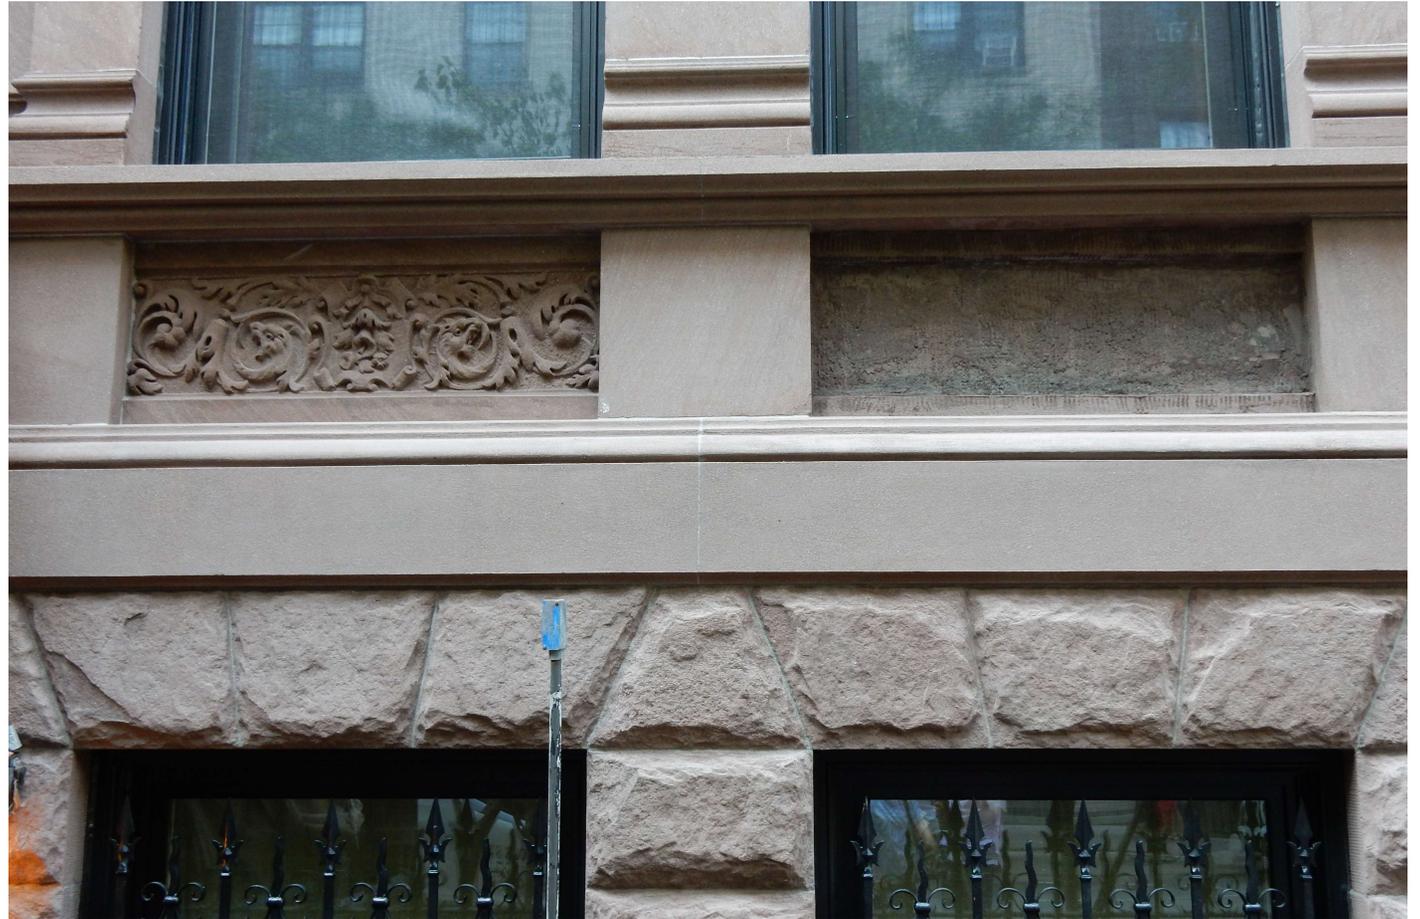
W. 71st Street During

Missing scroll
detail at air
conditioning
opening

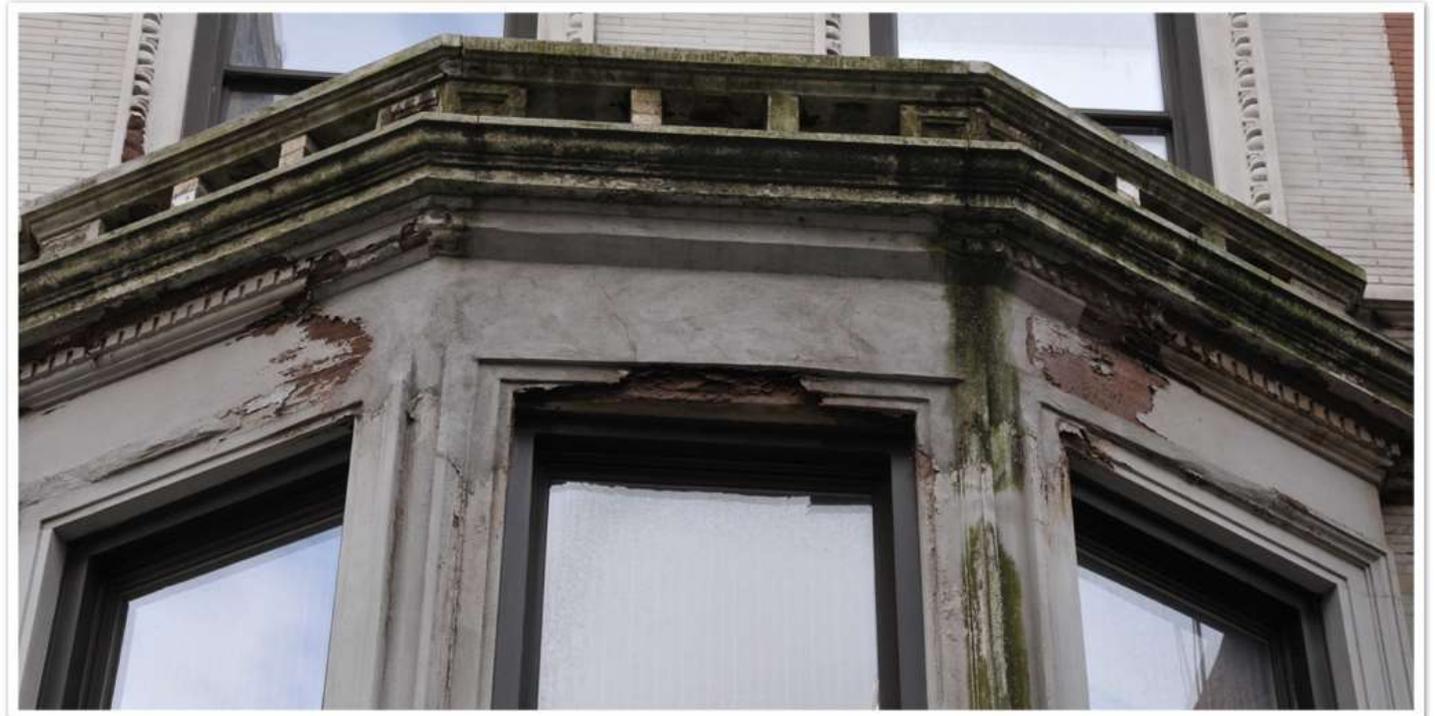
Poor Condition of Façade

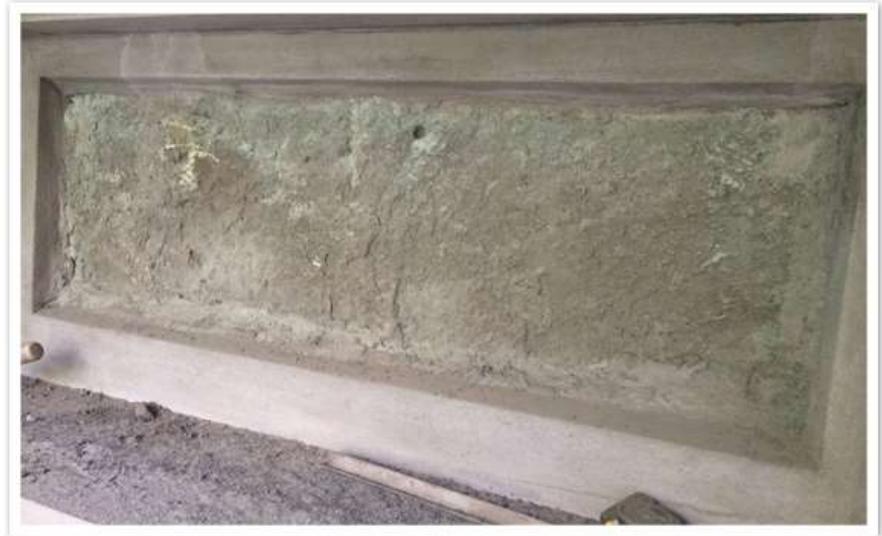
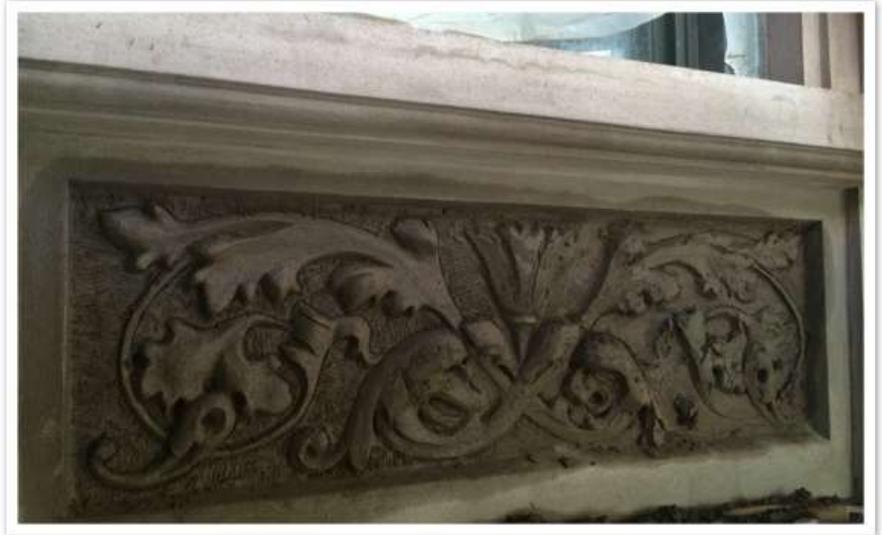
Before: Missing
Panel Detail and
During Carving
Detail Based on
Original

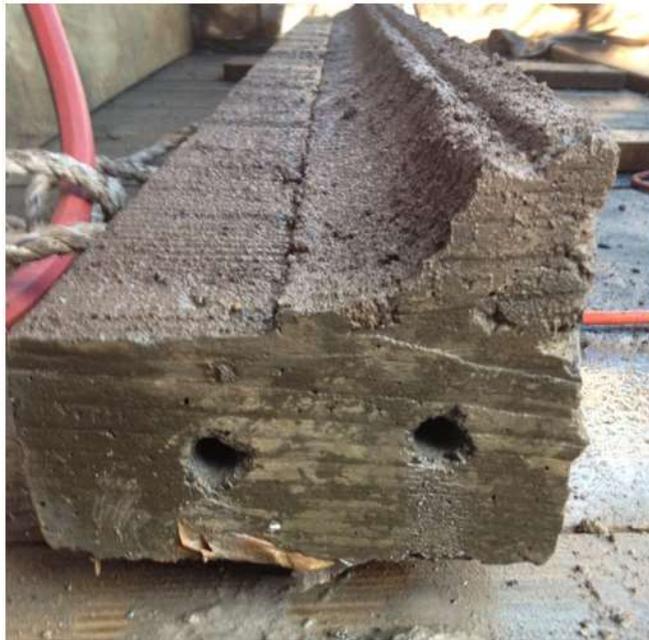
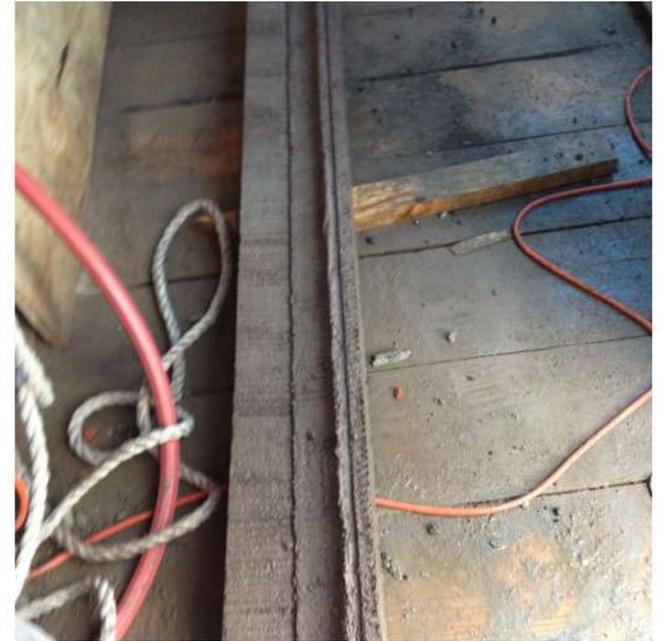
Window

Had to precast
missing window
surrounds

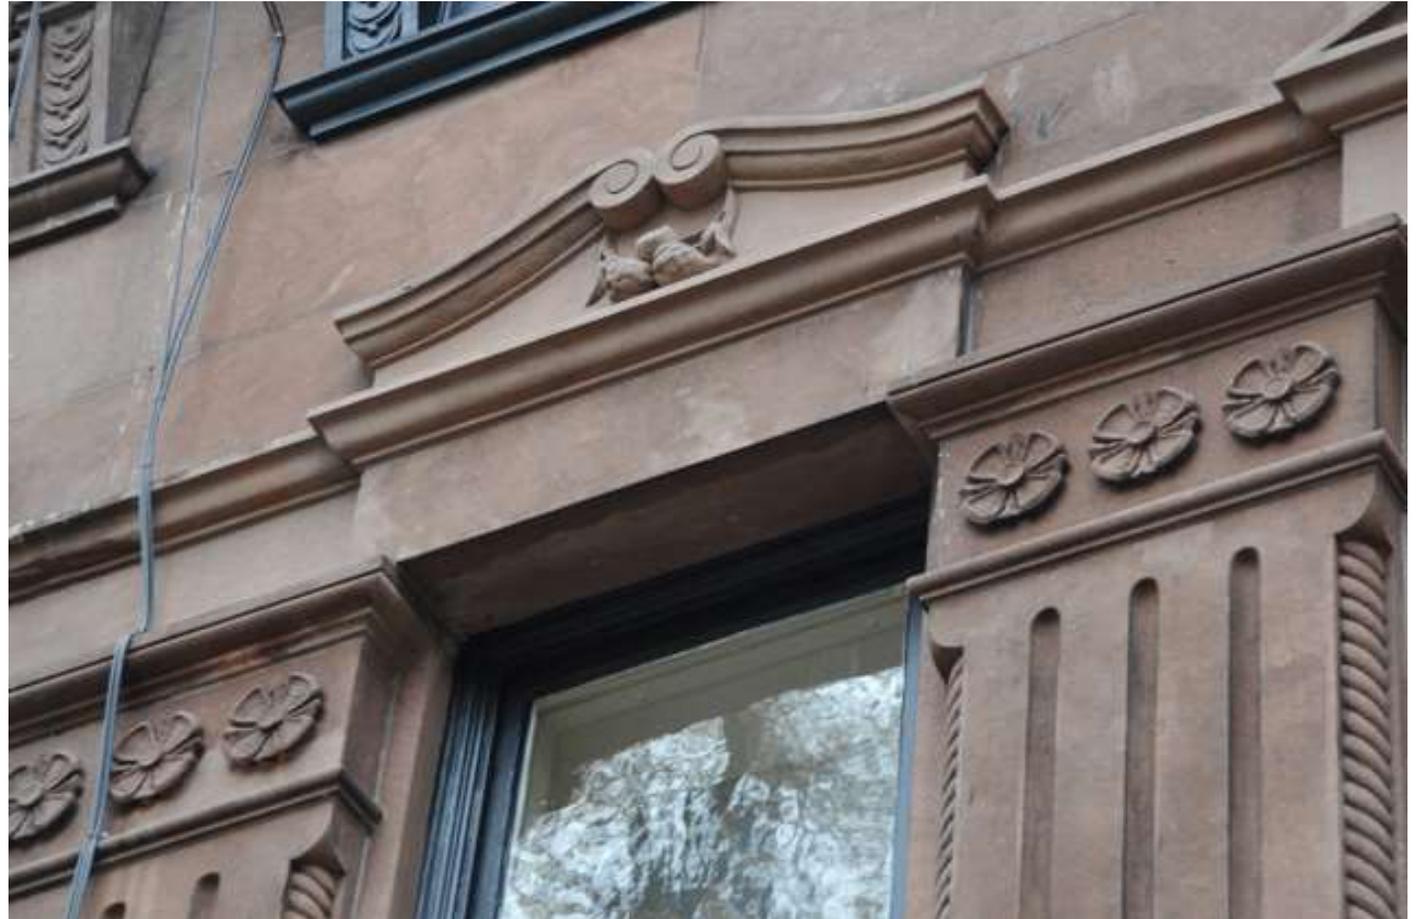
General:
W. 95th Street

Note the
integration of
replacement
stone with
original stone –
50% is new, 50%
is original

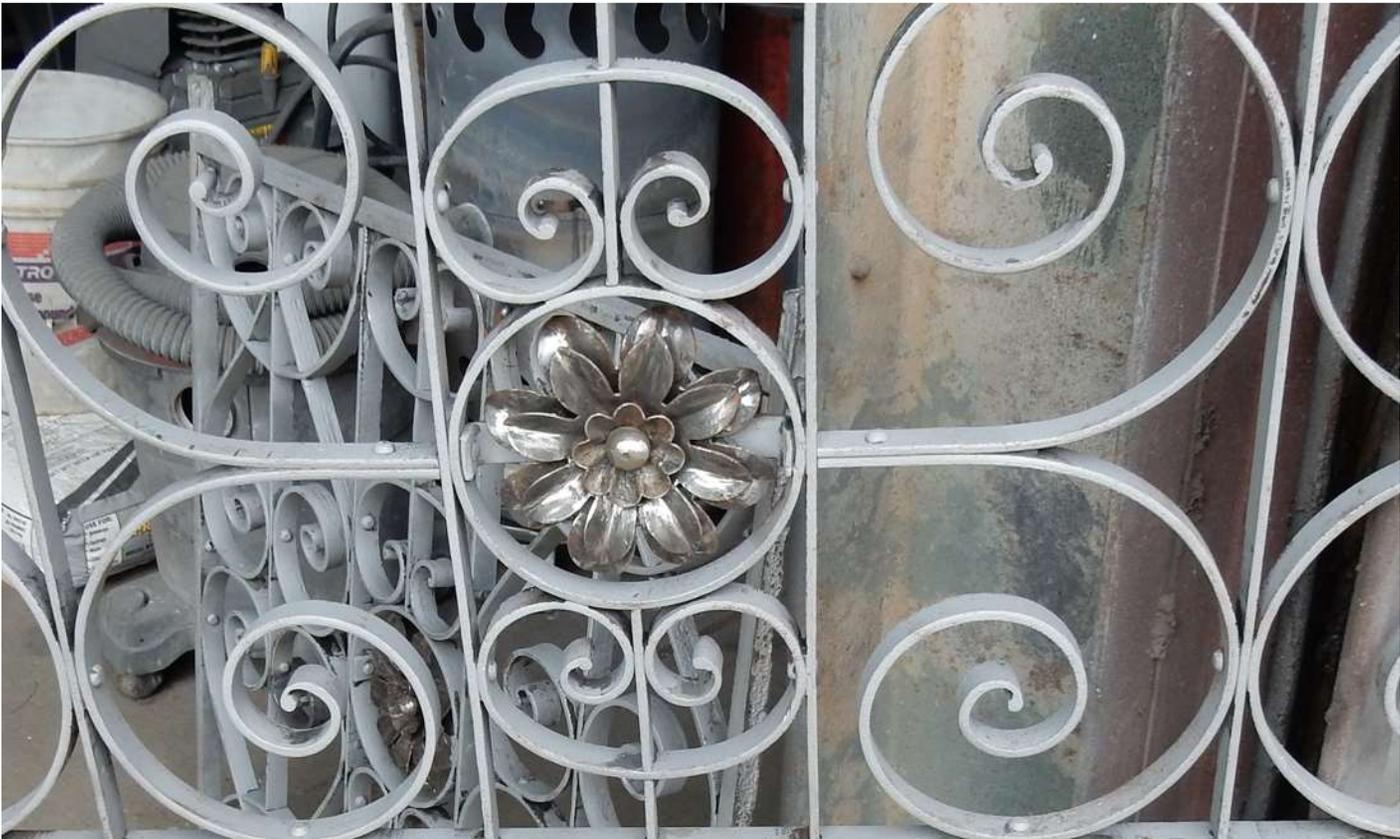
Duplication of original wrought iron window guards
