I <Heart> Brownstones: Not Just a Pretty Façade

LANDMARK   WEST!
THE COMMITTEE TO PRESERVE THE UPPER WEST SIDE

Michael Devonshire

Architectural Conservator

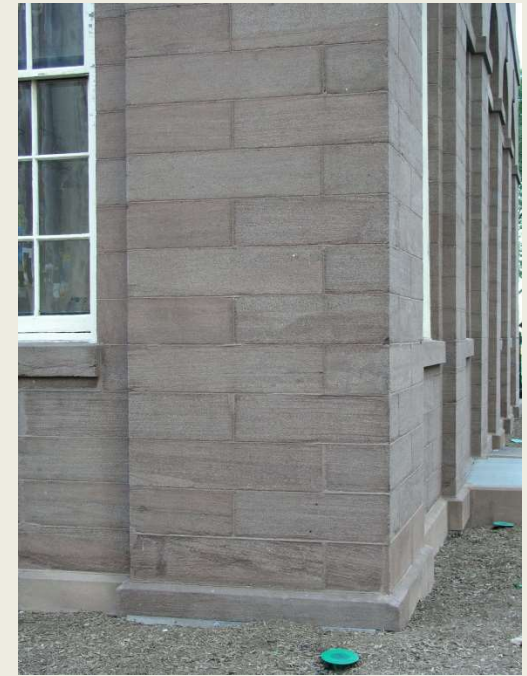
Combed

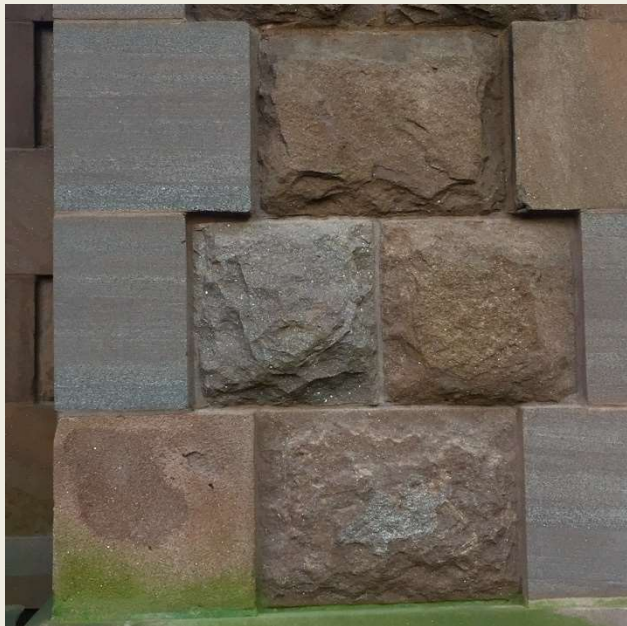
Hammered

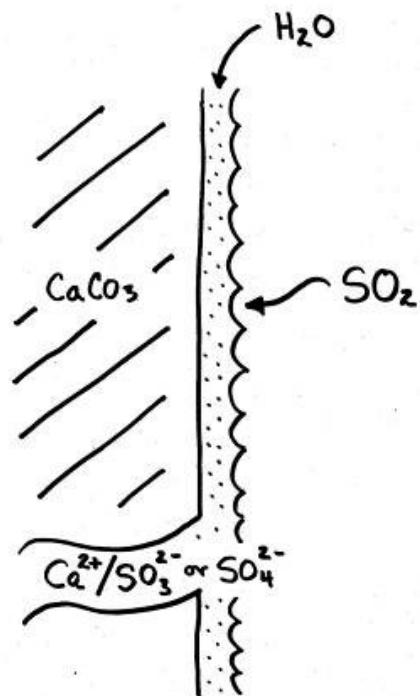
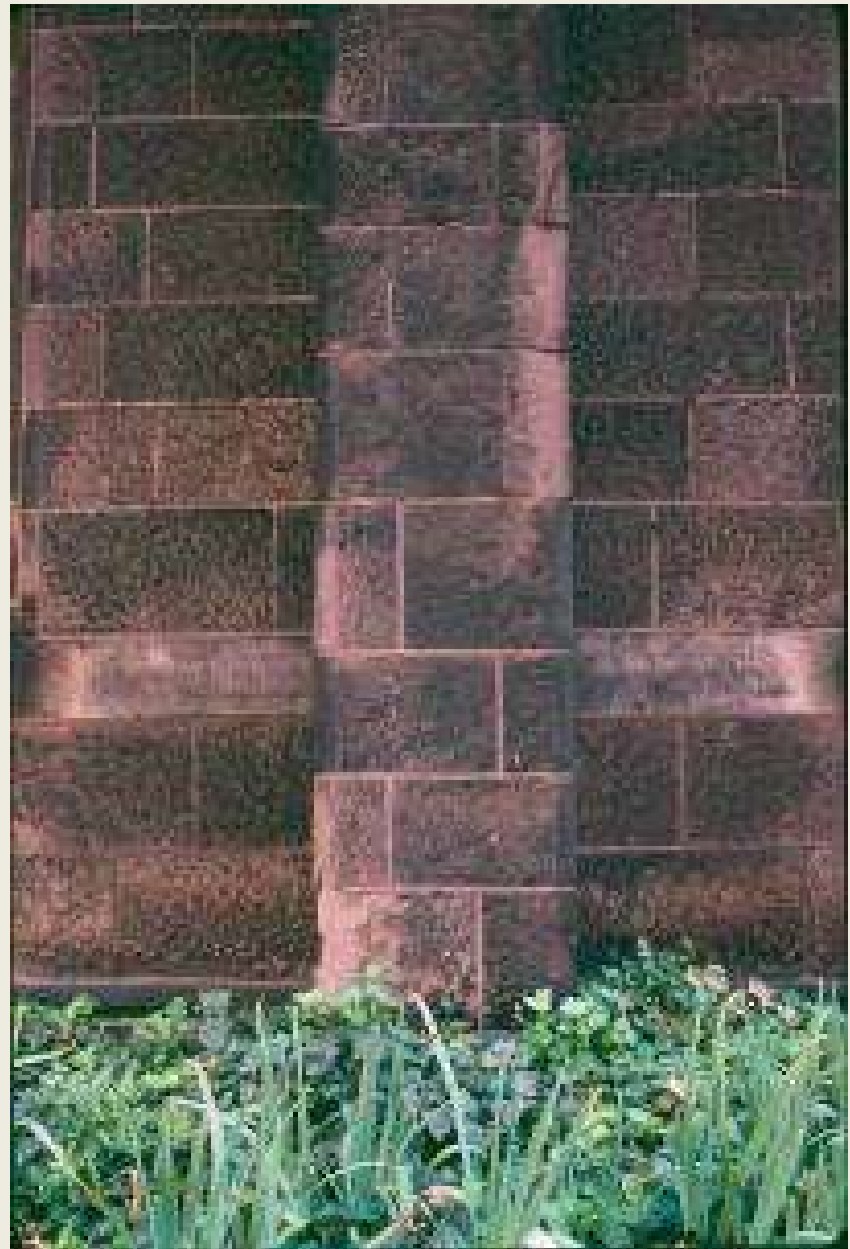
DRY DEPOSITION

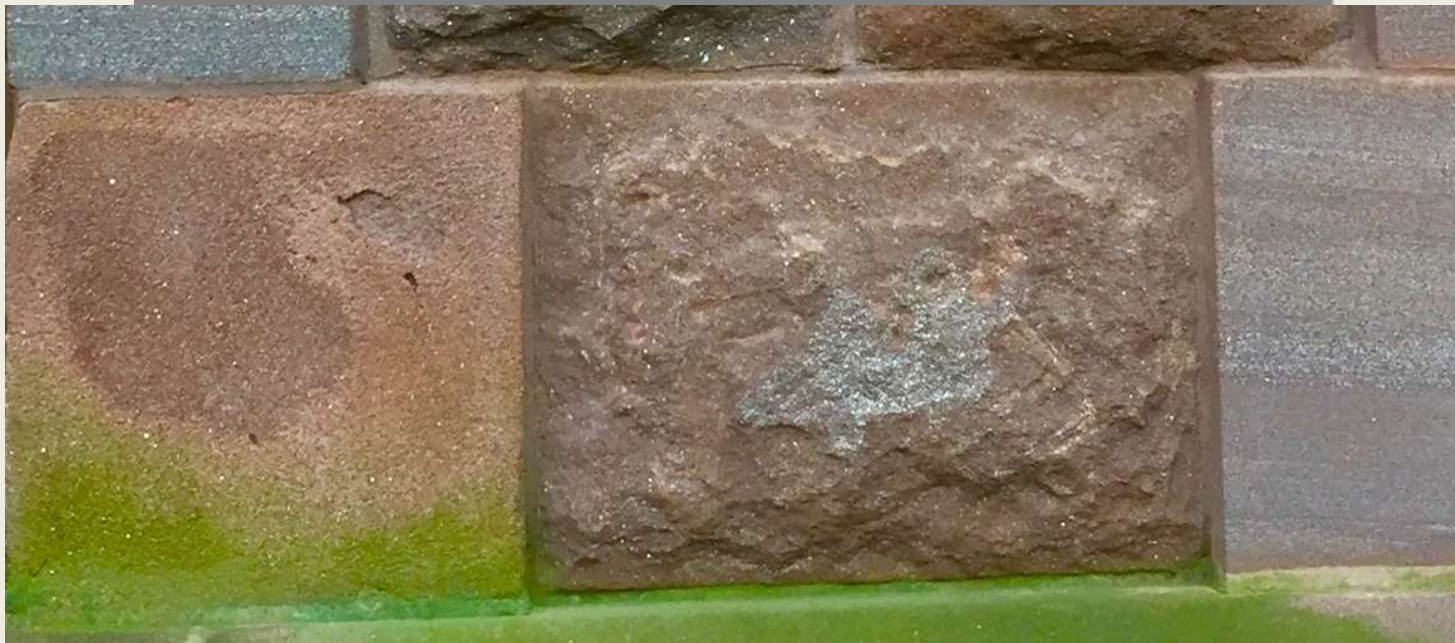
BIOLOGICAL EFFECTS

- Bacteria
- Algae
- Fungi
- Lichens
- Mosses
- Higher Plants
- Animals

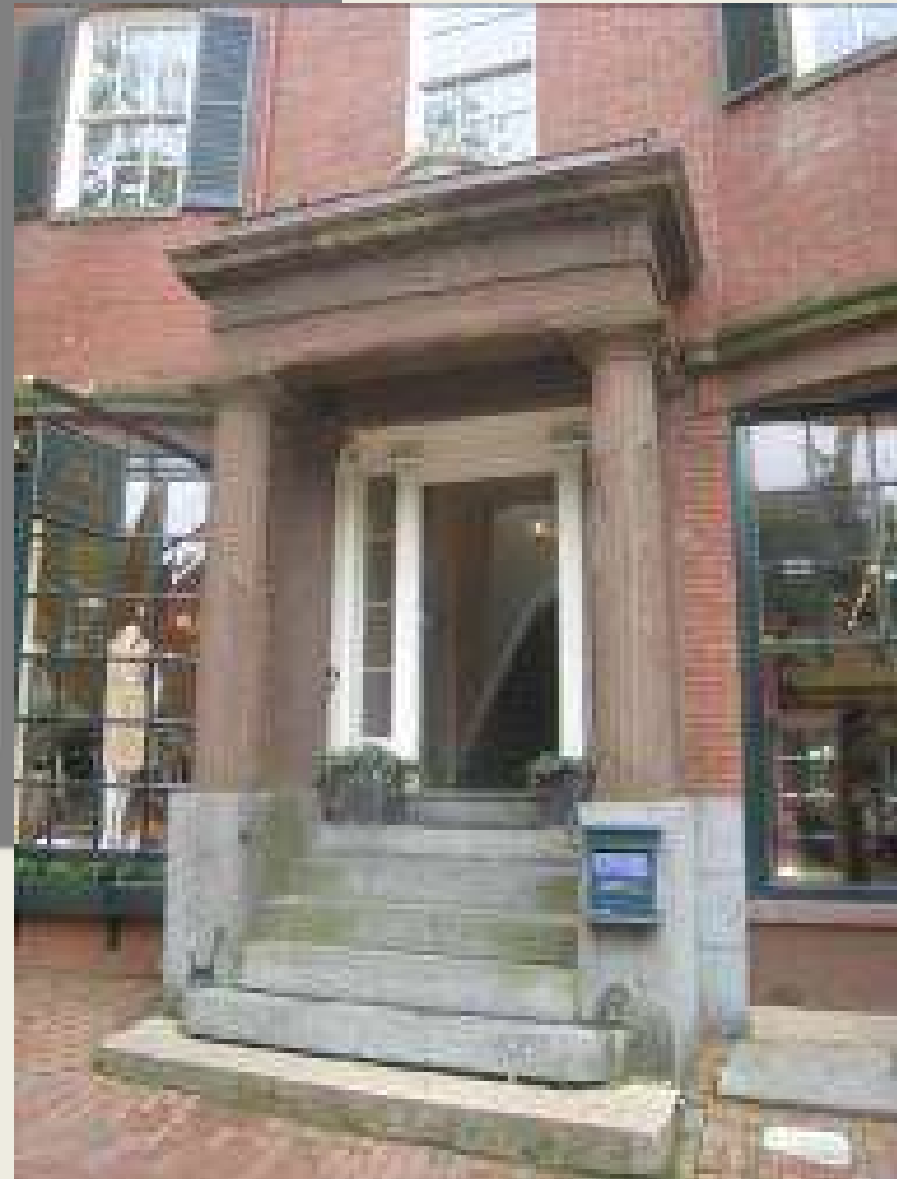
SWELLING WITH WATER

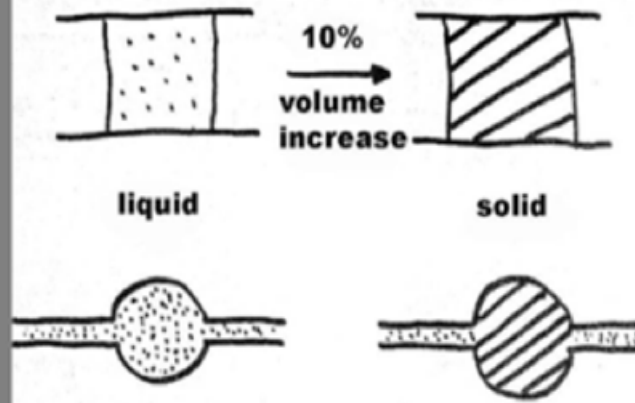
FREEZING WATER

$$\Delta T \propto \frac{2\gamma}{r}$$
