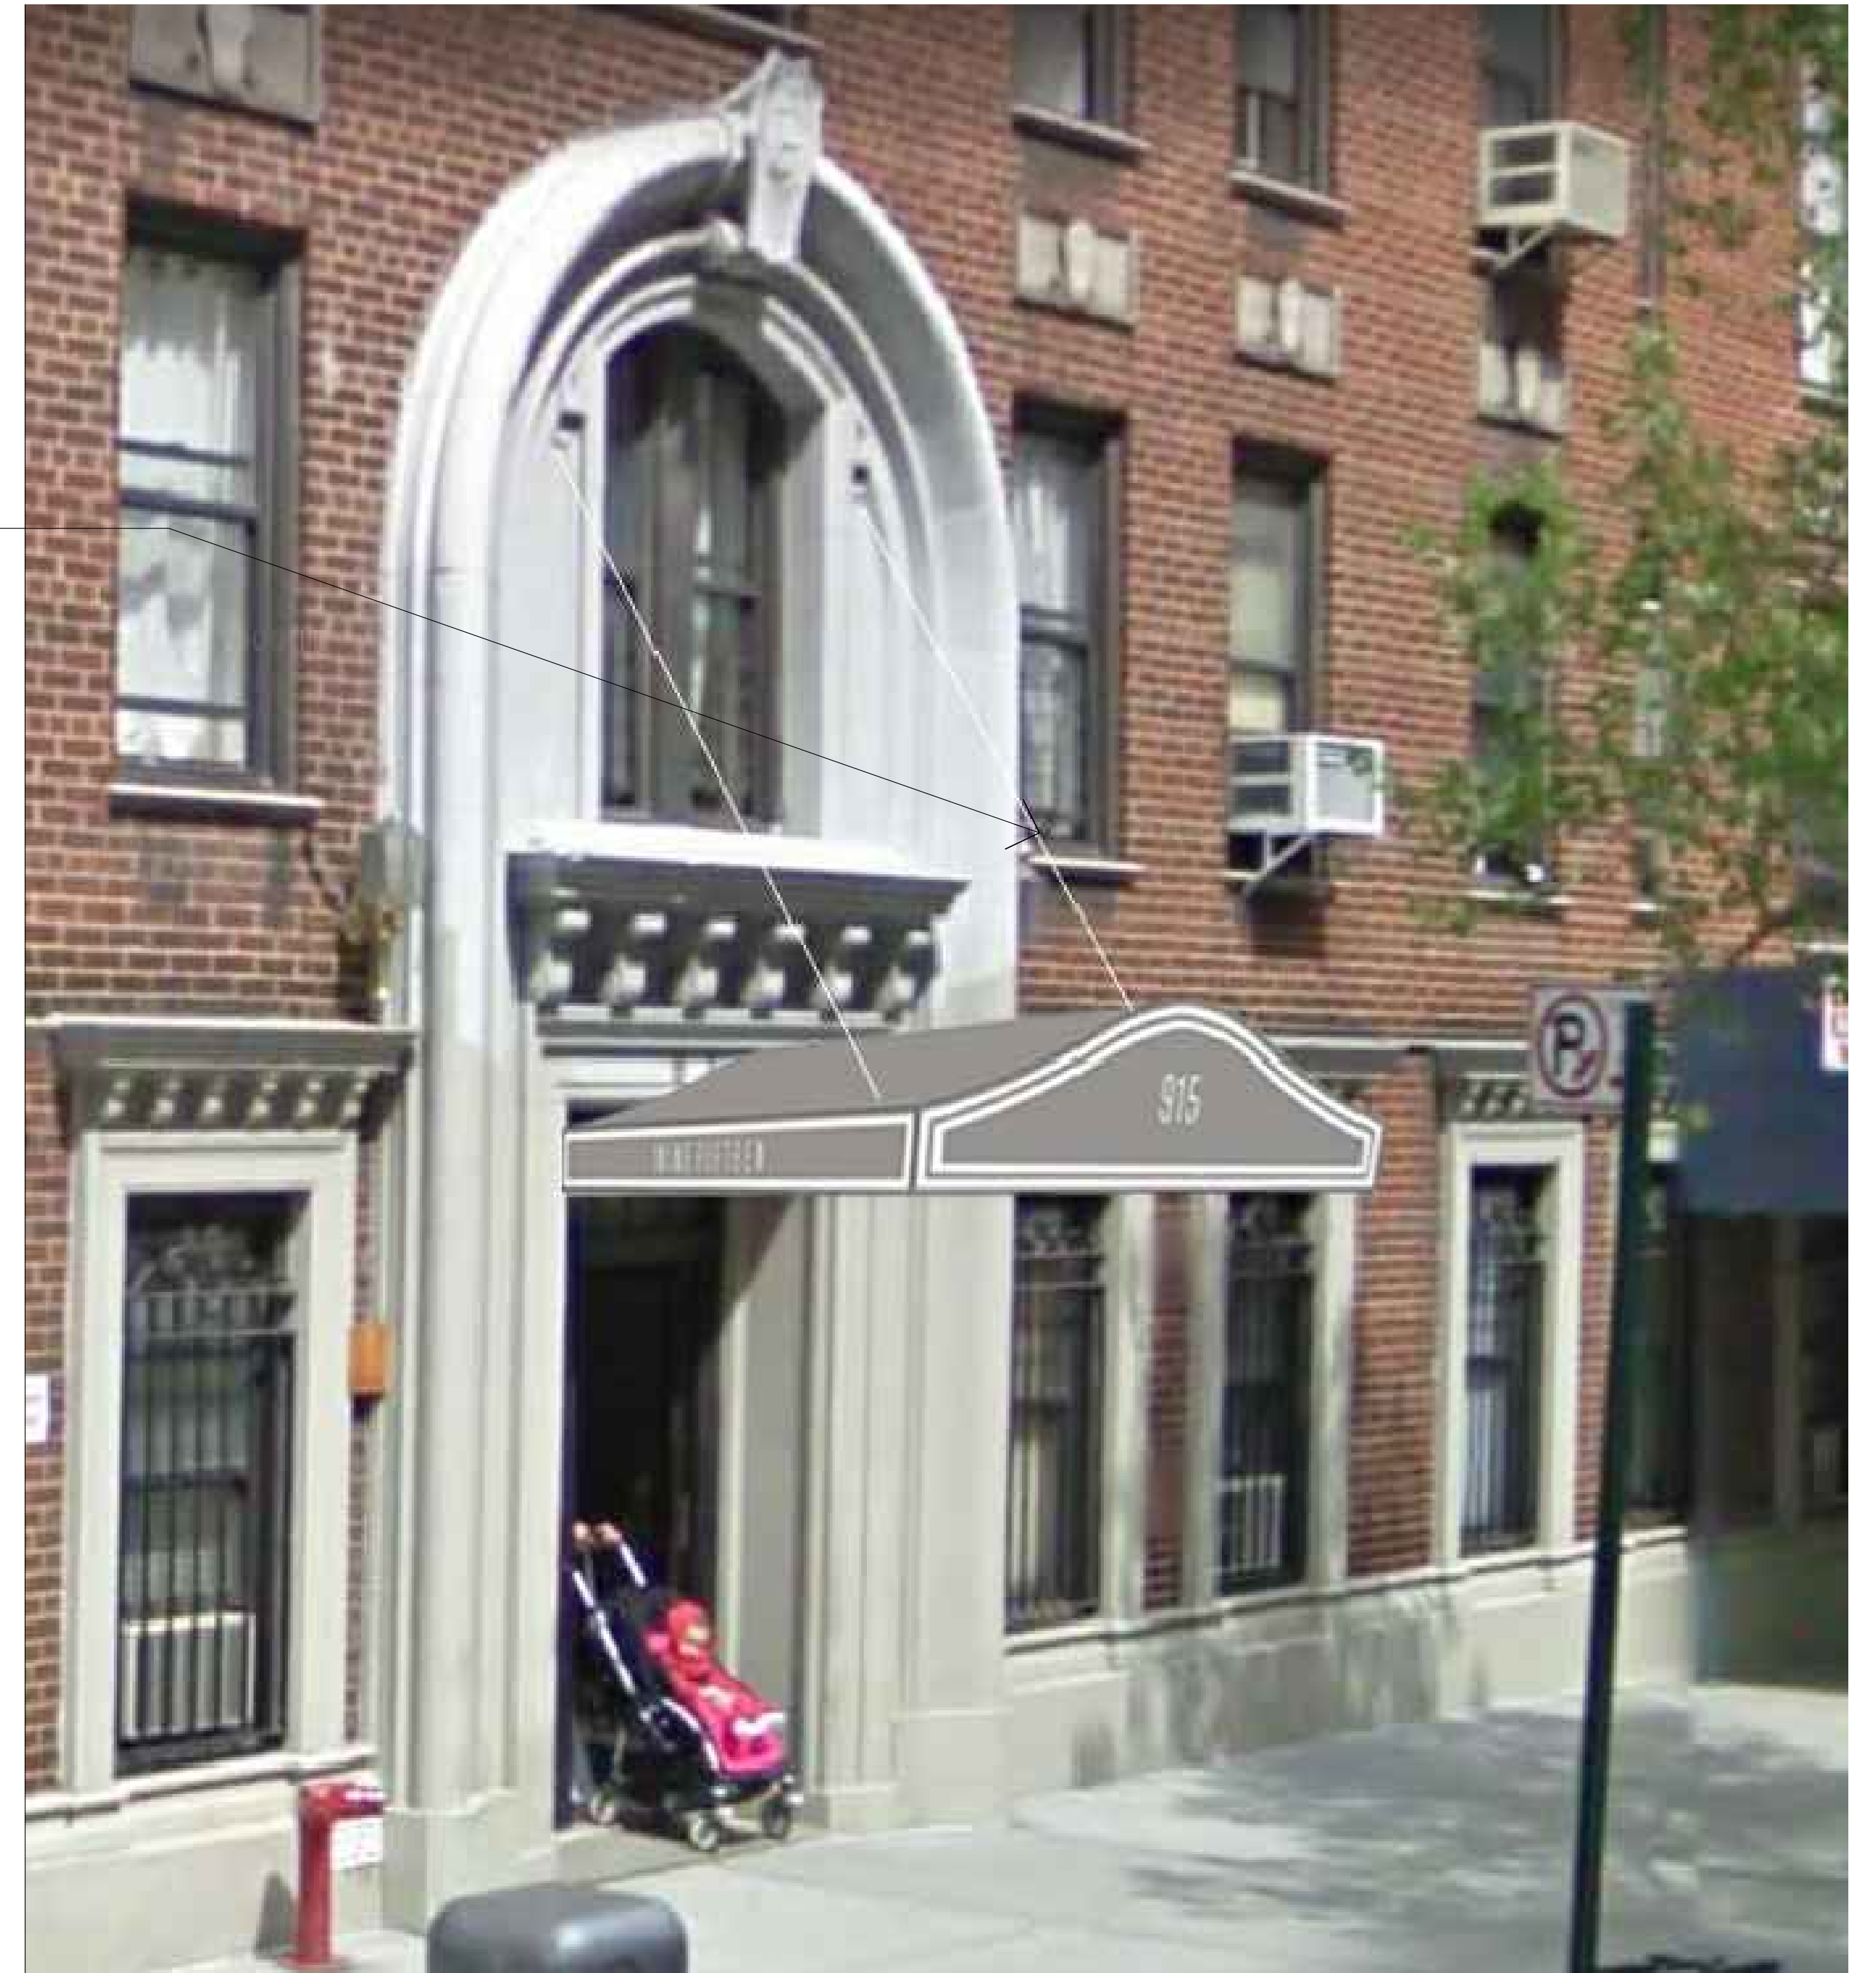
RENDERED IMAGE

GOLD FINISHED HANGING RODS

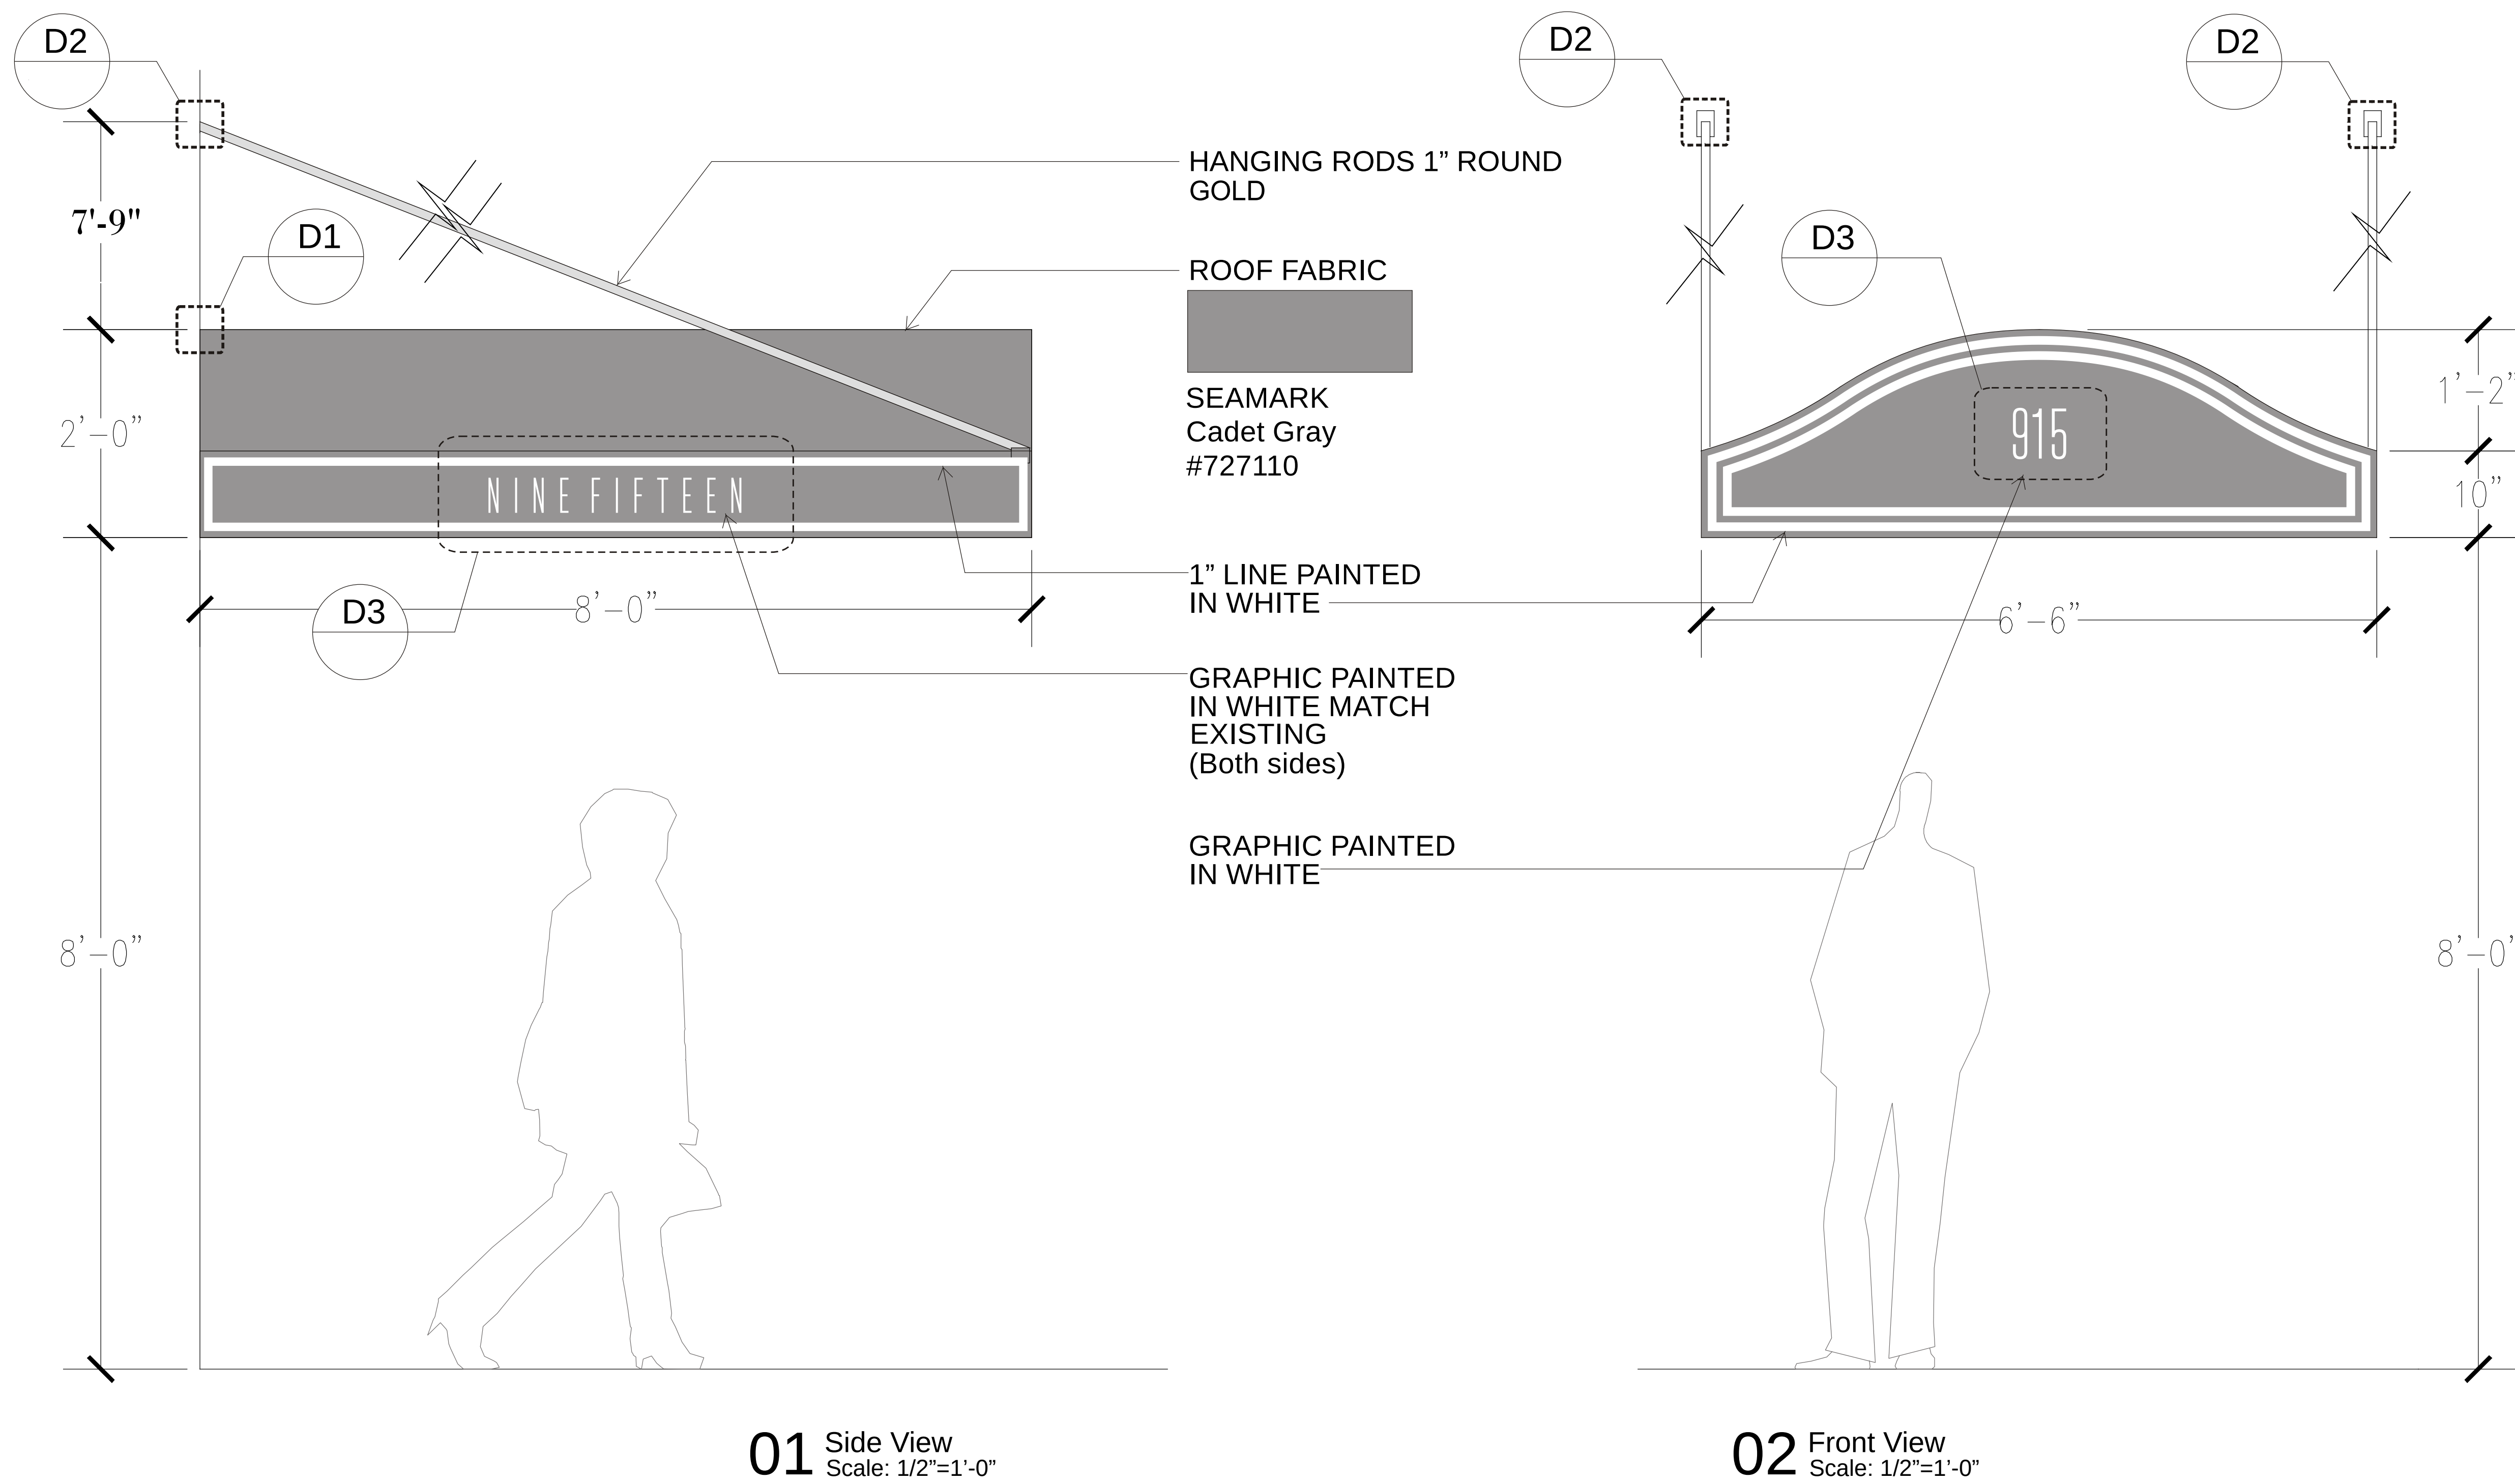
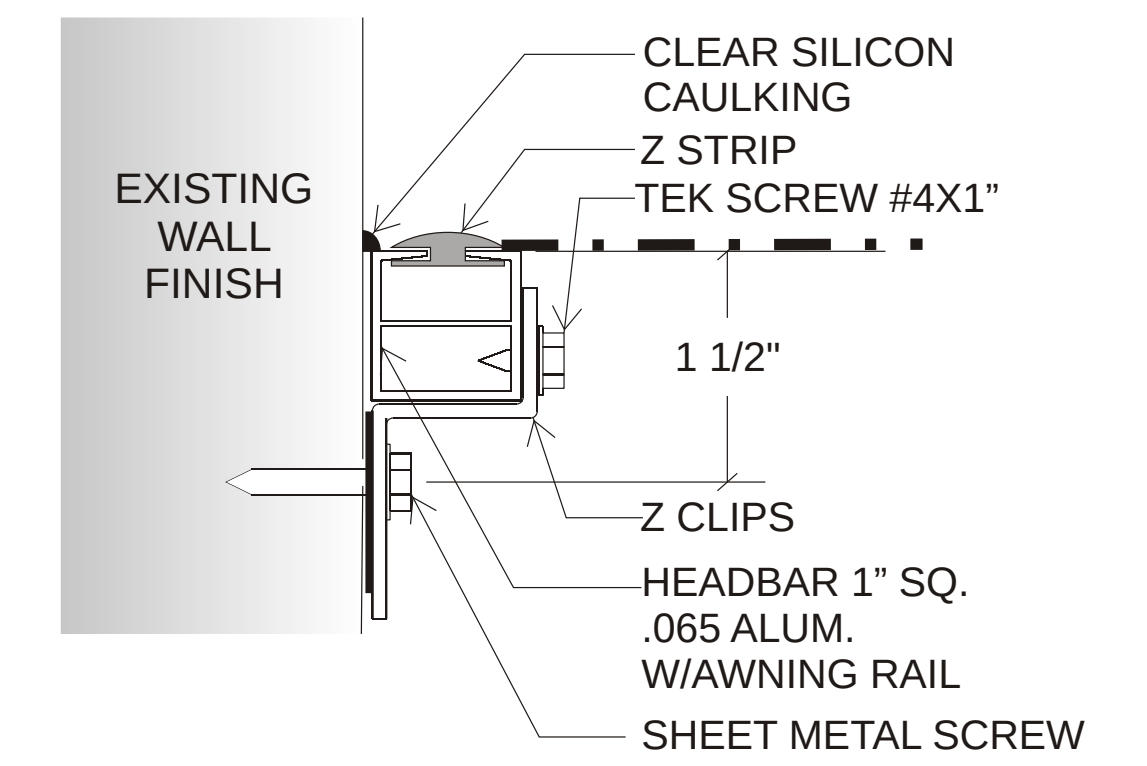
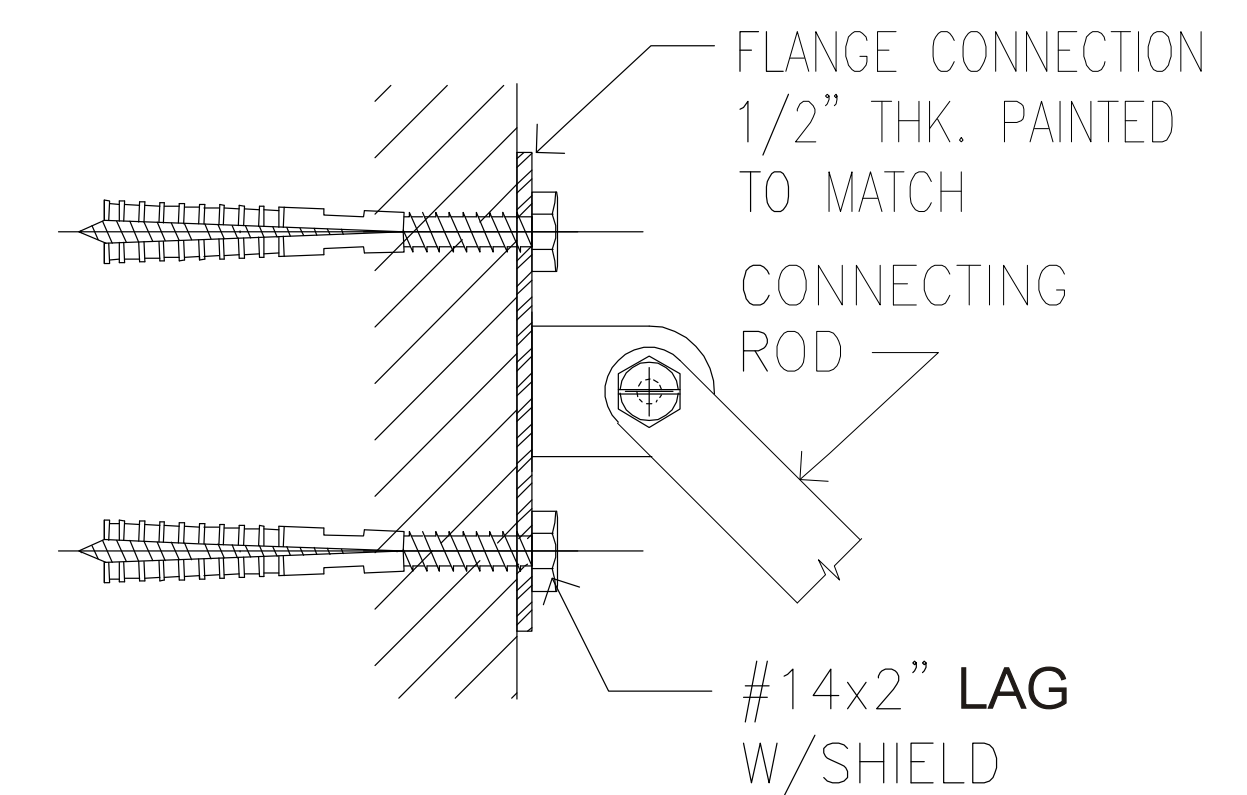
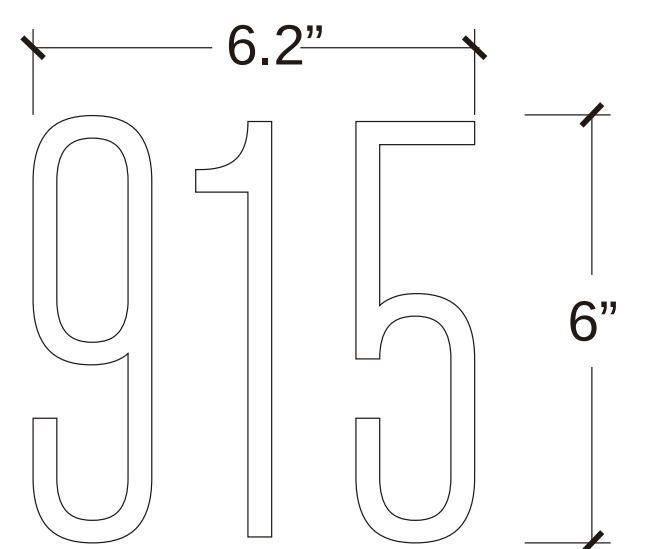
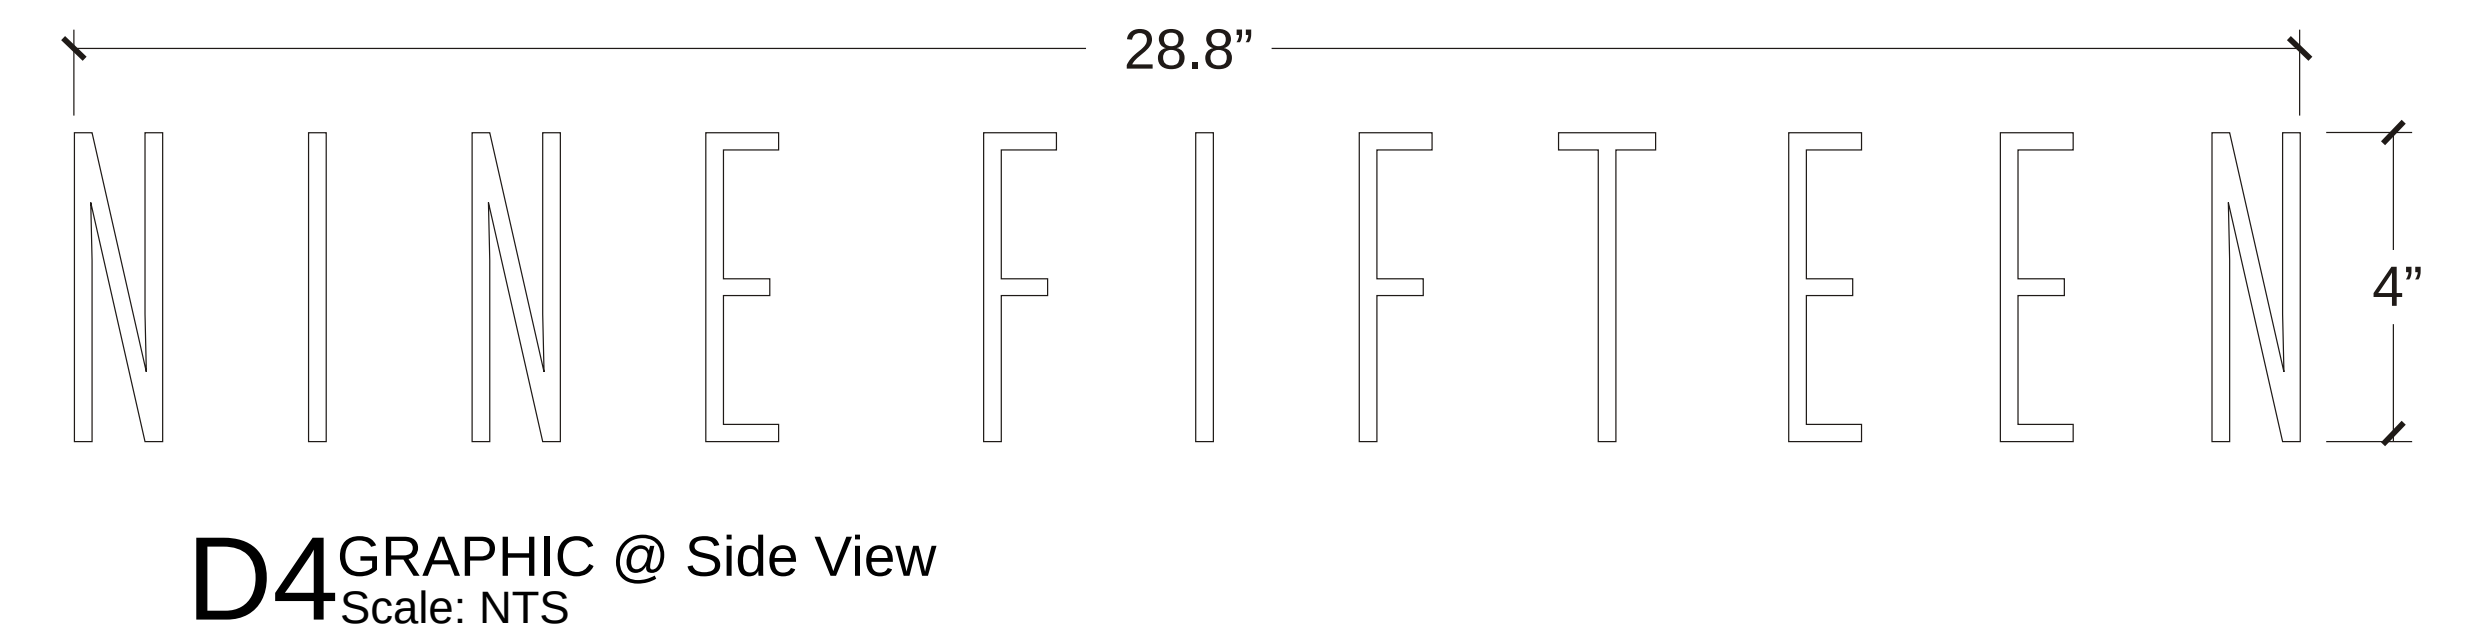
#### SPECIFICATION

FRAME: 1X1" ALUMINUM SQUARE TUBE, ALL WELDED, MILL FINISH  
 FABRIC ROOF: SEAMARK CADET GARY #727110  
 FABRIC CEILING: SUNBRELLA CADET GRAY #4630  
 HANGING RODS: 1" ROUND STAINLESS STEEL HANG RODS STOCK #4 BRUSHED FINISH

GRAPHIC: MASKED AND PAINTED IN WHITE  
 (Graphic shown is the best match to sample graphic, if different is required, please provide eps file or font name)

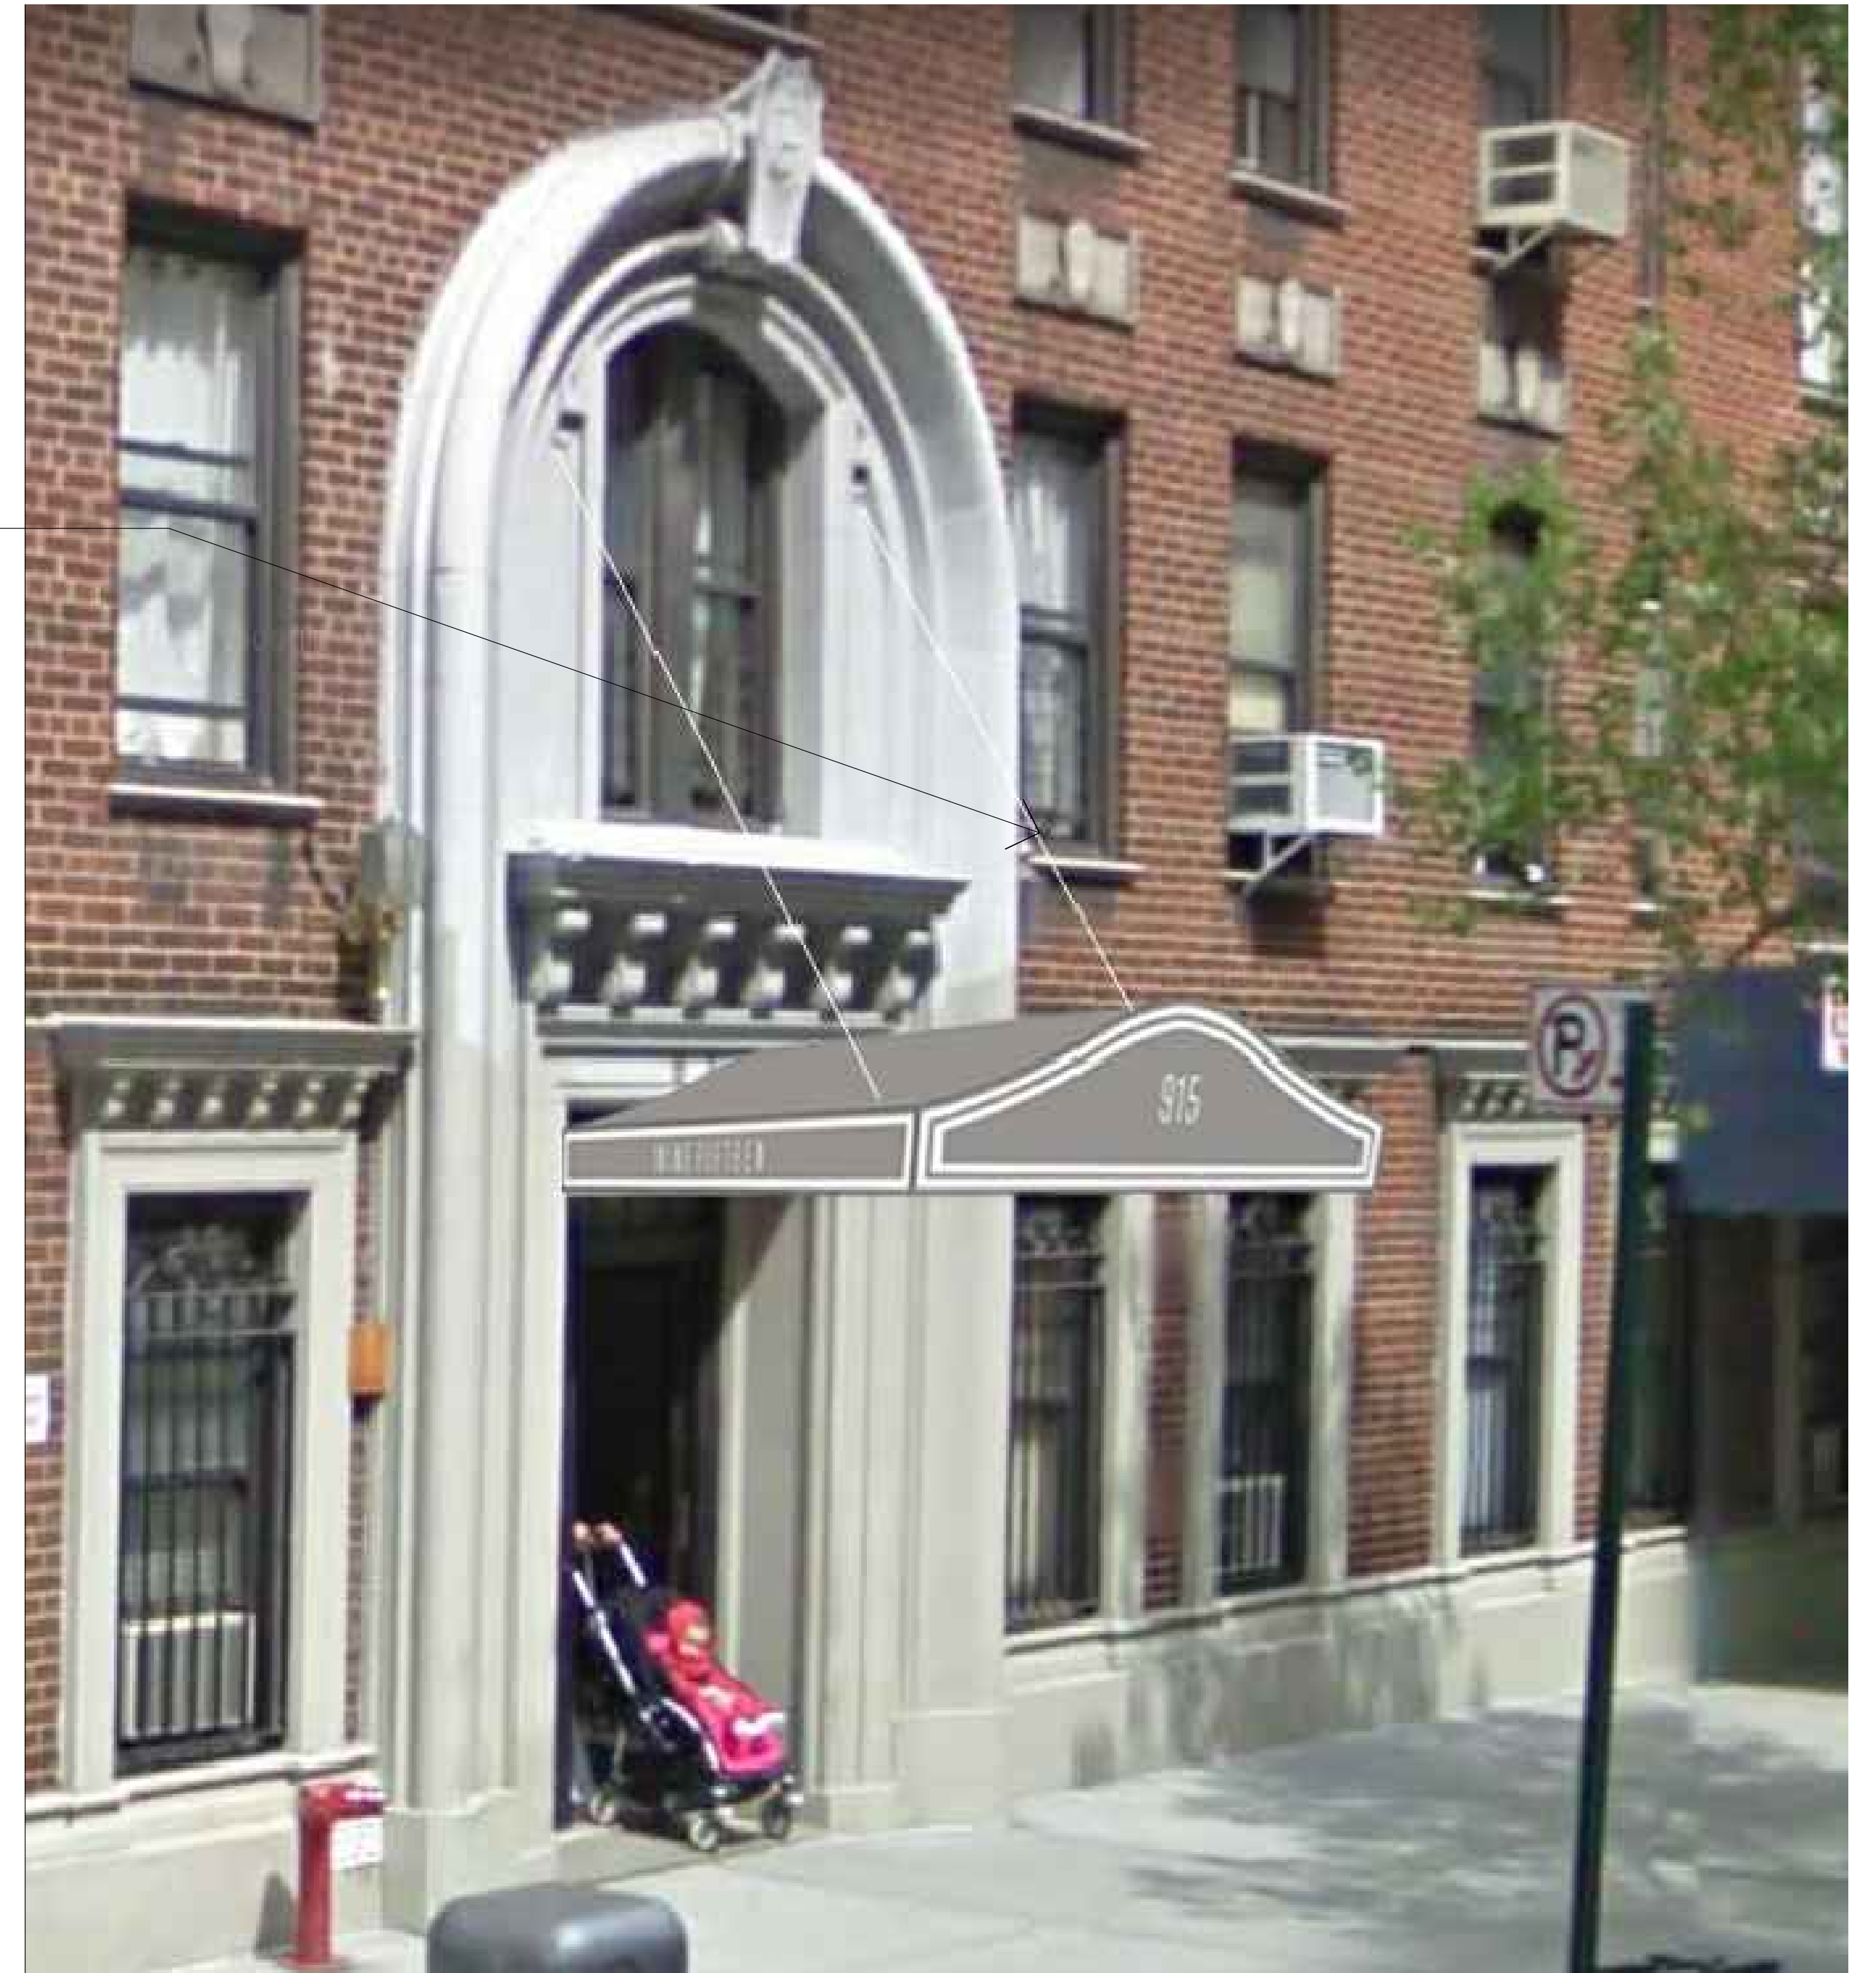
RENDERED IMAGE

GOLD FINISHED HANGING RODS
