Rehabilitation of the West 79th Street Rotunda Complex and West 79th Street Bridge Over Amtrak

Landmarks Preservation Commission
June 2019

Rehabilitation of the West 79th Street Rotunda
Complex And West 79th Street Bridge over Amtrak
June 2019

HDR|AECOM a Joint Venture

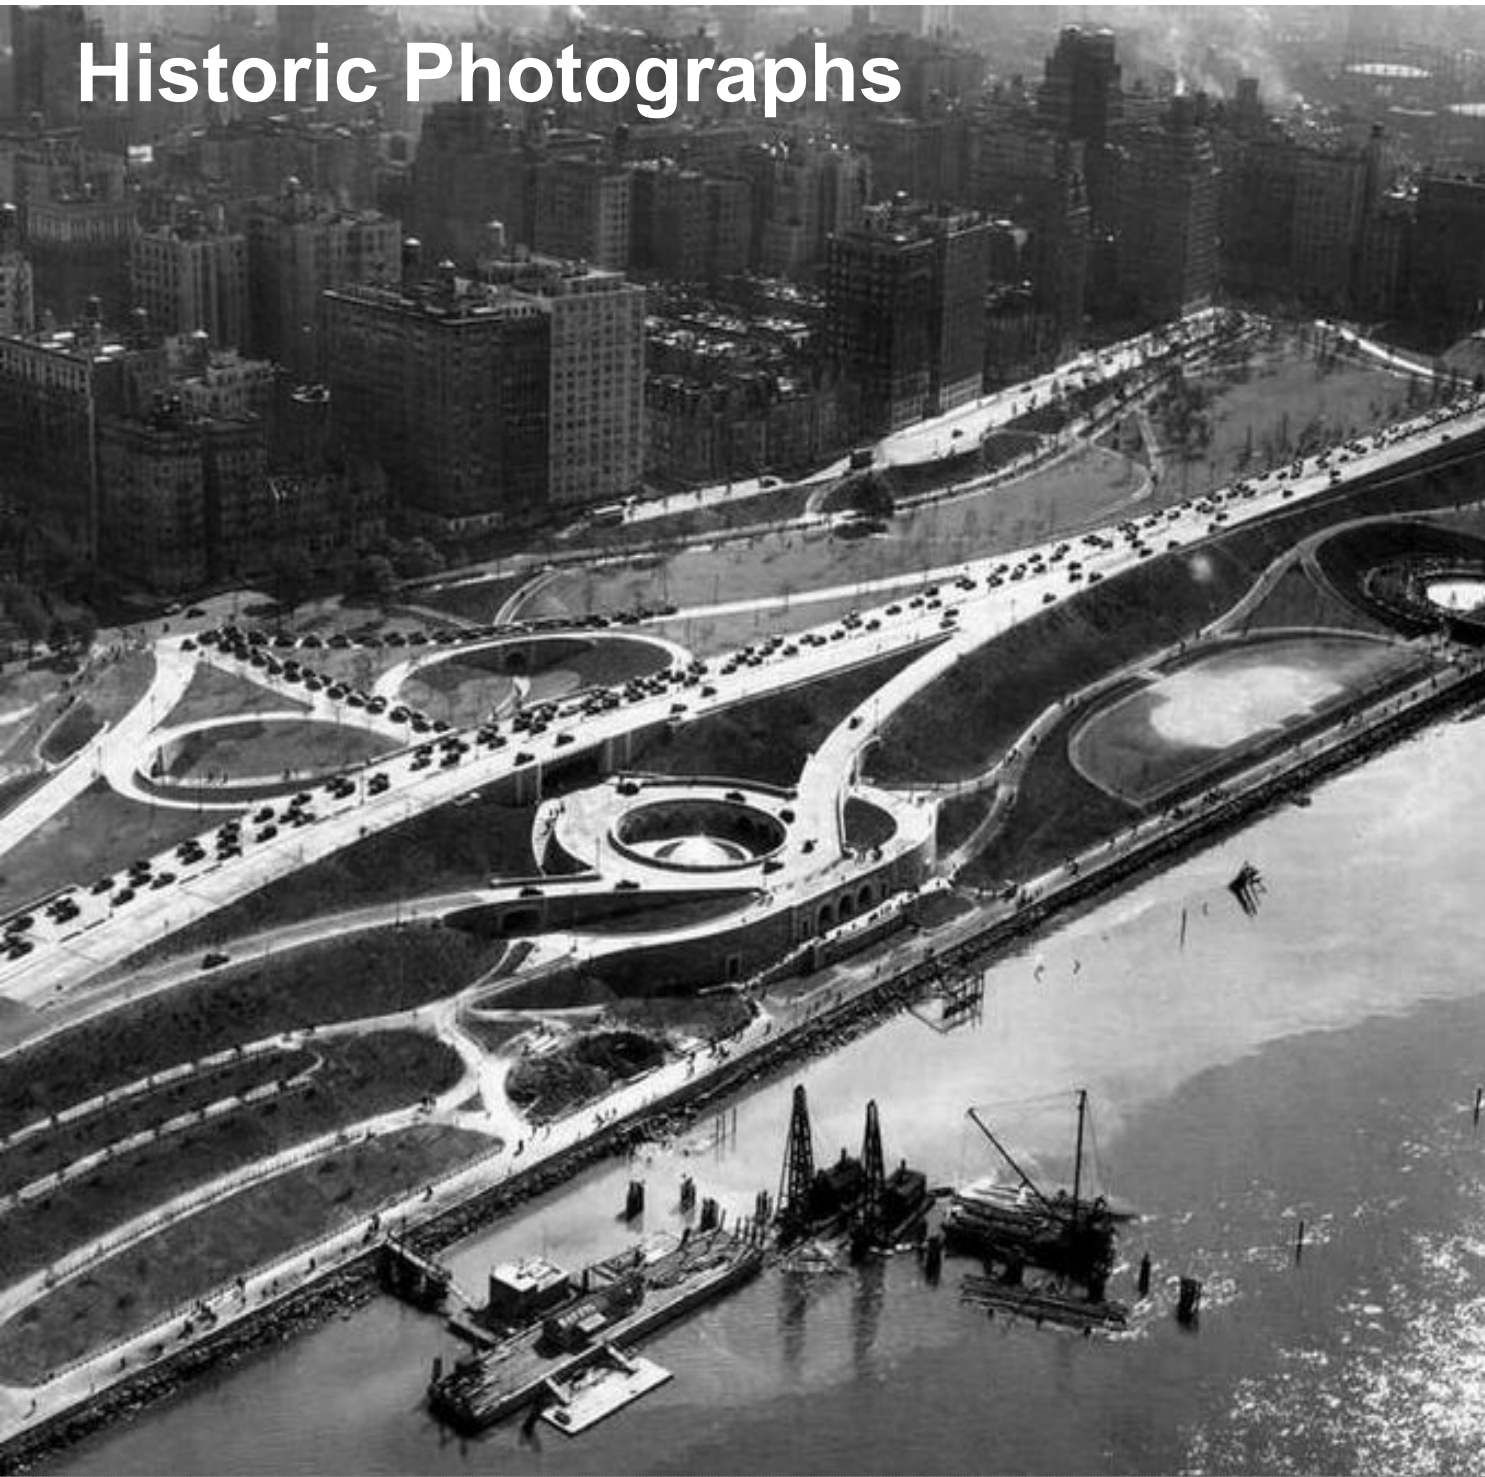
Aerial photograph over Hudson River,
1937

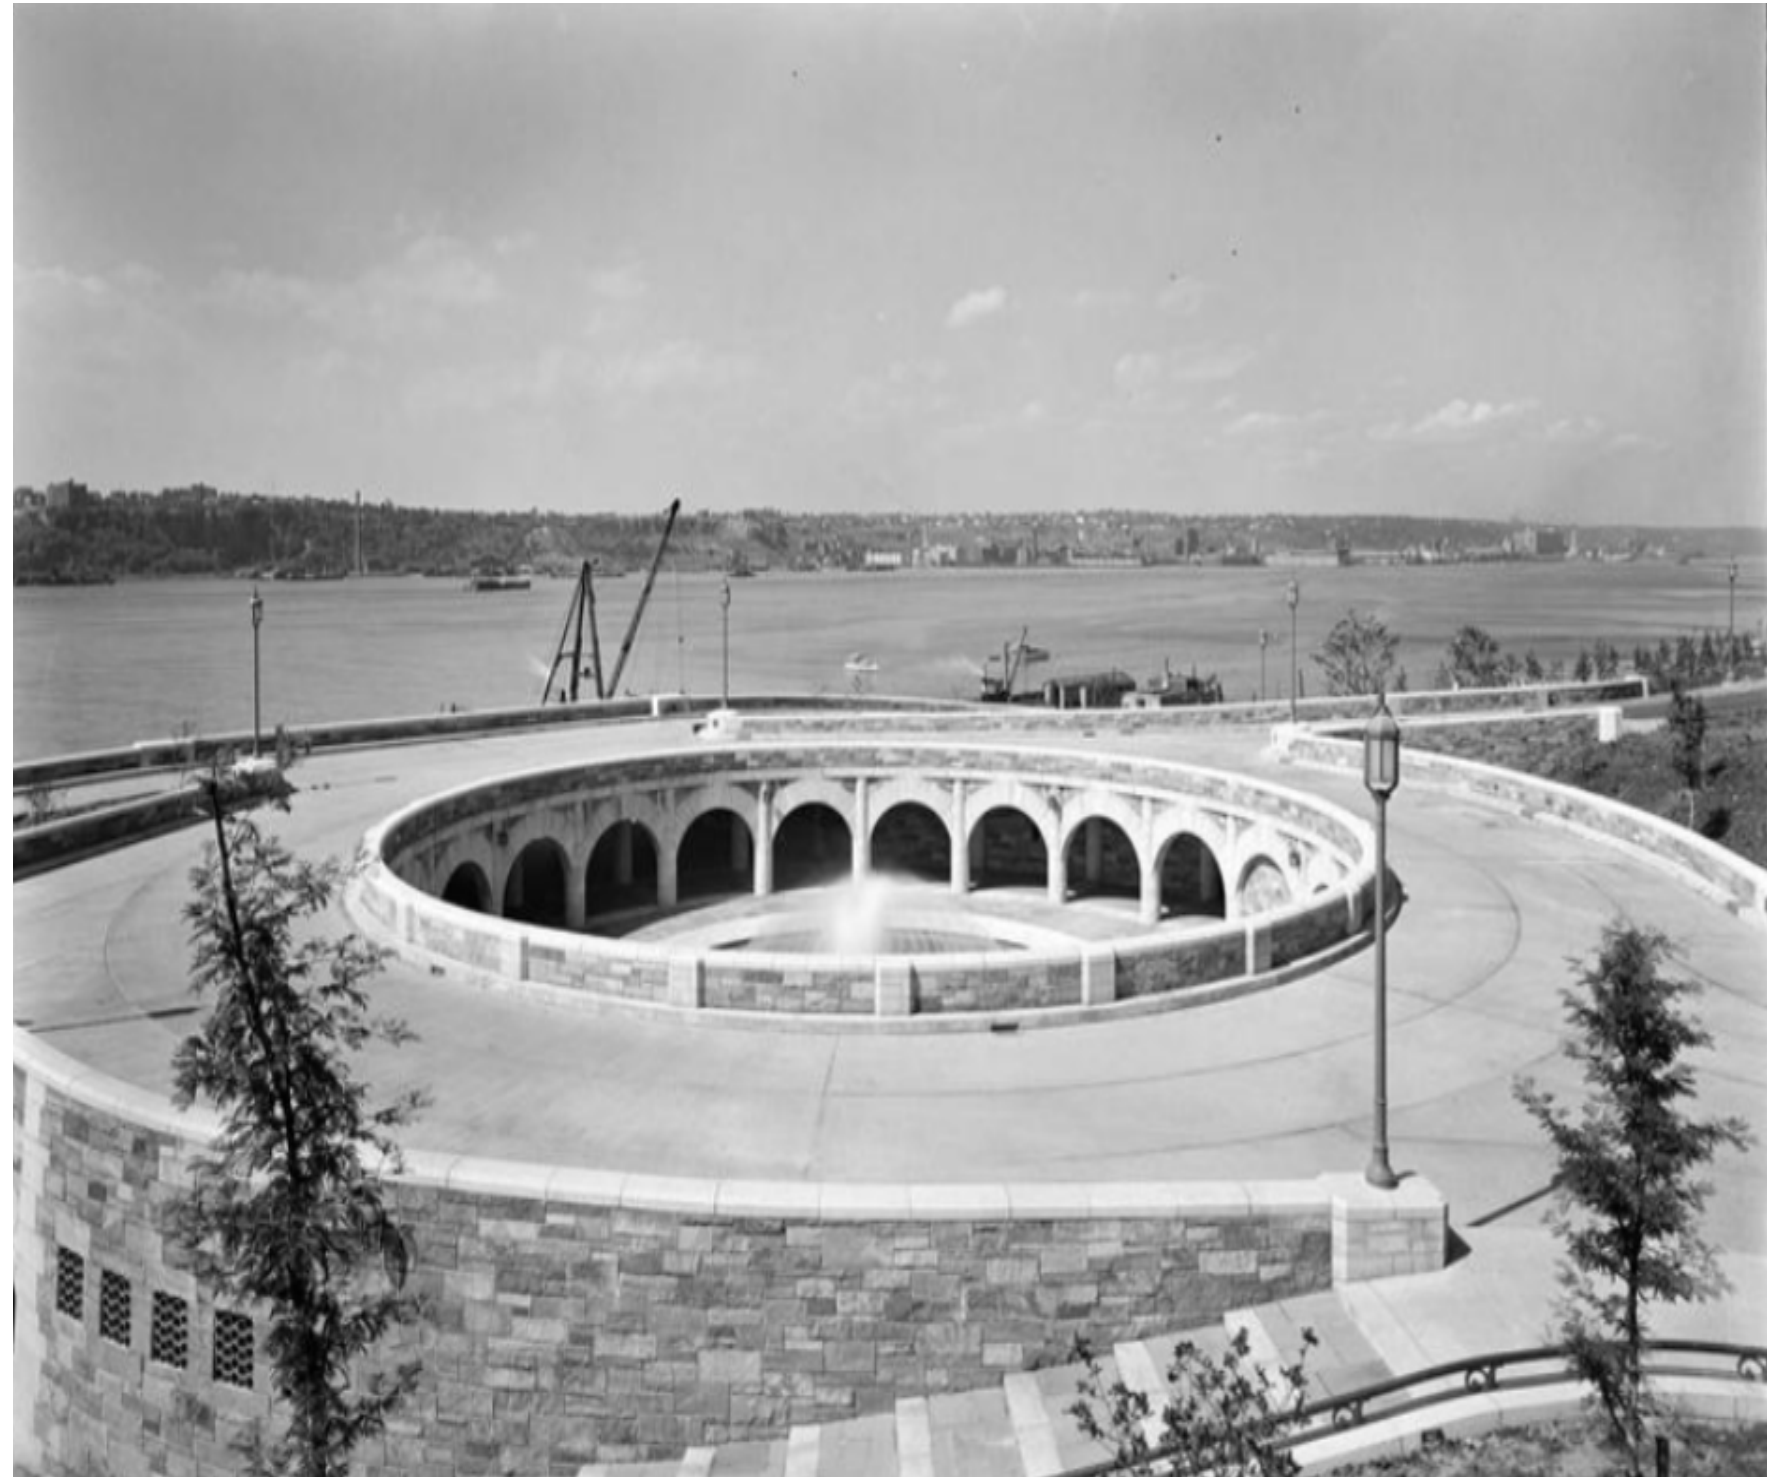
Rotunda and stepped ramp, 1937

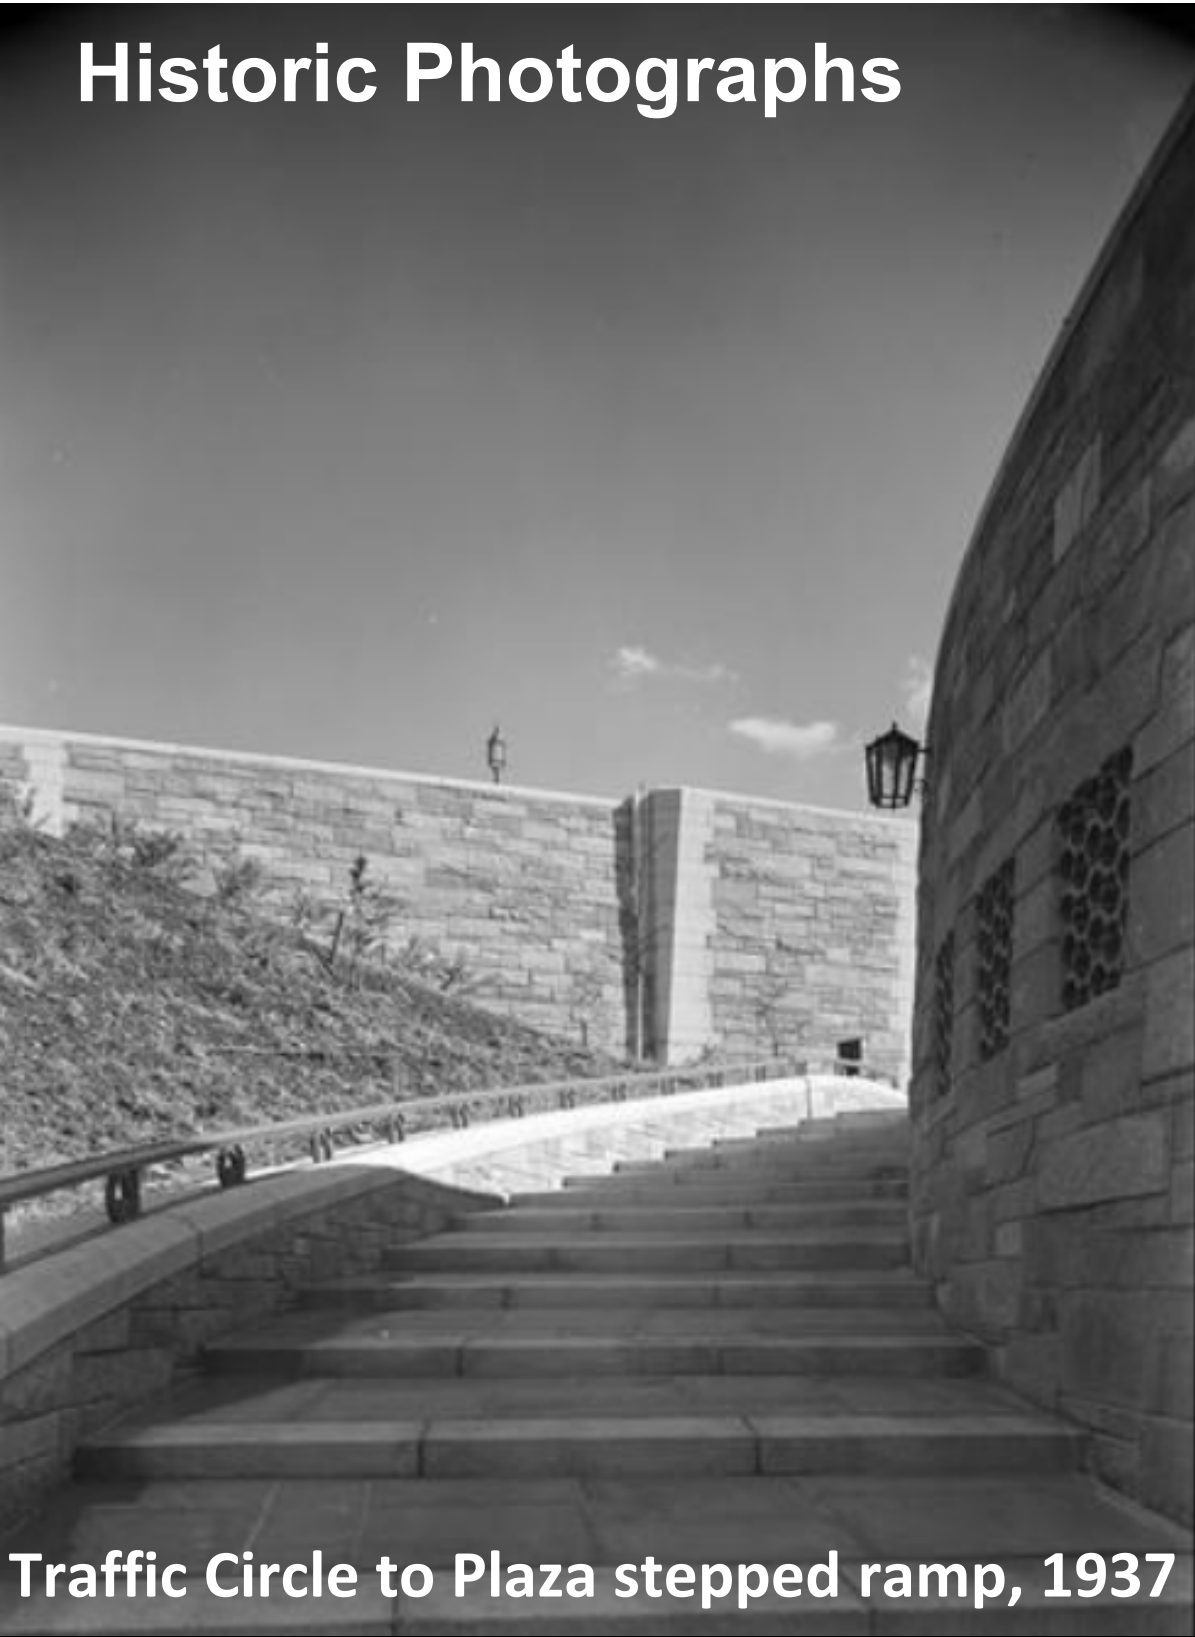
Traffic Circle to Plaza stepped ramp, 1937

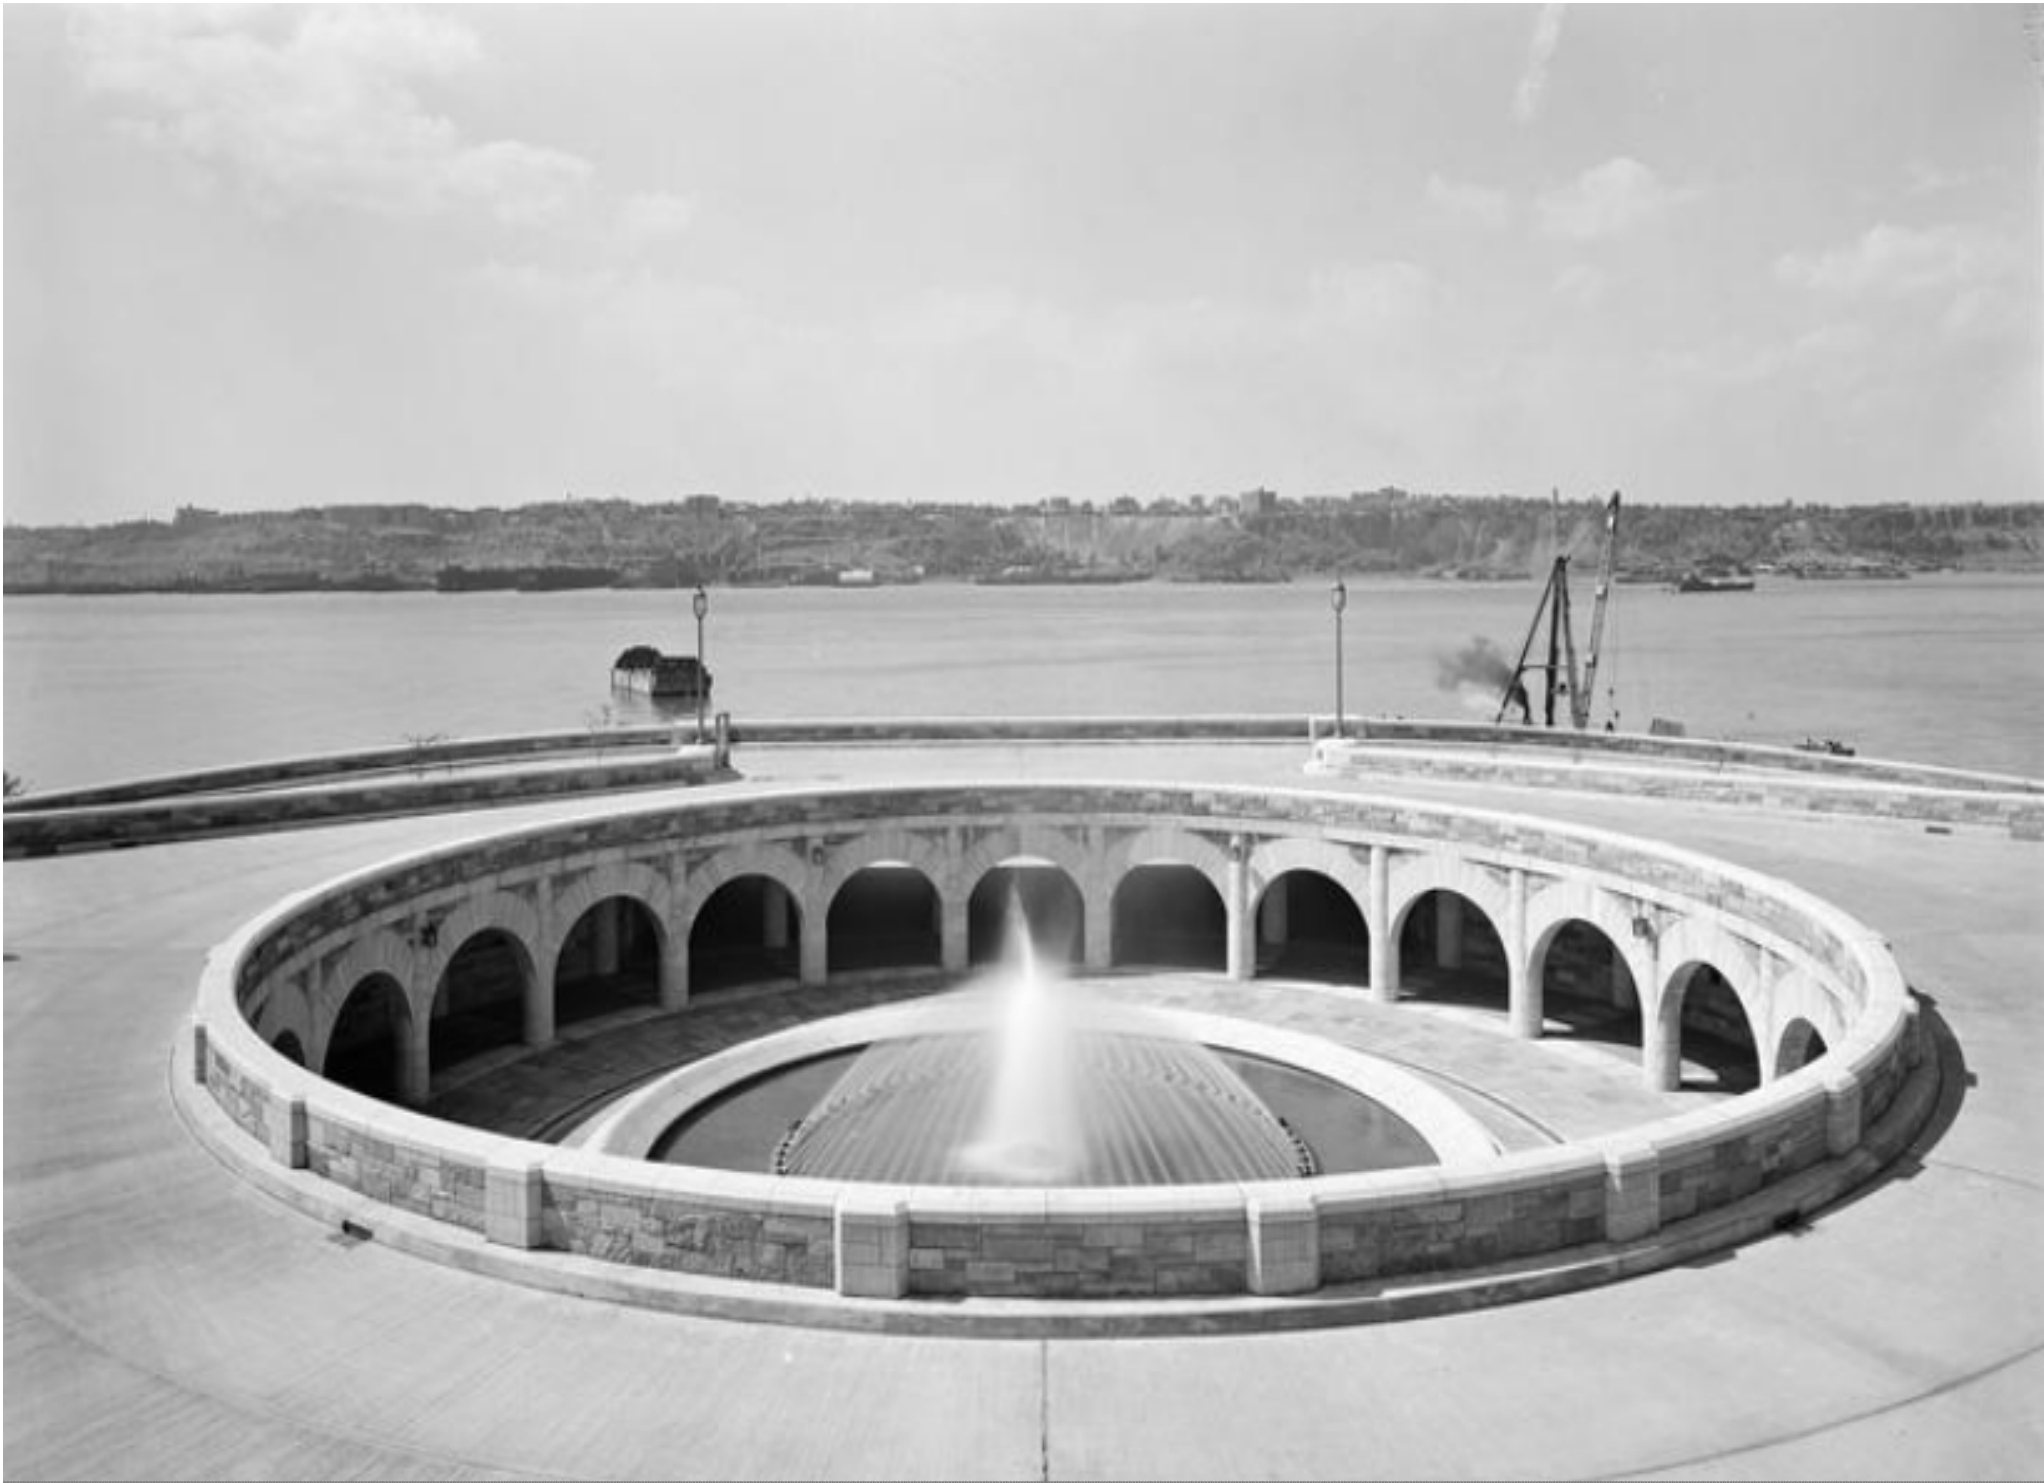
Traffic rotunda and park, 1937

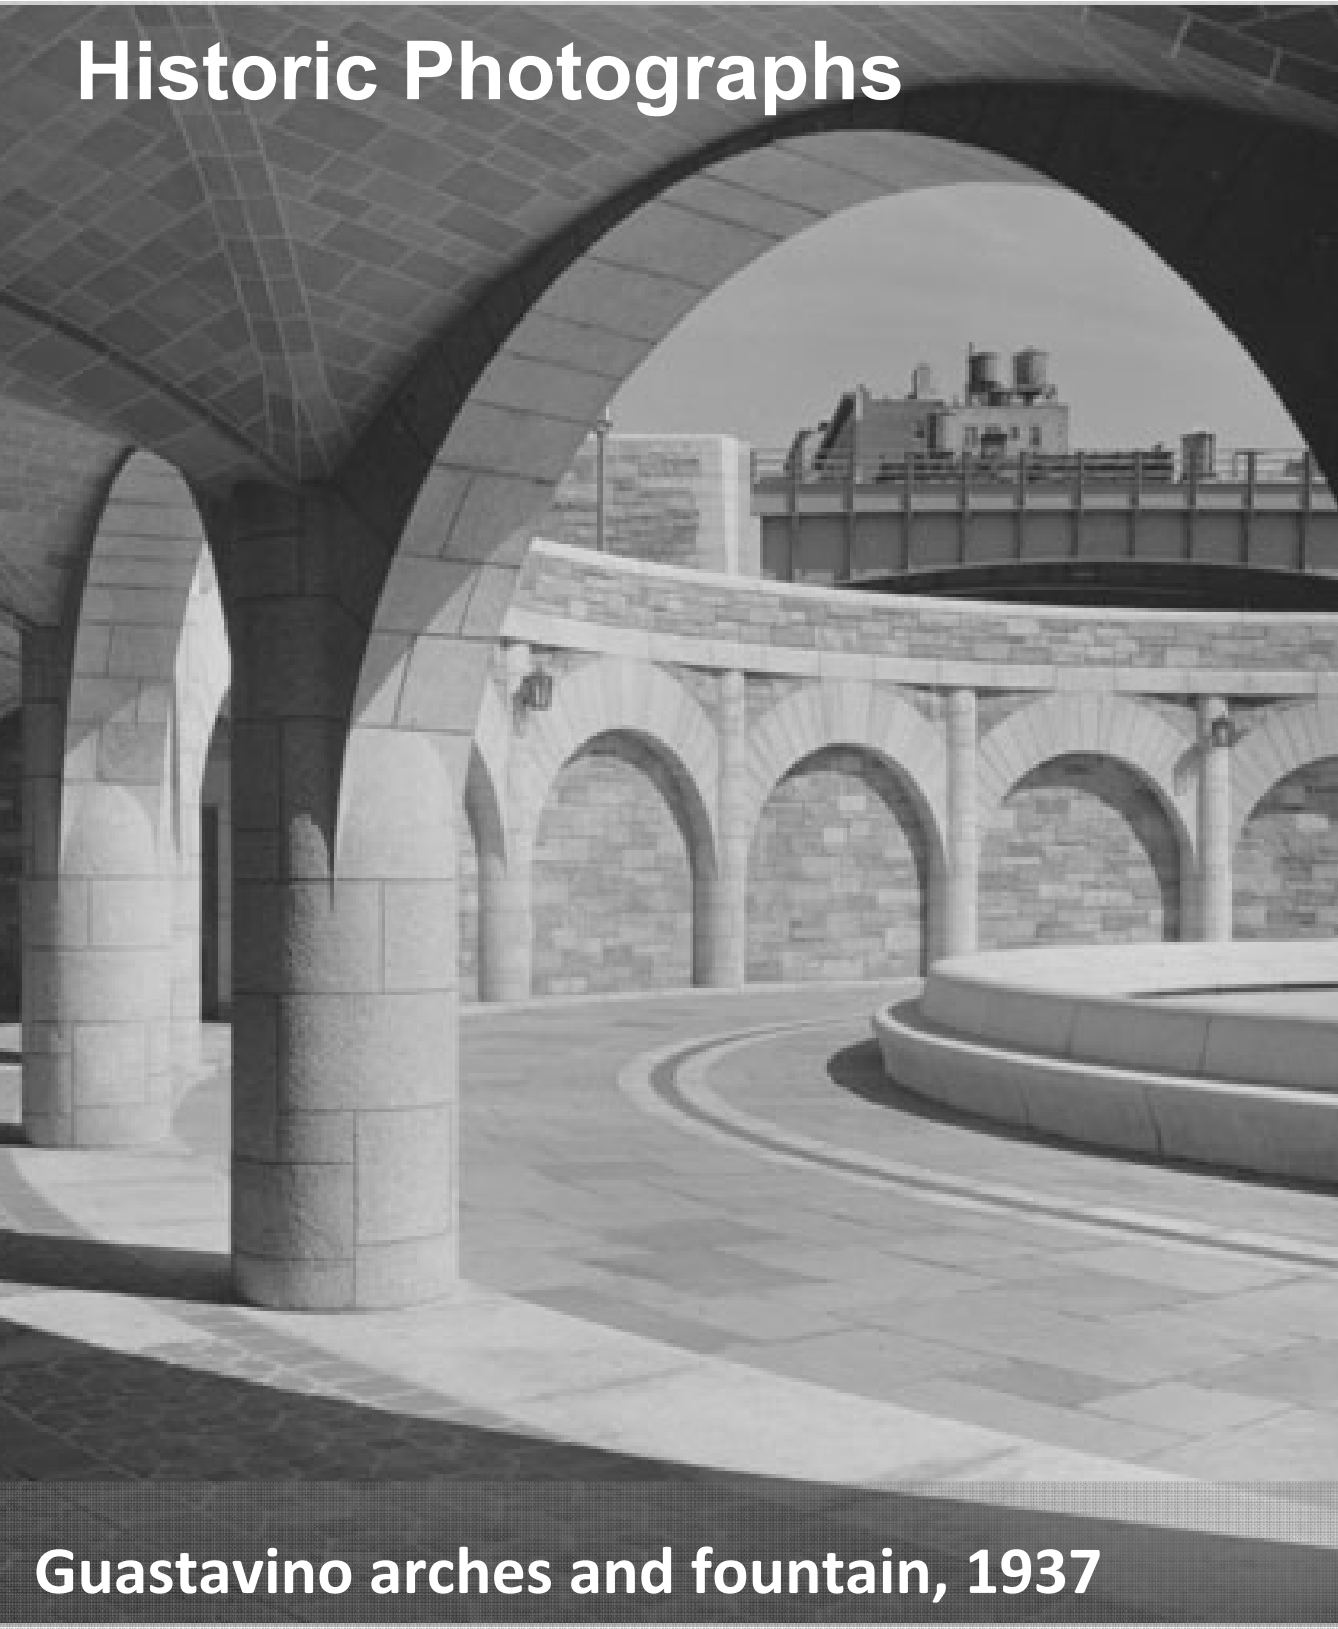
Guastavino arches and fountain, 1937

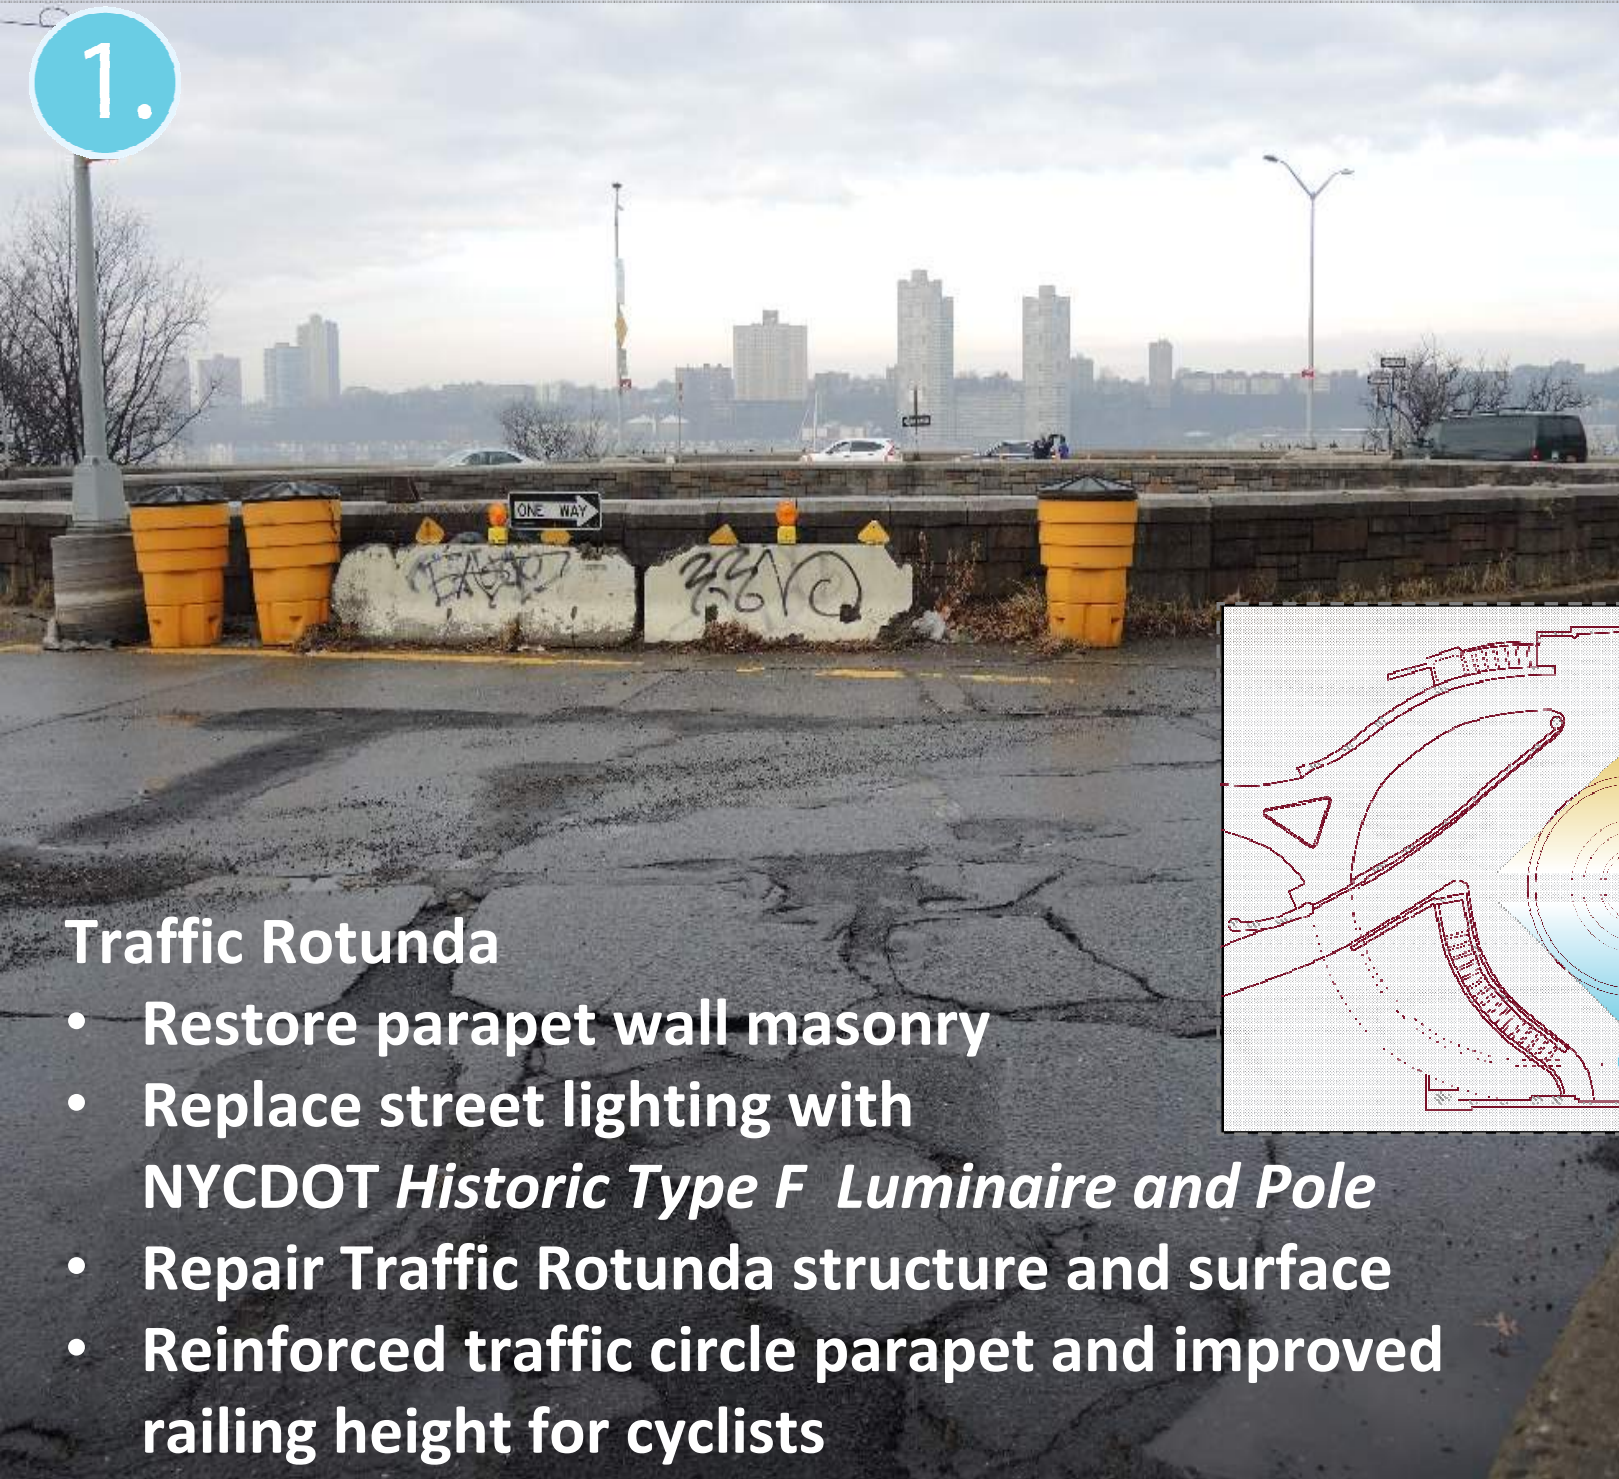
- Restore parapet wall masonry
- Replace street lighting with NYCDOT *Historic Type F Luminaire and Pole*
- Repair Traffic Rotunda structure and surface
- Reinforced traffic circle parapet and improved railing height for cyclists

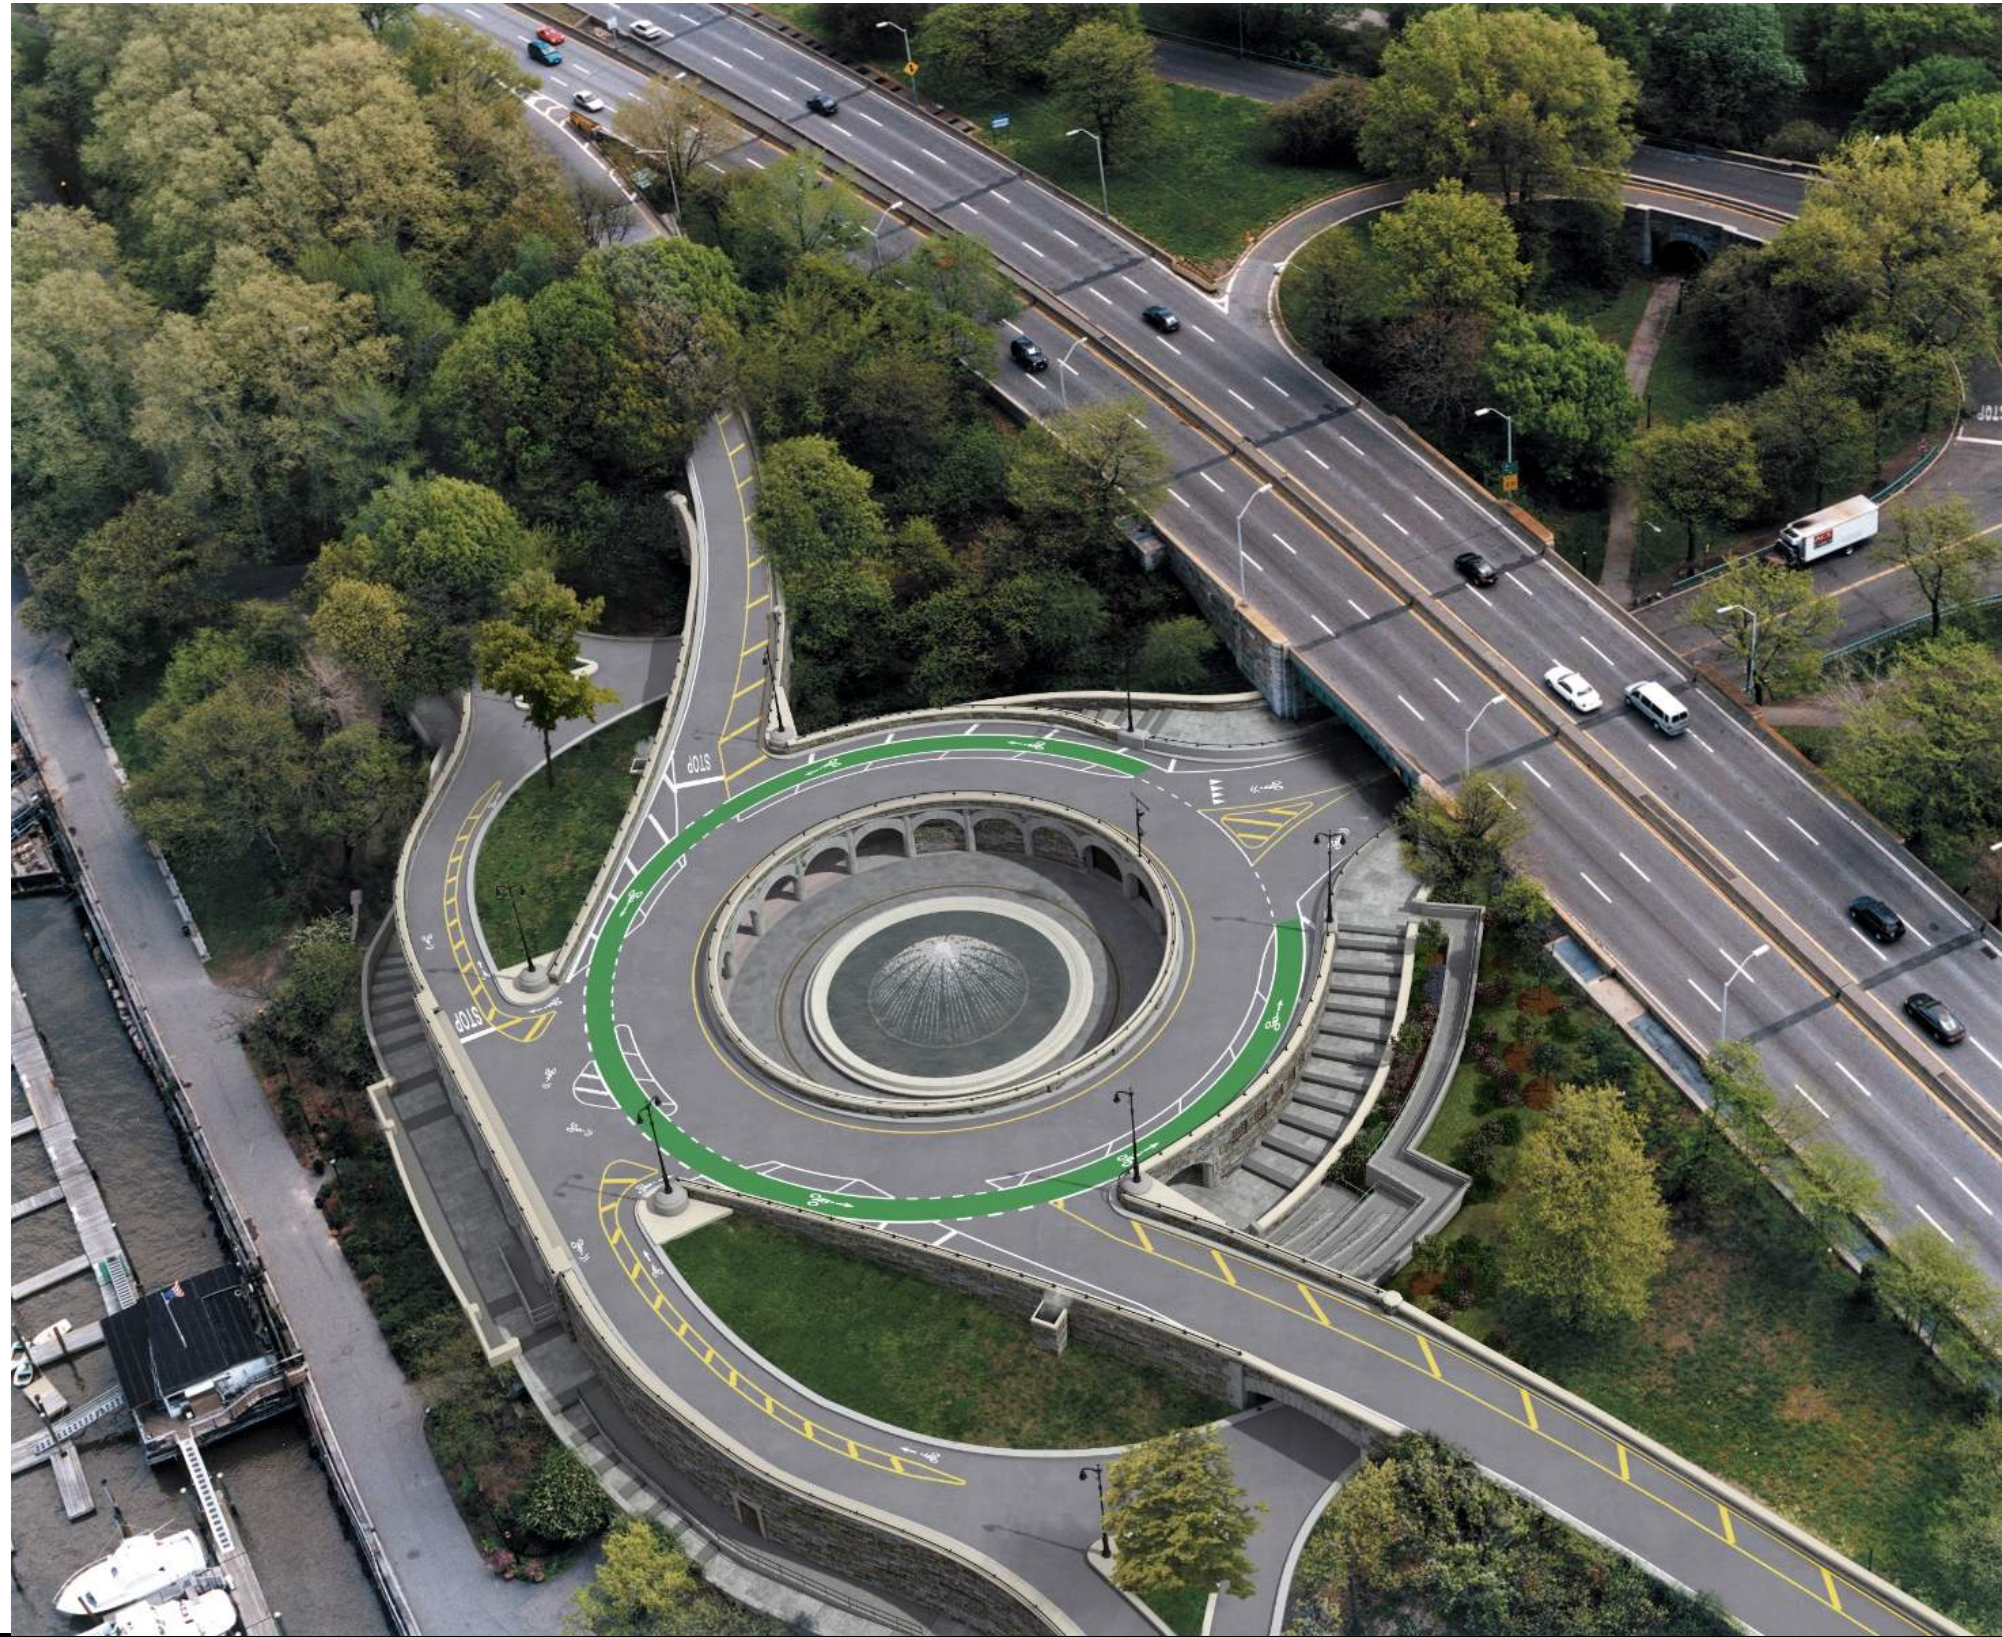
Geometric Design Improvements

- 18' Wide Traffic Circle Lane
- Maintains Operations of Large MTA Articulated Buses
- Improved Stopping Sight Distance at Henry Hudson Parkway Exit
- Encourages Reduced Travel Speeds in the Traffic Circle
- Provides Separation of Vehicles and Bicycles

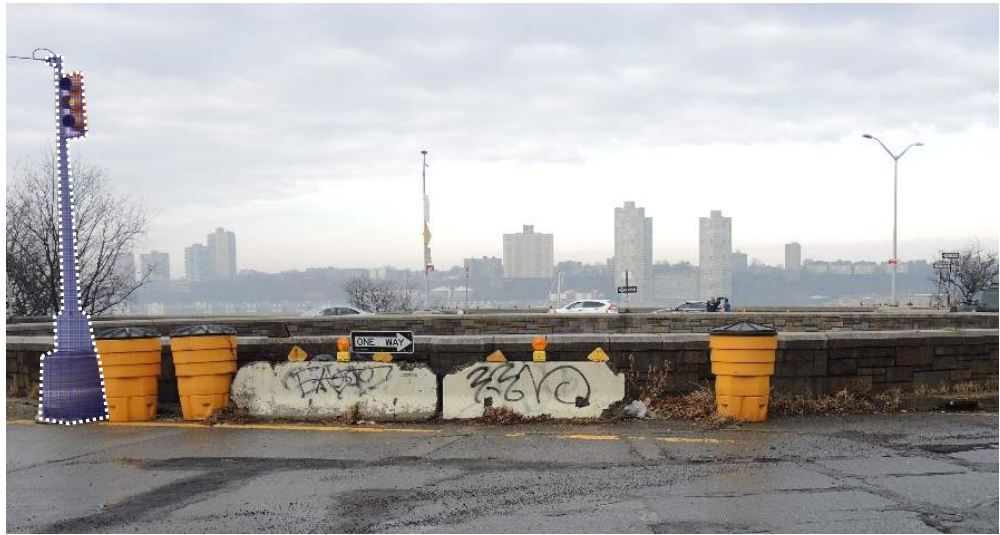
Existing Traffic Circle Light Post to be replaced with NYCDOT *Historic Type F Luminaire*

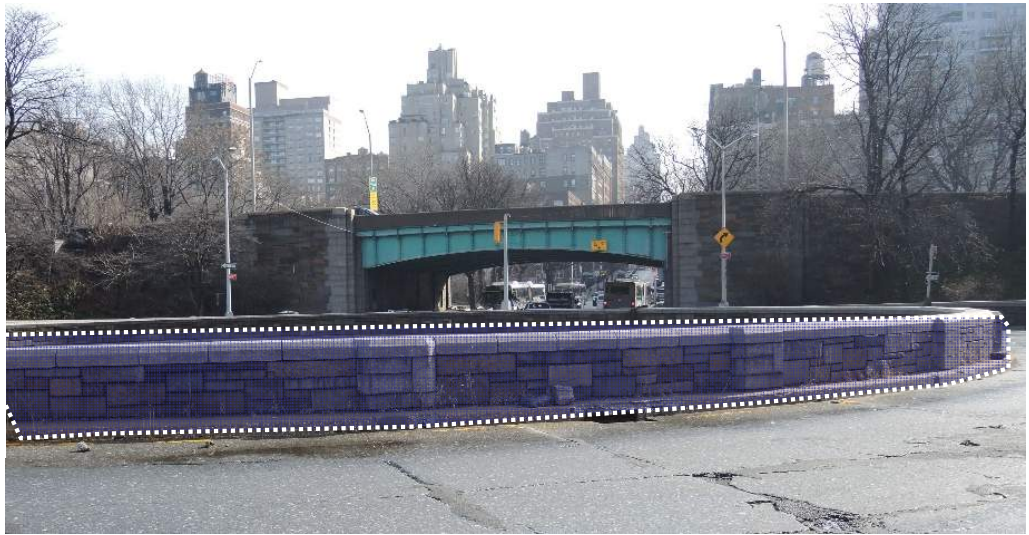
Existing Traffic Circle Barrier to be reinforced

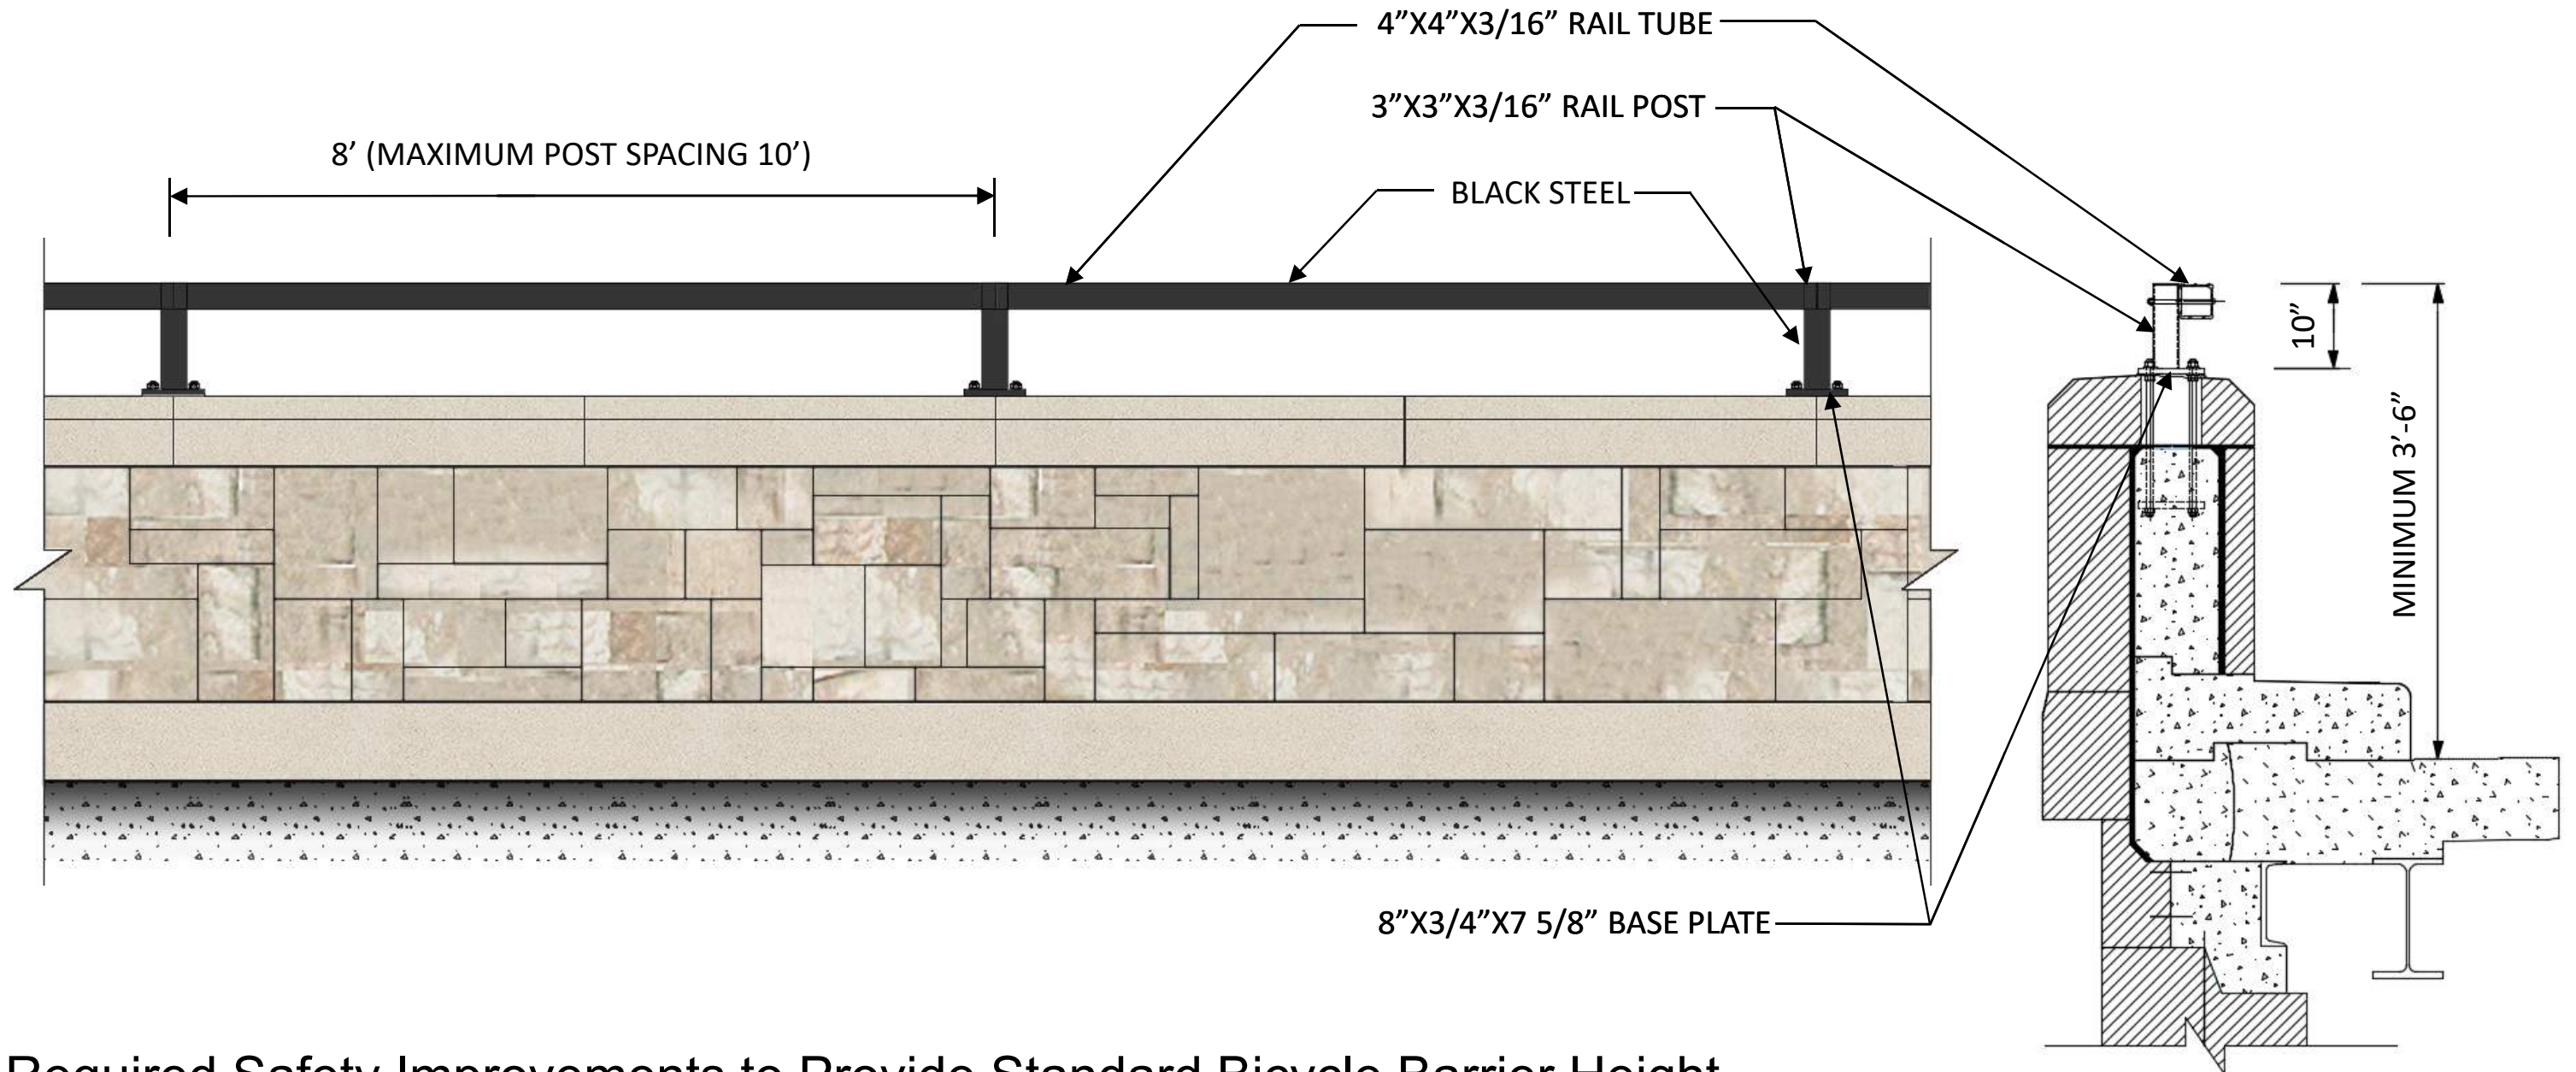
Roadway Traffic Barrier Improvements

- Required Safety Improvements to Provide Standard Bicycle Barrier Height
- Must Meet NYSDOT Standard Detailing Requirements
