Rehabilitation of the West 79th Street Rotunda Complex and West 79th Street Bridge Over Amtrak

Landmarks Preservation Commission
June 2019

Rehabilitation of the West 79th Street Rotunda
Complex And West 79th Street Bridge over Amtrak
June 2019

HDR|AECOM a Joint Venture

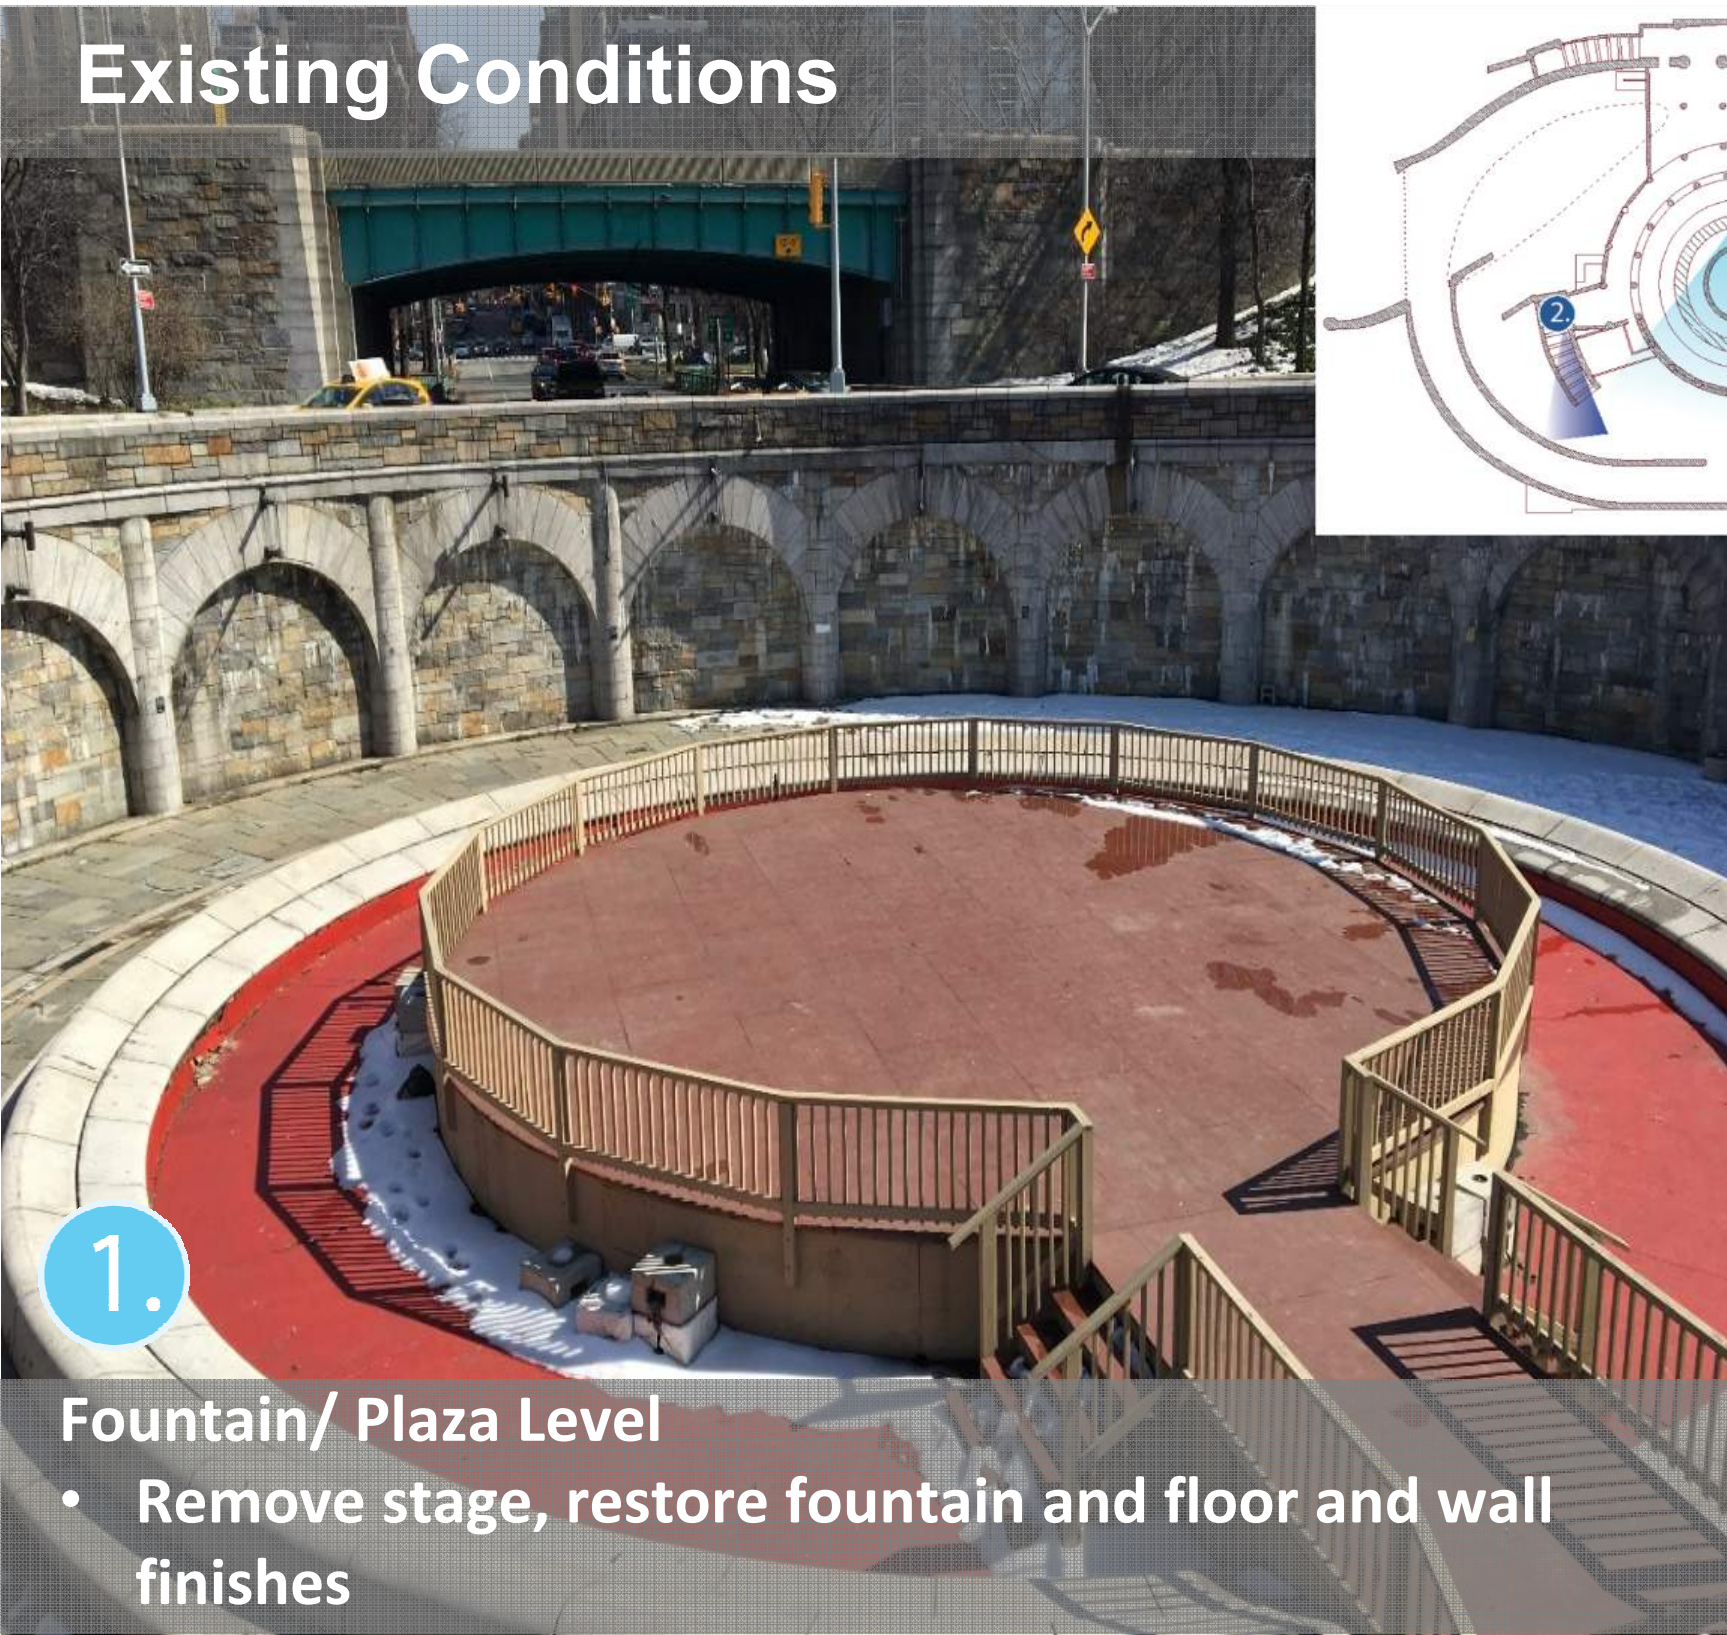
Fountain/ Plaza Level

- Remove stage, restore fountain and floor and wall finishes

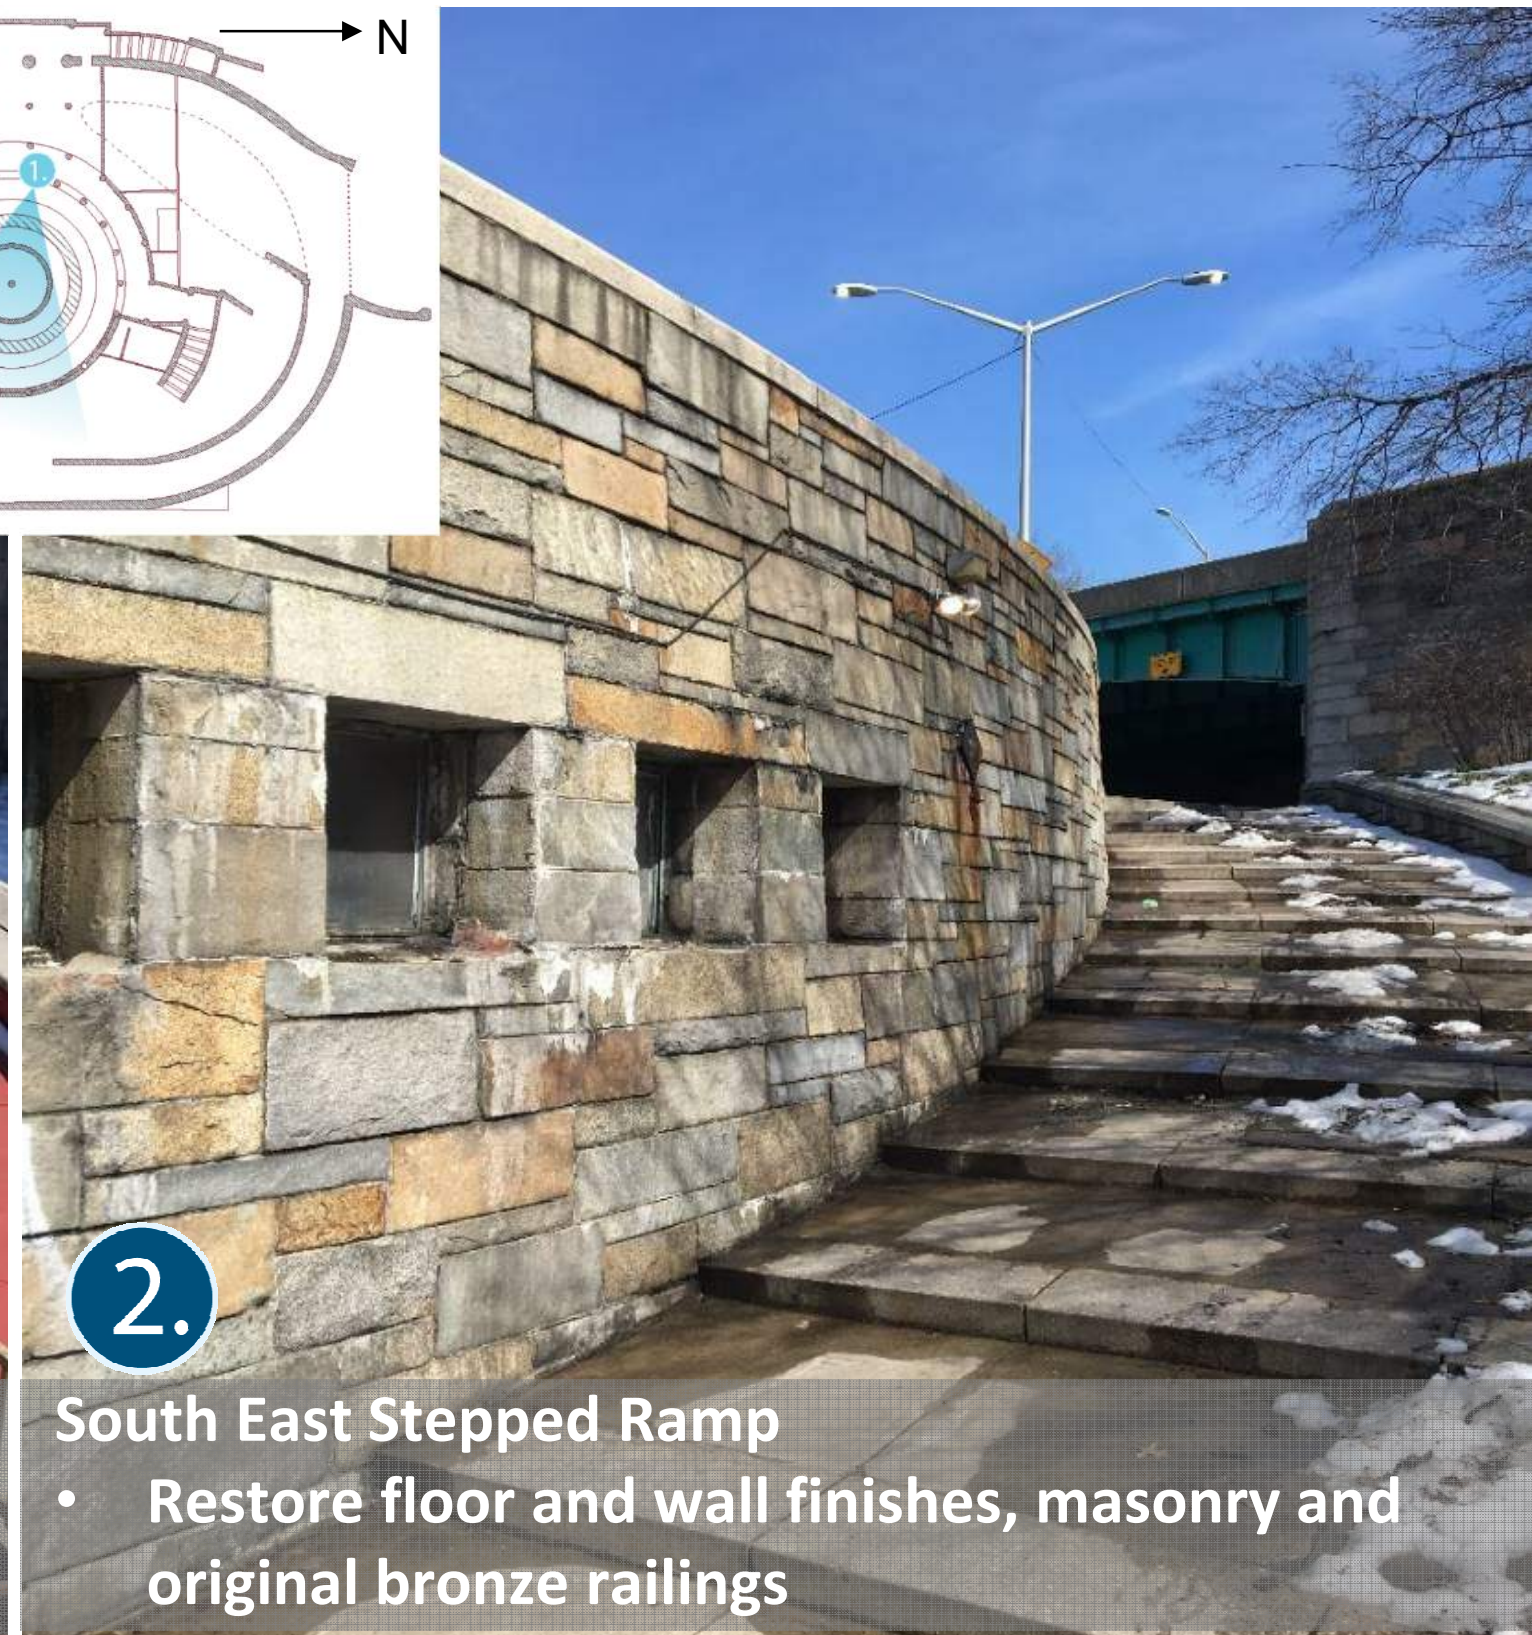
South East Stepped Ramp

- Restore floor and wall finishes, masonry and original bronze railings

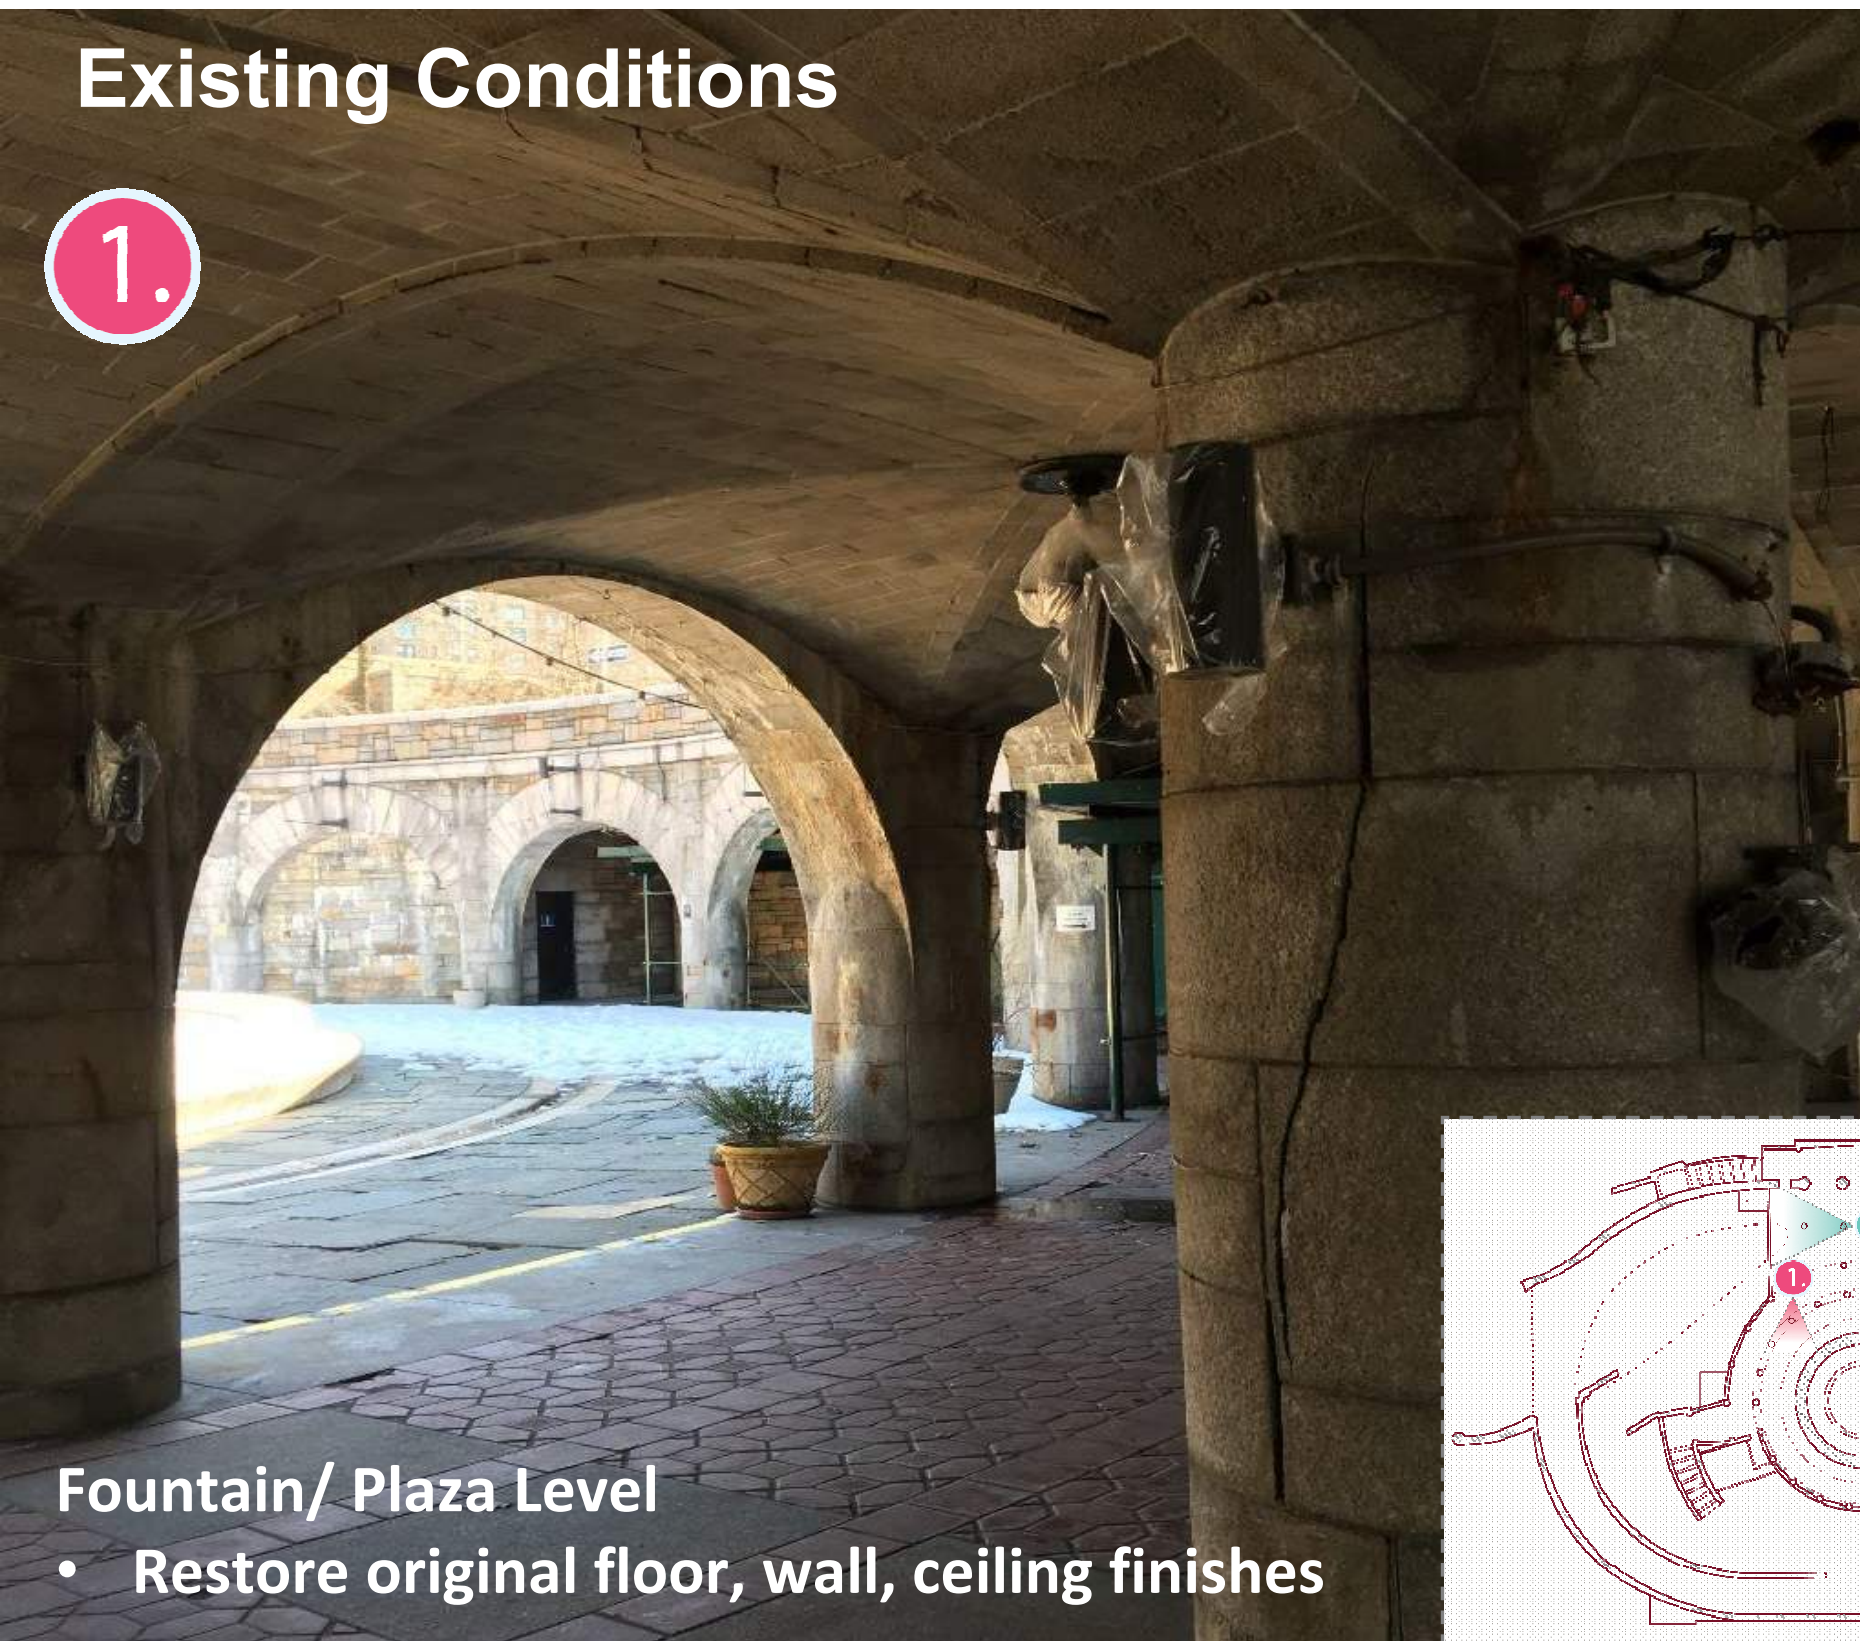
Fountain/ Plaza Level

- Restore original floor, wall, ceiling finishes

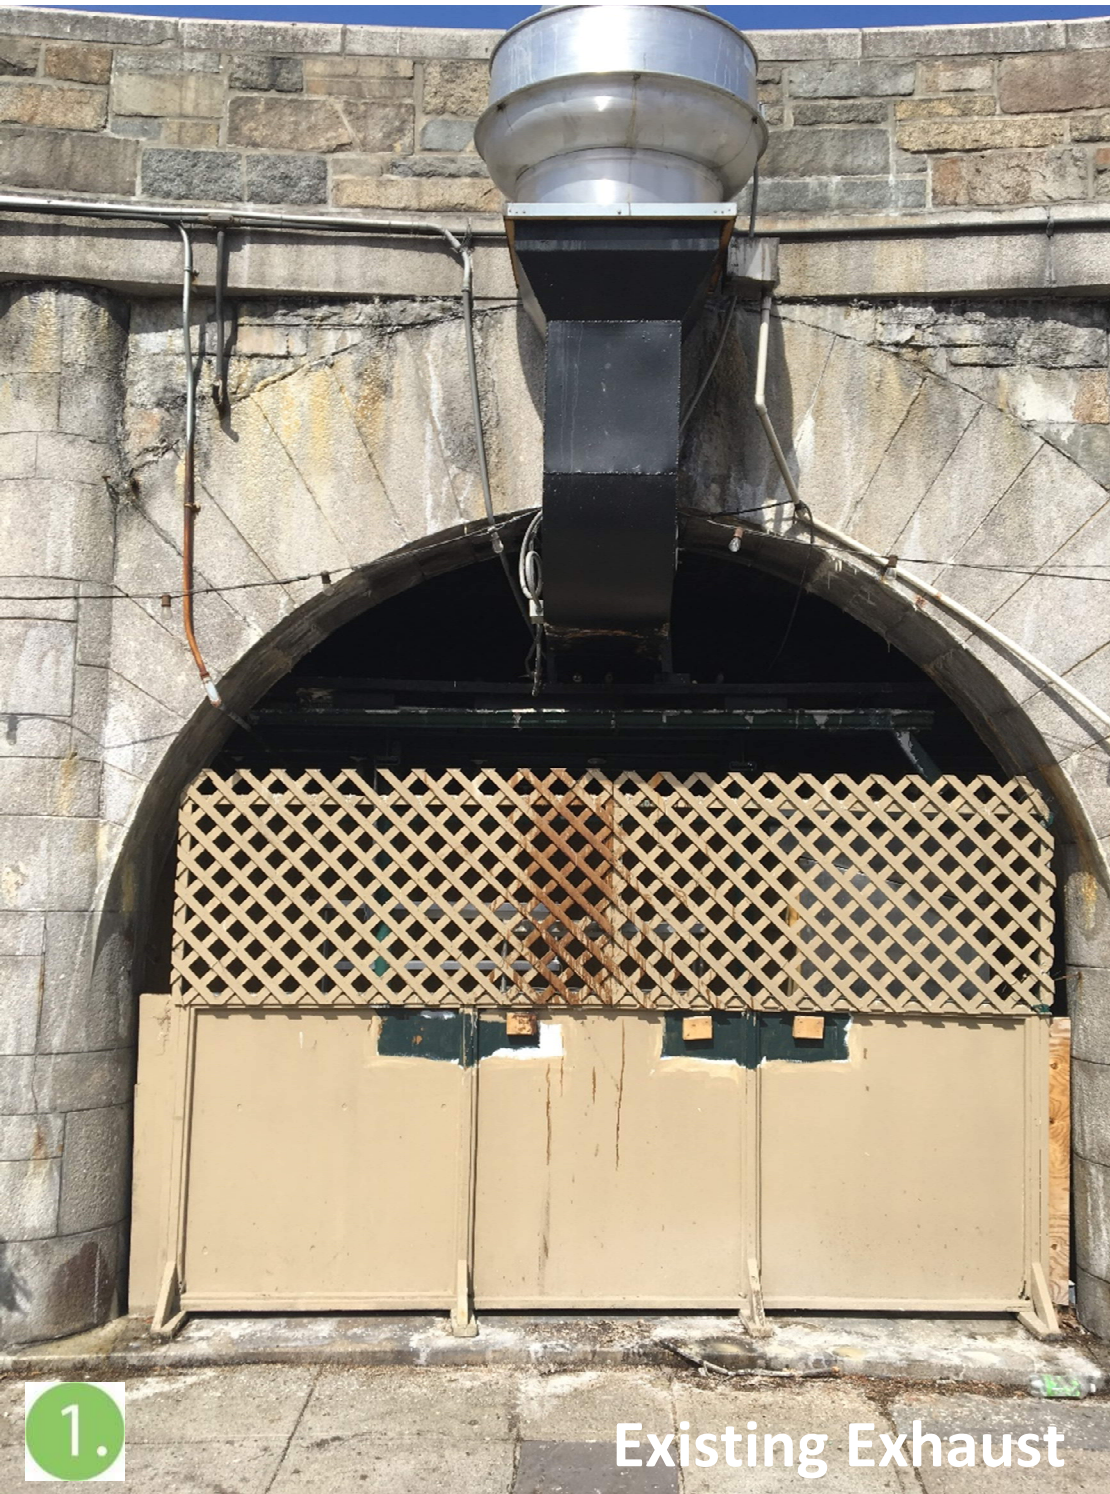
Existing Kitchen Exhaust Location

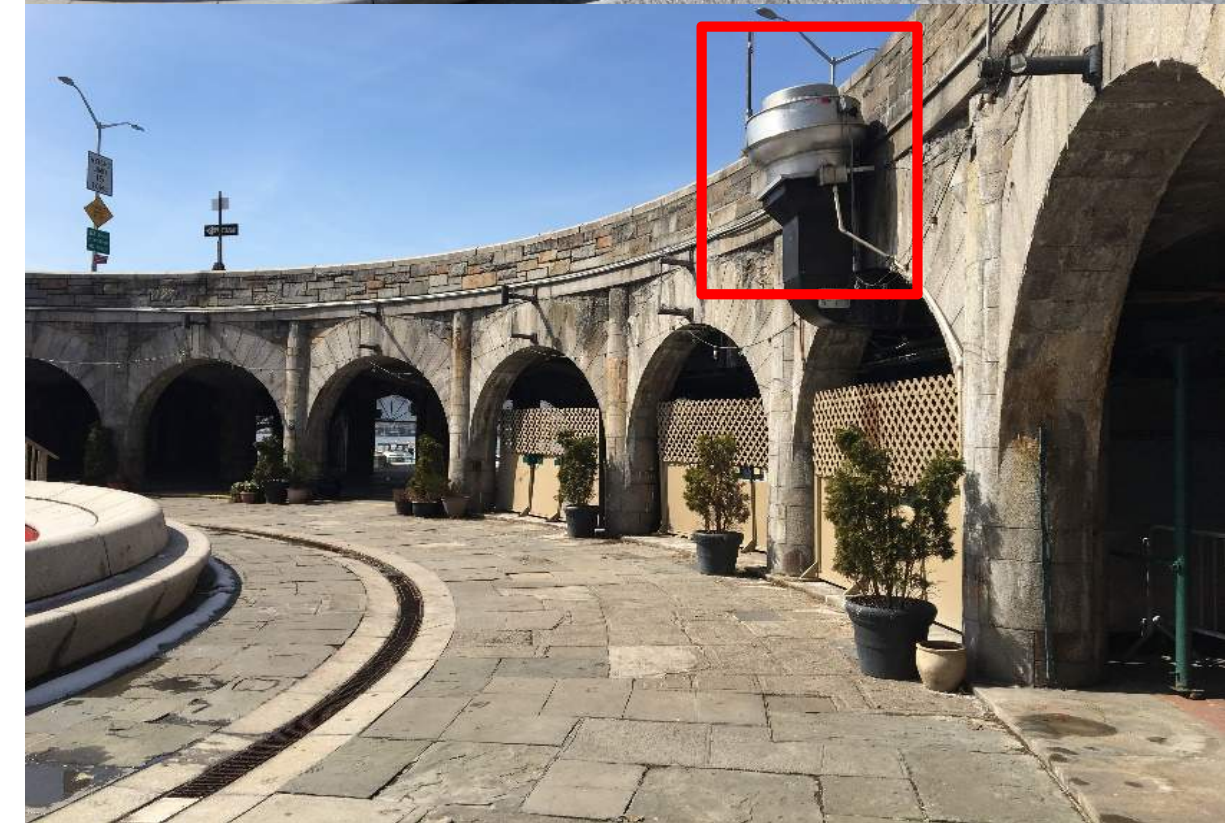
Proposed Kitchen Exhaust Locations

- Designed for North and South NYCDPR Spaces to provide flexibility for NYCDPR Operations
- Maintains symmetry (same condition on opposite side)
- NYC Building Code Compliant
- Minimally invasive structural modifications
- Reuse of existing stonework to blend with existing structure
- This project will provide the shaft enclosure, NYCDPR's concessionaire to provide the internal ventilation system at a later date

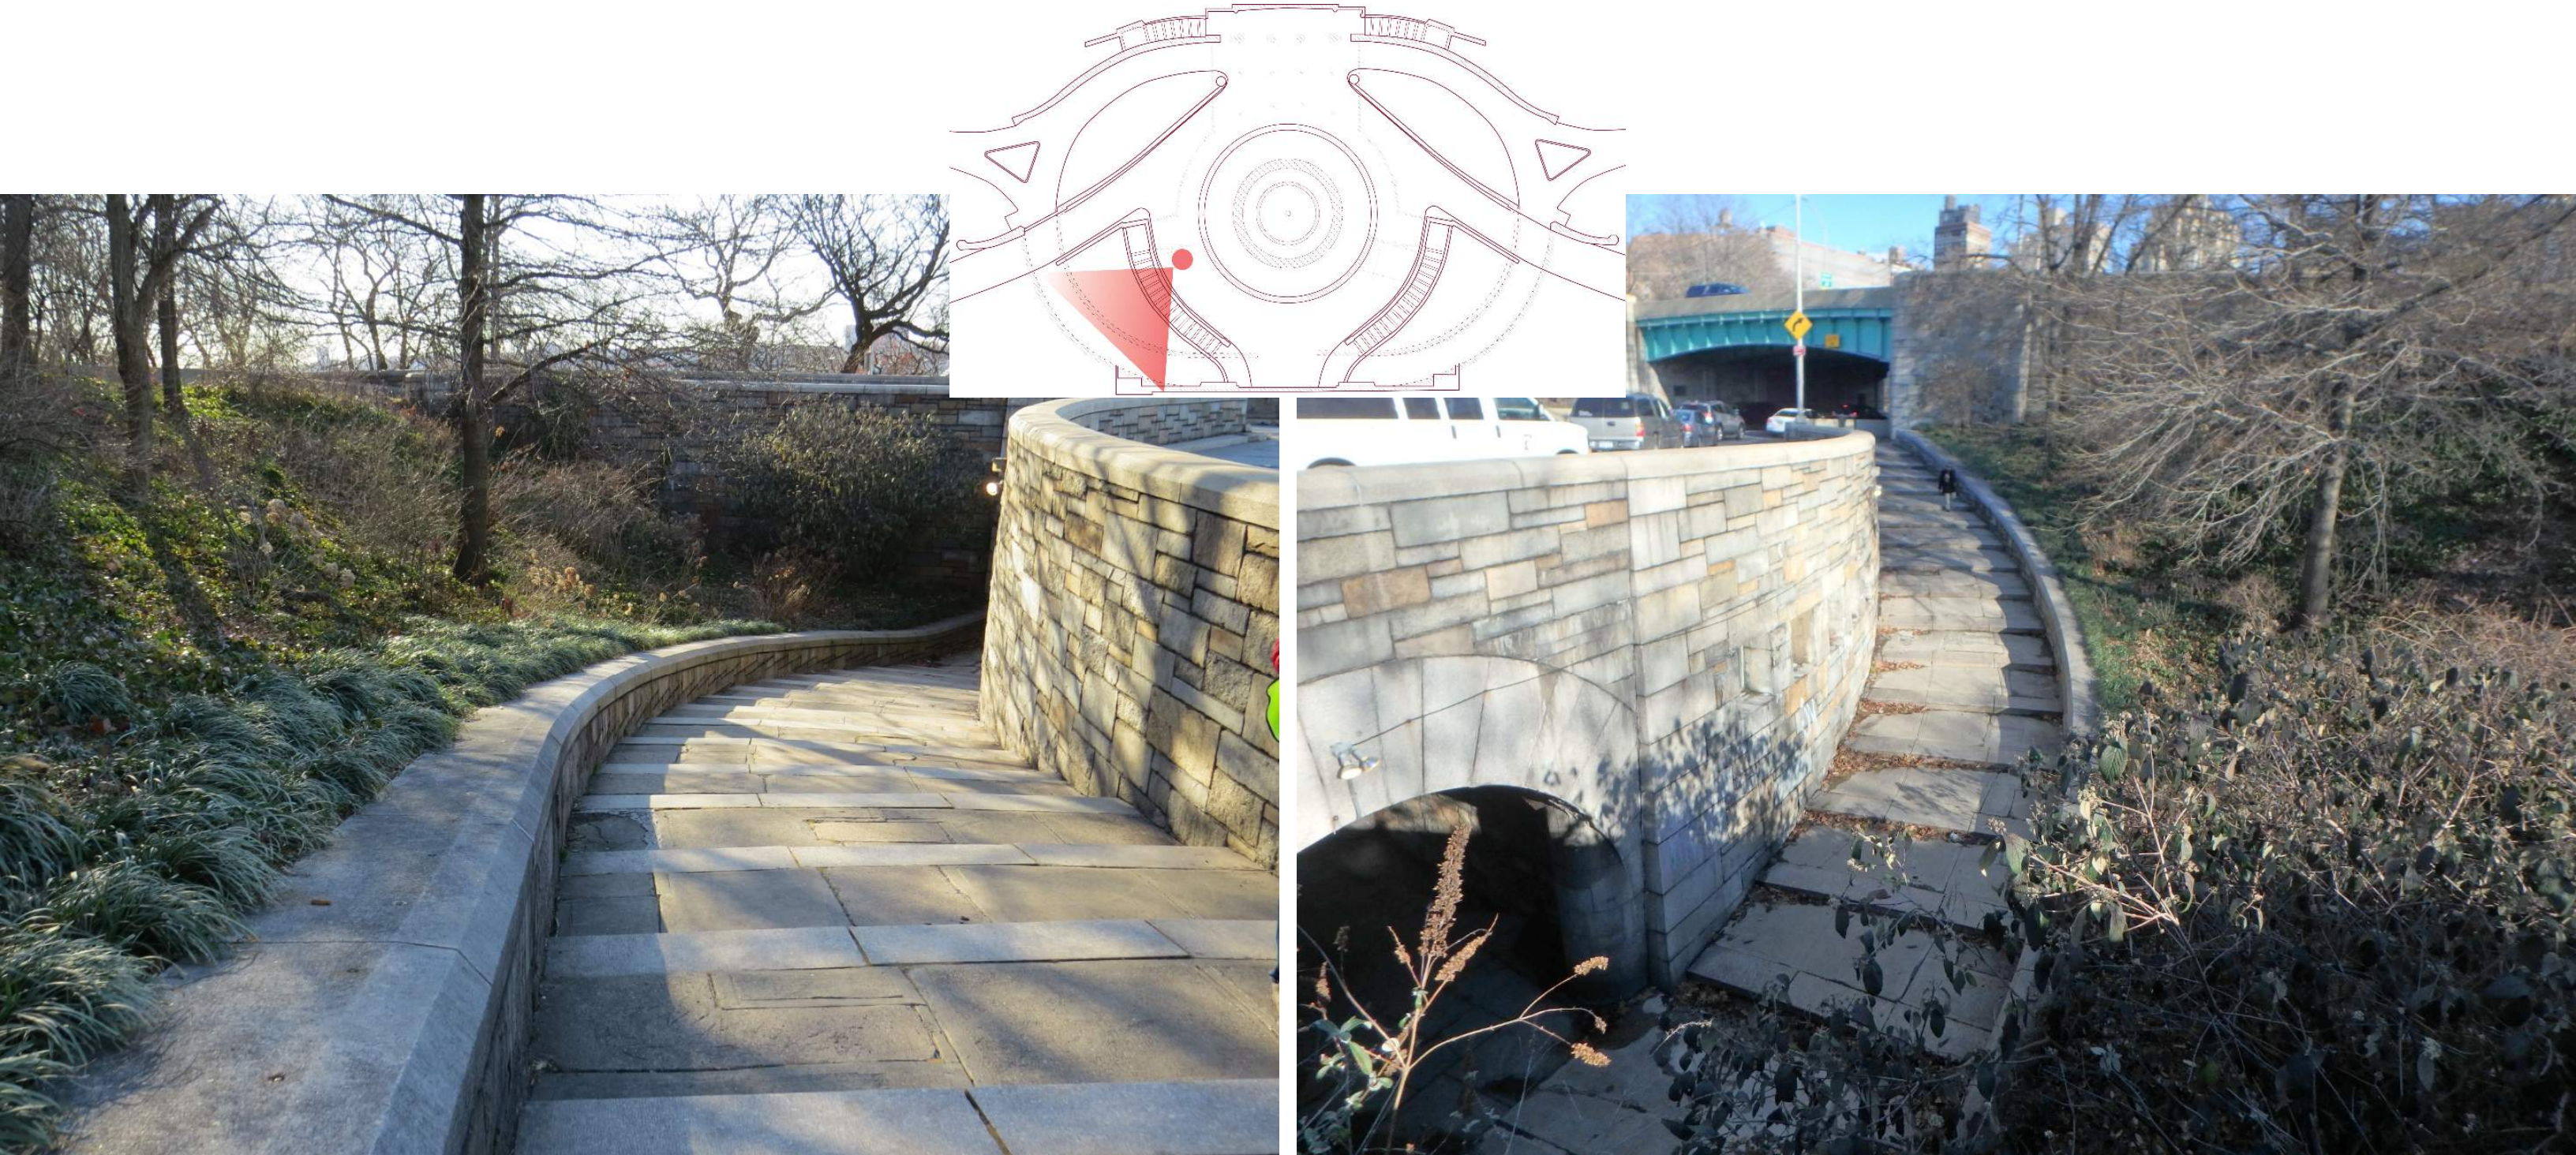
Existing Southeast Stepped Ramp (Street to Plaza)

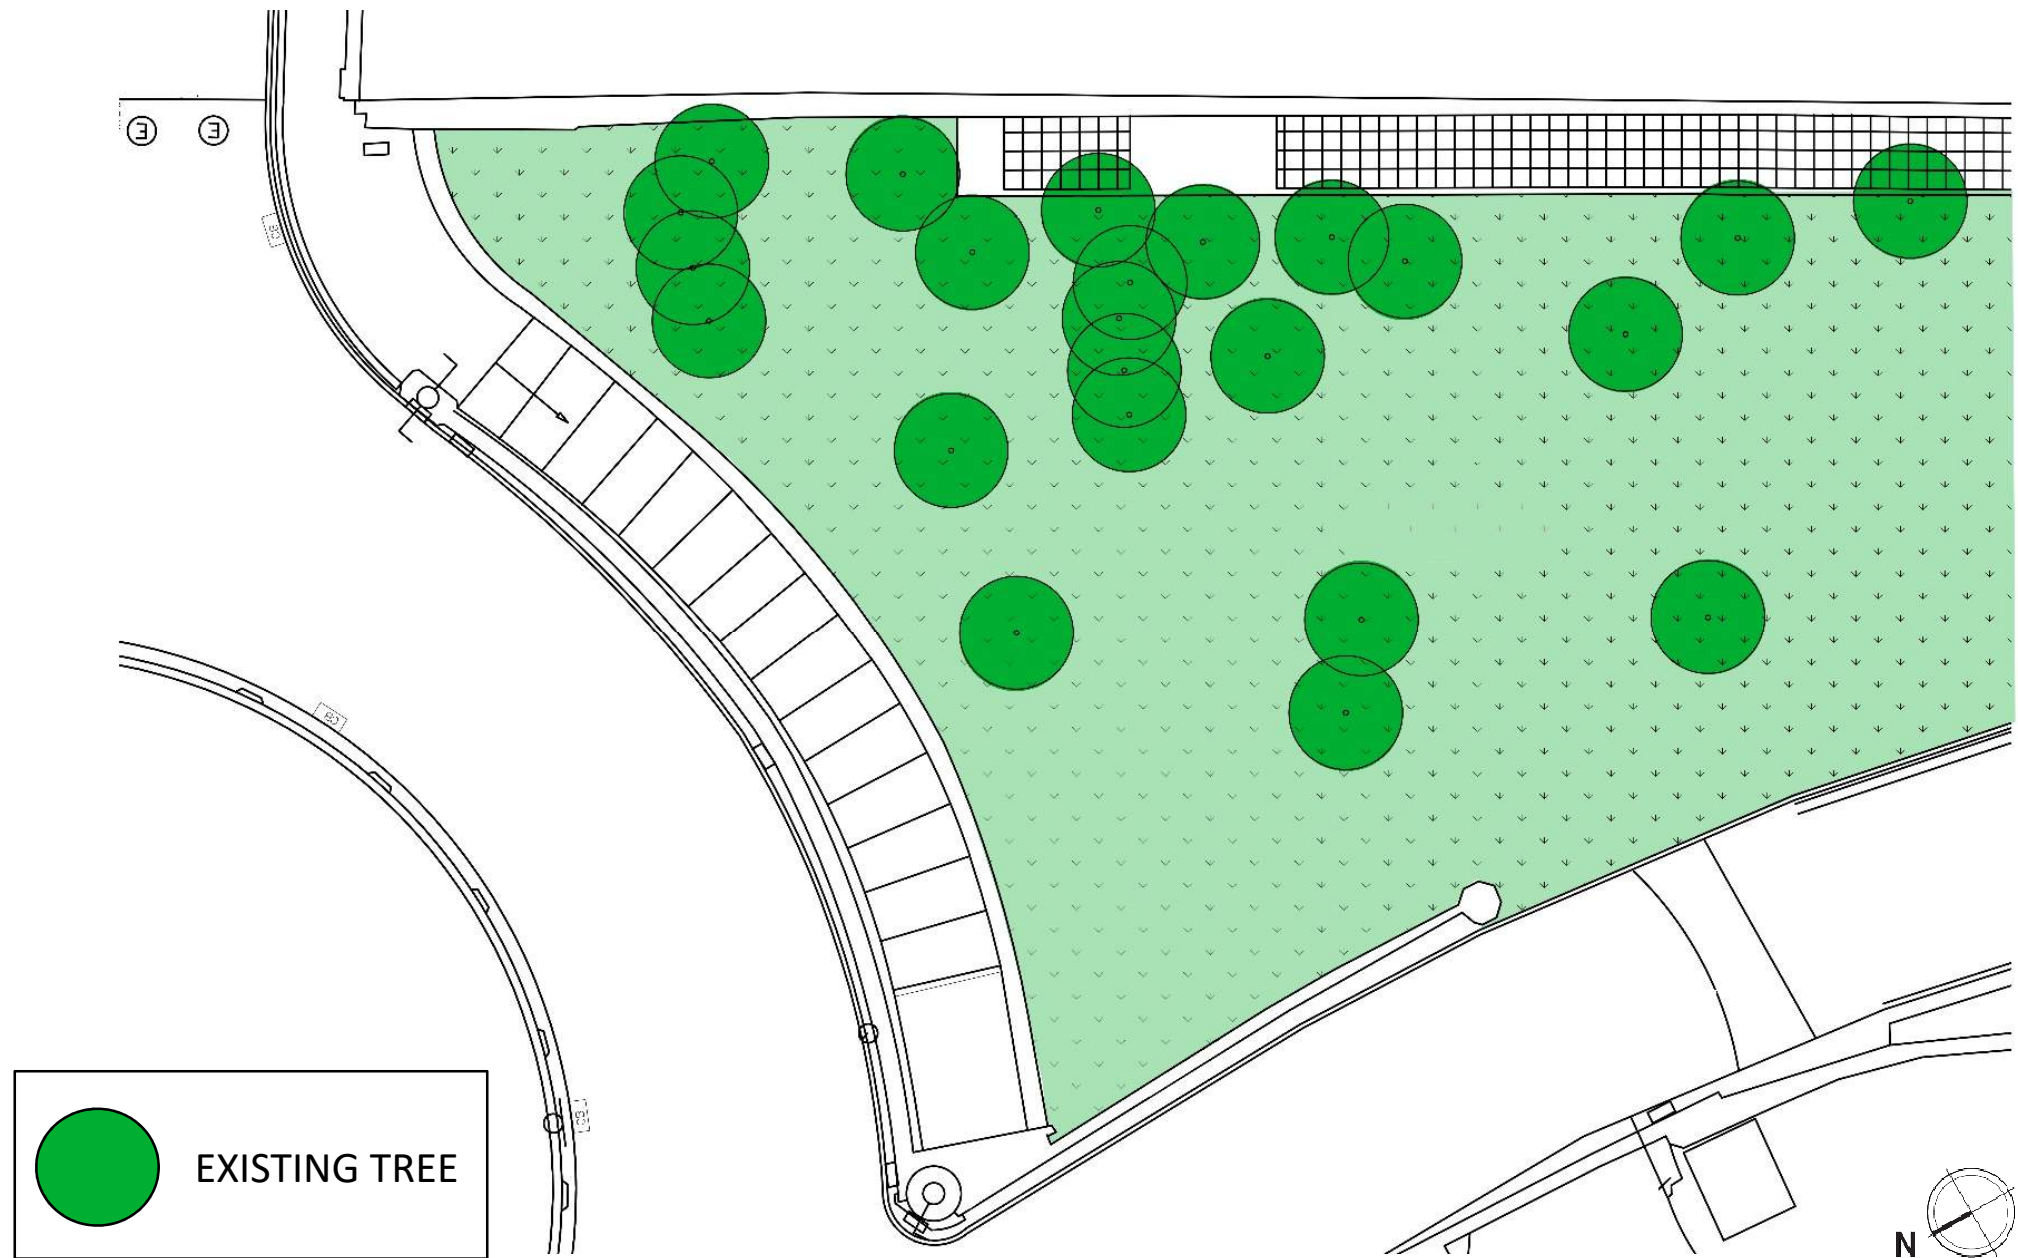
Existing Southeast Stepped Ramp (Street to Plaza)

- 1. The south planting area was chosen for the location of an accessible ramp due to the existing accessible infrastructure located along the south side of West 79th Street.
- 2. Landscape and vegetation will be re-graded and restored to accommodate proposed accessible ramp.
- 3. Tree and shrub locations are based on survey information. All locations shall be field verified. Tree assessment to be coordinated with NYCDPR forestry to determine tree health and potential restitution costs.
- 4. Landscape Plan still in development, final plan to be approved by NYC Department of Parks and Recreation.

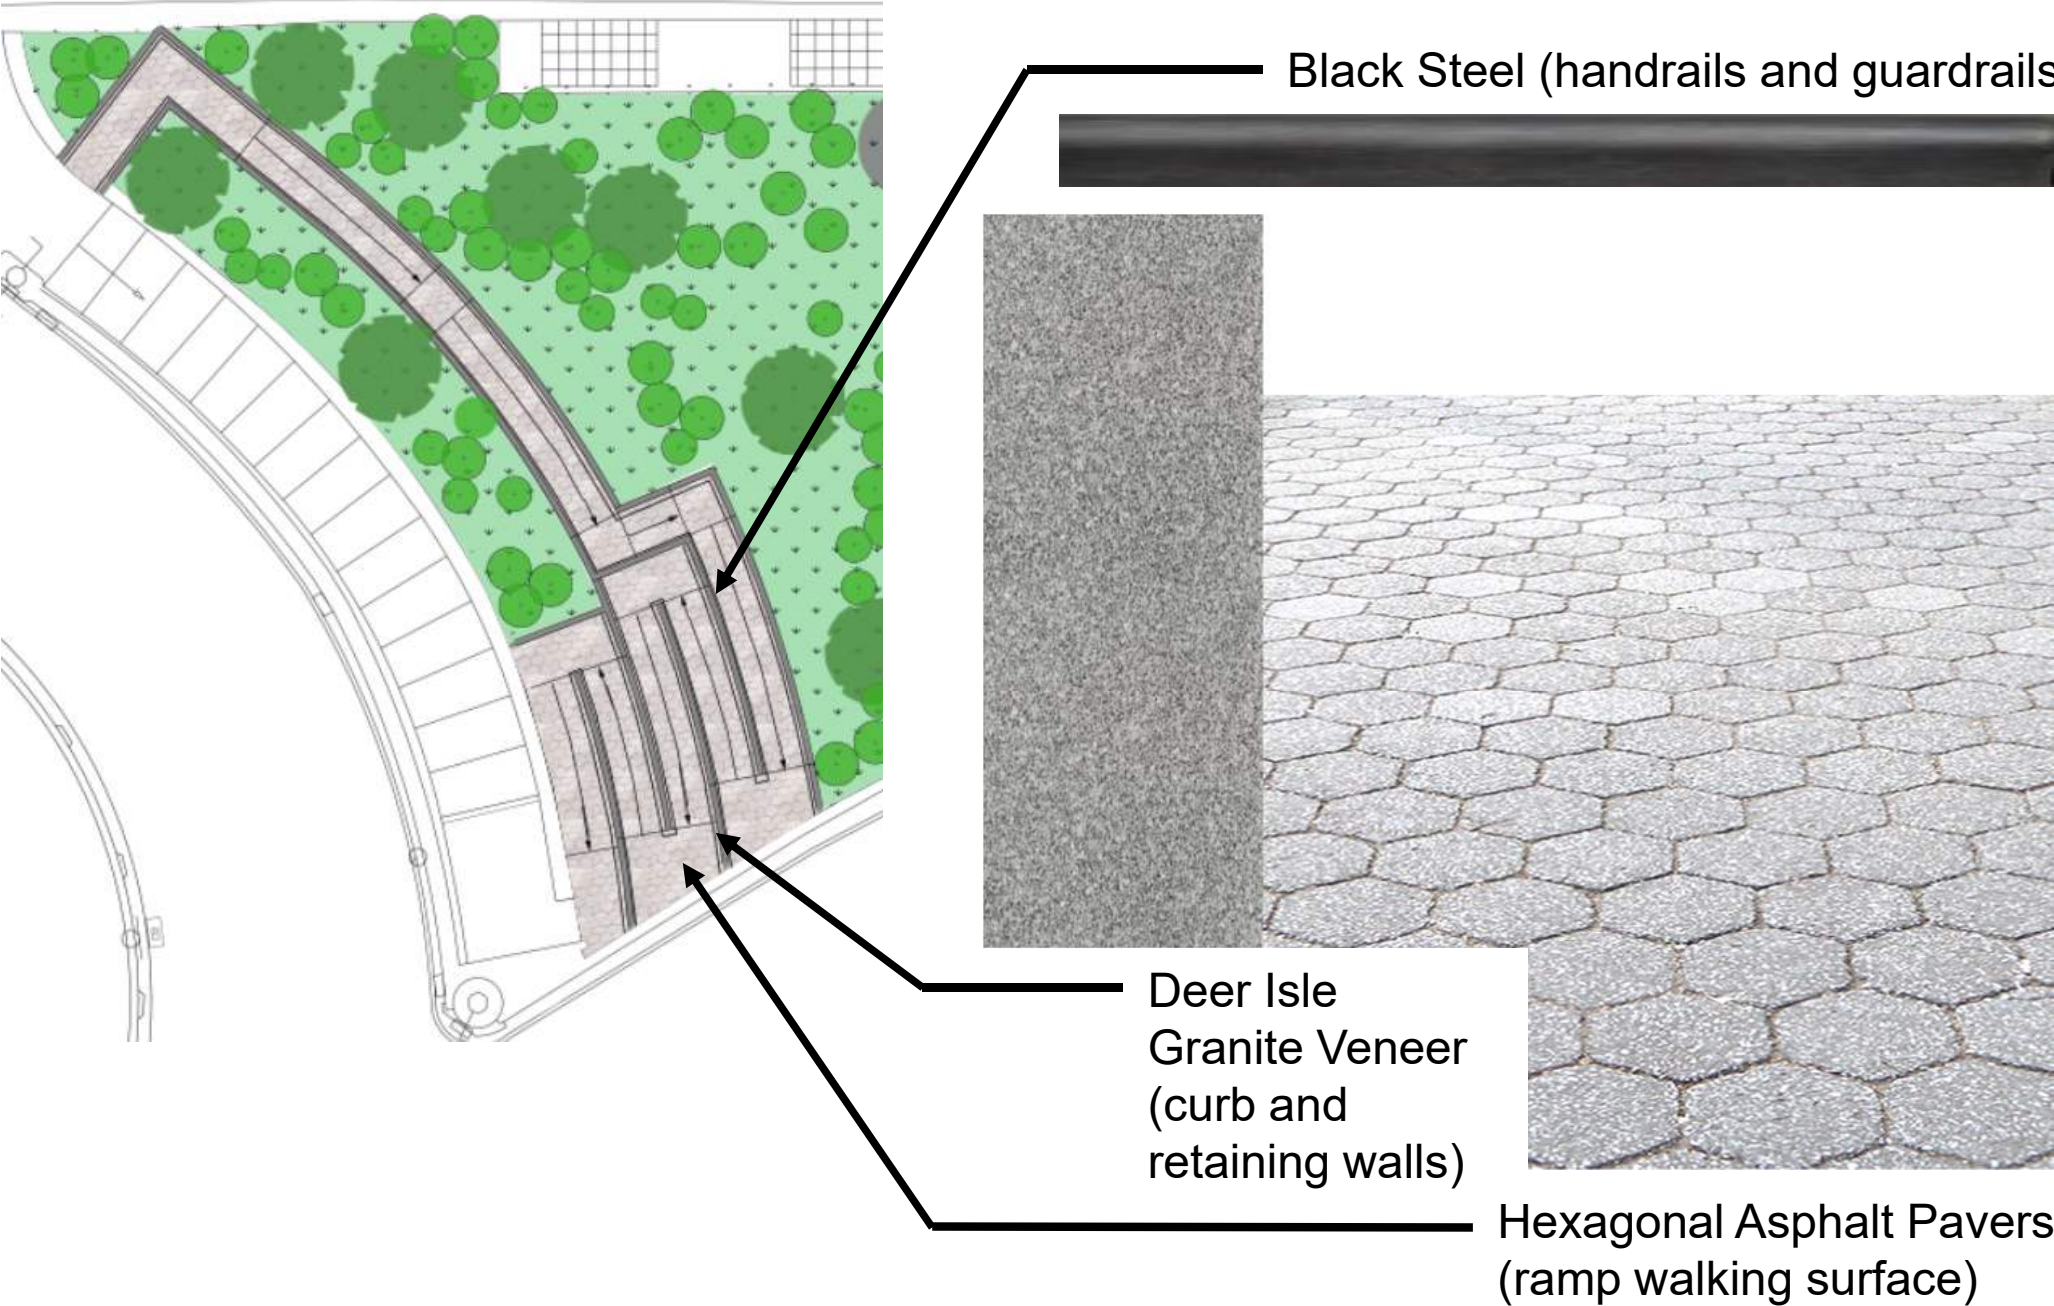
New Materials Palette: Asphalt Pavers, Deer Isle Granite, Blackened Steel

Precedent image: Hexagonal Asphalt Pavers are commonly used in NYC Parks.

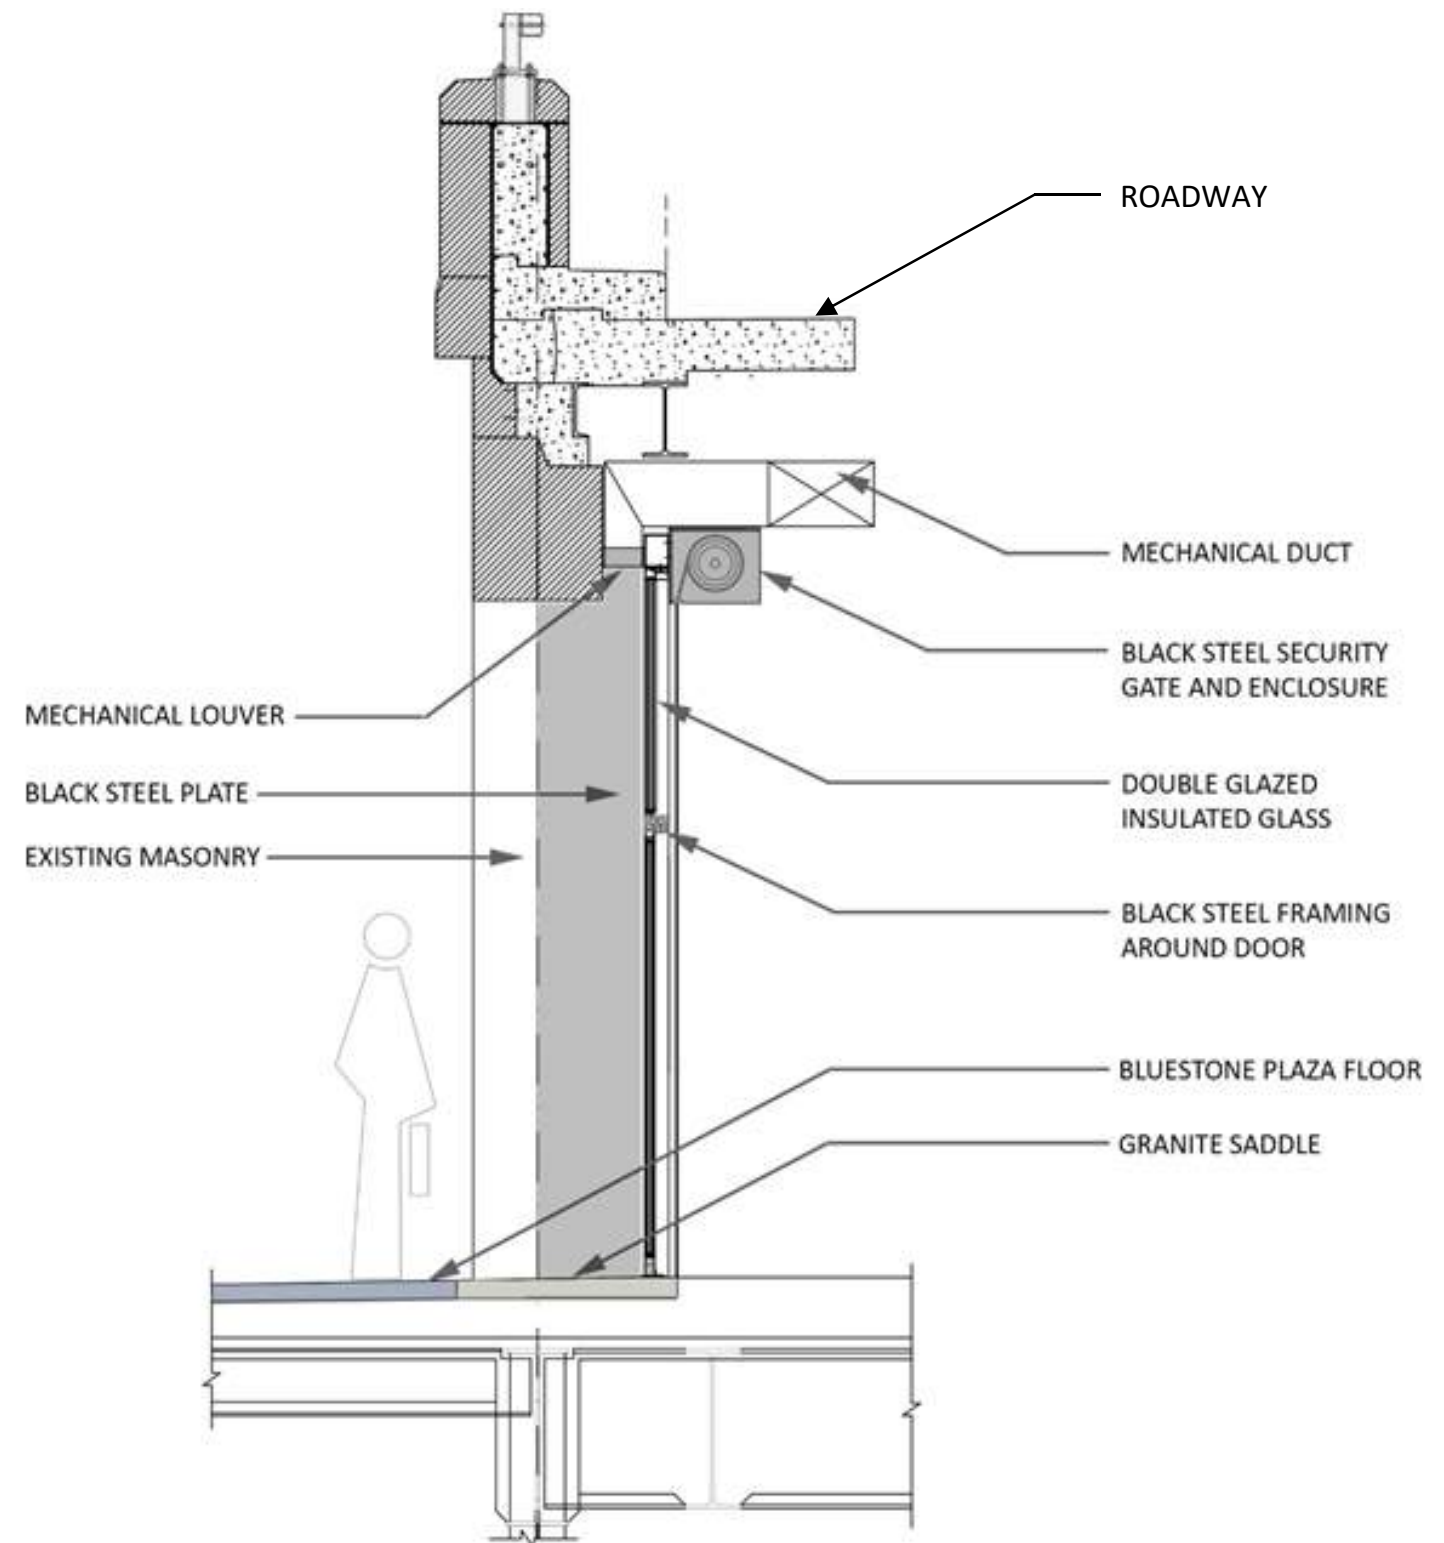
Proposed NYC Parks Administrative Office (continued)

- The automated security gate is proposed behind the glass storefront in accordance with LPC guidelines.
- Mullions, louvers, and electrical devices located behind existing historic structure, obscured from view from the Plaza.

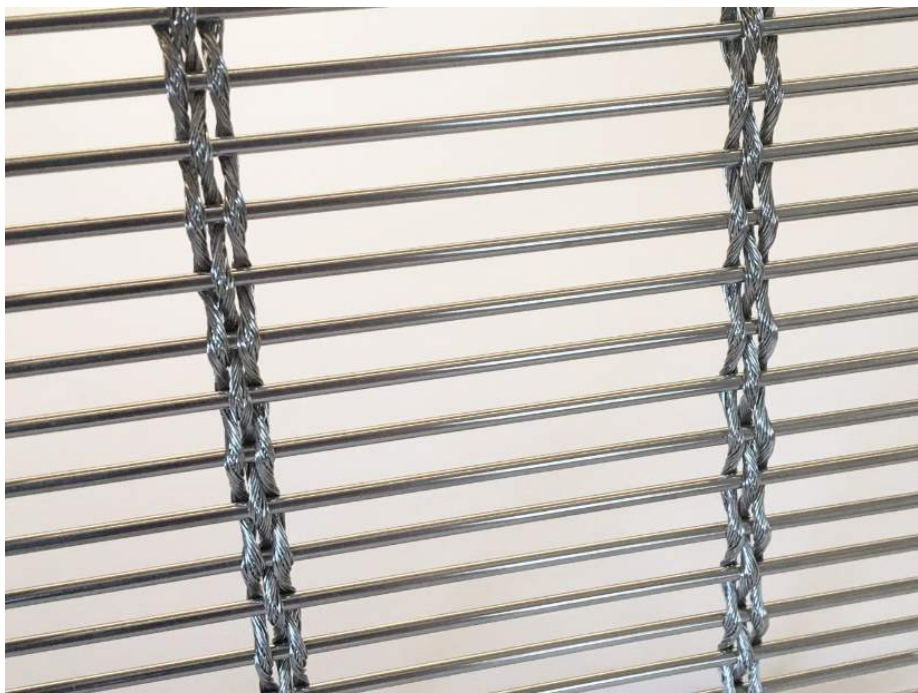
SteelWeave Metal Mesh Grille

- Motor Operation
- Mesh provides transparency
- Aesthetic Trim
- Placed behind glass facade for minimal visual impact
