Rehabilitation of the West 79th Street Rotunda Complex and West 79th Street Bridge Over Amtrak

Landmarks Preservation Commission
June 2019

Rehabilitation of the West 79th Street Rotunda
Complex And West 79th Street Bridge over Amtrak
June 2019

HDR|AECOM a Joint Venture

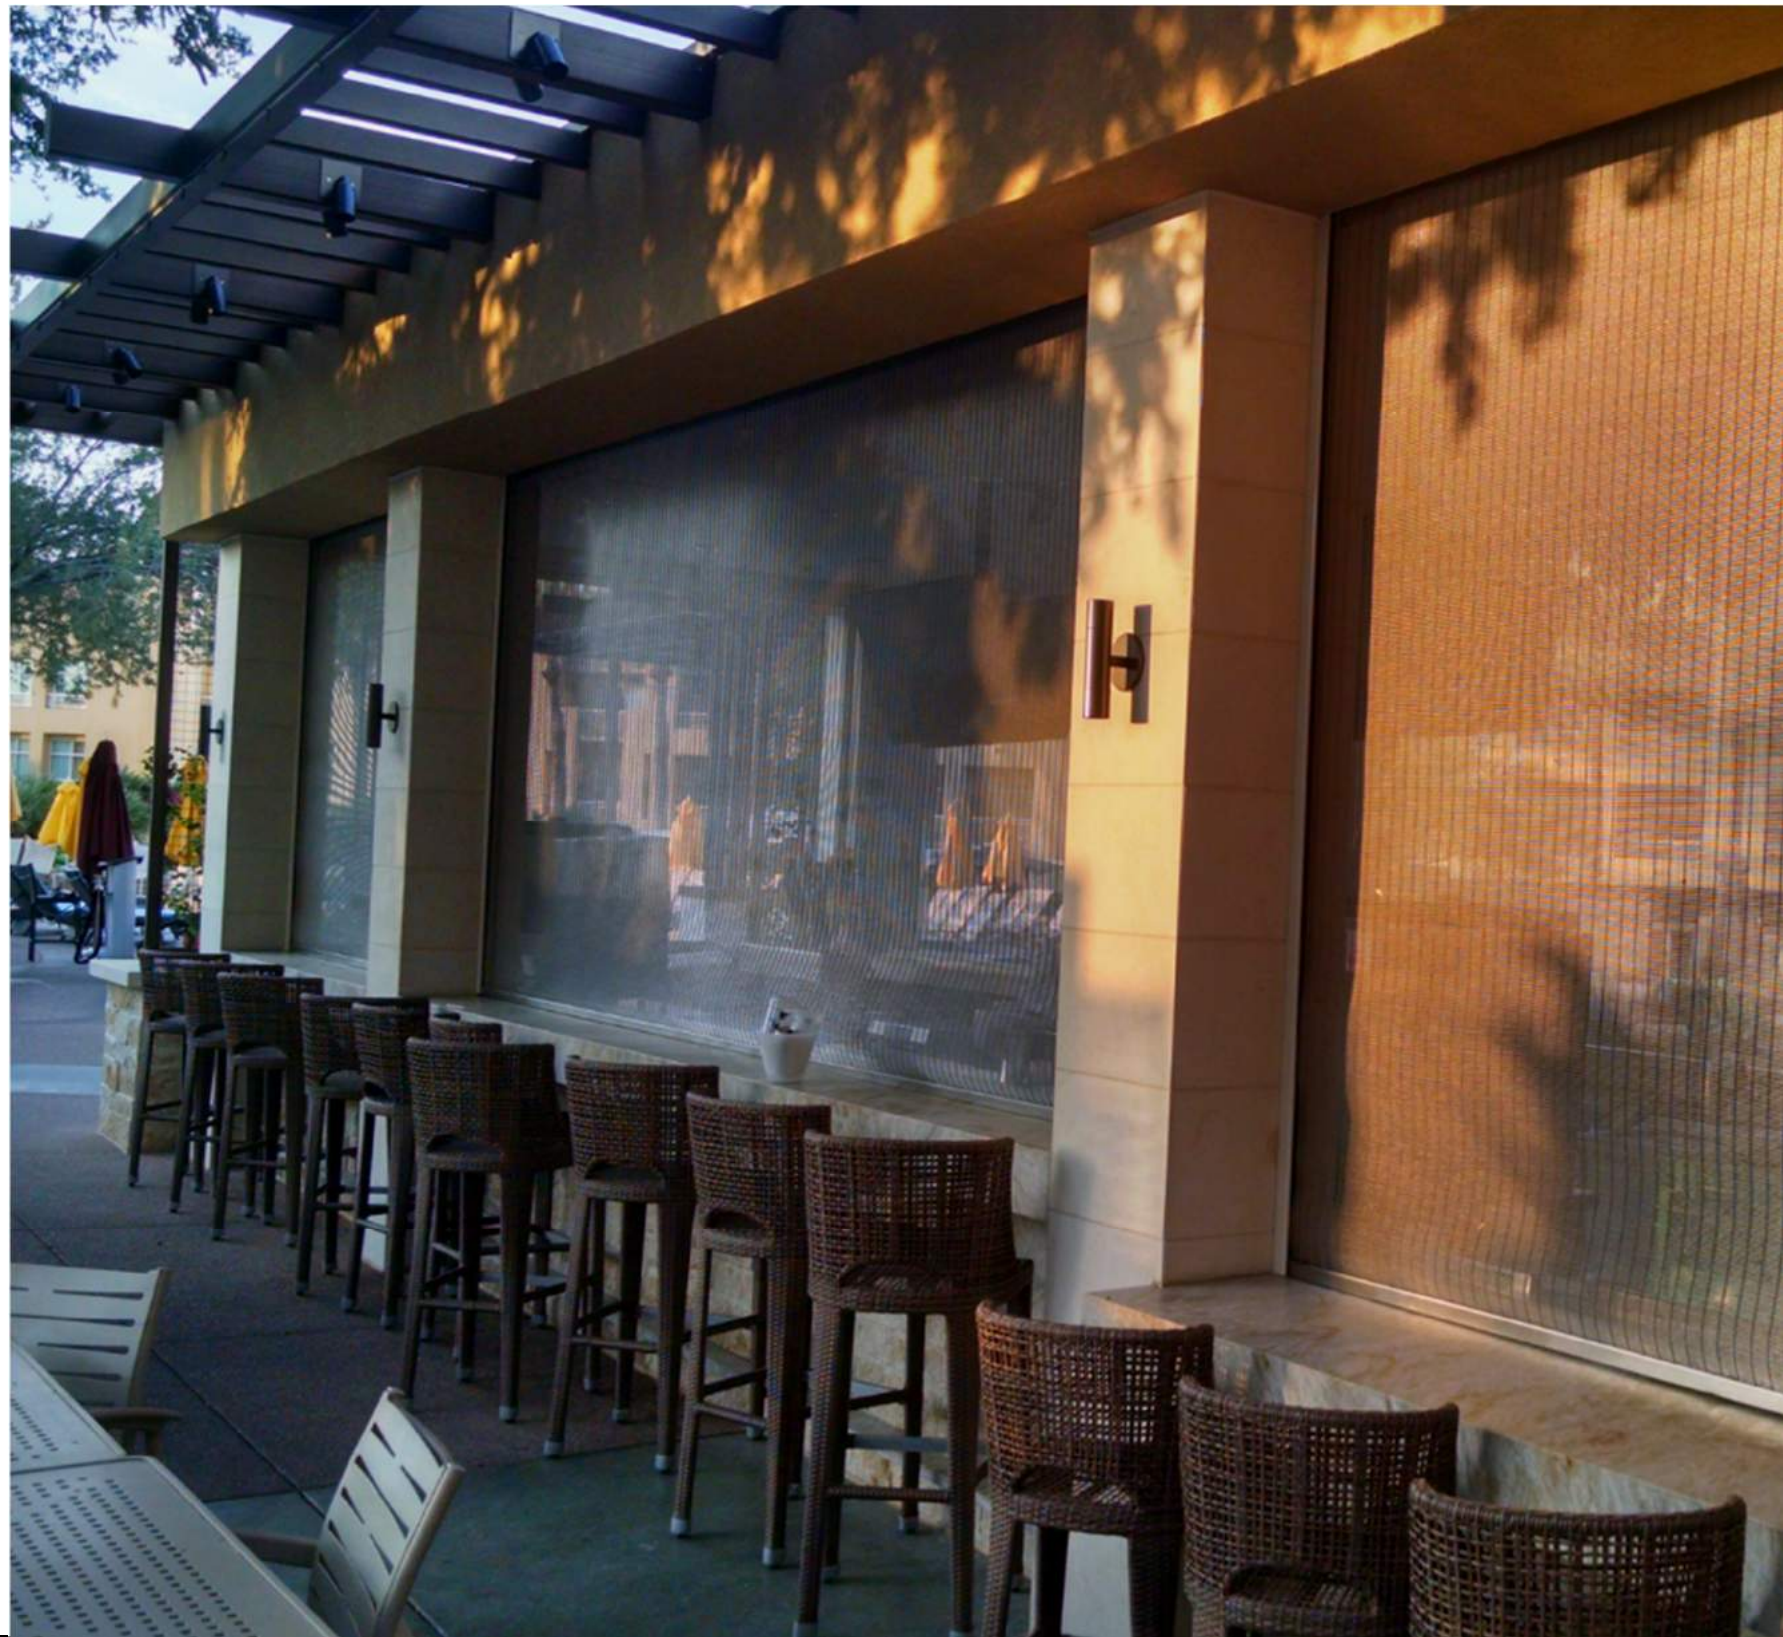
Security Doors

SteelWeave Metal Mesh Grille

- Motor Operation
- Mesh provides transparency
- Aesthetic Trim
- Placed behind glass facade for minimal visual impact

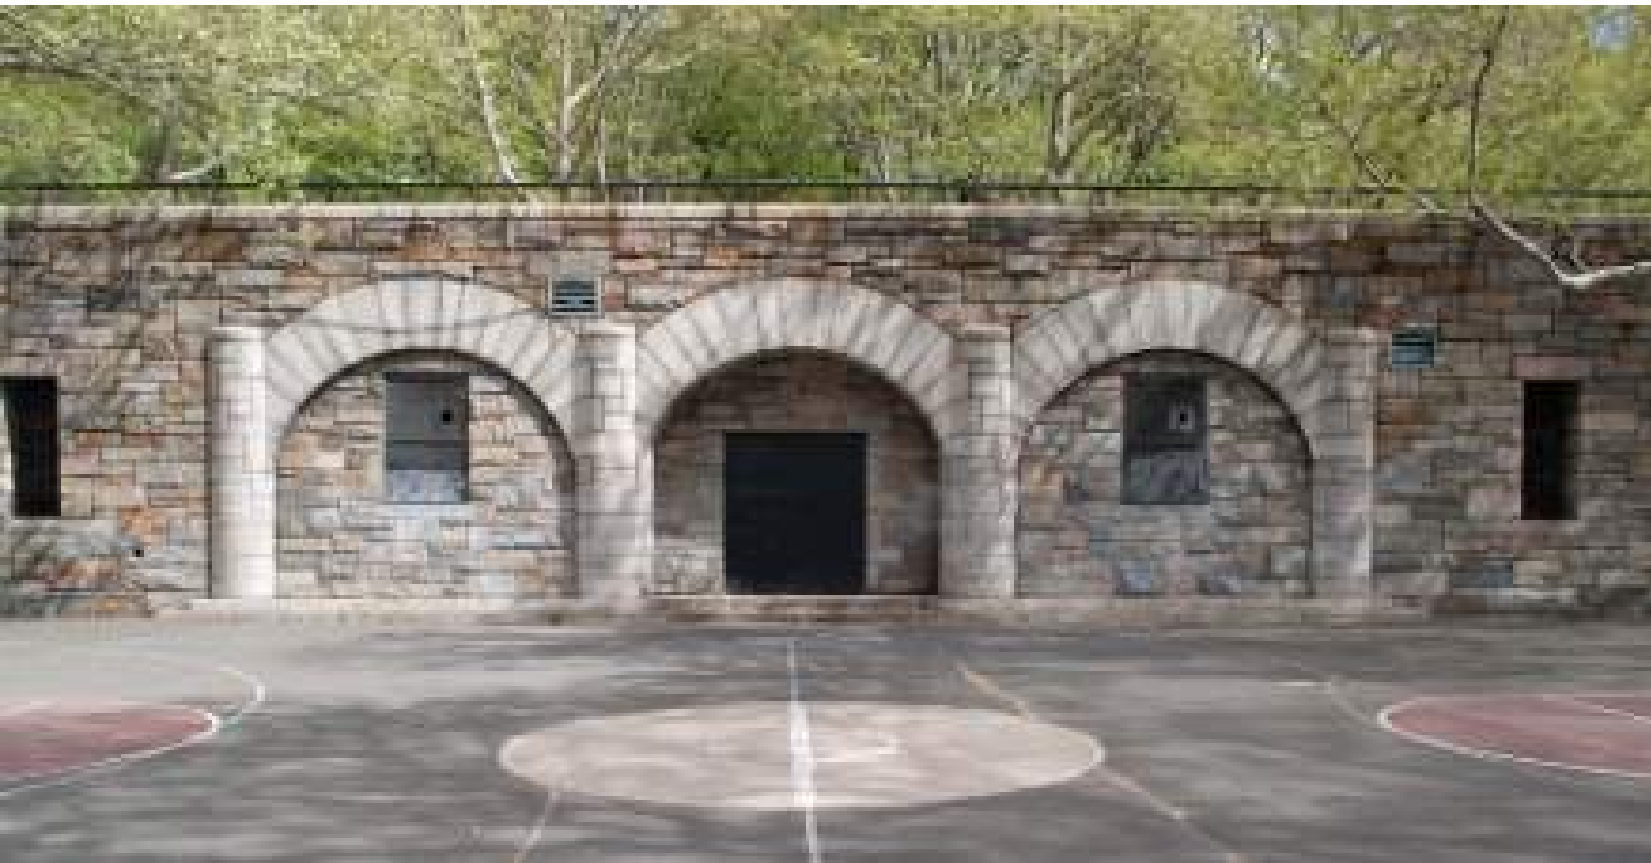
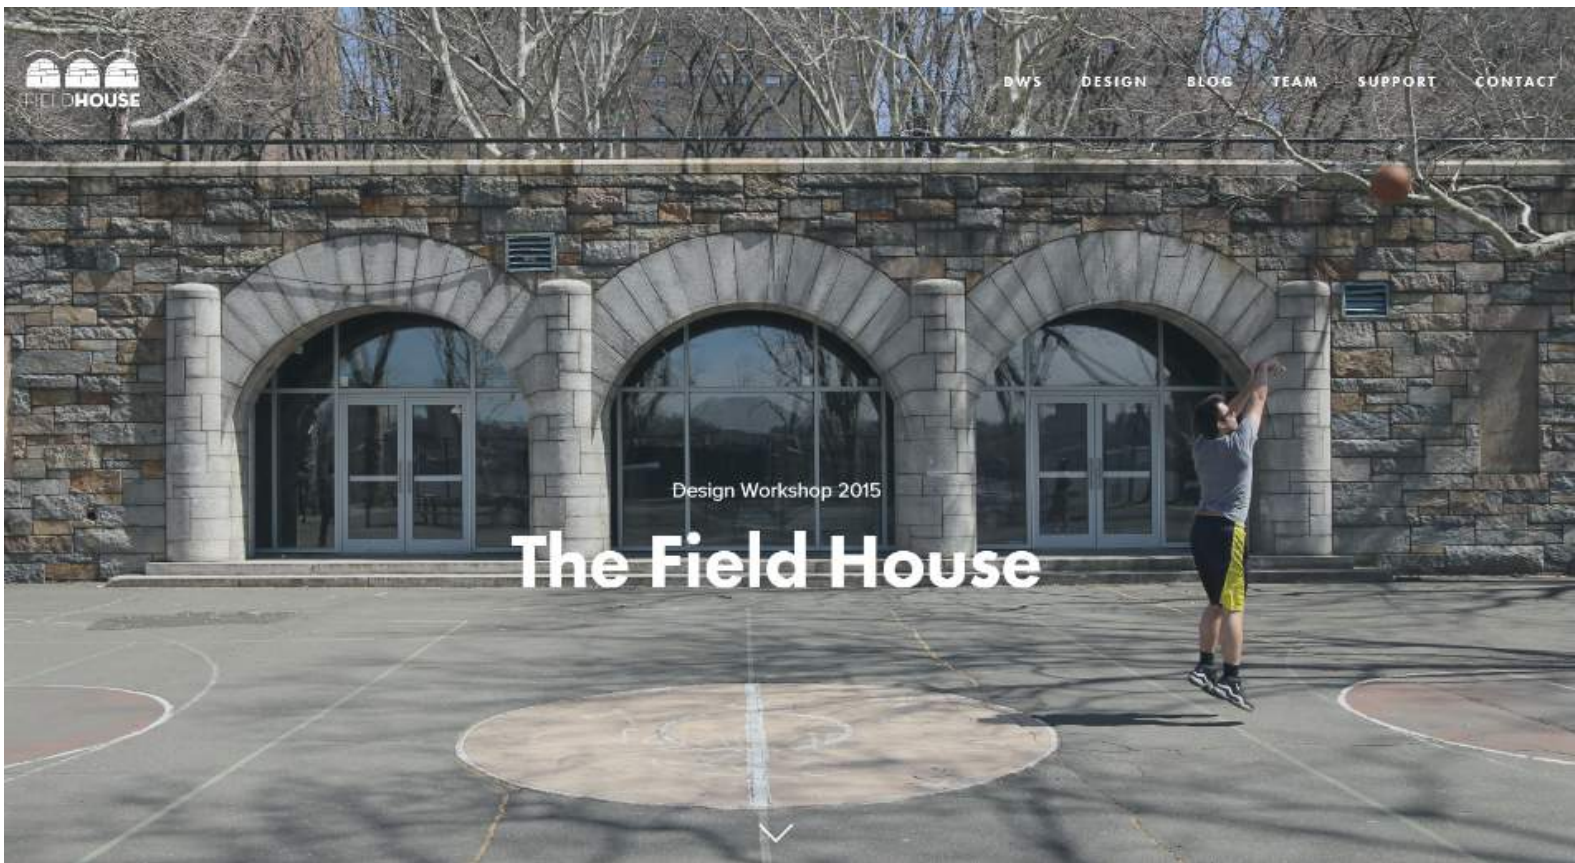
Precedent Restoration
of 102nd St Field House
52

Precedent for Storefront Replacement at Blind Arcade:

Restoration of 102nd Street Field House

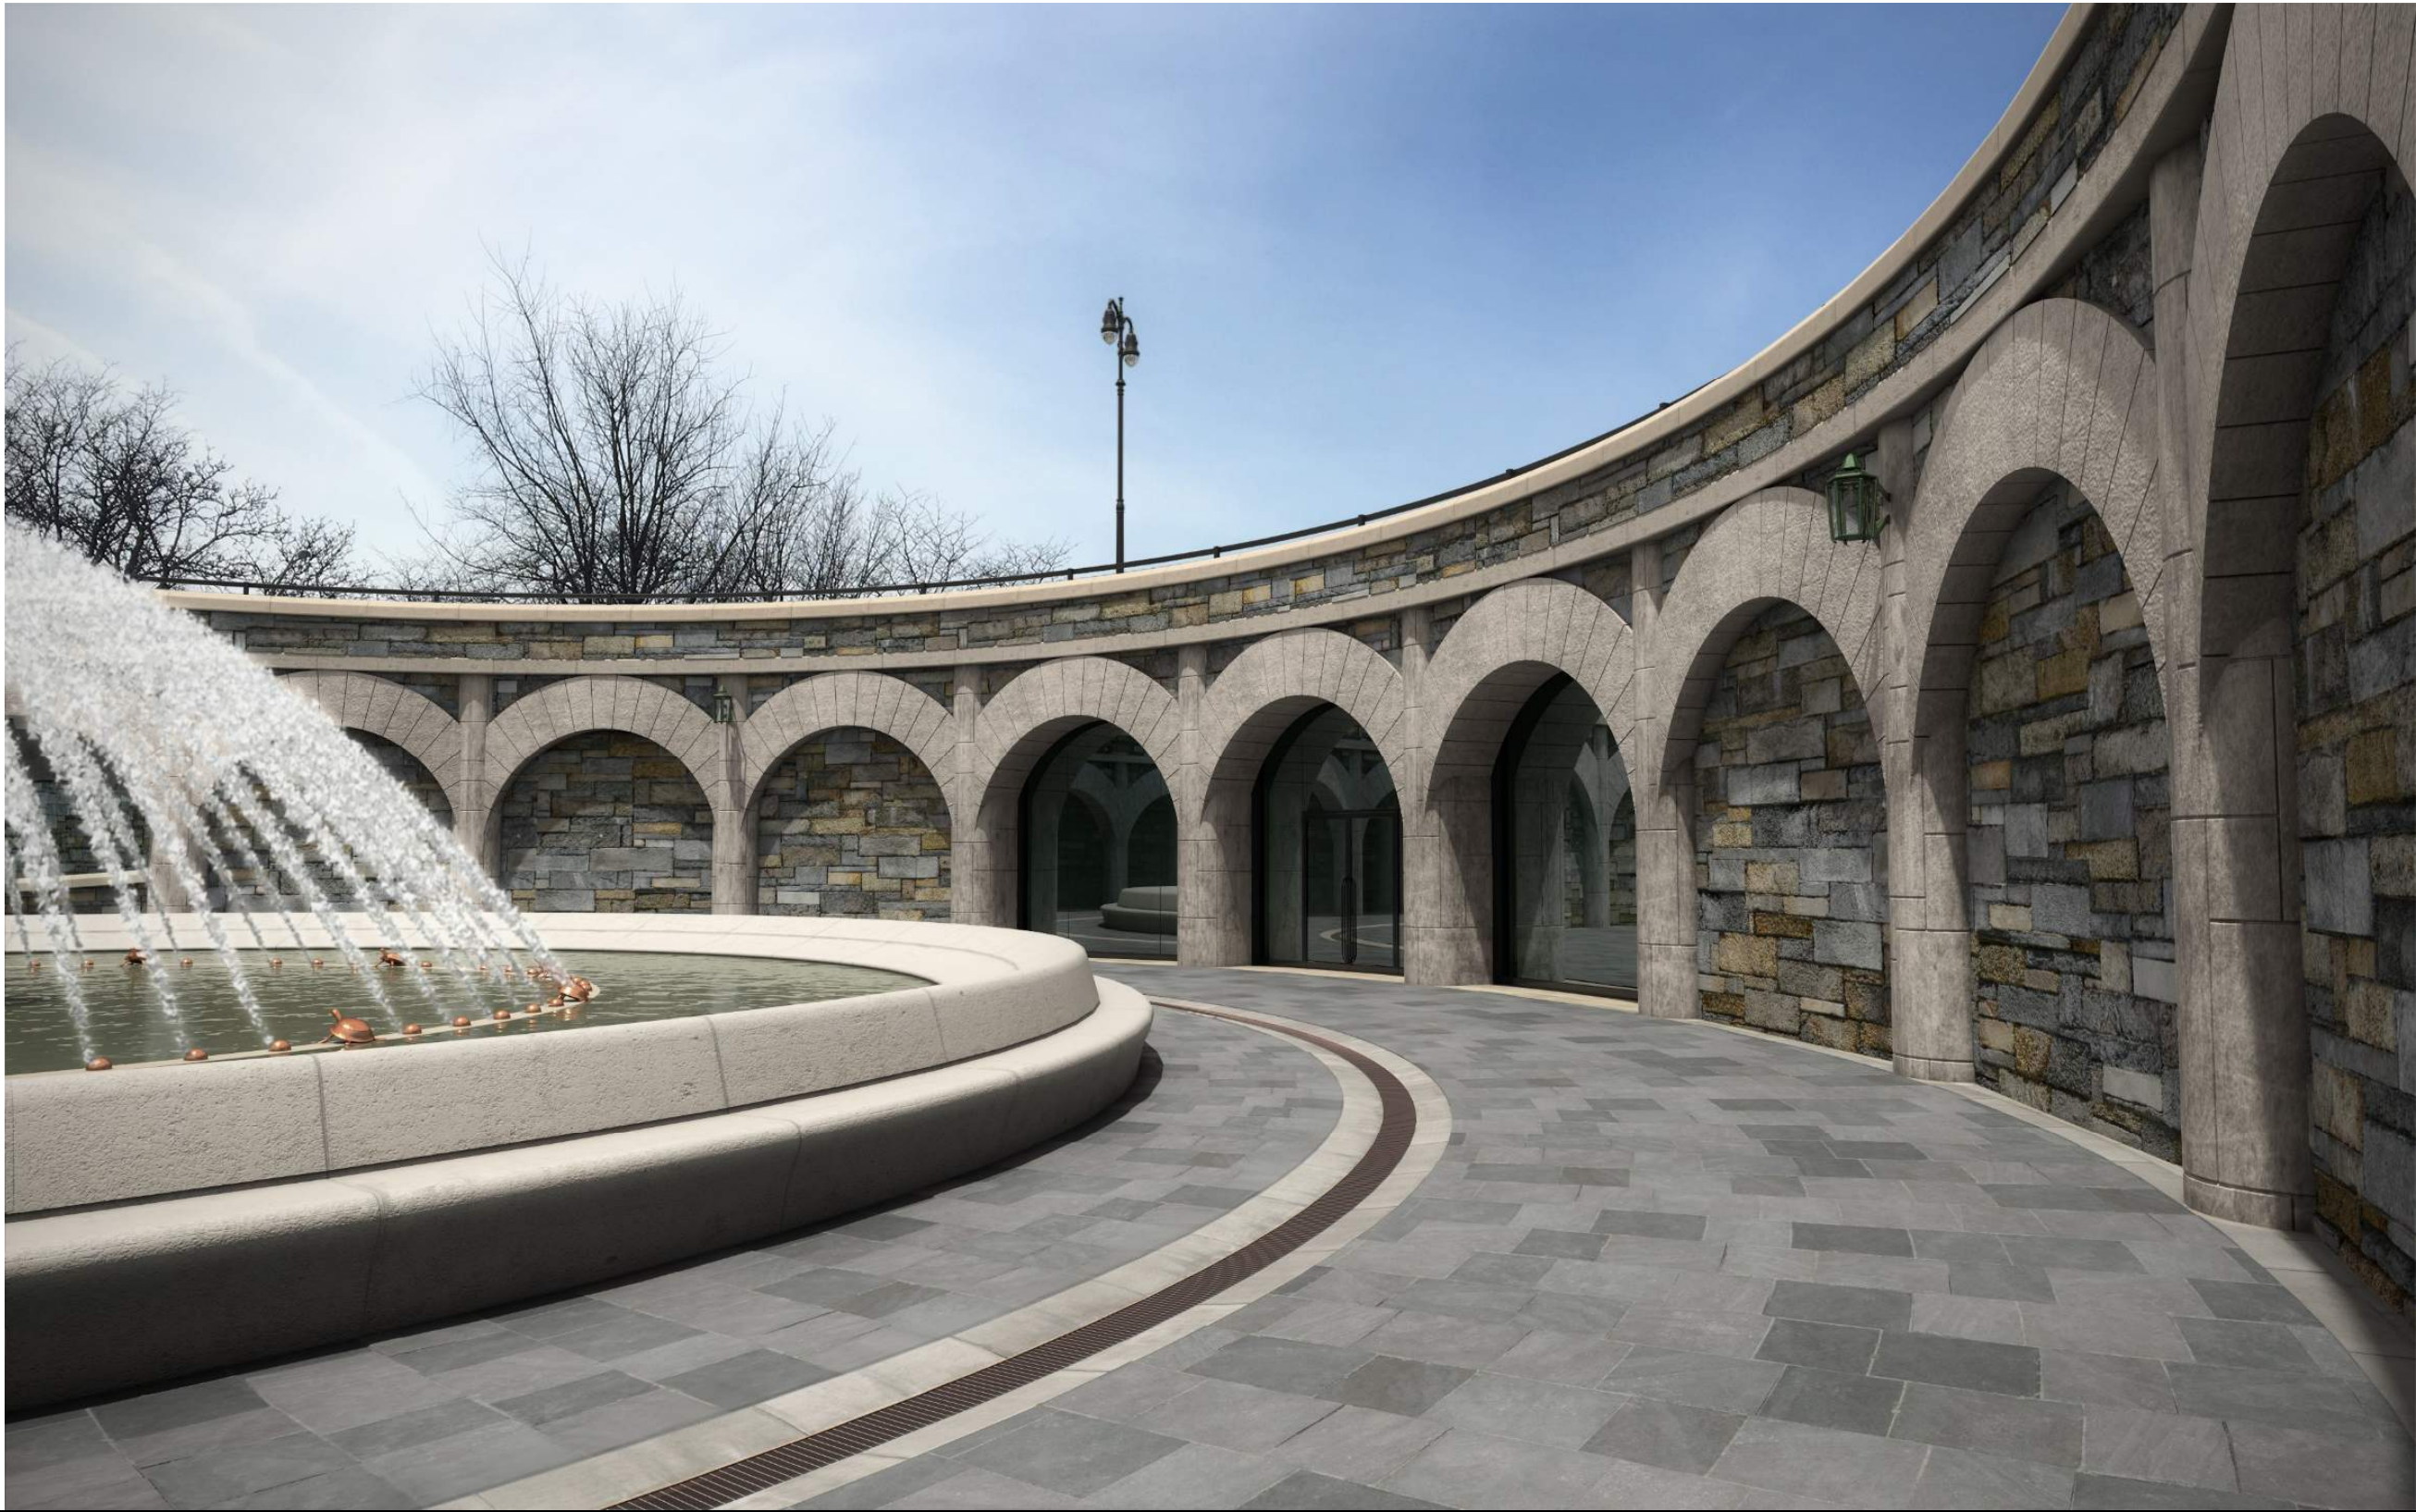
NYC Parks Administrative Office and Fountain Level Restoration Rendering

Note:
Safety railing at traffic circle level
Is currently under development

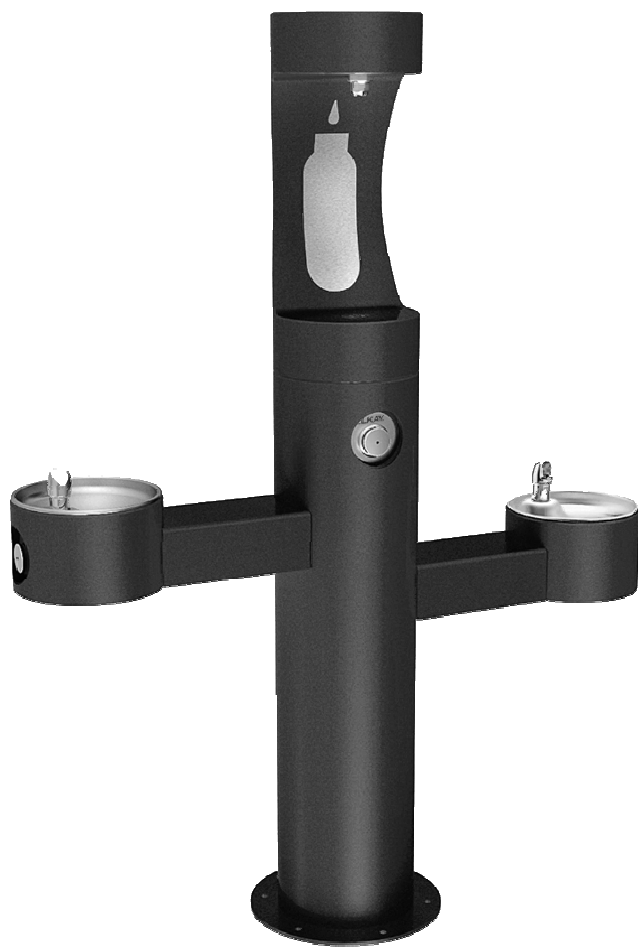
Accessible Drinking Fountain/Bottle Filler

- NYCDPR Standard Details
- Conveniently Located Near Bike Path and Esplanade

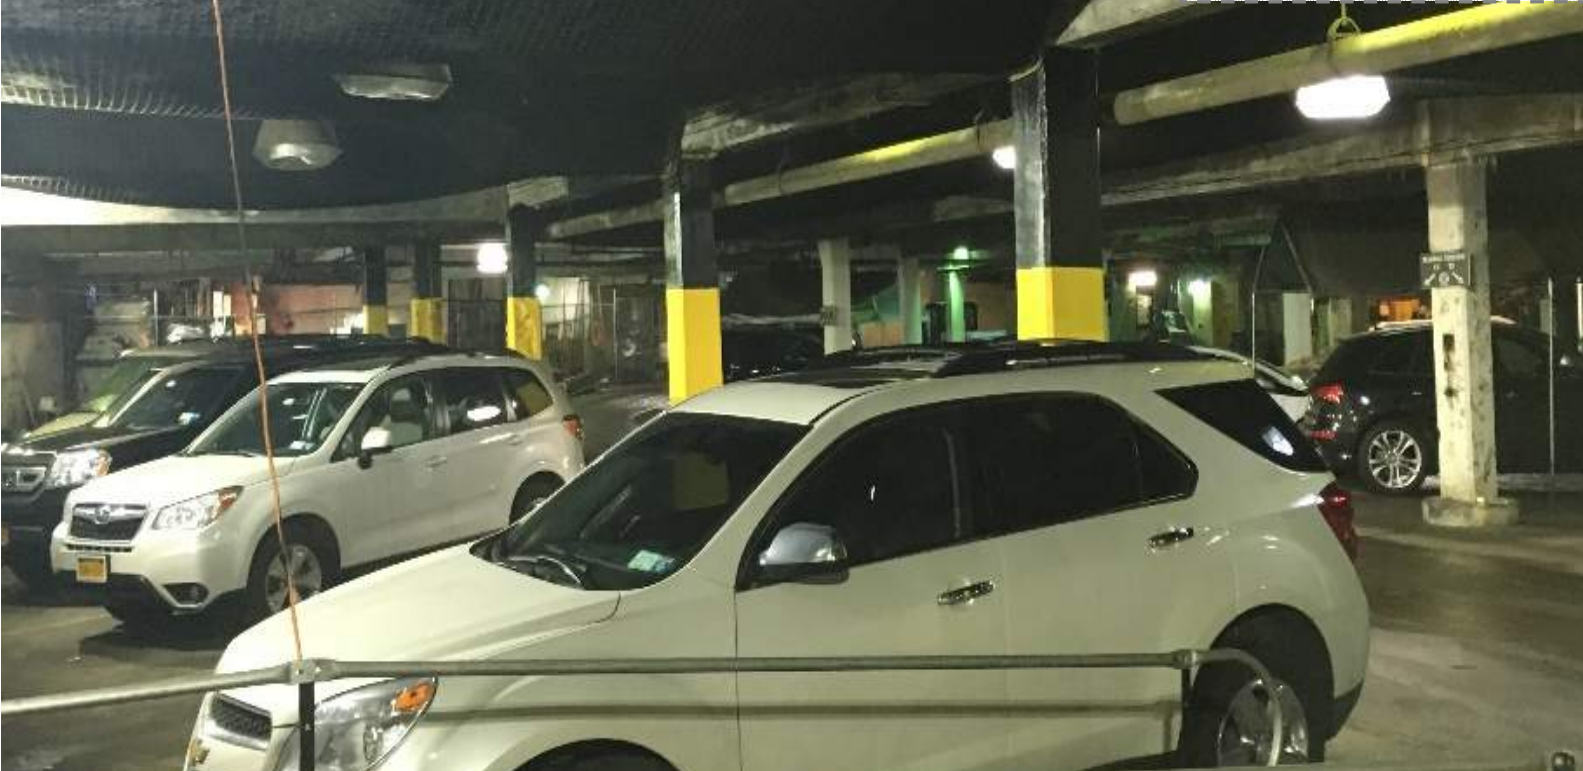
1.

Garage Level
Structure supporting the historic plaza and Rotunda levels above will also be rehabilitated to mitigate leaking, structural, and electrical issues.

- Expand NYCDPR Maintenance and Operations Office
- Repair concrete ramps
- Removal of existing concrete encasement to accommodate structural framing repairs and upgrades
- Replace all three stairs to pedestrian plaza
- Restore stone masonry on exterior
- Replace lighting and drainage systems
- Replace or repair mechanical, electrical, and plumbing elements

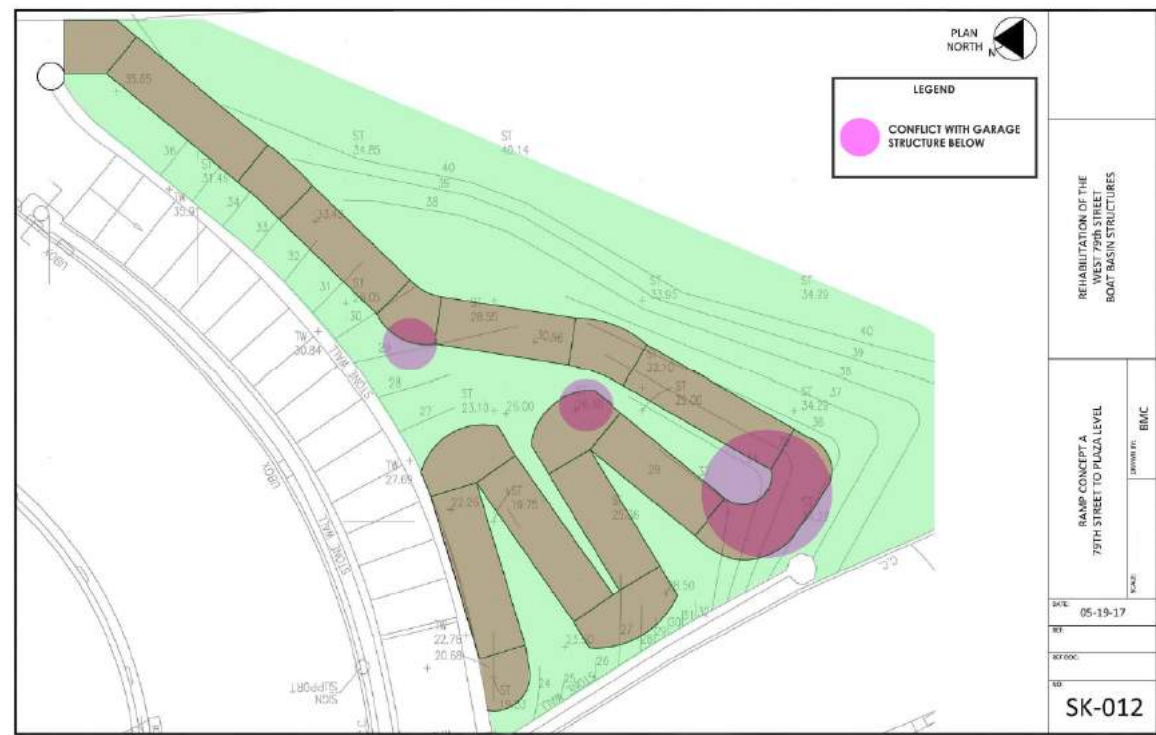
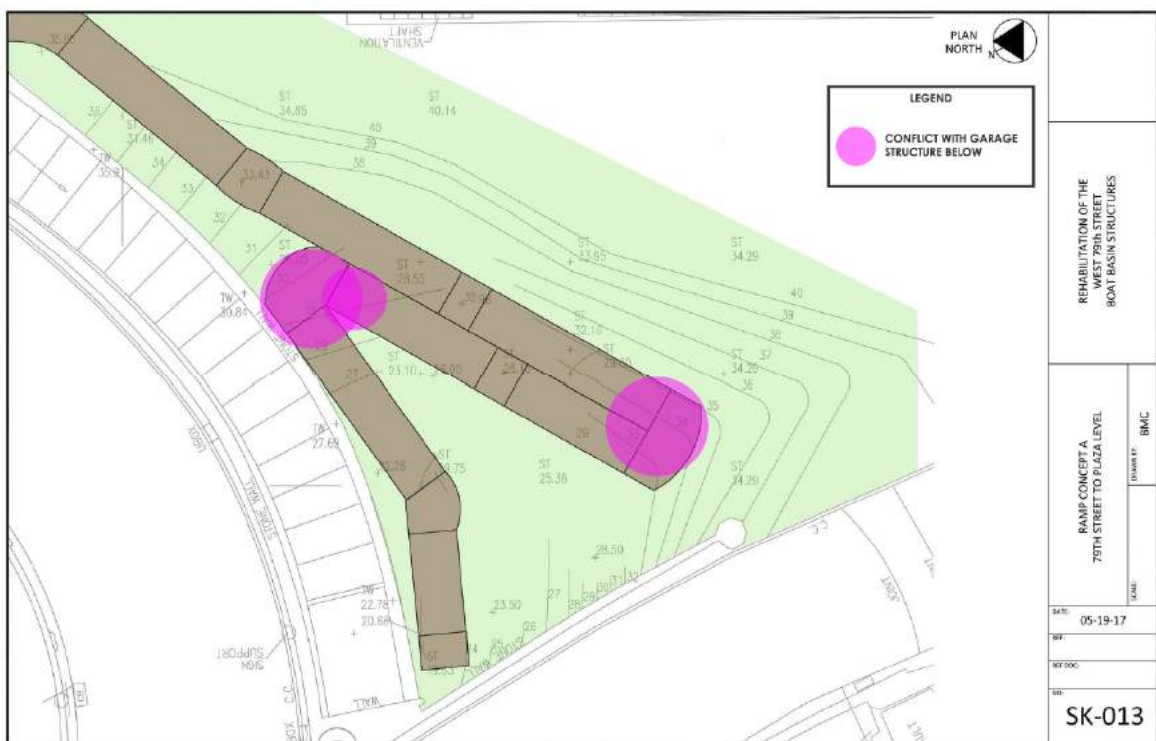
Ramp Studies (continued)

Several ramp configuration designs were tested. Due to the conflicts with the garage roof structure directly below, these designs were not feasible.

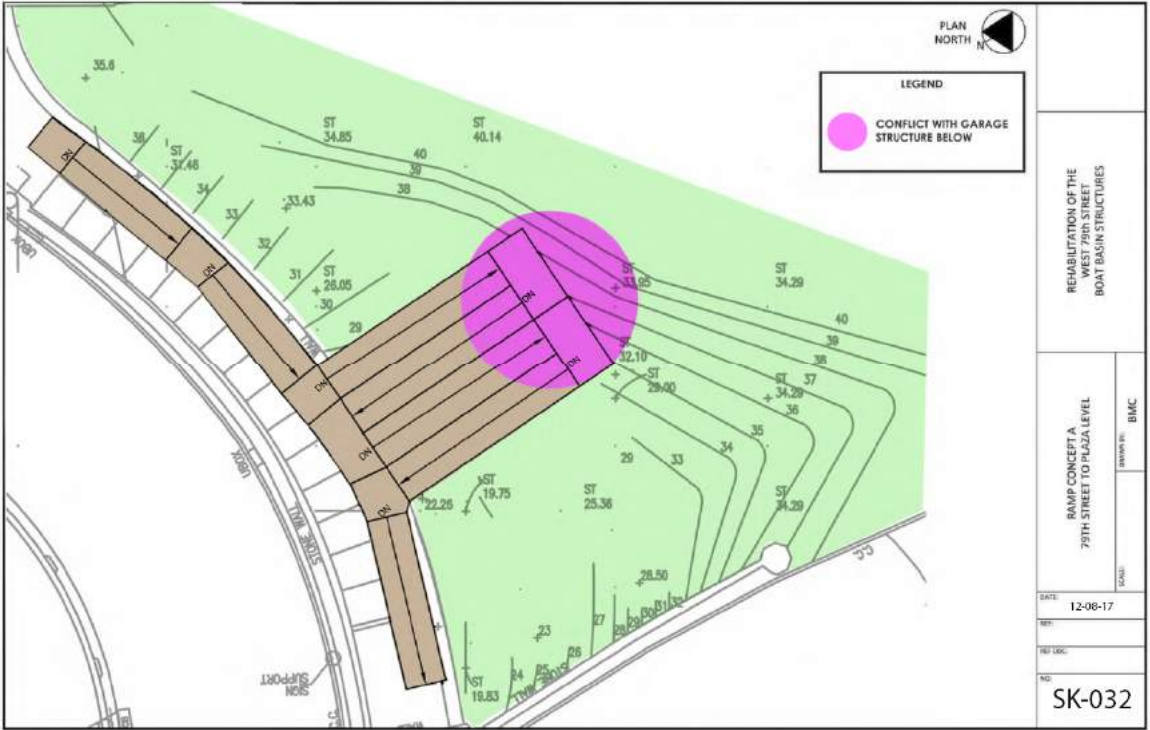
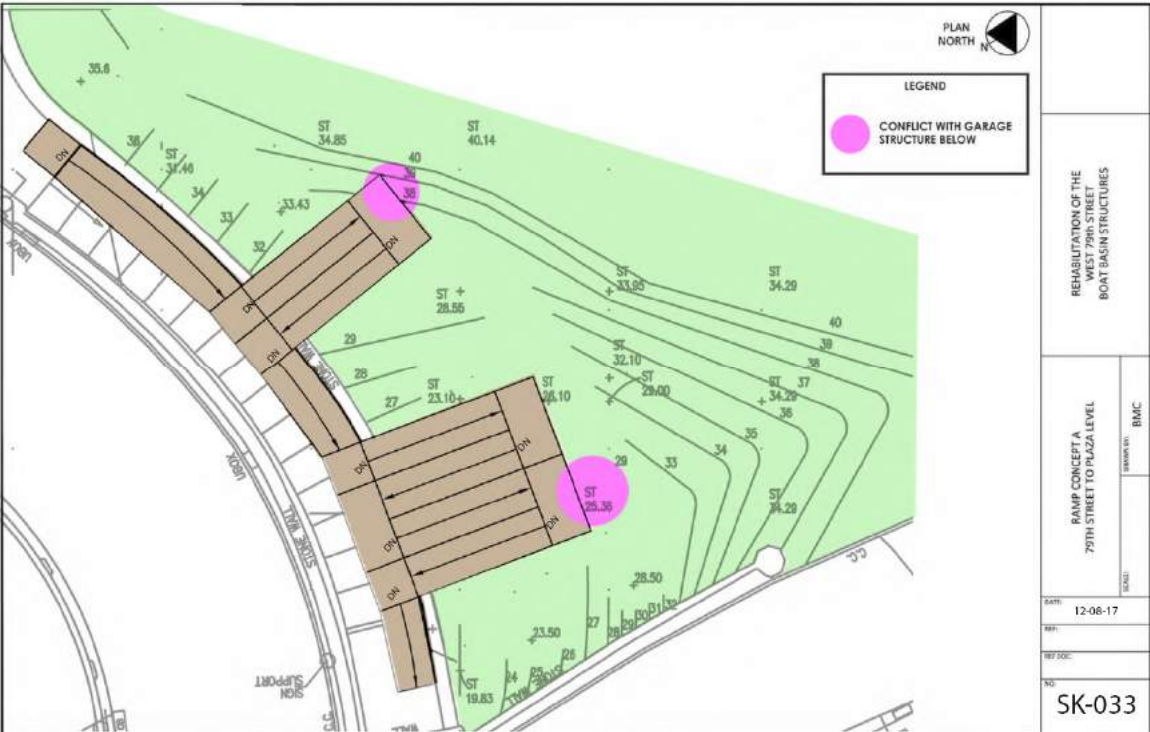
Ramp Studies (continued)

Several ramp configuration designs were tested. Due to the conflicts with the garage roof structure directly below, these designs were not feasible.

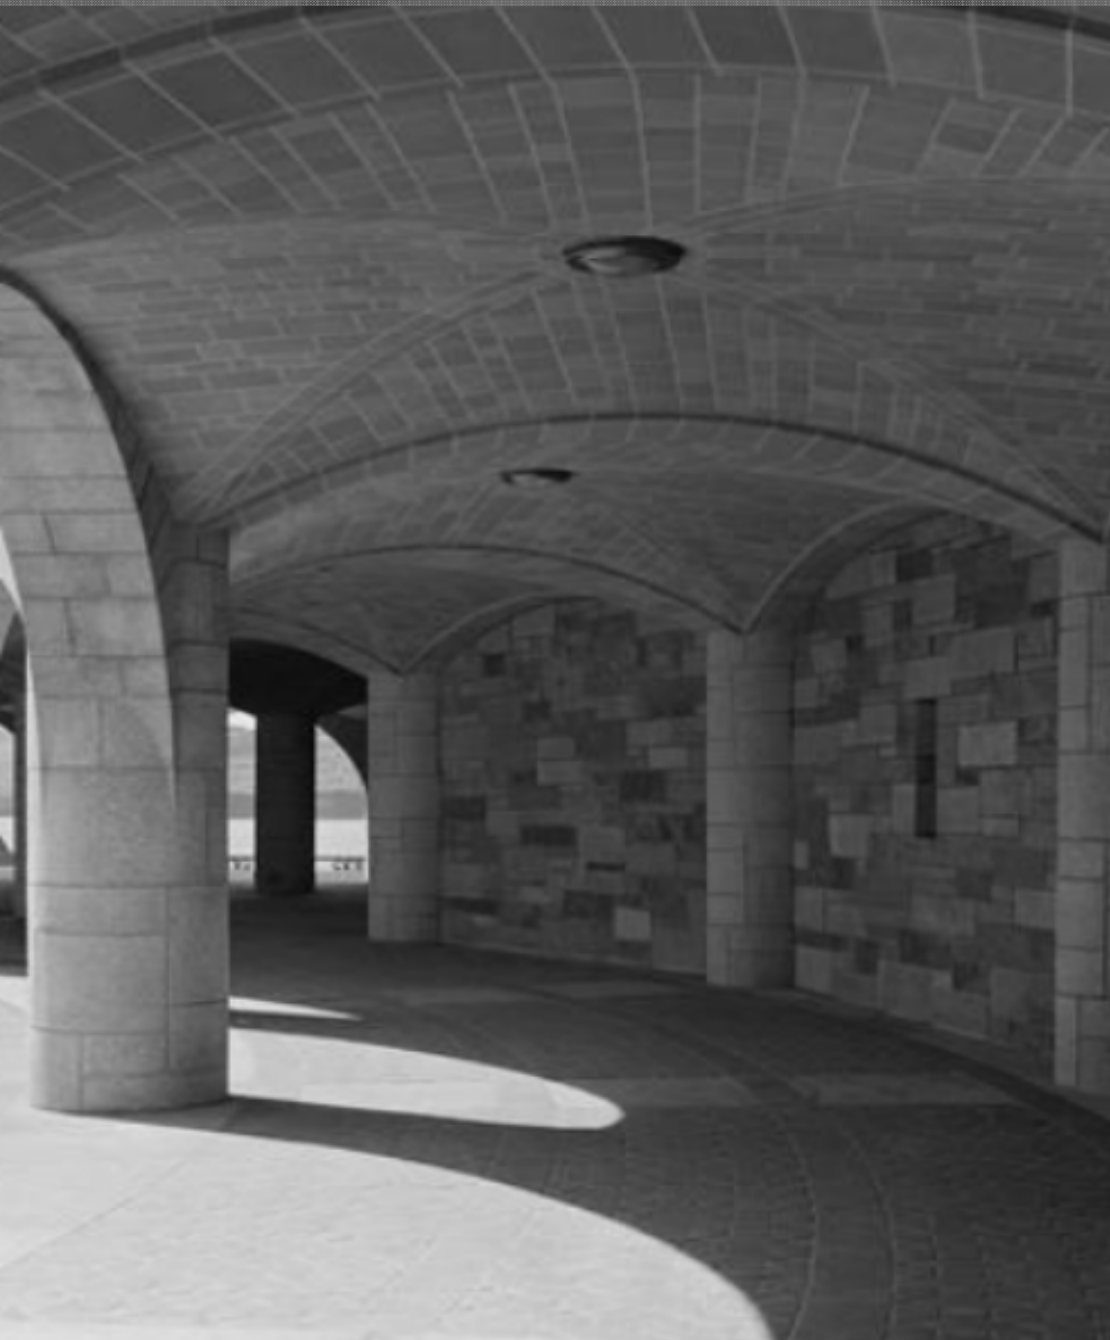
Historic Features to be Restored: Guastavino Ceilings

Guastavino Ceilings, 1937

- Provide replica historic handrails on terrace and ramps
- Remove wooden stage and restore fountain
- Repair and restore existing masonry walls
- Restore exterior floor finishes
- Restore Guastavino ceilings and resolve water infiltration
- Provide replica historic lighting within the structure

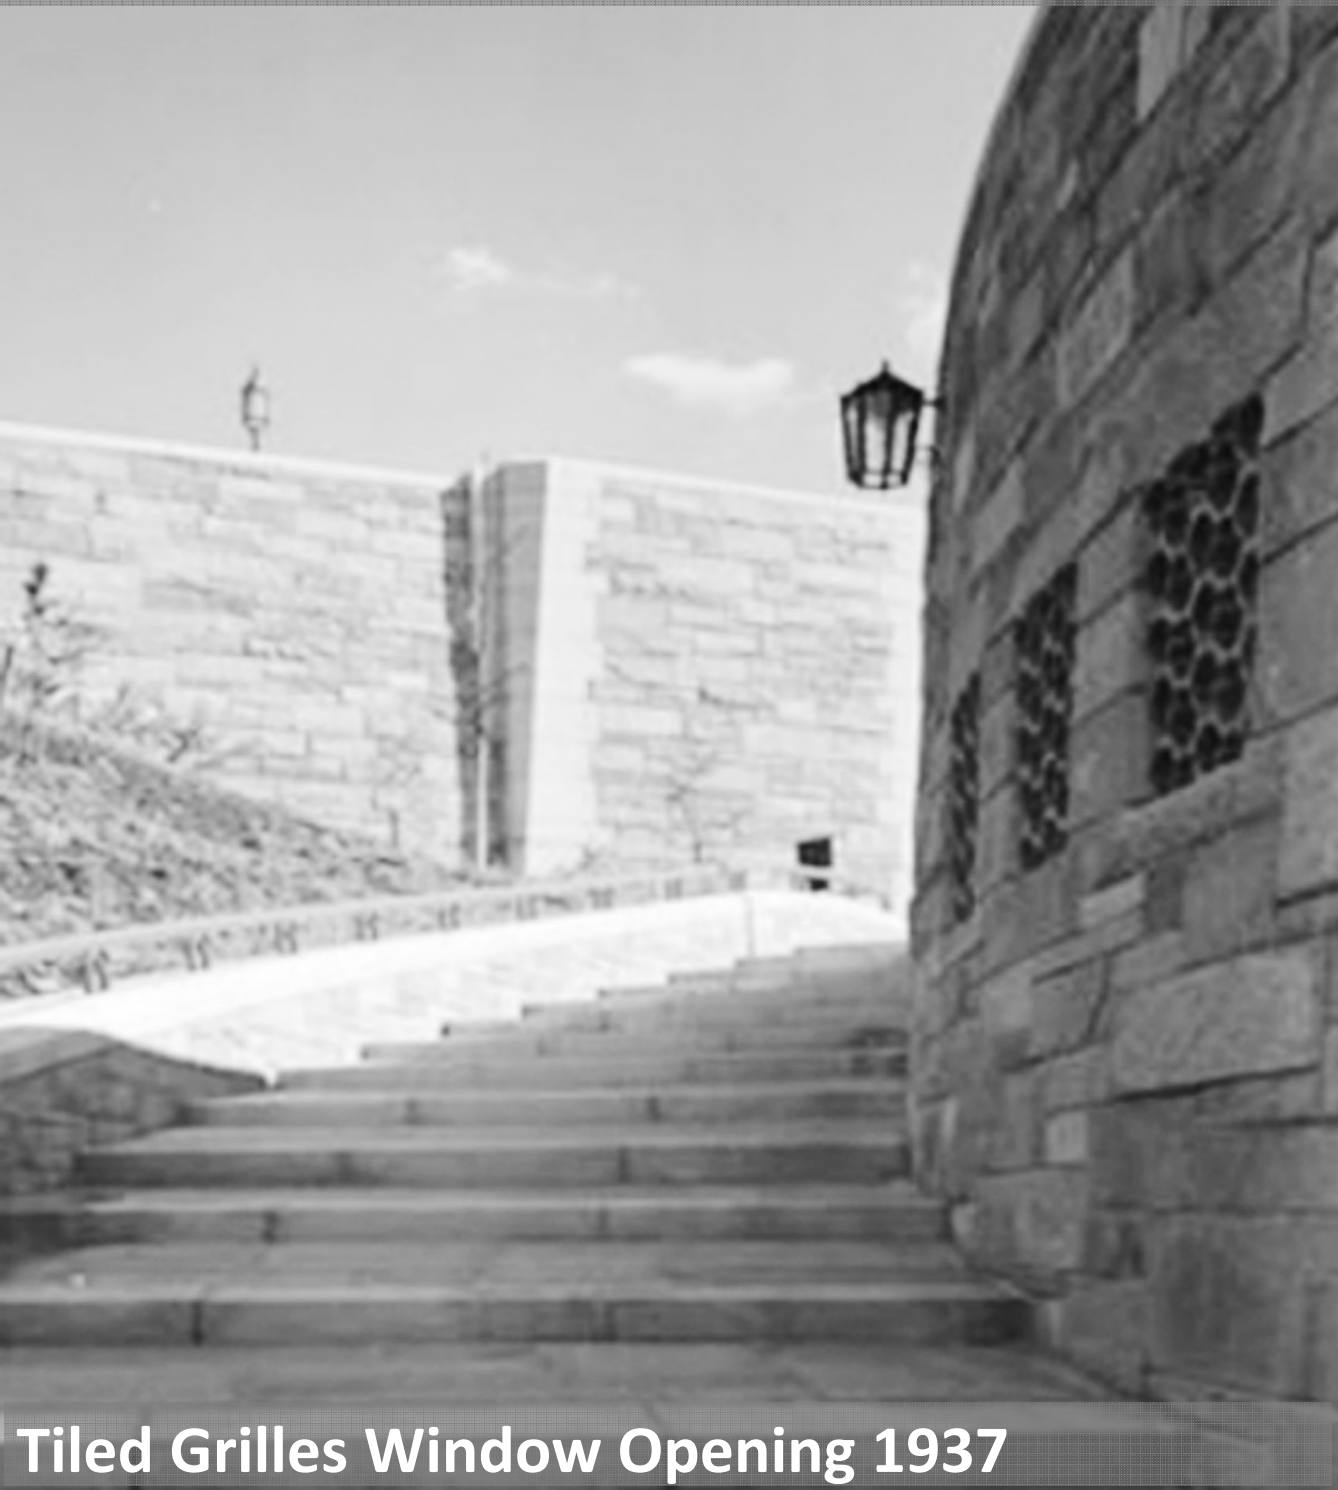
Historic Features to be Restored: Terracotta Tile Grilles at Restrooms

Tiled Grilles Window Opening 1937

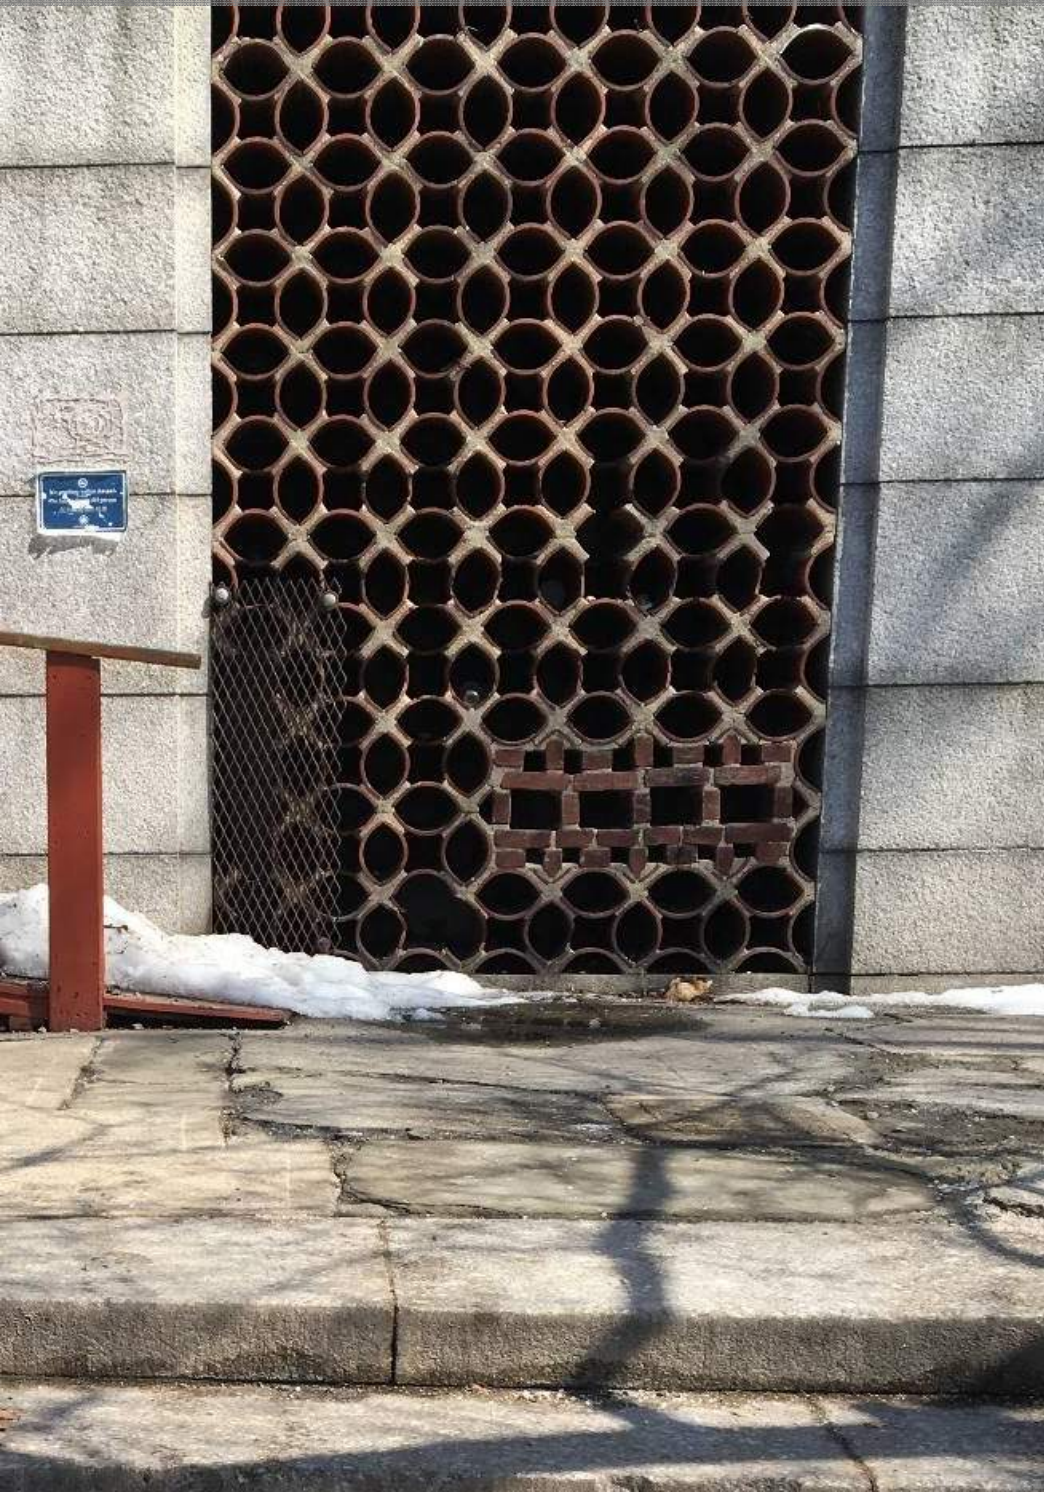
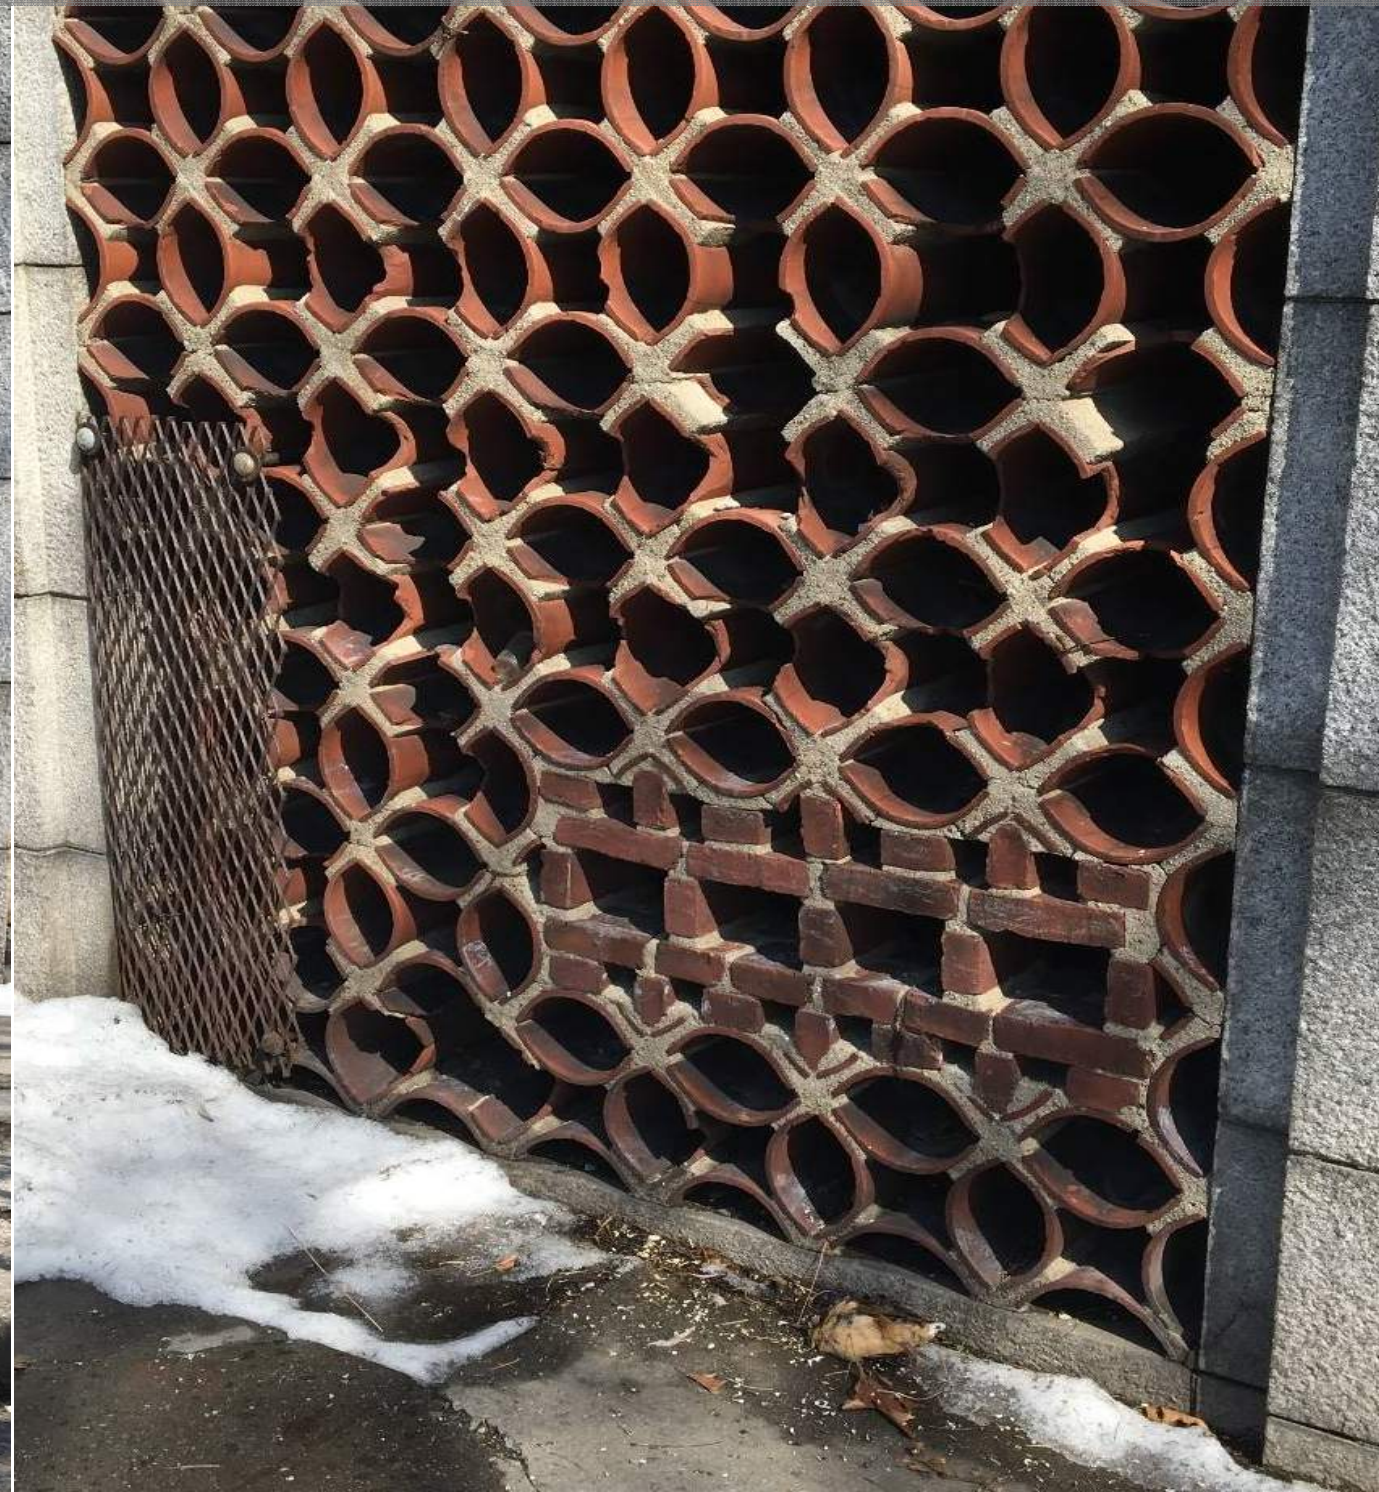
Historic Features to be Restored: Terracotta Tile Grilles at Vents

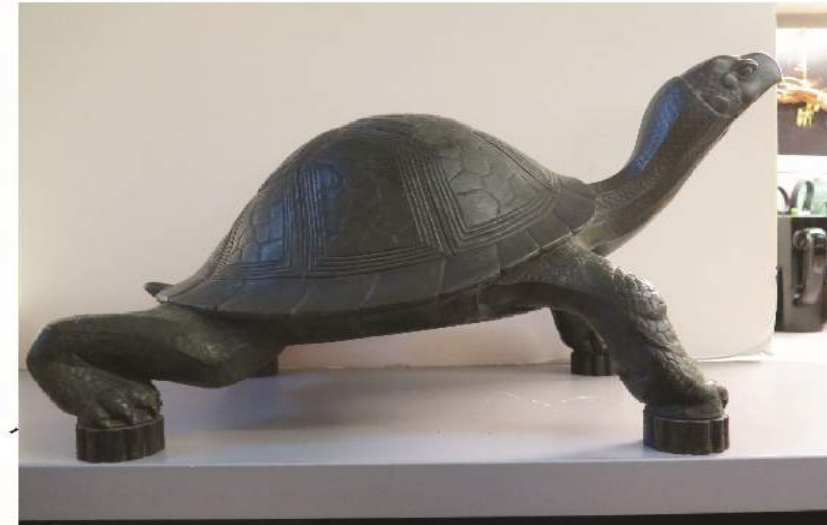
Historic Materials and Finishes to be Restored: Bronze

Fountain Turtle Sculpture

- a) Turtle Sculptures** **b) Fountain Inlet Cap**
- c) Continuous Bronze Drain** **d) Bronze Railing**

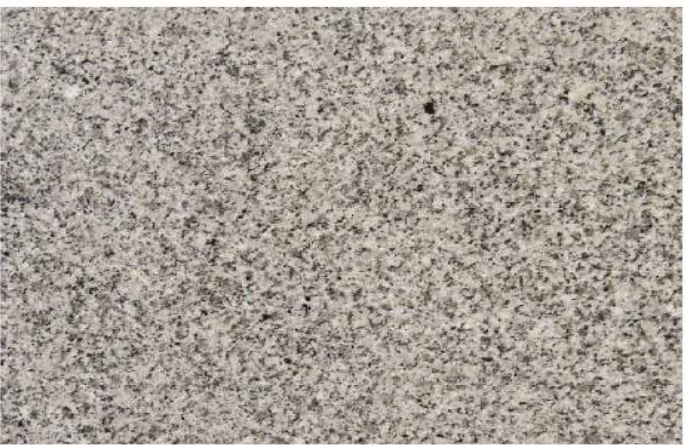
Historic Materials and Finishes to be Restored: Granite

Granite Texture

- a** Fountain Seating
- b** Paving
- c** Borders
- d** Spout Basin
- e** Rotunda Steps
