262 Central Park West, looking northwest  
2019

LPC-Approved Window Replacements Since 2000

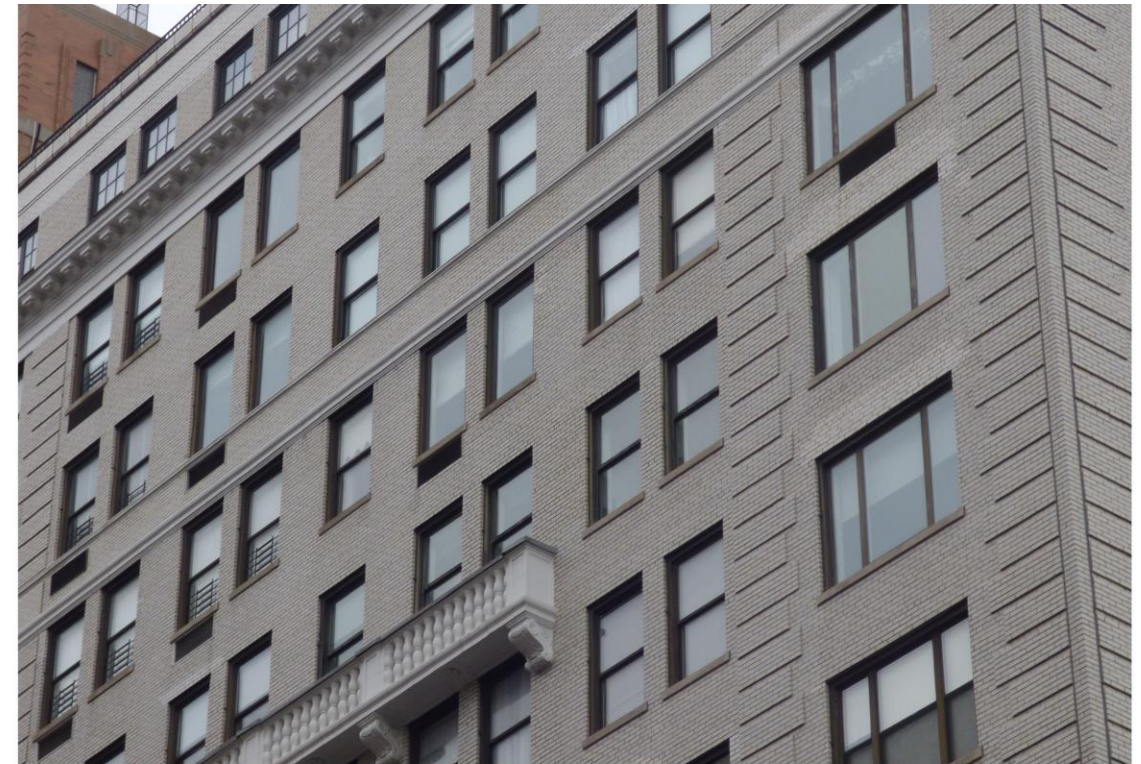
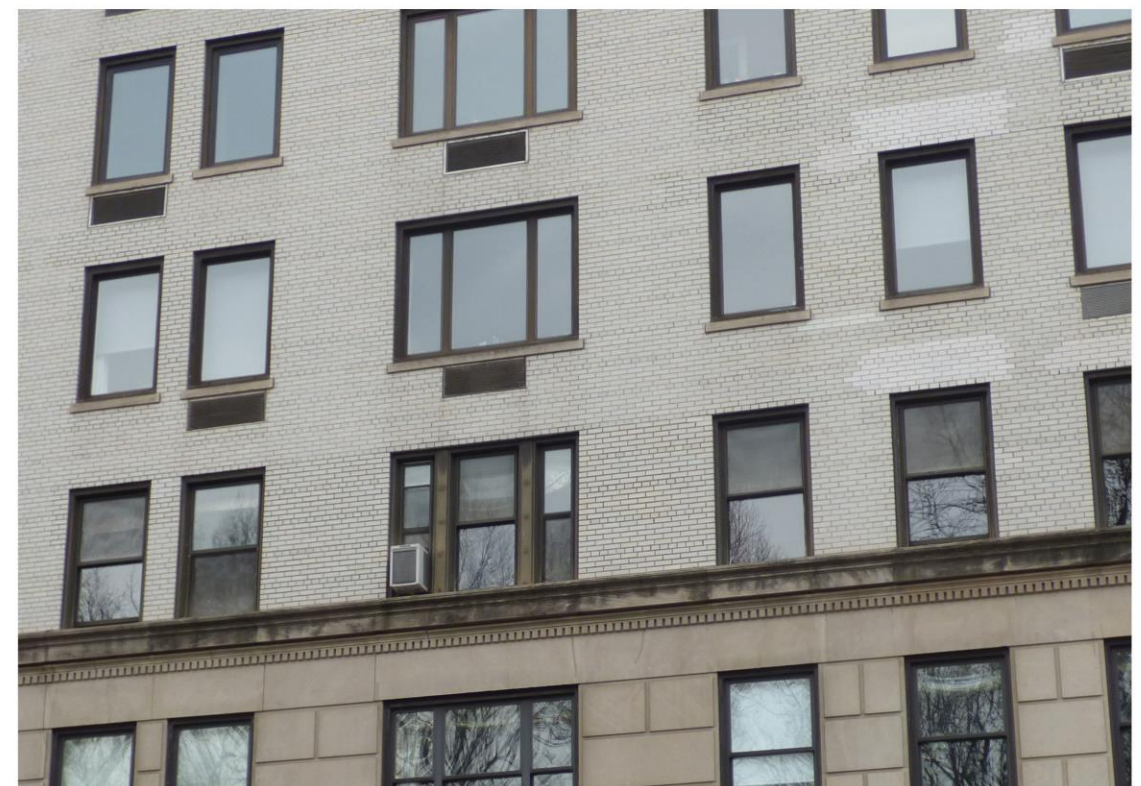
The differences in window operations create variation in mullion size and projection.

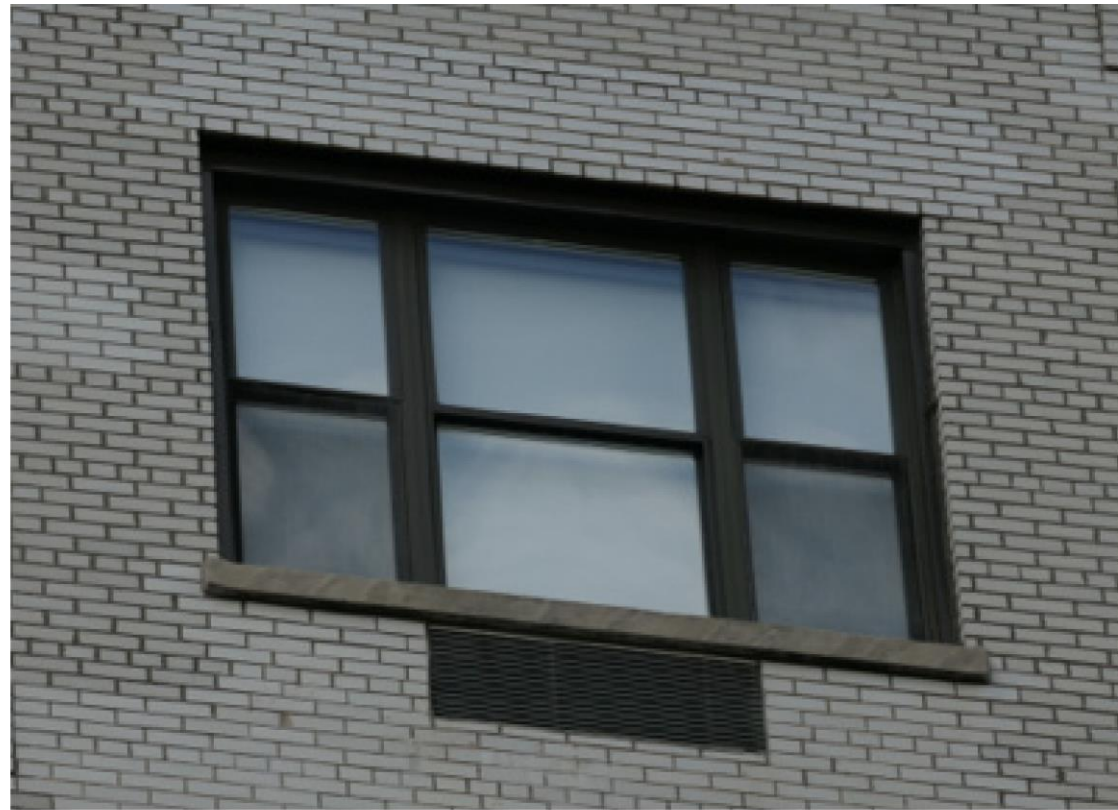
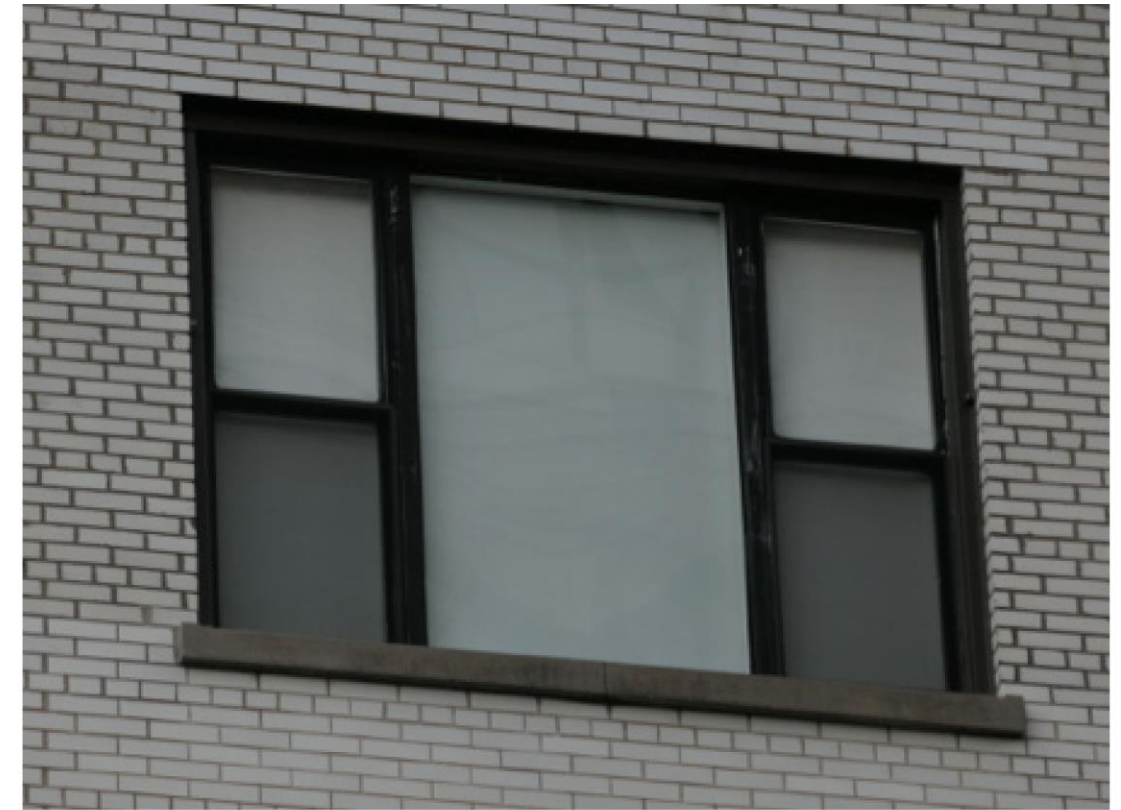
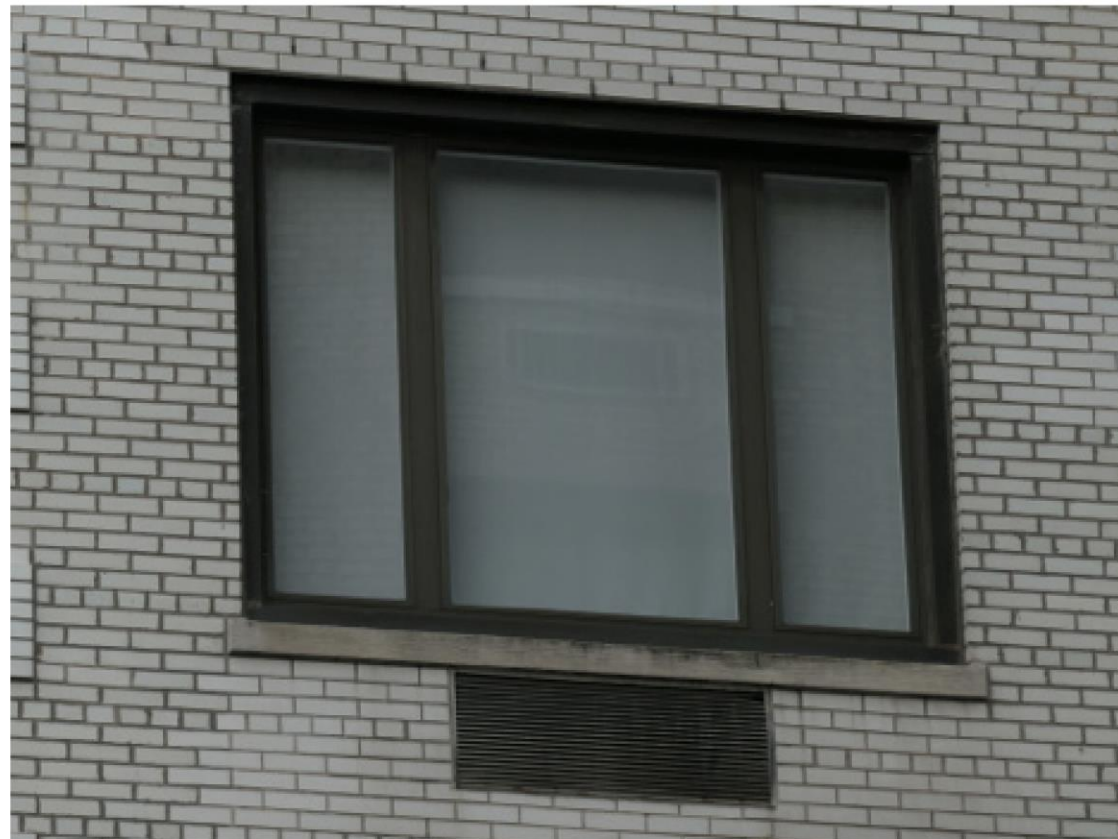
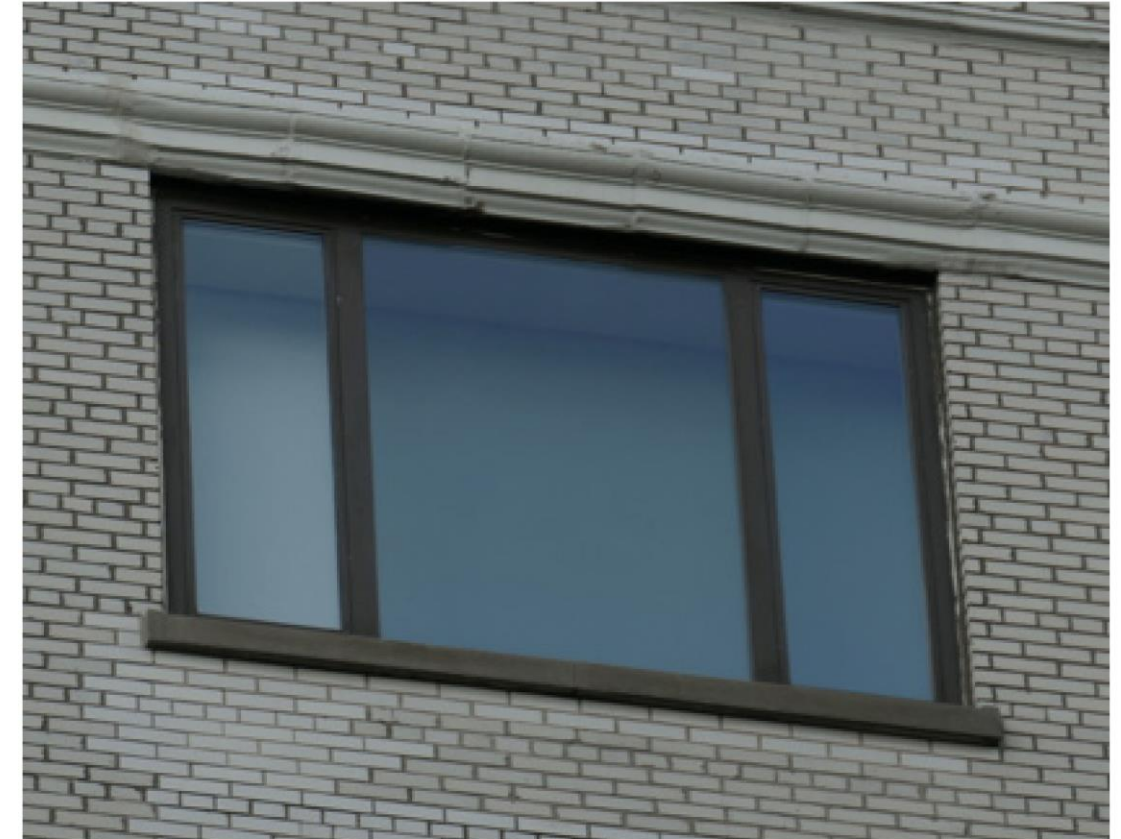
Photos showing the variation in triple-gang windows across the facades. The mullion thicknesses, spacing and projections vary significantly. The result is a loss of articulation in these large window openings.

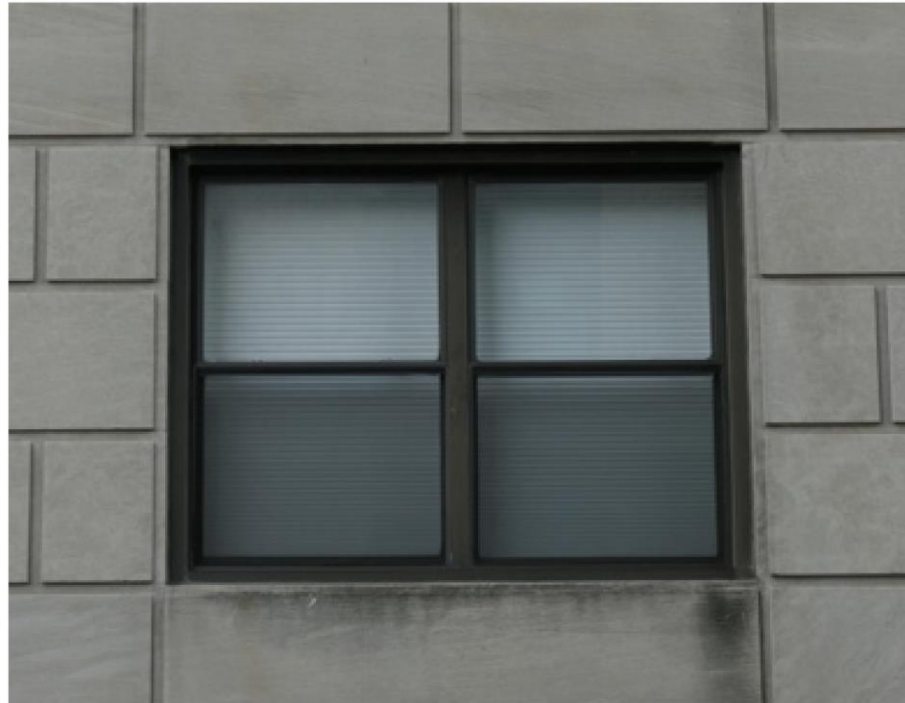
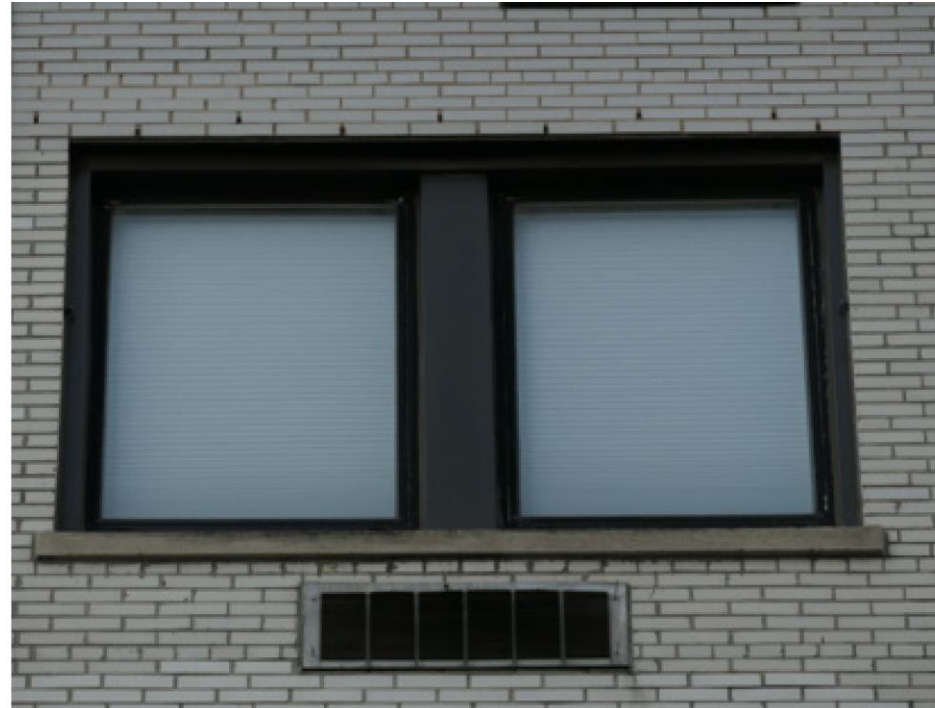
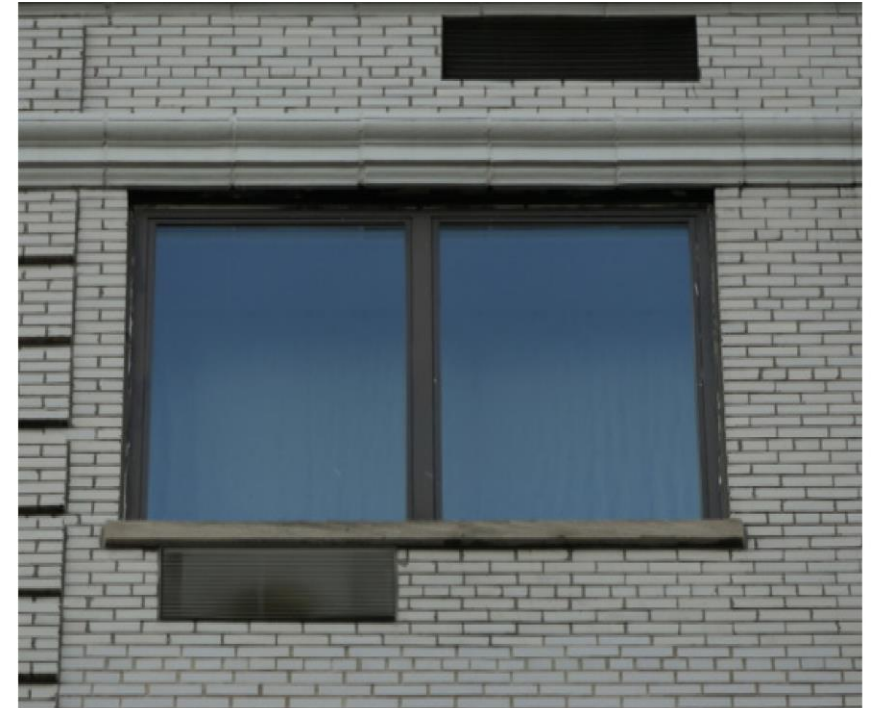
Photos showing the variation in double-gang windows across the facades. The mullion thicknesses and projections vary significantly.

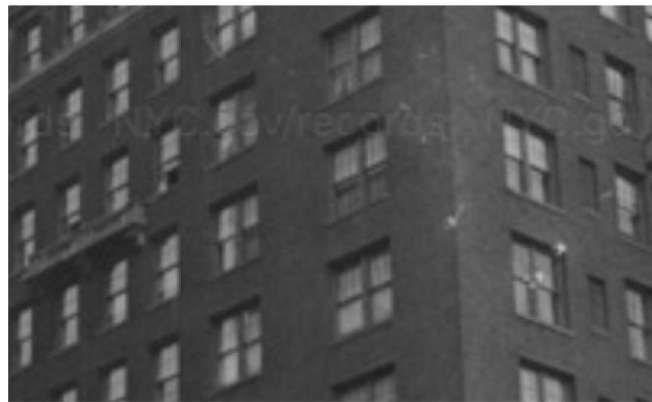
Original configuration: six-over-one

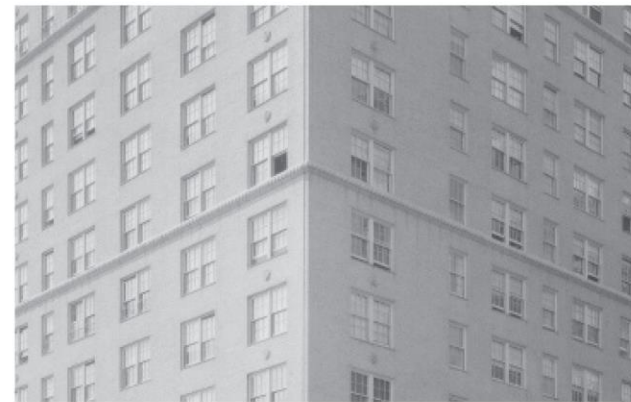
Original configuration: six-over-six

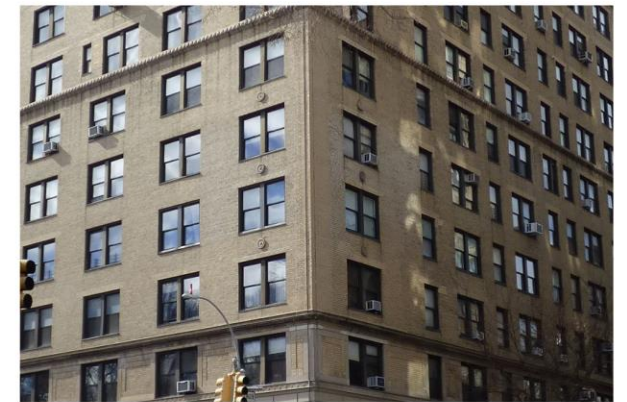
LPC-approved configuration: one-over-one

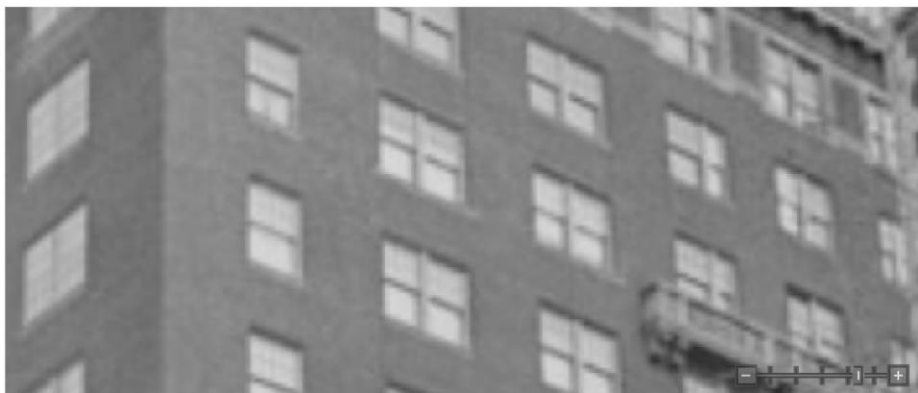
Original configurations: eight-over-eight, six-over-six, and four-over-four

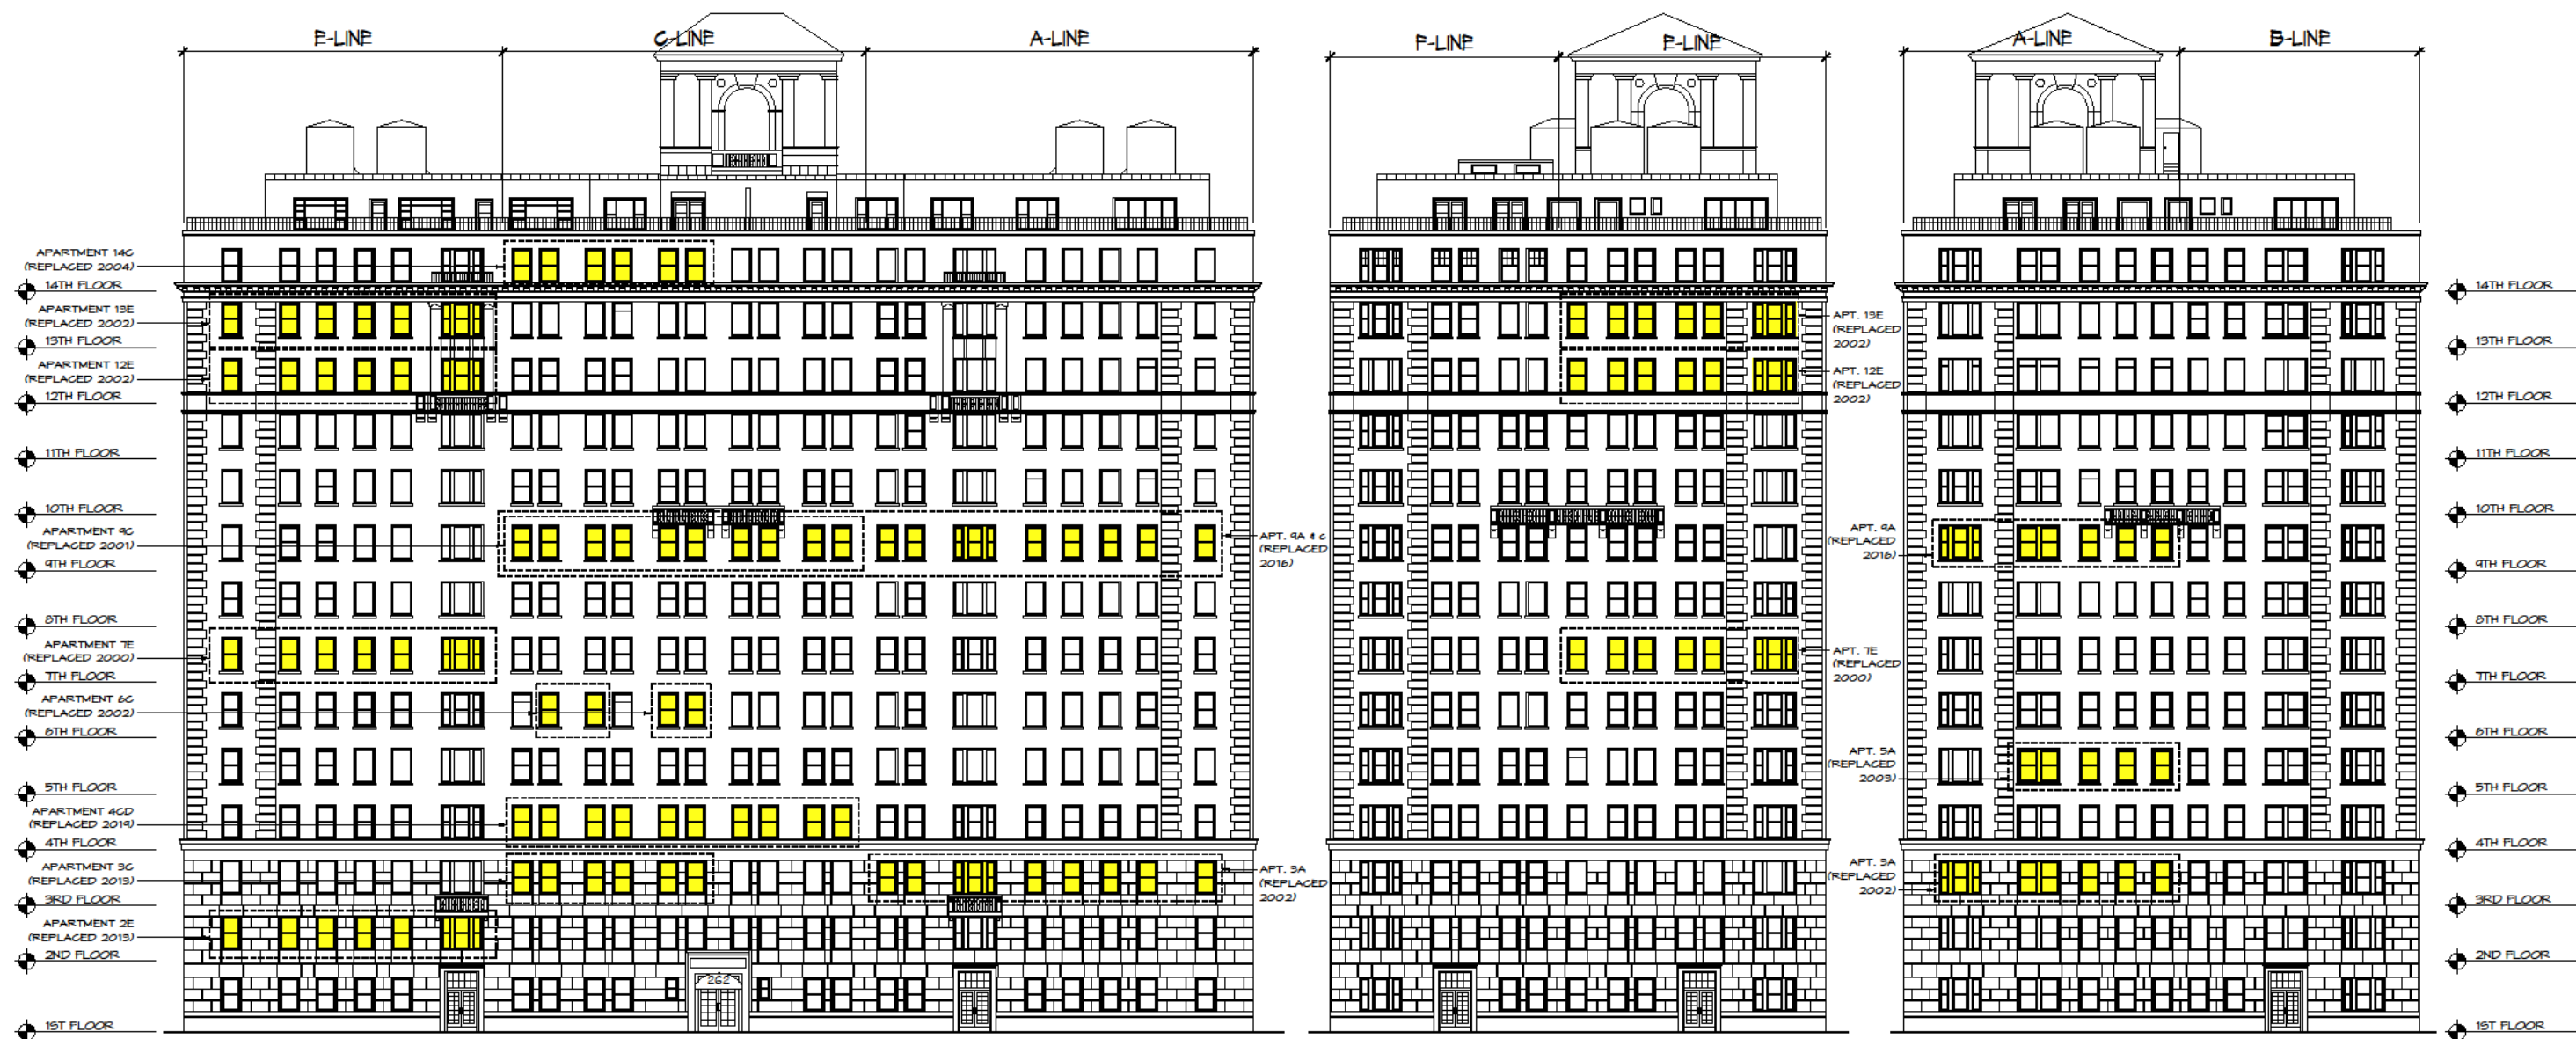
EXISTING DOUBLE HUNG WINDOW  
REPLACEMENTS APPROVED BY  
LPC 2000-PRESENT

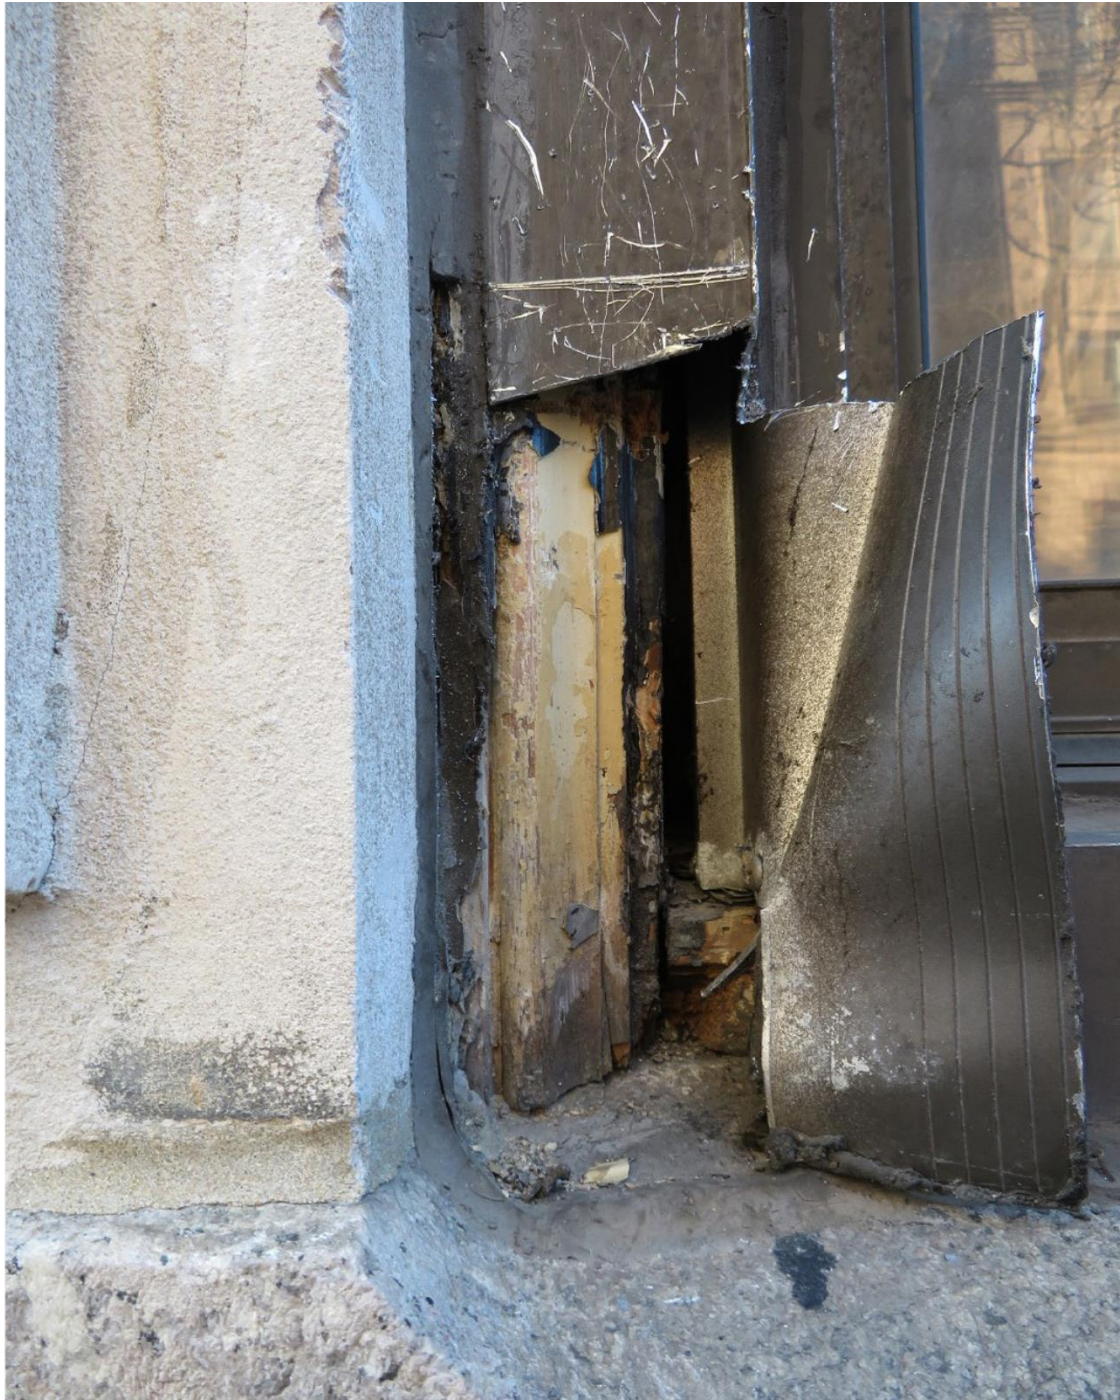
Probe at West 87th Street showing original brick mold

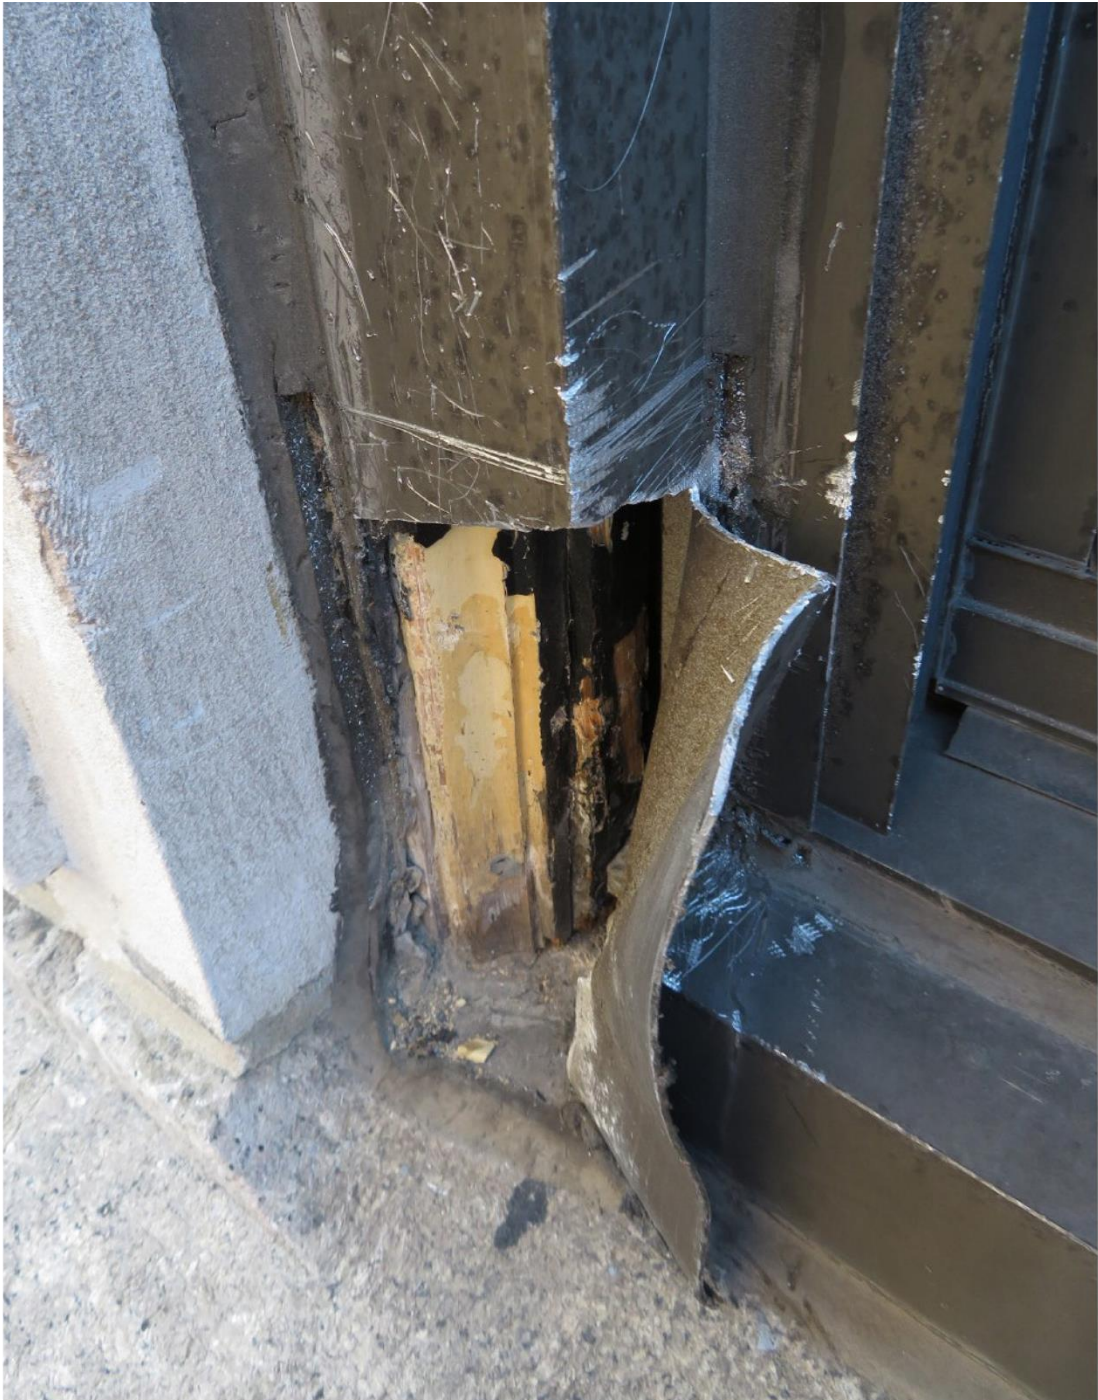
Probe at West 87th Street showing original brick mold
