LPC-21-07897 43 WEST 74TH STREET MANHATTAN-1127-11

PROPOSED WORK

REMOVE PORTION OF REAR YARD EXTENSION TO MATCH ARCHITECT"S

ORIGINAL CONFIGURATION, TO ALIGN WITH ADJACENT BUILDINGS AT REAR YARD

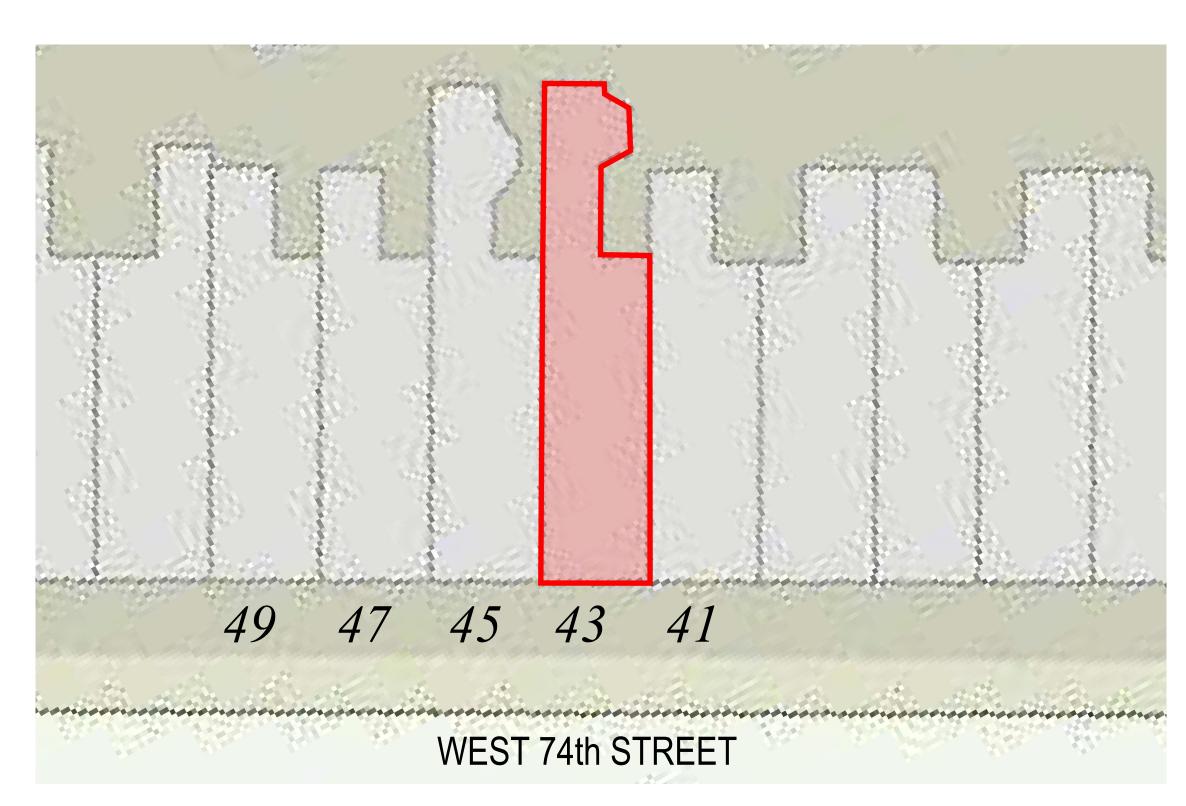
CITY MAP - 2021
SHOWING CURRENT CONFIGURATION

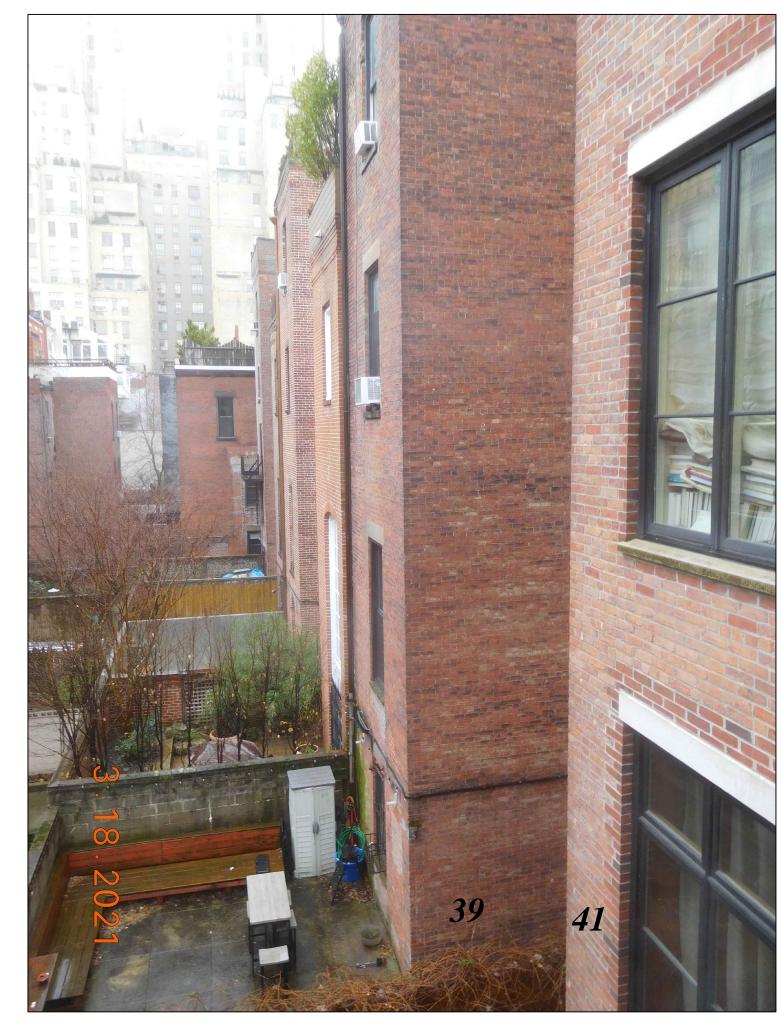
LPC-104.00

PHOTO OF ADJACENT BUILDINGS (EAST)
SHOWING EXISTING LINE OF REAR WALLS.

PROPOSE TO REMOVE PORTION OF REAR EXTENSION AT 43W74 TO ALIGN WITH EXISTING BUILDINGS AS PER ORIGINAL BUILDING ARCHITECTS DESIGN

EXISTING BUILDING PLANS

SHOWING PORTION AT REAR YARD TO BE REMOVED

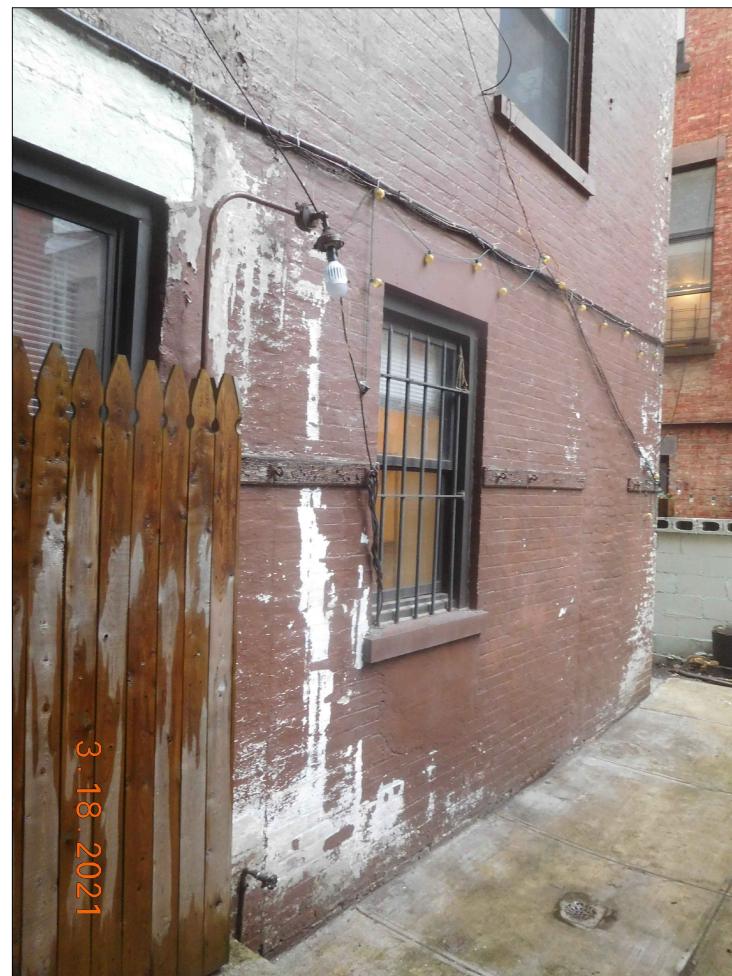
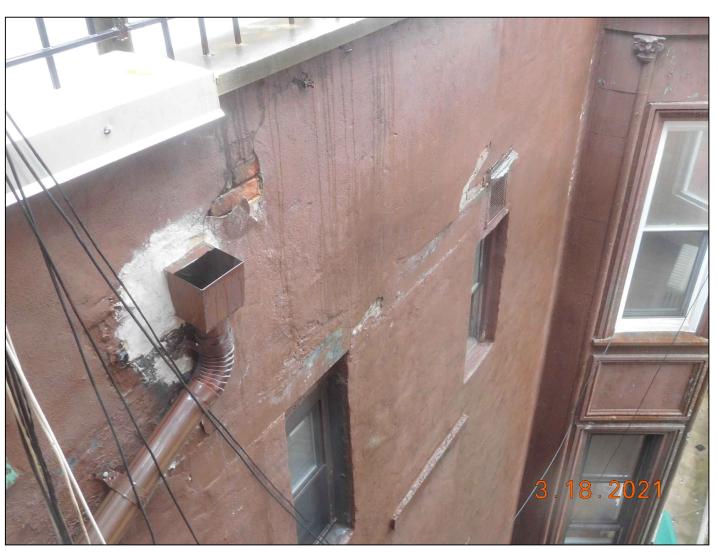
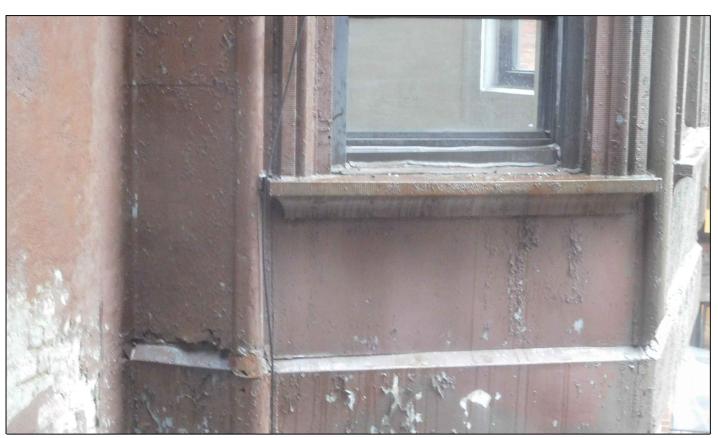
PHOTOS OF REAR EXTENSION TO BE REMOVED SHOWING POOR CONDITION OF EXISTING MASONRY

ARCHITECT'S ORIGINAL DESIGN INTENT TO PROVIDE OPEN REAR YARD FOR OWNER'S ENJOYMENT WAS ELIMINATED WITH LATER ADDITION OF EXTENDED BUILDING.

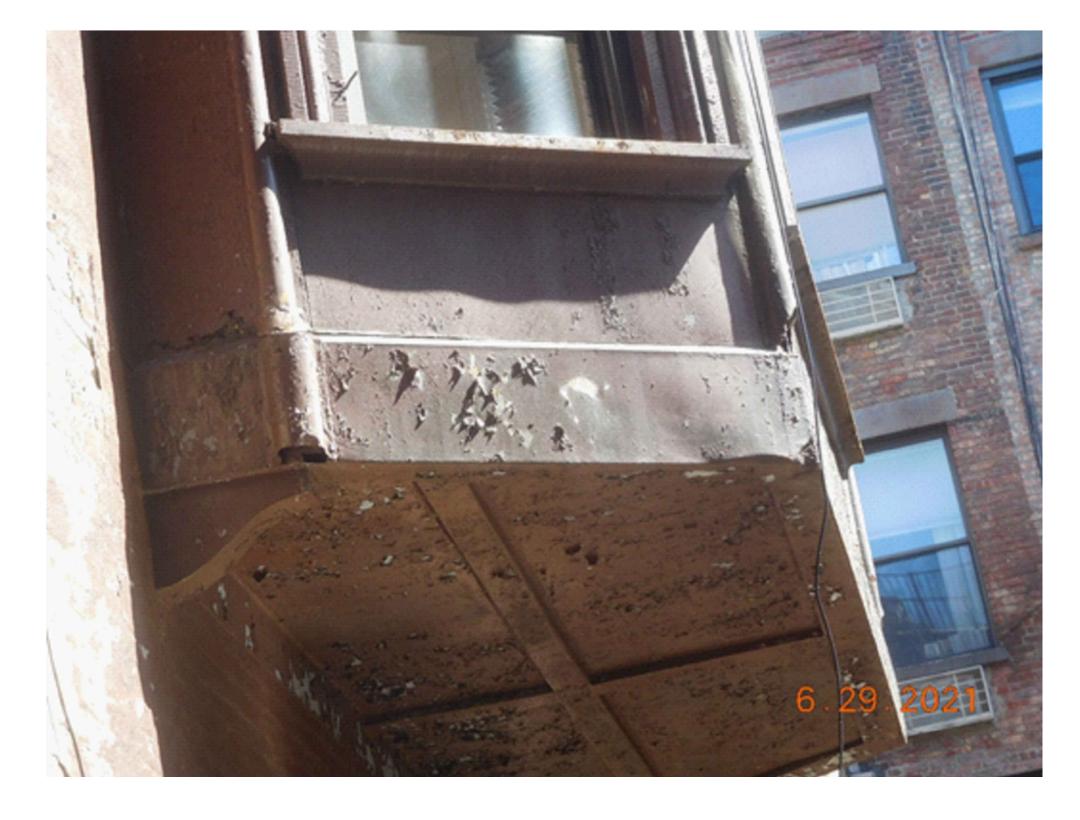
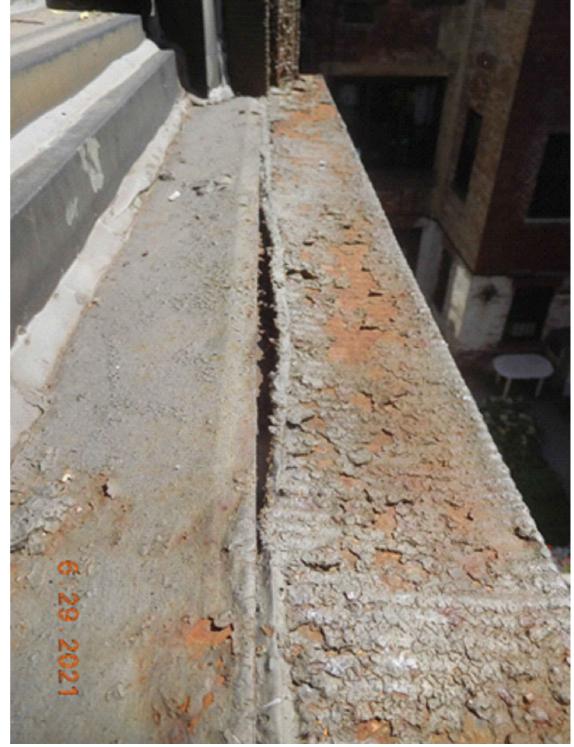
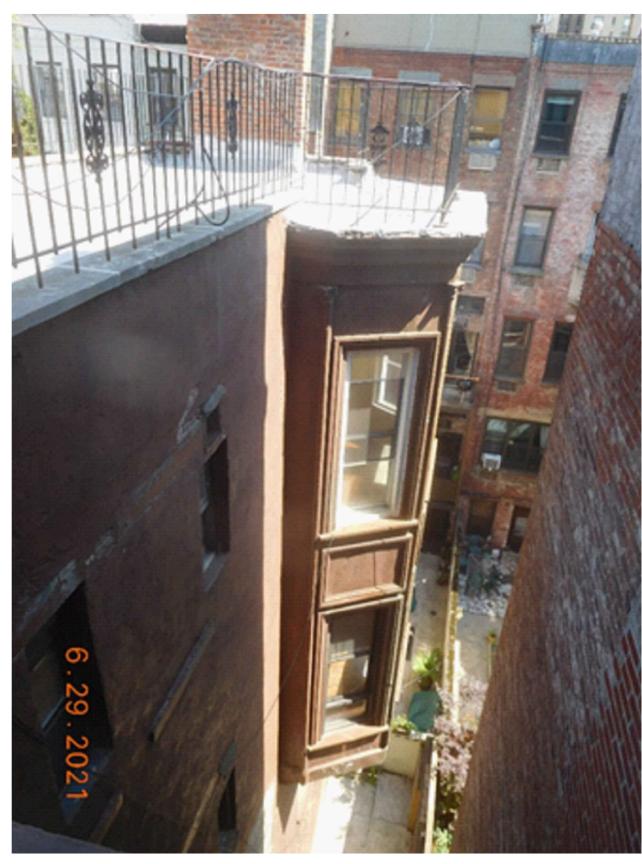
DWG NO
LPC-106.00

CONDITION OF BAY WINDOWS: EXTERIOR FINISHES ARE EXTENSIVELY DAMAGED AND CORRODED, WITH PIECES MISSING. NOT FEASIBLE TO RESTORE OR SALVAGE THE BAY WINDOWS.

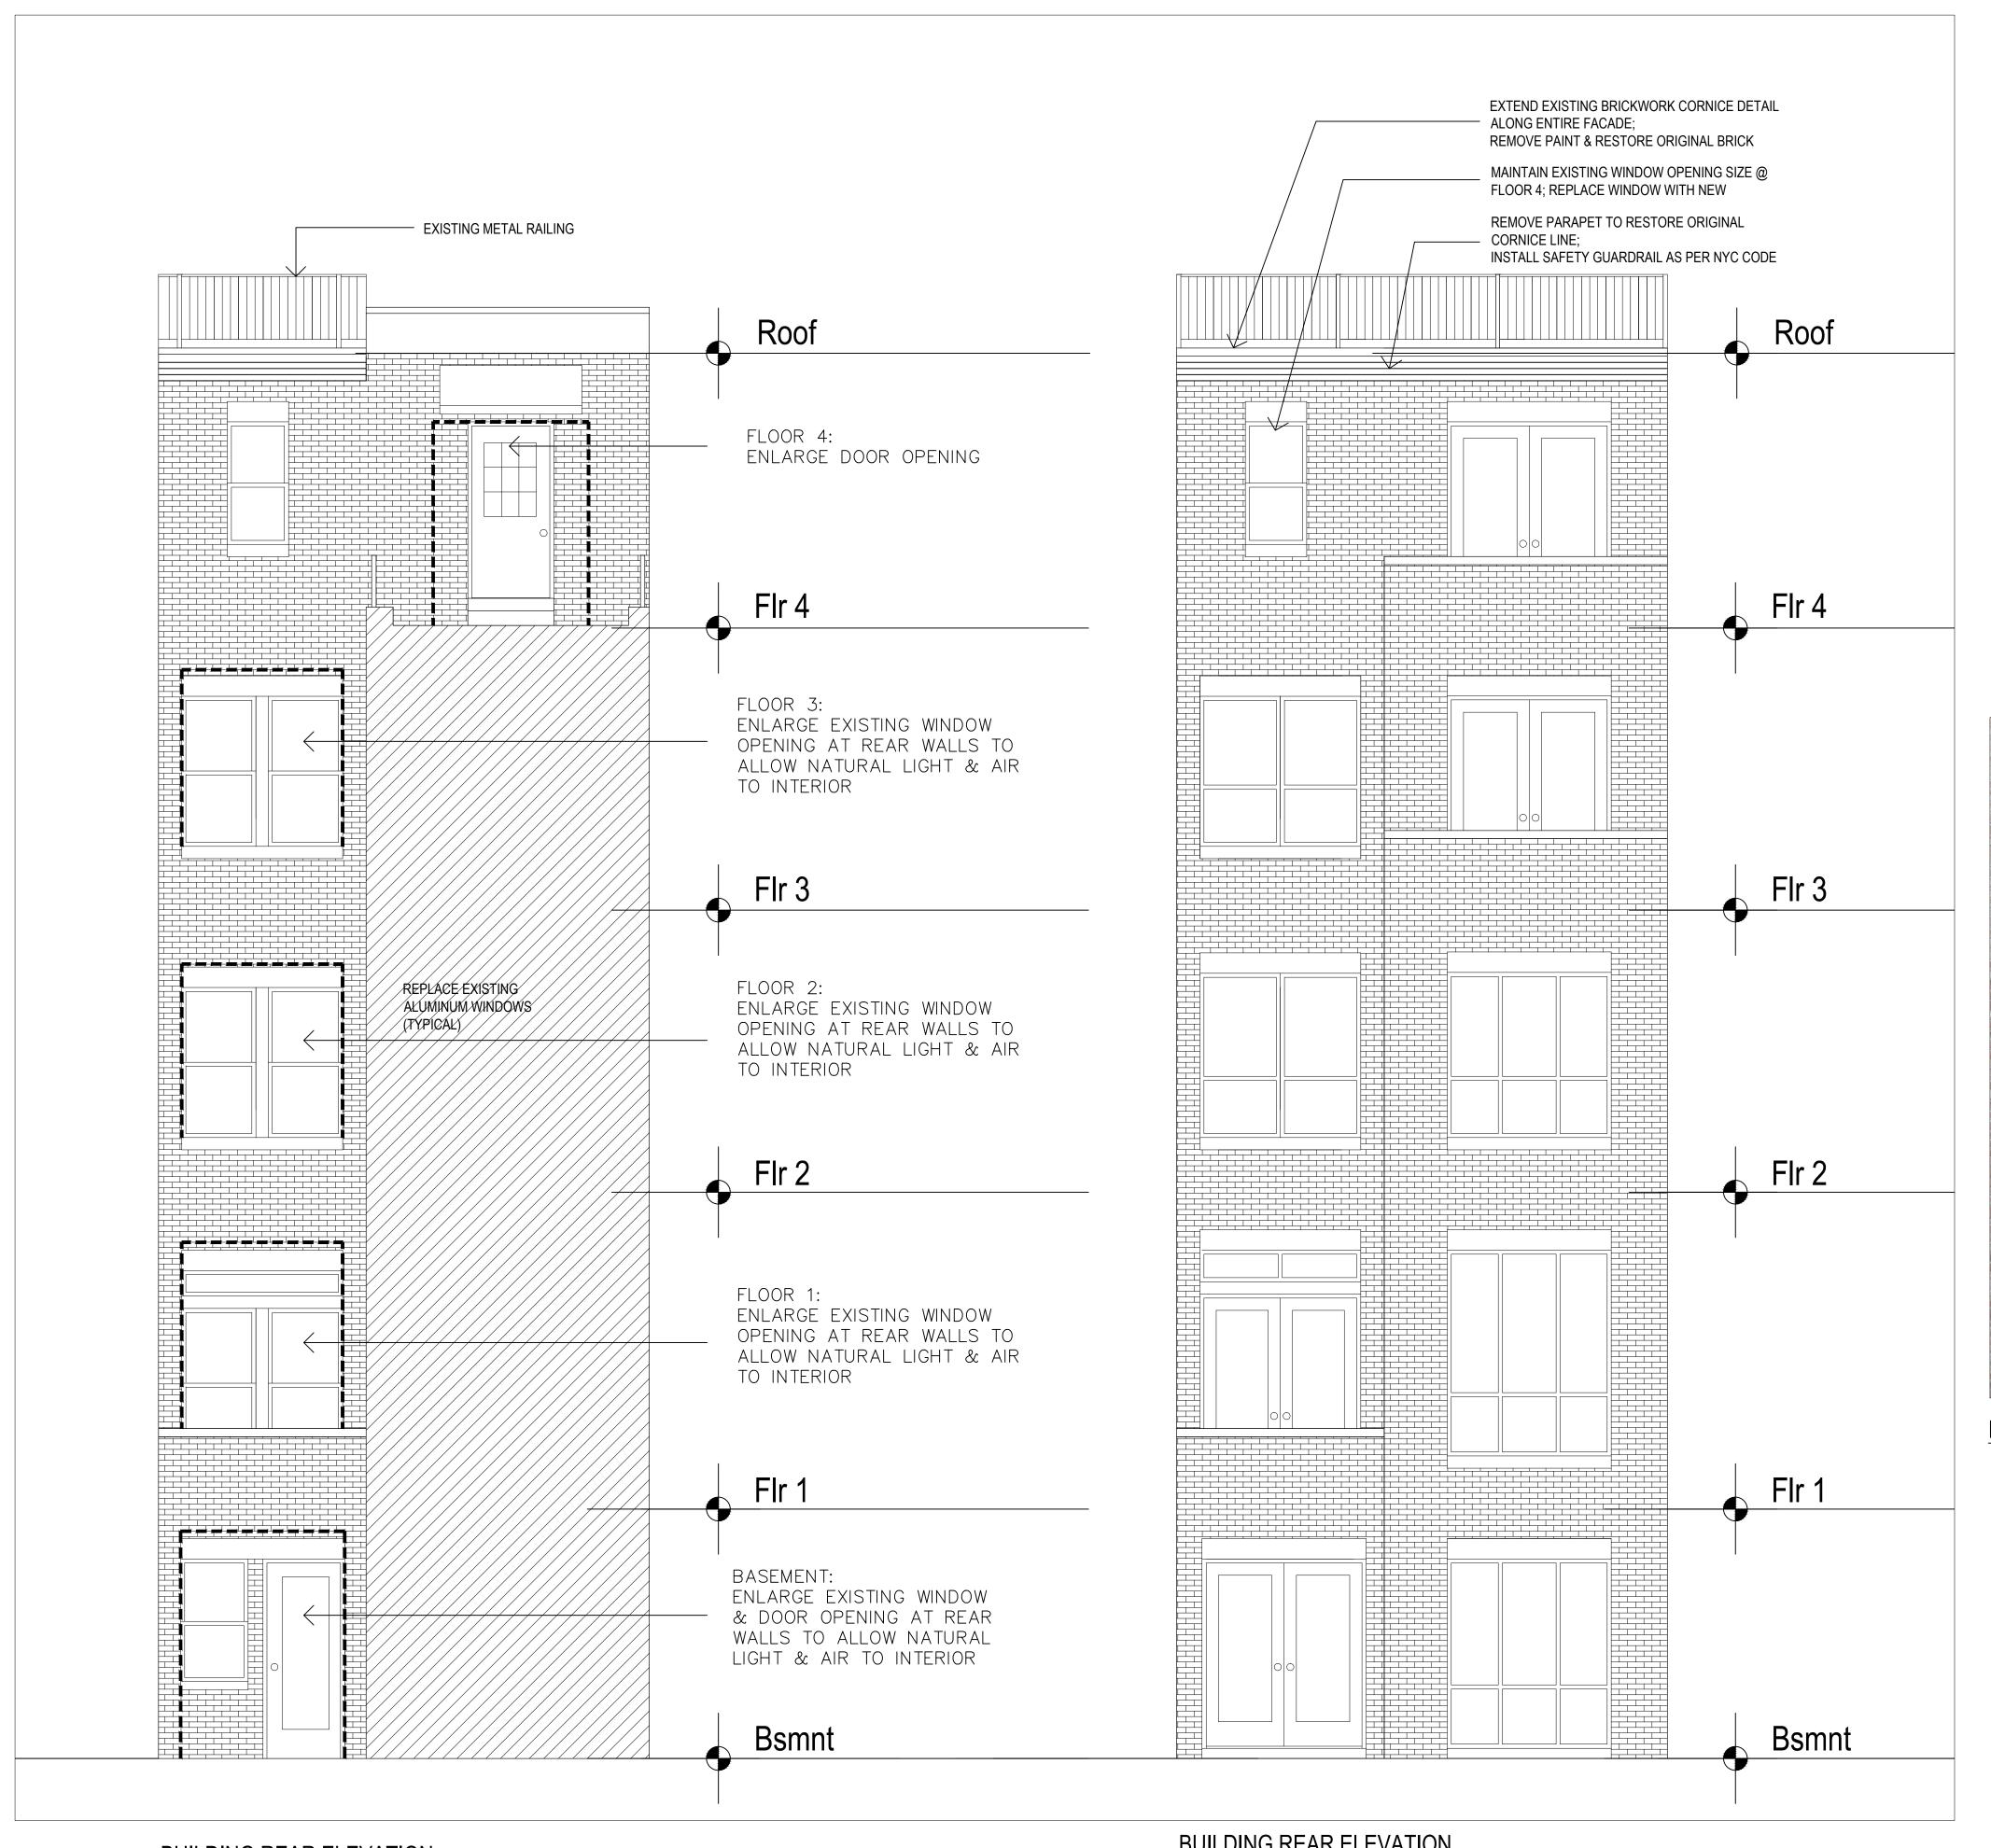
LPC-108.00

BUILDING REAR ELEVATION

(Existing & Proposed)

BUILDING REAR ELEVATION PROPOSED

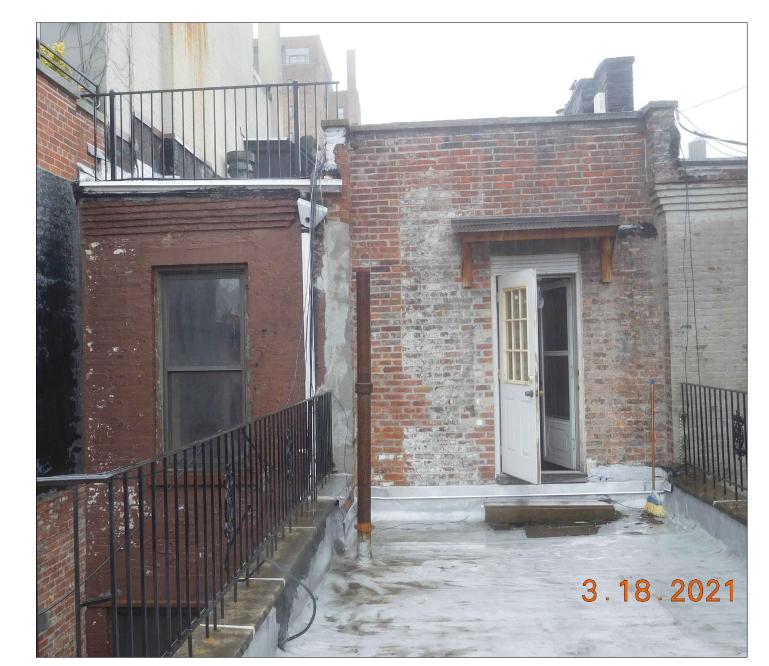
PHOTO OF EXISTING CONDITIONS AT TOP FLOOR REAR WALL

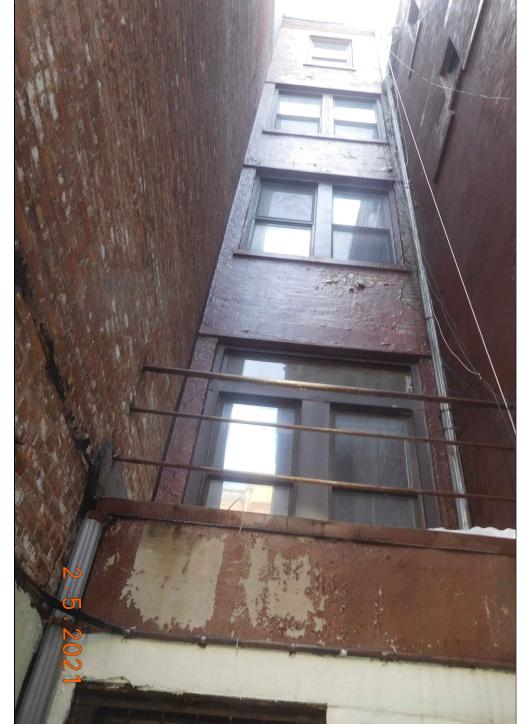
PHOTOS OF EXISTING WINDOWS AT REAR WALL
