6-16 West 77th Street
New York

LPC - Design Update
January 25th 2022

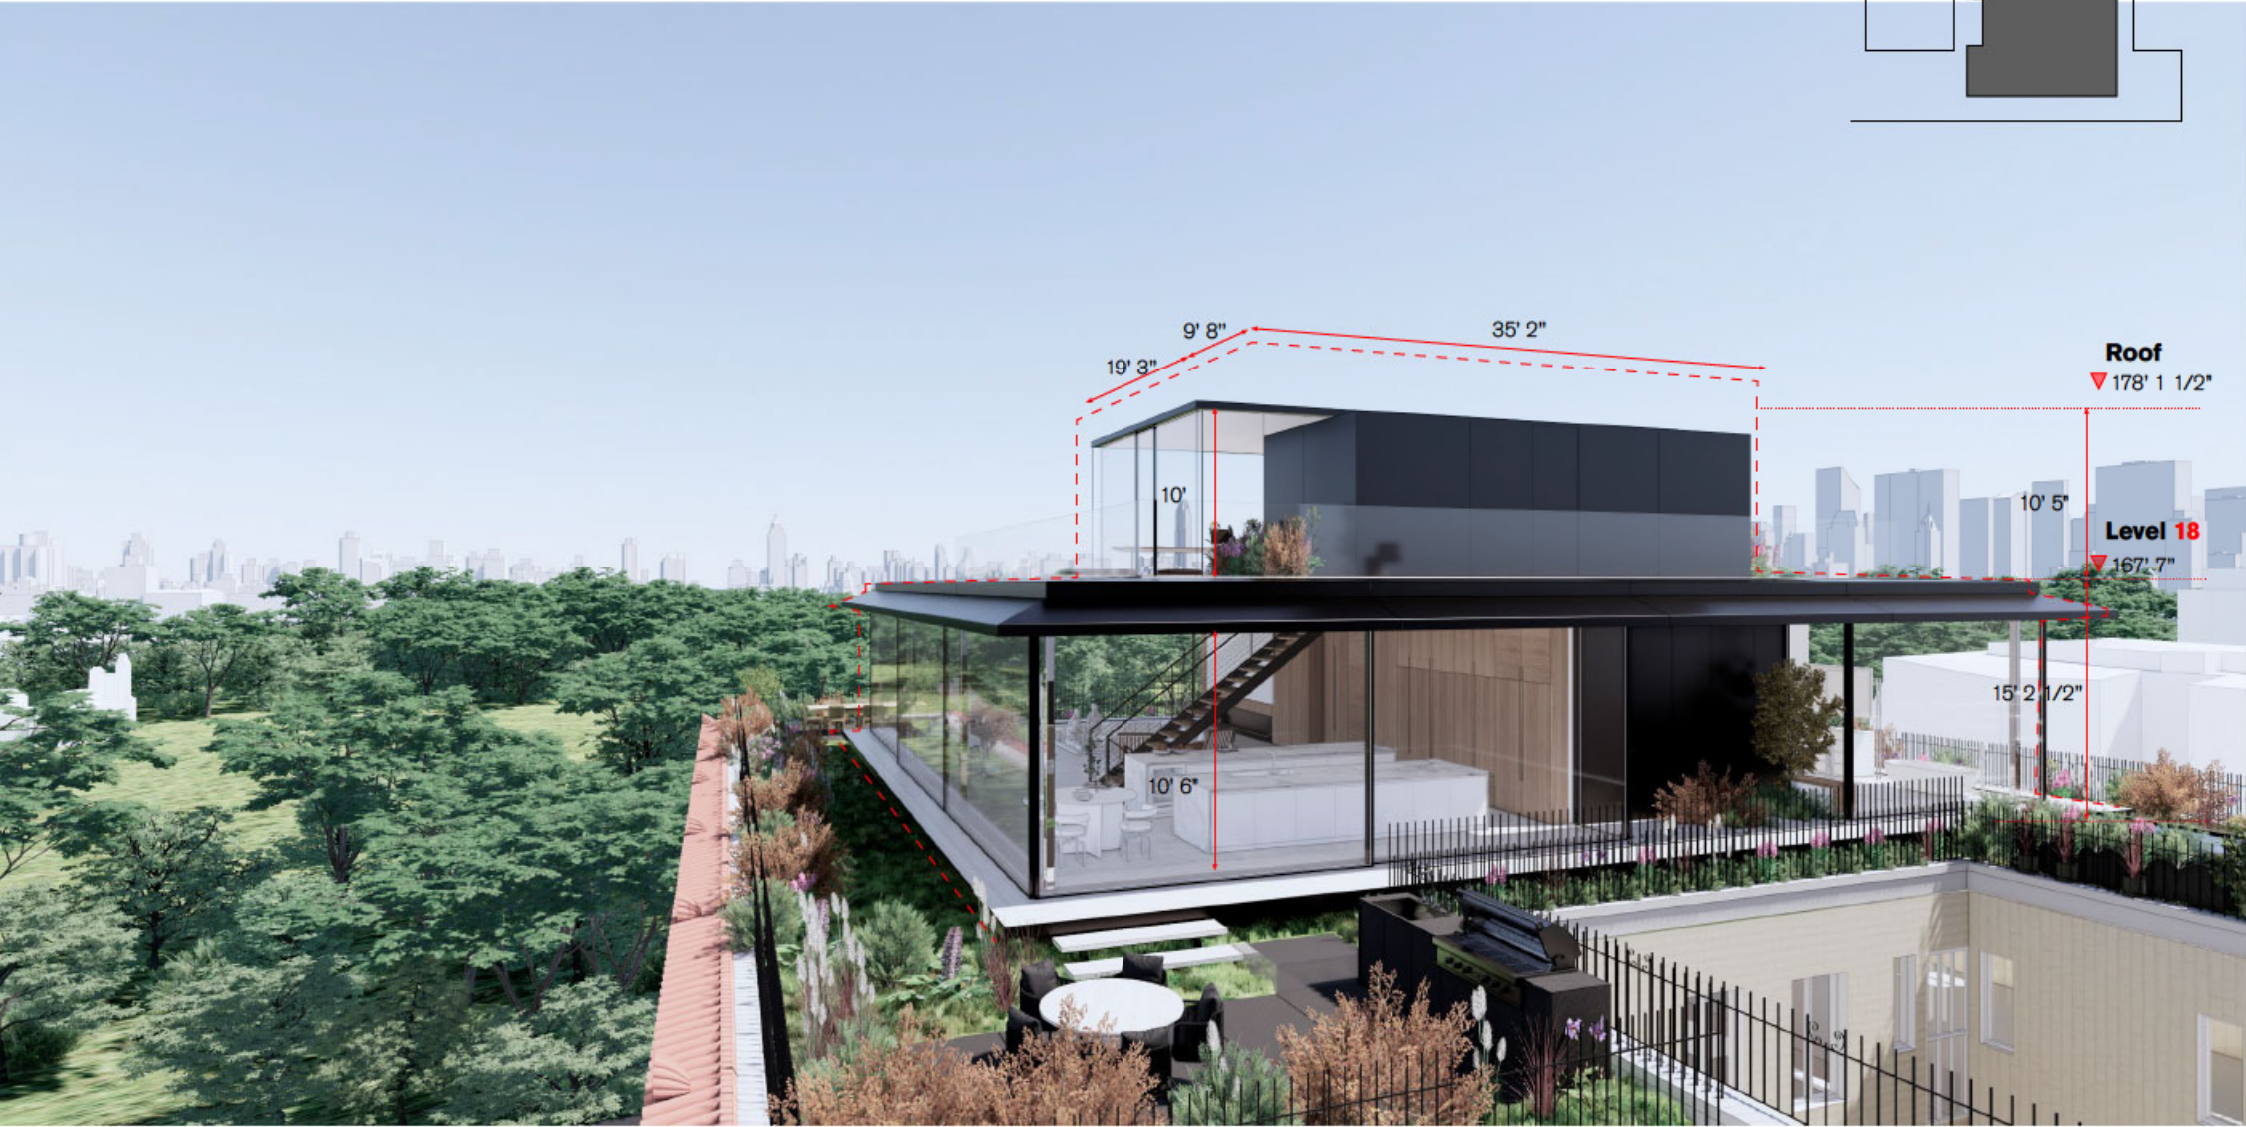
Revised Scheme

Roof

▽ 178' 1 1/2"

Level 18

▽ 167' 7"

--- Presented Massing Outline

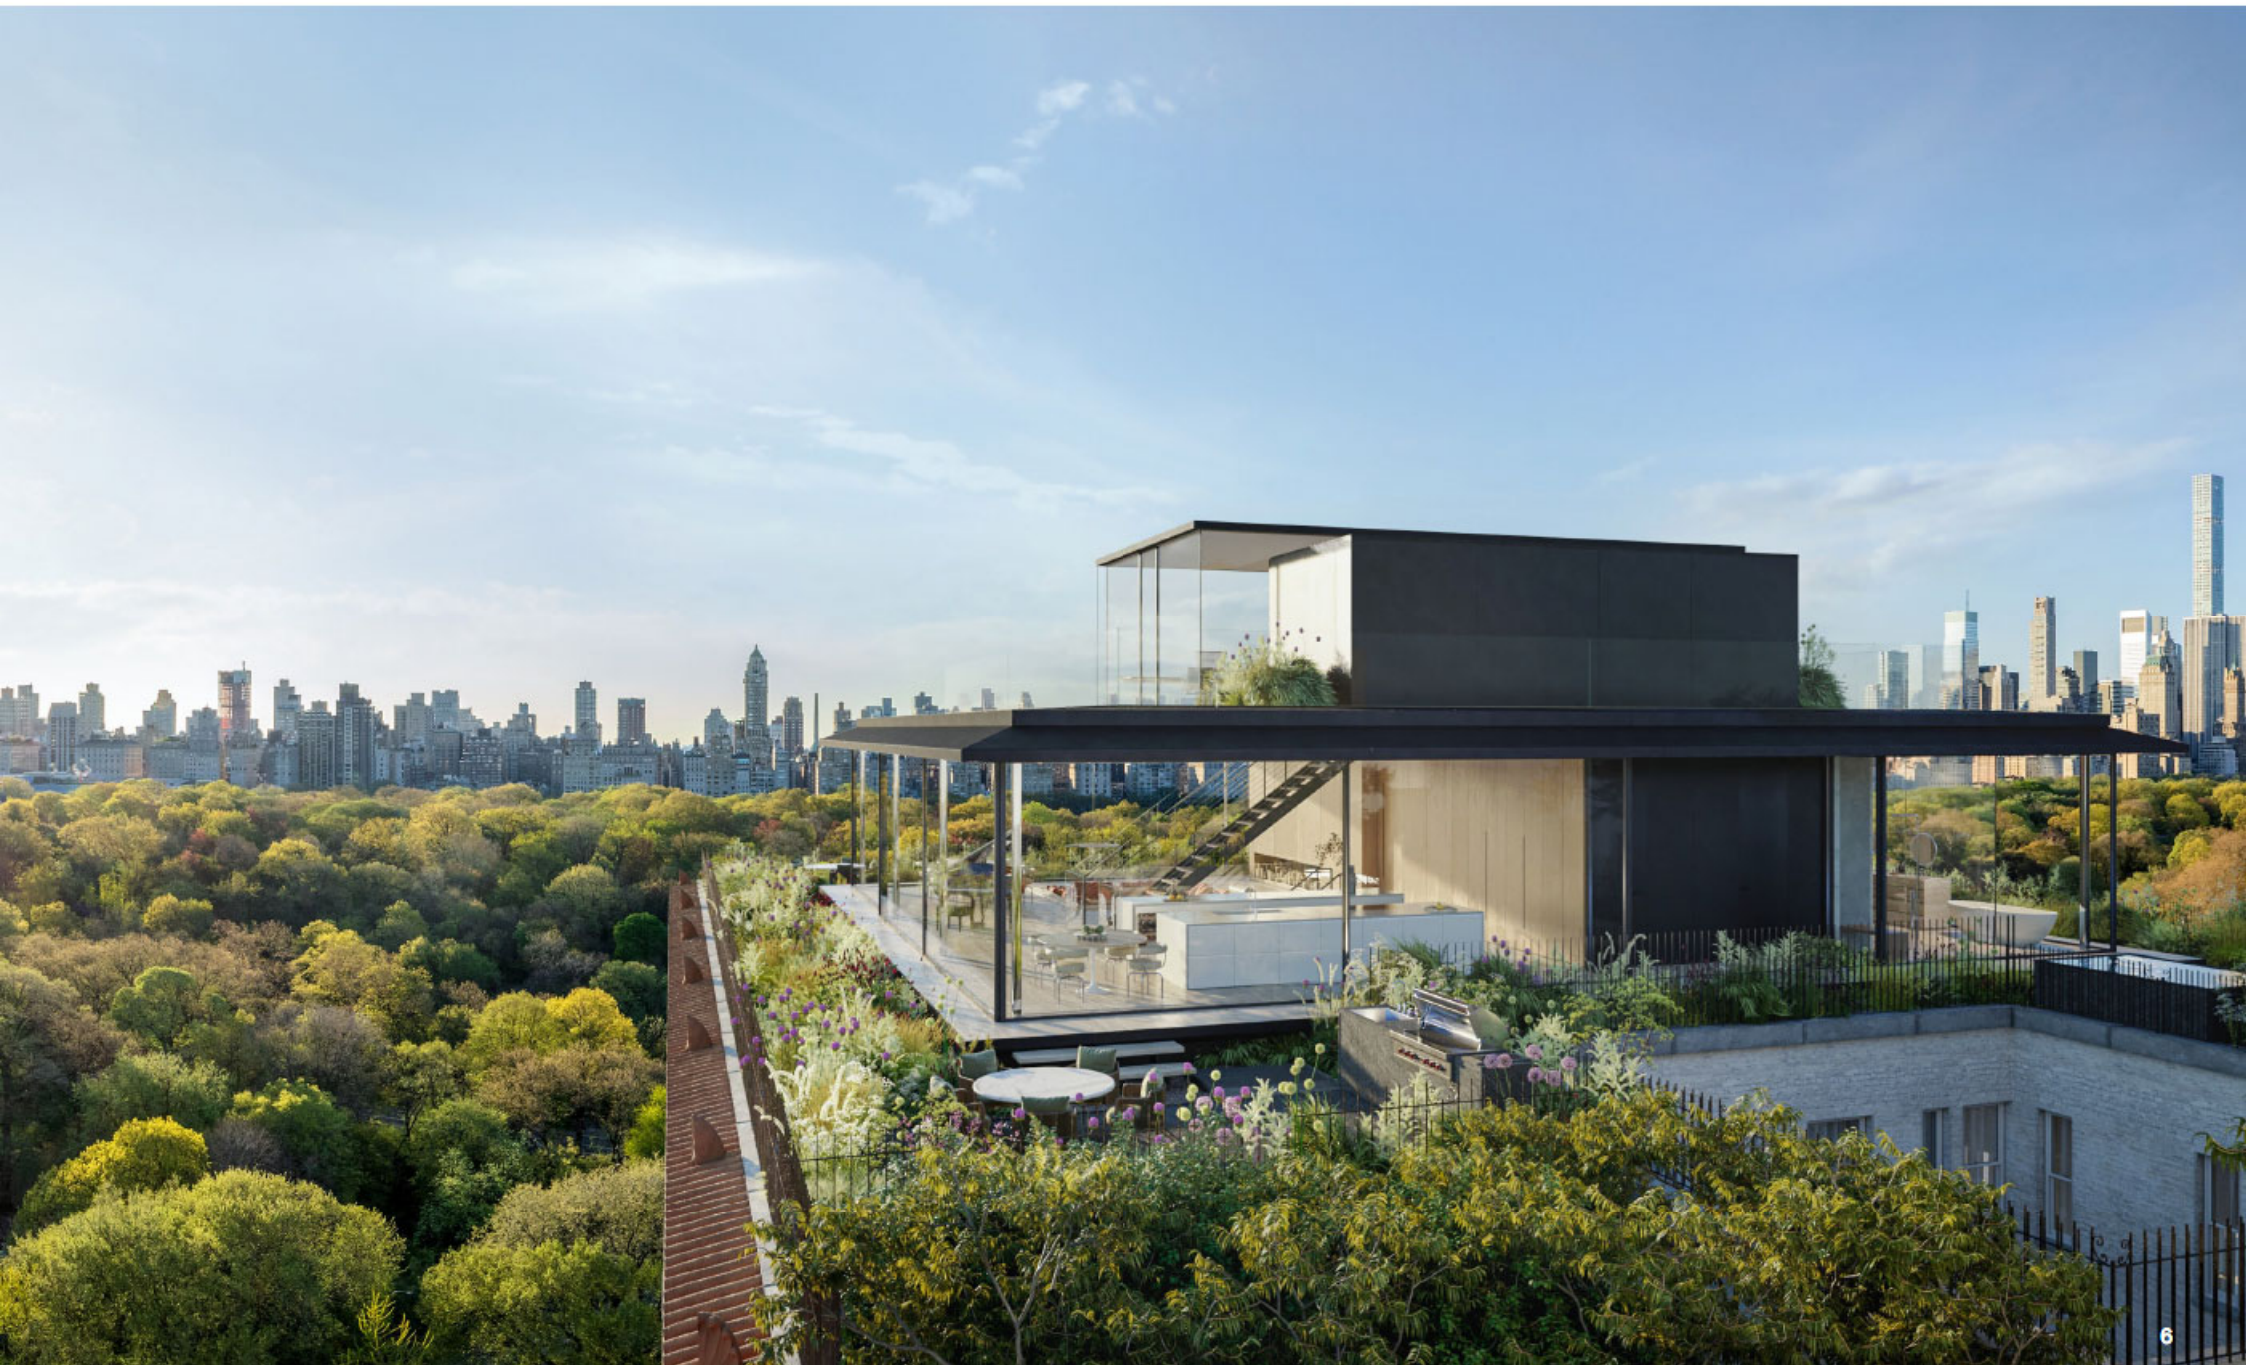
Revised Scheme

Current Elevation

210' Height Limit

202' 8 7/8" Approx.

177' 3 1/8"

167' 7"

152' 4 1/2"

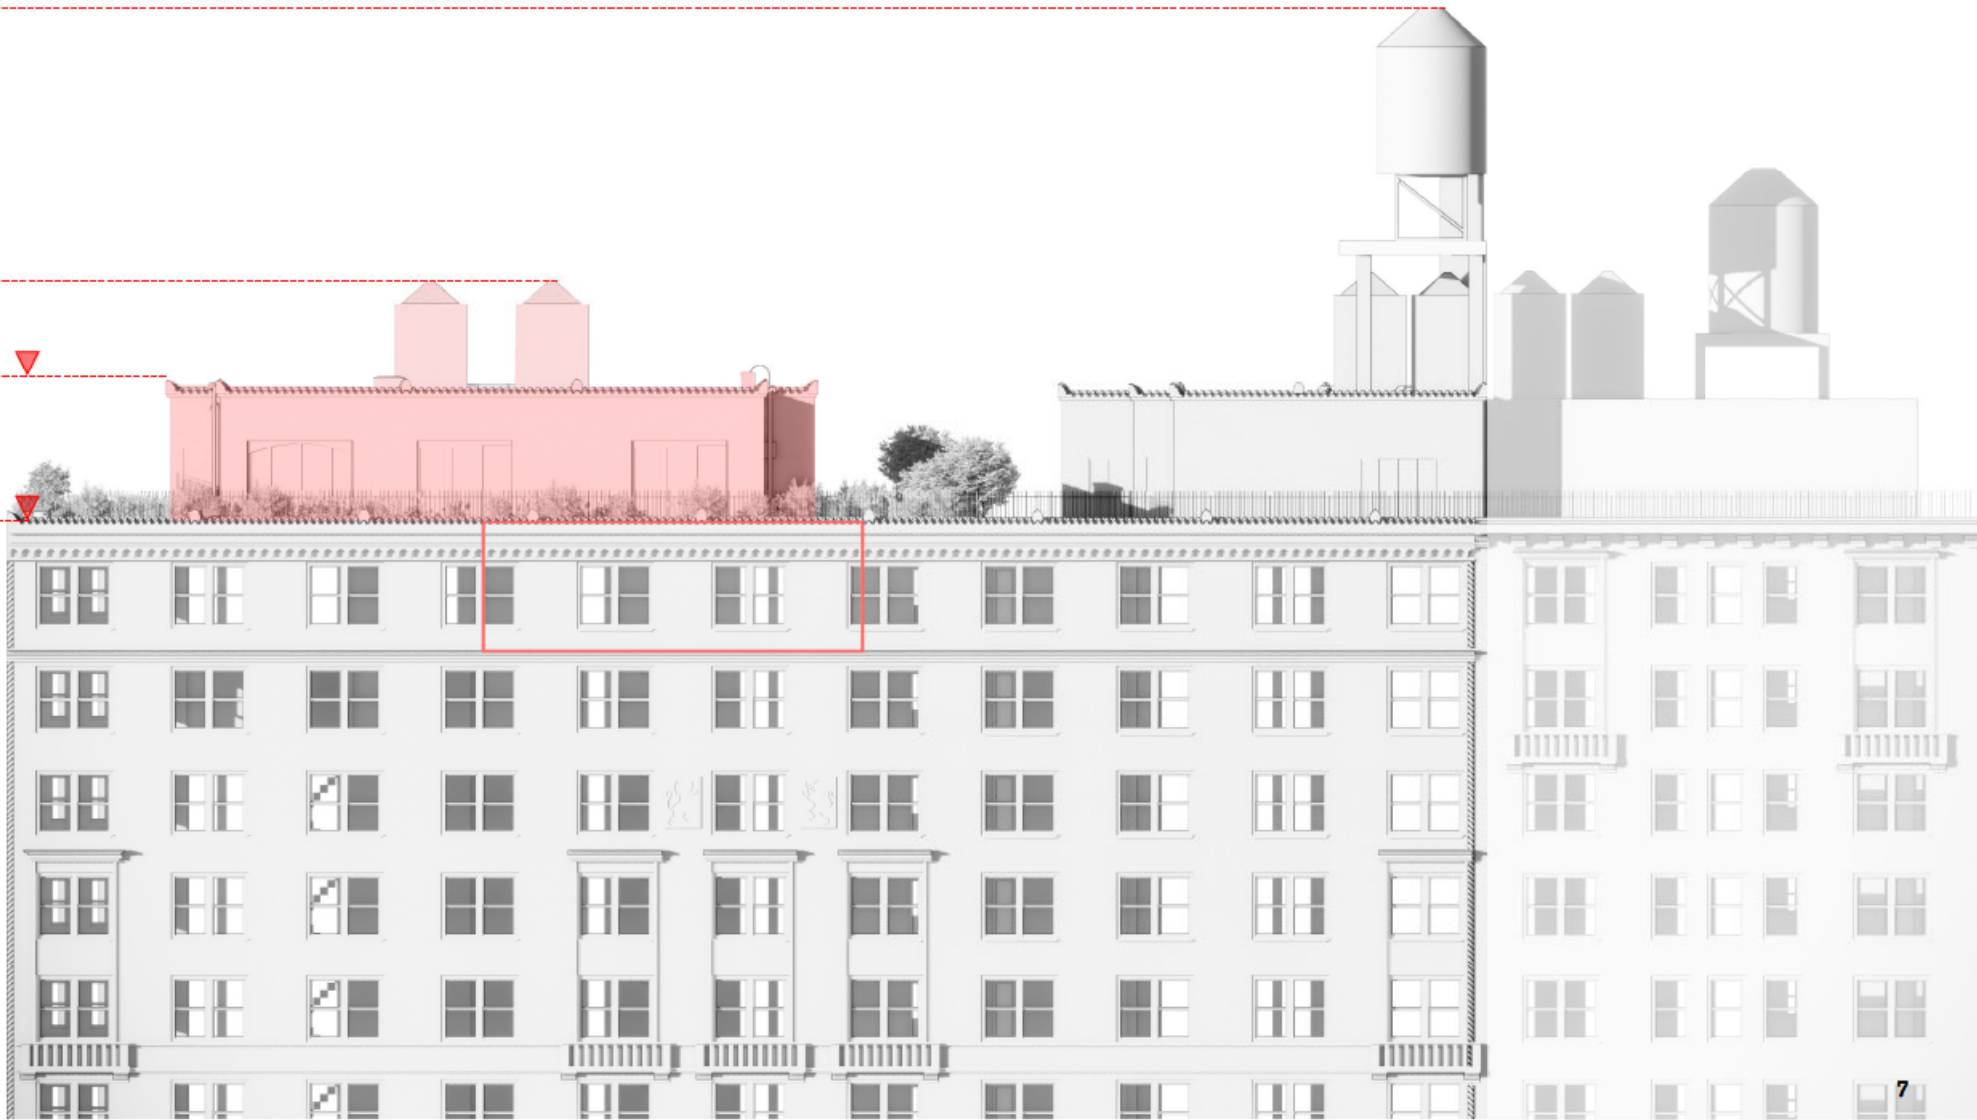
Massing As Presented - Nov 16th 2021

210' Height Limit

202' 8 7/8" Approx.

179' 8 1/2"

167' 7"

152' 4 1/2"

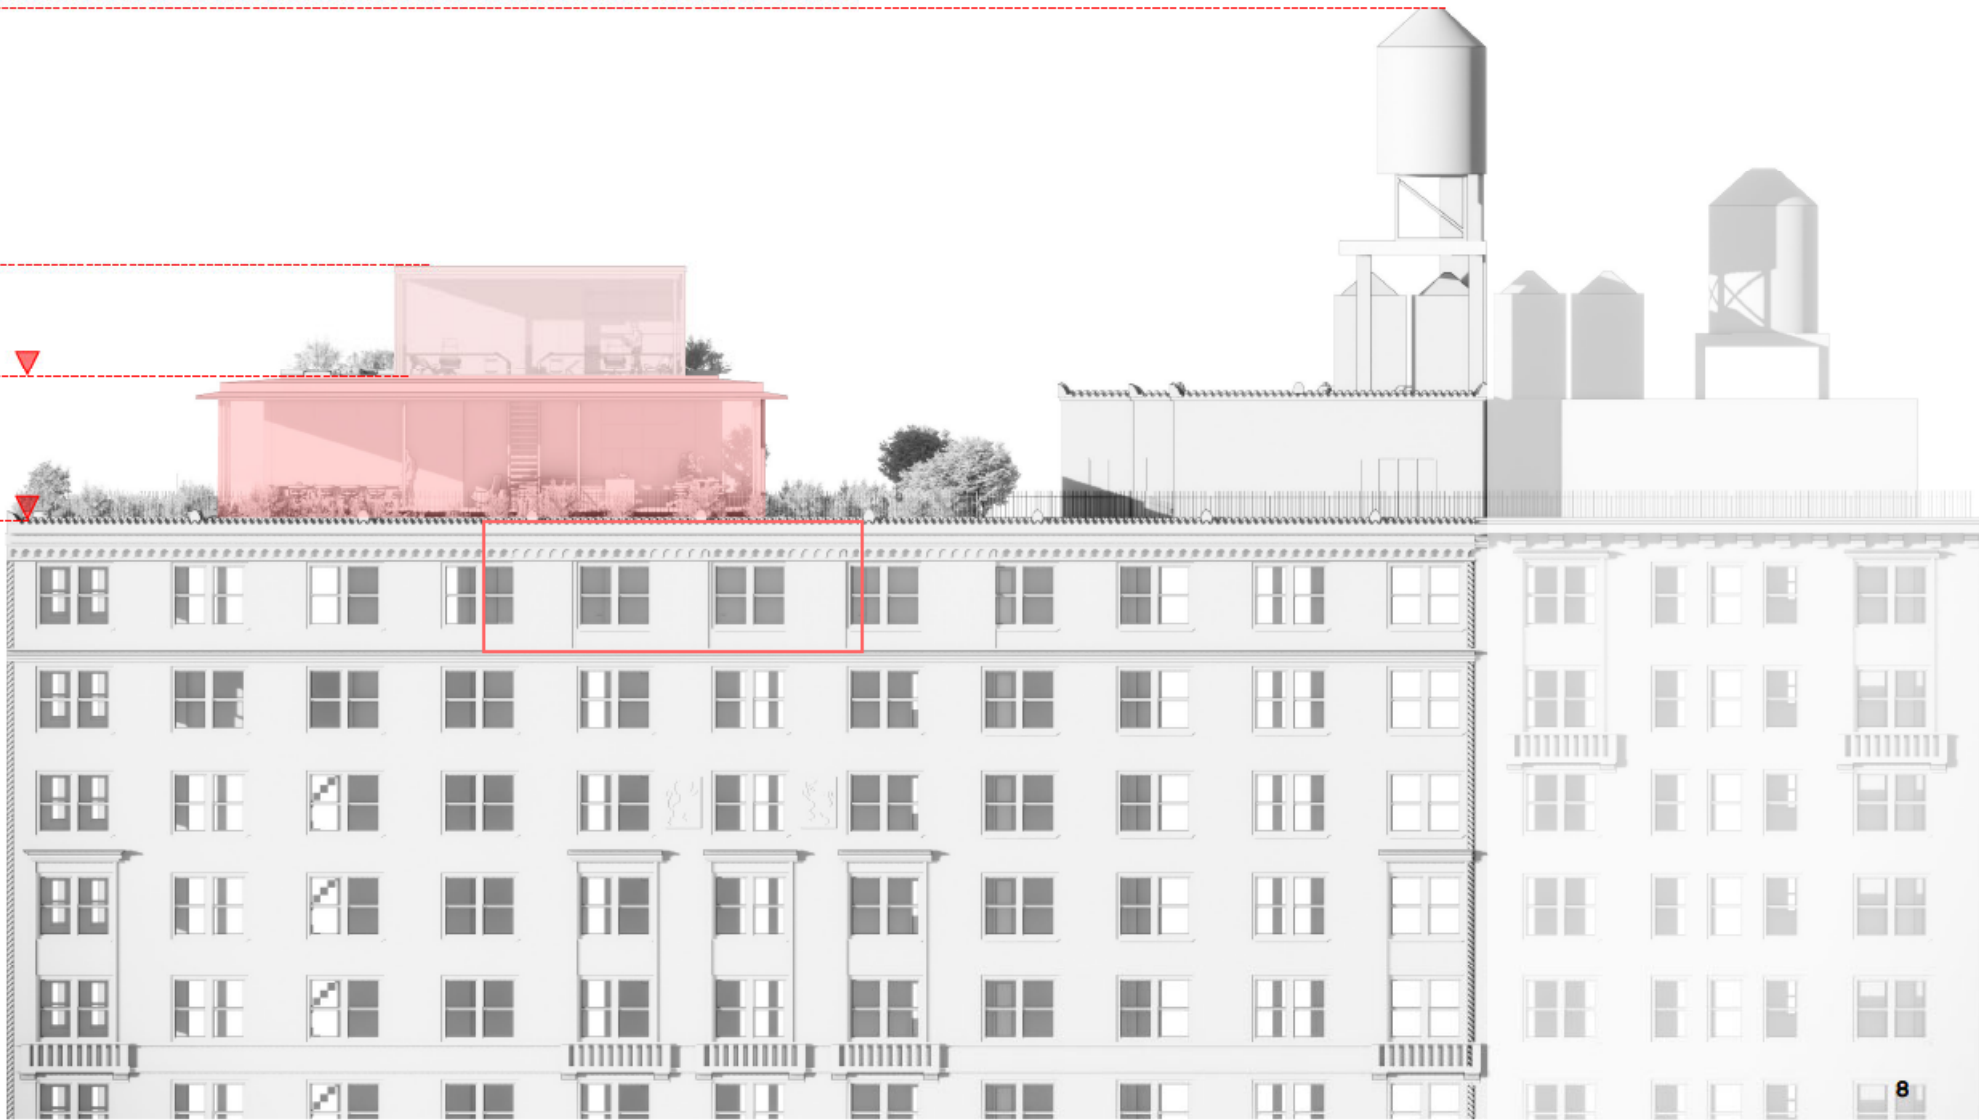
Revised Massing

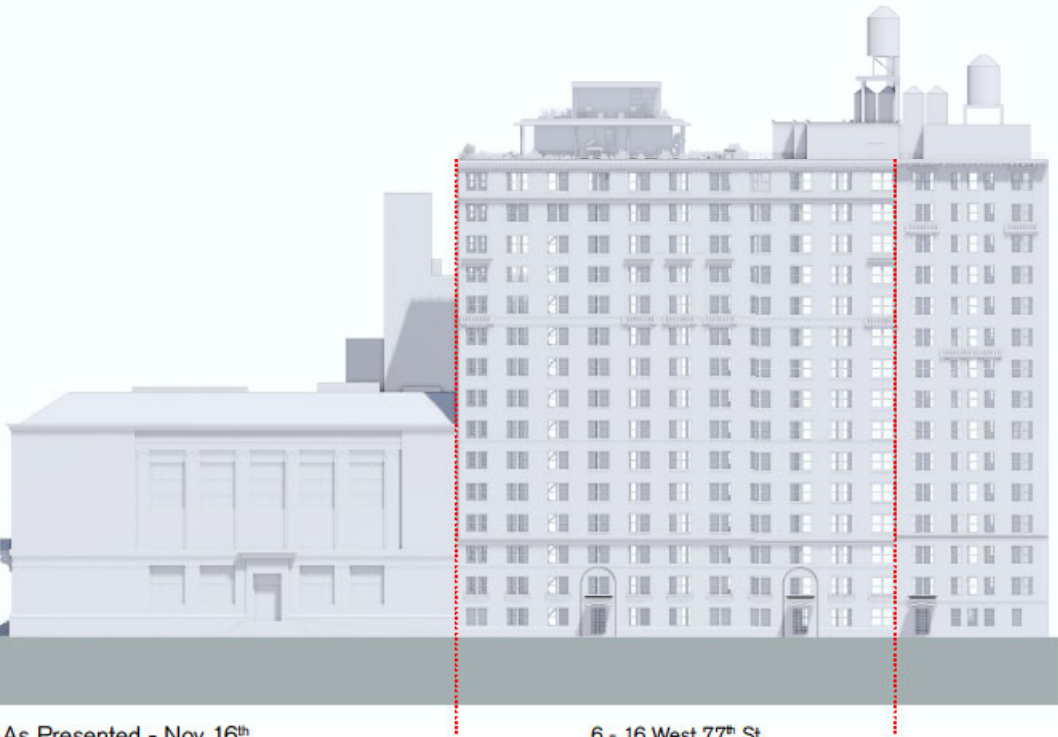
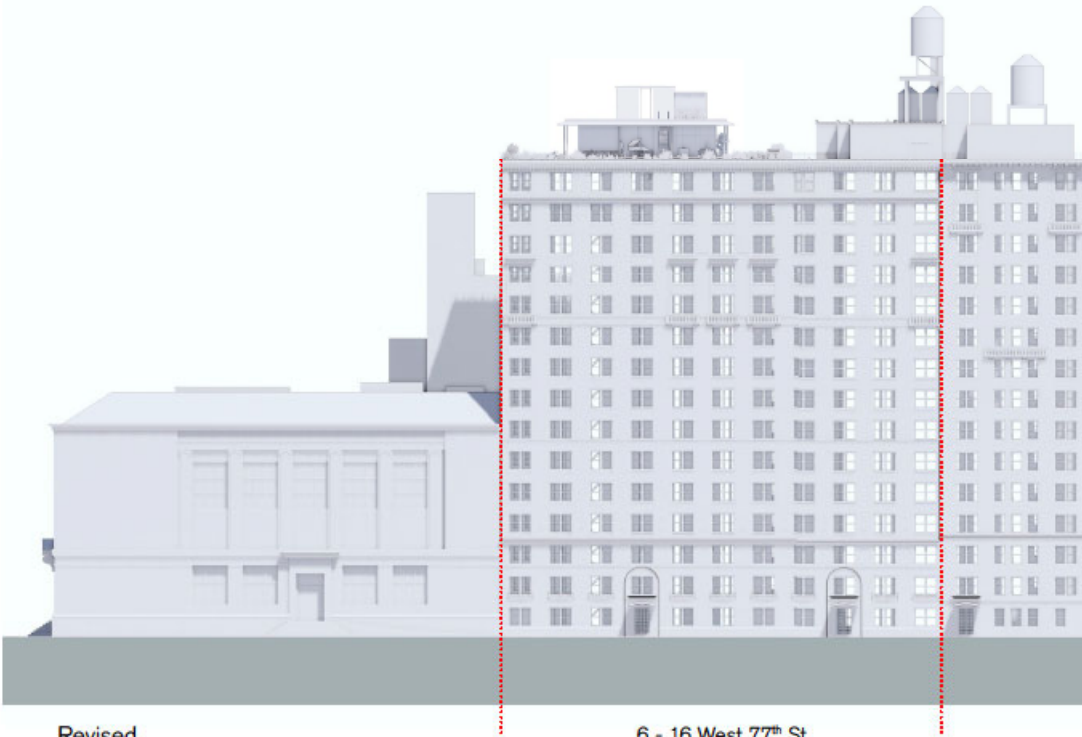
Main Facade Comparison

210' Height Limit

As Presented - Nov 16th

Revised

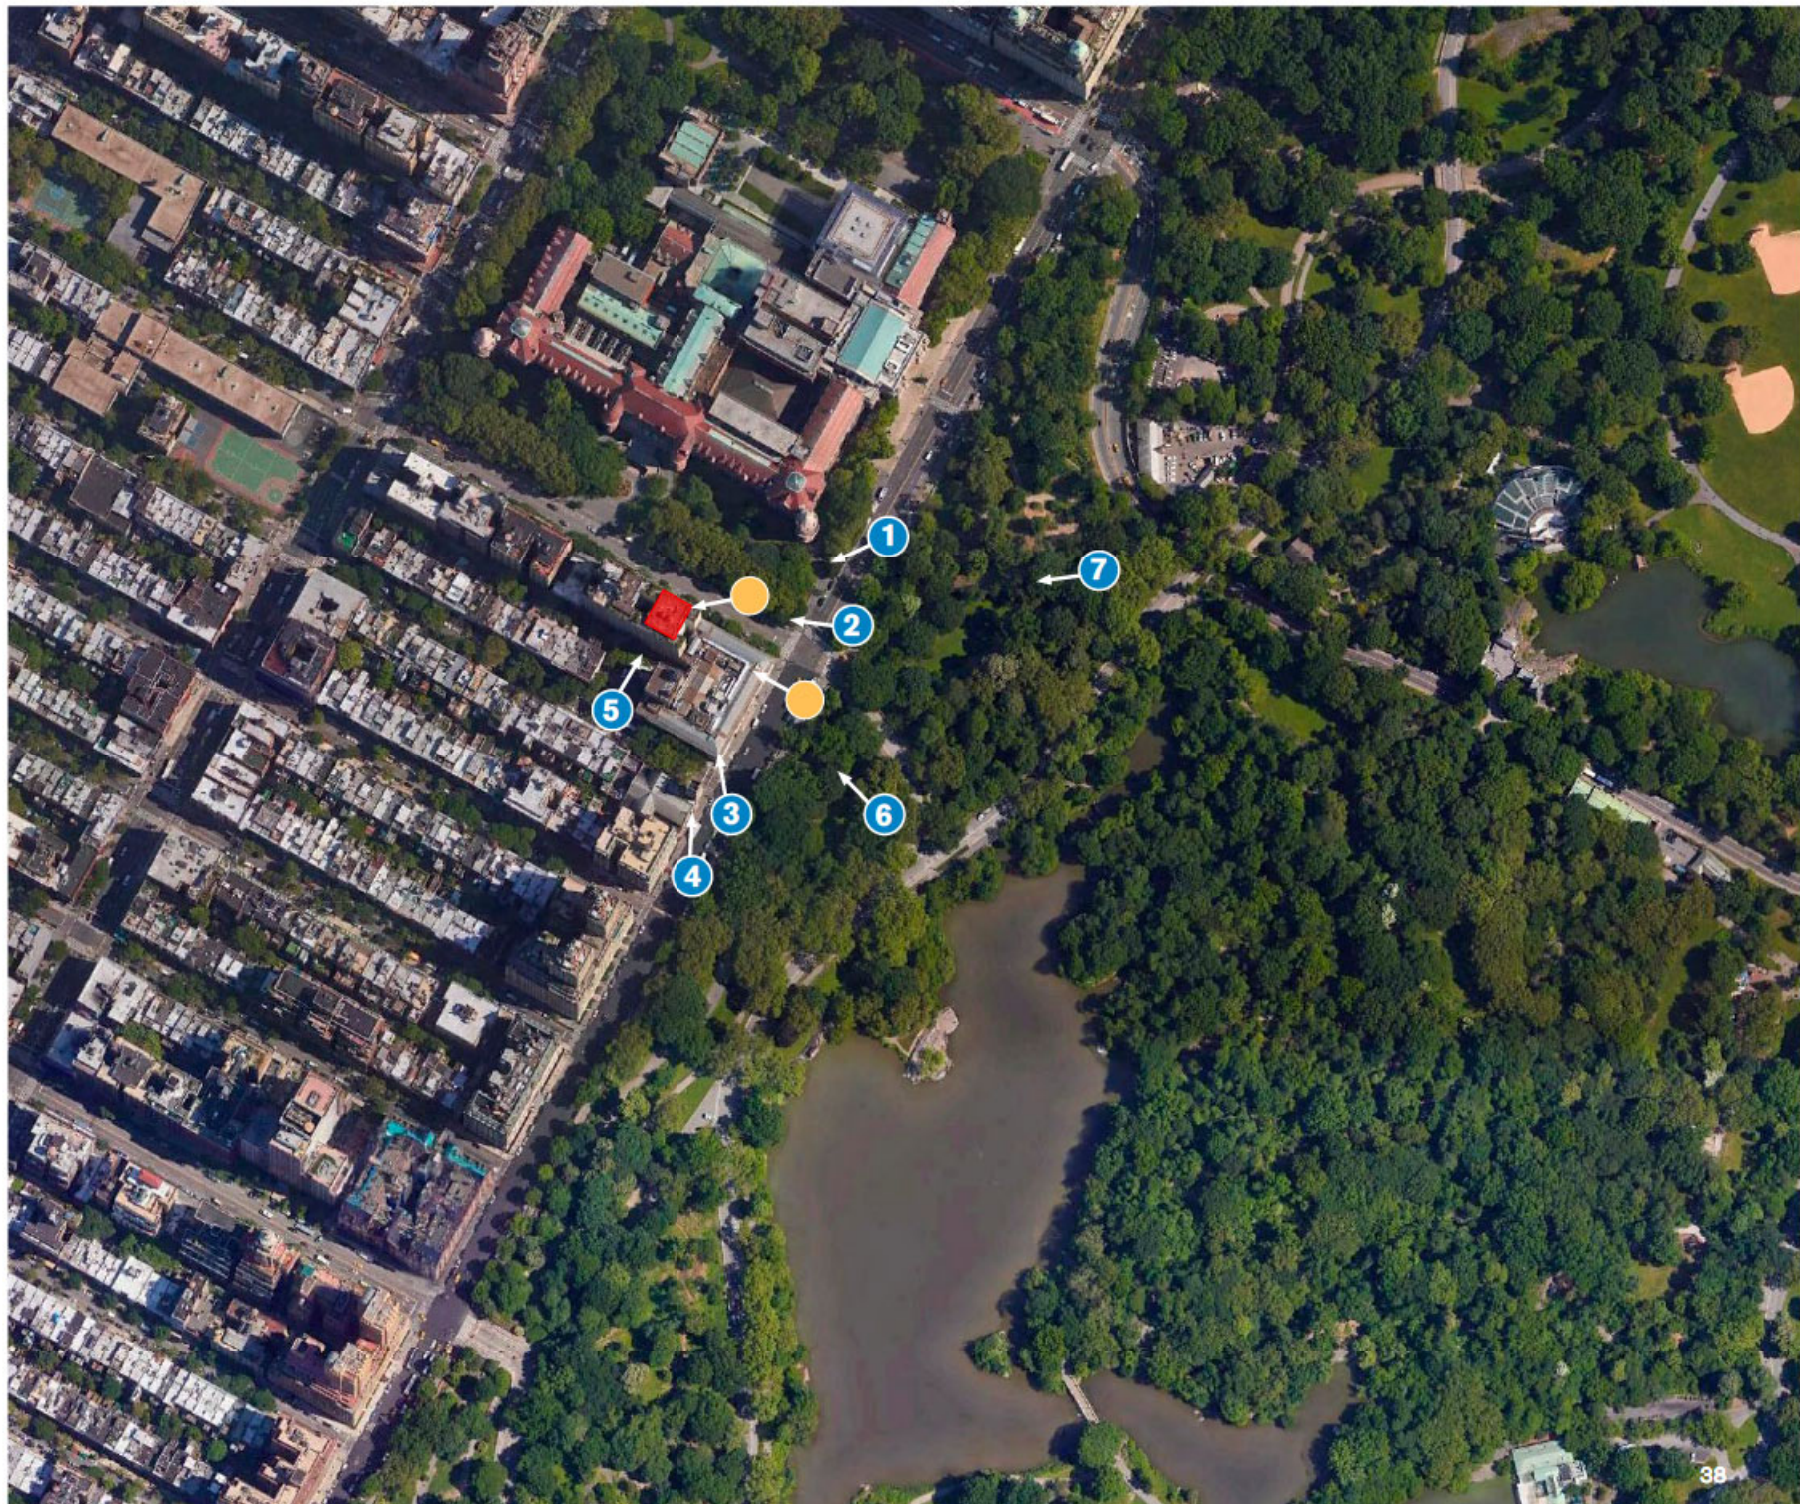
Visibility Studies

● No visibility

● Limited visibility
