6-16 West 77th Street New York

Landmarks Preservation Comission Updated Presentation May 3rd 2022 Comments Received - Nov 16th 2021 and Jan 25th

LPC Design Recomendations

- Reduce visibility of the level 18 enclosure
- Restudy the colour of the cladding

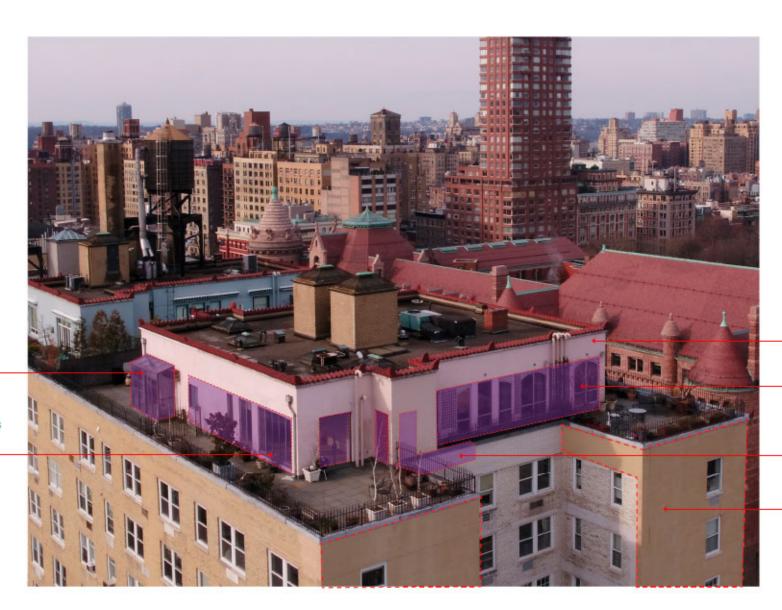
Historical changes to Rooftop Apartment

Glass and metal framed extension to facade

Multiple windows and openings enlarged and relocated Original Brick Covered with Stucco and painted

Multiple windows and openings enlarged and relocated

Metal walkway and door removed

Painted brick

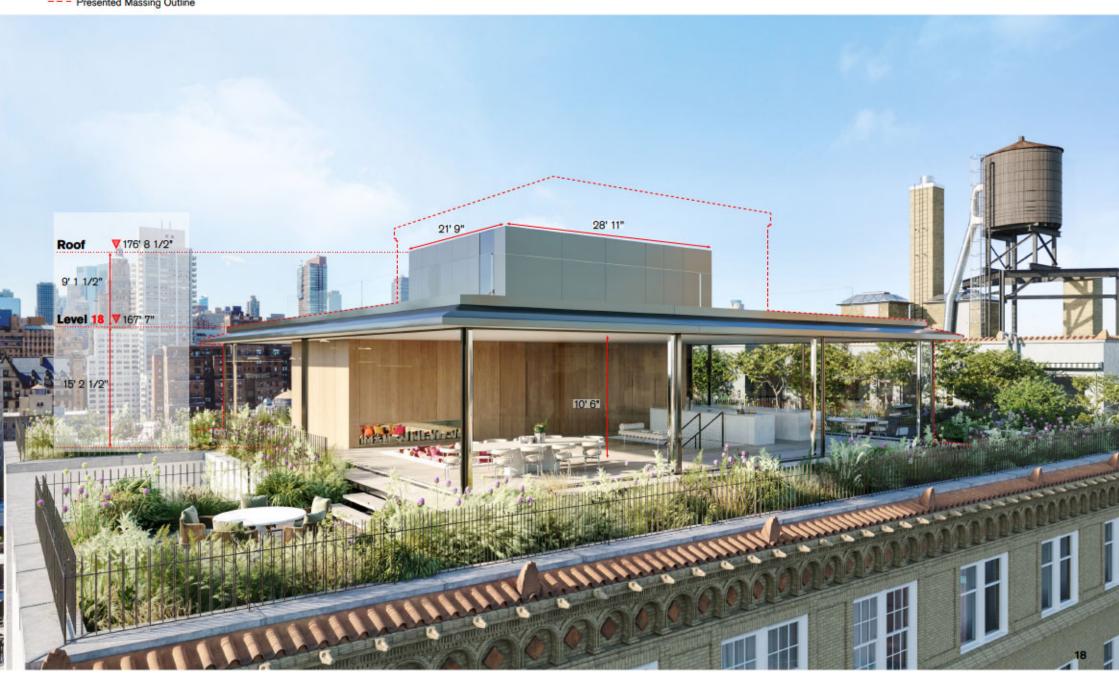
Current Revised Proposal

--- Presented Massing Outline

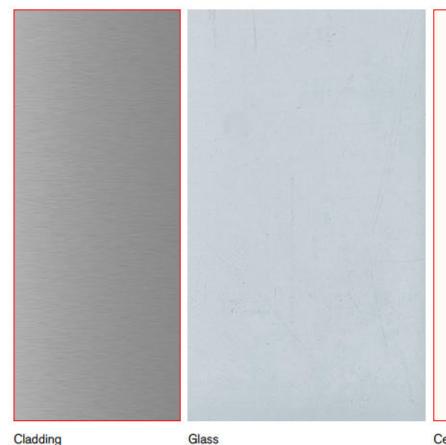
Materiality As Presented - Nov 16th 2021 & Jan 25th 2022

Cladding Glass - Blackened Stainless - Low Iron Steel - Low Reflectivity

Wood Travertine Floor

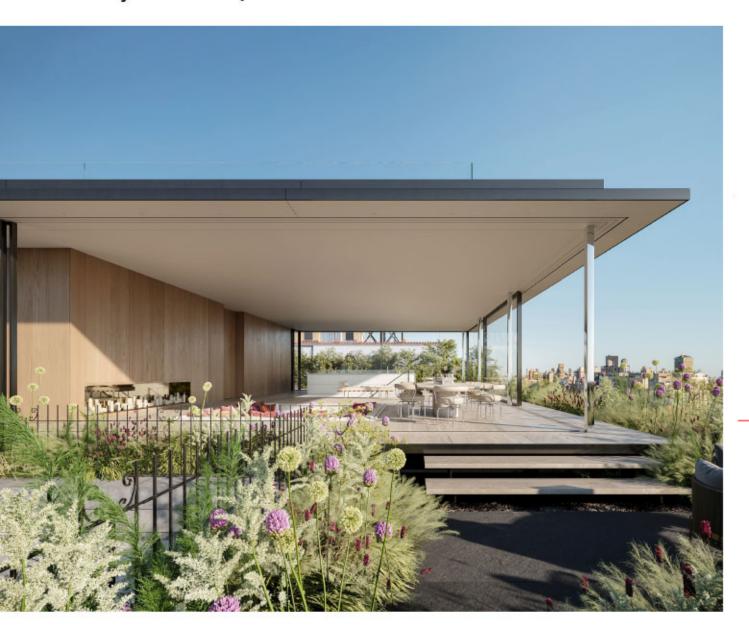
Luminosity Control - Daytime

Roof Ledge Detail Section

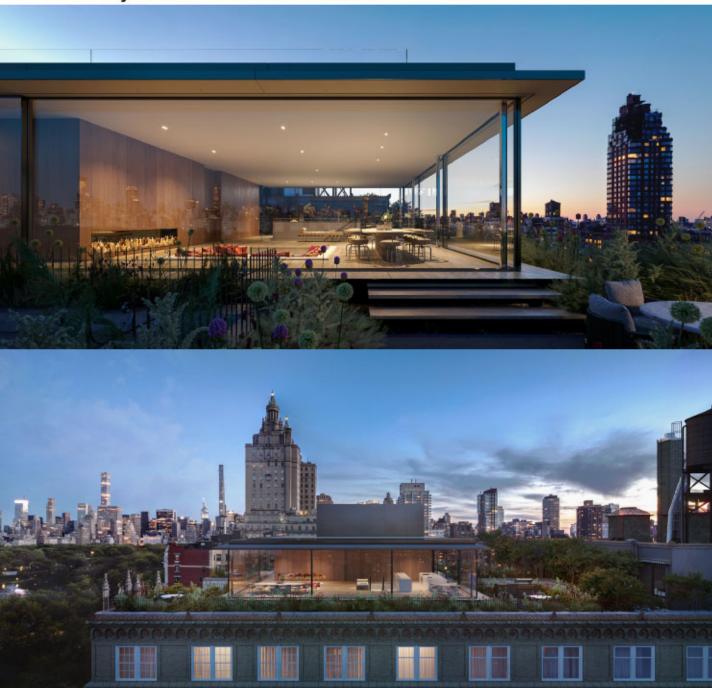
Luminosity Control - Dusk

Roof Ledge Detail Section

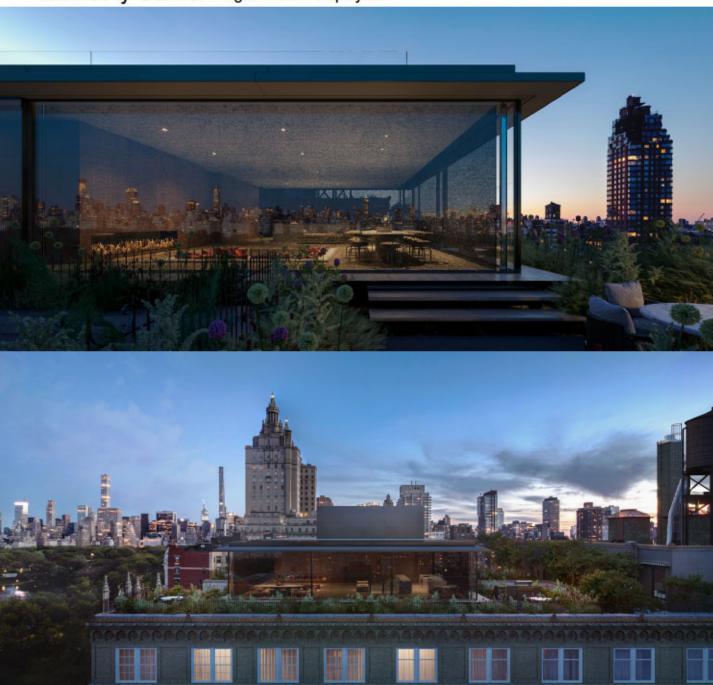
Luminosity Control - Light Difuser Deployed

Roof Ledge Detail Section

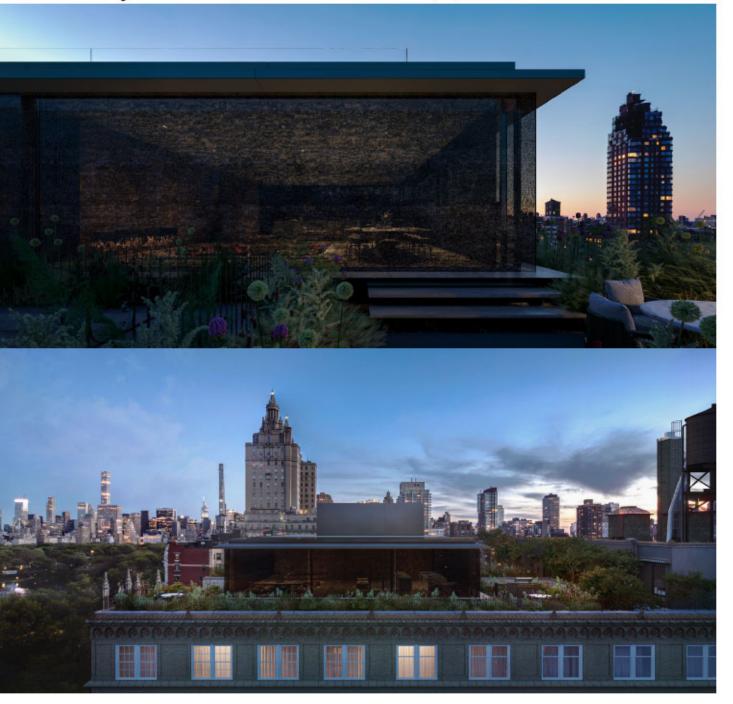
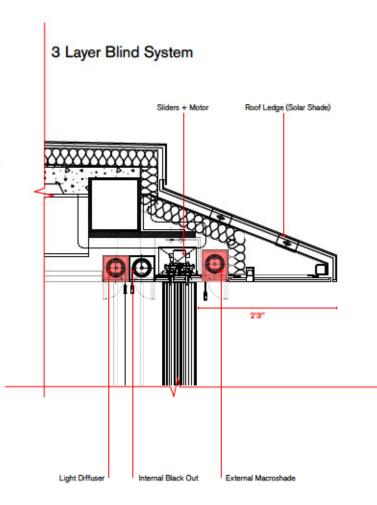
Luminosity Control - Light Difuser + Macroshade Deployed

Roof Ledge Detail Section
