WEST-PARK PRESBYTERIAN CHURCH

165 WEST 86TH STREET

LPC DOCKET # LPC-22-09135

Application for a Notice to Proceed to allow for Demolition on the Grounds of Hardship

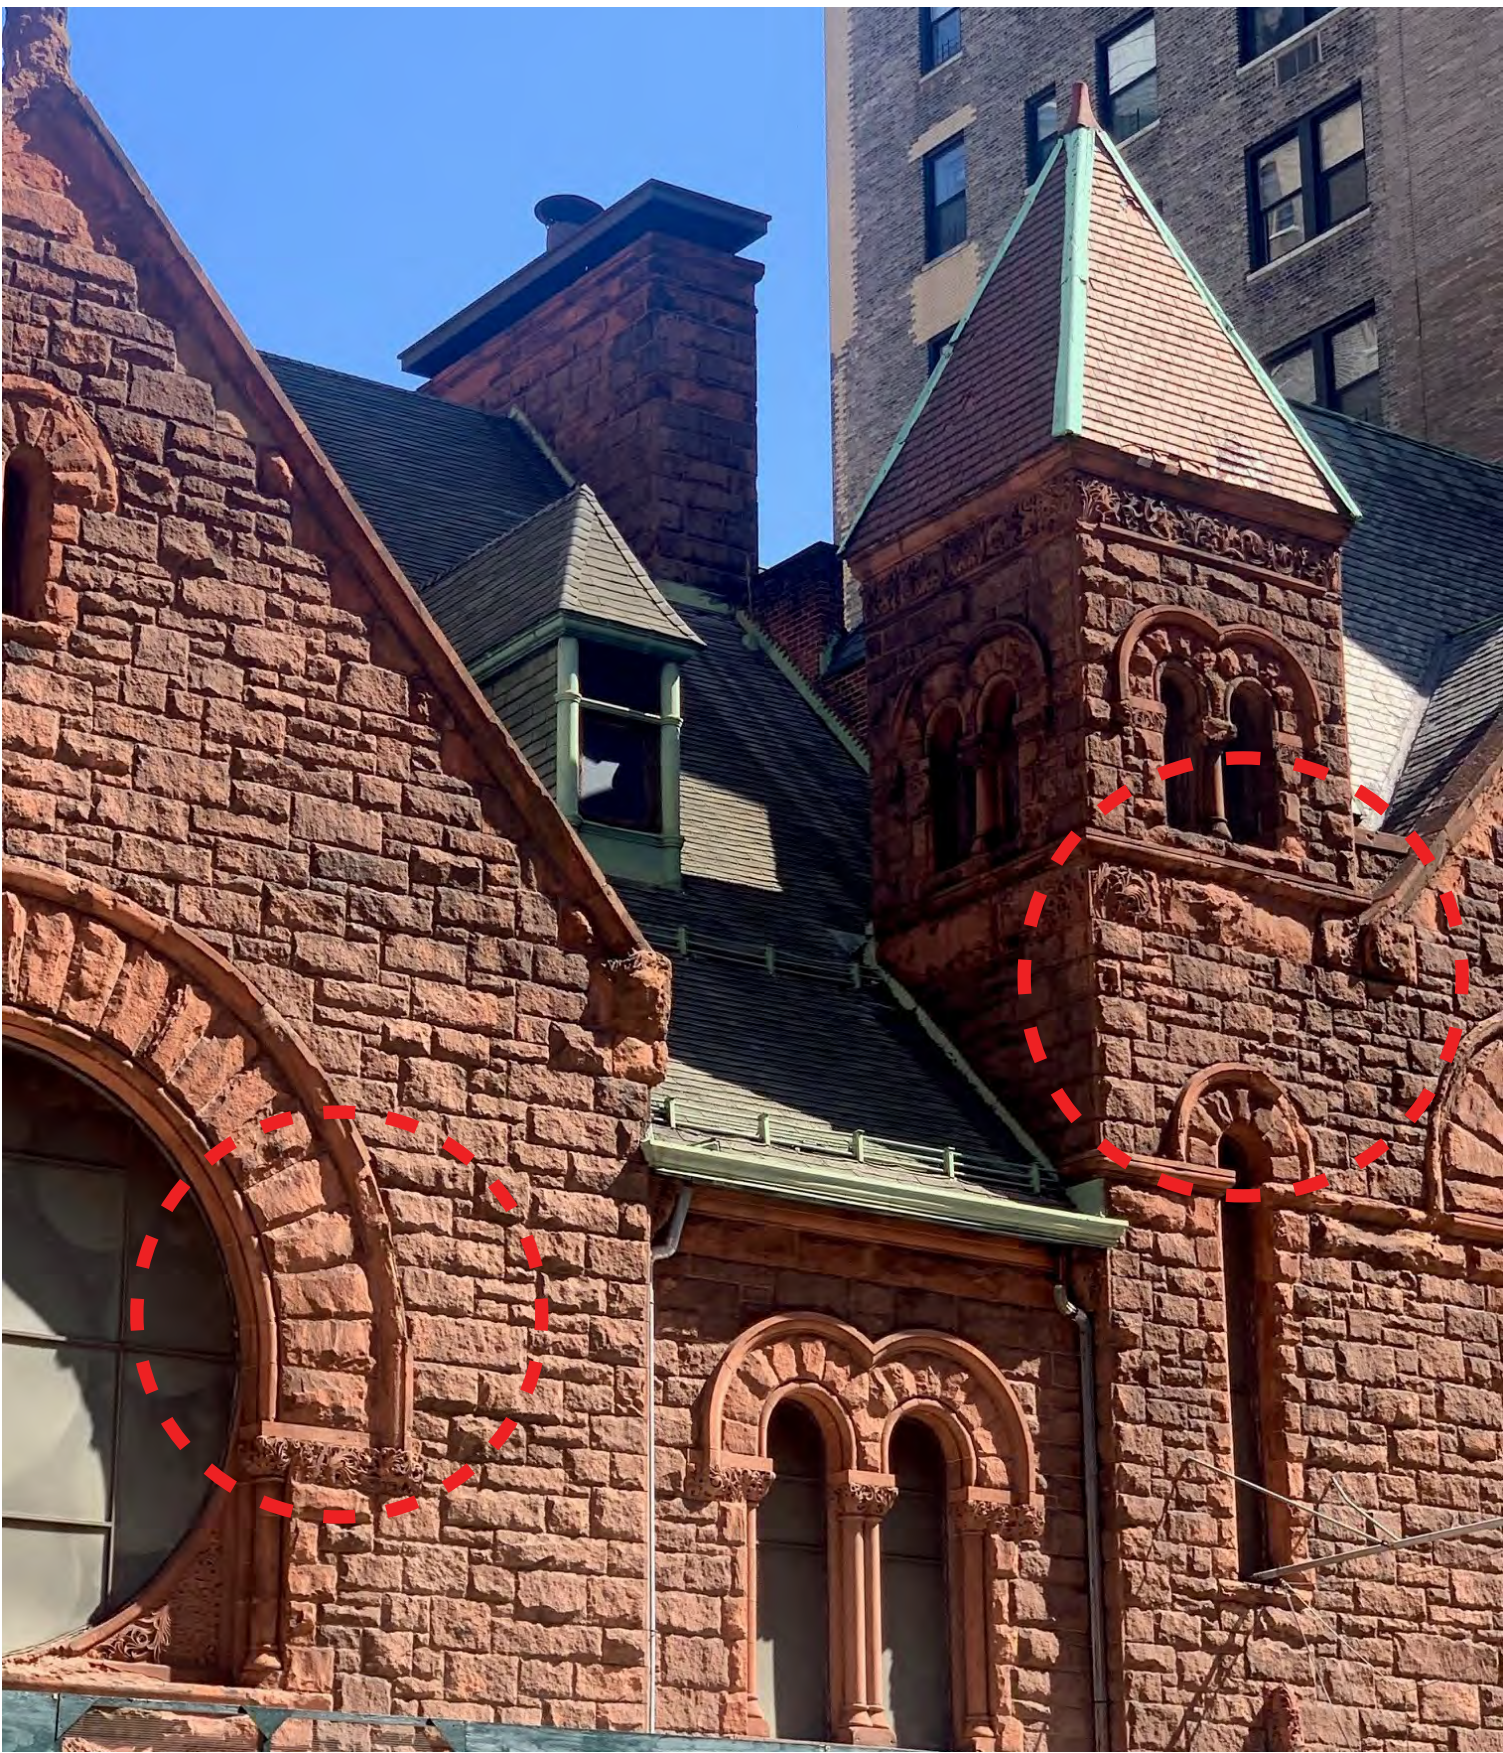
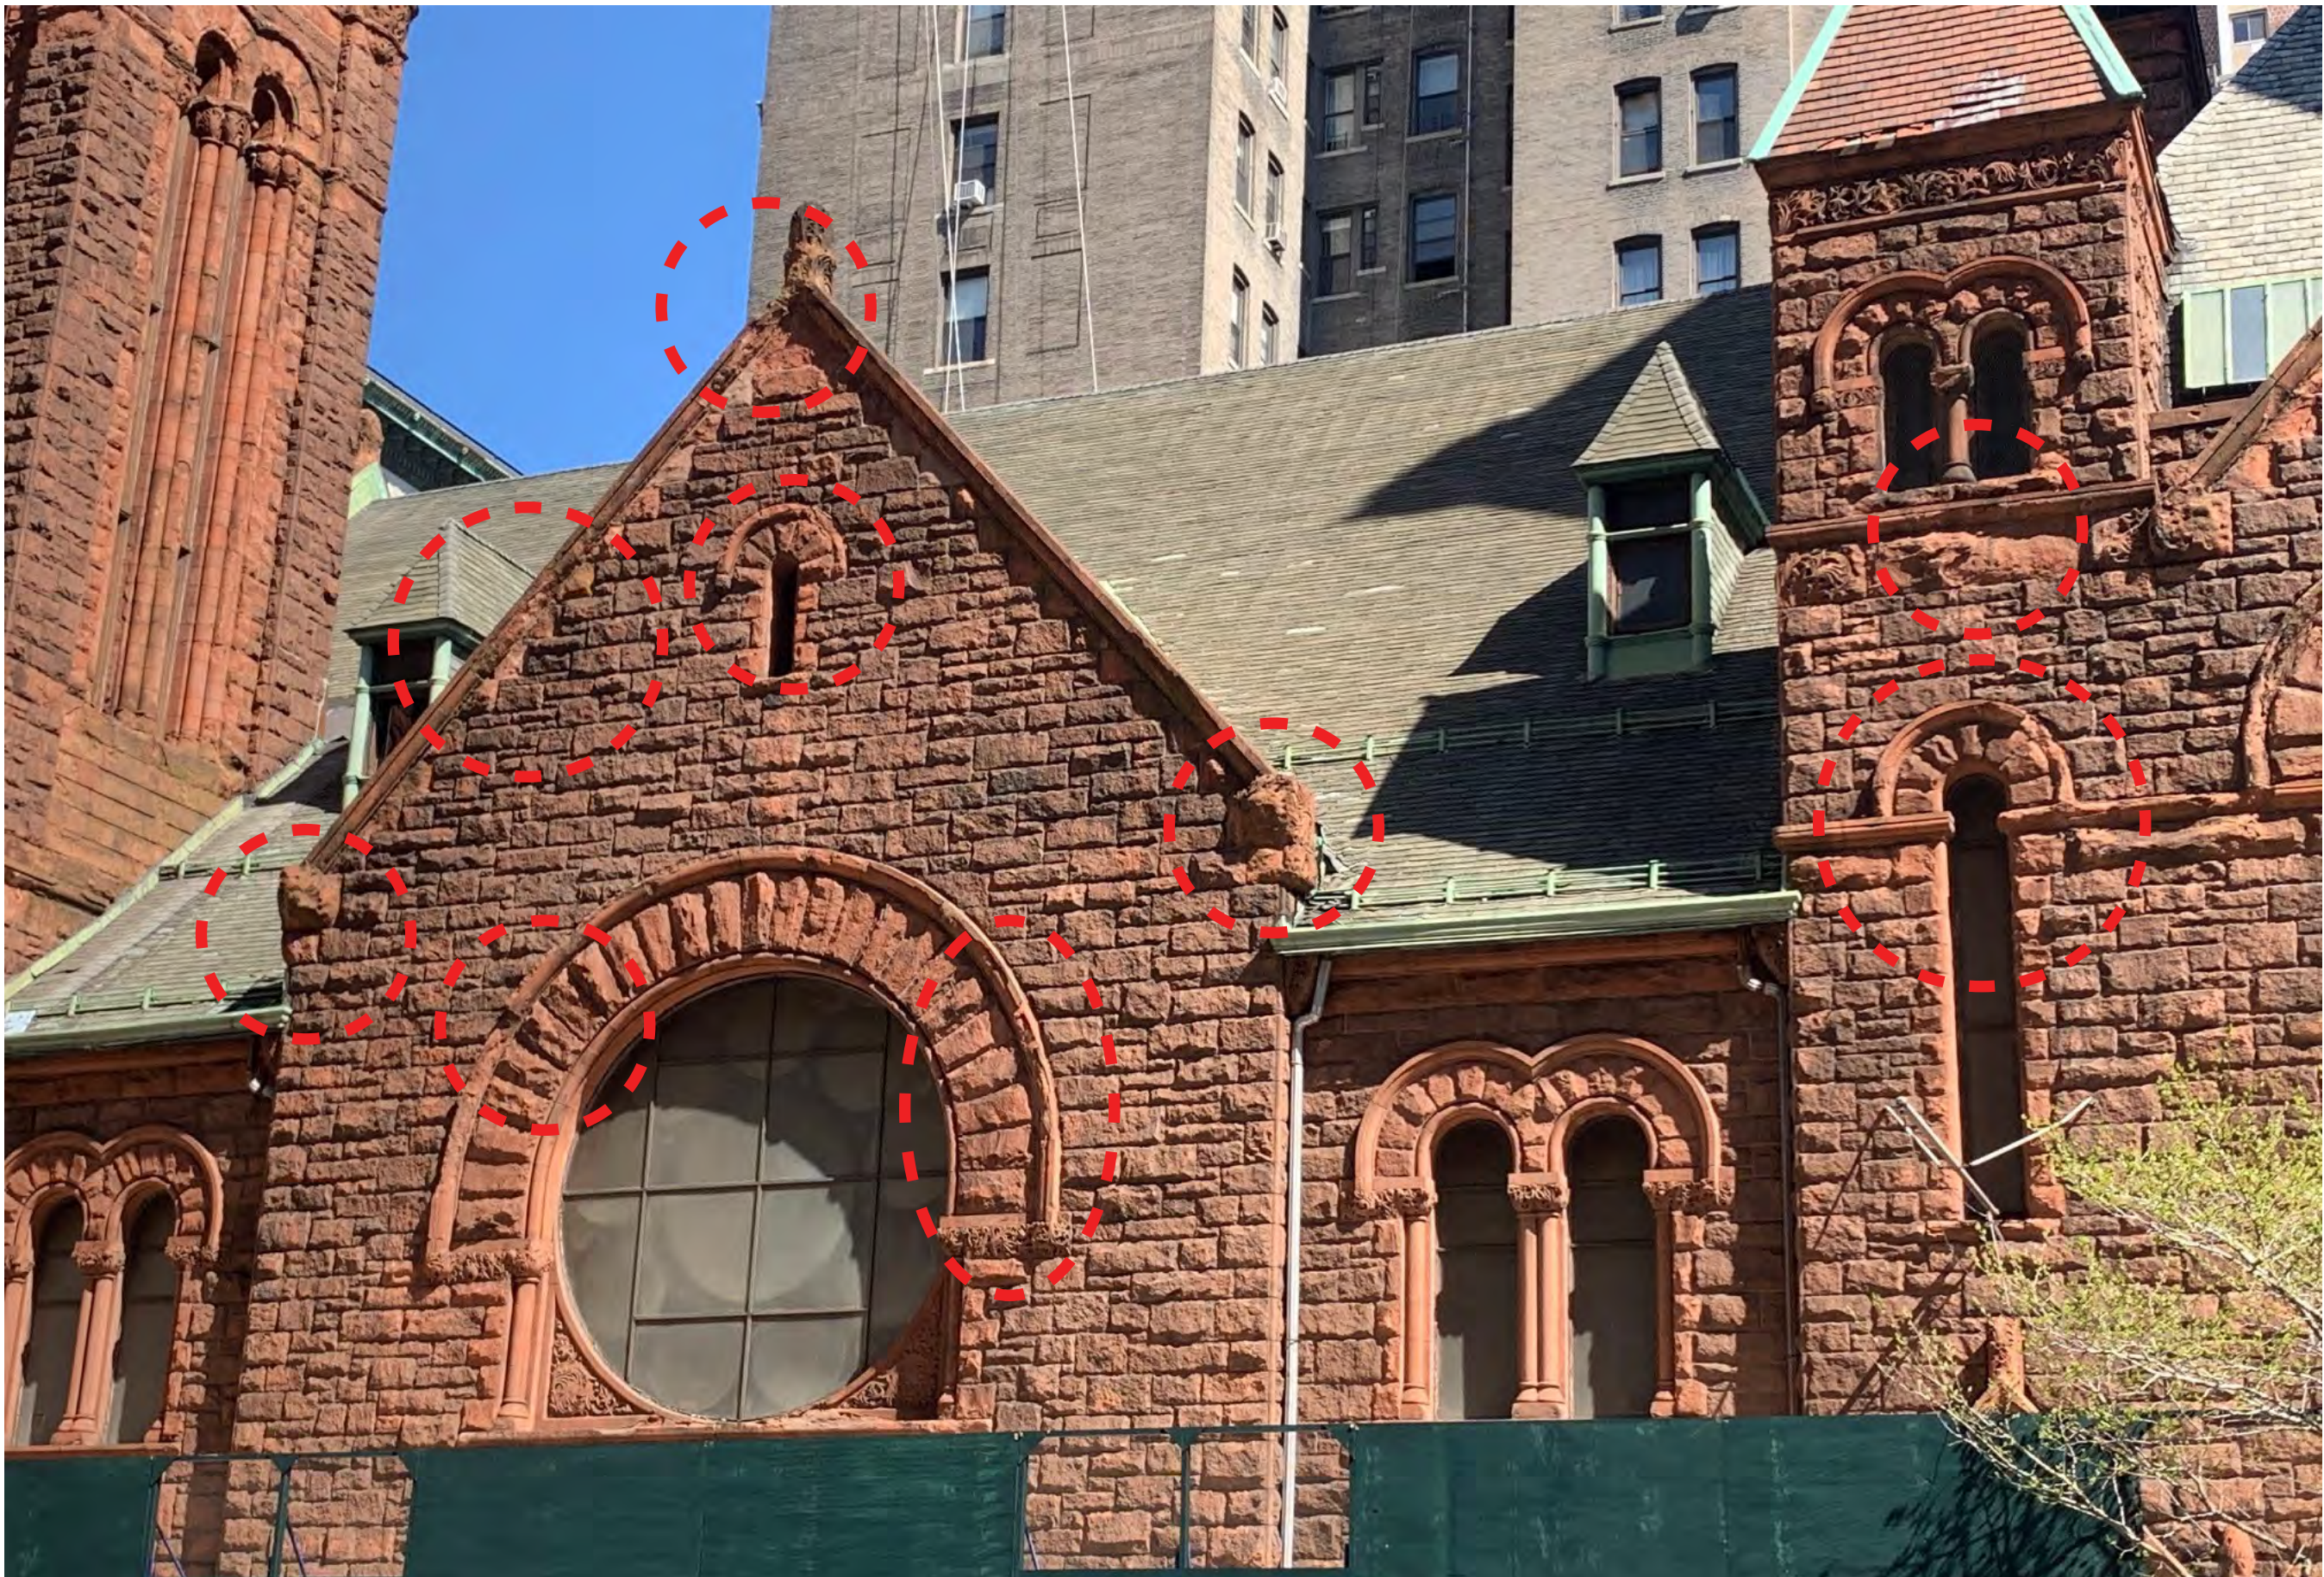
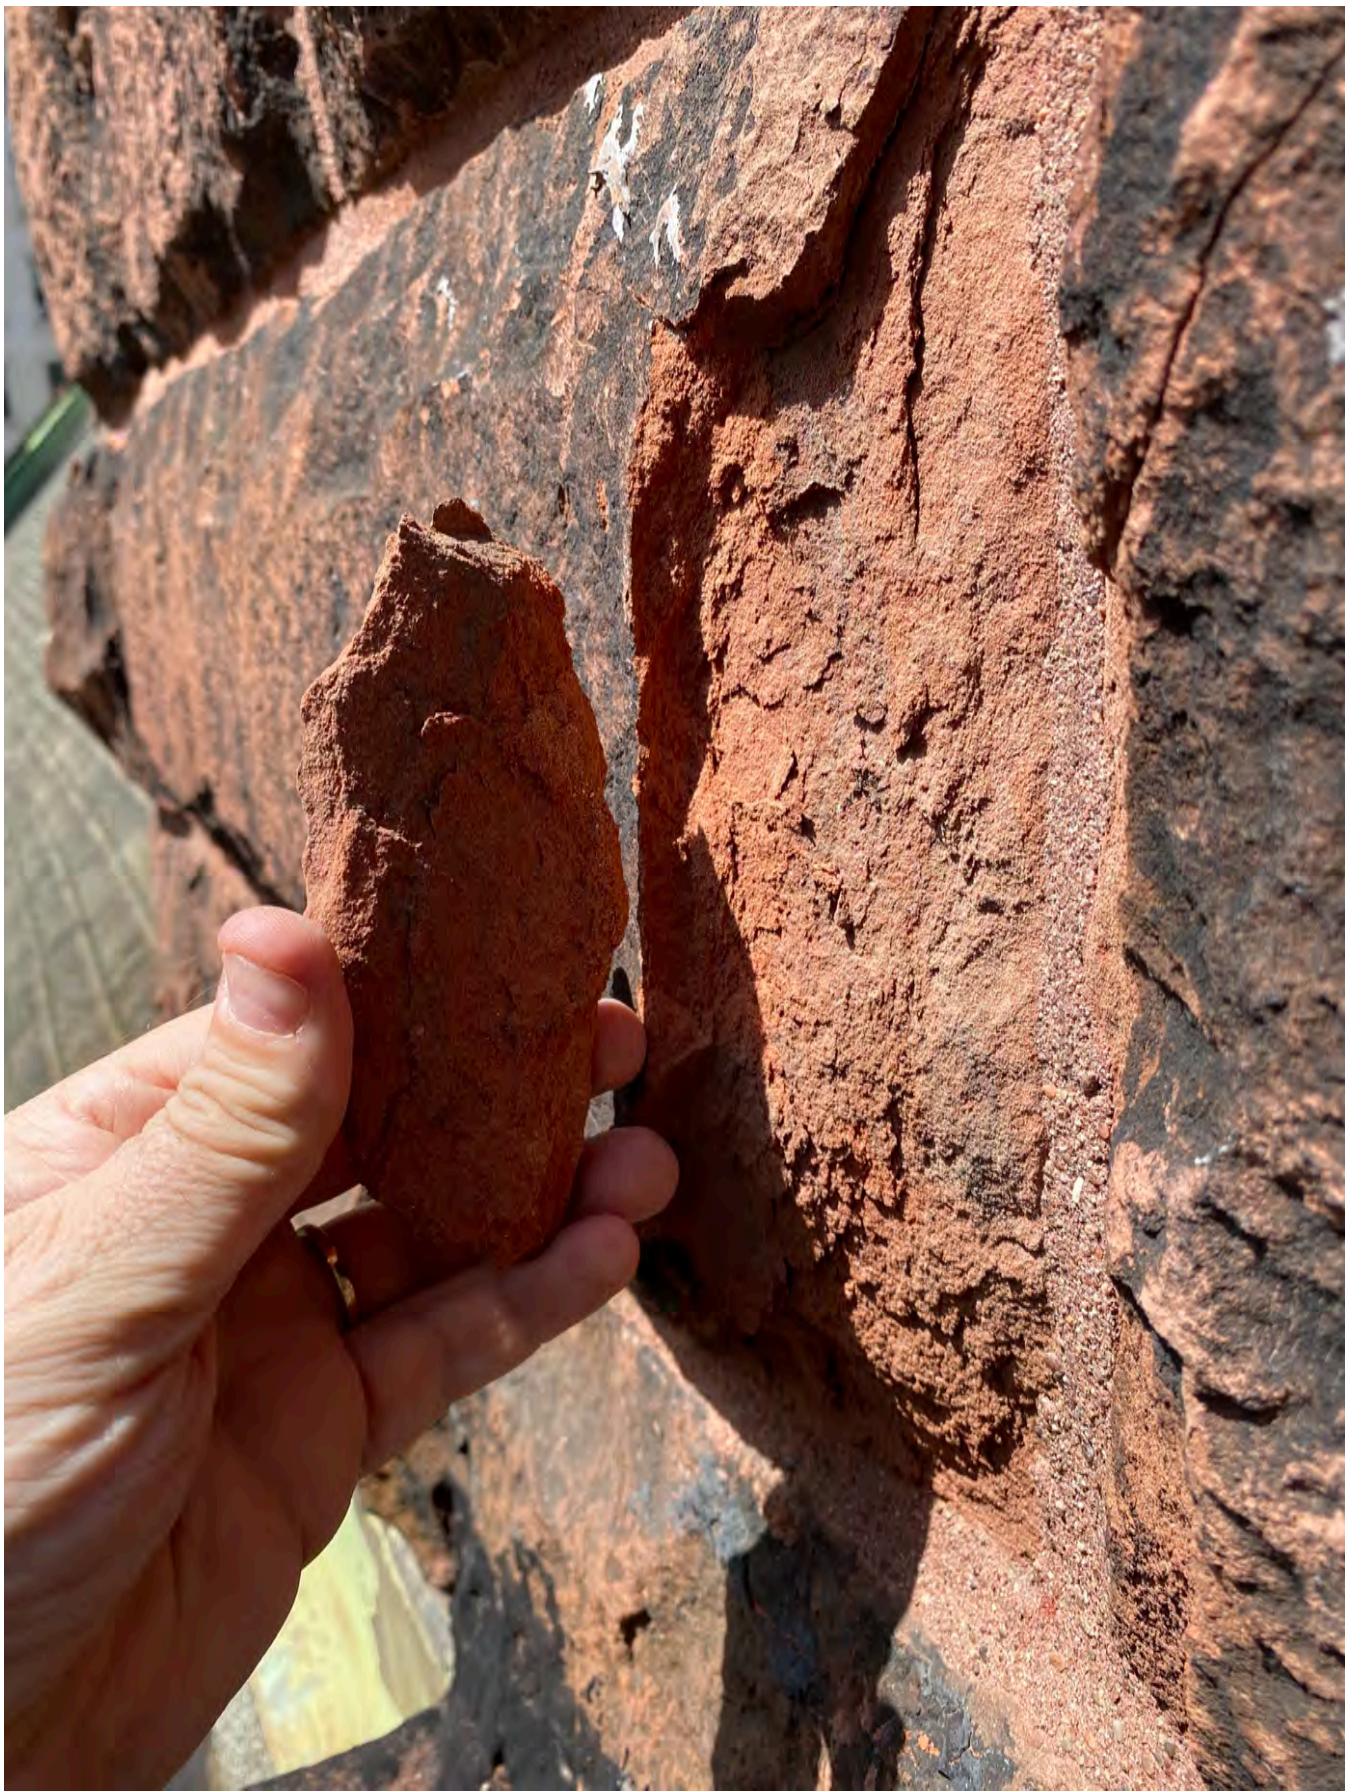
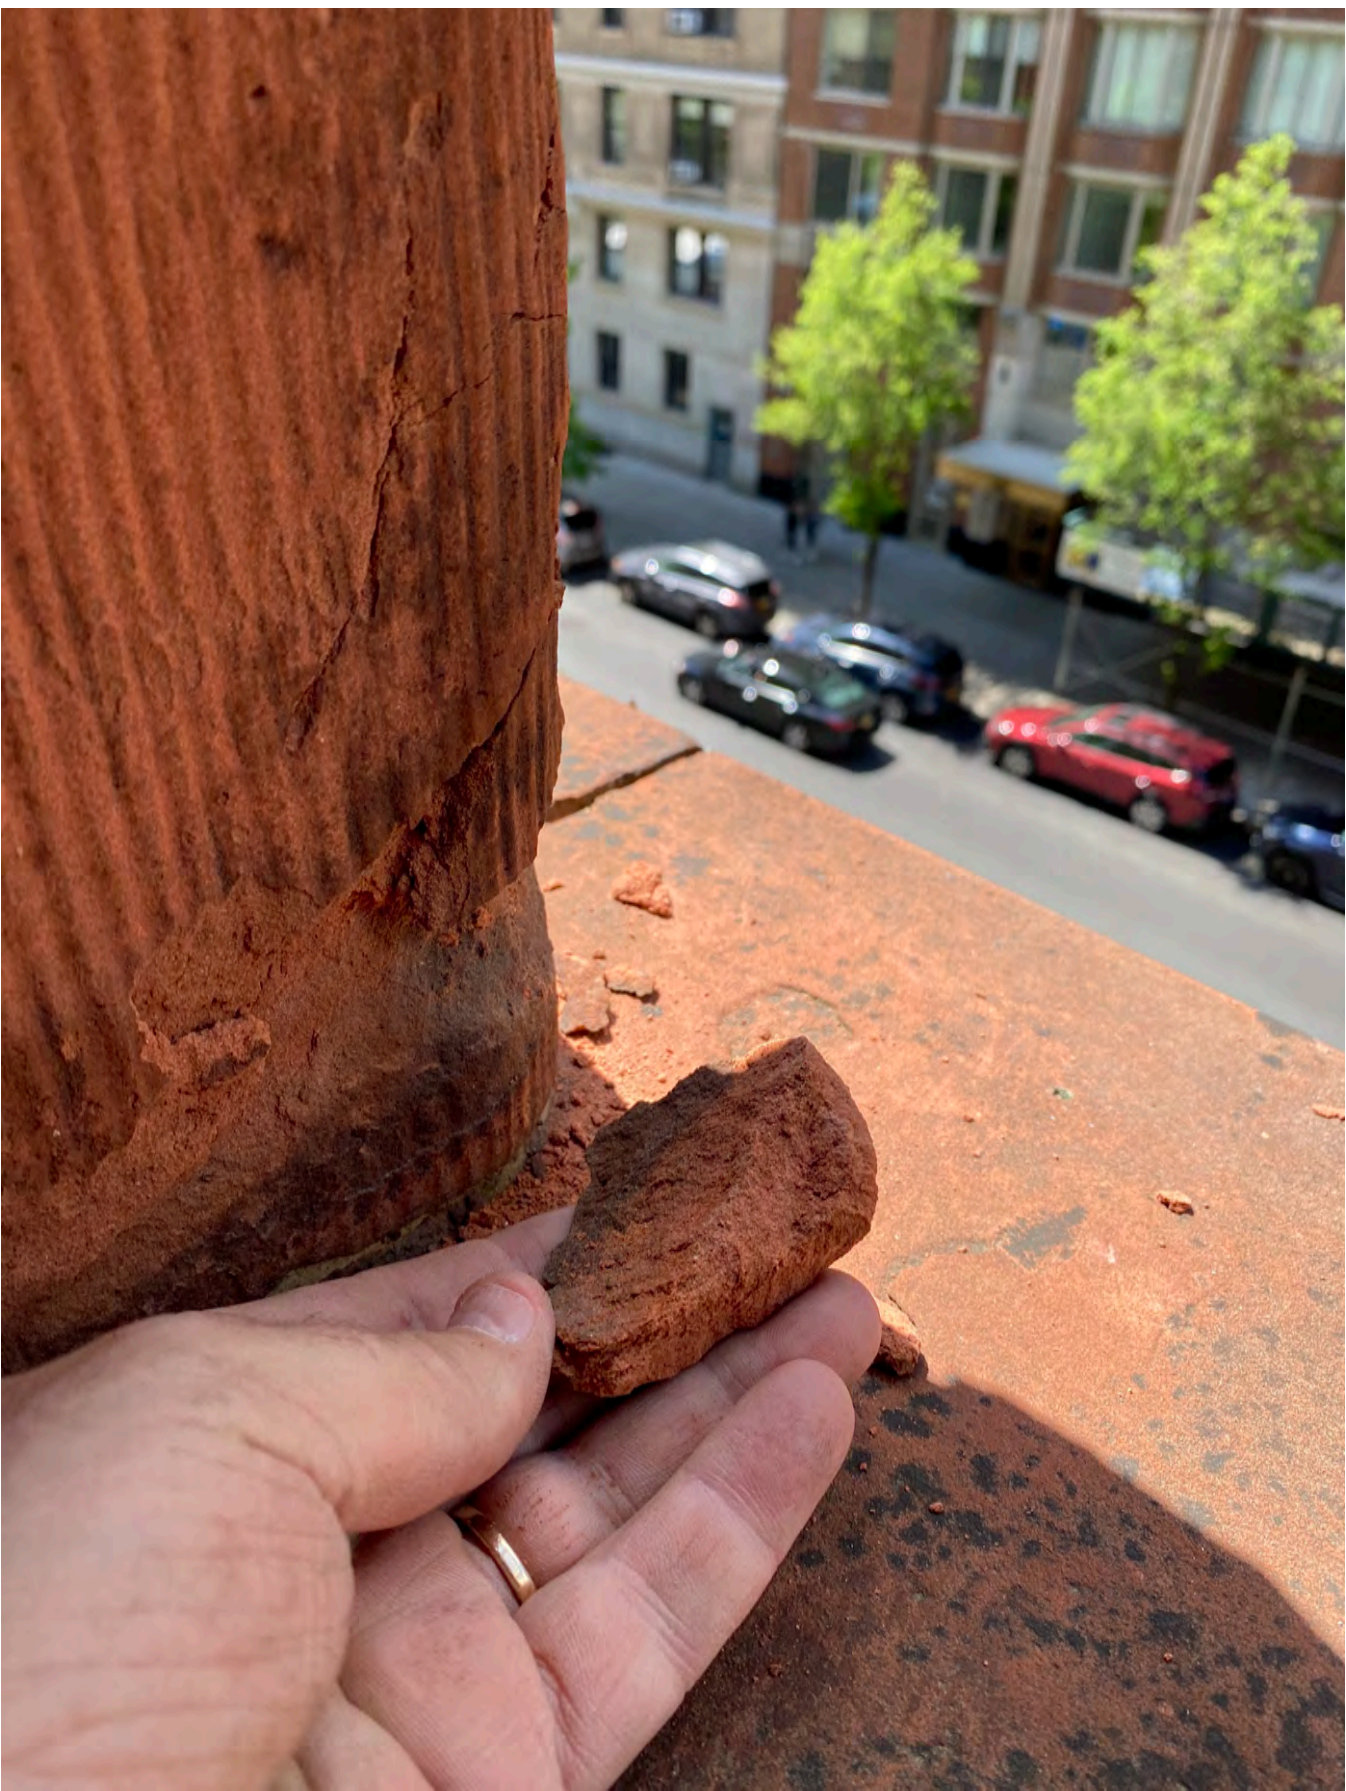
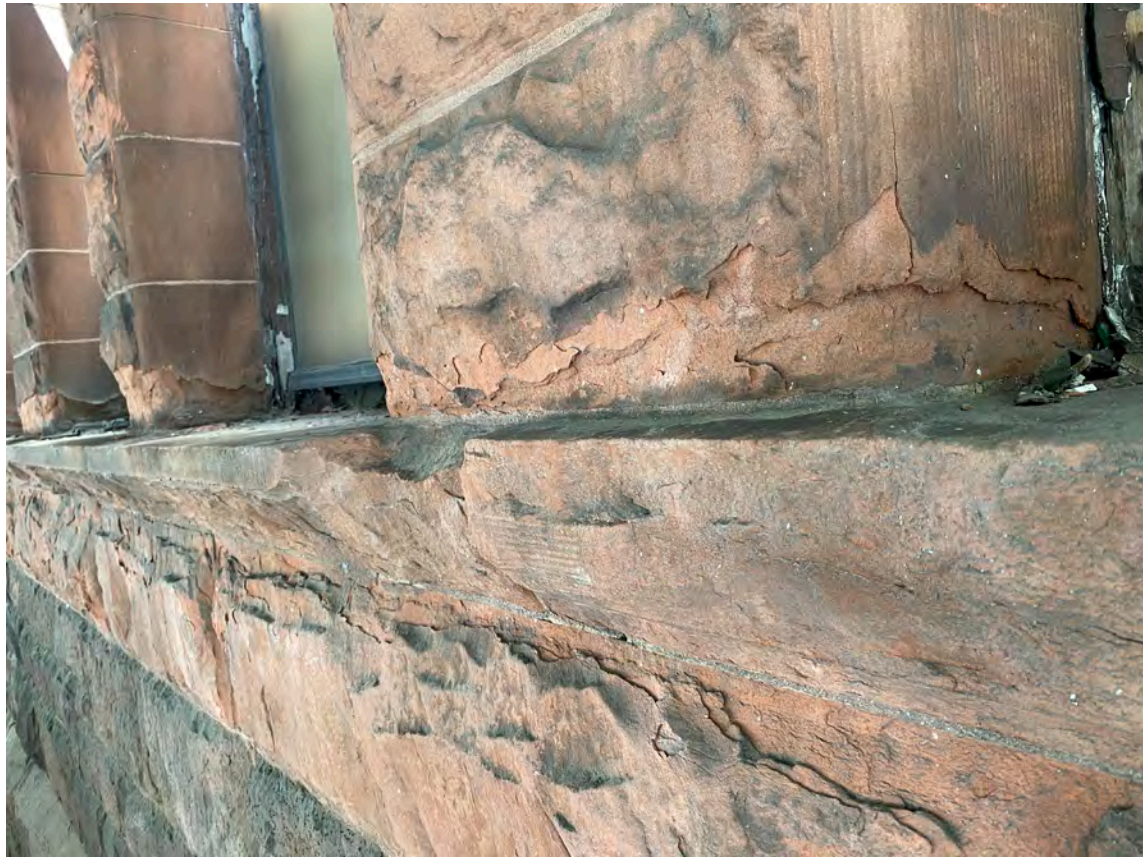
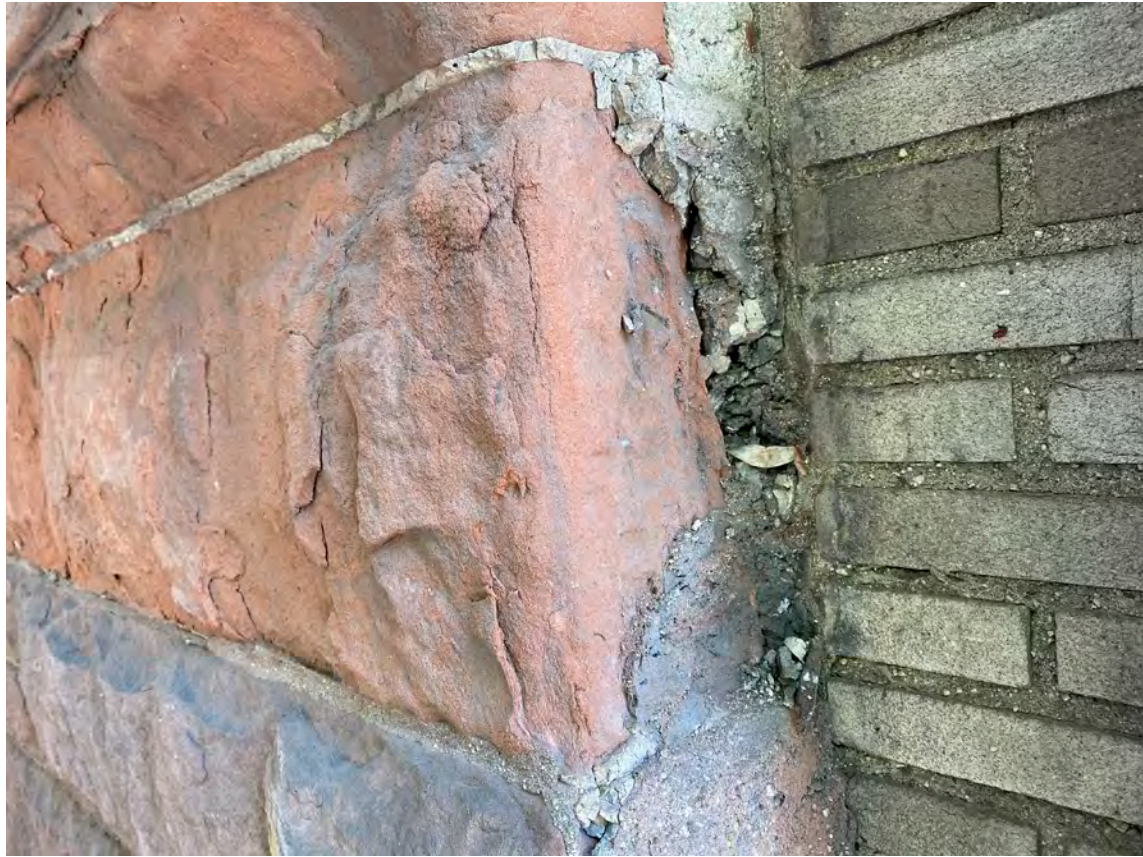
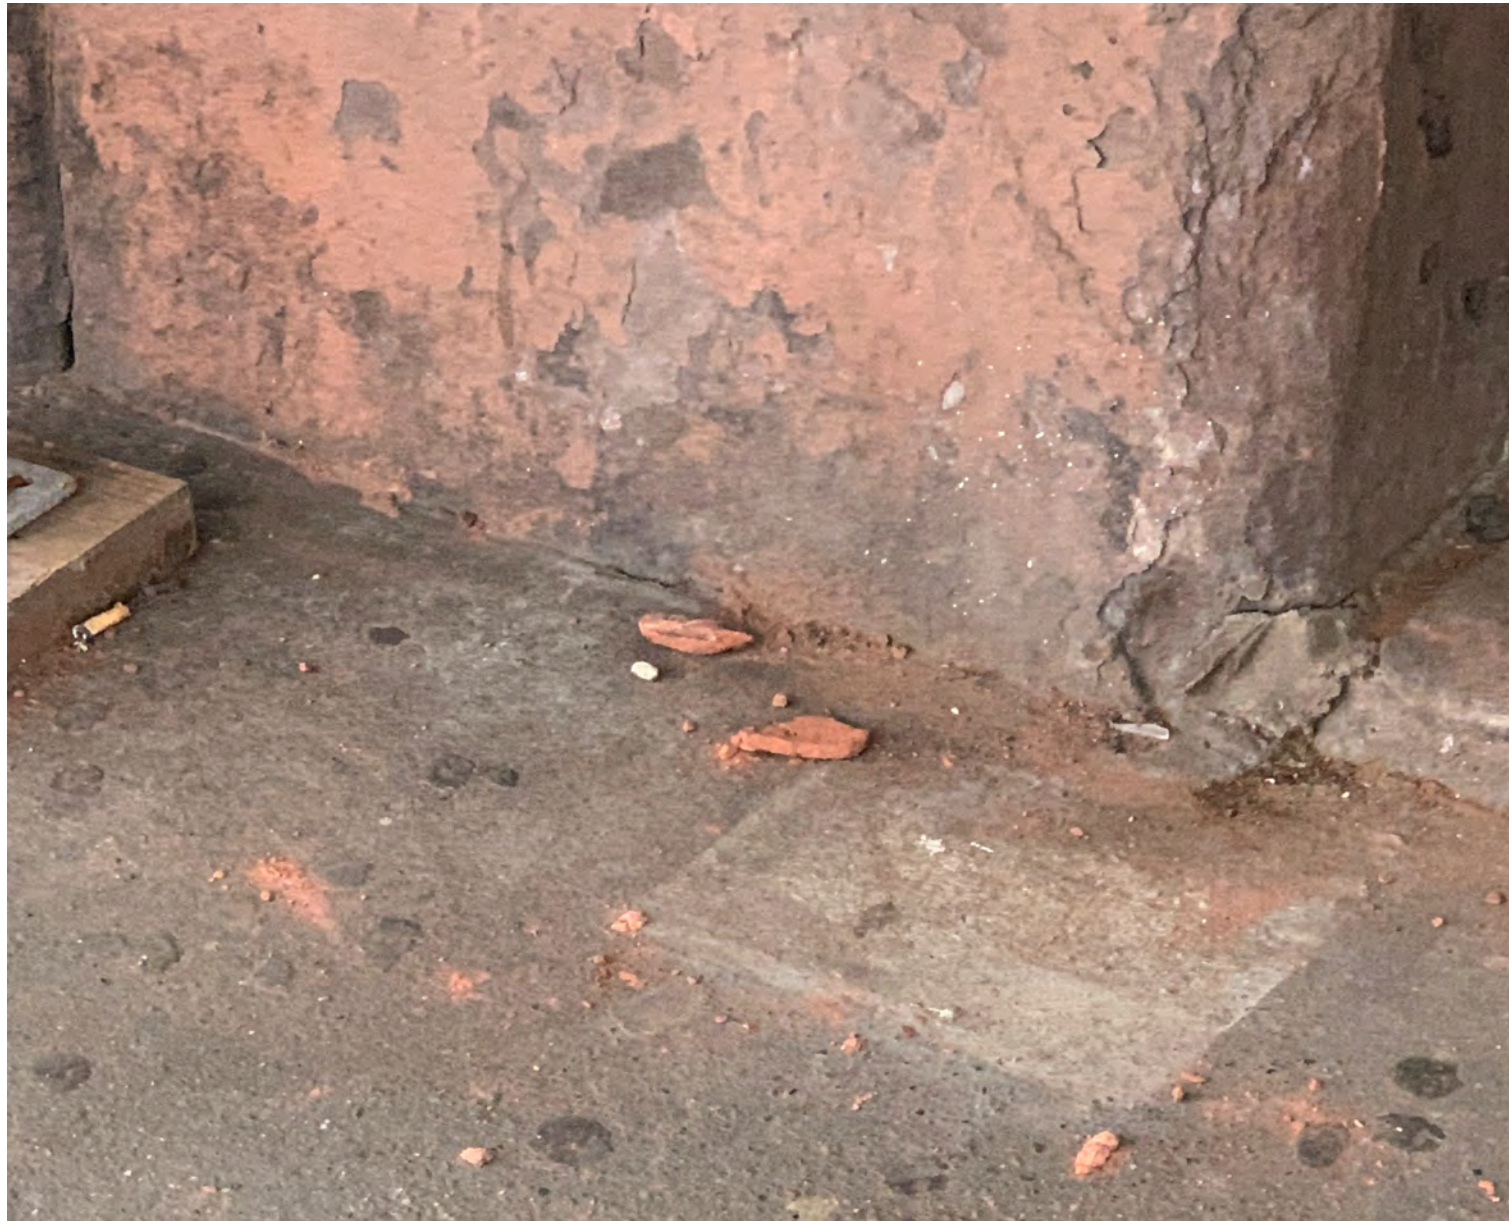
Facade *

- Ornamental sandstone finial located at top of the West 86th Street Chapel façade at the end of the roof ridge beam is severely cracked and spalled.
- Extensive stone spalling, cracks, mortar deterioration and deteriorated windows noted throughout the building.
- Façade conditions are unsafe.
- Loose or unsafe material should be removed and the remaining masonry stabilized.

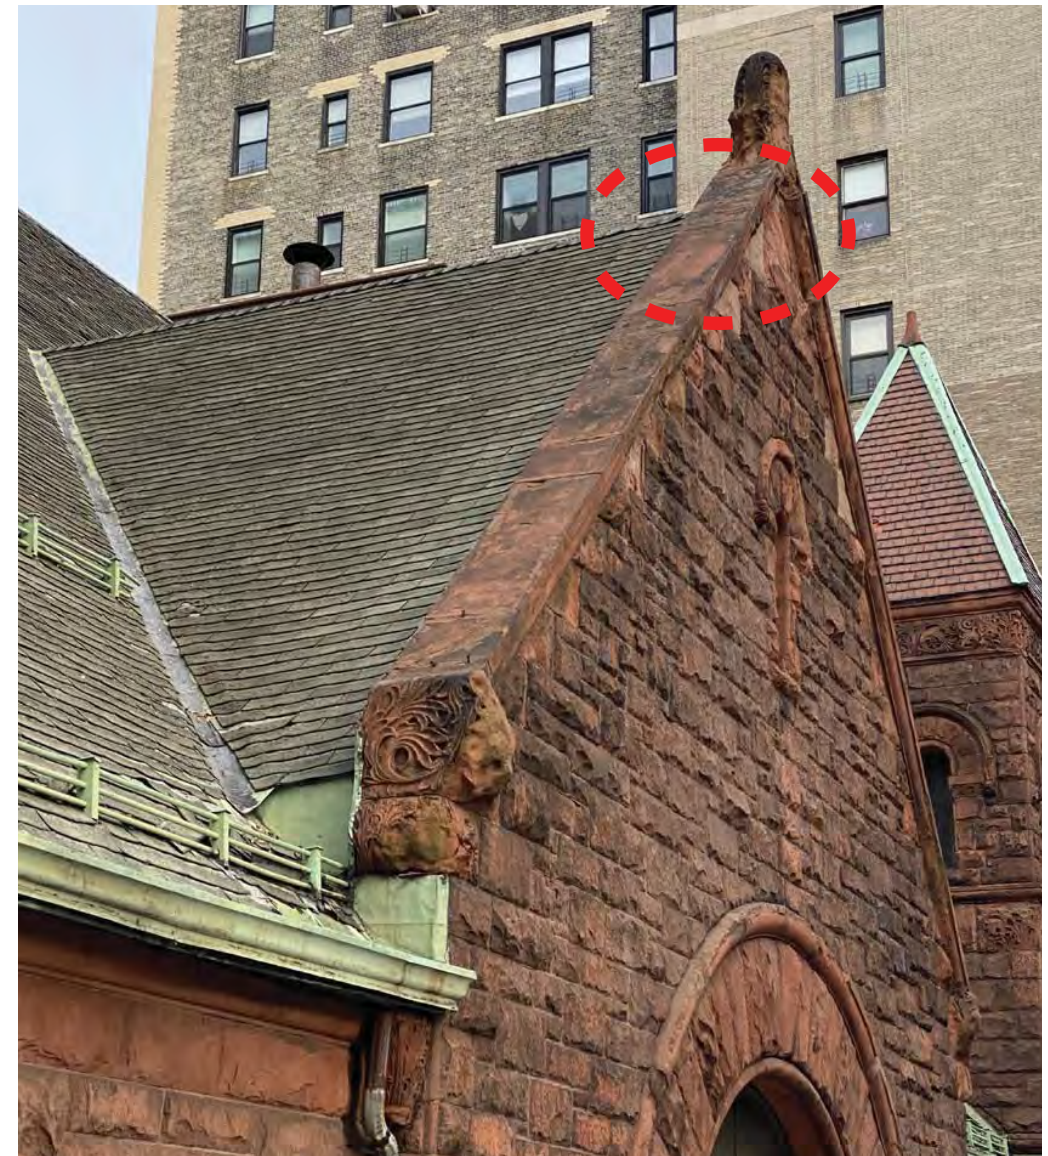
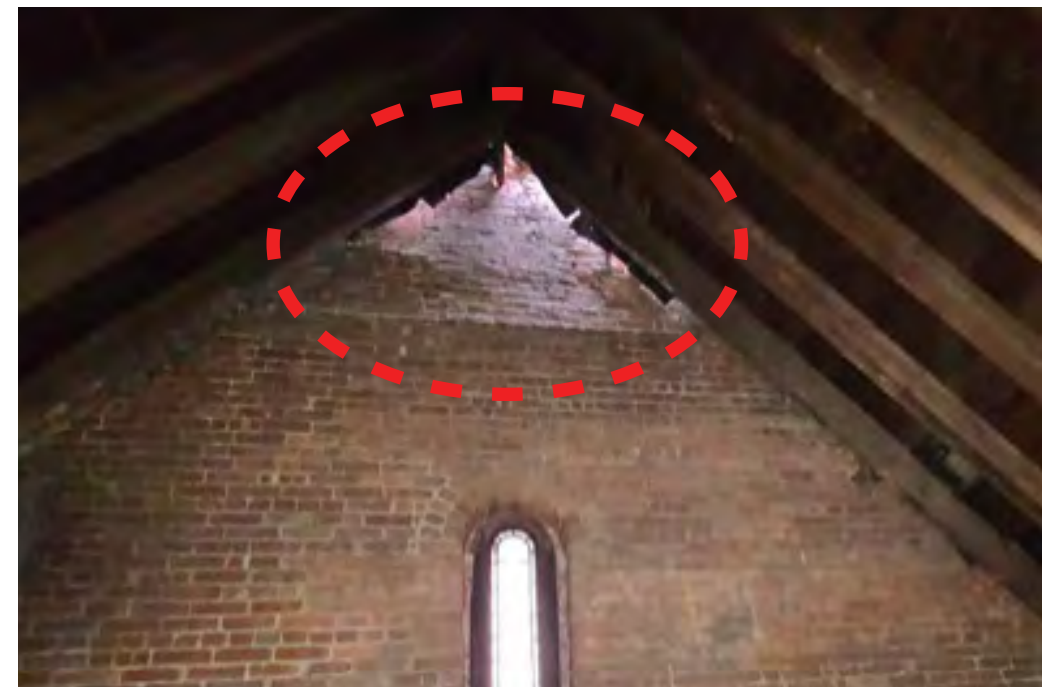
Structural Conditions *

- Section of façade adjacent to 86th St. separated from roof by up to 4". Wall is not adequately braced against wind loads and roof and sanctuary ceilings are not adequately supported.
- Sandstone façades exhibit deterioration in varying degrees from minor to severe. Areas of cracked, hollow sounding and delaminated surface observed, Large spalls, voids pits and cracks observed throughout.

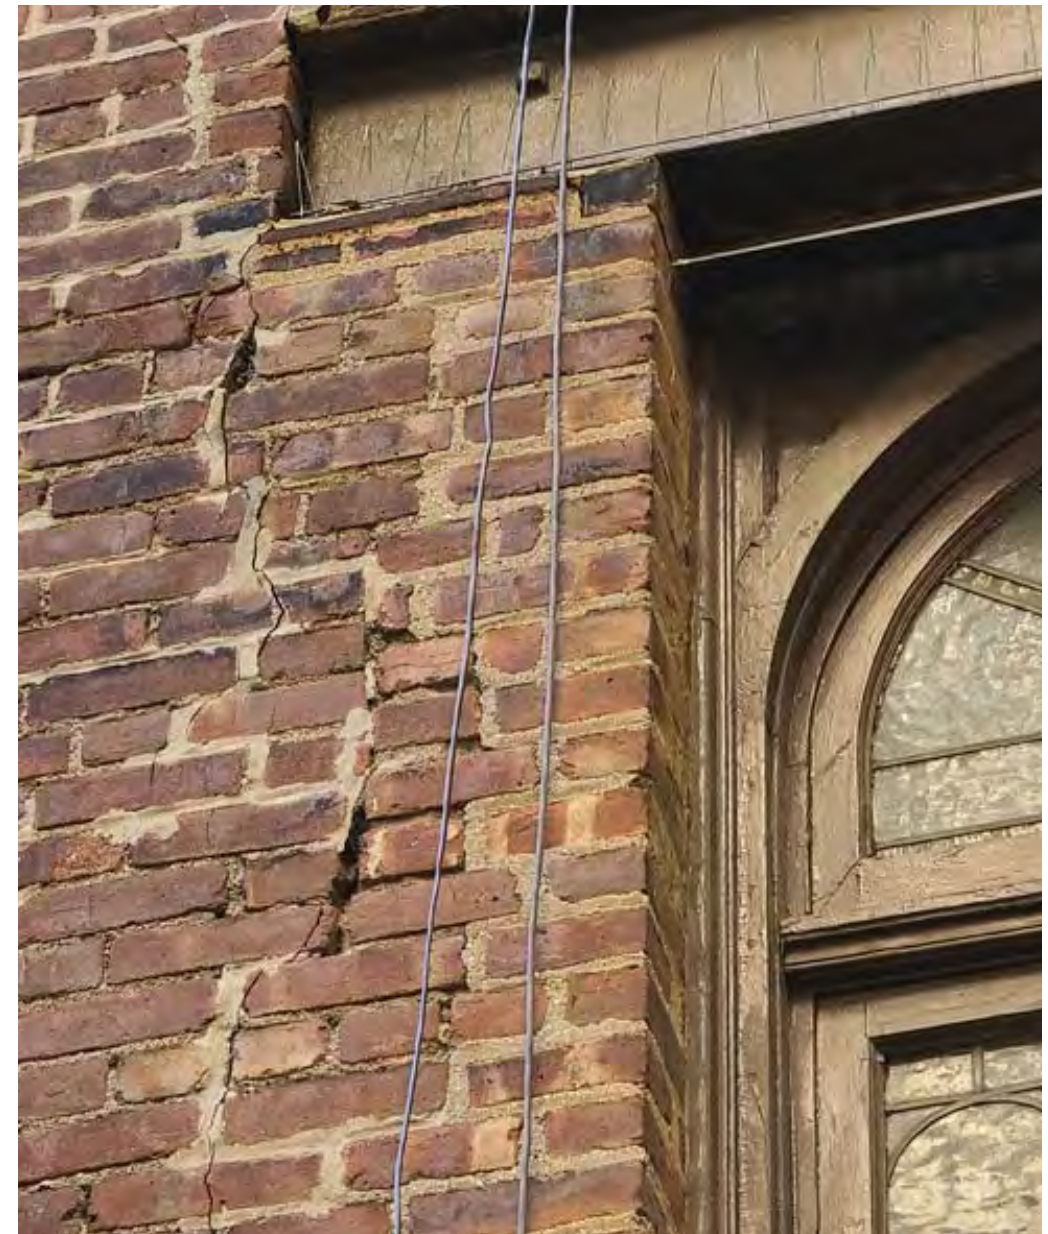
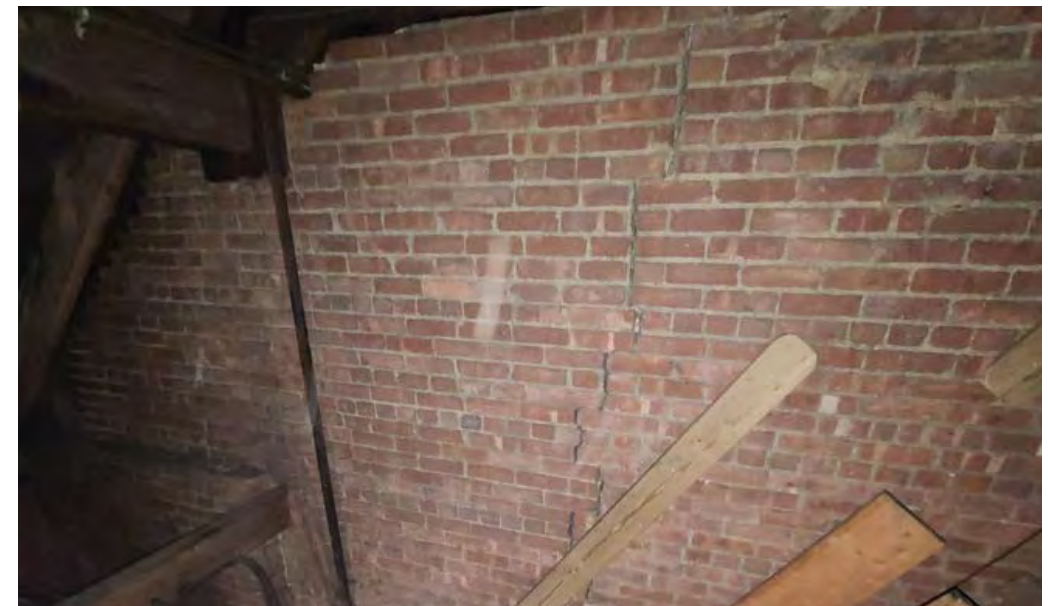
Structural Conditions (Continued) *

- 25% of brick on interior walls of bell tower which support the tower and serve as backup to the sandstone façade has cracked, deteriorated or missing mortar.
- Various through-cracks, areas of missing and deteriorated mortar or signs of trapped moisture observed at the exterior brick bearing walls at north and east faces. Interior signs of trapped moisture.

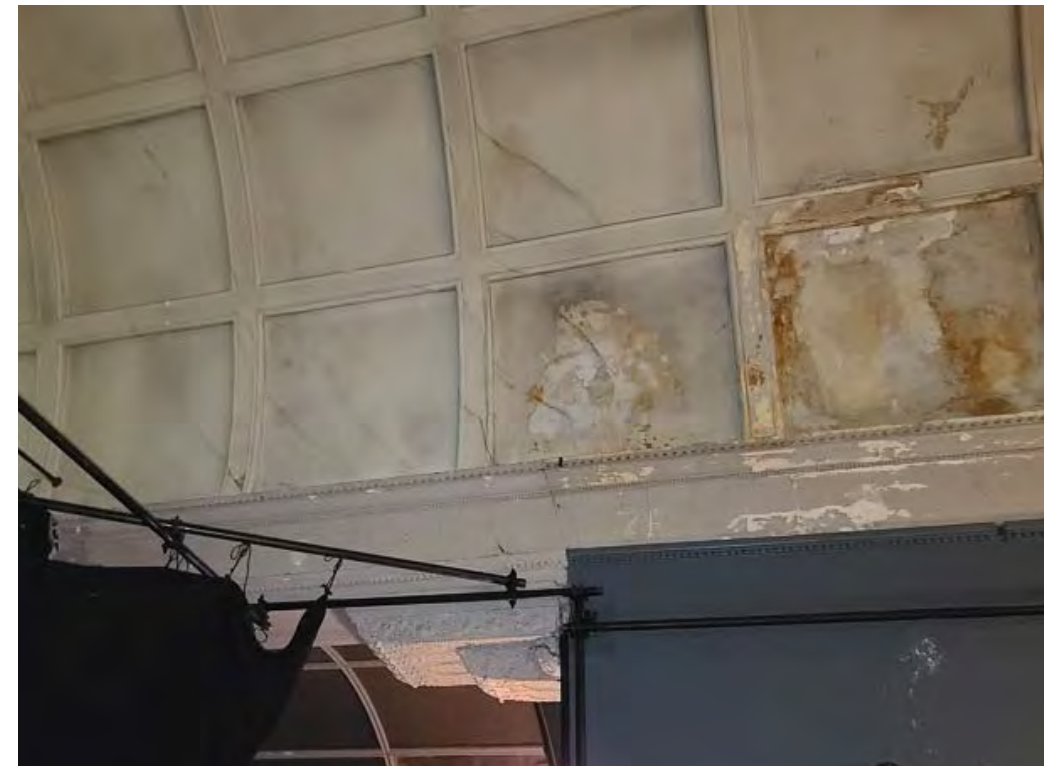
Structural Conditions (Continued) *

- Various cracks and water discoloration at sanctuary walls and ceilings and near wood trusses indicating excessive deformation of wood truss and/or excessive lateral movement or settlement at the truss bearing points.
- 20 foot long wide vertical and stepped crack at east end of southernmost roof truss.
- Wood header and joist supporting a stair and portion of storage room east of 86th Entrance observed to be severely cracked and deformed.
- Cracks at underside of north-east egress stair at second floor indicate excessive deflection of floor.

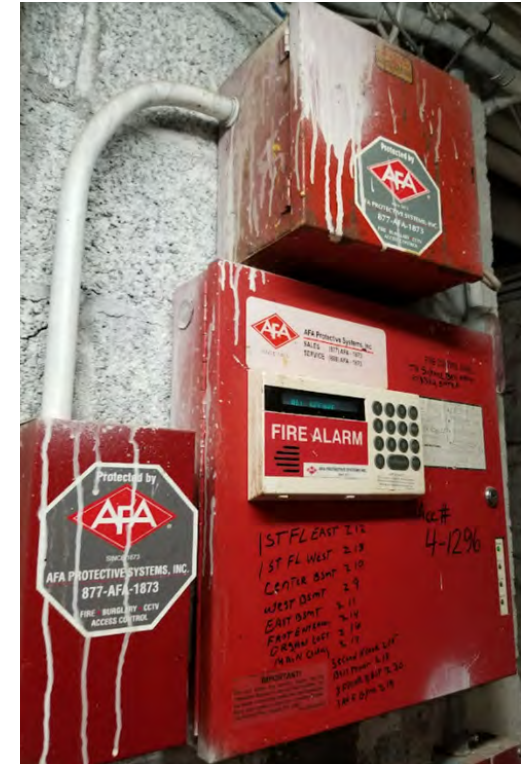
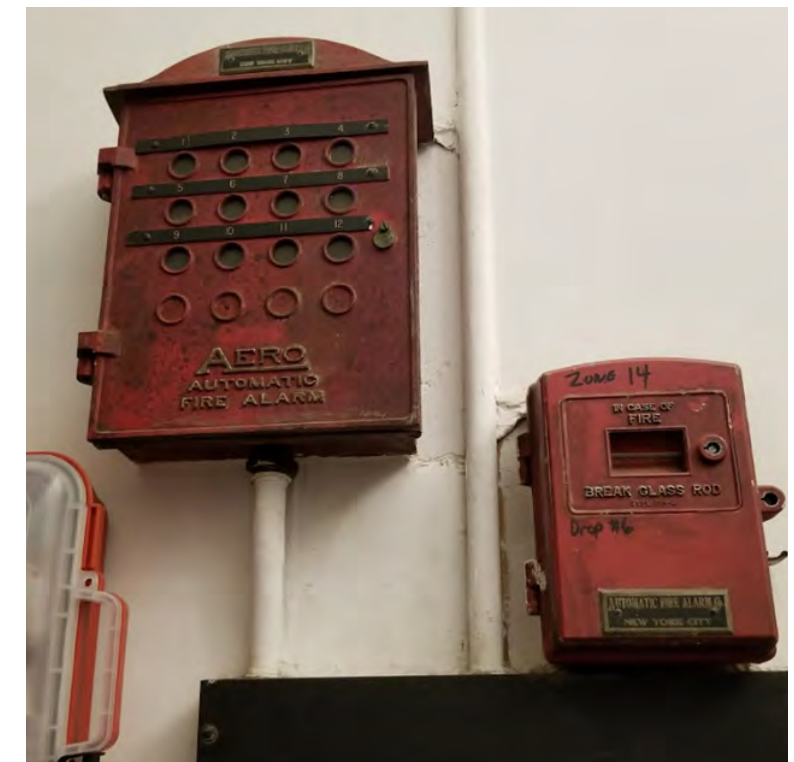
Fire Protection & Life Safety *

- The existing building is in significant disrepair and would require significant and intensive upgrades to comply with any of the currently adopted and enforced New York City Construction Codes.
- The building does not have an automatic sprinkler system and the automatic fire alarm system is antiquated and lack audible and visible notifications.
- The building has open stair halls.
- The building does not provide two means of egress for the office and assembly spaces located east of the sanctuary.
- There is no emergency lighting throughout the building.

Note: Change of dominate use and/or alteration costs in excess of 60% of the value of the building trigger a requirement for full building code compliance. If the change of use is limited to specific spaces and ranges from 30-60 % of value of the building, then compliance obligation may be limited to the work area.
