WEST-PARK PRESBYTERIAN CHURCH

165 WEST 86TH STREET

LPC DOCKET # LPC-22-09135

Application for a Notice to Proceed to allow for Demolition on the Grounds of Hardship

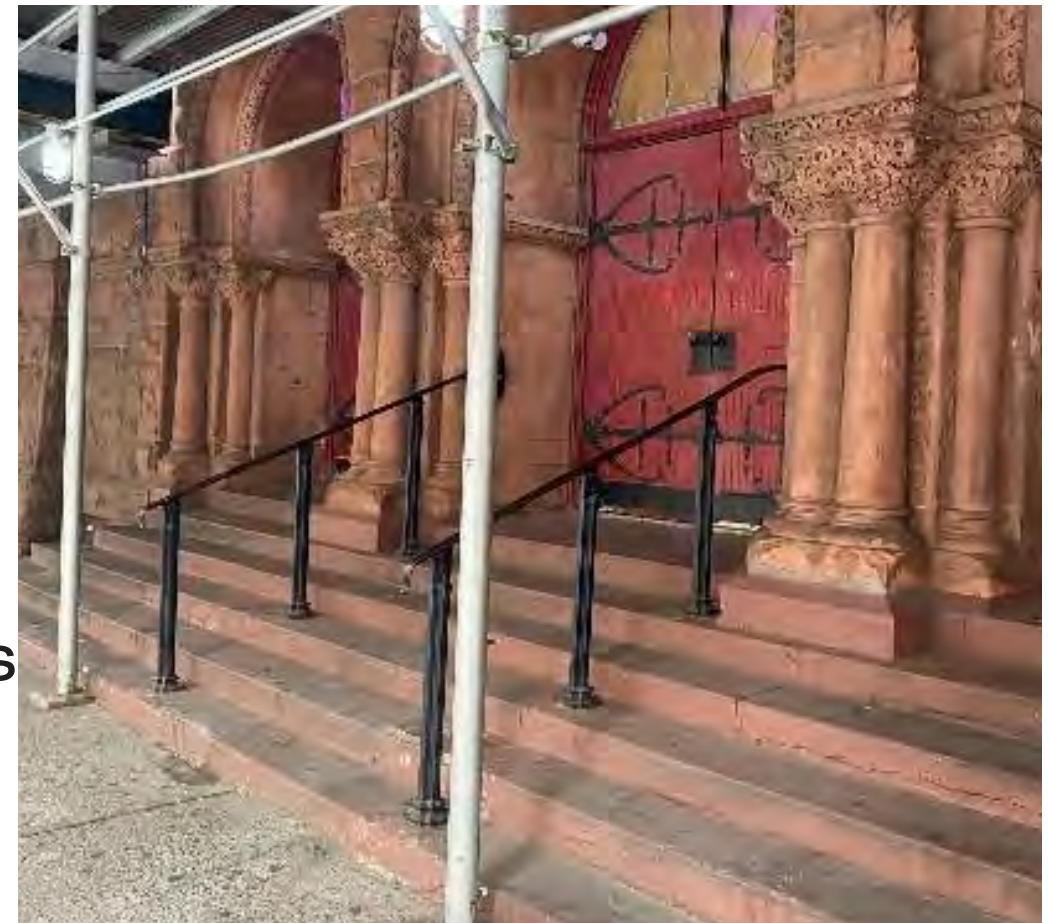
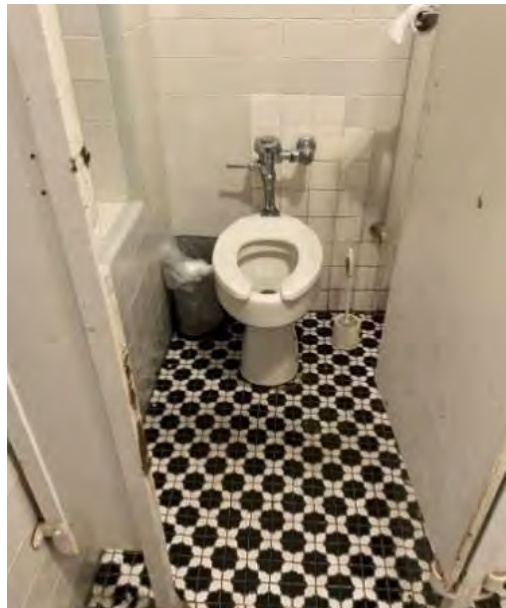
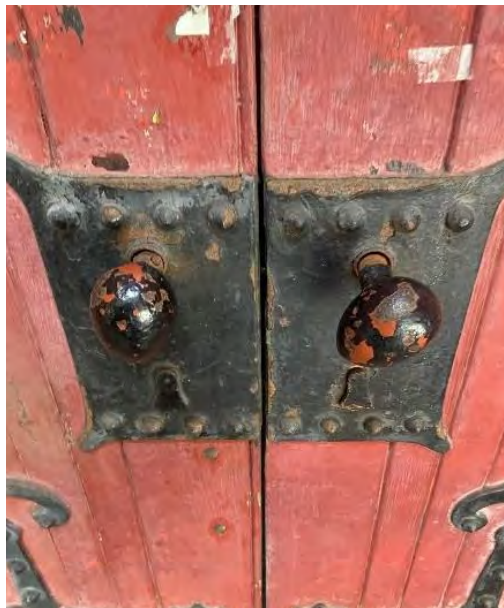
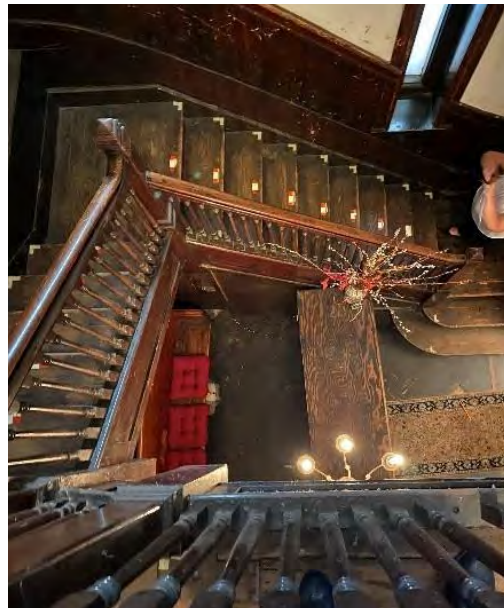
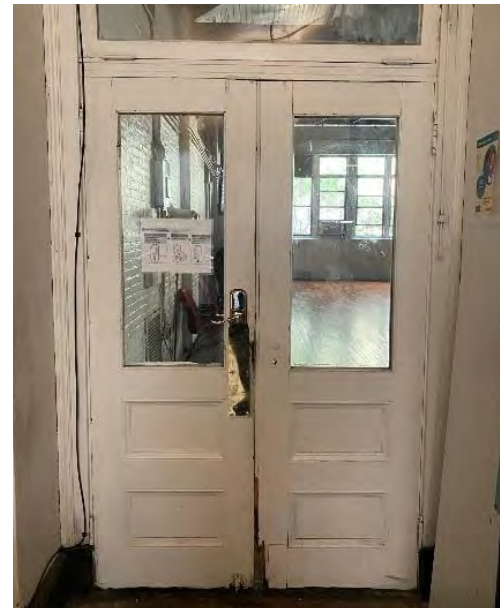
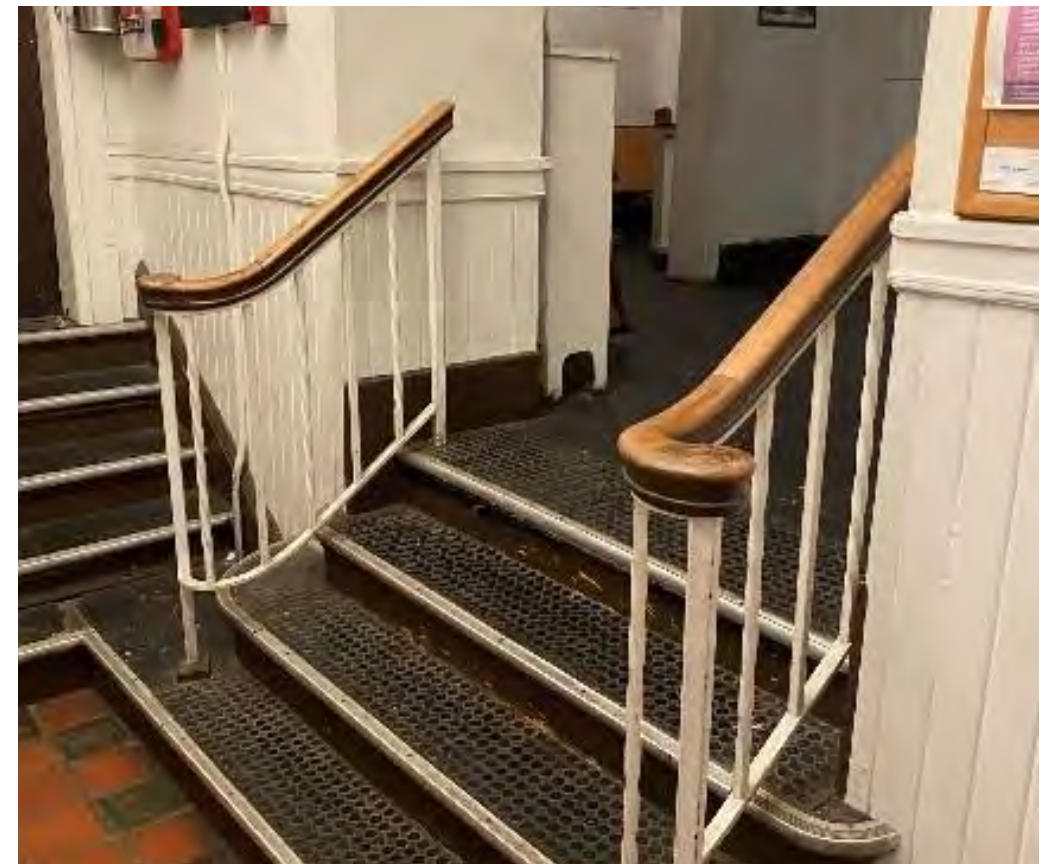
Accessibility *

- Amsterdam Avenue and West 86th Street entrances are not accessible.
- No accessible routes from sanctuary to any of the levels of the building including the balcony.
- No accessible restrooms.
- Interior doors, hardware and railings are non-compliant.

Note: Any new or altered element must be designed and constructed to meet 2010 ADA Standards. Change of dominate use and/or alteration costs in excess of 50% of the value of the building trigger a requirement for full ADA compliance.

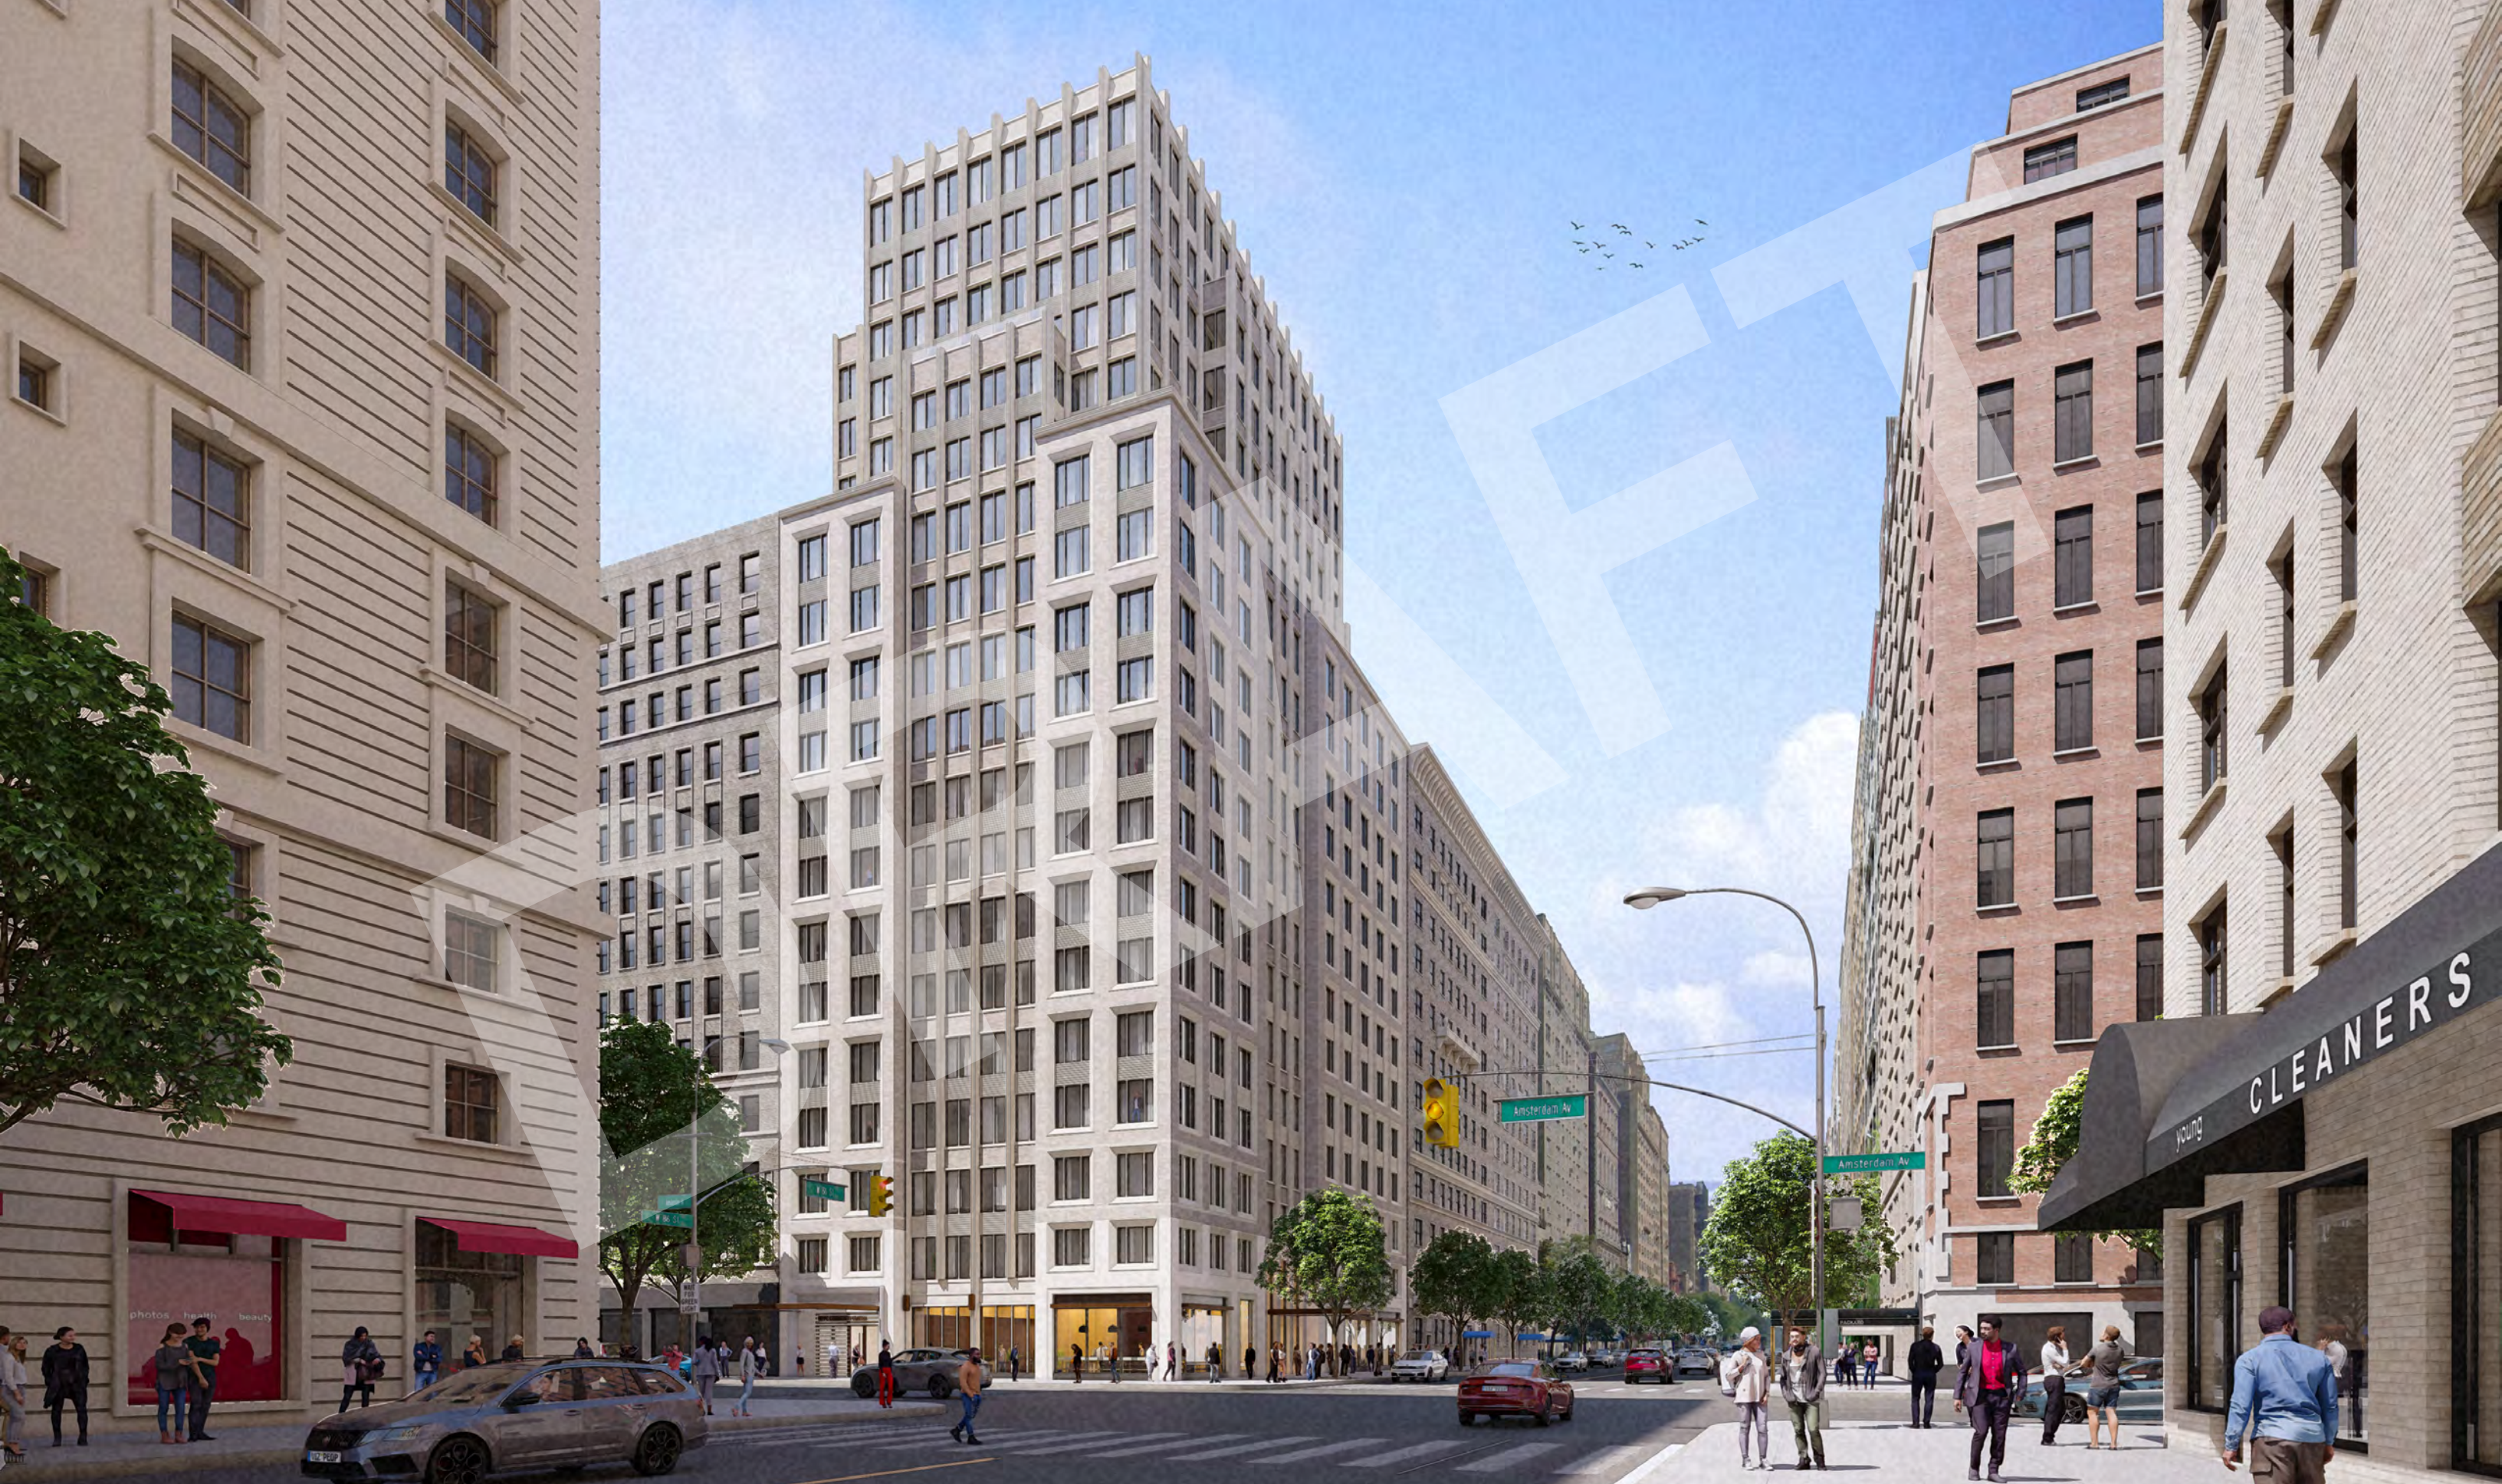
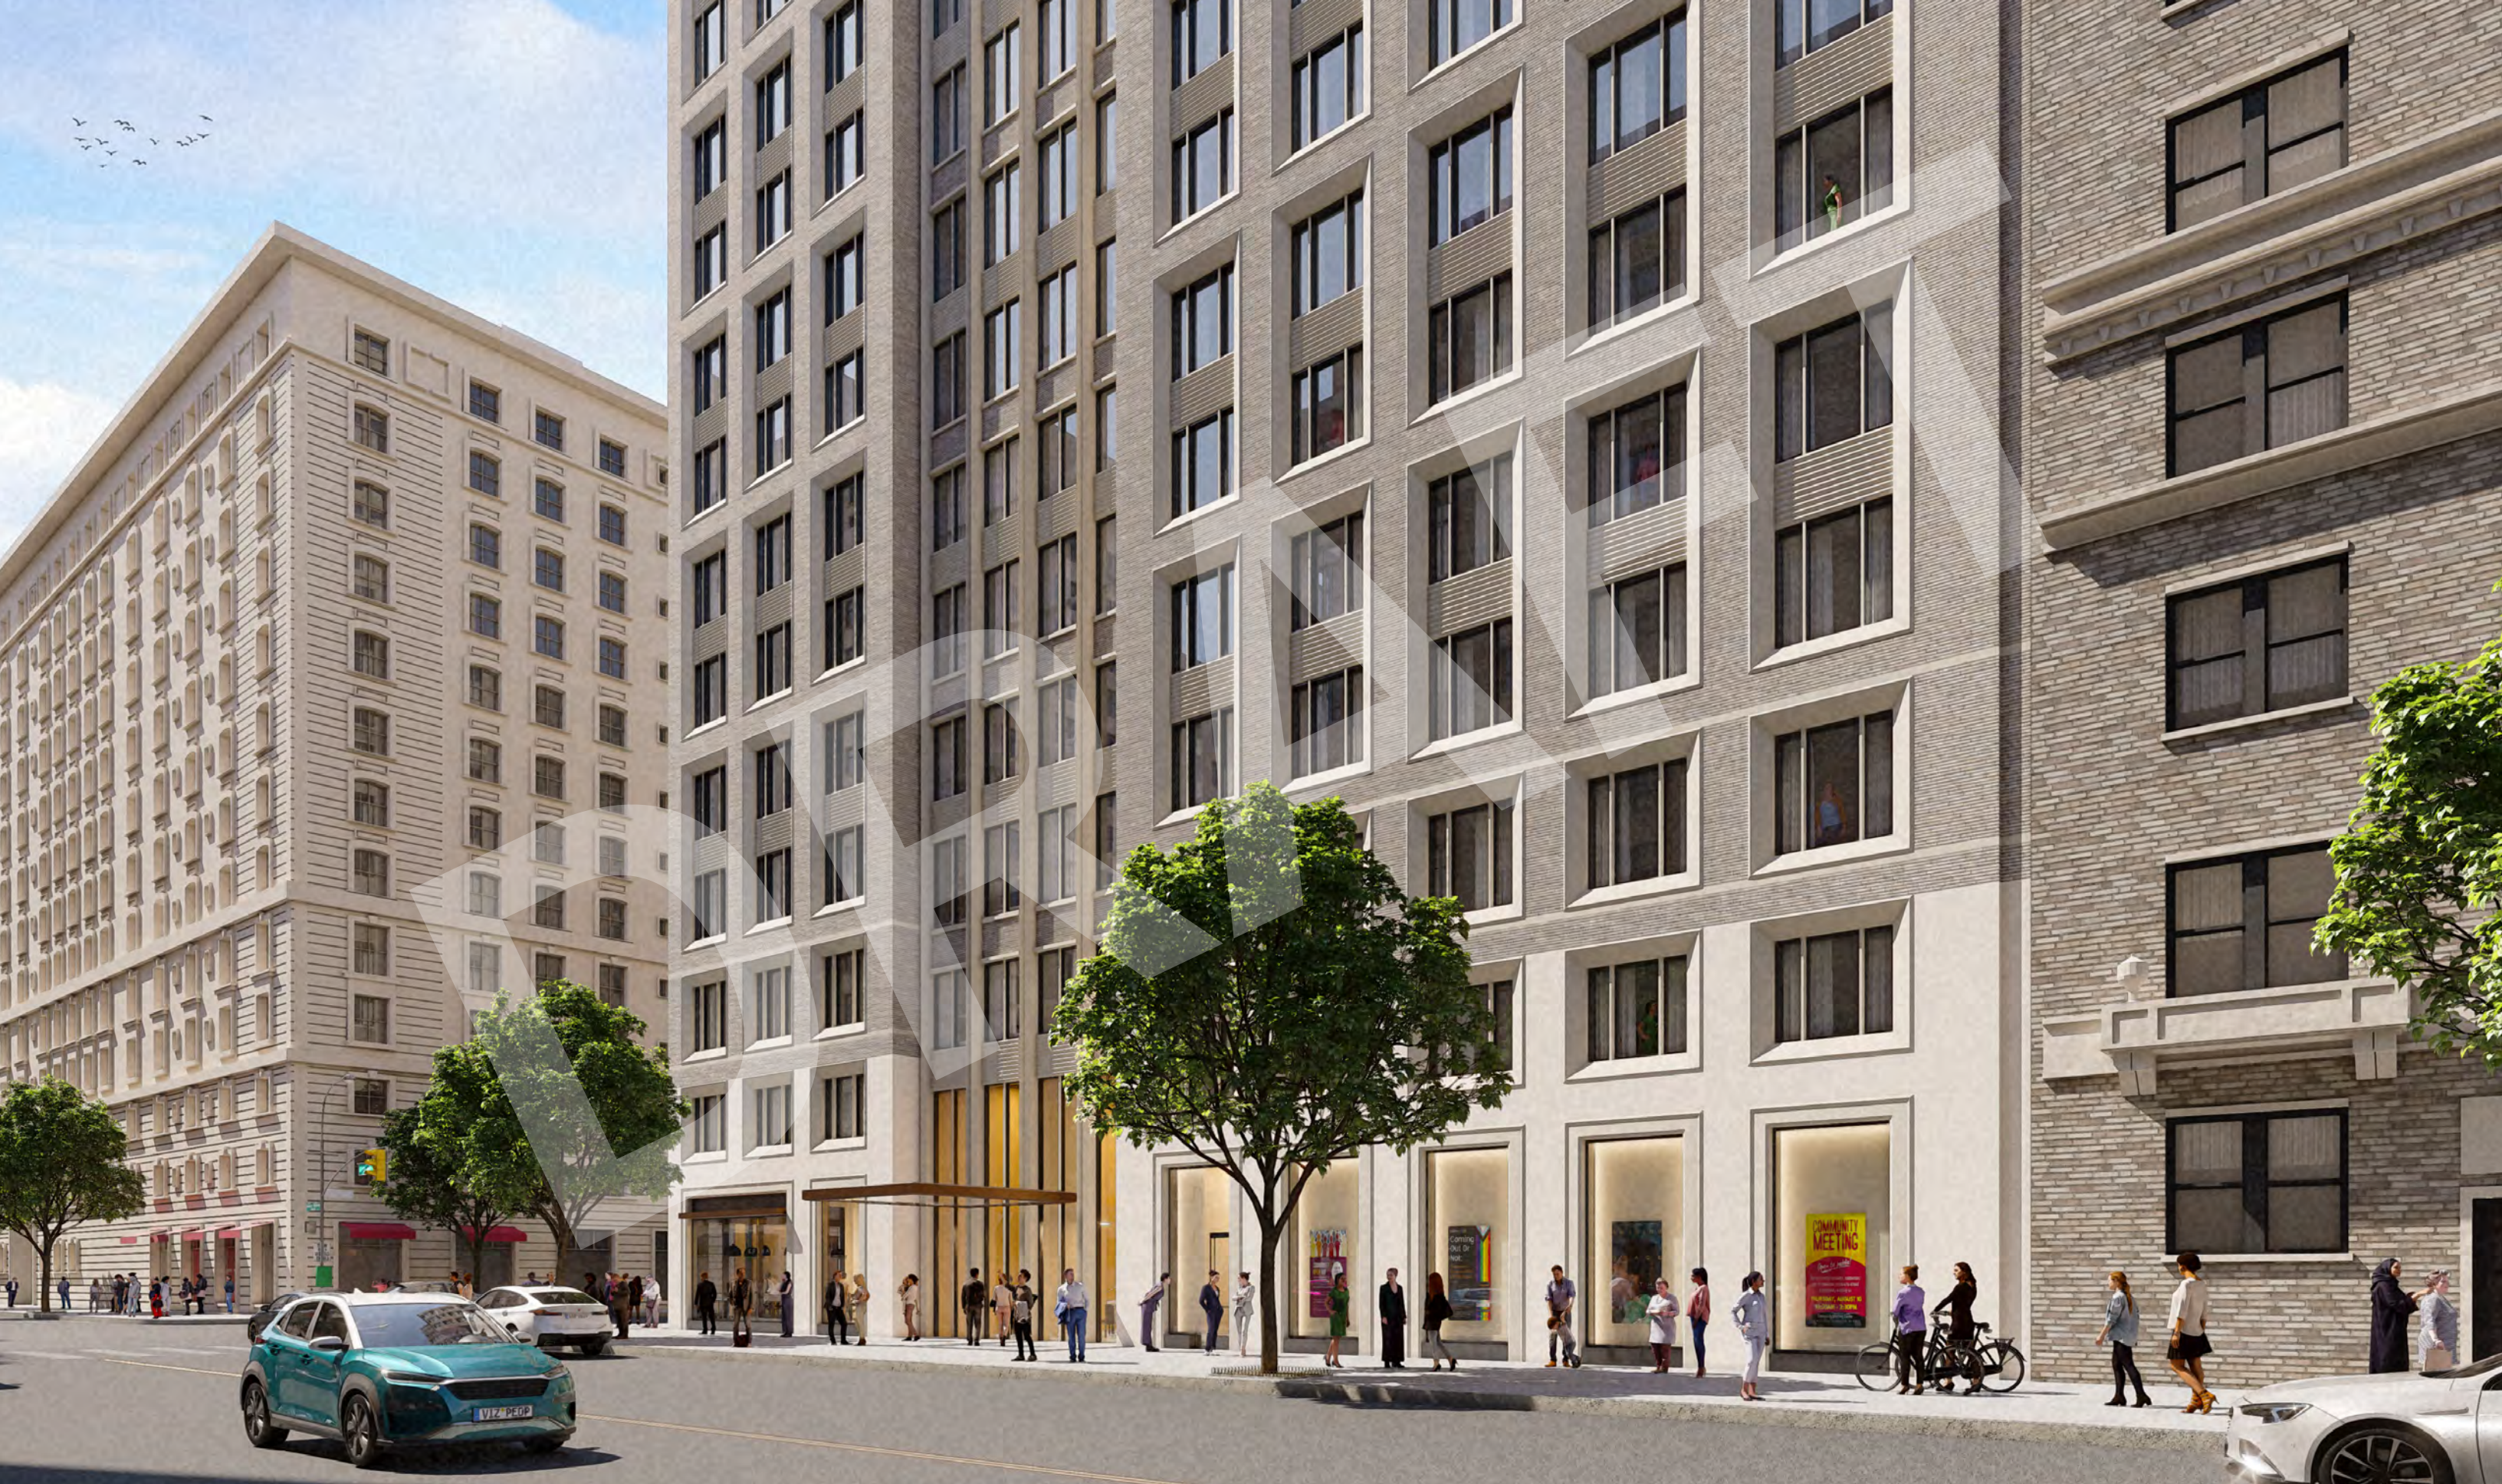
210' (MAX. HEIGHT : 210')

144.25' (MAX. BASE HEIGHT : 150')

AMSTERDAM AVENUE
(100' - WIDE STREET)

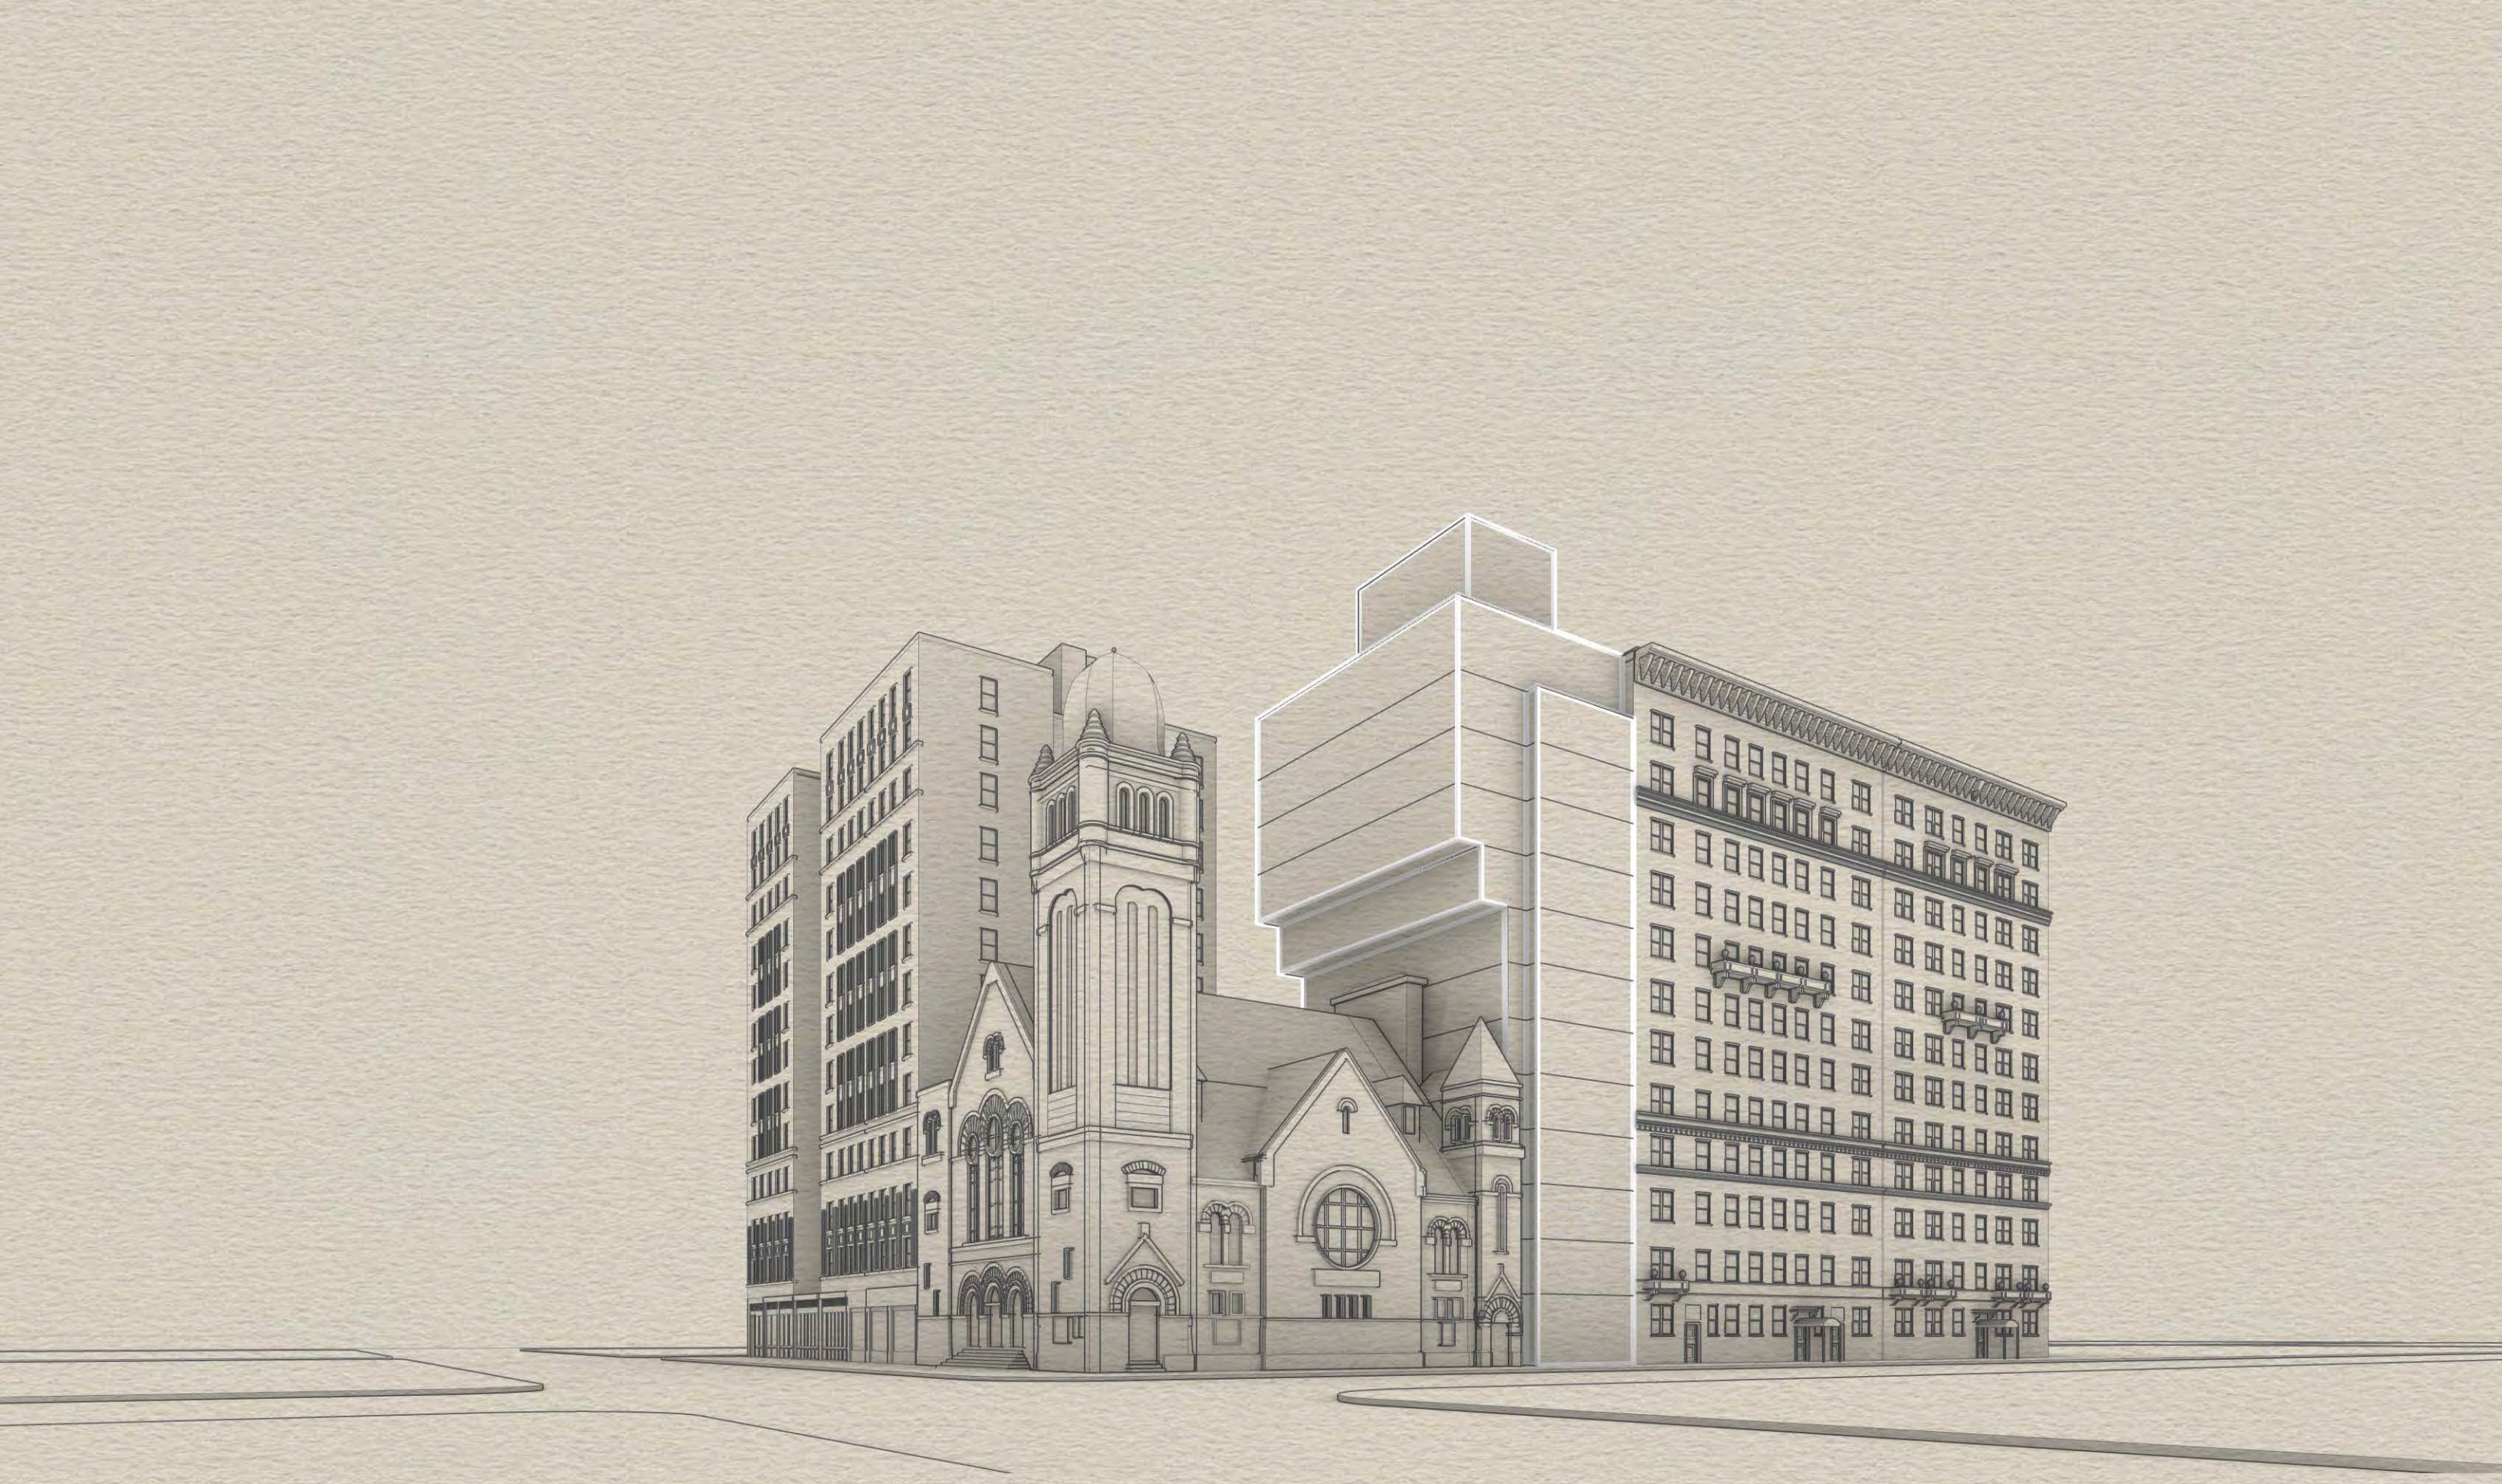
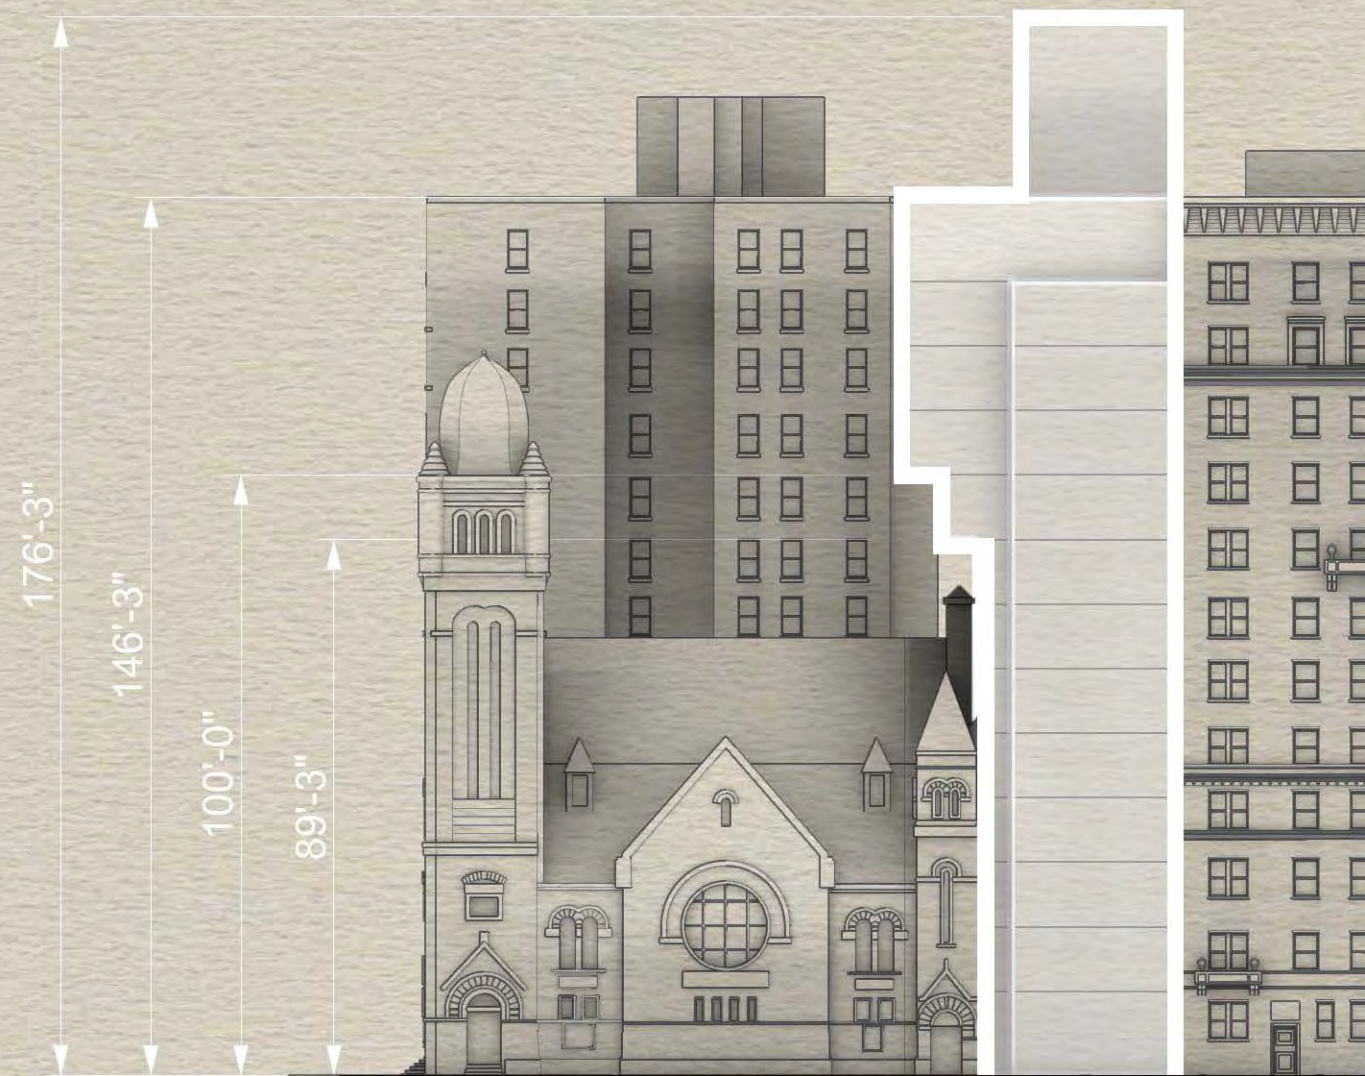
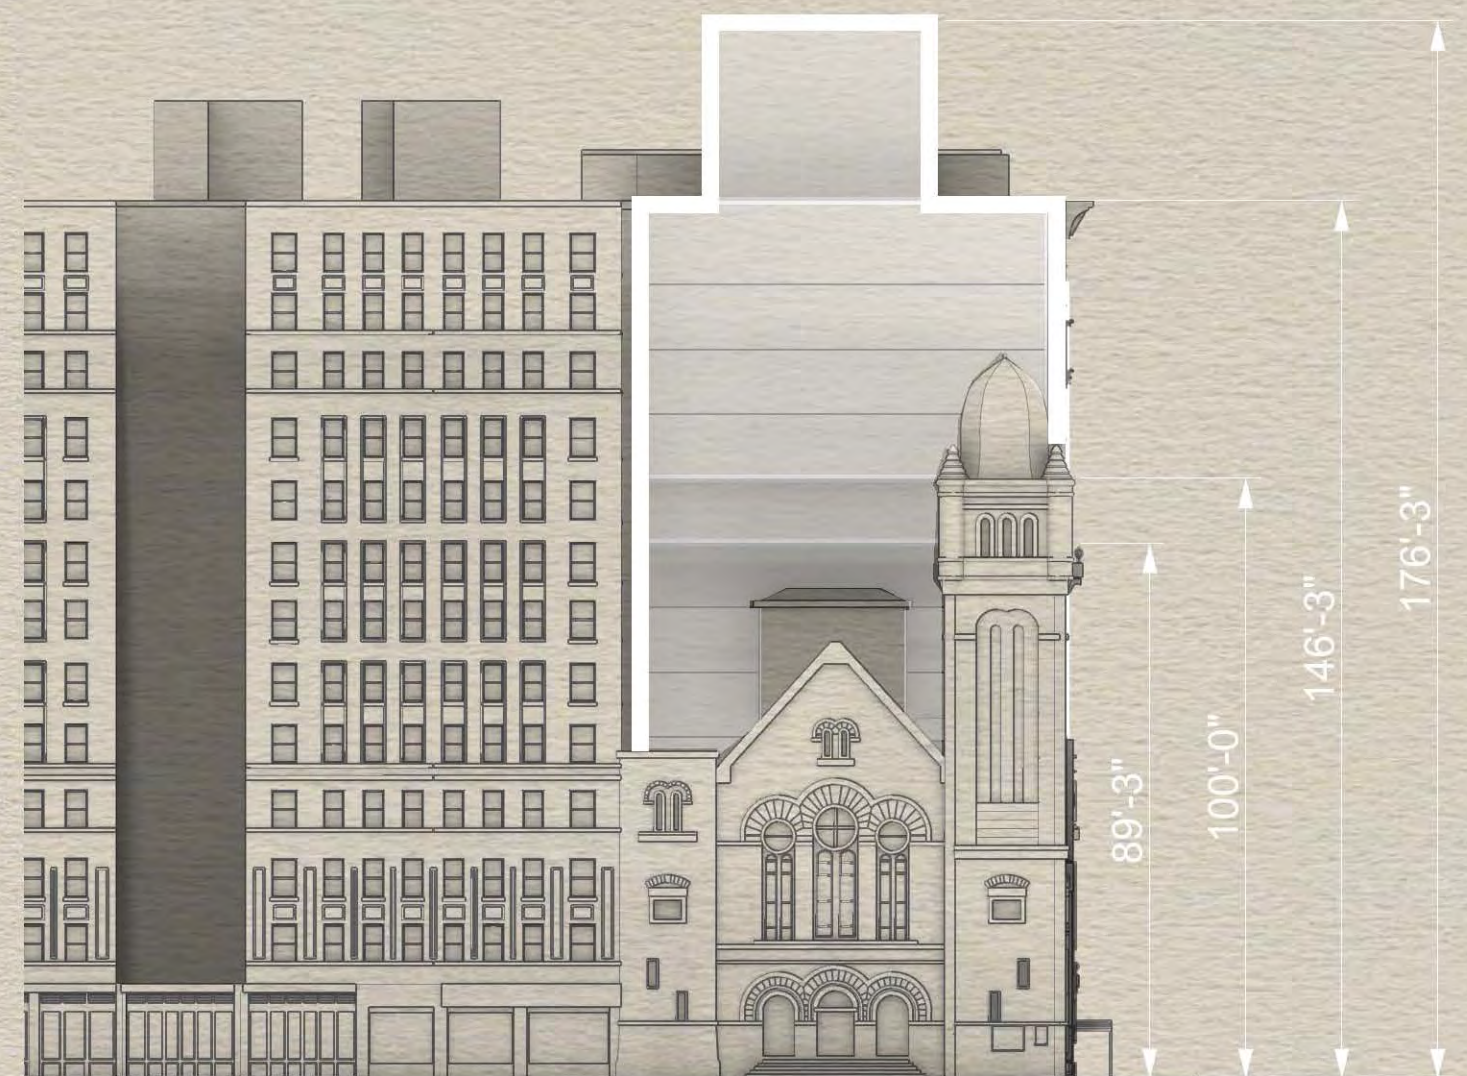
Scenario 2

- Parish House demolished.
- New residential building constructed in its place and cantilevers over sanctuary.
- Sanctuary renovated and used as a community facility.
- New residential building would be costly and complex to construct and would yield small, inefficient floor plans.
- The Existing facade will most likely need to be completely replaced.
- Utilizes only a quarter of the site's allowable area.

SOUTH ELEVATION

WEST ELEVATION
