NORTH MEADOW CENTER

PROJECT PURPOSE

- Renovate public facilities (recreation courts and restrooms)
- Renovate and optimize vitally-needed park operations space
- Site work to support and screen park operations

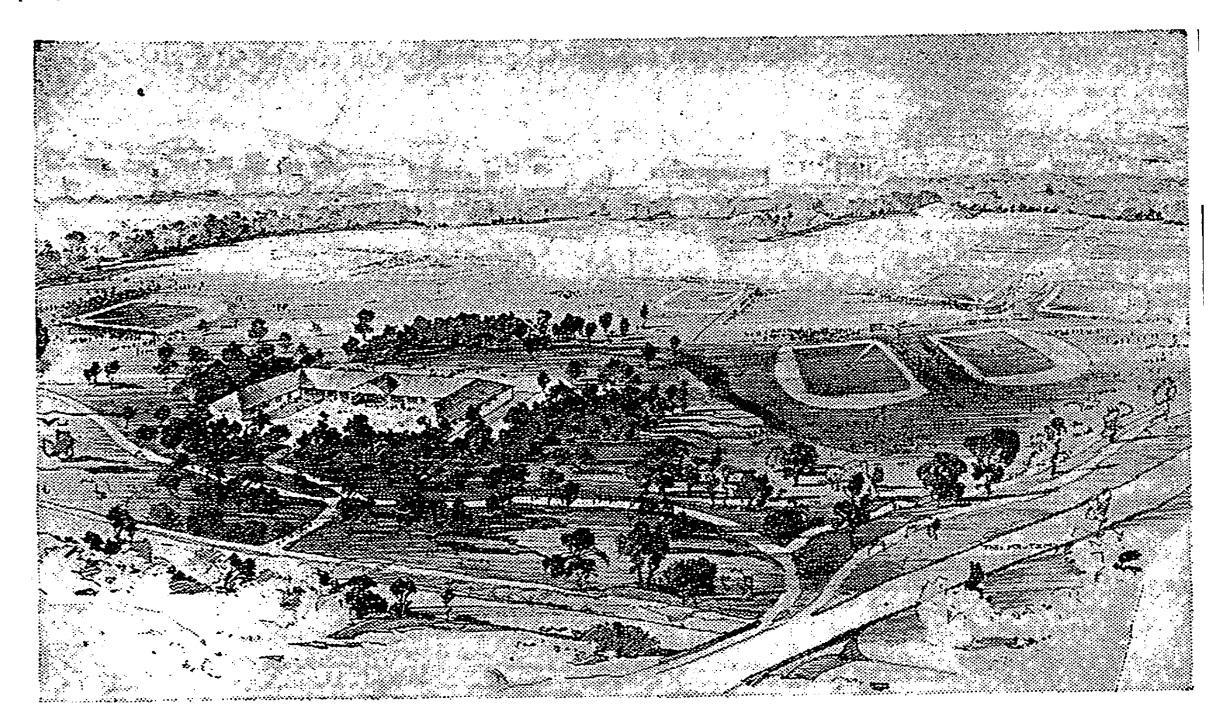
NEW PLAYGROUNDS UNDER CONSTRUCTION IN CENTRAL

An Architect's Drawing Showing a Birdseye View of the Baseball Diamonds and Additional Play Facilities

Now Under Way.

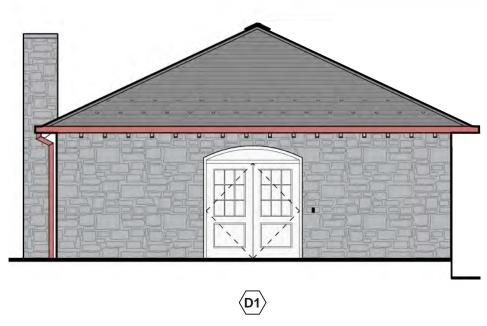
PROPOSED SOUTHWEST

- 1 SLATE ROOF REPAIRS
- 2 SNOW GUARD REPLACEMENT
- (3) MASONRY CLEANING
- 4 SELECT MASONRY REPOINTING
- **5** SELECT MASONRY REPAIRS

- **6** GUTTER AND LEADER REPLACEMENT
- 7 CAST IRON COLUMN RESTORATION
- **8** EXTERIOR LIGHTING REPLACEMENT
- 9 IN KIND WINDOW AND DOOR REPLACEMENT U.O.N.
- 10 NEW FULL HEIGHT WINDOW PANEL @ EXISTING DOOR OPENING

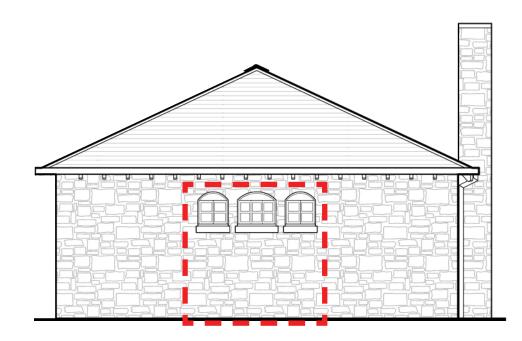
PROPOSED SOUTHEAST

- 11 NEW DOORS @ EXISTING WINDOW OPENINGS. MODIFY MASONRY AS NEEDED.
- 12 TRANSLUCENT FILM APPLIED ON GLAZING AT BATHROOMS / LOCKER ROOMS (SHOWN IN GREY)

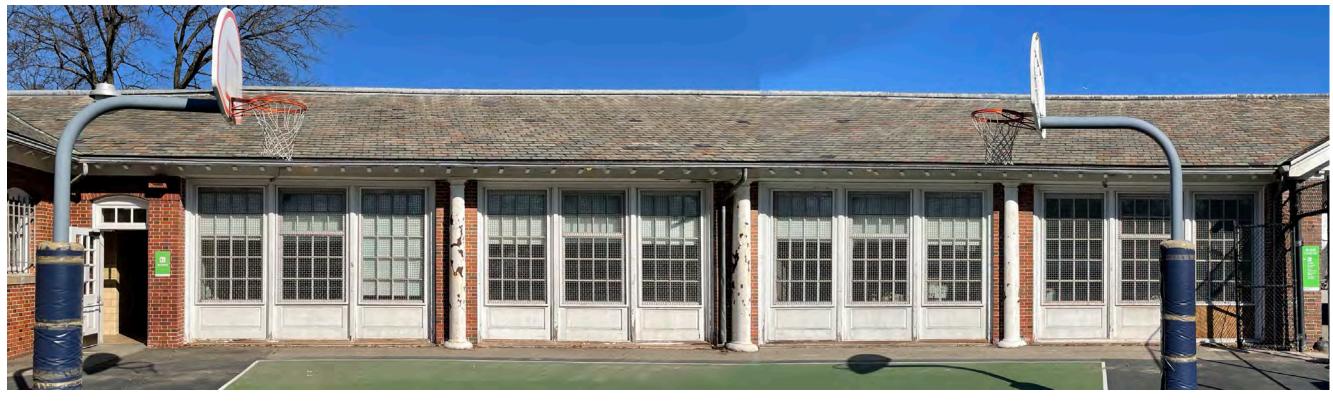
C - COURTYARD SOUTHWEST

- 1 SLATE ROOF REPAIRS
- 2 SNOW GUARD REPLACEMENT
- **3** MASONRY CLEANING
- 4 SELECT MASONRY REPOINTING
- 5 SELECT MASONRY REPAIRS

- **6** GUTTER AND LEADER REPLACEMENT
- 7 CAST IRON COLUMN RESTORATION
- **8** EXTERIOR LIGHTING REPLACEMENT
- 9 IN KIND WINDOW AND DOOR REPLACEMENT U.O.N.
- 10 NEW FULL HEIGHT WINDOW PANEL @ EXISTING DOOR OPENING
- 11 NEW DOORS @ EXISTING WINDOW OPENINGS. MODIFY MASONRY AS NEEDED.
- 12 TRANSLUCENT FILM APPLIED ON GLAZING AT BATHROOMS / LOCKER ROOMS (SHOWN IN GREY)

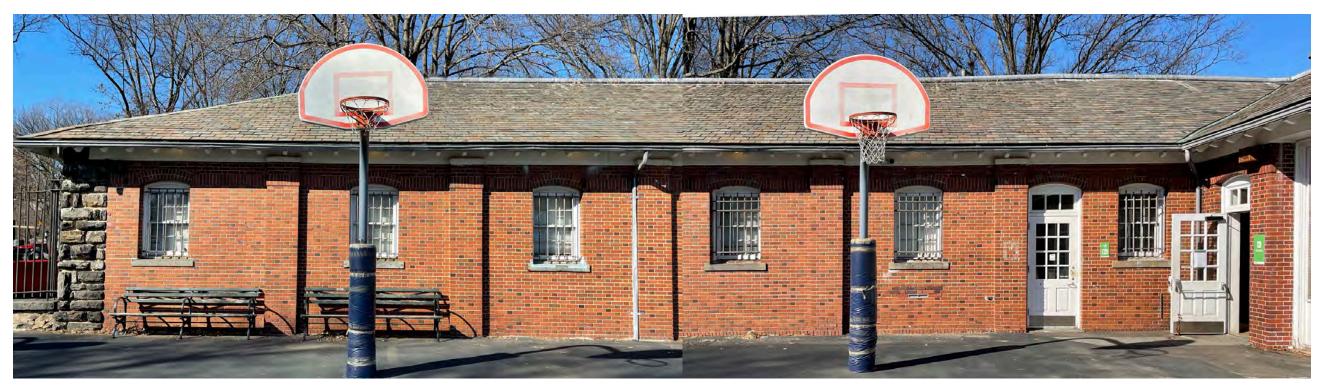
E - COURTYARD WEST

- 1 SLATE ROOF REPAIRS
- 2 SNOW GUARD REPLACEMENT
- 3 MASONRY CLEANING
- 4 SELECT MASONRY REPOINTING
- **5** SELECT MASONRY REPAIRS

- **6** GUTTER AND LEADER REPLACEMENT
- 7 CAST IRON COLUMN RESTORATION
- 8 EXTERIOR LIGHTING REPLACEMENT
- 9 IN KIND WINDOW AND DOOR REPLACEMENT U.O.N.
- 10 NEW FULL HEIGHT WINDOW PANEL @ EXISTING DOOR OPENING
- 11 NEW DOORS @ EXISTING WINDOW OPENINGS. MODIFY MASONRY AS NEEDED.
- 12 TRANSLUCENT FILM APPLIED ON GLAZING AT BATHROOMS / LOCKER ROOMS (SHOWN IN GREY)

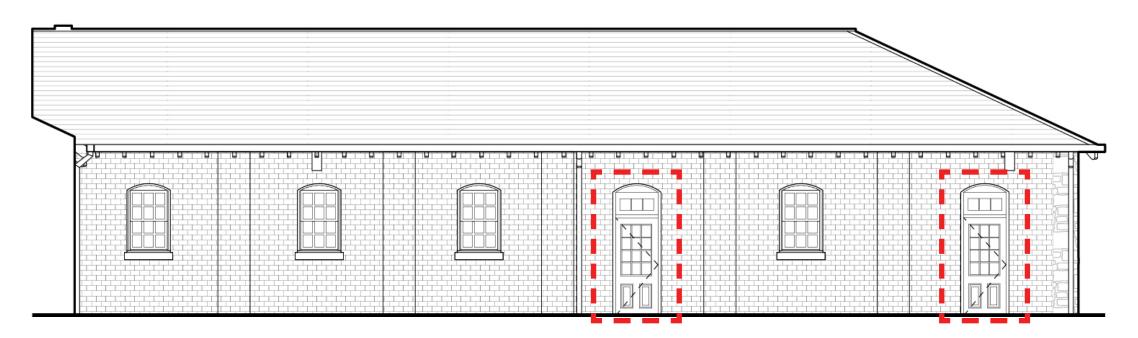
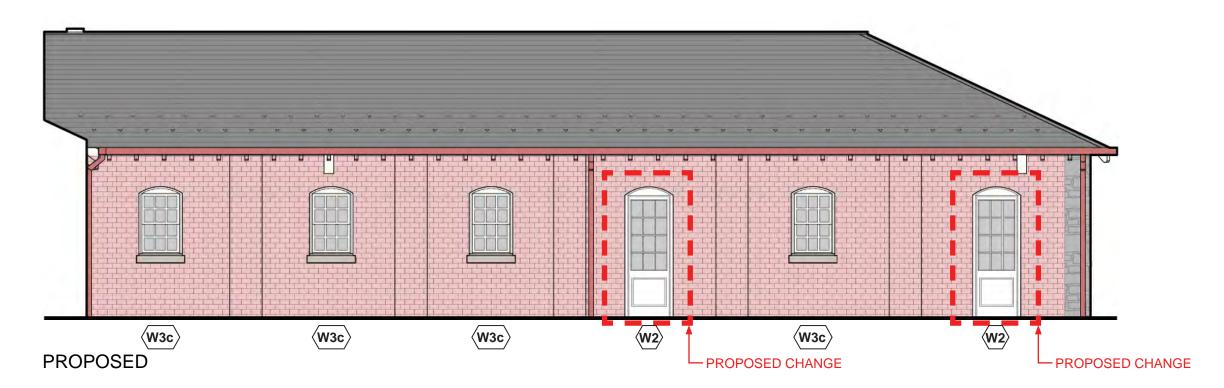
- 1 SLATE ROOF REPAIRS
- 2 SNOW GUARD REPLACEMENT
- **3** MASONRY CLEANING
- 4 SELECT MASONRY REPOINTING
- **5** SELECT MASONRY REPAIRS

- **6** GUTTER AND LEADER REPLACEMENT
- 7 CAST IRON COLUMN RESTORATION
- **8** EXTERIOR LIGHTING REPLACEMENT
- 9 IN KIND WINDOW AND DOOR REPLACEMENT U.O.N.
- 10 NEW FULL HEIGHT WINDOW PANEL @ EXISTING DOOR OPENING
- 11 NEW DOORS @ EXISTING WINDOW OPENINGS. MODIFY MASONRY AS NEEDED.
- 12 TRANSLUCENT FILM APPLIED ON GLAZING AT BATHROOMS / LOCKER ROOMS (SHOWN IN GREY)

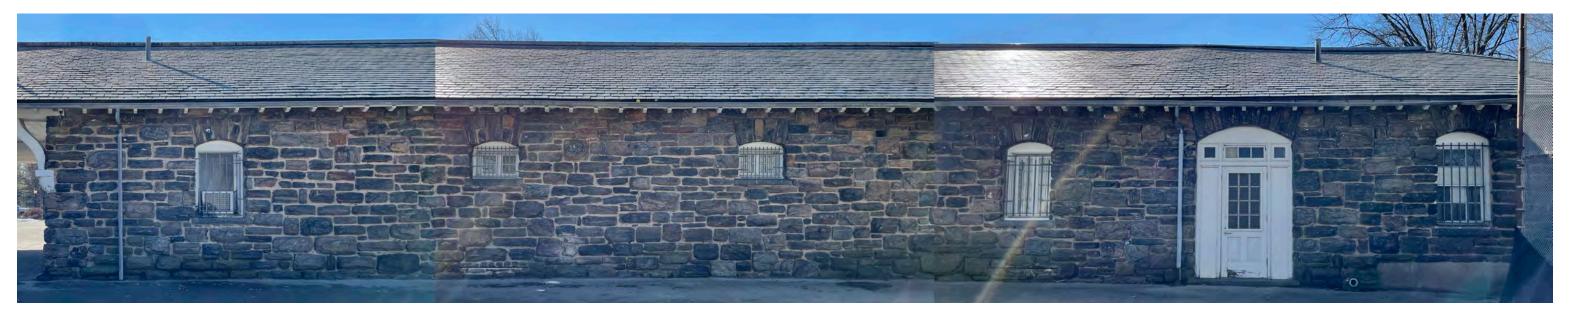
I - NORTH WEST ELEVATION

- 1 SLATE ROOF REPAIRS
- 2 SNOW GUARD REPLACEMENT
- 3 MASONRY CLEANING
- 4 SELECT MASONRY REPOINTING
- **5** SELECT MASONRY REPAIRS

- 6 GUTTER AND LEADER REPLACEMENT
- 7 CAST IRON COLUMN RESTORATION
- 8 EXTERIOR LIGHTING REPLACEMENT
- (9) IN KIND WINDOW AND DOOR REPLACEMENT U.O.N.
- 10 NEW FULL HEIGHT WINDOW PANEL @ EXISTING DOOR OPENING
- 11 NEW DOORS @ EXISTING WINDOW OPENINGS. MODIFY MASONRY AS NEEDED.
- 12 TRANSLUCENT FILM APPLIED ON GLAZING AT BATHROOMS / LOCKER ROOMS (SHOWN IN GREY)

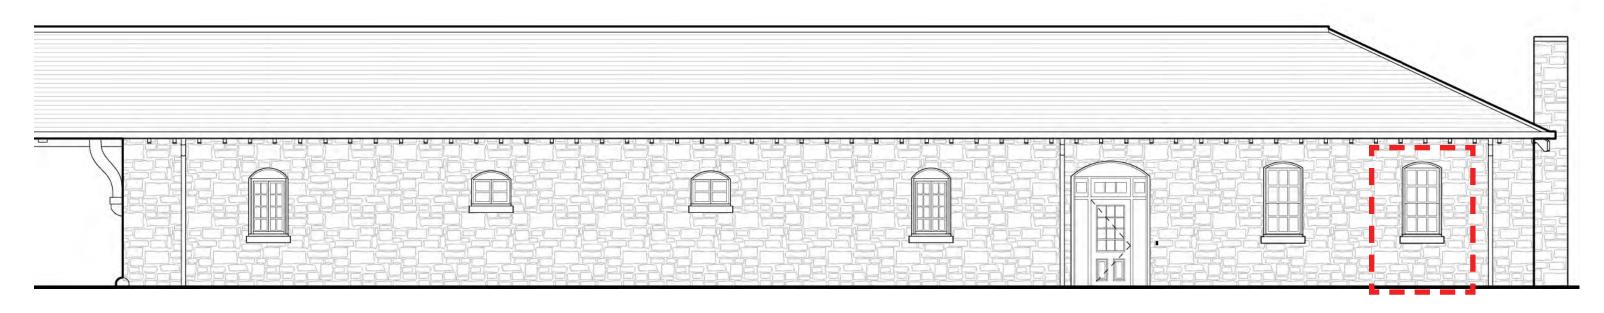
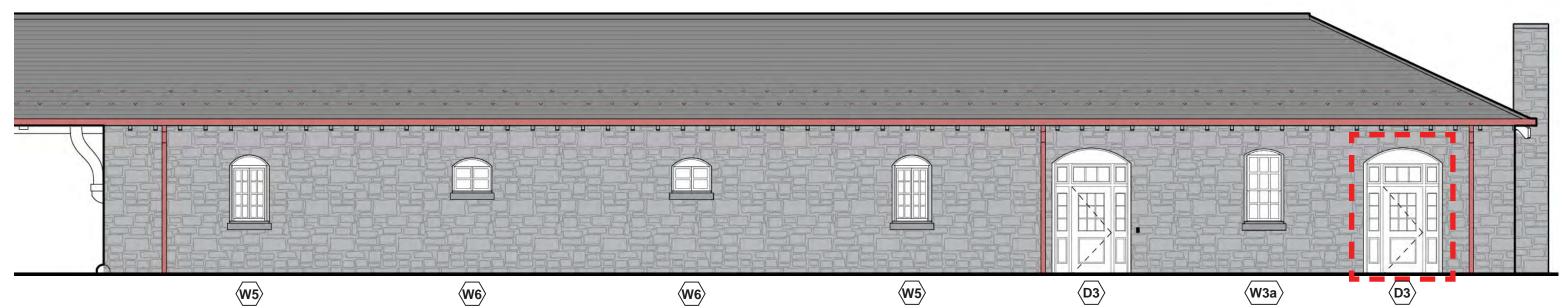
PROPOSED

- 1 SLATE ROOF REPAIRS
- 2 SNOW GUARD REPLACEMENT
- 3 MASONRY CLEANING
- 4 SELECT MASONRY REPOINTING
- 5 SELECT MASONRY REPAIRS

- **6** GUTTER AND LEADER REPLACEMENT
- 7 CAST IRON COLUMN RESTORATION
- 8 EXTERIOR LIGHTING REPLACEMENT
- 9 IN KIND WINDOW AND DOOR REPLACEMENT U.O.N.
- 10 NEW FULL HEIGHT WINDOW PANEL @ EXISTING DOOR OPENING
- 11 NEW DOORS @ EXISTING WINDOW OPENINGS. MODIFY MASONRY AS NEEDED.
- 12 TRANSLUCENT FILM APPLIED ON GLAZING AT BATHROOMS / LOCKER ROOMS (SHOWN IN GREY)

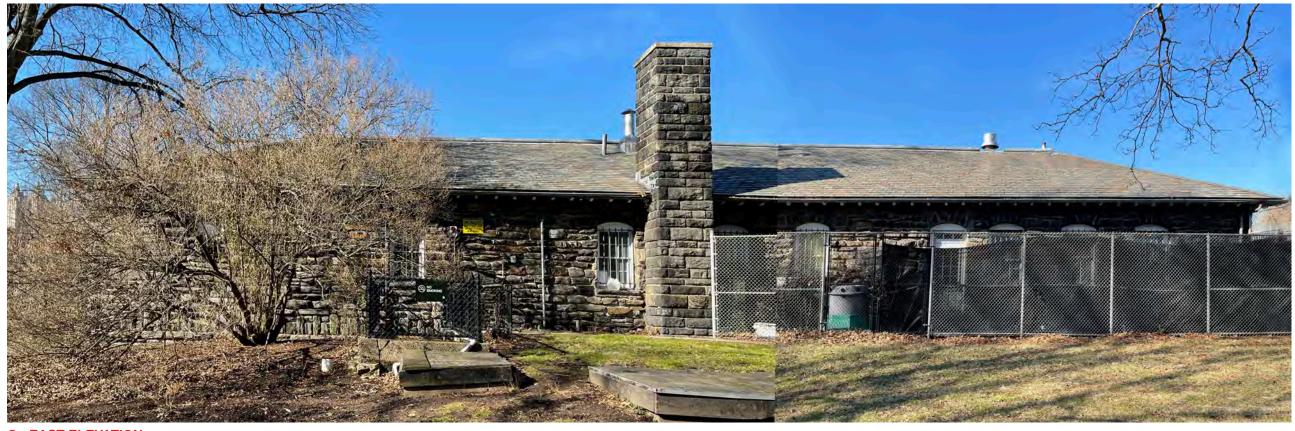
G - EAST ELEVATION

- 2 SNOW GUARD REPLACEMENT
- **3** MASONRY CLEANING
- 4 SELECT MASONRY REPOINTING
- **5** SELECT MASONRY REPAIRS

- **6** GUTTER AND LEADER REPLACEMENT
- 7 CAST IRON COLUMN RESTORATION
- **8** EXTERIOR LIGHTING REPLACEMENT
- 9 IN KIND WINDOW AND DOOR REPLACEMENT U.O.N.
- 10 NEW FULL HEIGHT WINDOW PANEL @ EXISTING DOOR OPENING
- 11 NEW DOORS @ EXISTING WINDOW OPENINGS. MODIFY MASONRY AS NEEDED.
- 12 TRANSLUCENT FILM APPLIED ON GLAZING AT BATHROOMS / LOCKER ROOMS (SHOWN IN GREY)

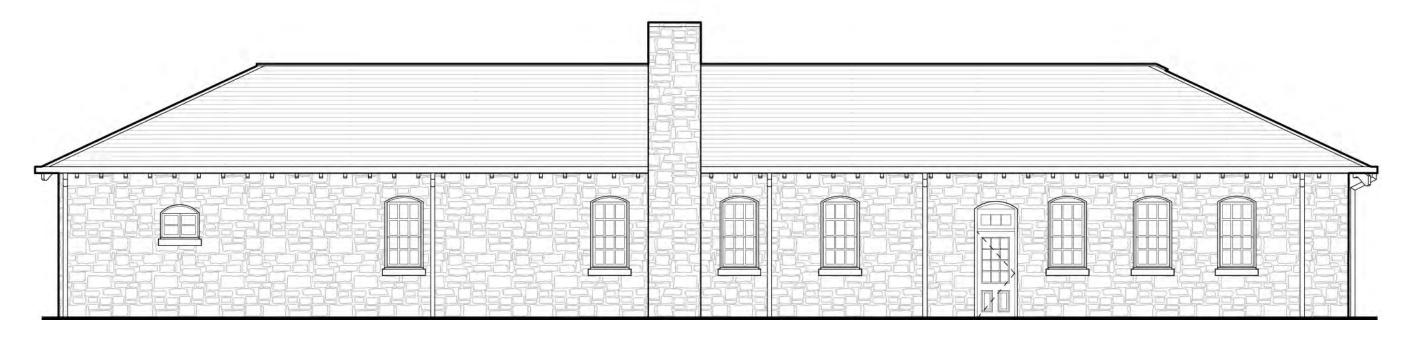
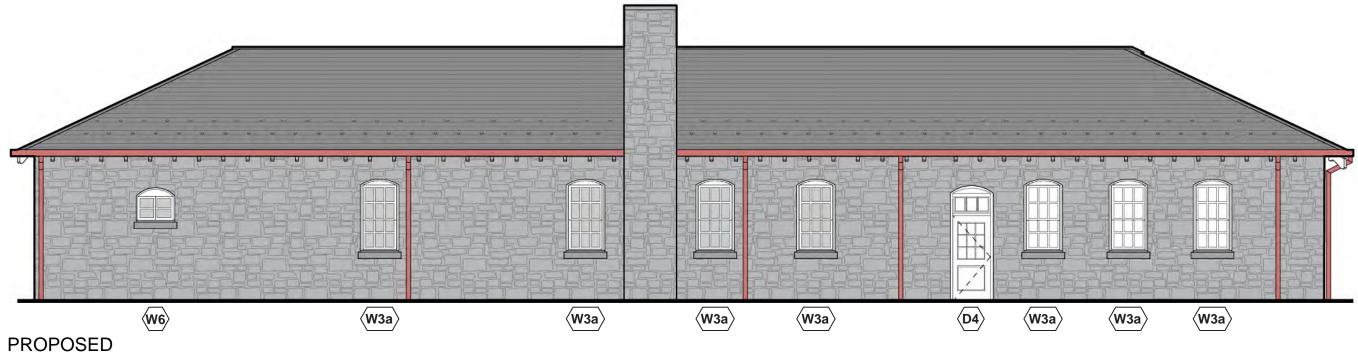
1 SLATE ROOF REPAIRS

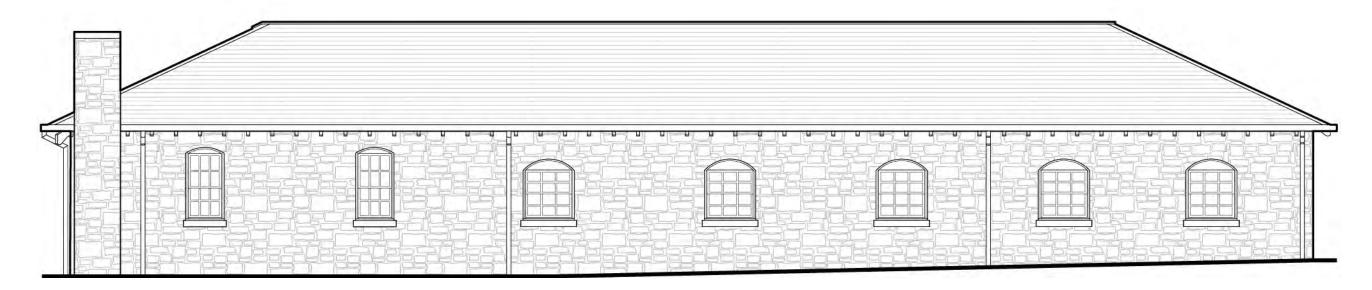
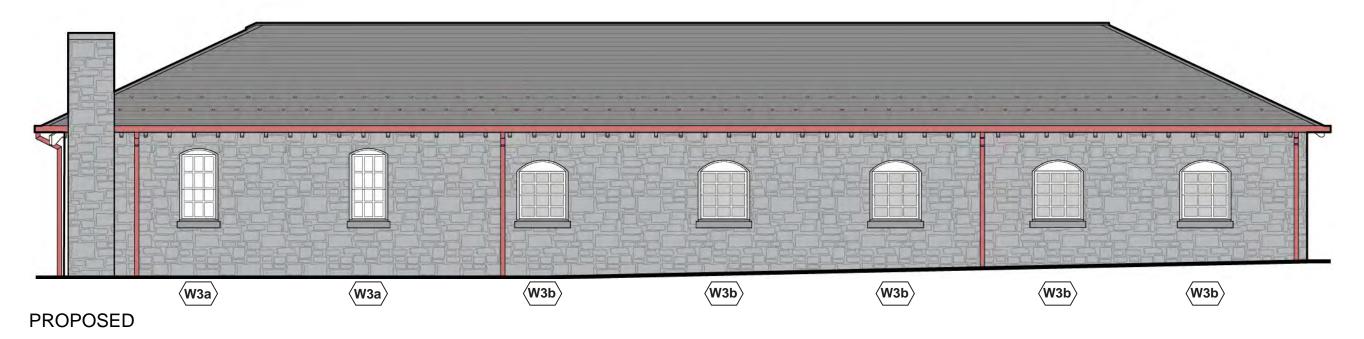
- 1 SLATE ROOF REPAIRS
- 2 SNOW GUARD REPLACEMENT
- 3 MASONRY CLEANING
- 4 SELECT MASONRY REPOINTING
- 5 SELECT MASONRY REPAIRS

- 6 GUTTER AND LEADER REPLACEMENT
- 7 CAST IRON COLUMN RESTORATION
- **8** EXTERIOR LIGHTING REPLACEMENT
- (9) IN KIND WINDOW AND DOOR REPLACEMENT U.O.N.
- 10 NEW FULL HEIGHT WINDOW PANEL @ EXISTING DOOR OPENING
- 11 NEW DOORS @ EXISTING WINDOW OPENINGS.
 MODIFY MASONRY AS NEEDED.
- 12 TRANSLUCENT FILM APPLIED ON GLAZING AT BATHROOMS / LOCKER ROOMS (SHOWN IN GREY)

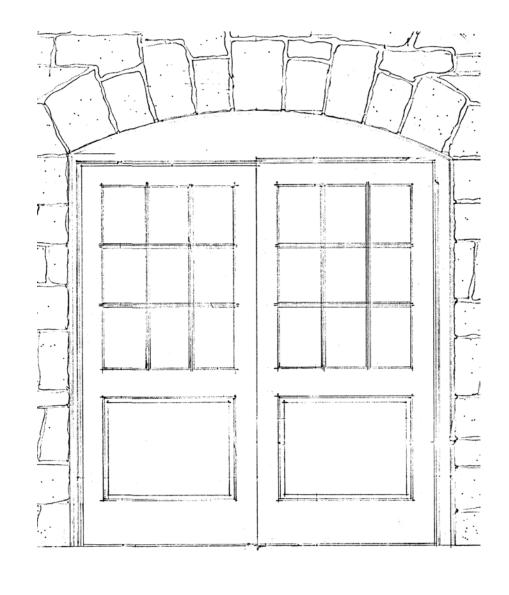
HISTORIC ELEVATION 1936 DOOR PROFILE

PROPOSED ELEVATION
PROFILE TO MATCH 1936 DOOR PROFILE

*ALL DIMENSIONS TO BE V.I.F.

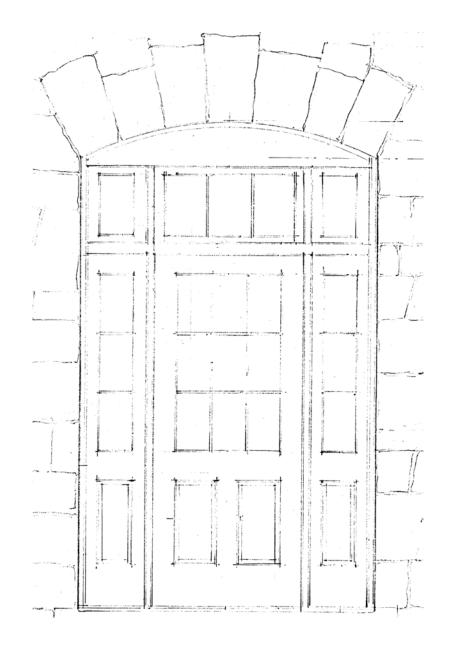
HISTORIC ELEVATION 1936 DOOR PROFILE

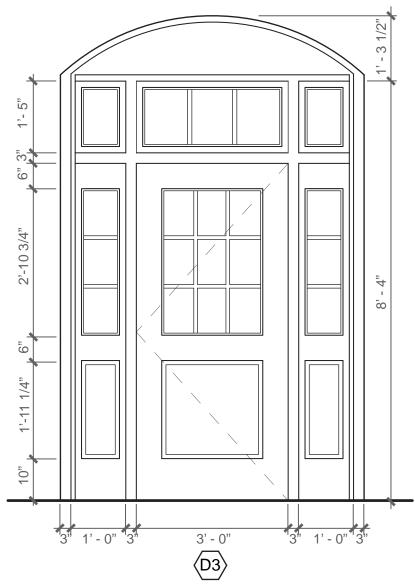
PROPOSED ELEVATION
PROFILE TO MATCH 1936 DOOR PROFILE

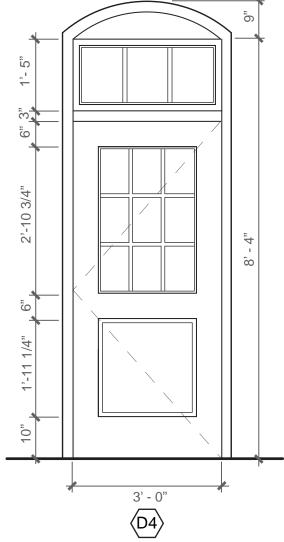
PROPOSED ELEVATION
PROFILE TO MATCH 1936 DOOR PROFILE

*ALL DIMENSIONS TO BE V.I.F.

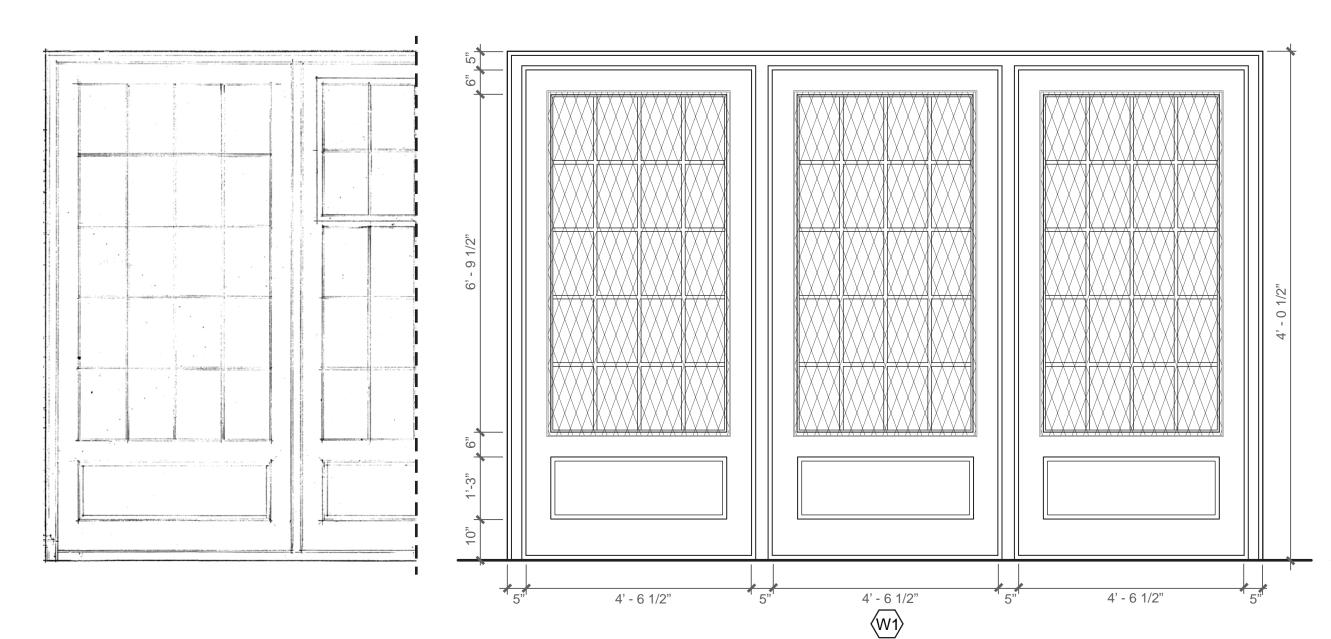
PROPOSED ELEVATIONFIXED WINDOW WITH PANEL

PROPOSED ELEVATION
PROFILE TO MATCH EXISTING
FIXED WINDOW TO REPLACE OPERABLE WINDOW
LIGHTWEIGHT STEEL MESH REPLACING GRILLES

*ALL DIMENSIONS TO BE V.I.F.
*TRANSLUCENT FILM APPLIED ON INTERIOR OF
GLAZING AT RESTROOMS AND LOCKERS

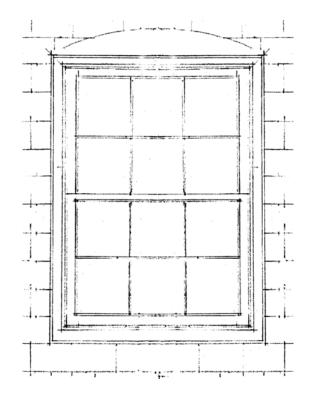
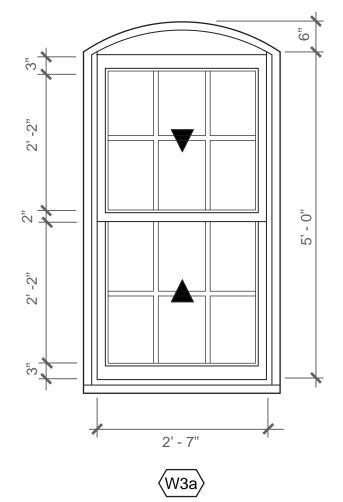
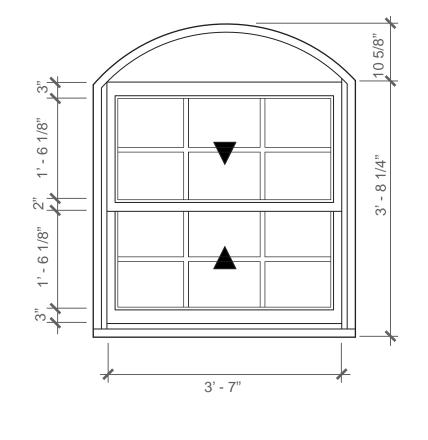
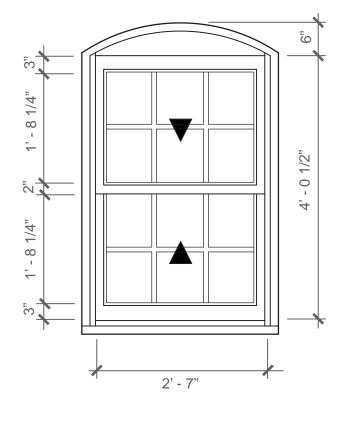
HISTORIC ELEVATION
1936 DOUBLE HUNG WINDOW PROFILE

PROPOSED ELEVATION
PROFILE TO MATCH EXISTING DOUBLE HUNG

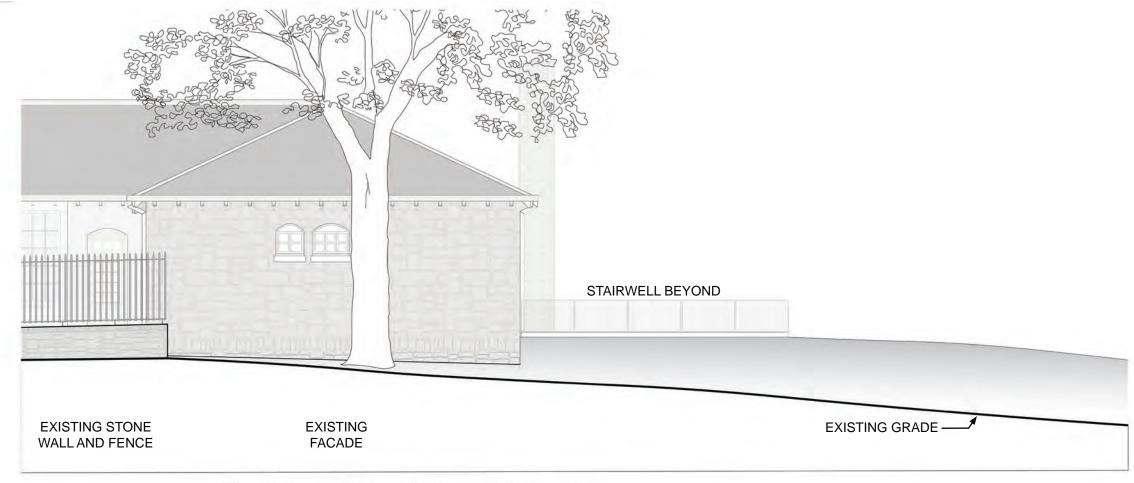
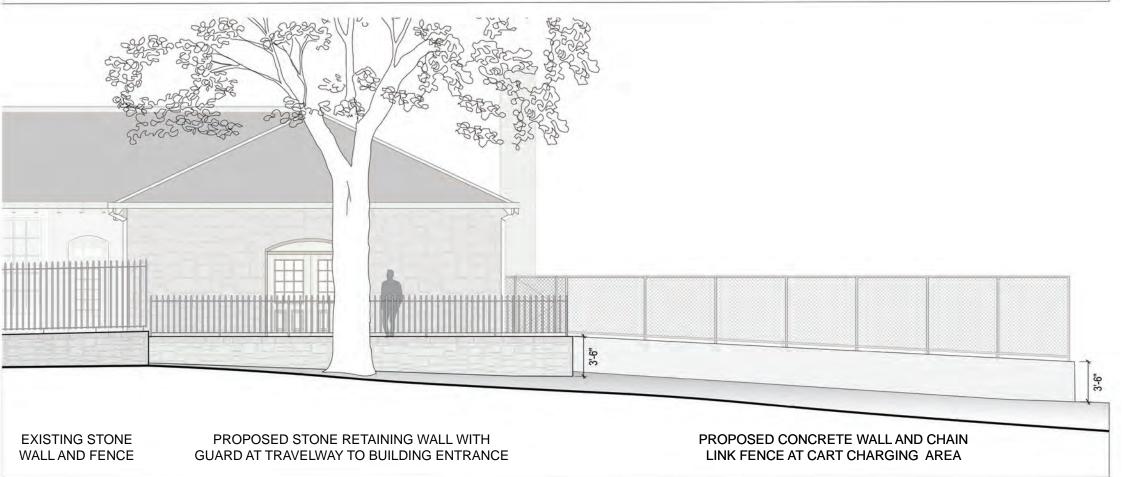
PROPOSED

SOUTH ELEVATION

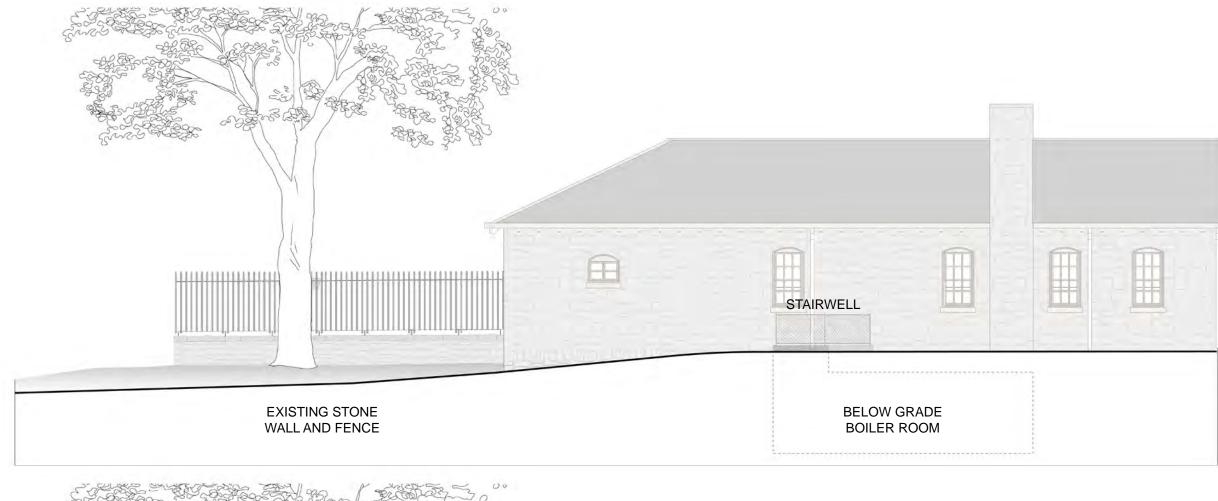
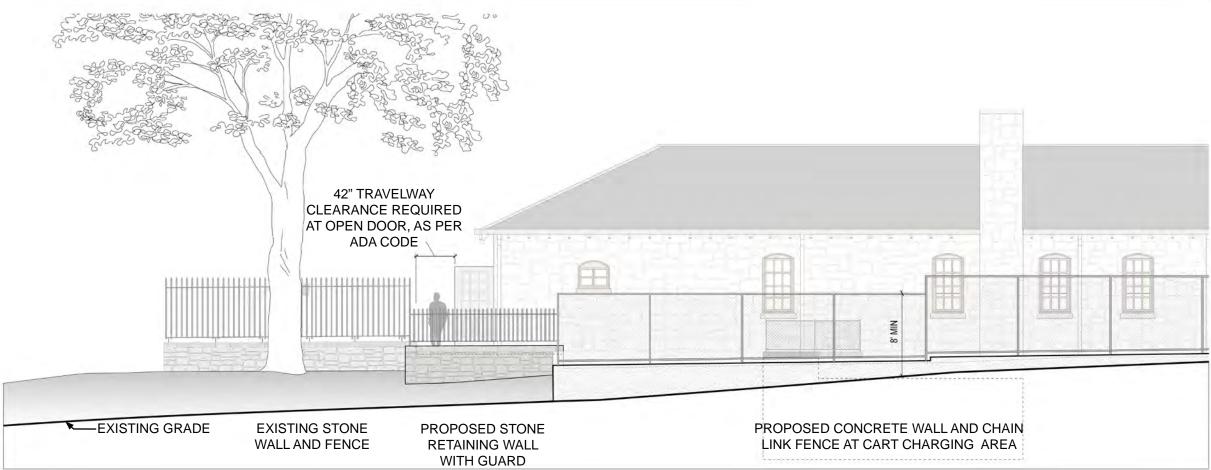
PROPOSED
