6 West 95th Street

New York, NY - June 29, 2022

Aerial Views of Block 1208 Showing Multiple Rooftop & Rear Additions - Rooftop Additions Highlighted in Red (Bing Maps, 2022)

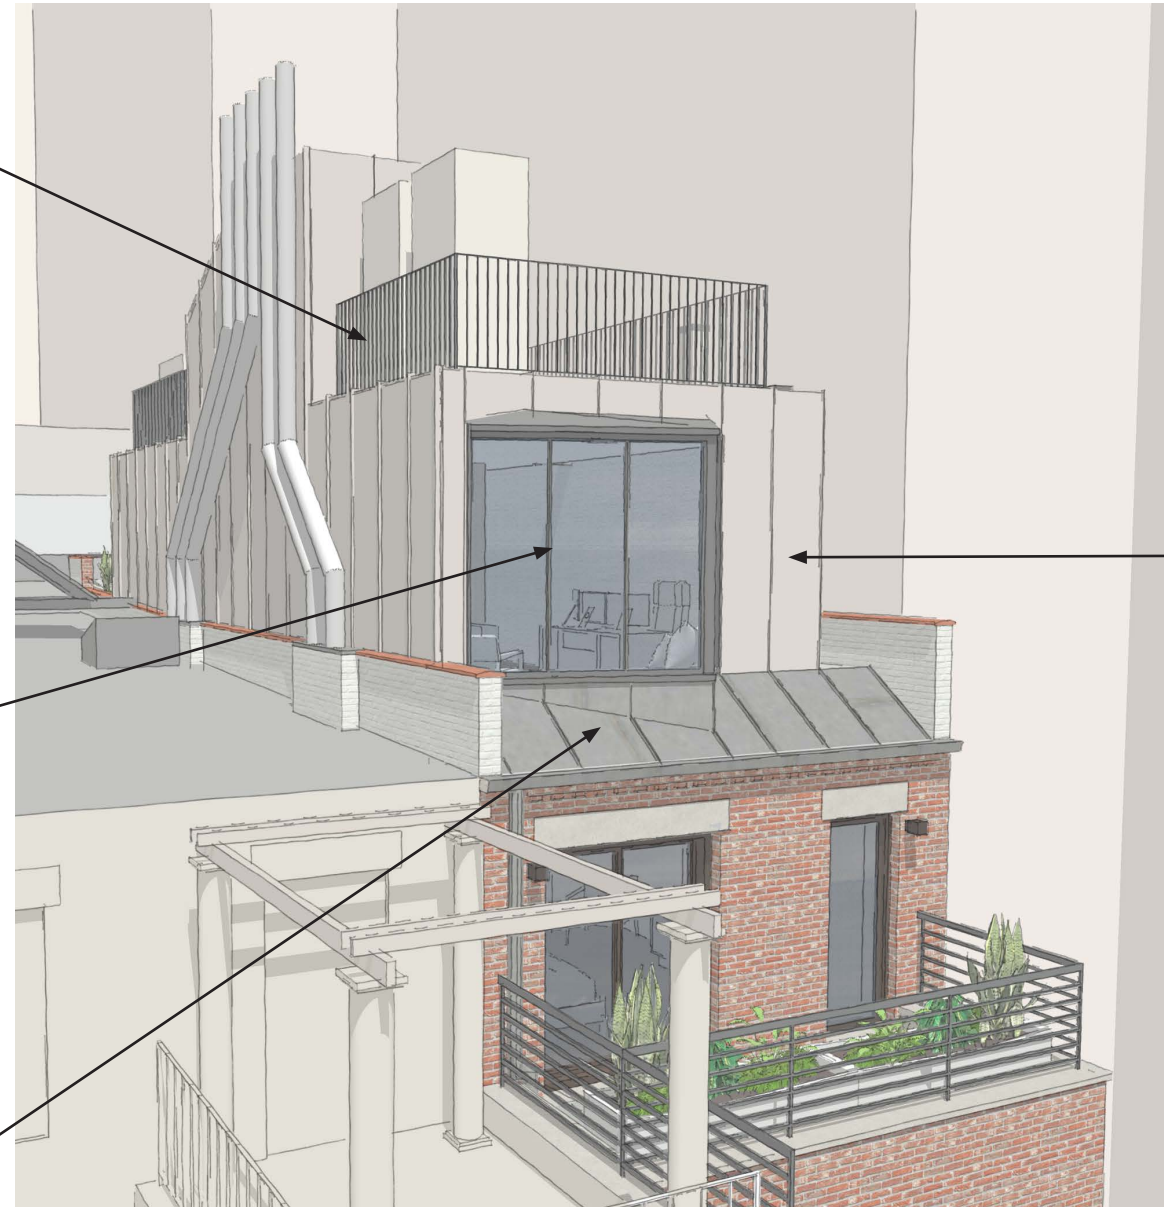
Reveal panel detail

Standing seam detail

Painted metal rainscreen panels.

Painted Metal Rainscreen & Pre-Cast Lintels
Light grey / beige color palette

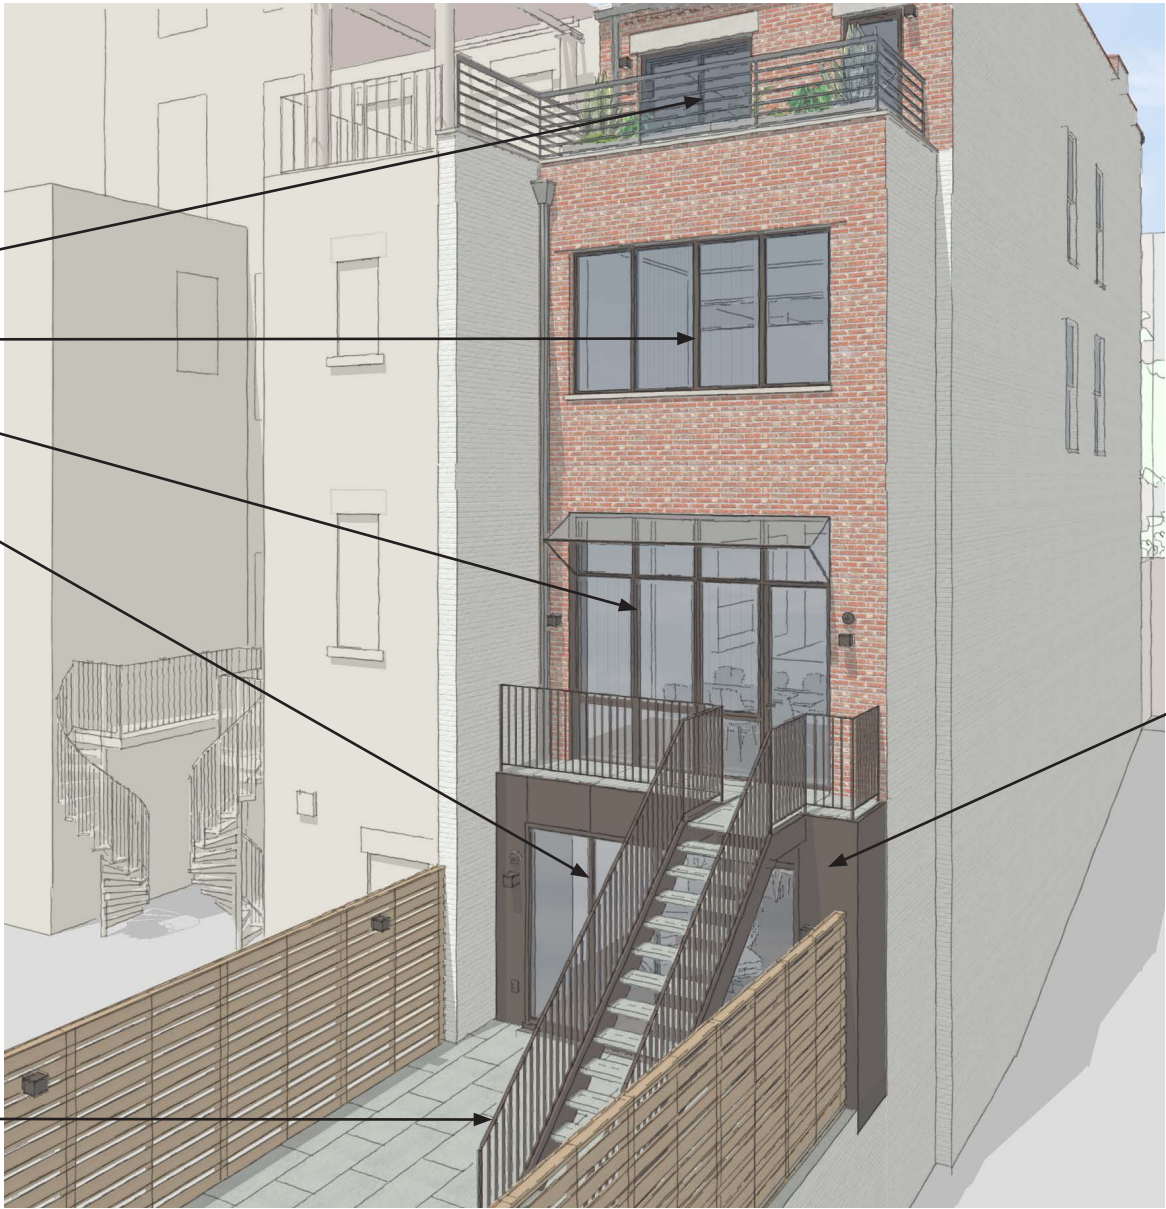
Reveal panel detail

Standing seam detail

Painted metal rainscreen panels.

Metal Rainscreen, Stair Stringer, Metal Railing
Dark Bronze-Black paint color palette

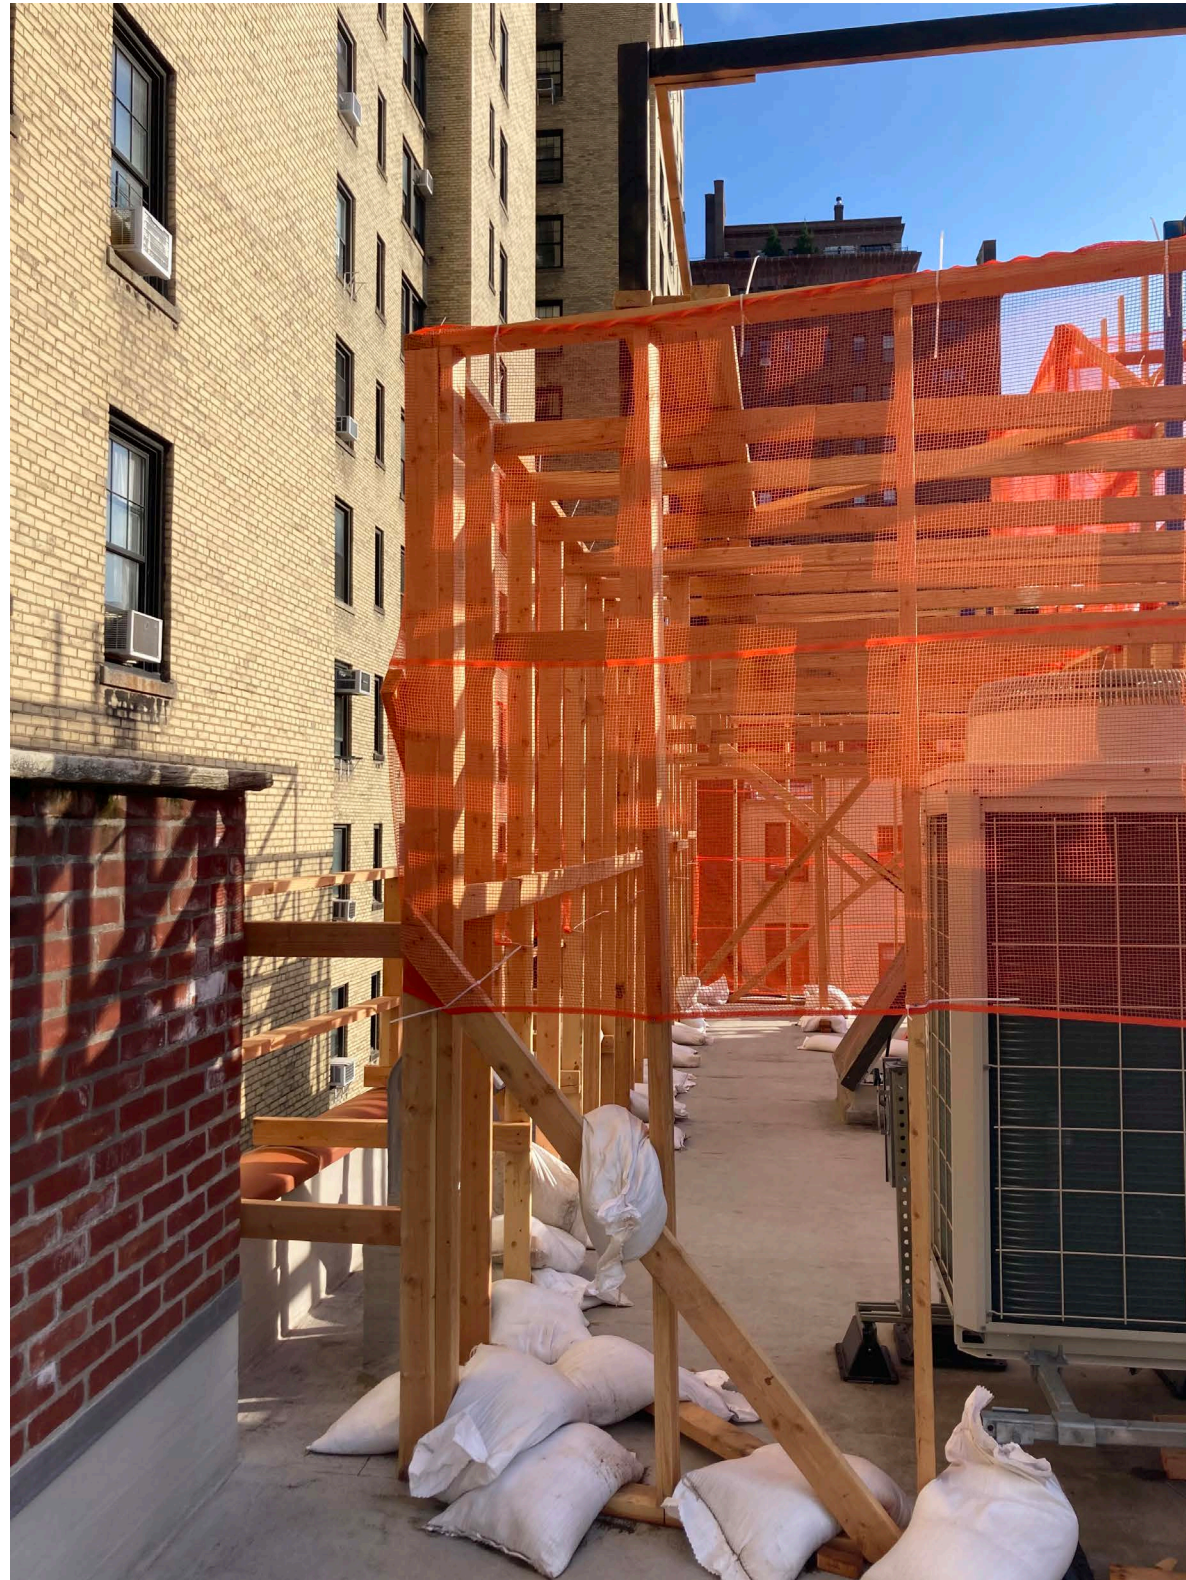
North-East Corner: Showing proposed additional story, guardrail, & raised parapet heights

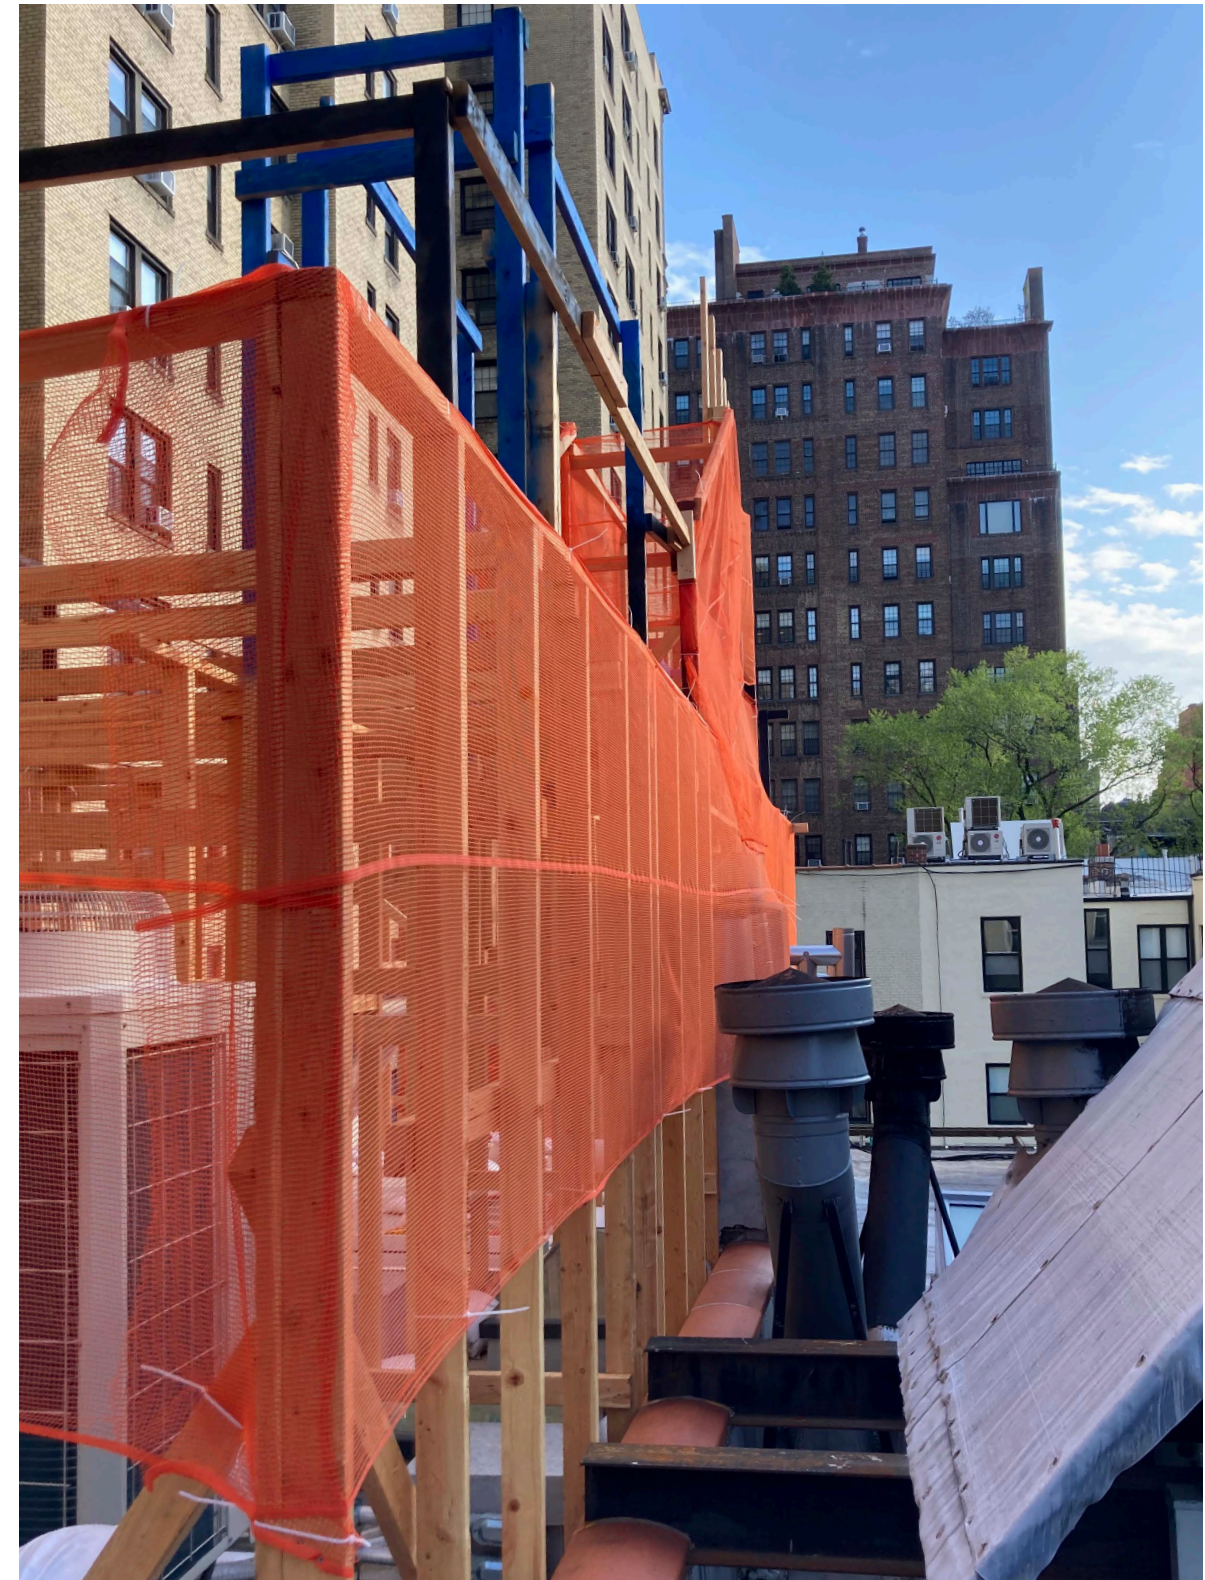
North-West Corner: Showing proposed additional story, bulkhead, MEP units, guardrail, & chimney flues

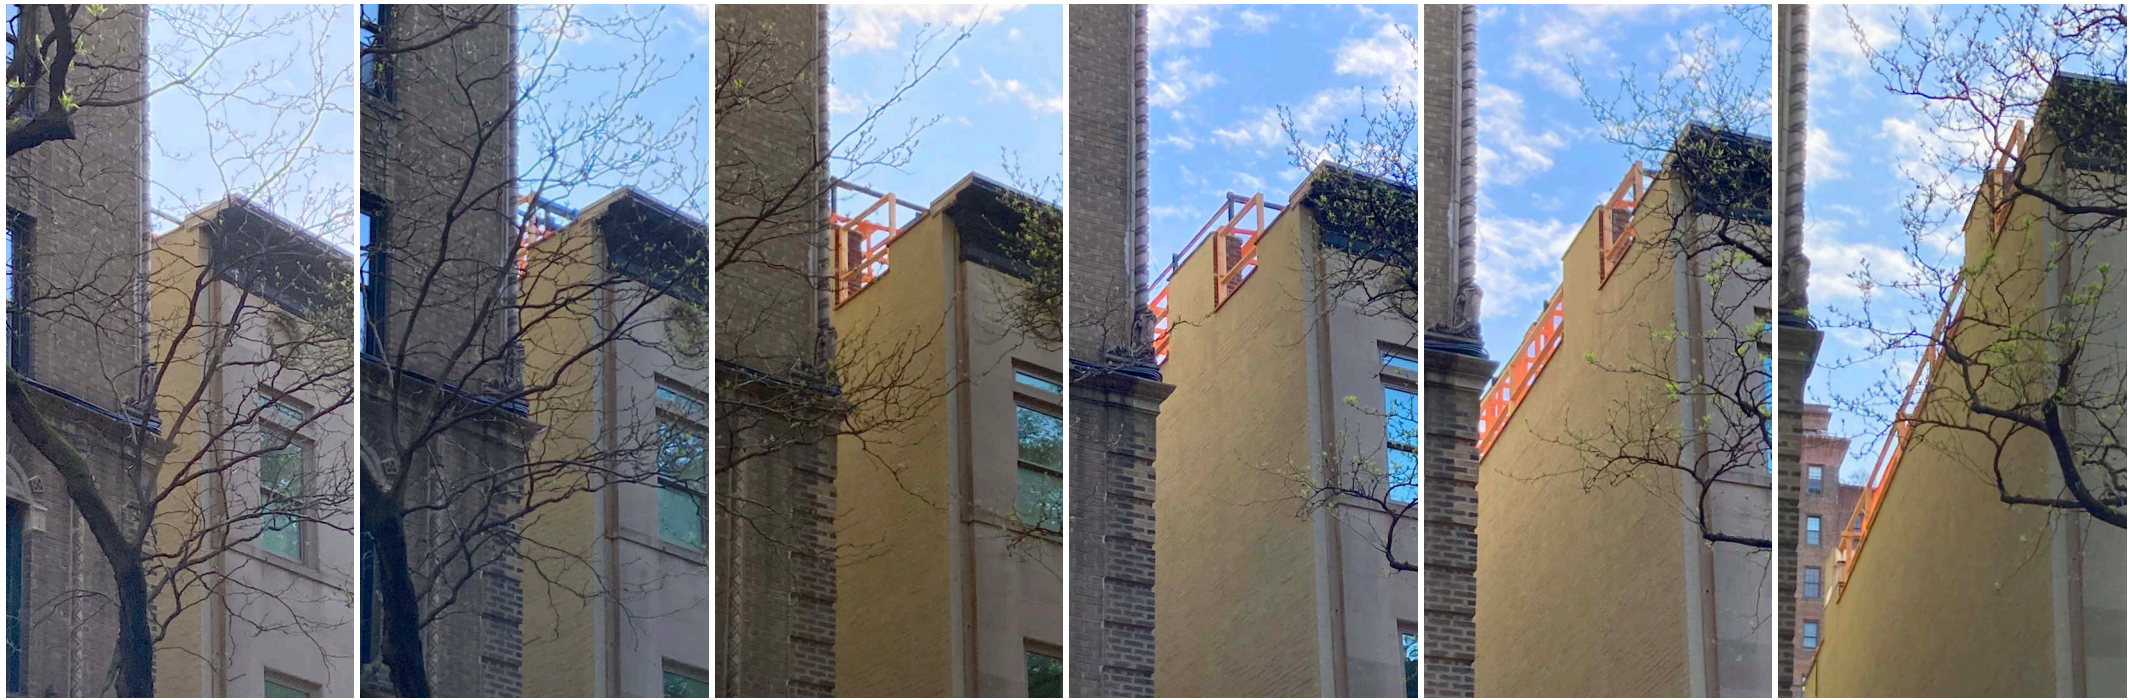
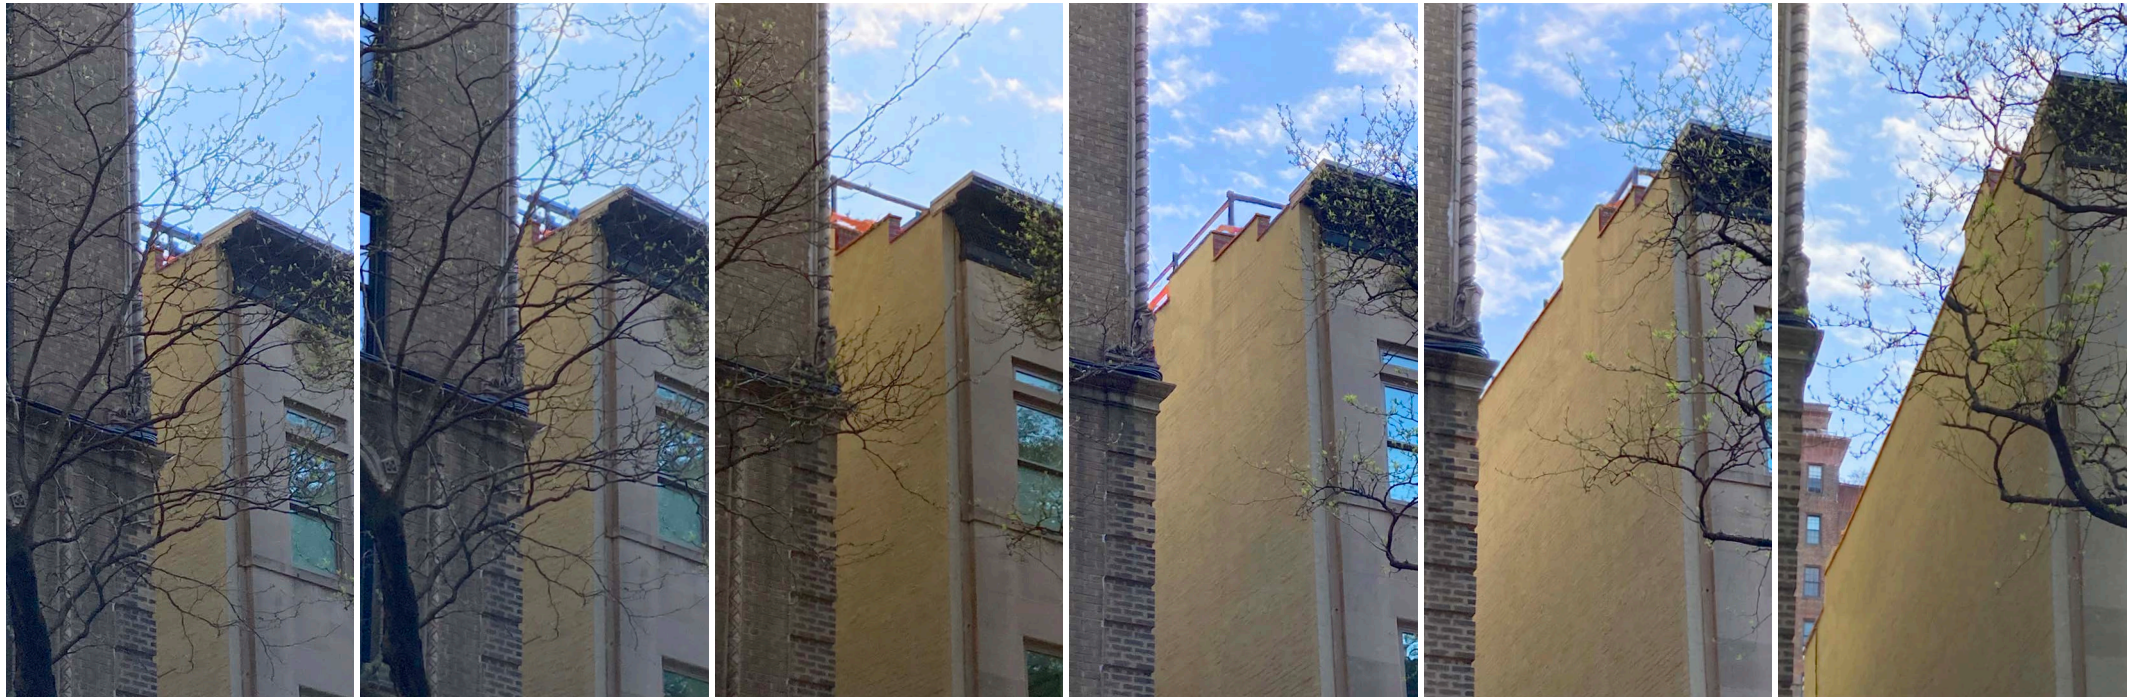
Close-Up photos from Sidewalk on North side of 95th Street to the East of the property. Photos each taken (4) steps apart.

Proposed parapet digitally raised per elevation drawings. (Parapet mock-up digitally removed for clarity)

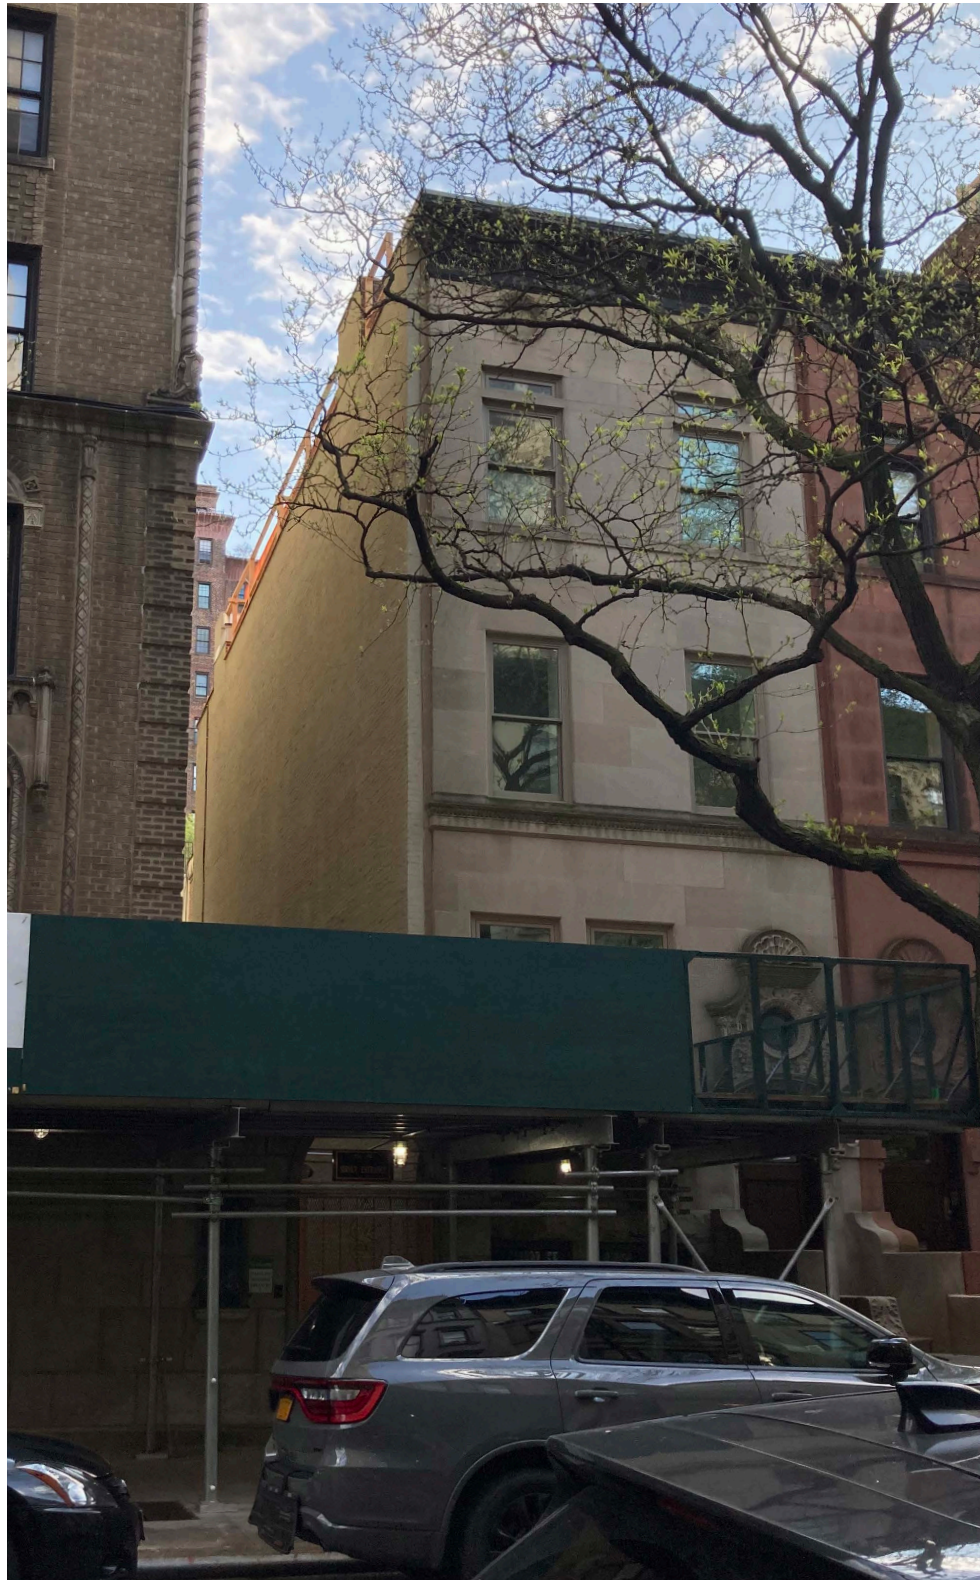
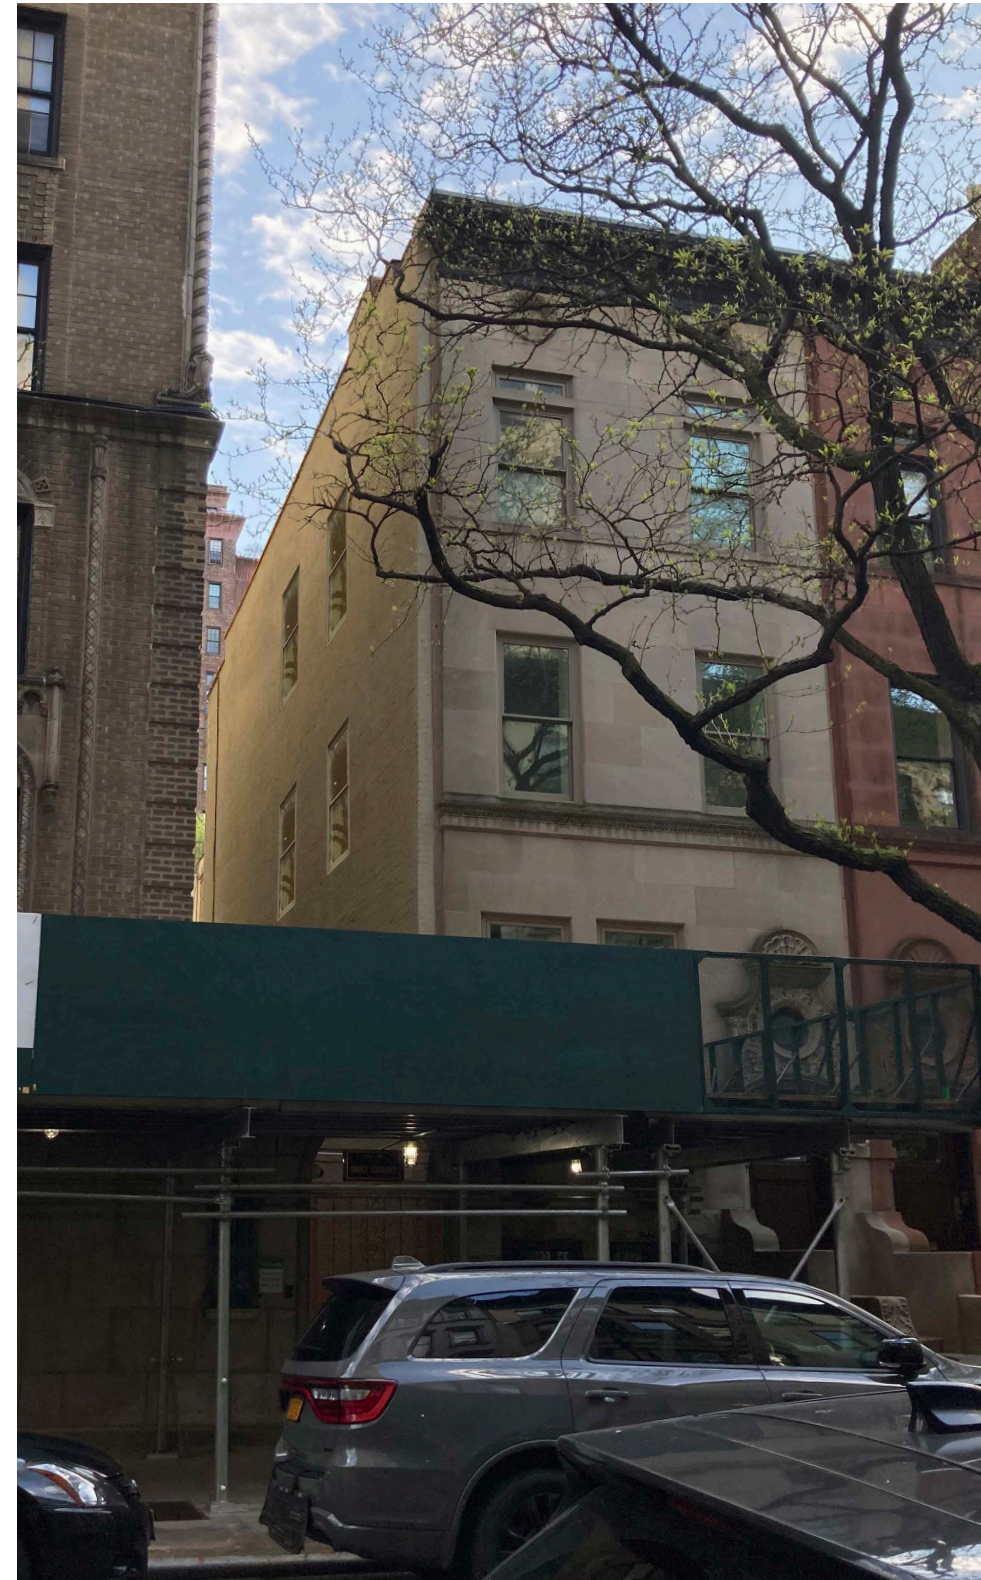
Mock-Up

Montage
East facade window frame color to match existing windows on front facade.

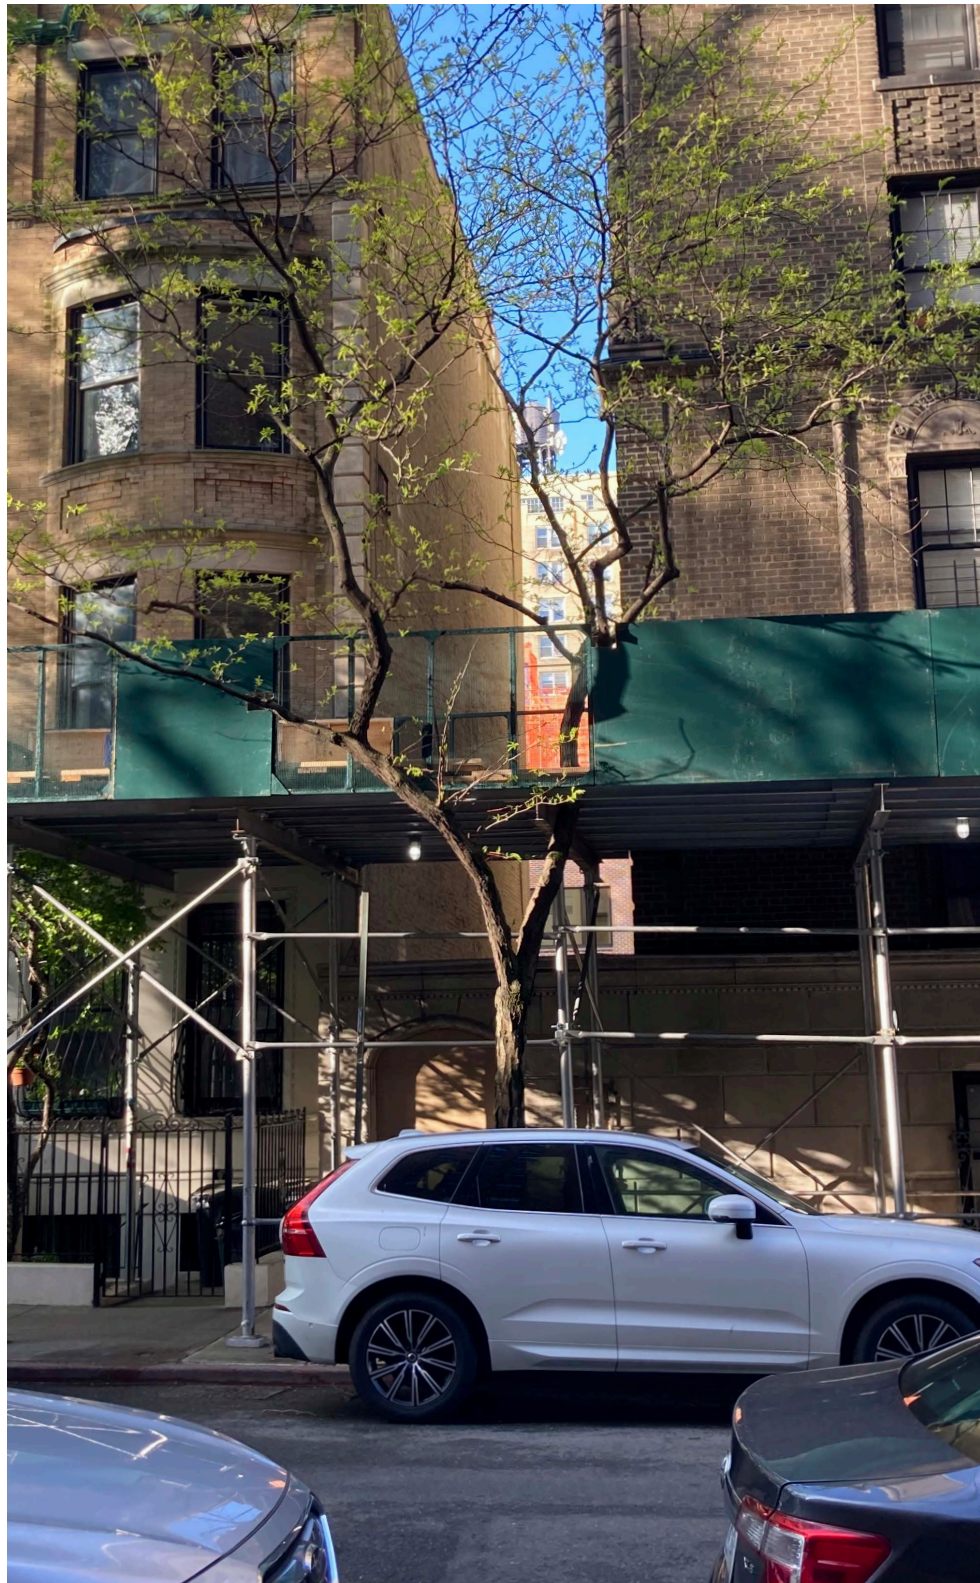
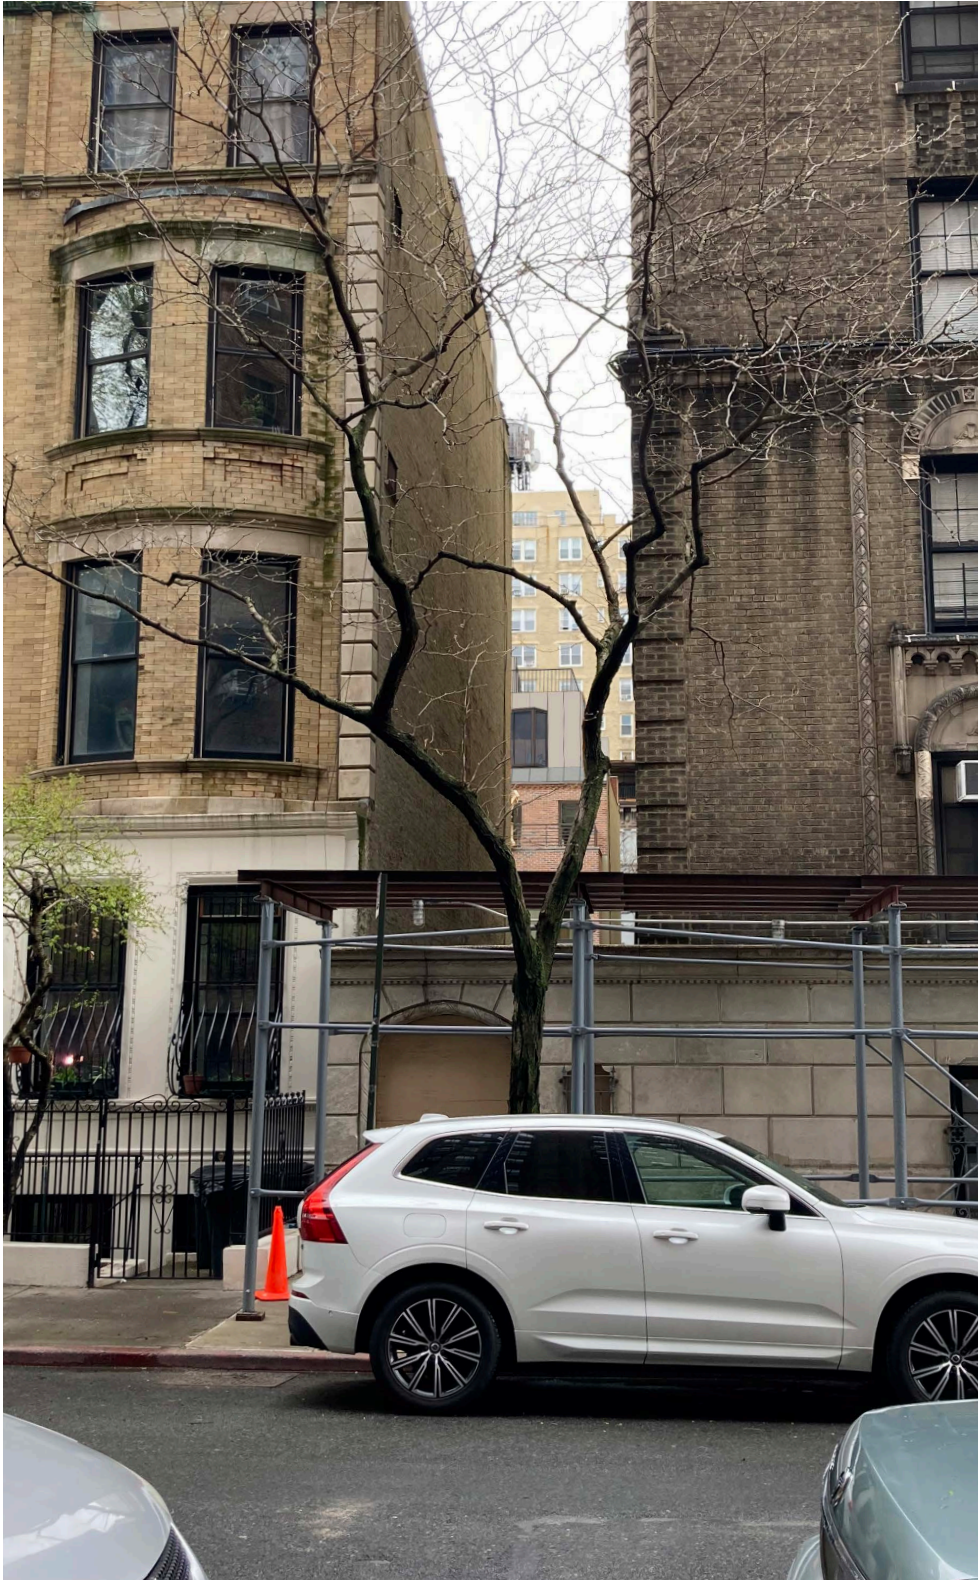
Mock-Up (Sidewalk bridge is current condition)

Montage (Shown over photo where sidewalk bridge was removed for reference)
