DXA studio
140 W 81 STREET
June 08, 2023

PROPOSED KEIM MINERAL STAIN
SCOPE OF WORK: LPC PACKAGE

Re: 140 W 81st Street – Façade Coating Recommendations

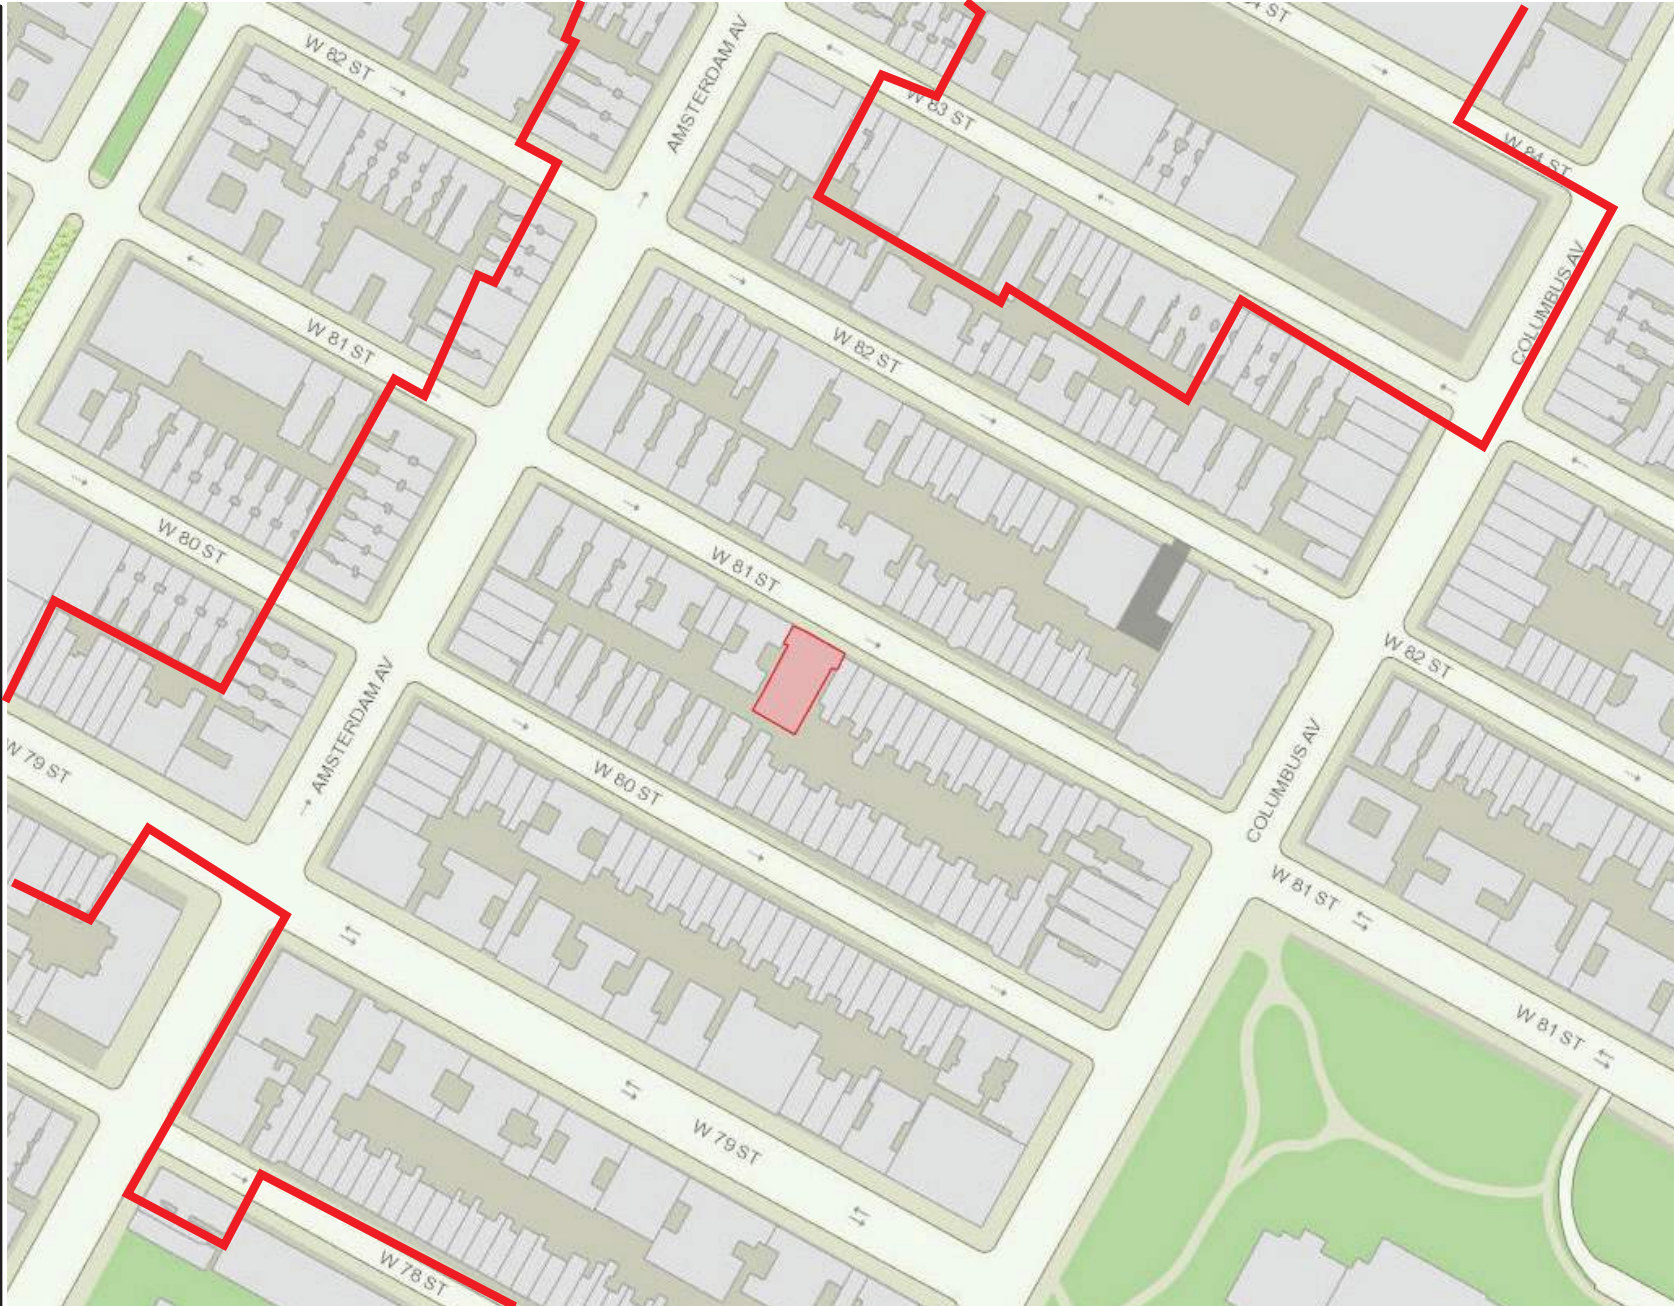
140 WEST 81ST · HISTORIC DISTRICT MAP + SITE PLAN

SITE PLAN

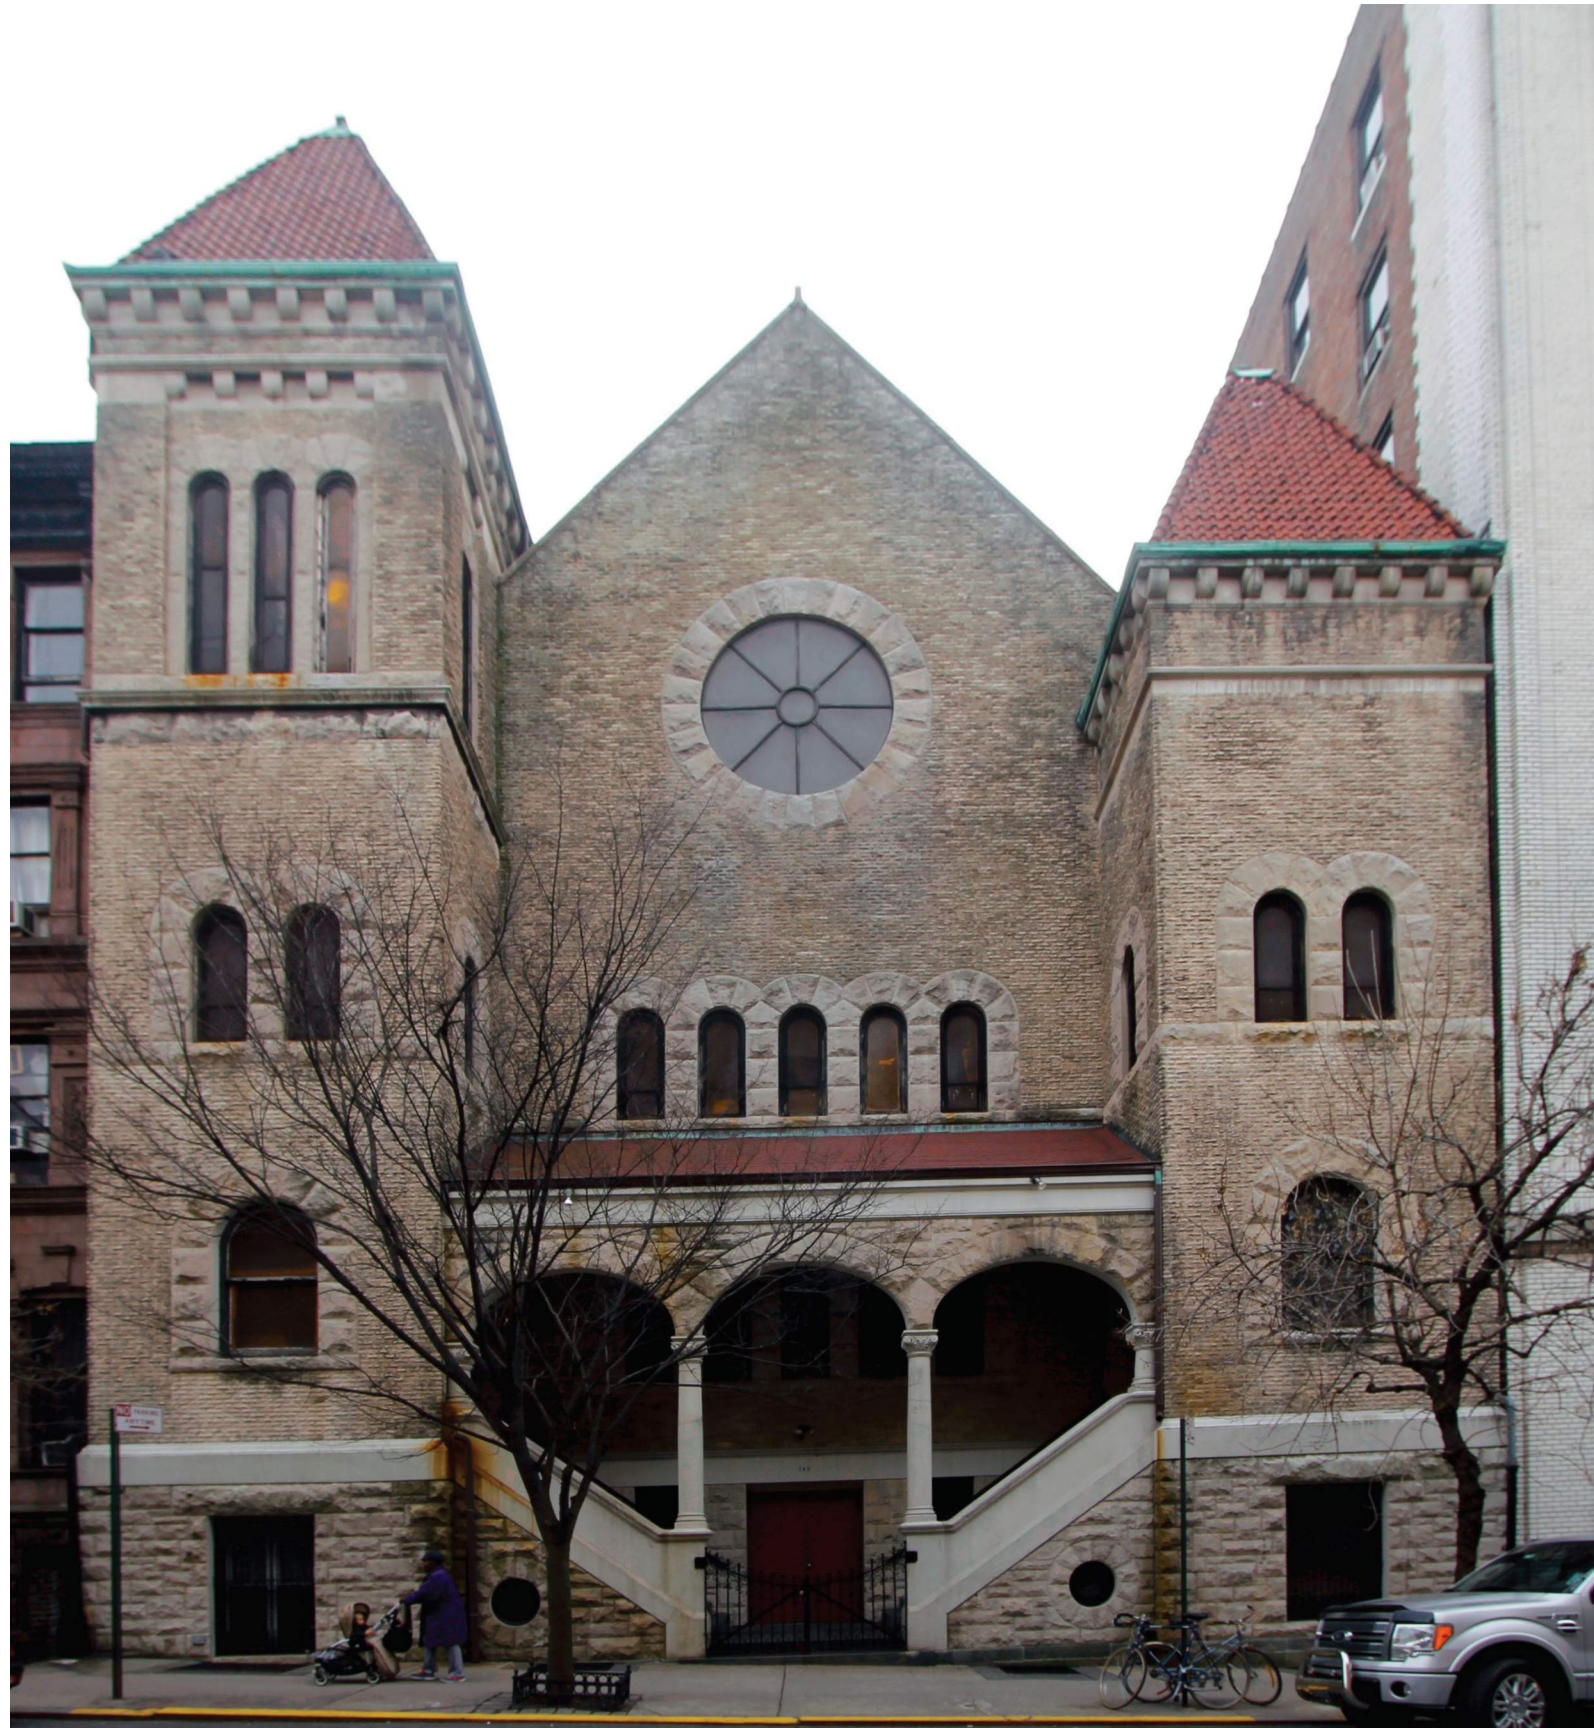
BUILDING NAME:
-Church of the Eternal Hope (former)
-Mt. Pleasant Baptist Church (current/33 years)

DATE: 1887

ARCHITECT: John F. Capen

DEVELOPER/OWNER: Third Universalist Society of
New York City

STYLE/ORNAMENT: Romanesque Revival

MATERIALS: Rusticated Stone, Brickwork,
Terracotta Tiles, Copper

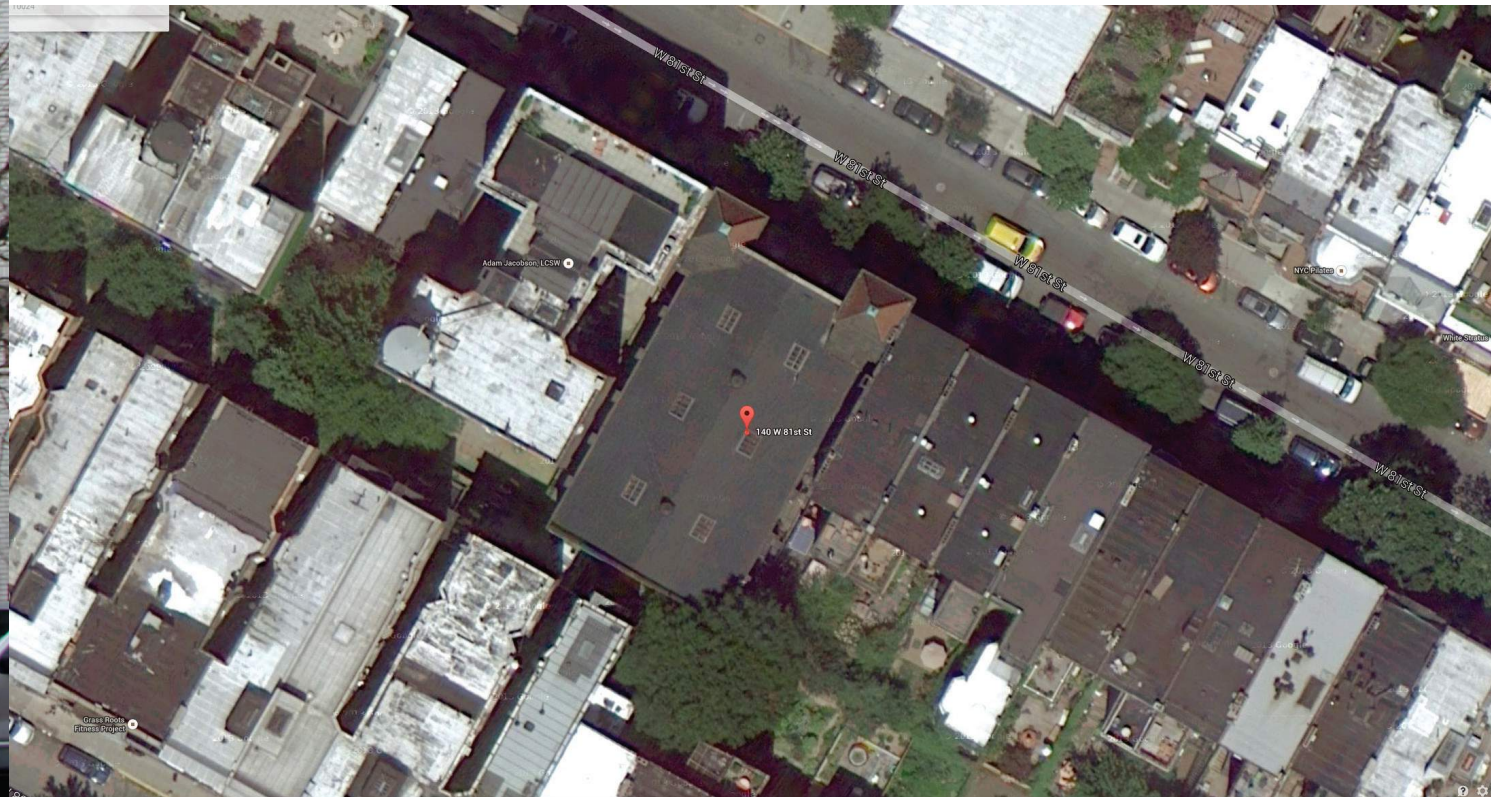
140 WEST 81ST · **SATELLITE LOCATION & PROJECT PHOTO**

PHOTO DATED 12/06/2014 (NOT REPRESENTATIVE OF CURRENT MASONRY CONDITIONS, SEE PAGE 06)

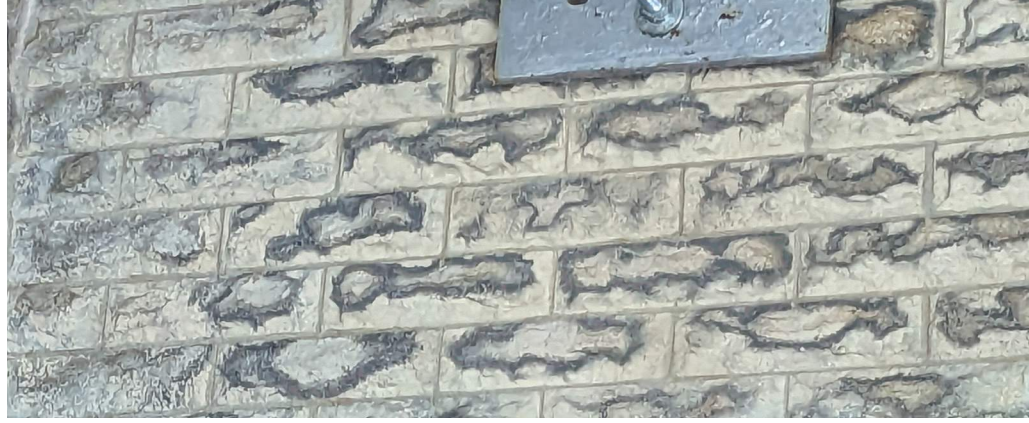
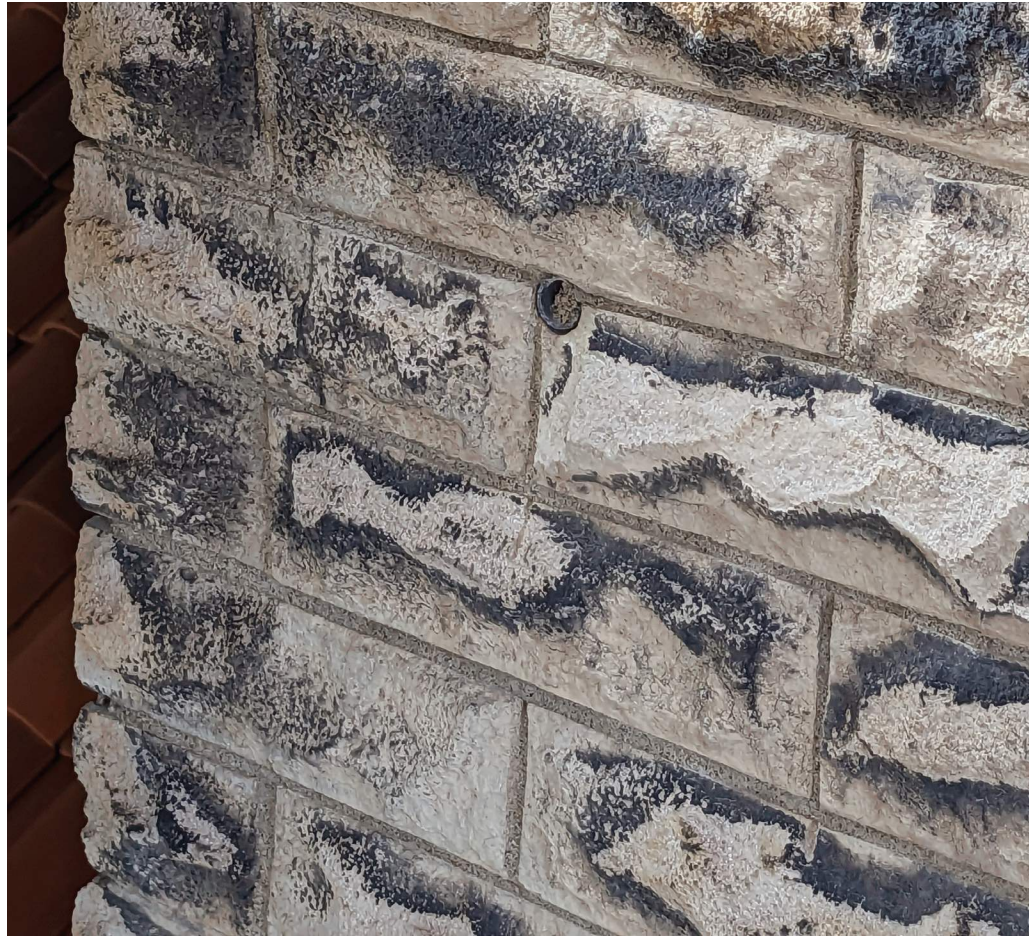
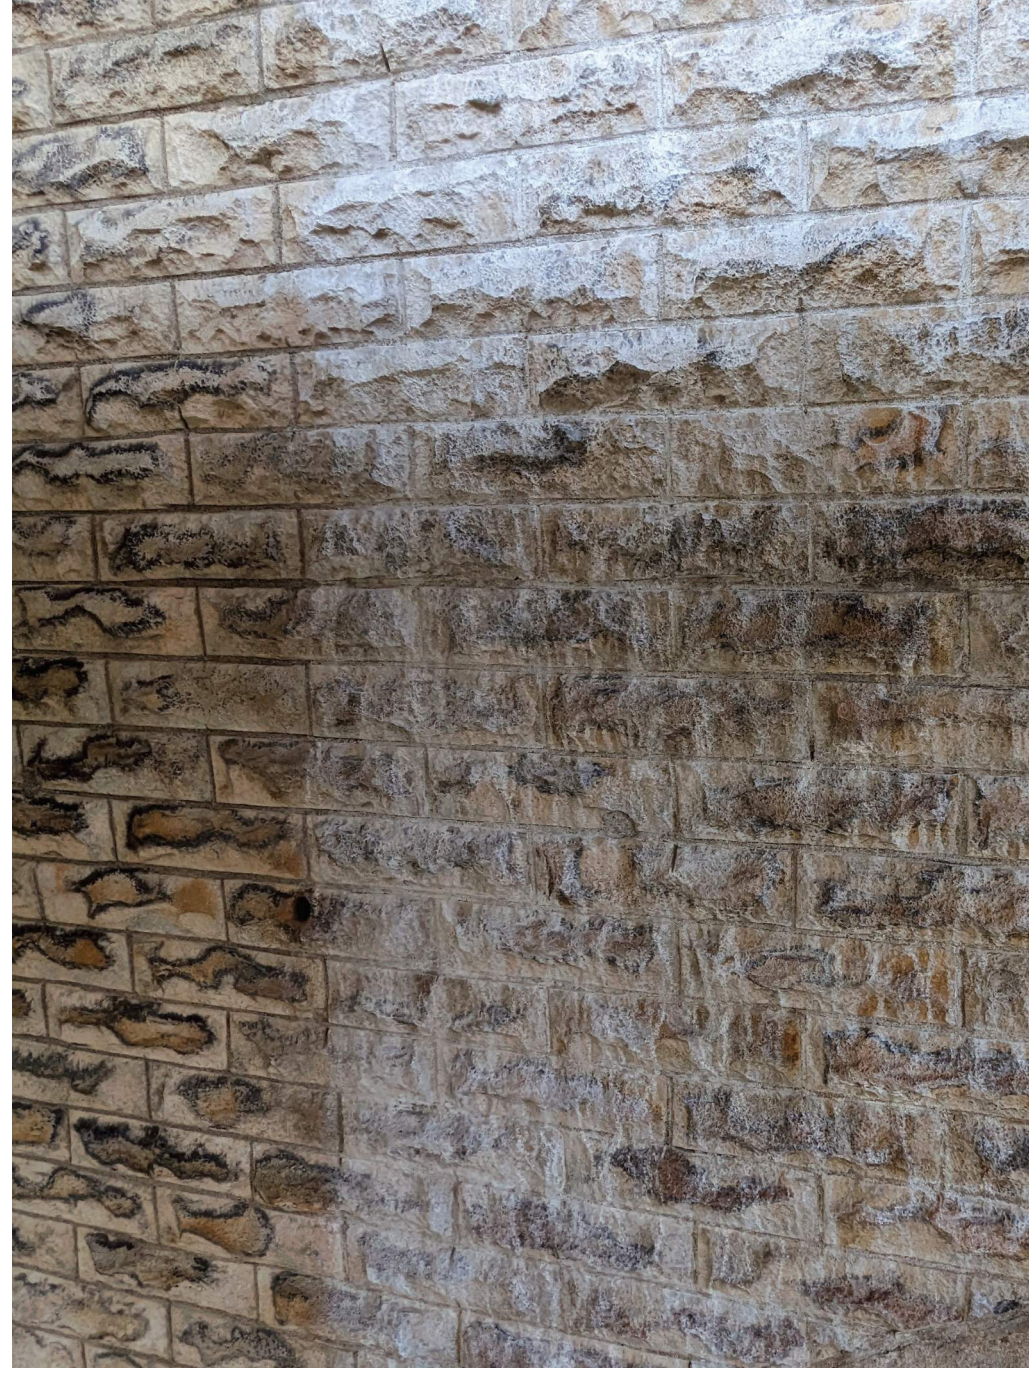
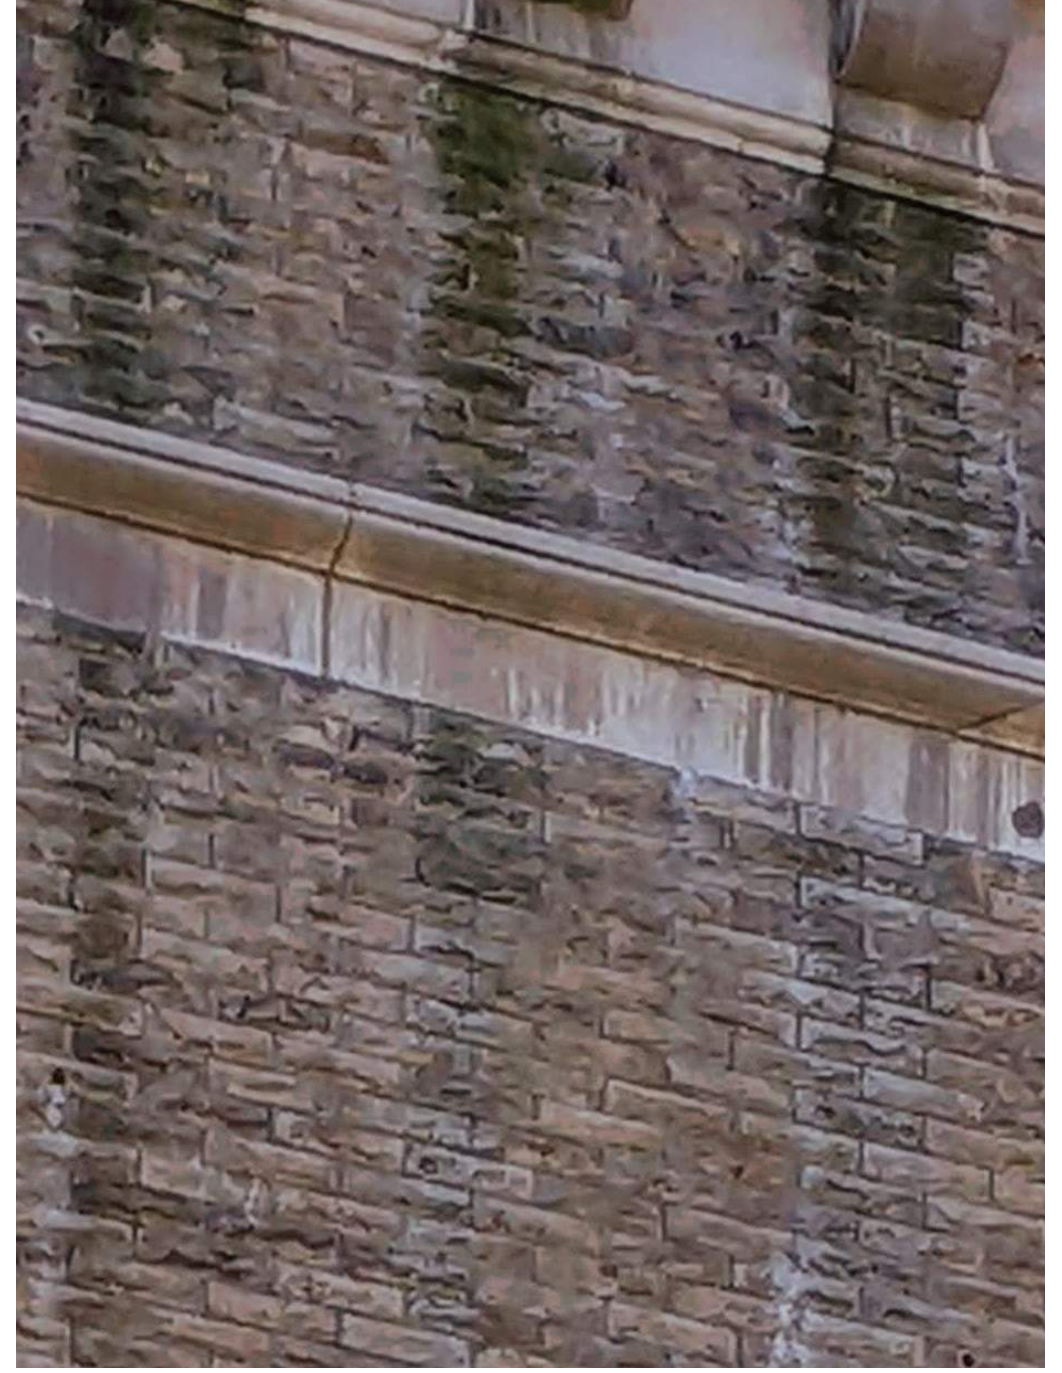
140 W 81 STREET — **CURRENT MASONRY CONDITIONS**

PHOTOS DATED 04/12/2023 SHOWING GYPSUM, LIME, AND COPPER DEPOSITS THROUGHOUT MAIN (NORTH) FACADE

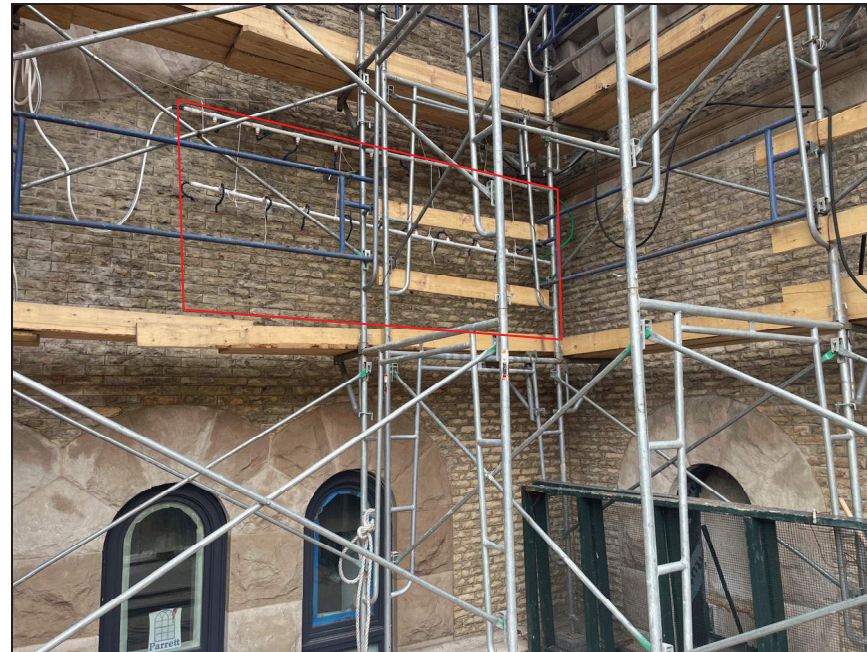
On March 24, 2023, we visited the site to review a large-scale mockup of the specified cleaning procedure. The contractor reported misting the mockup area for four days, followed by spot treatment of heavily soiled areas and rust staining. While the cleaning procedure removed some of the soiling, the area continued to have a very uneven appearance (Figures 1 to 3). Unfortunately, we do not believe it is possible to remove the remaining soiling. Our previous tests demonstrated that more aggressive cleaning methods will either etch the brick or cause it to discolor. Further, we note that JBC's initial cleaning recommendations were based on small-scale tests performed in another location. Owing to inherent variation in soiling conditions across the façade, it was always possible that the recommended procedure would not be effective in all locations.

Figure 1. Cleaning mockup (indicated) after completion, from 20' away.

The project team has now exhausted available cleaning options, and we understand that the uneven appearance of the treated area is unacceptable. Therefore, we now recommend that the brickwork be coated to conceal the soiling and provide an even appearance. A potassium silicate coating, such as those manufactured by Keim or Beeck, should be used as these have the highest permeability ratings of any masonry coatings on the market. Silicate coatings also have a matte sheen that is similar to the existing brick surface. The coating should be custom color-matched to a cleaned surface of the existing brick within the portico. This small area of brickwork was protected from the heaviest soiling and retains much of its original appearance. The limestone portions of the façade have been cleaned effectively and should not be coated.

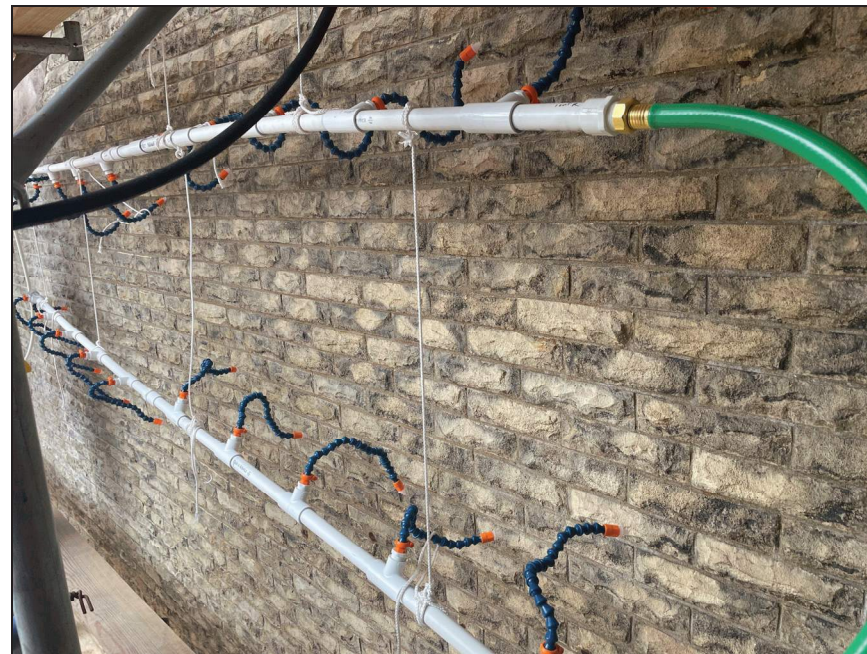
Figure 2. Cleaning mockup after completion.

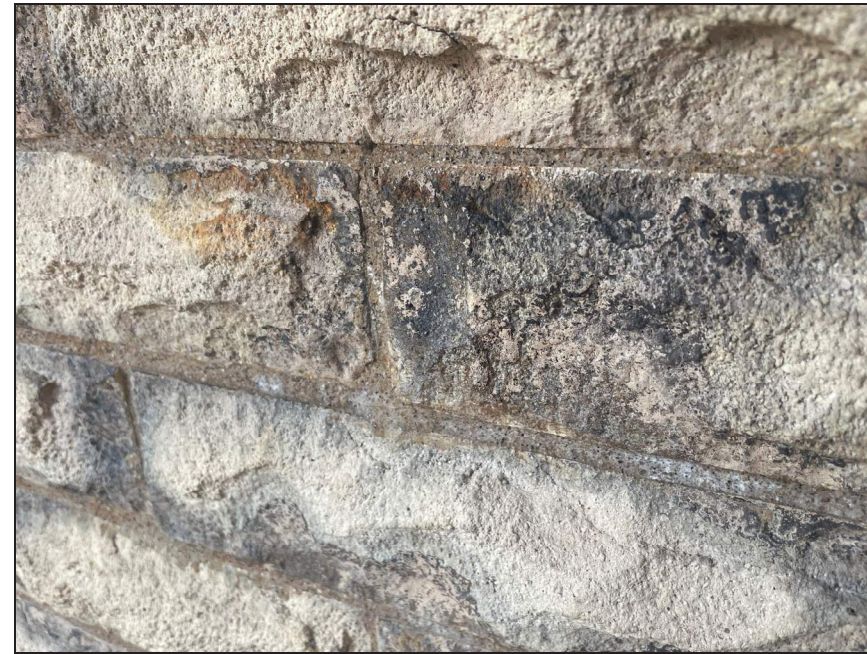
In 2016, JBC tested 16 different chemical cleaning agents as well as micro-abrasion and water misting to clean the rock-faced brick and limestone façade. We found that it was very difficult to remove soiling without altering or damaging the brick. We determined that water misting followed by limited chemical spot treatment was the gentlest, most effective cleaning method and that complete soiling removal would not be possible. We specified this procedure for the full-scale work, believing that it would reduce the soiling sufficiently to provide a more even appearance.

Figure 3. Detail of soiled bricks after cleaning.

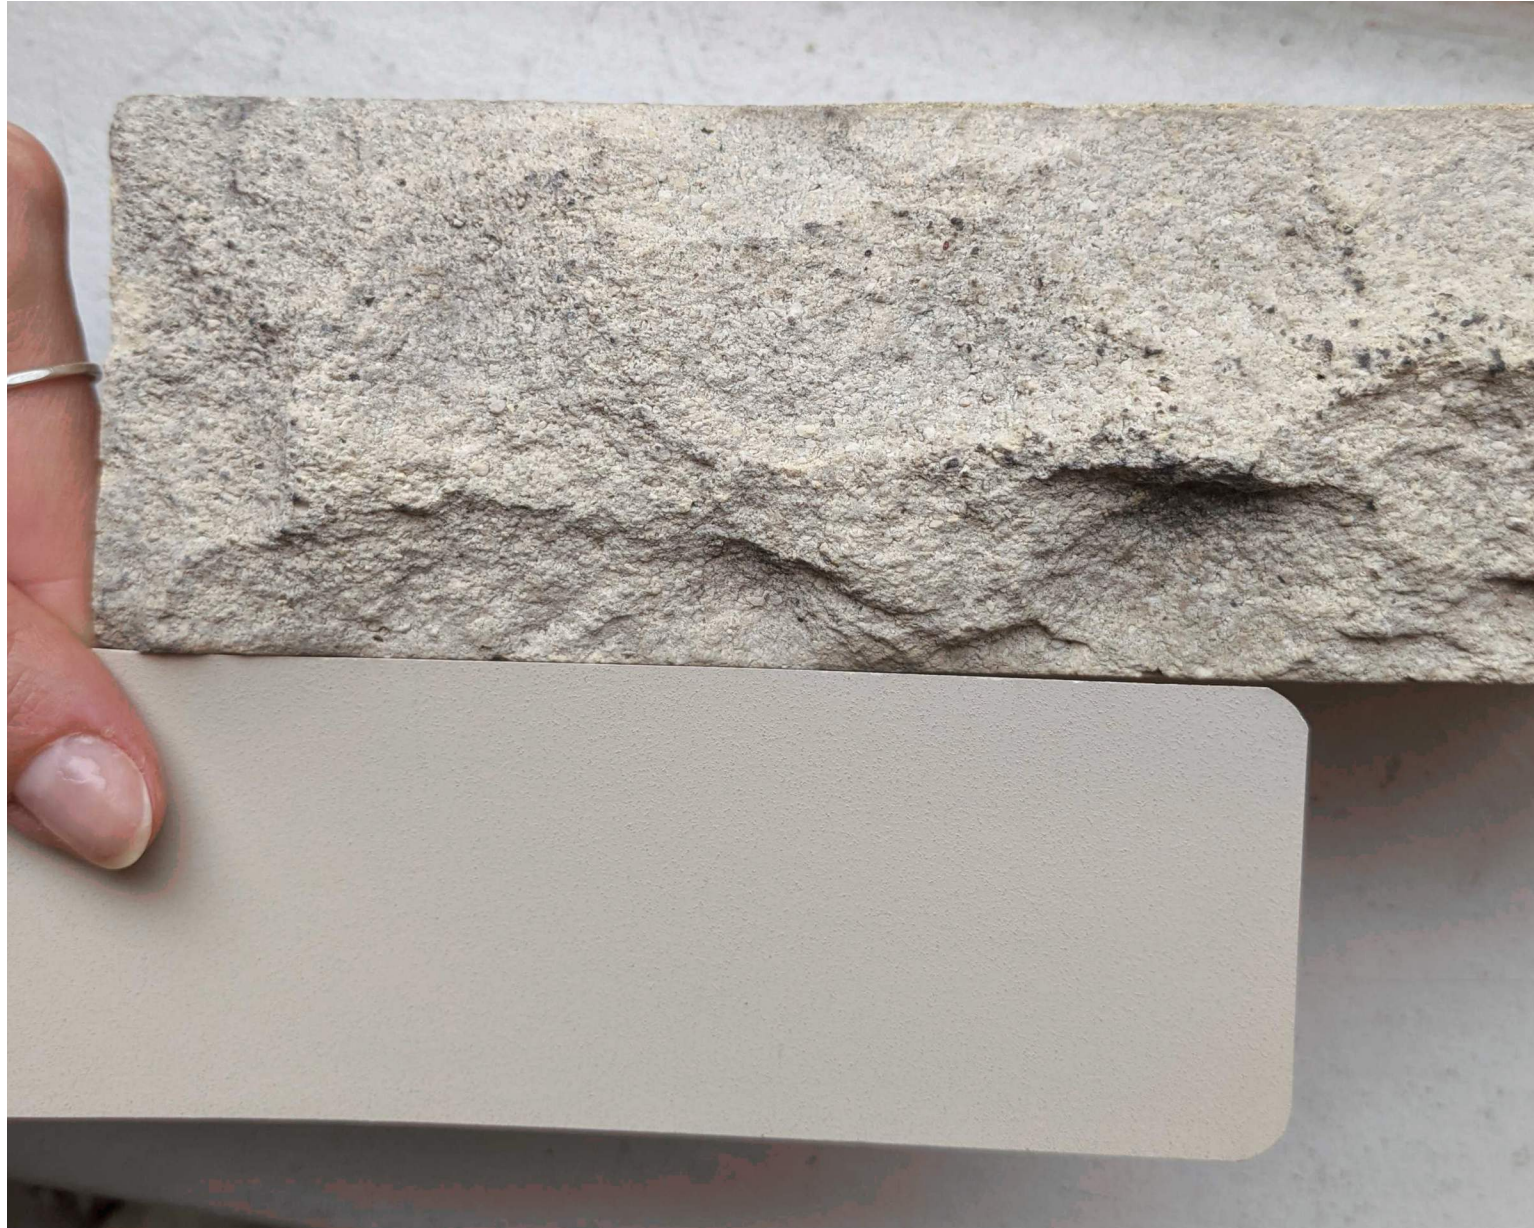
KEIM S119 SWATCH (PREFERRED), SHOWN NEXT TO A REMOVED MAIN FACADE HISTORIC BRICK

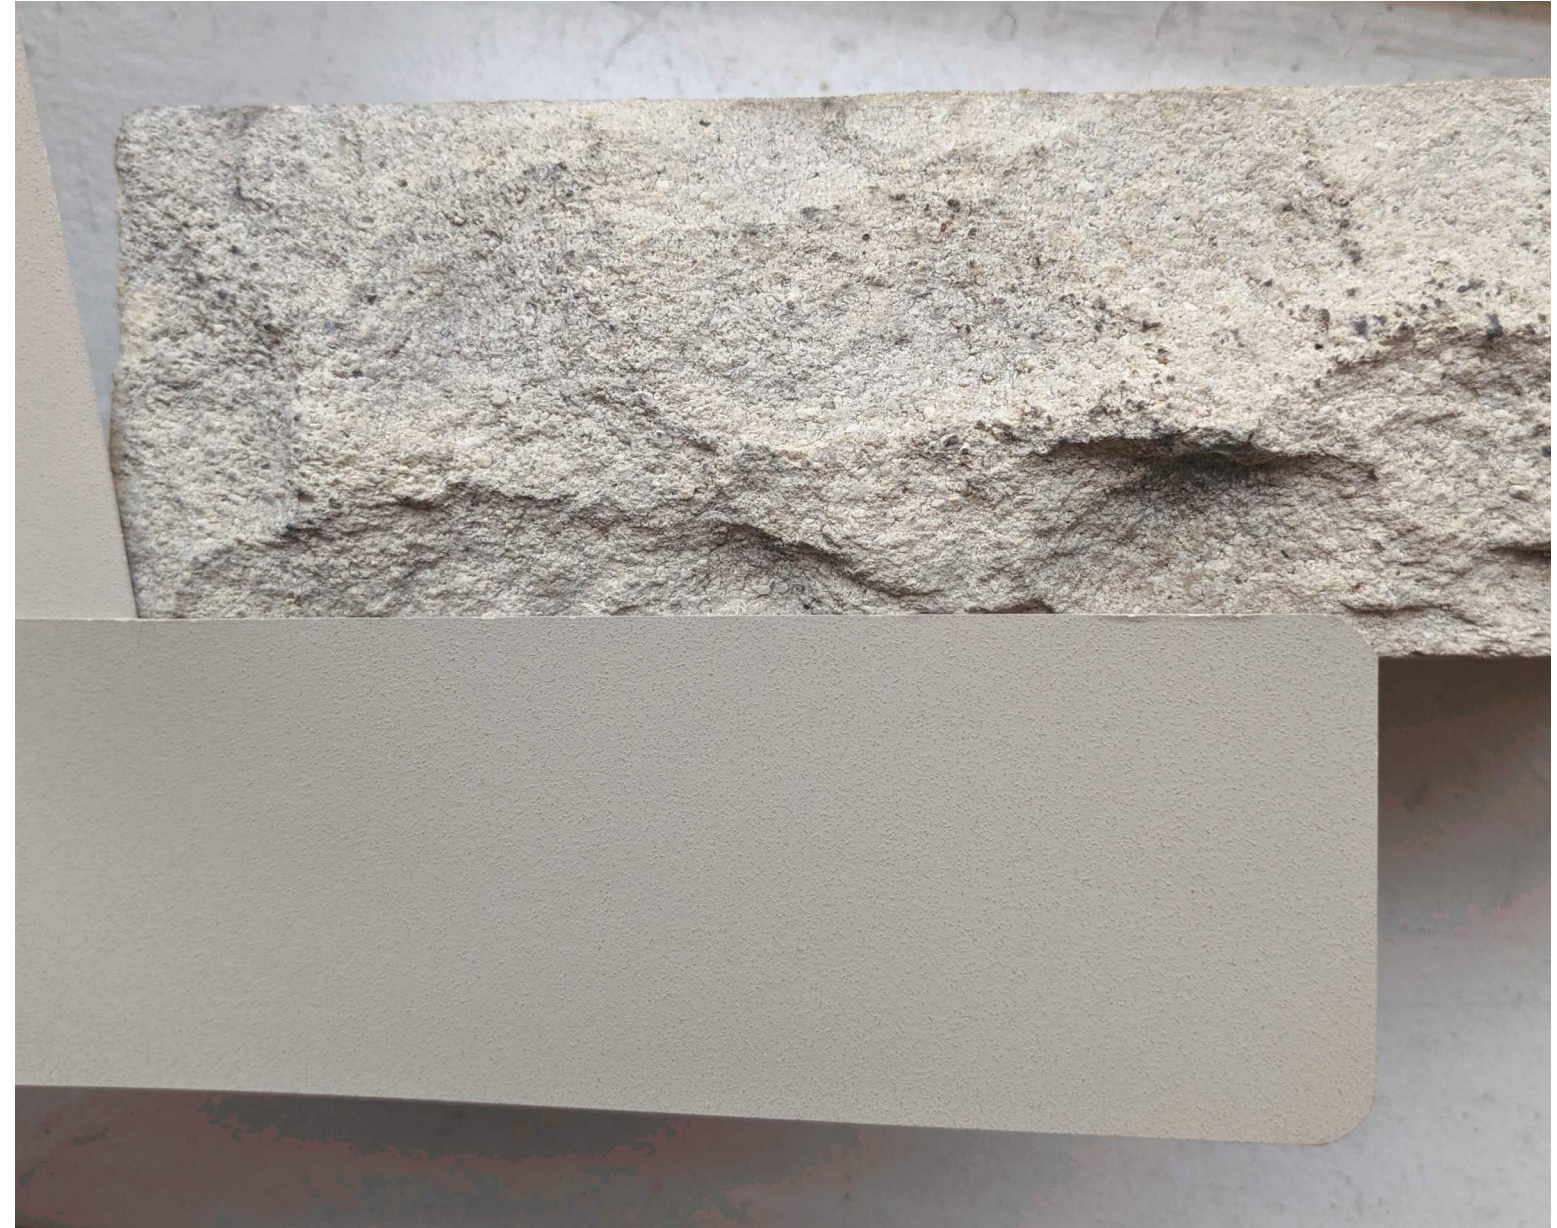
KEIM S117 SWATCH (ALTERNATIVE), SHOWN NEXT TO A REMOVED MAIN FACADE HISTORIC BRICK

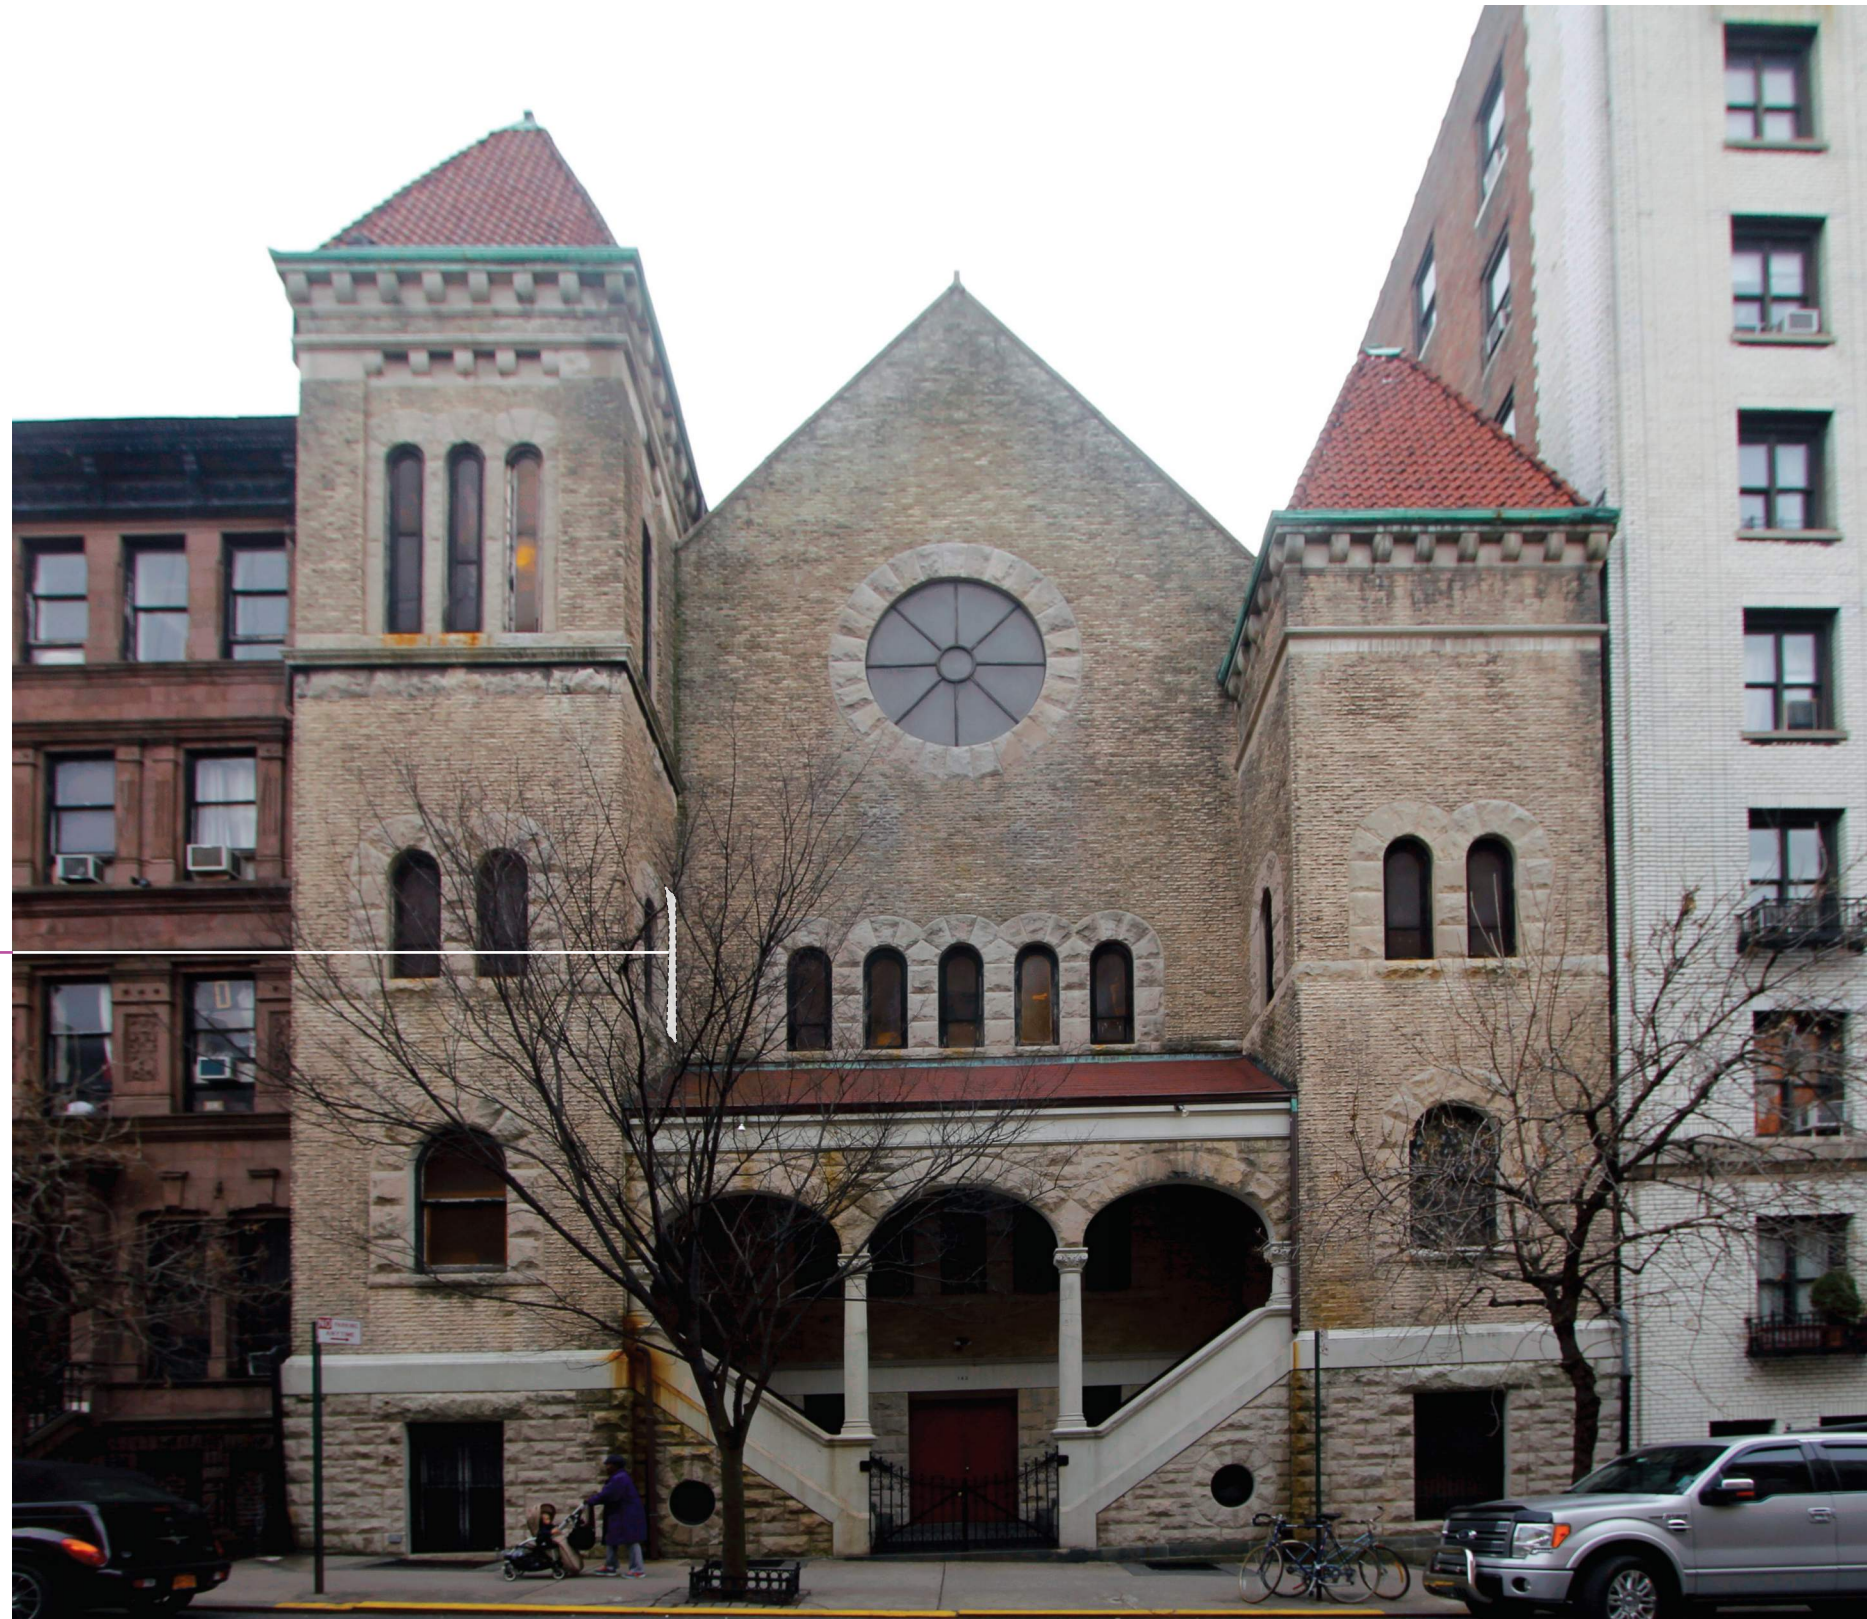
140 W 81 STREET — KEIM MINERAL STAIN MOCKUP LOCATION (LPC-APPROVED)

AREA FOR MASONRY STAIN MOCKUPS:

1. MOCKUP APPLICATION TO FOLLOW KEIM MANUF. INSTRUCTIONS
2. MOCKUPS TO BEGIN AS CLOSE TO PORTICO ROOF AS POSSIBLE TO MINIMIZE STREET VISIBILITY.
3. EACH MOCKUP TO NOT EXCEED 24"X24"
4. LIMETONE, ROOF TILES, GLAZING, ETC. TO BE PROTECTED AS REQUIRED.
5. NO MOCKUPS TO BE DONE ON MAIN NORTH-FACING FACADE PORTION. IF MORE SPACE IS NEEDED, CONTRACTOR TO CONTACT DESIGNER FOR DIRECTION.
