DXA studio
140 W 81 STREET
June 08, 2023

PROPOSED KEIM MINERAL STAIN
SCOPE OF WORK: LPC PACKAGE

Re: 140 W 81st Street – Façade Coating Recommendations

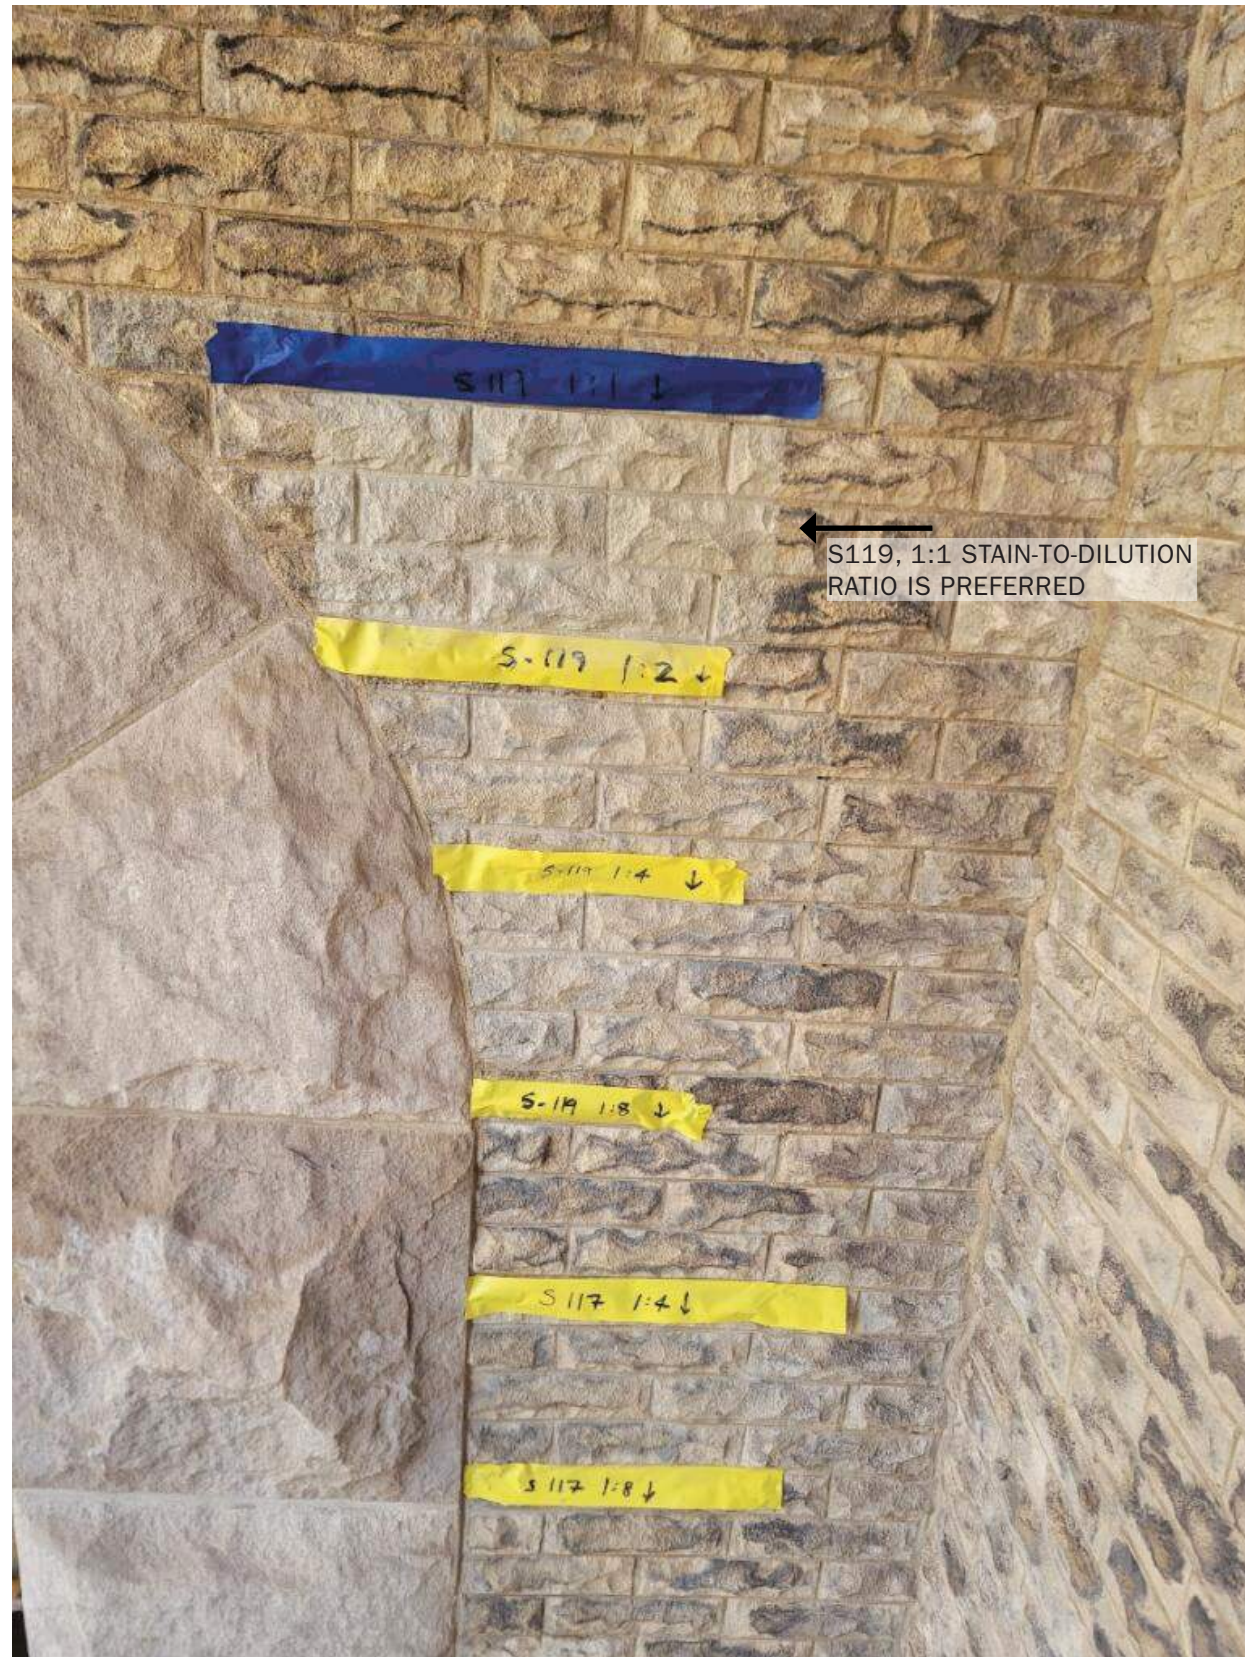
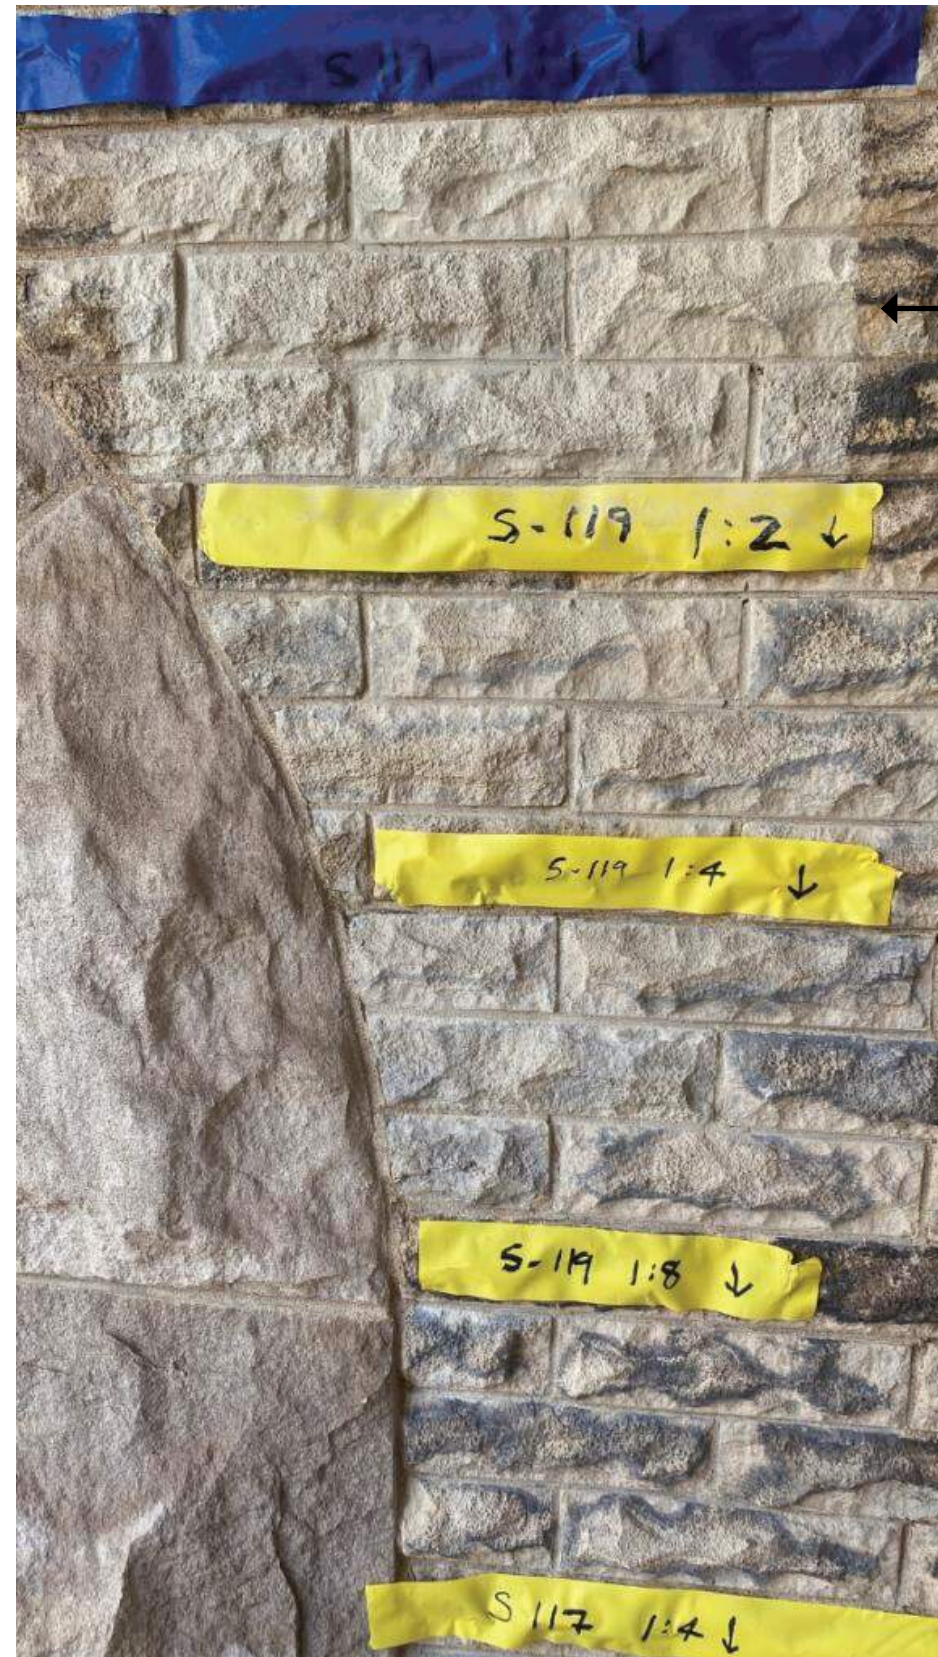
140 W 81 STREET — PROPOSED KEIM MINERAL STAIN MOCKUP PHOTOS

PHOTO DATED 05/25/2023

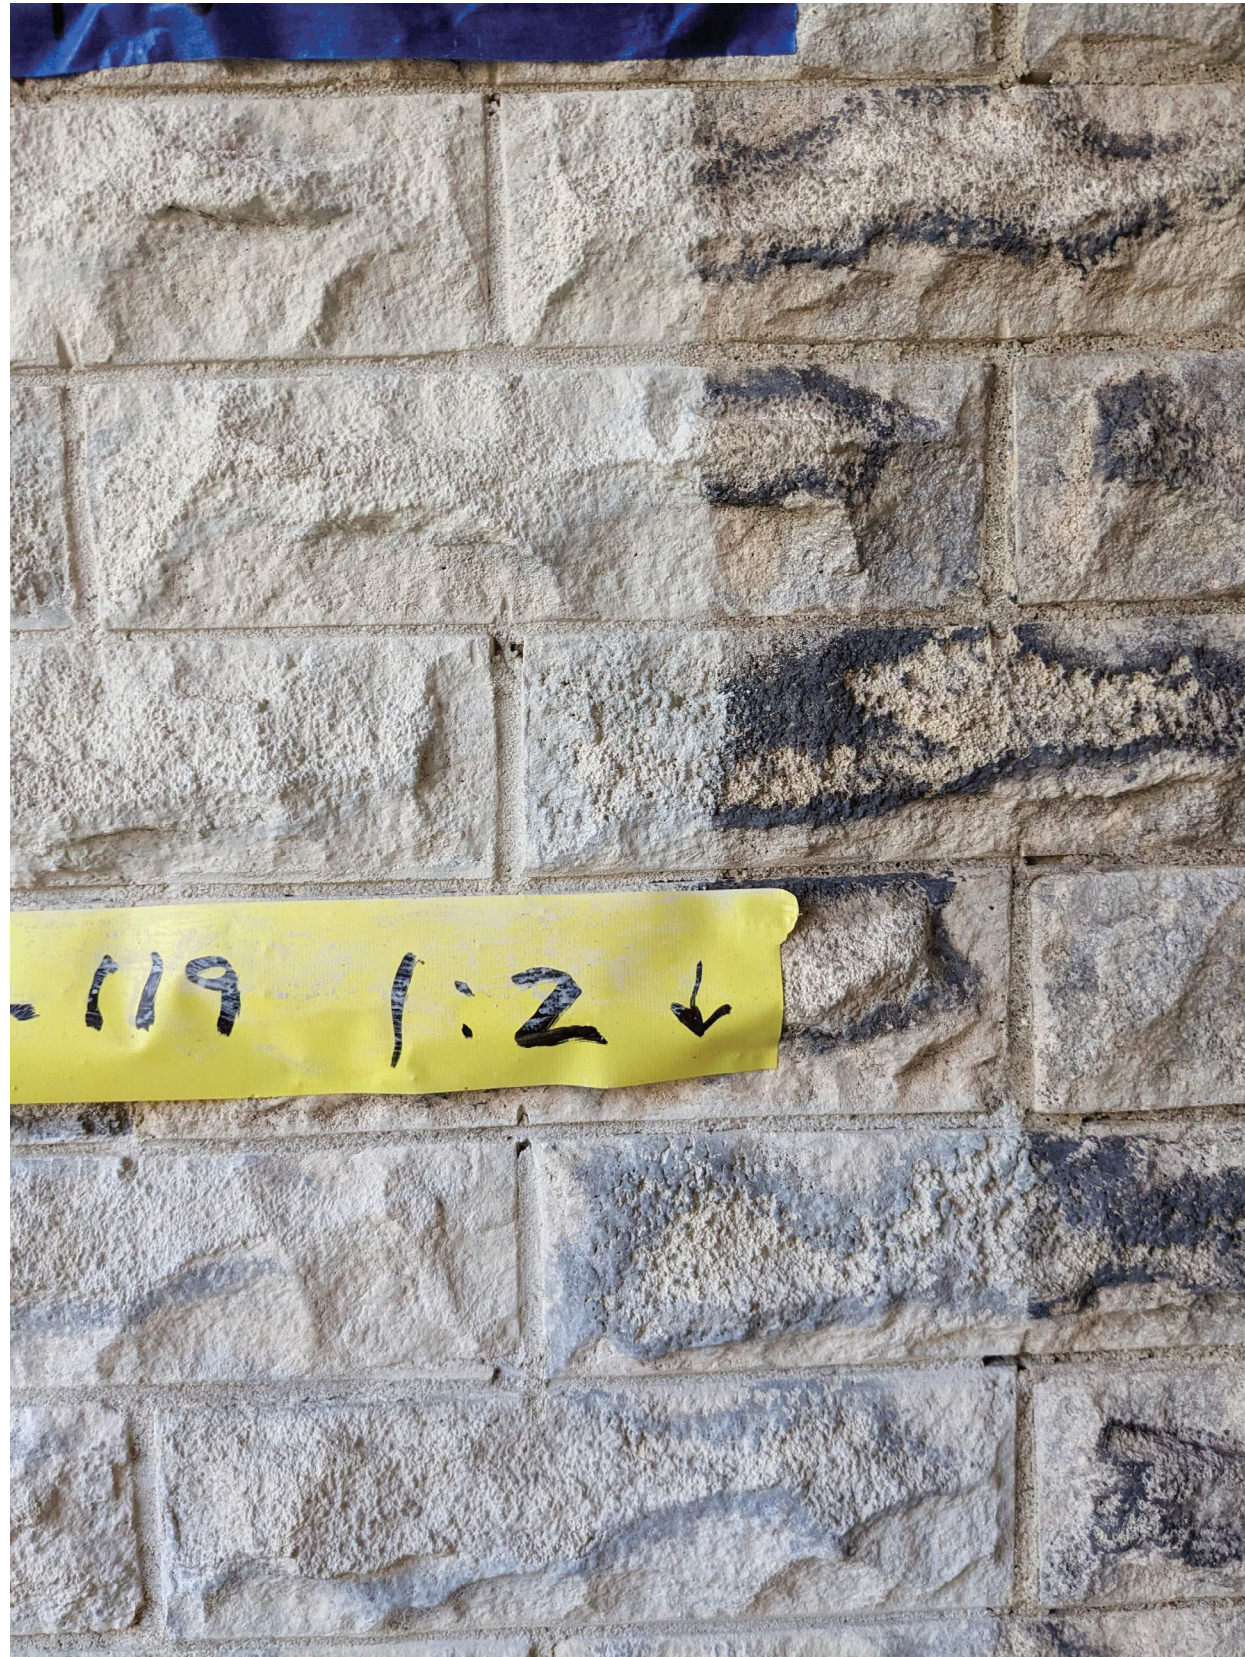
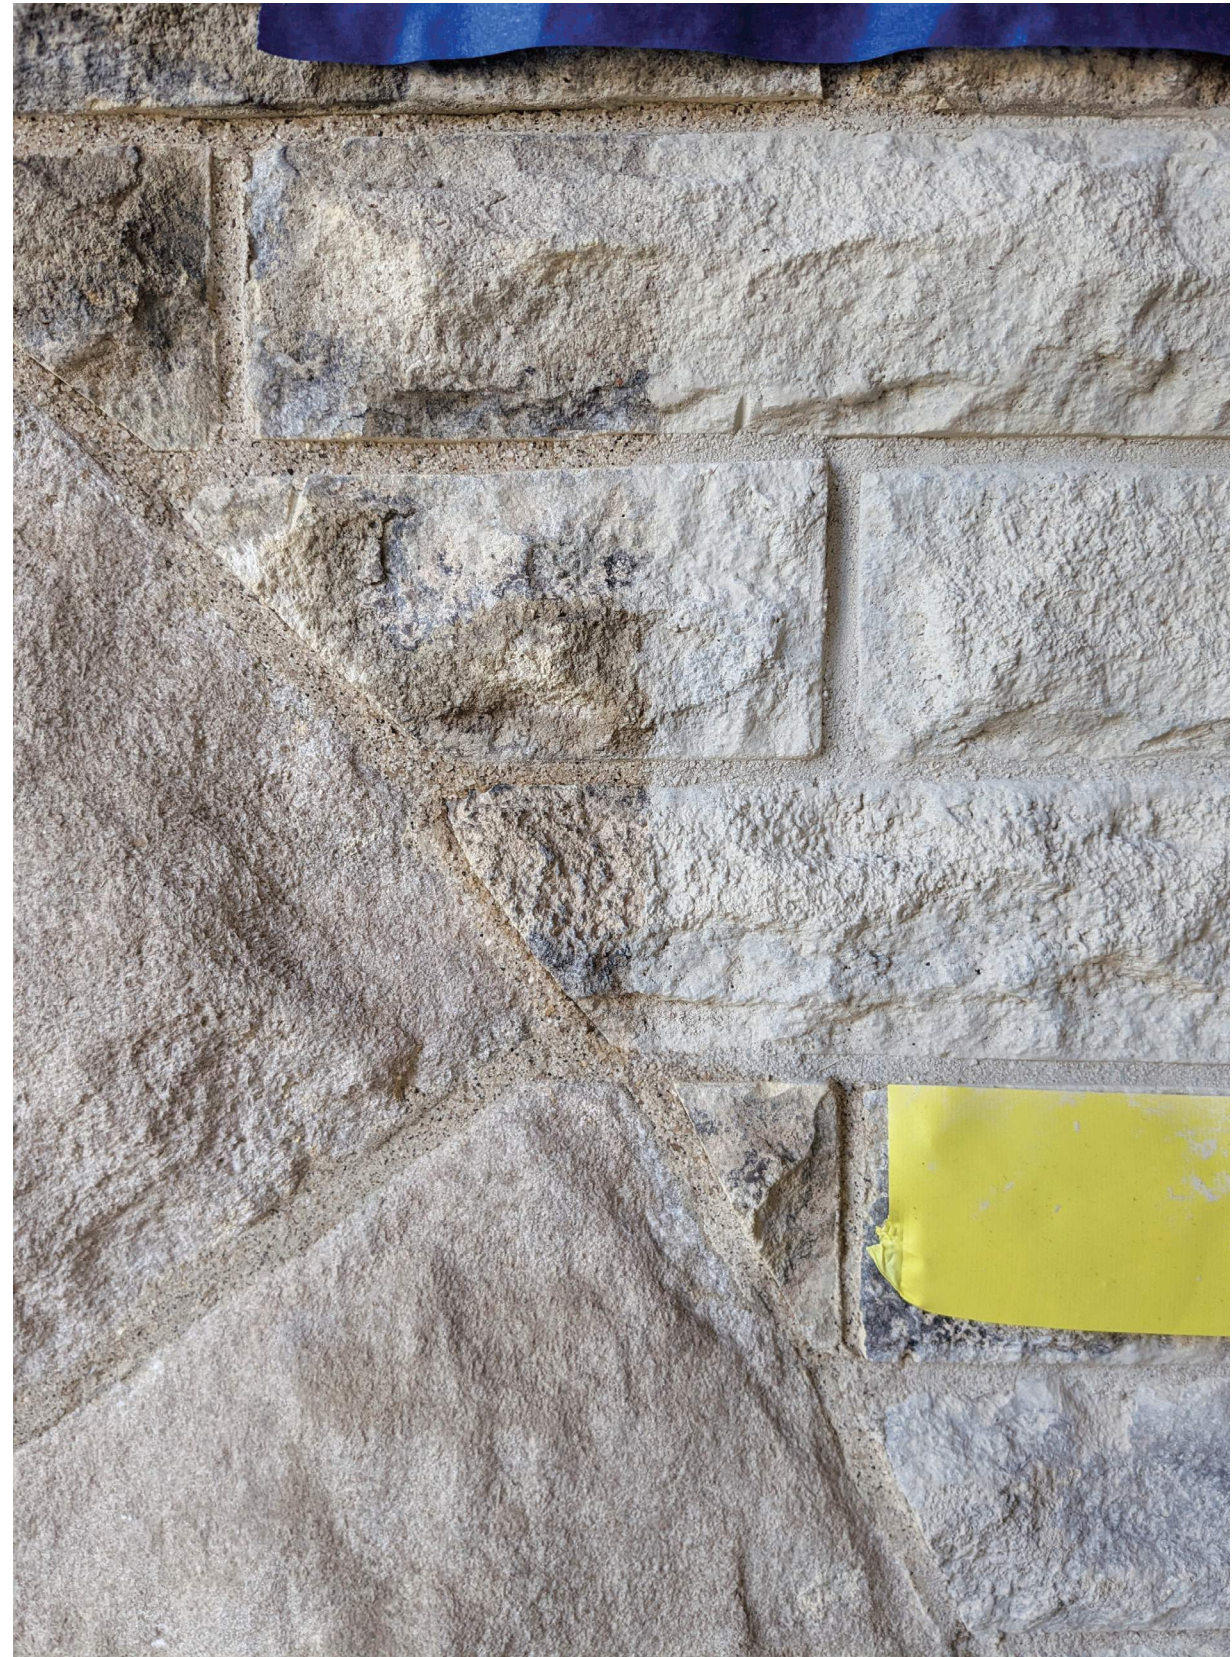
140 W 81 STREET — PROPOSED KEIM MINERAL STAIN MOCKUP PHOTOS: CLOSEUP OF S119 1:1

PHOTO DATED 05/25/2023

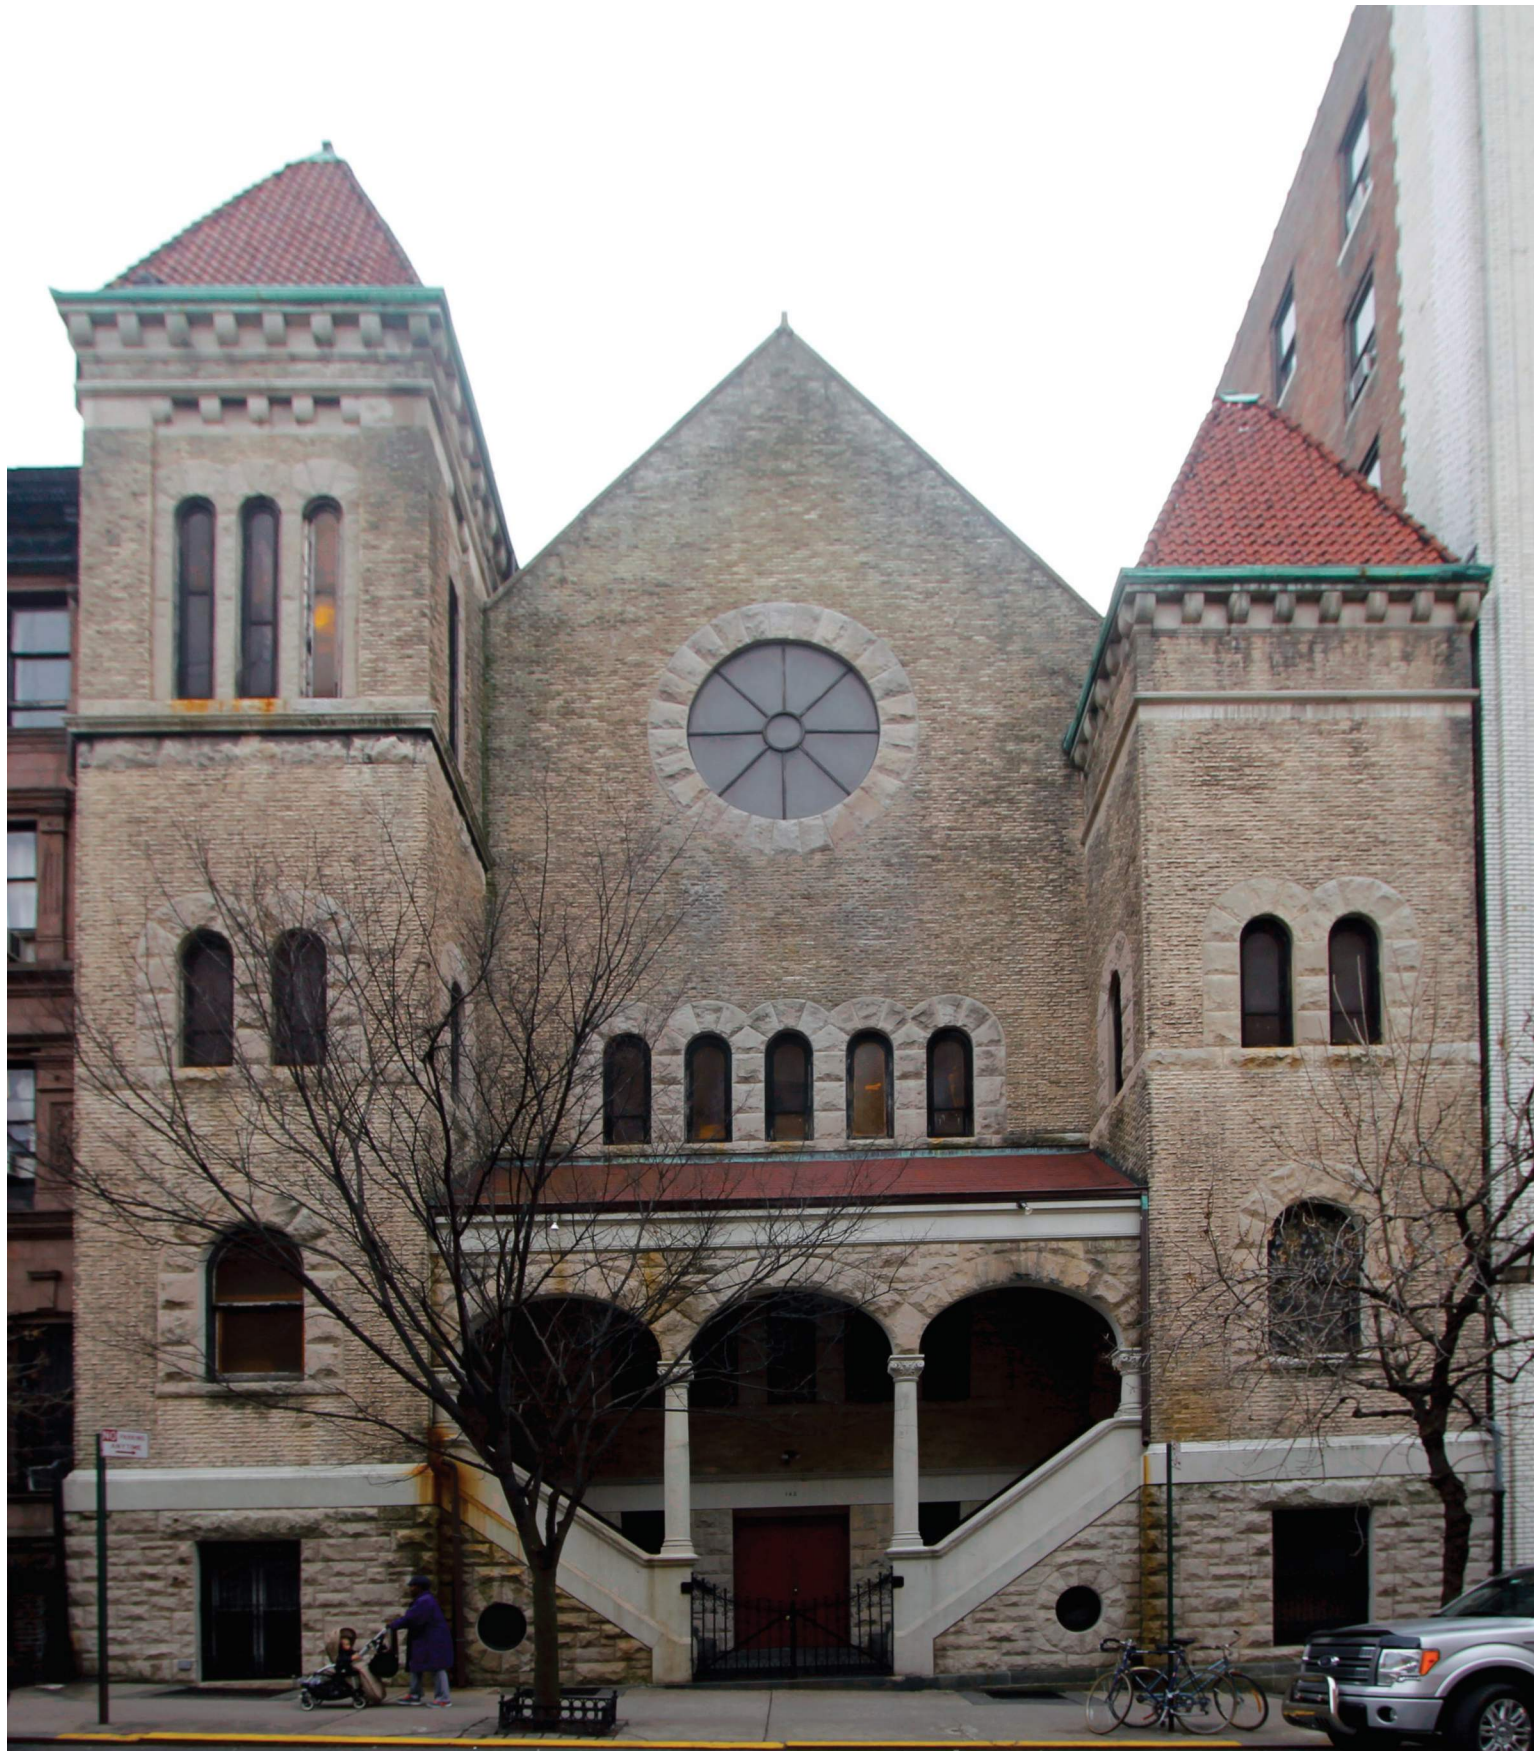
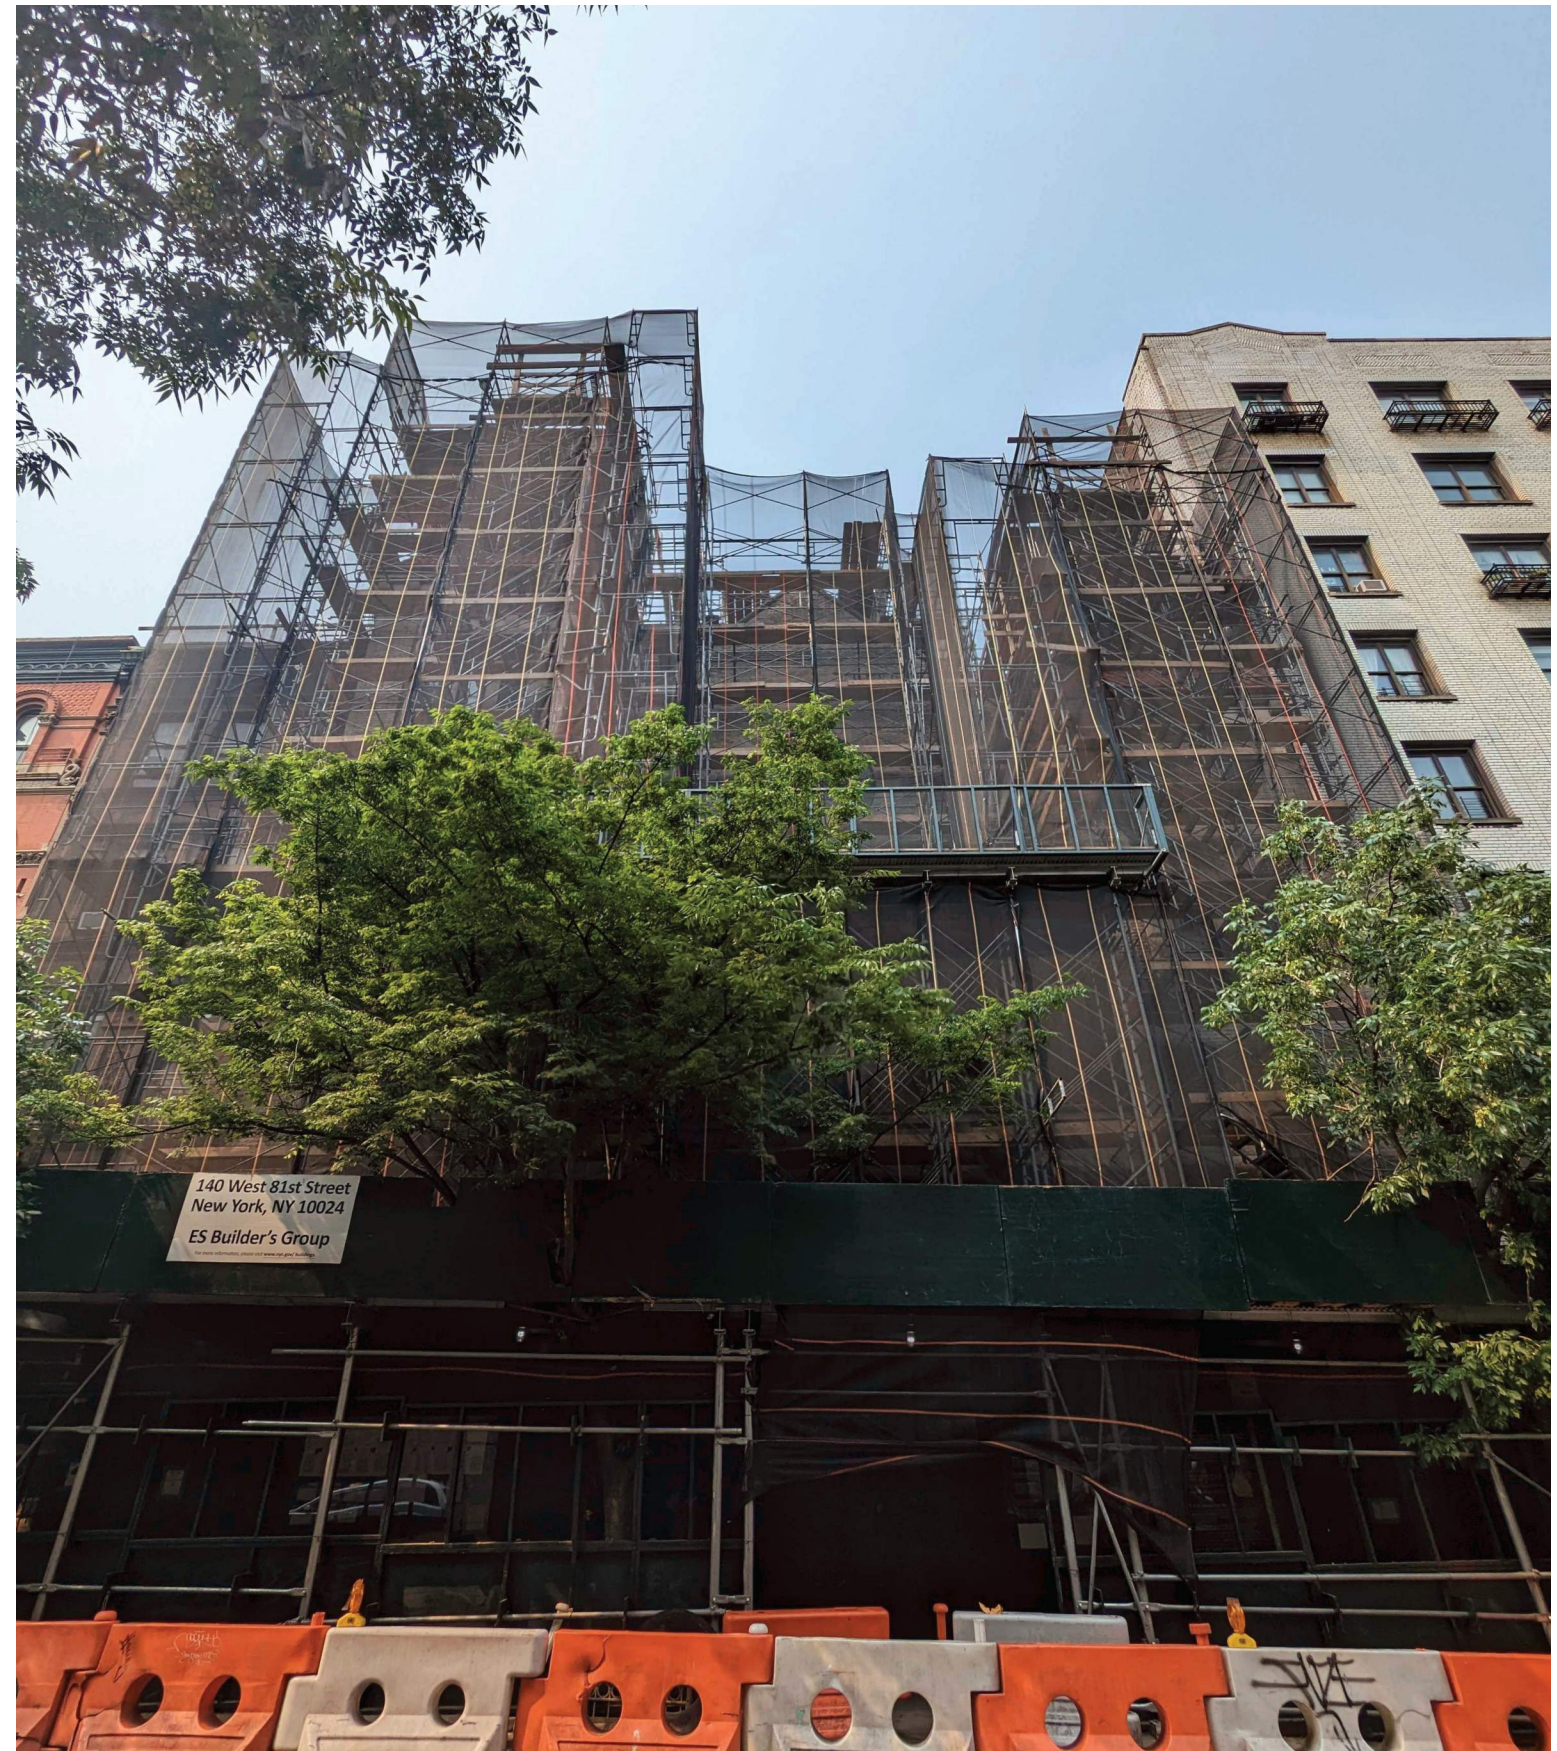
140 W 81 STREET — PROPOSED KEIM MINERAL STAIN MOCKUP PHOTOS: CLOSEUP OF S119 1:1

PHOTO DATED 12/06/2014

PHOTO DATED 06/07/2023
