WEST-PARK PRESBYTERIAN CHURCH

165 WEST 86TH STREET

JUNE 13, 2023

Application for a Notice to Proceed to allow for Demolition on the Grounds of Hardship

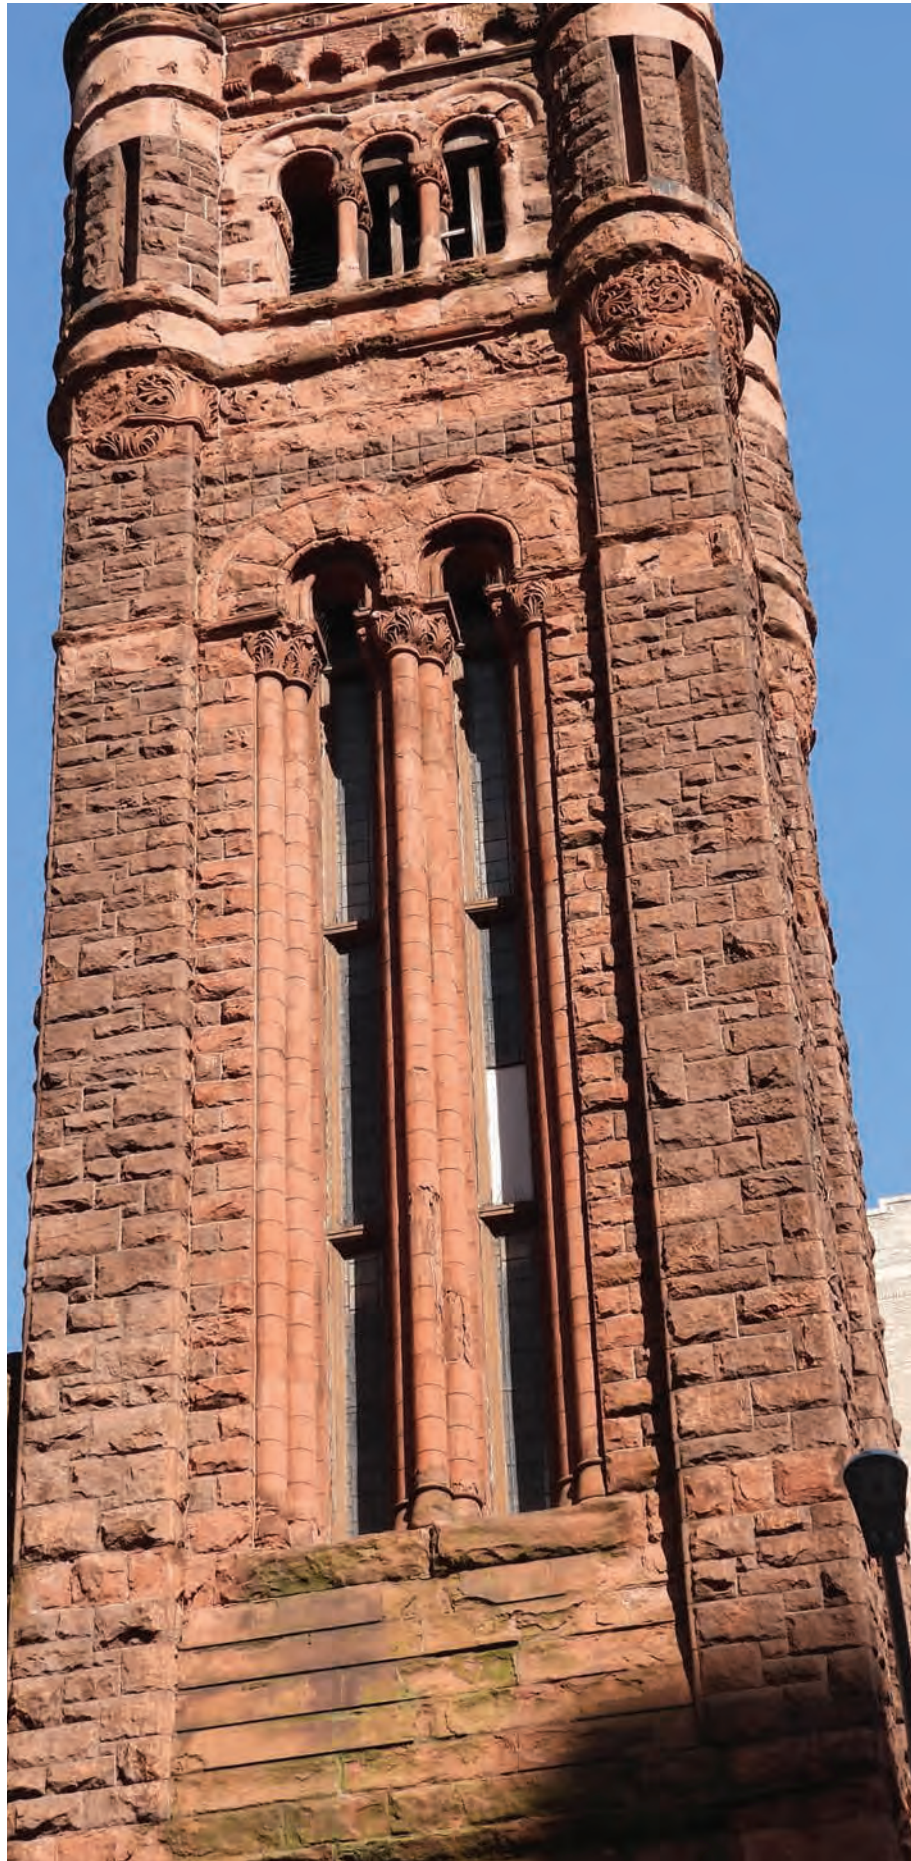
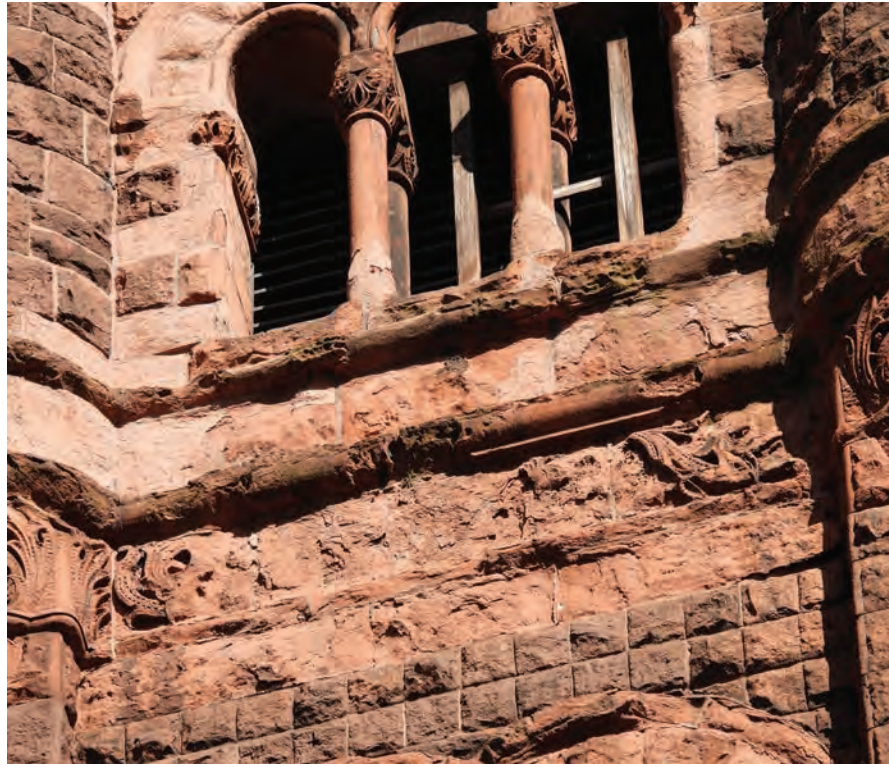
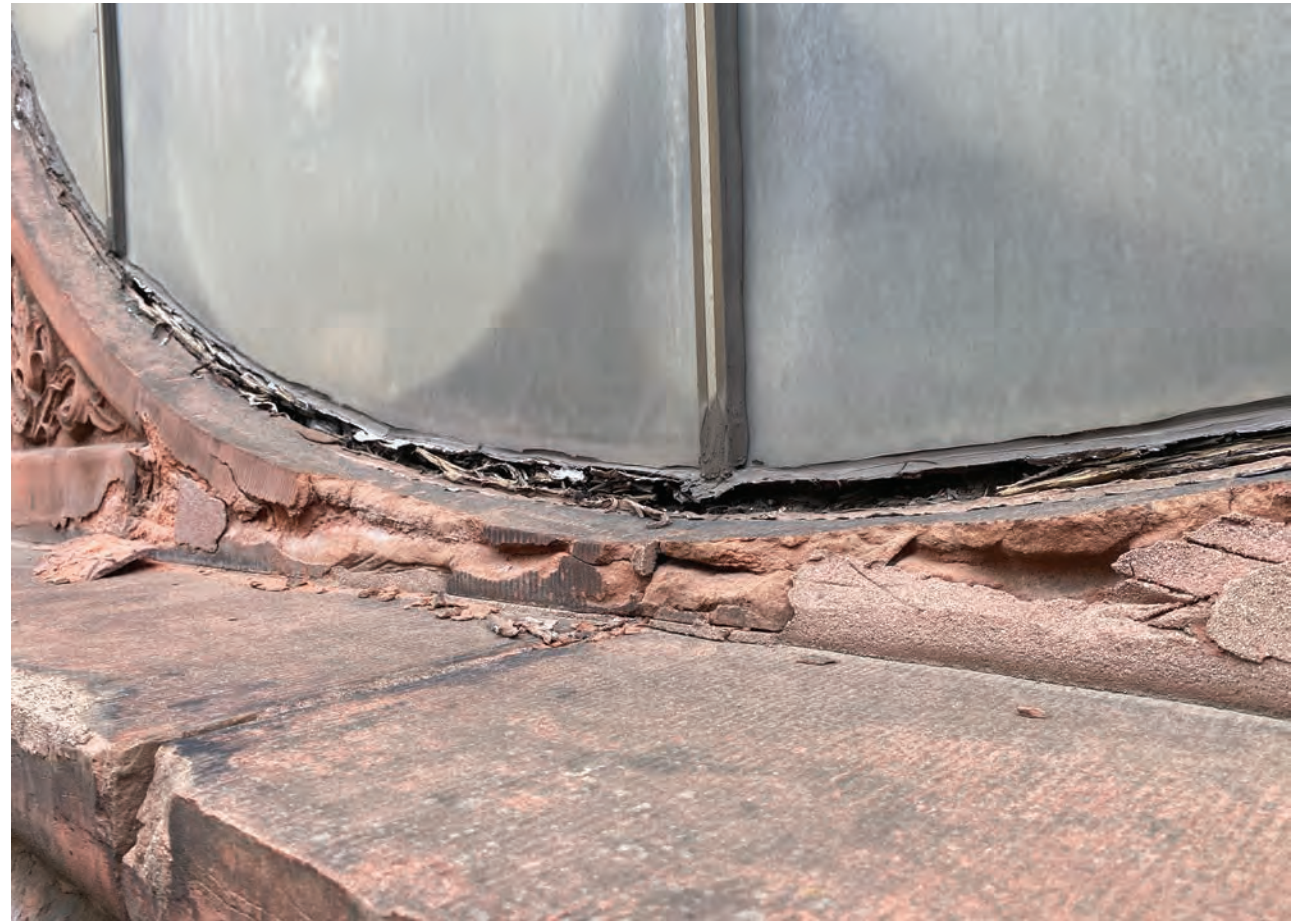
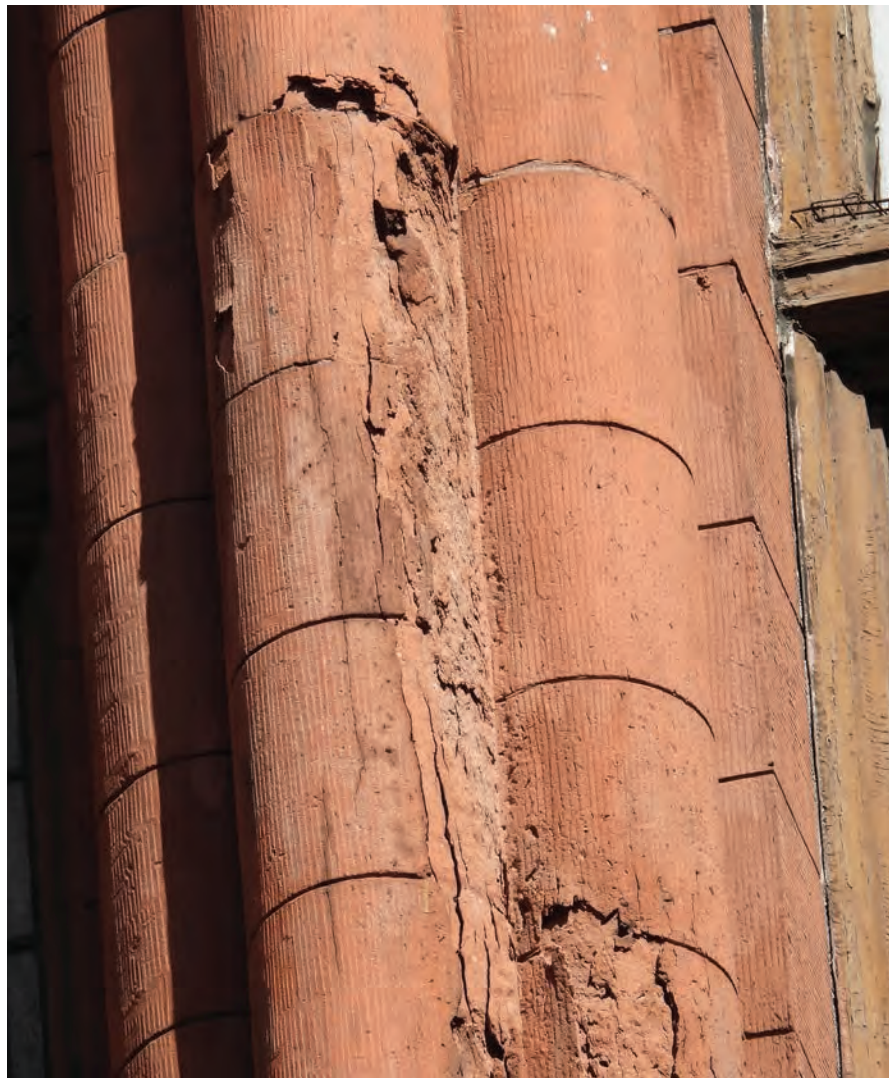
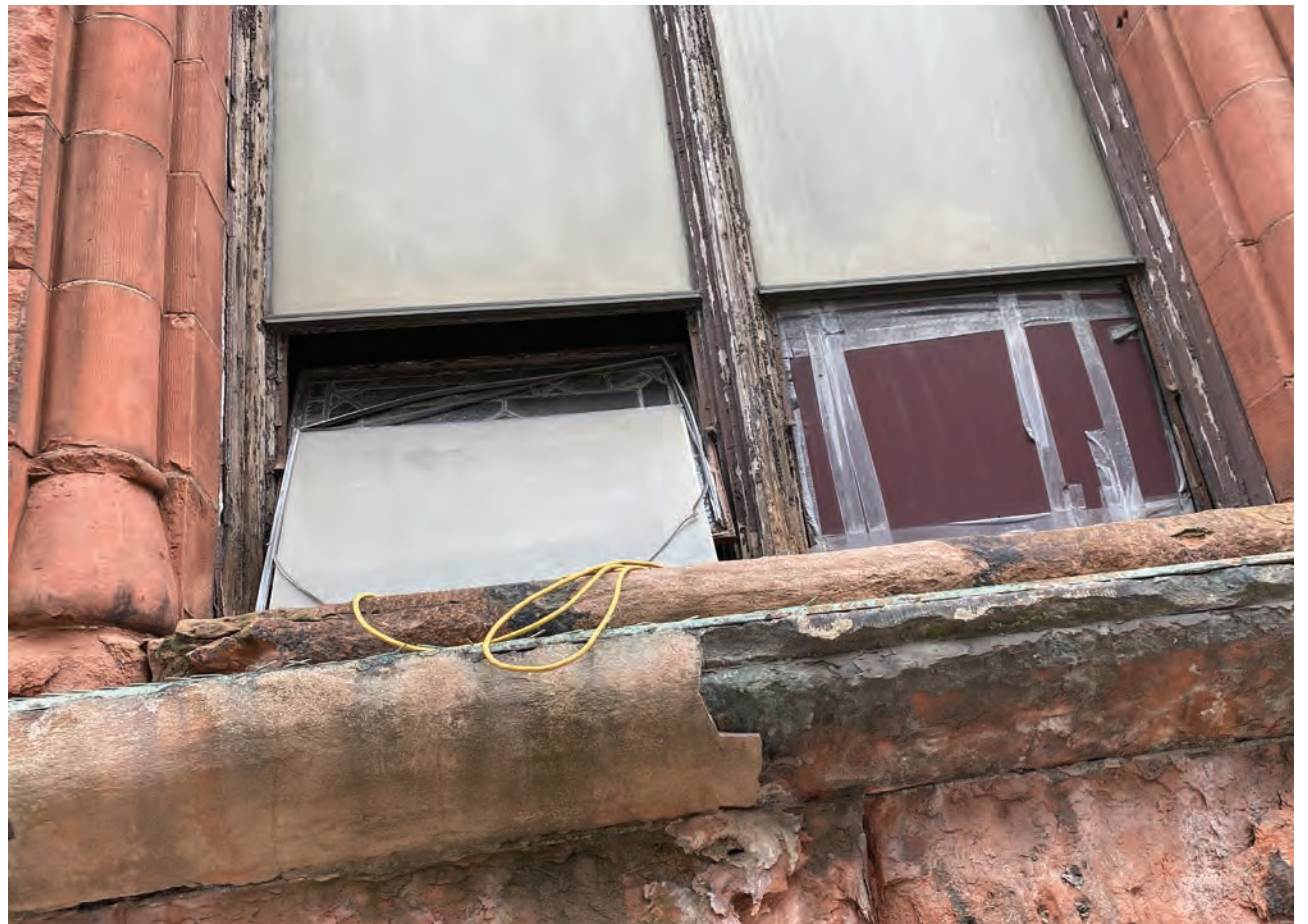
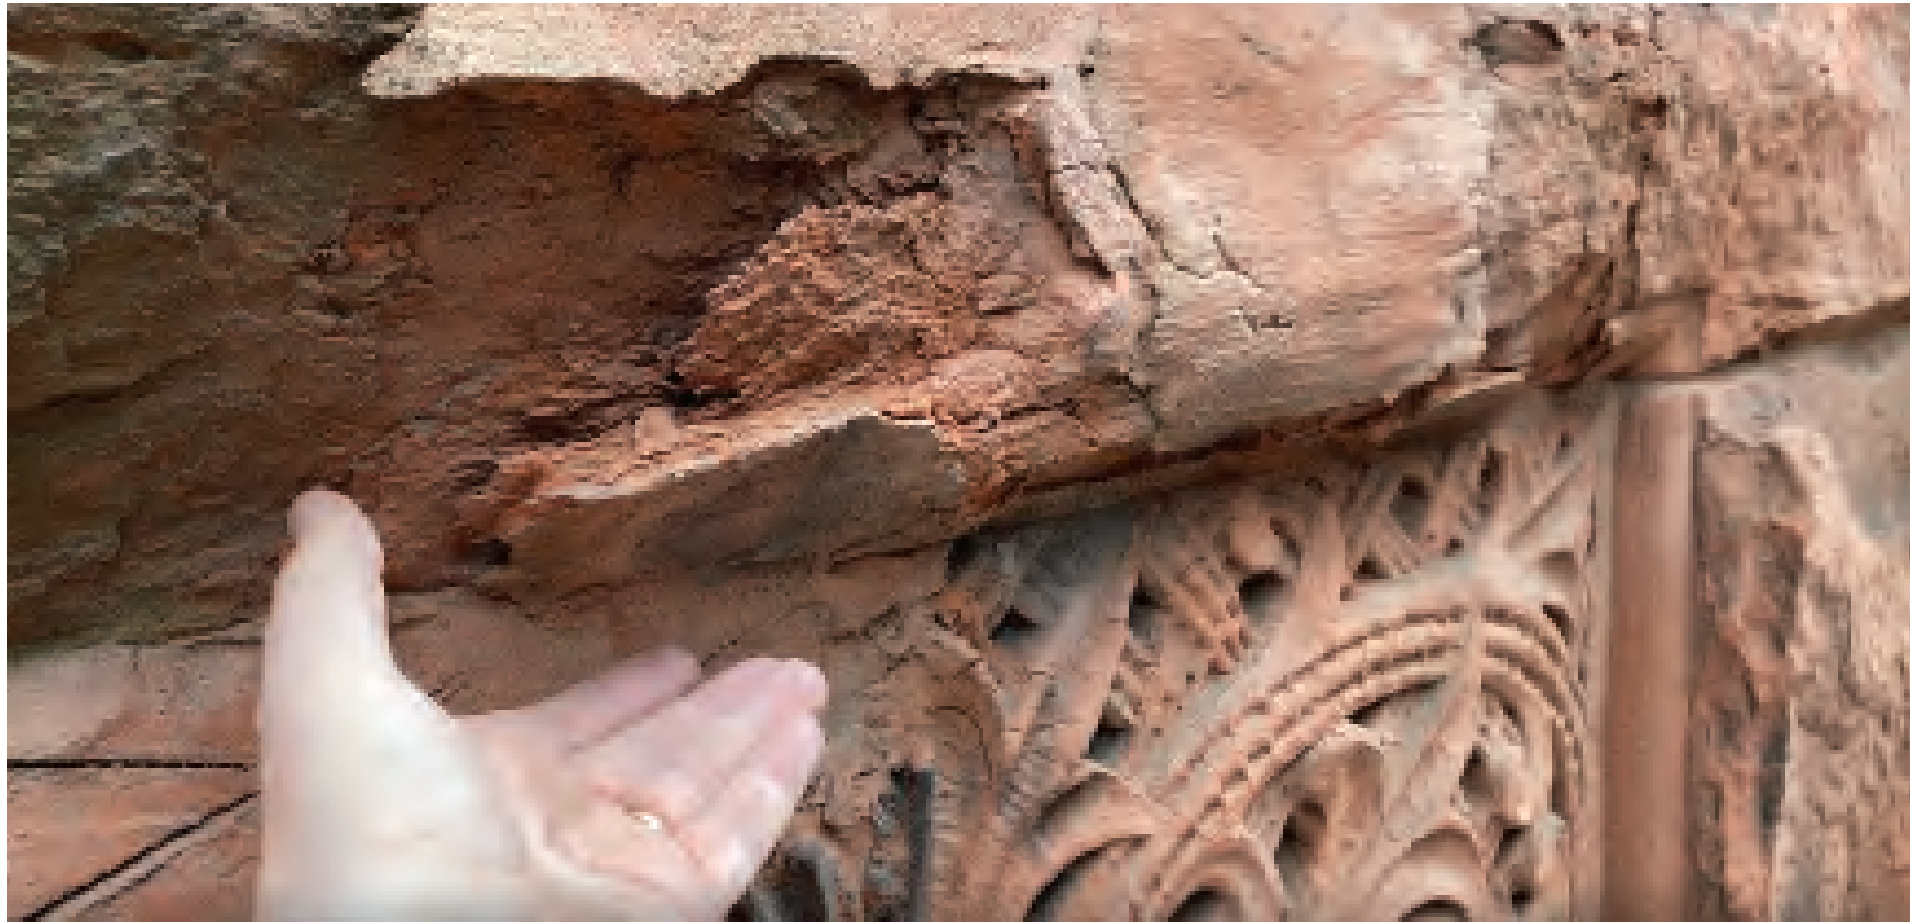
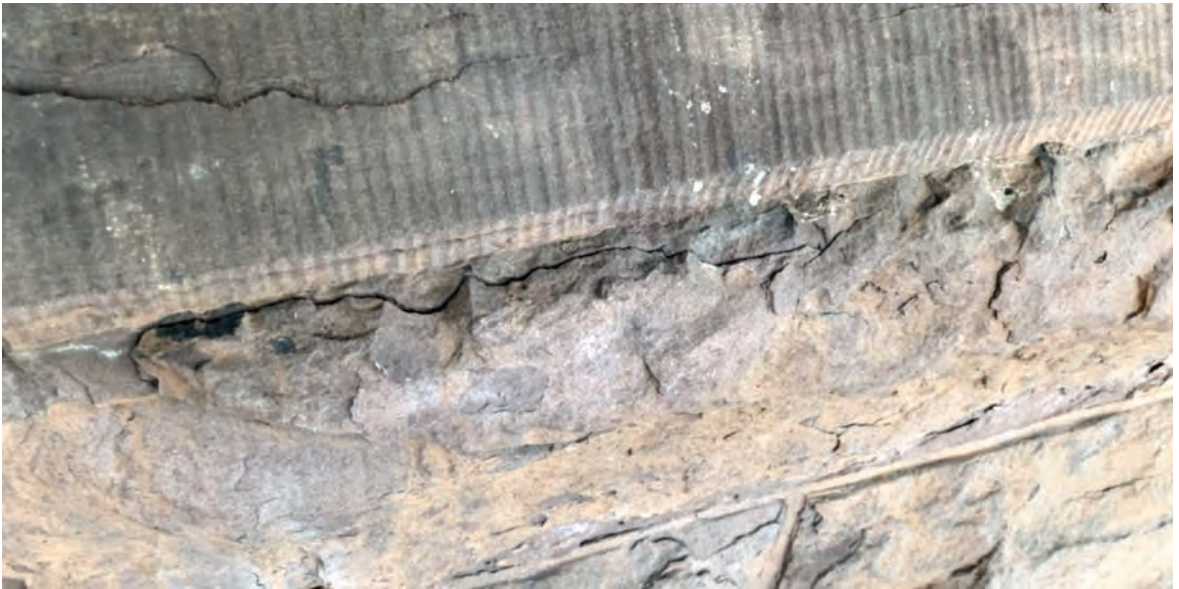
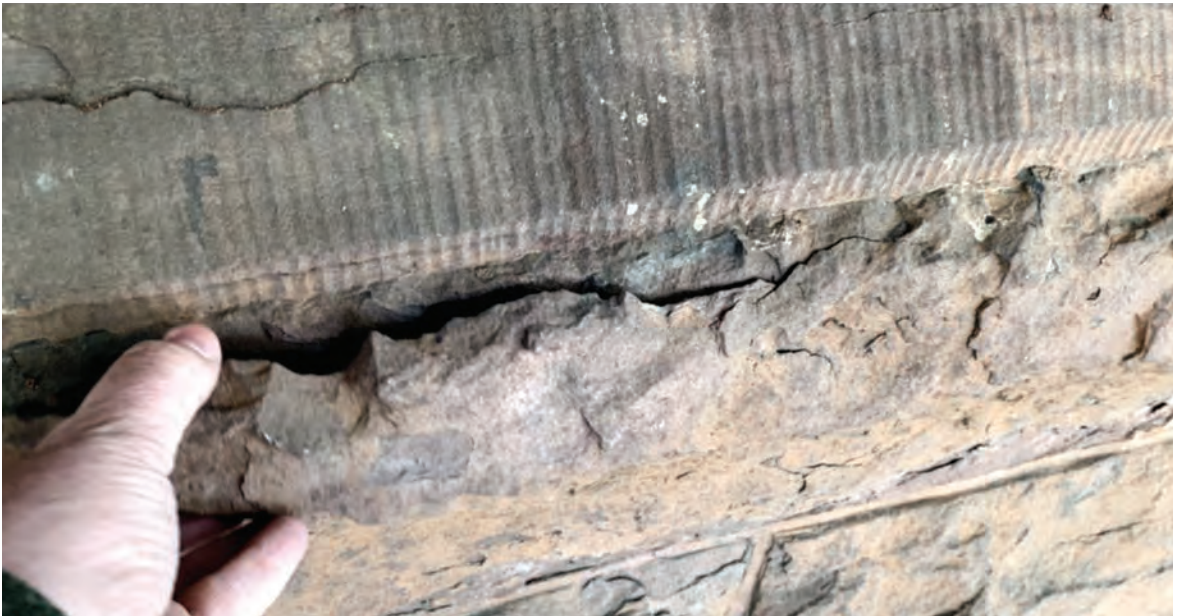
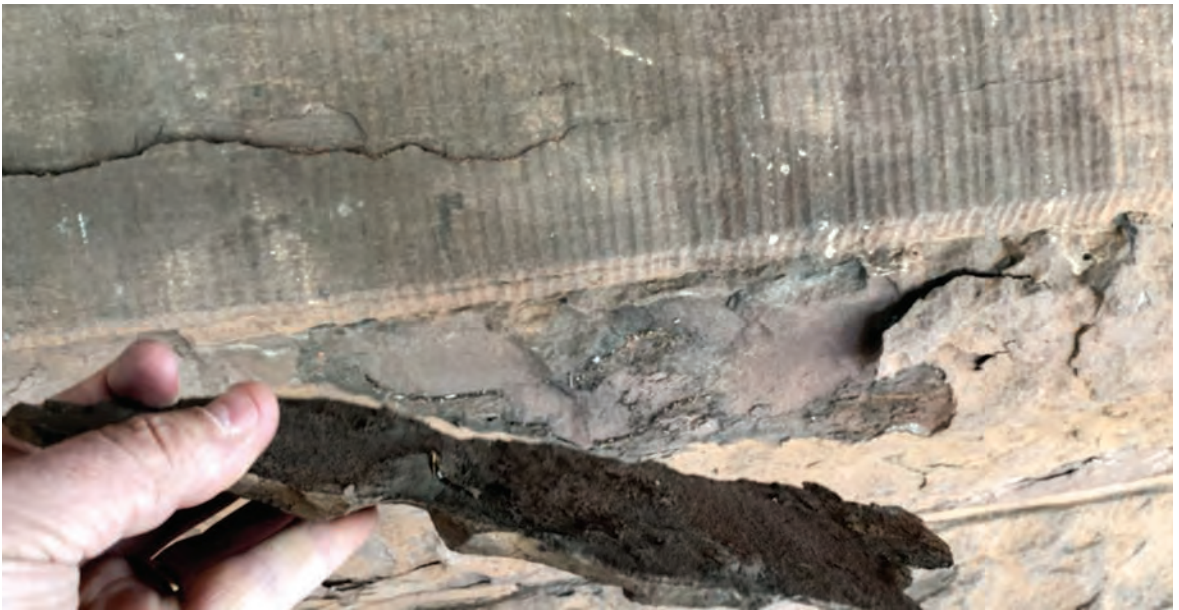
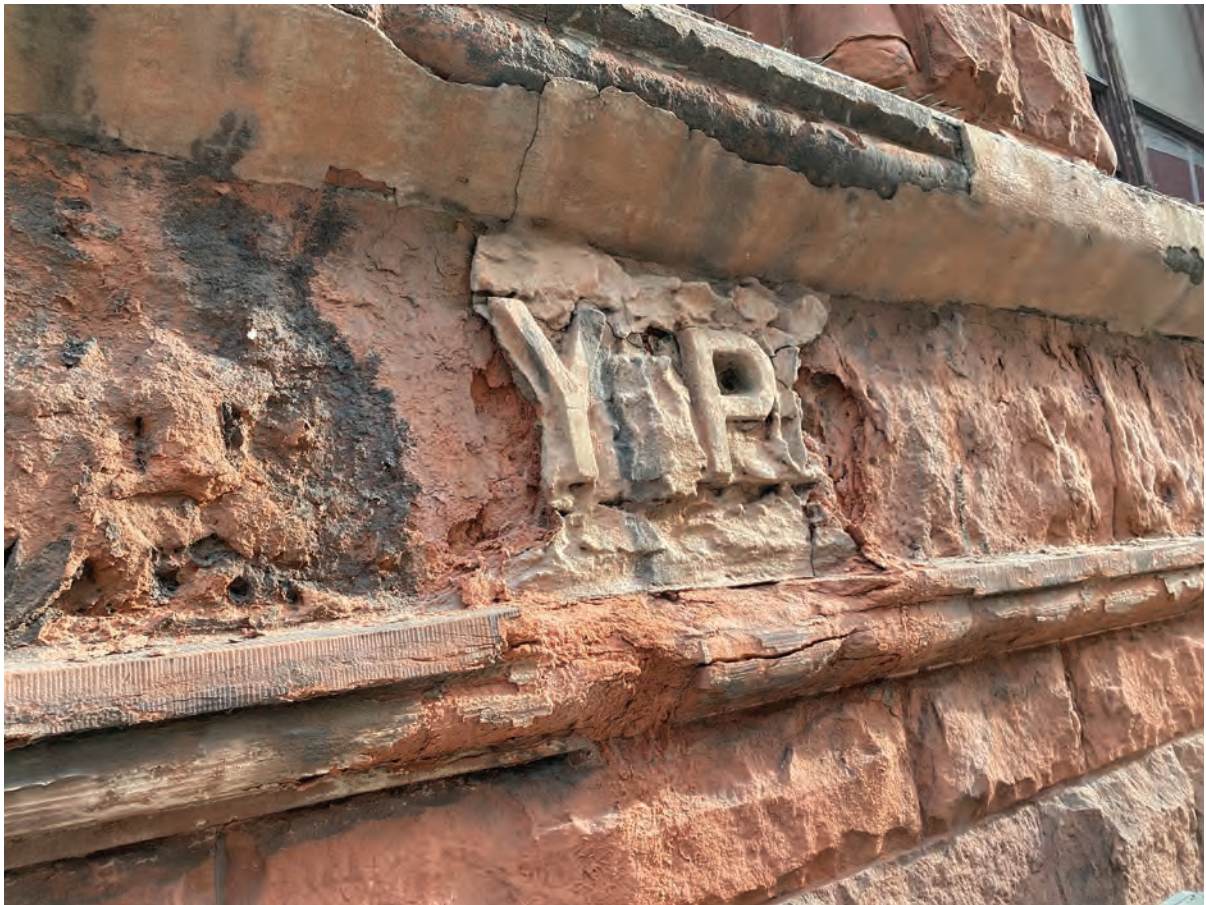
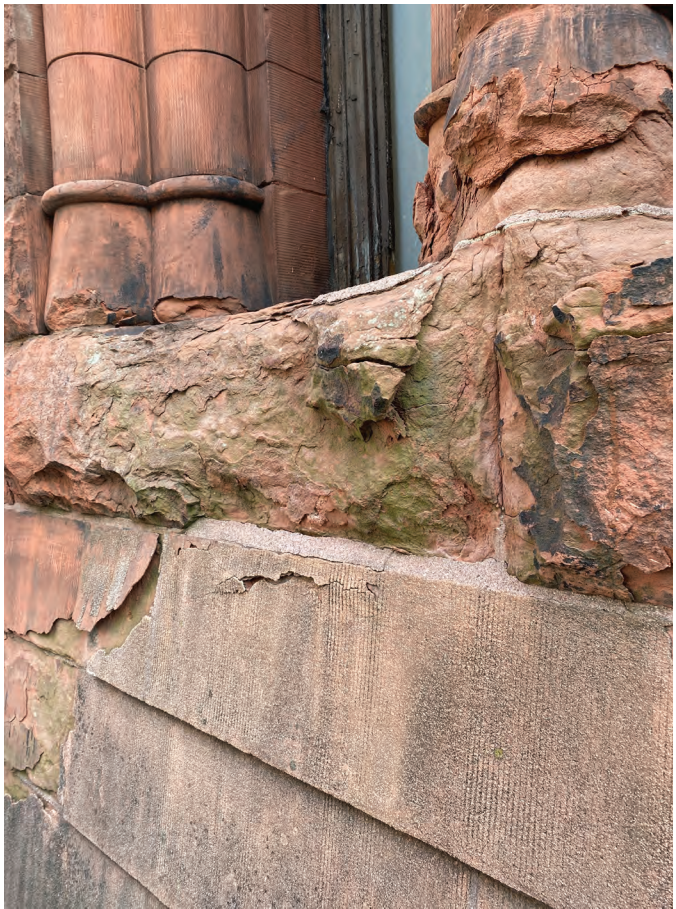
Facade Conditions Report Summary *

- Extensive stone spalling, cracks, mortar deterioration and deteriorated windows noted throughout the building.
- Ornamental sandstone finial severely cracked and spalled.
- Façade conditions are unsafe. Sidewalk bridge has been in place for over 20 years to protect the public.
- Extensive area of stone must be removed and replaced, and the remaining masonry stabilized.

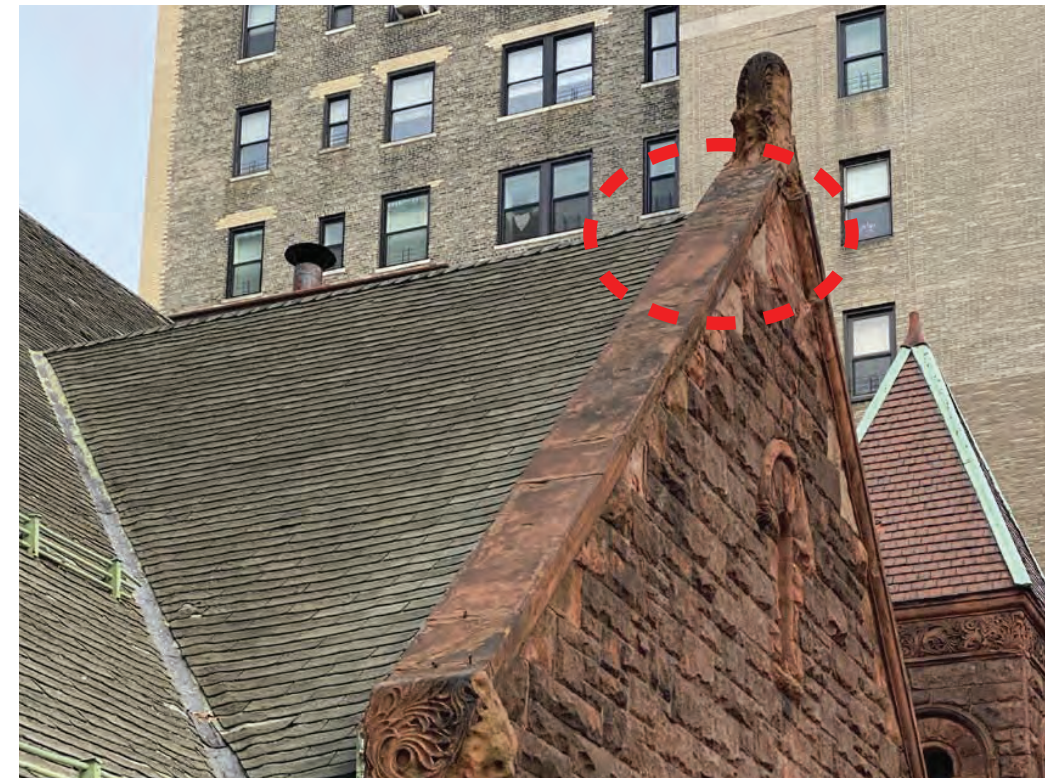
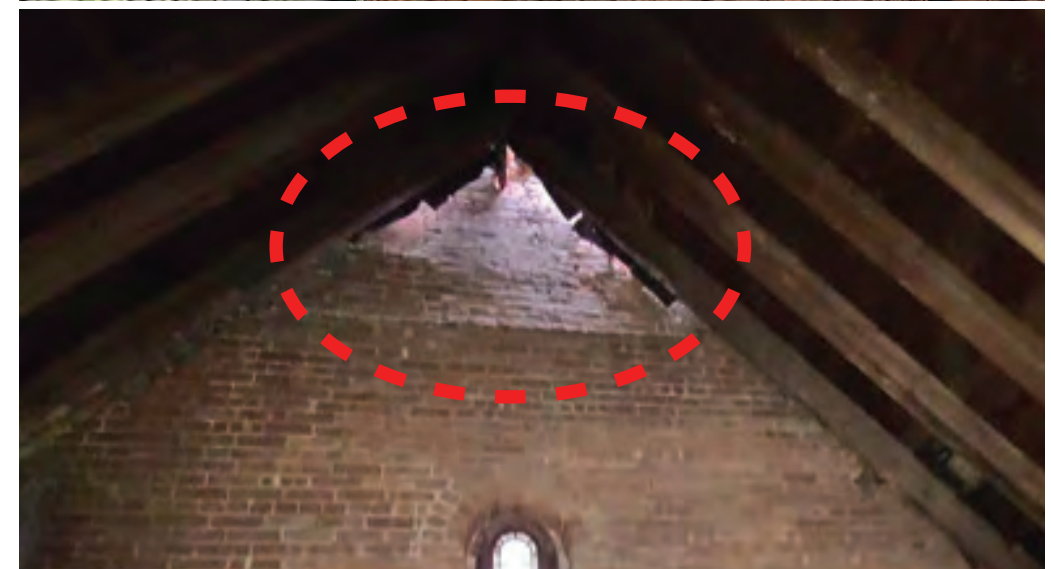
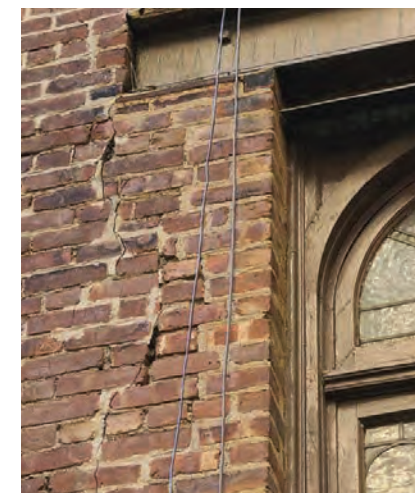
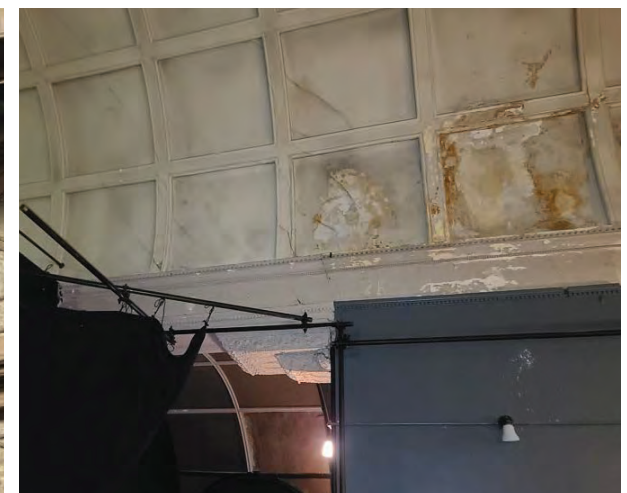
Structural Conditions Report Summary *

- Section of façade adjacent to 86th St. separated from roof. Wall is not adequately braced against wind loads and roof and sanctuary ceilings are not adequately supported.
- Indication of excessive deformation of wood truss and/or excessive lateral movement or settlement at the truss bearing points, and cracks at roof truss.
- Various through-cracks, areas of missing and deteriorated mortar or signs of trapped moisture at bearing walls.
- 25% of brick on bell tower walls are cracked, deteriorated or missing mortar.
- Stair joist severely cracked and deformed.

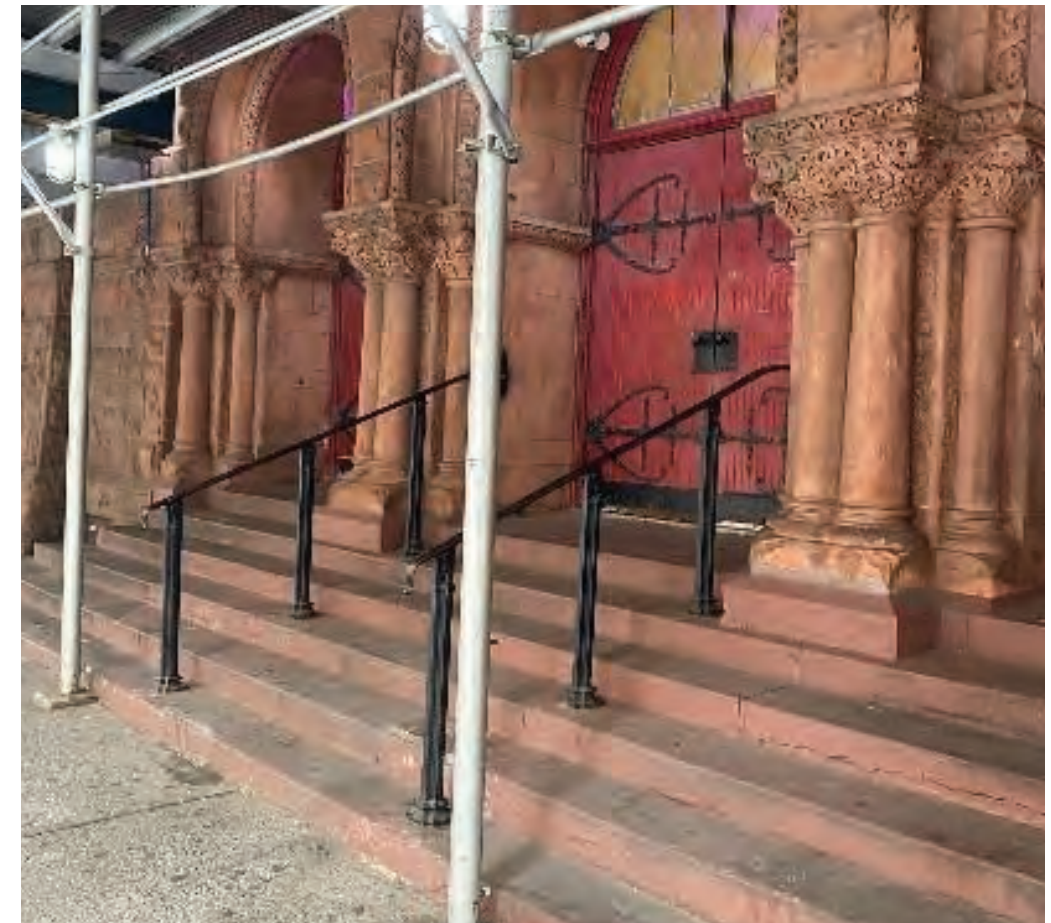
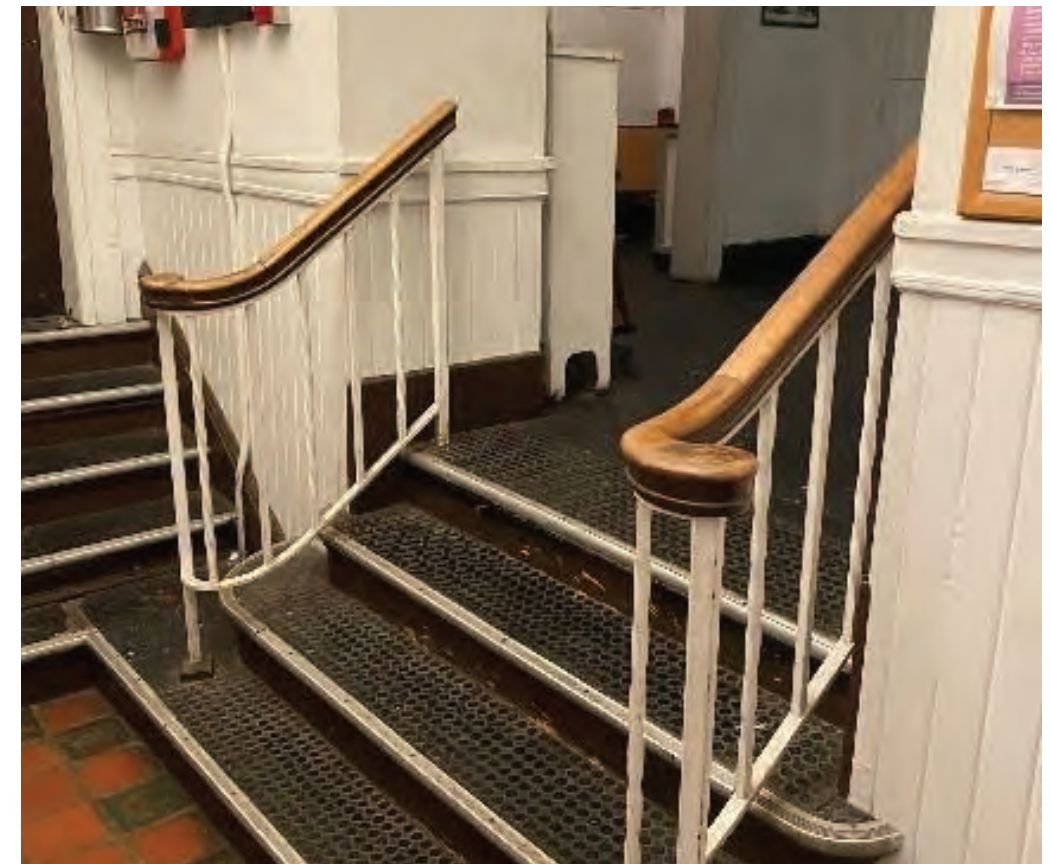
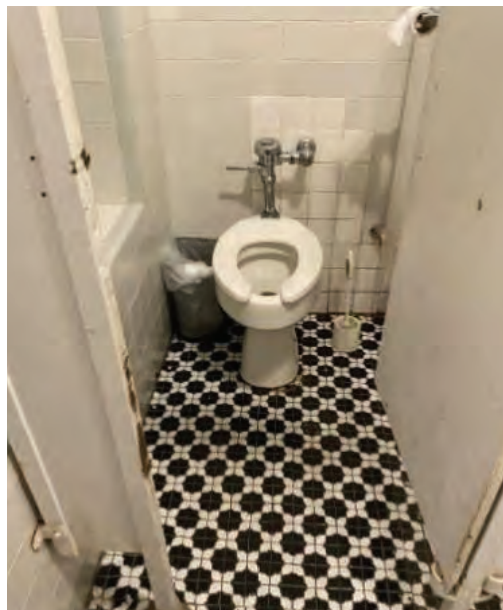
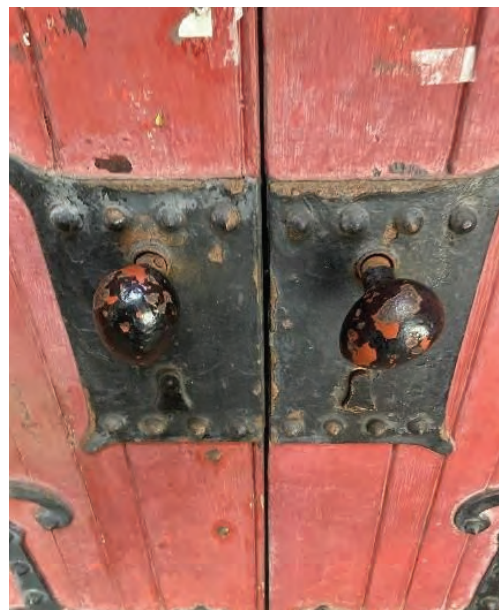
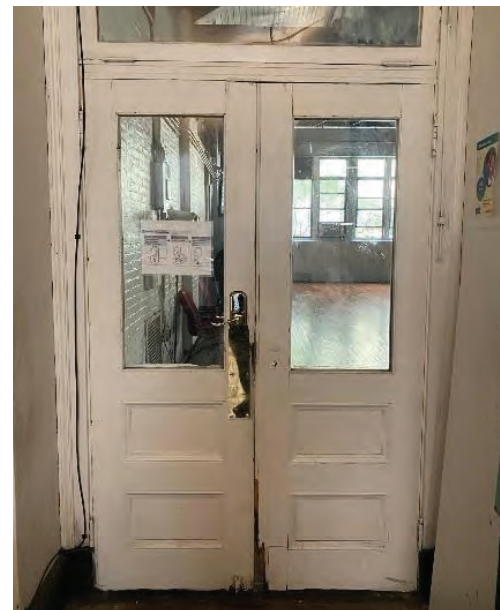
Accessibility Report Summary *

- Amsterdam Avenue and West 86th Street entrances are not accessible.
- No accessible routes from sanctuary to any of the levels of the building including the balcony.
- No accessible restrooms.
- Interior doors, hardware and railings are non-compliant.

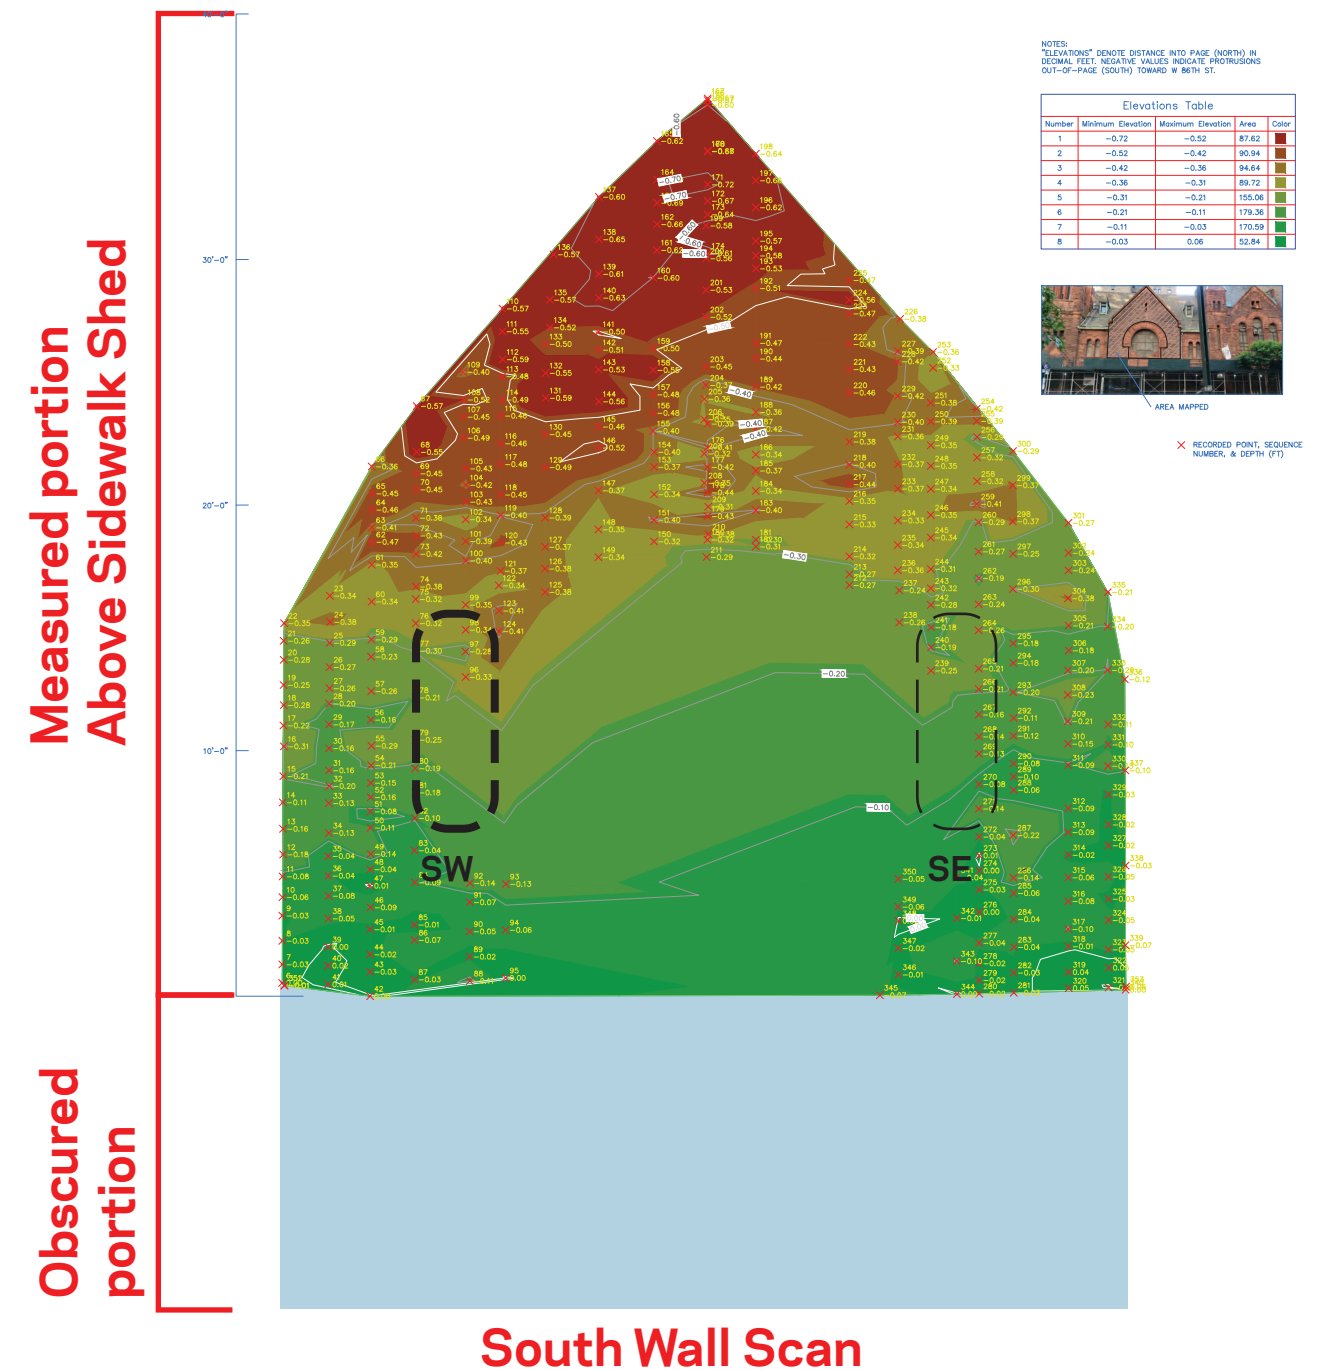
Leaning North and South Walls

- North and south walls are both leaning outward, which in the professional opinion of Severud Associates is “excessive”
 - South wall above sidewalk shed is 8” out of plane - wall below shed not surveyed
 - North wall, which is considerably shorter, is 4” out of plane
- Likely caused by outward forces on trusses supporting the roof.
- In 2022, south wall was discovered to have detached from the roof, leaving roof ridge beam unsupported.

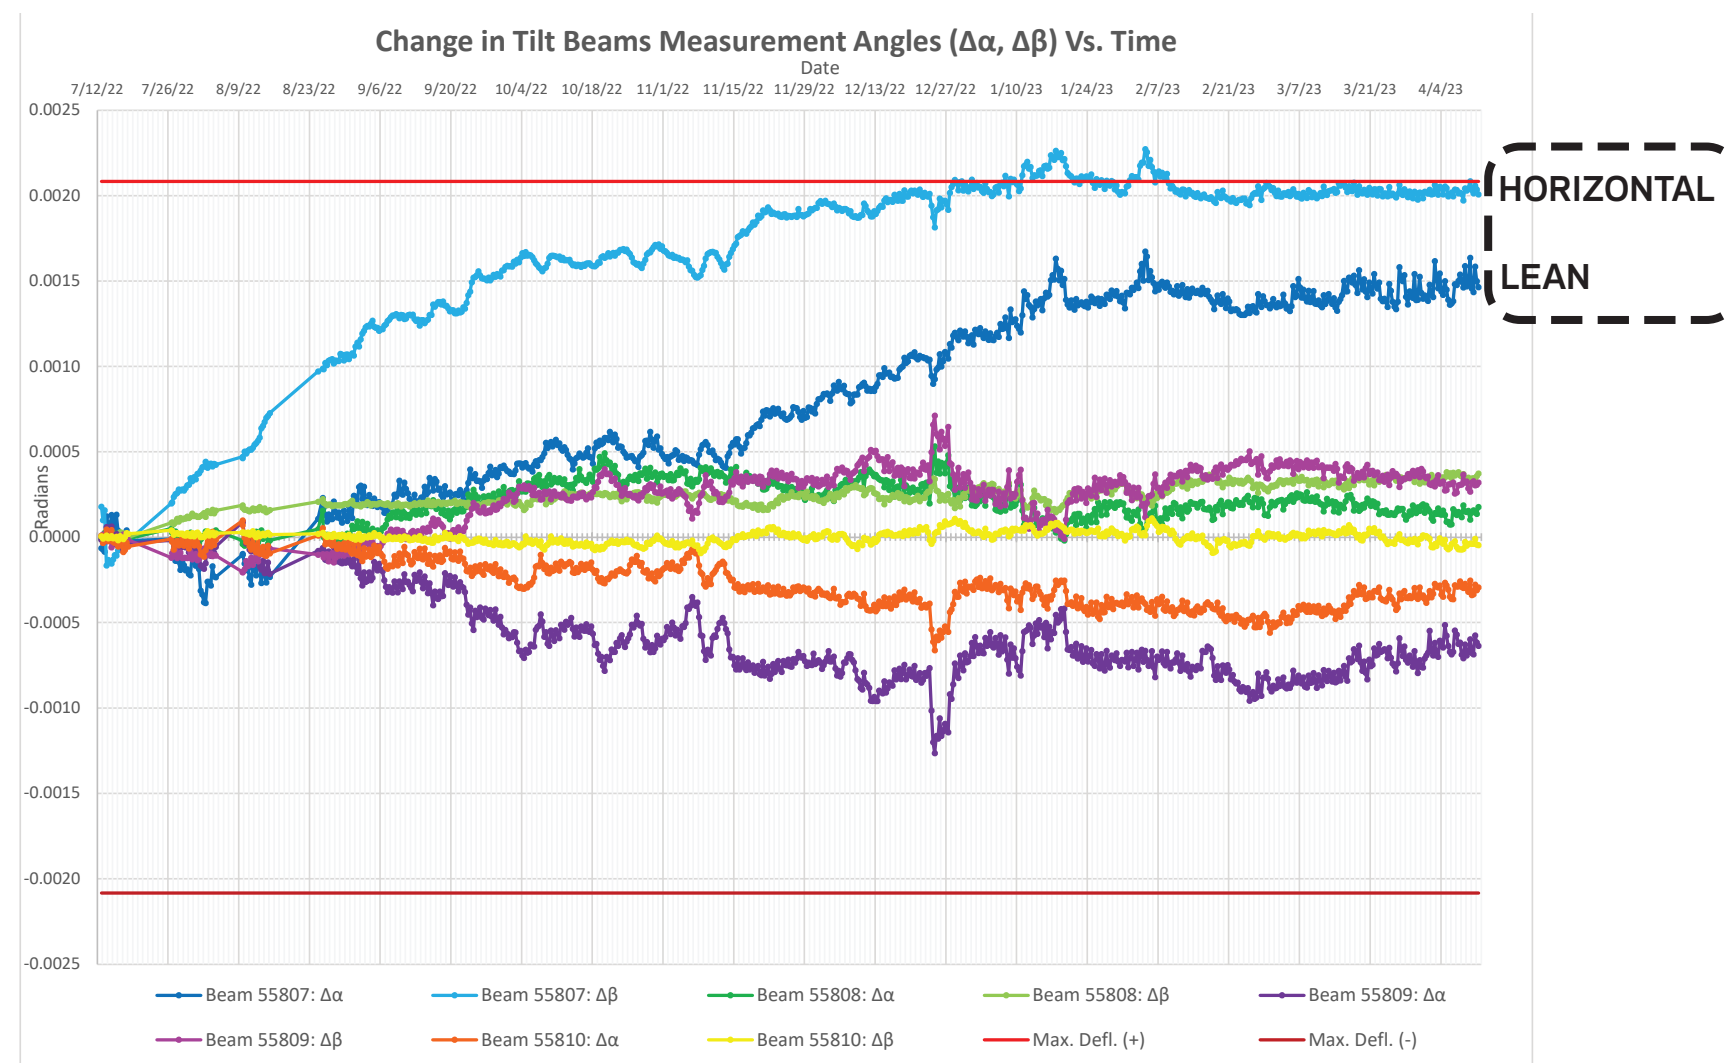
Continued Movement

- Four “tilt monitors” were installed by Krypton Engineering in July 2022 on the interior of the north and south sanctuary walls to monitor both horizontal and leaning movement over time.
- The west side of the south wall, below the area of the wall with the greatest outward lean, shows the greatest continuous movement.

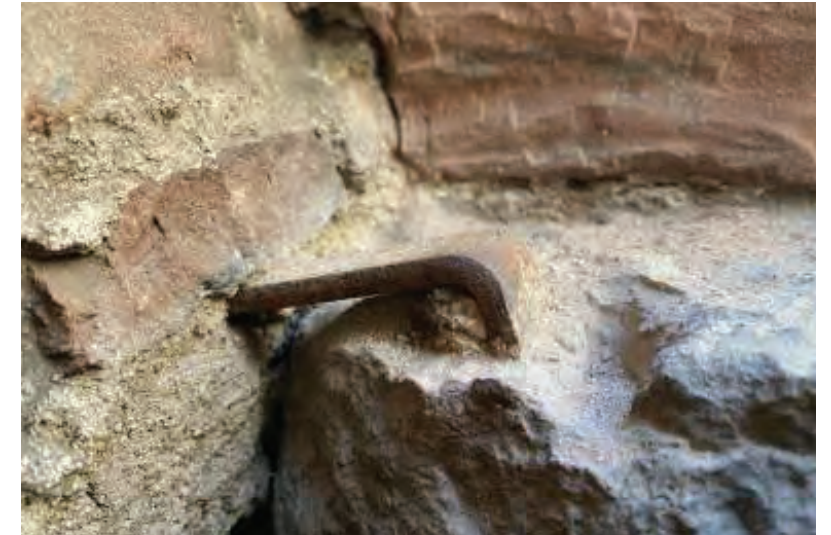
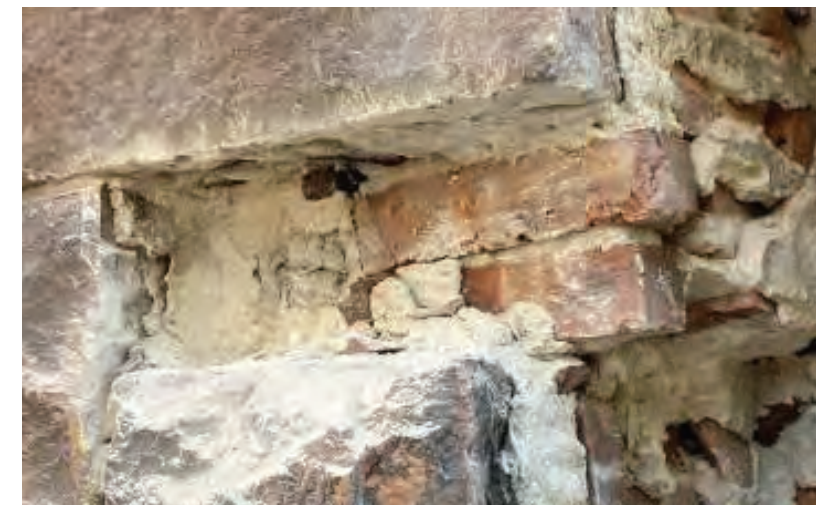
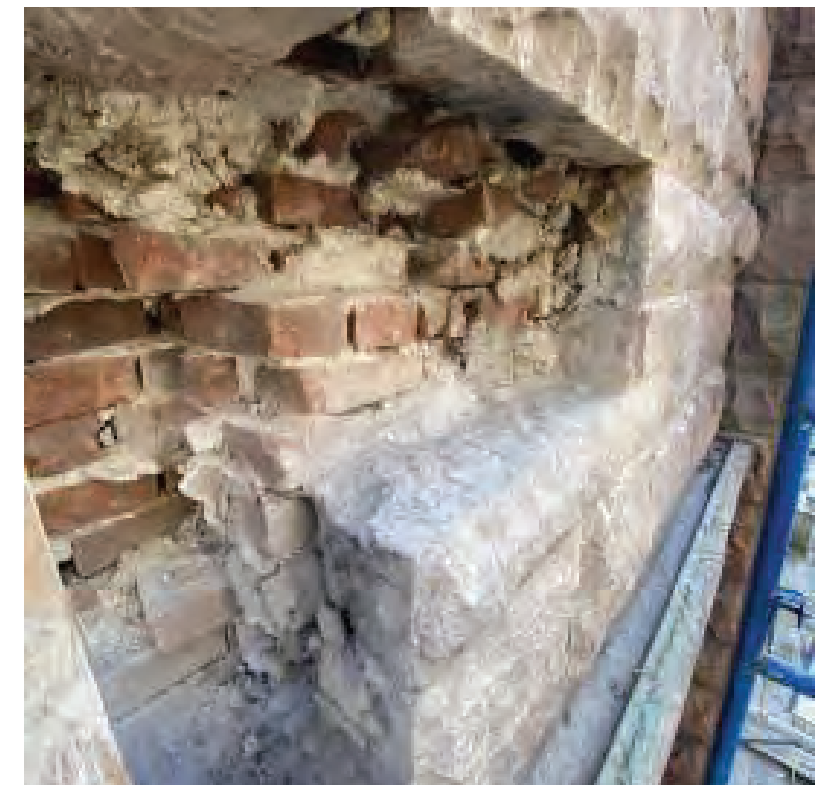
Façade Probes

- Commissioners asked the Church to conduct probes to determine the underlying condition of the façade and bearing walls.
- No evidence of functional connection between bearing brick wall and stone facade.
- Iron ties are either missing or completely deteriorated.
- Facade only connected through friction - highly problematic on outward leaning walls.
- Remediation - Install approximately 3,700 steel rods to reaffix the façade to the bearing walls .

- Install a system of steel girts on north and south sanctuary walls.
- Connect girts with tie rods running through the attic.
- Reinforce the walls to prevent excessive stresses in masonry units and mortar joints.
- Stabilize the roof system so that the tops of the walls do not continue to thrust outward.

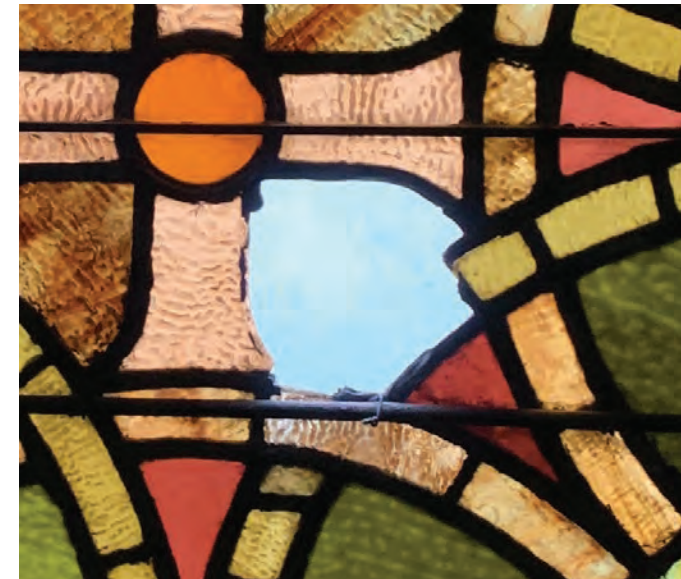
There are many untreated breaks, broken pieces that have been totally or partially lost and evidence of previous repairs.

Detail from window S 12 where a piece of glass and the surrounding matrix have been lost. The pieces are unstable.

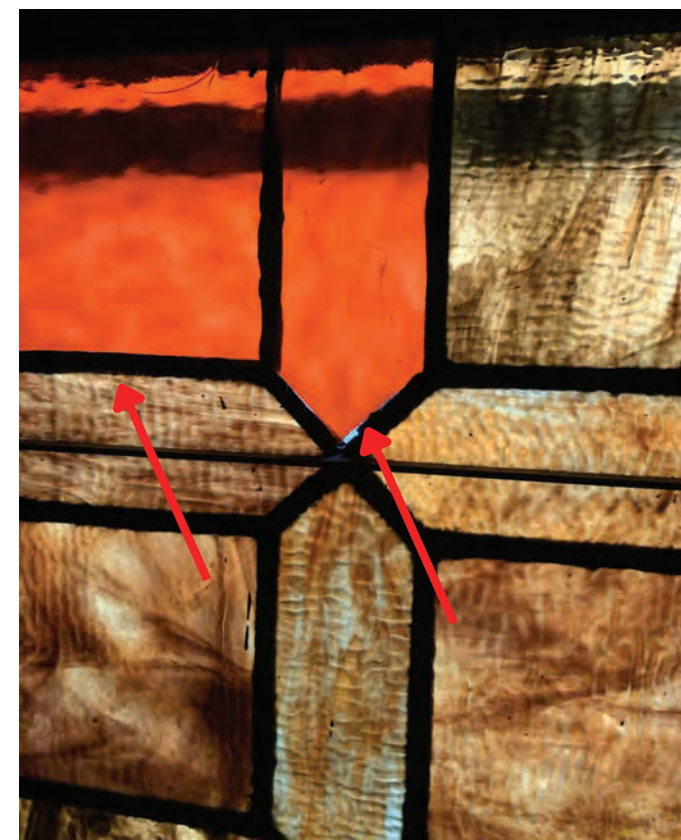
Detail of a poor repair in window S 13. The replacement glass is not a good match to the surrounding material.
