WEST-PARK PRESBYTERIAN CHURCH

165 WEST 86TH STREET

JUNE 13, 2023

Application for a Notice to Proceed to allow for Demolition on the Grounds of Hardship

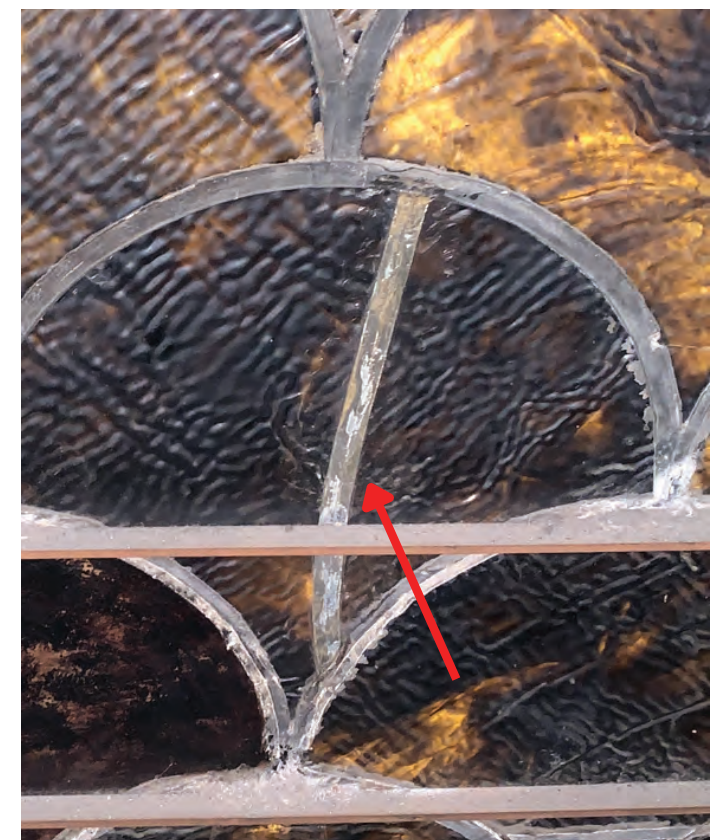
Detail of typical strap lead in window W 15. Strap leads are not true repairs, they merely cover the break.

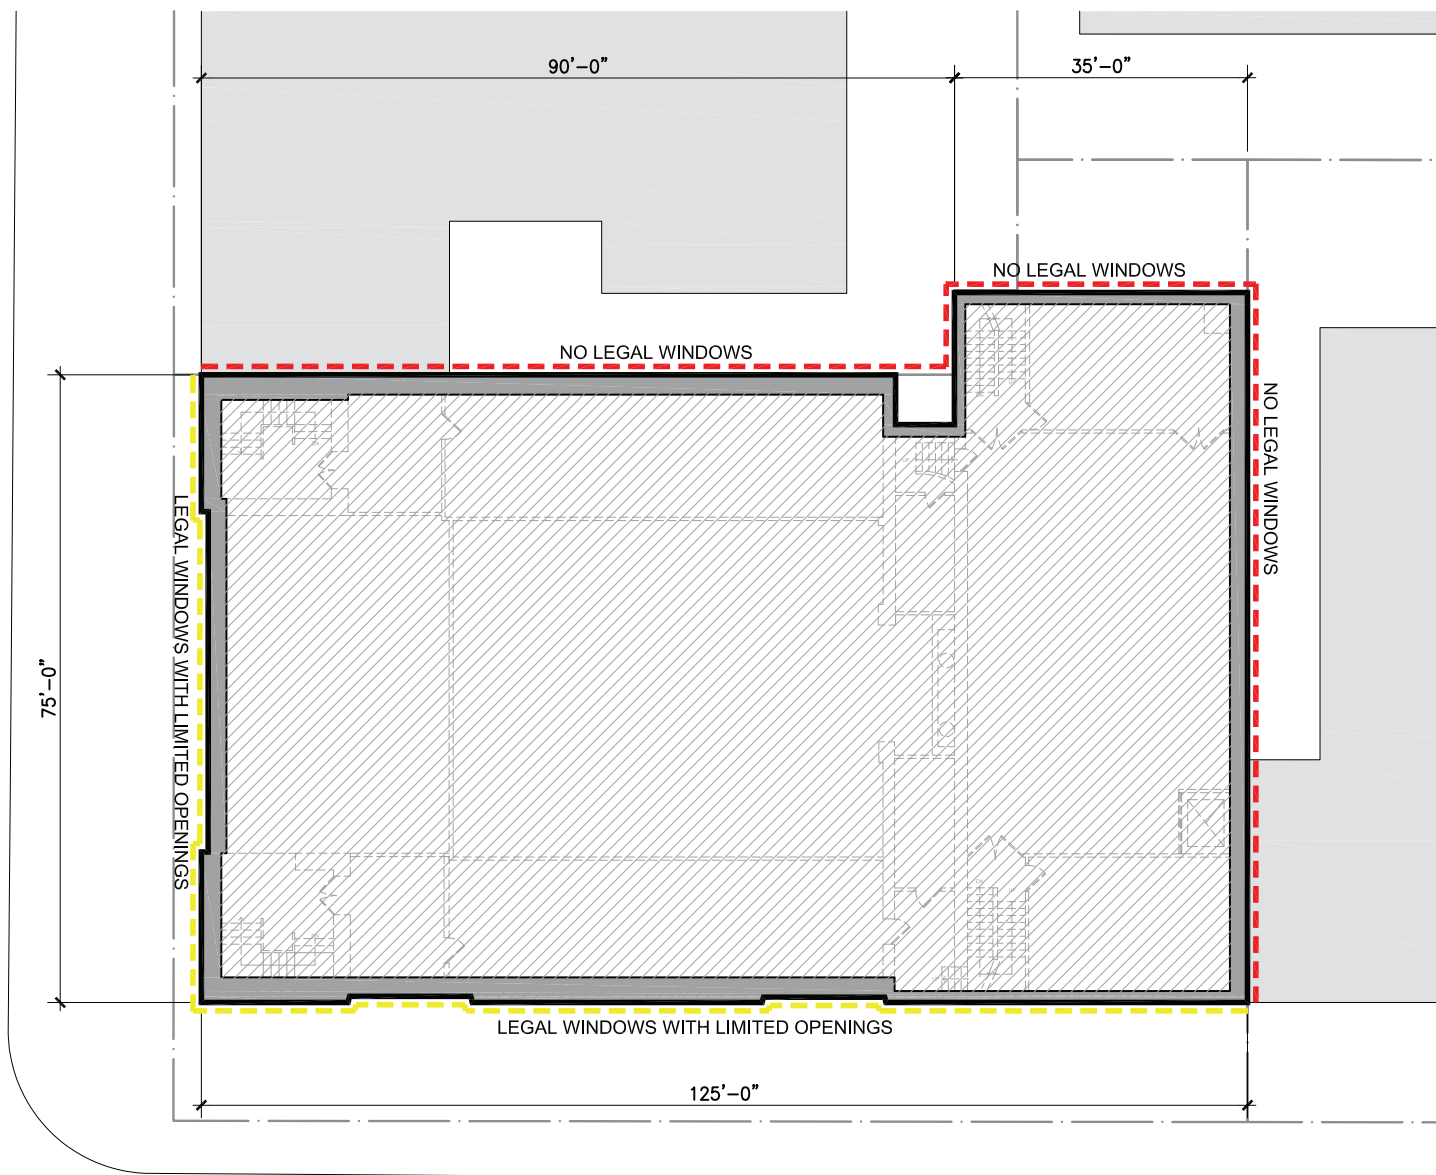
Plan showing extent of "Legal Windows"

- A new Inner Court to be carved out of existing building for “Legal Windows”
- Existing internal structure to be replaced with new fireproof concrete structure.
- Four new floors to be added to align with existing windows.
- The existing facade will most likely need to be completely replaced.
- Extensive number of new windows to be cut into existing facade.

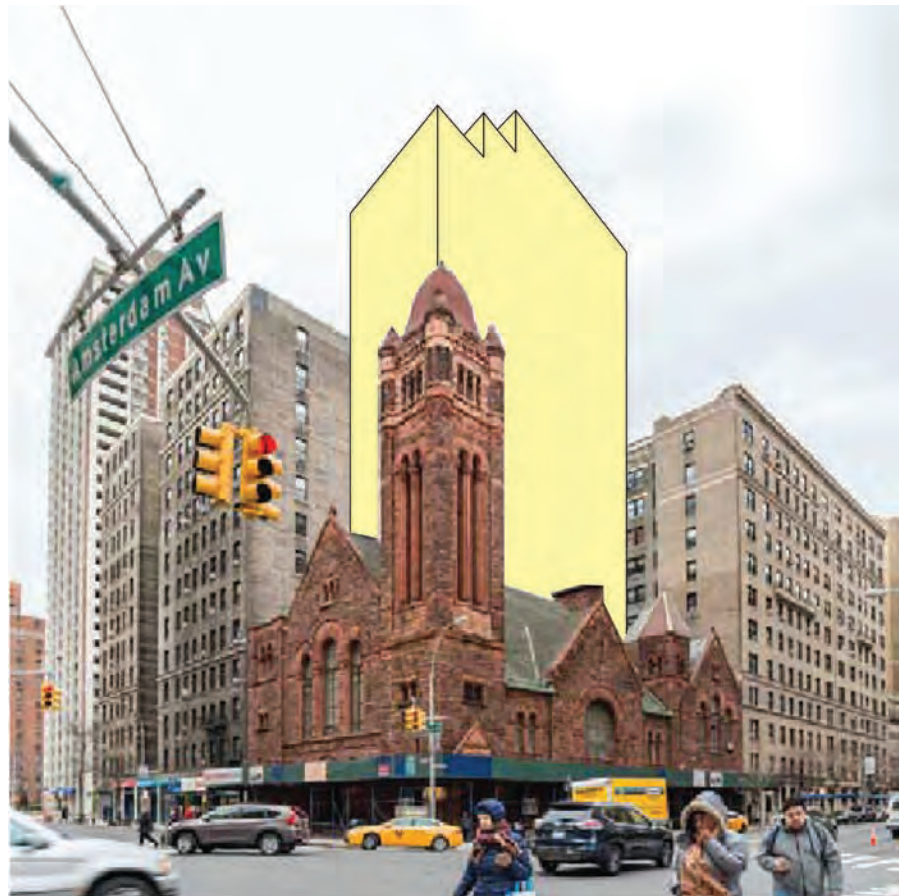
Study C: Repair and restore façade; demolish & rebuild Sanctuary structure and interior in reconfigured form for use as Community Facility; demolish & rebuild Parish house structure and interior in reconfigured form for use as Residential entrance + amenities; construct new 210' slab-form residential tower on NE quadrant of site

Above grade Gross SF:	68,900 sf
Zoning SF used:	65,400 sf
Unused ZSF:	30,170 sf
Net Residential Rentable / Sellable :	47,900 sf
Community Facility SF:	5,500 sf

- Requires BSA Variance for rear yard / legal windows
- Requires Landmarks approval for demolition, alterations and overbuilds to buildings
- Requires expensive façade repair and stabilization.
- Requires extensive underpinning, structural complexities and protection of the existing church façade during construction of new building.
- Yields limited, floor area
- Yields compromised Community Facility space

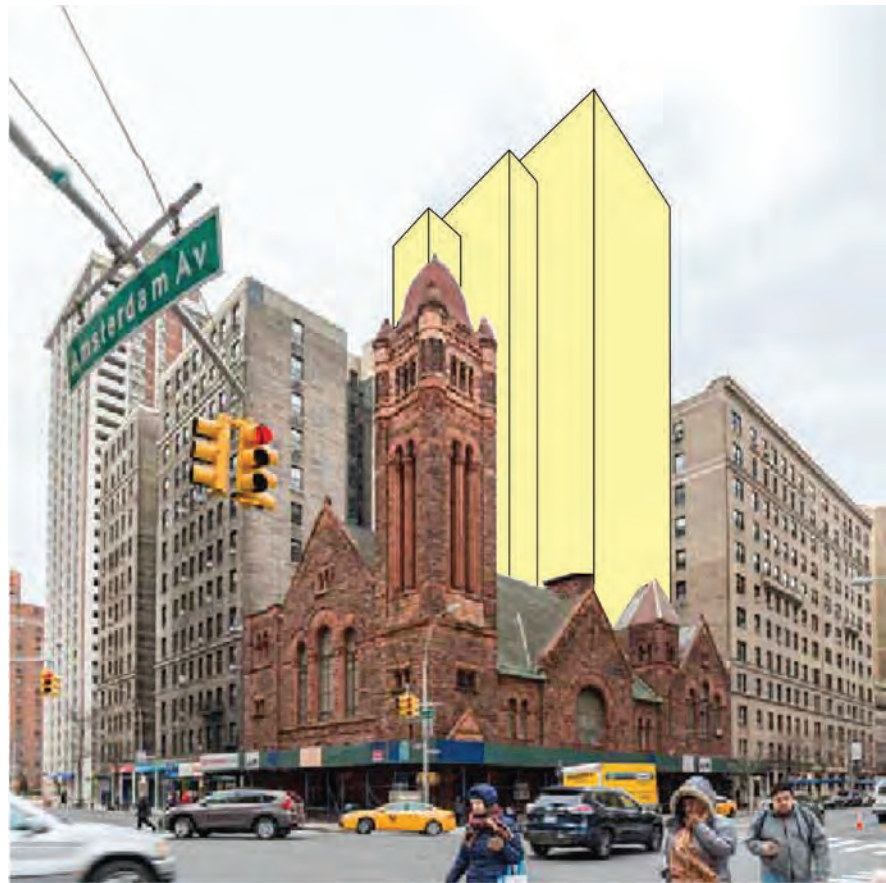
Study D: Repair and restore façade; demolish & rebuild Sanctuary structure and interior in reconfigured form for use as Community Facility; demolish & rebuild Parish house structure and interior in reconfigured form for use as Residential entrance + amenities; construct new 210' tall stepped-form residential tower on NE quadrant of site

Above grade Gross SF:	65,000 sf
Zoning SF used:	62,000 sf
Unused ZSF:	33,570 sf
Net Residential Rentable / Sellable:	44,000 sf
Community Facility:	5,500 sf

- Requires BSA Variance for rear yard / legal windows
- Requires Landmarks approval for alterations to buildings
- Requires expensive façade repair and stabilization.
- Requires extensive underpinning, structural complexities (separating the two buildings) and protection of the existing church façade during construction of new building.
- Yields inefficient, limited, floor area
- Yields compromised community facility space

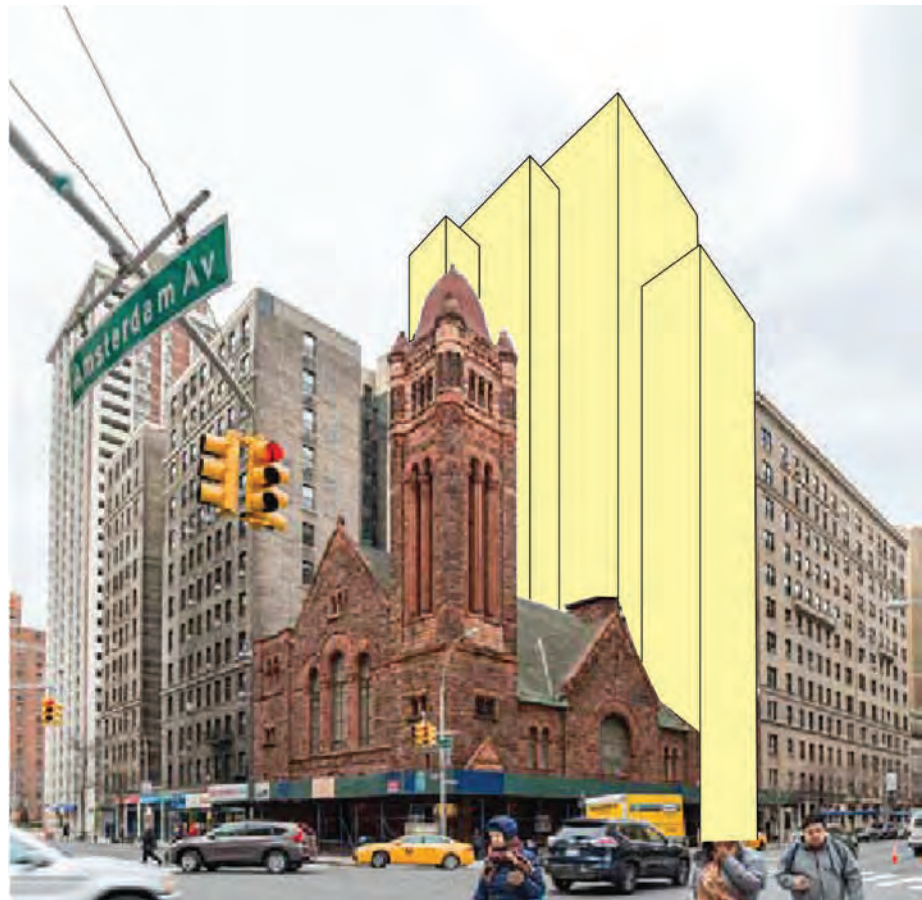
Study E: Repair and restore Sanctuary façade; demolish & rebuild Sanctuary structure and interior in reconfigured form for use as Community Facility; demolish Parish house in its entirety; construct new 210' tall, stepped form Residential tower on eastern portion of site

Above grade Gross SF:	68,500 sf
Zoning SF used:	65,000 sf
Unused ZSF:	30,570 sf
Net Residential Rentable / Sellable:	47,500 sf
Community Facility:	5,500 sf

- Requires BSA Variance for rear yard / legal windows
- Requires Landmarks approval for alterations to buildings
- Requires expensive façade repair and stabilization.
- Requires extensive underpinning, structural complexities (separating the two buildings) and protection of the existing church façade during construction of new building.
- Yields inefficient, limited, floor area
- Yields compromised Community Facility space

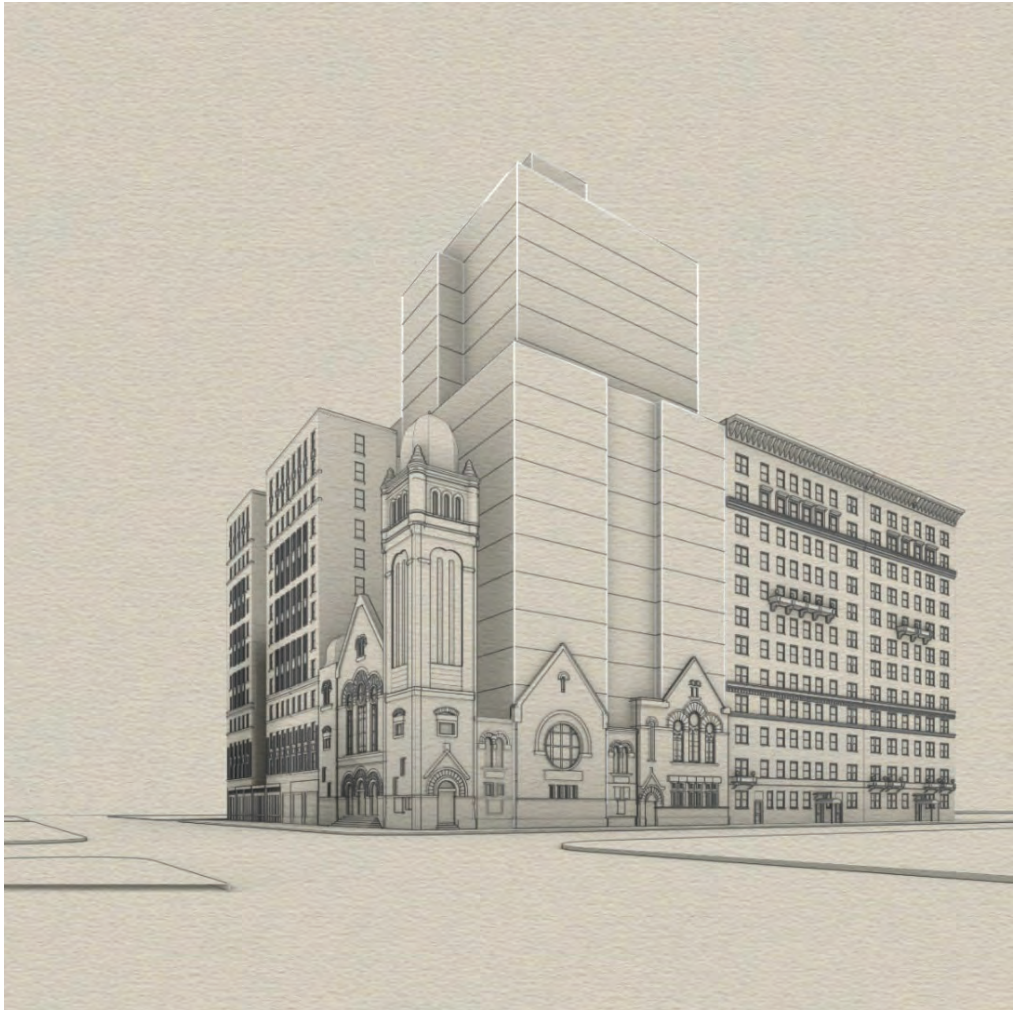
Study H: Repair and restore façade; demolish Sanctuary and Parish house structures and interiors; construct new 210' tall Residential tower on majority of site, behind and above existing façade avoiding belltower on western portion of site

Above grade Gross SF:	103,147 sf
Zoning SF used:	93,600 sf
Unused ZSF:	7,970 sf
Net Residential Rentable /Sellable:	76,800 sf
Community Facility Area:	6,000 sf

- Requires BSA Waiver for non-complying streetwall
- Requires Landmarks approval for demolition and alterations to buildings
- Requires expensive façade repair and stabilization.
- Requires extensive underpinning, structural complexities and protection of the existing church façade during construction of new building.
- Inappropriate treatment of existing historic fabric / “facadism”

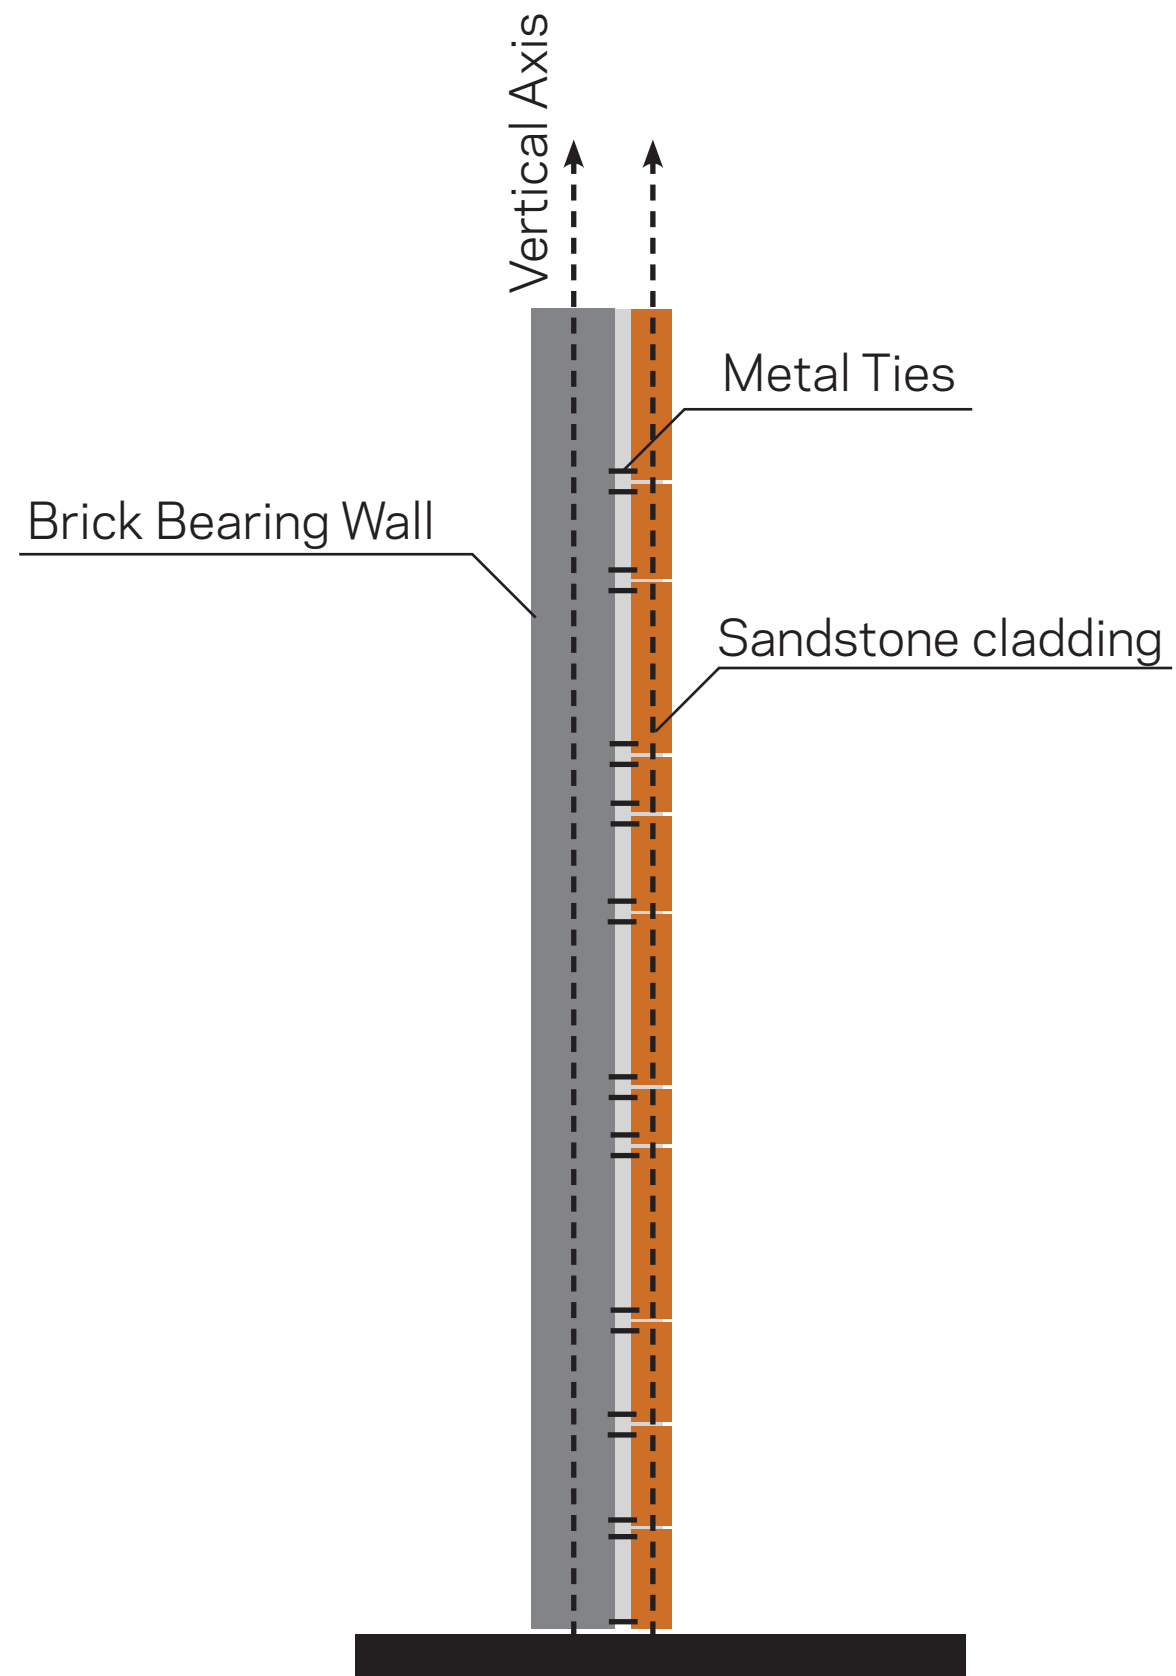
**Typical Stone on
Brick Bearing Wall**

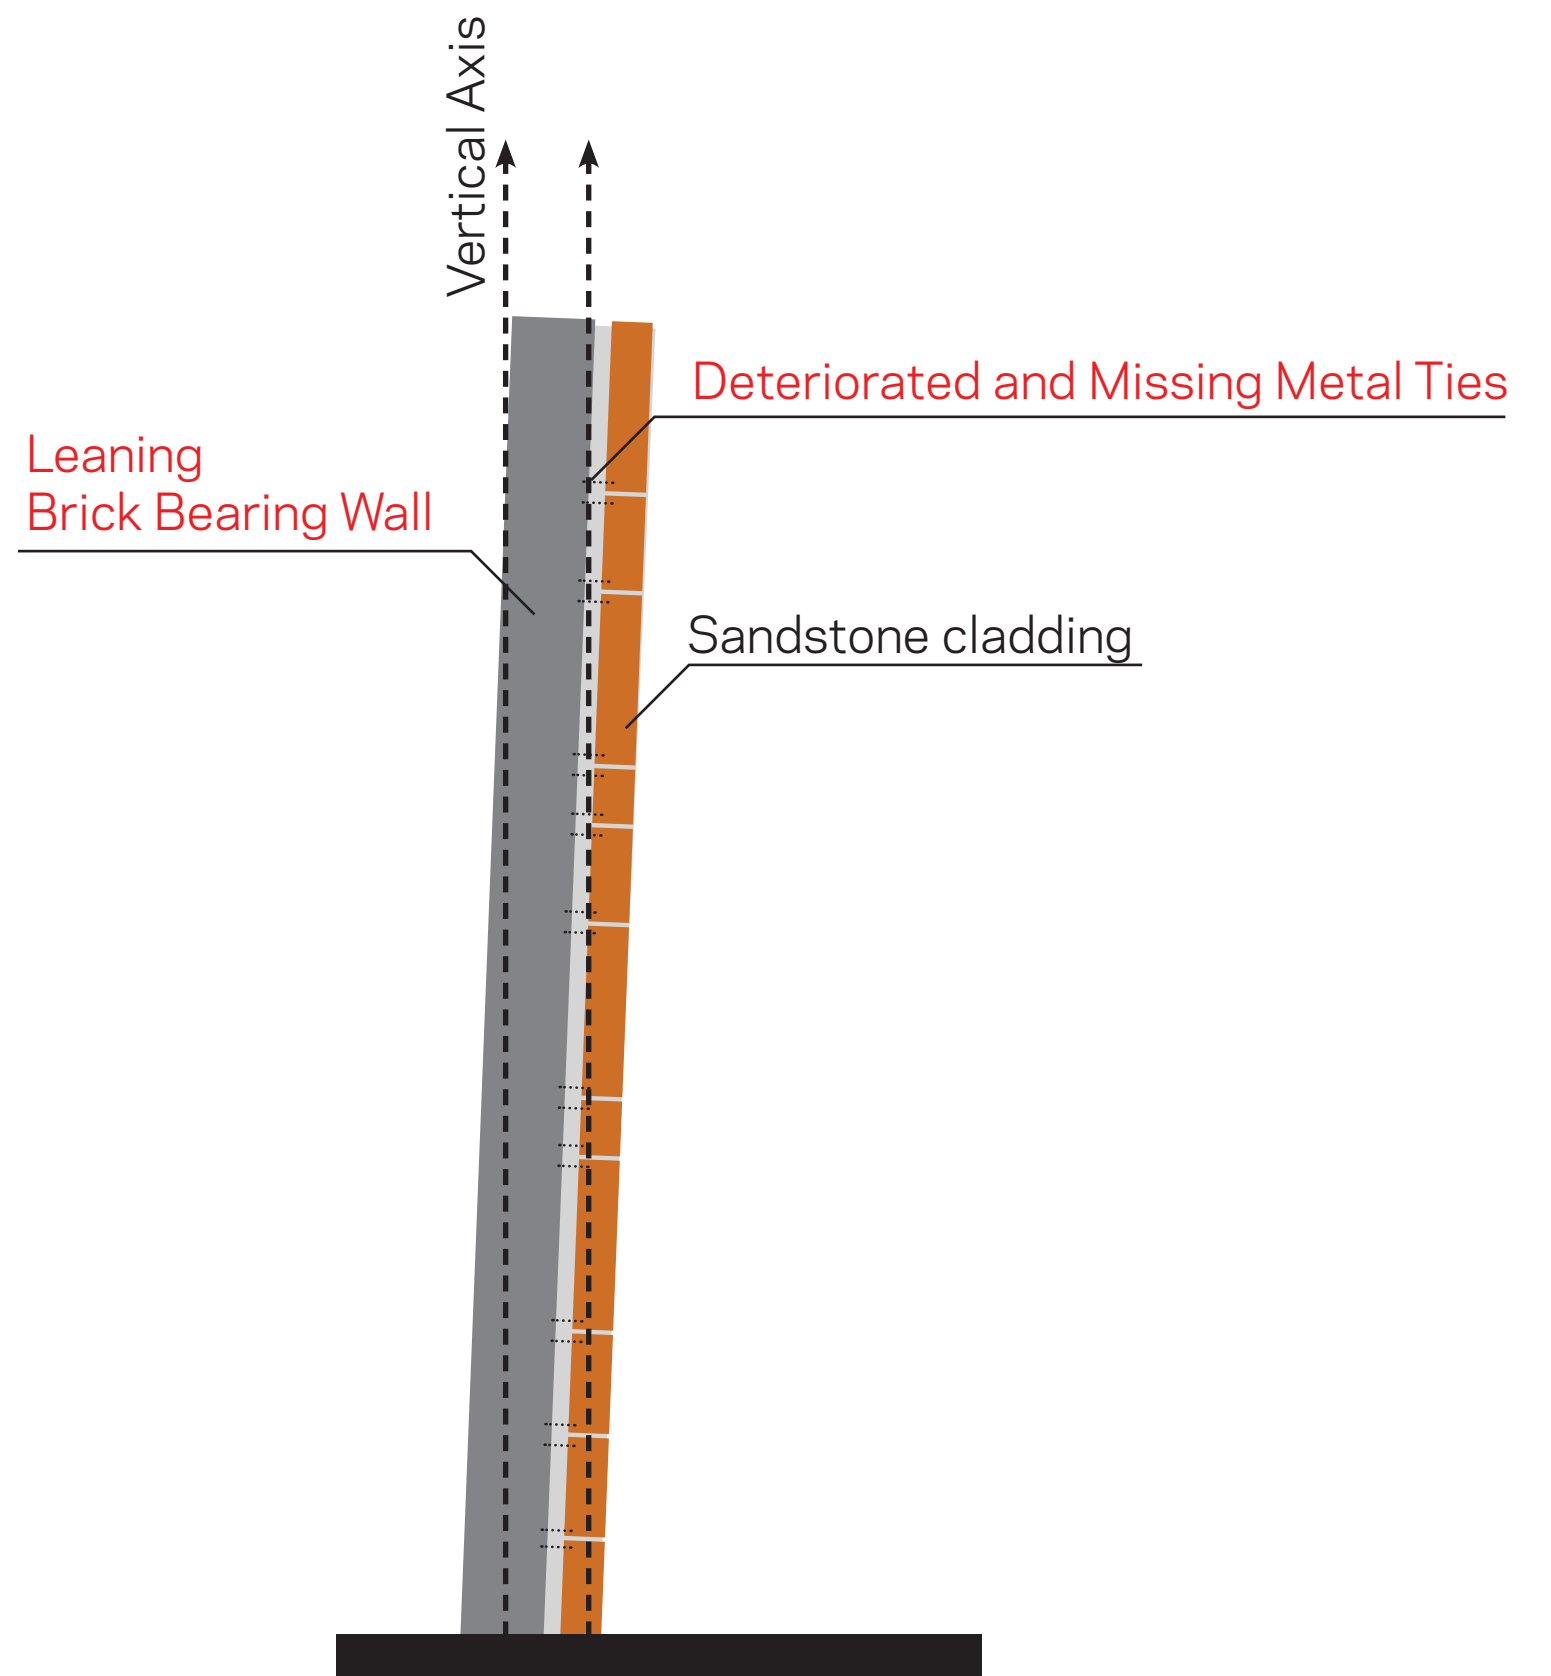
Failing wall
