Riverside Park 105th Street Staircase Reconstruction M071-222M

Located near West 105th Street and Riverside Drive,
Borough of Manhattan.

PDC Review
September 29, 2023
Eunju Beddoe, NYC Parks

- Reconstruct spalled and deteriorated staircases at West 105th Street
- Granite risers, ashlar masonry and other features will be replaced to match the original appearance.
- Install ADA compliant hand rails at the center of stairway and guardrails on the top of the cheek walls.

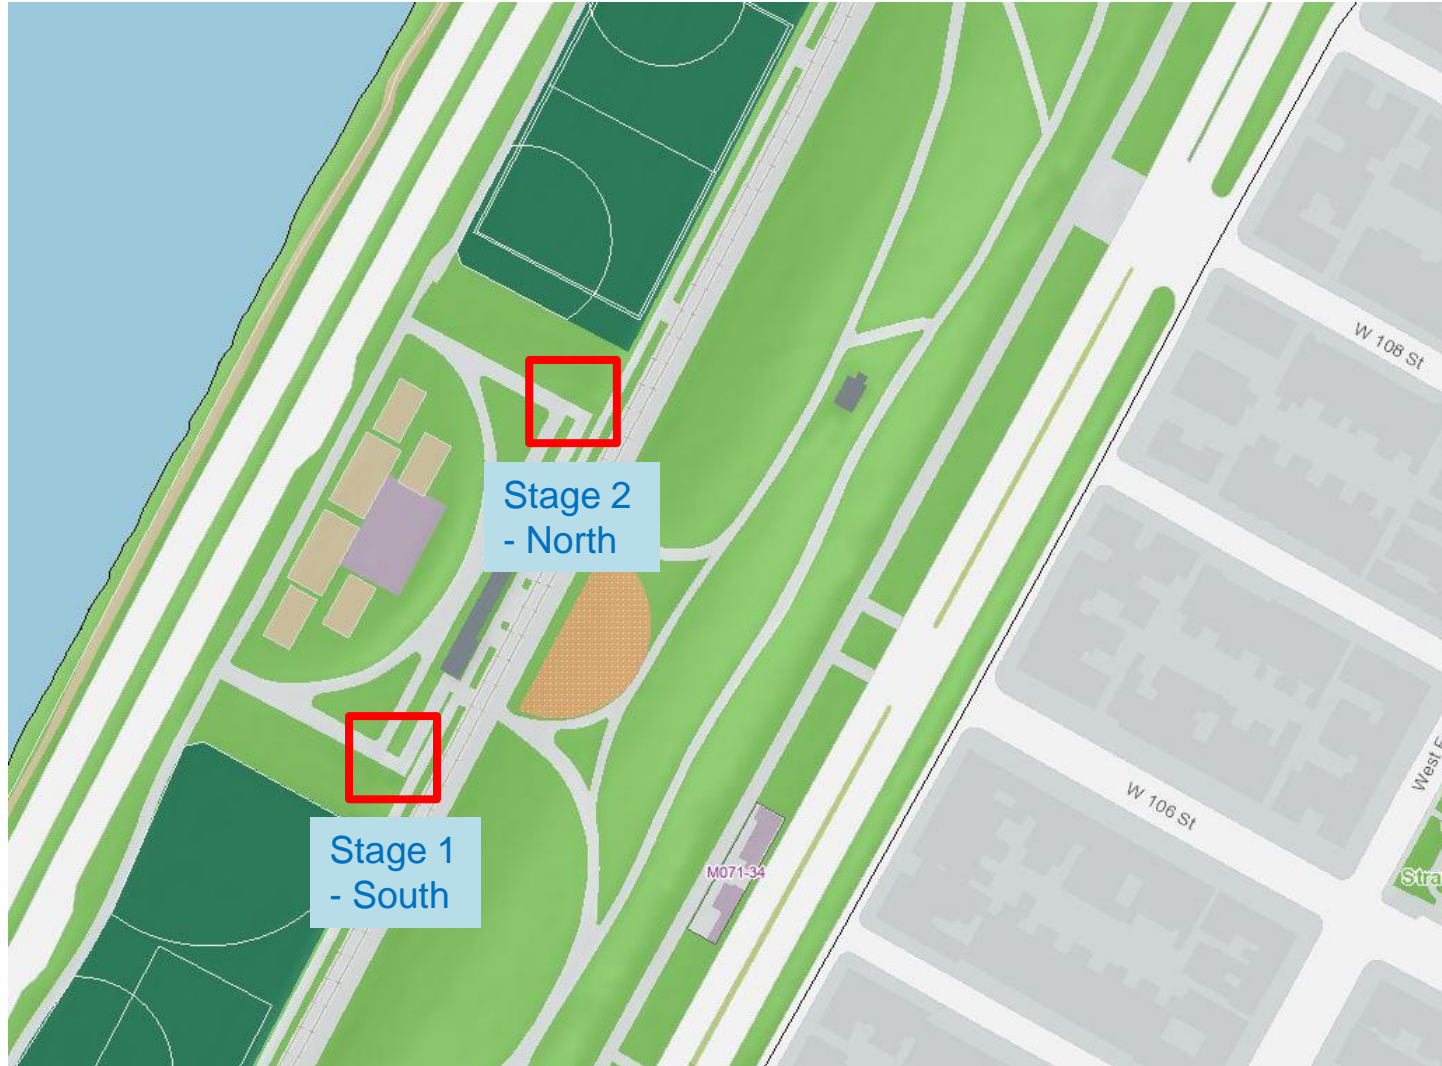
1. Construction and staging will be phased to allow the use of one stair at all times.
2. The concession/restrooms will continue to operate throughout, seasonally.

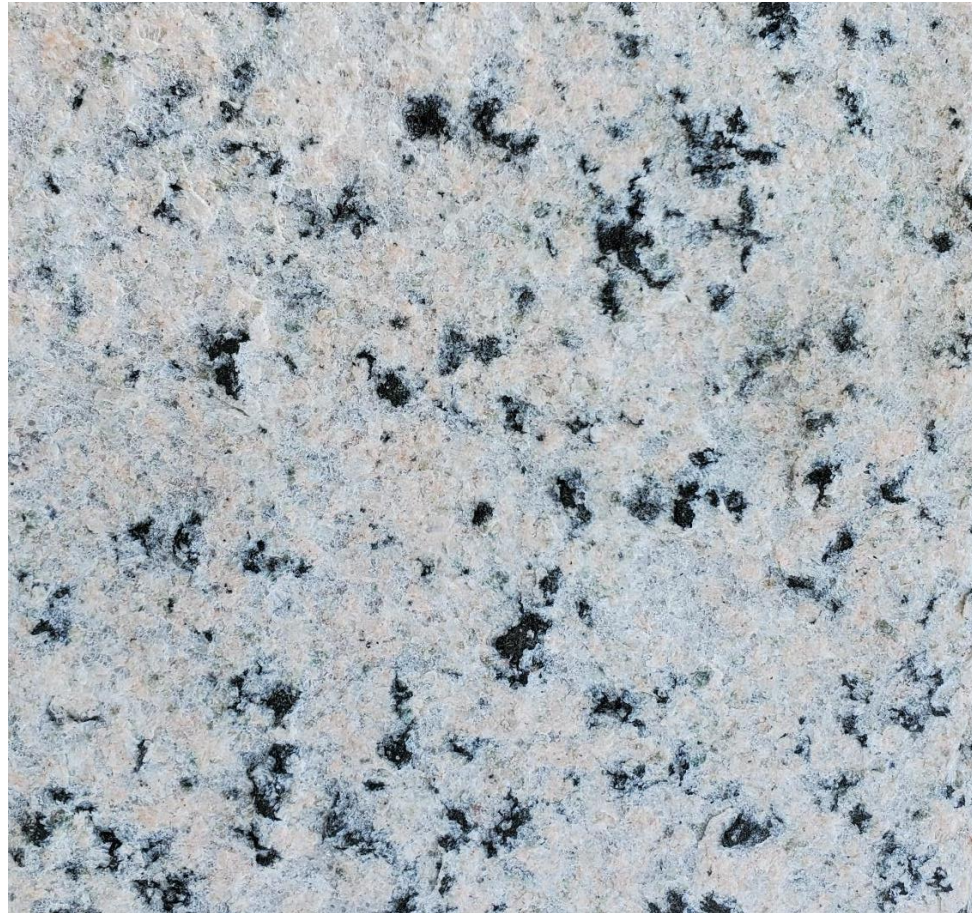
Milford Pink Granite

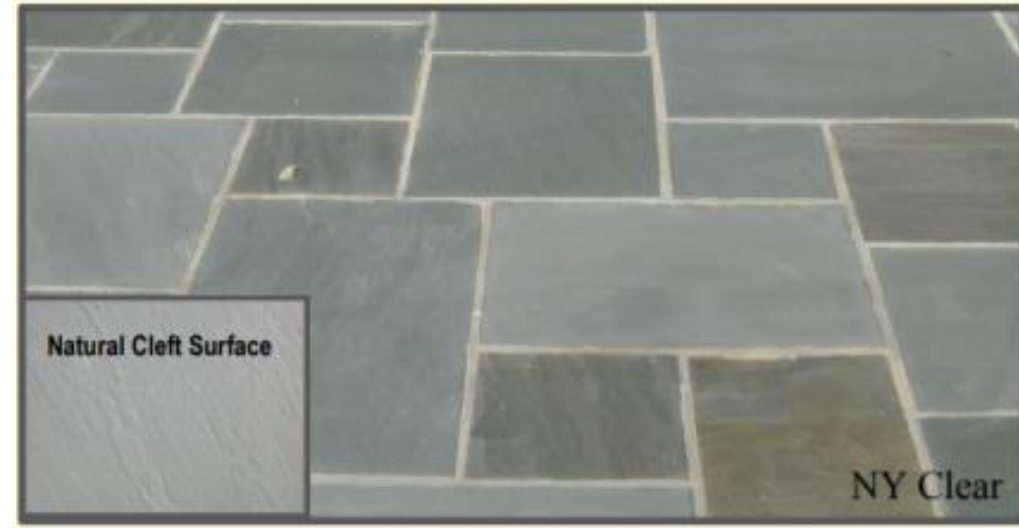
Natural Cleft NY State
Bluestone – Blue Gray

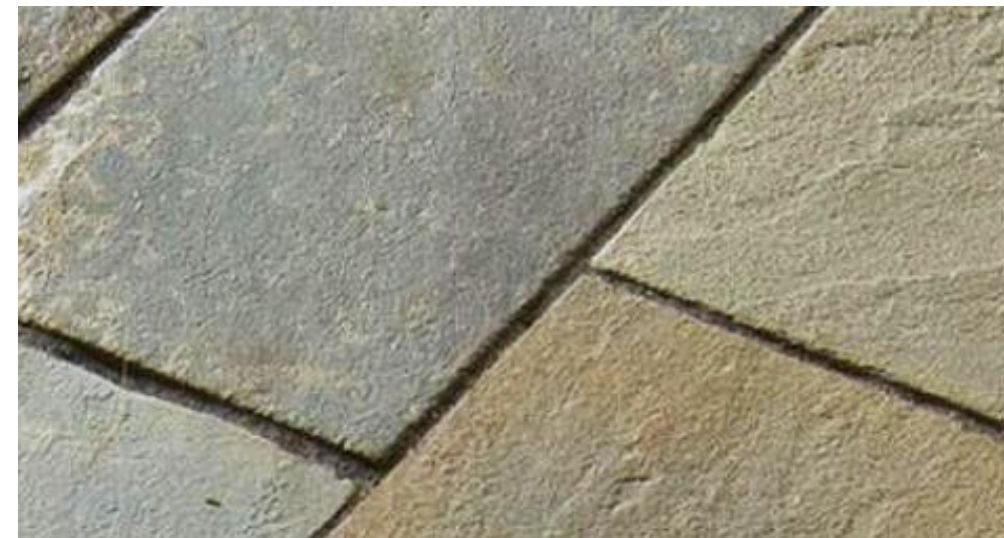
Natural Cleft NY
State Bluestone #2

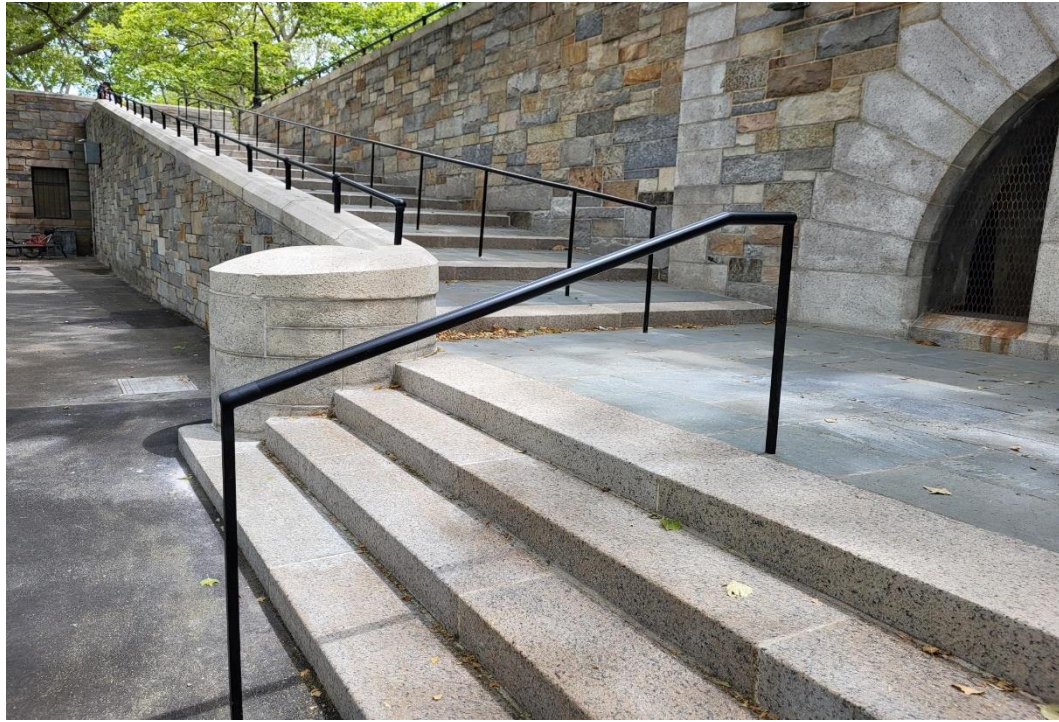
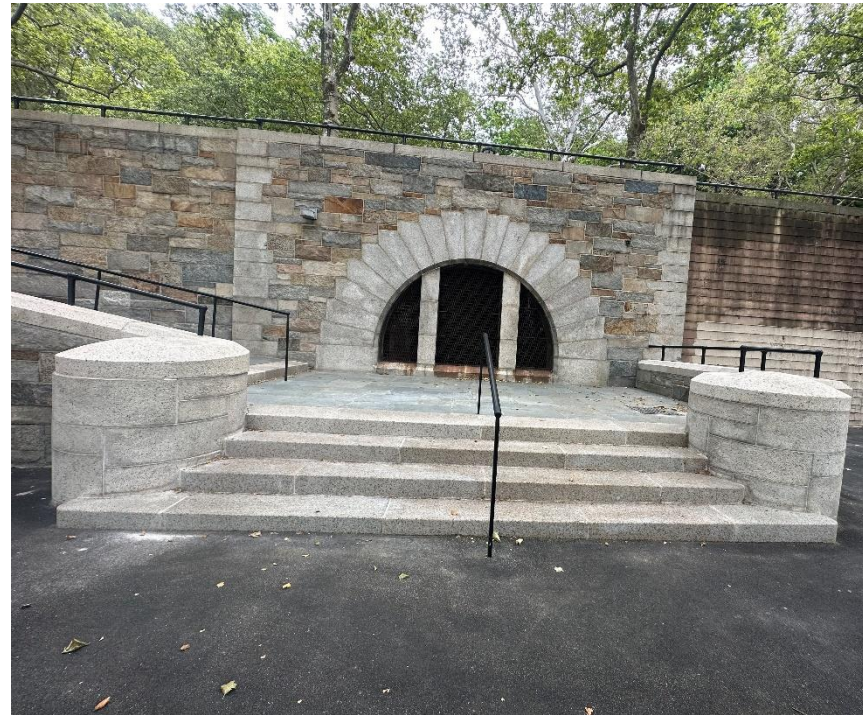
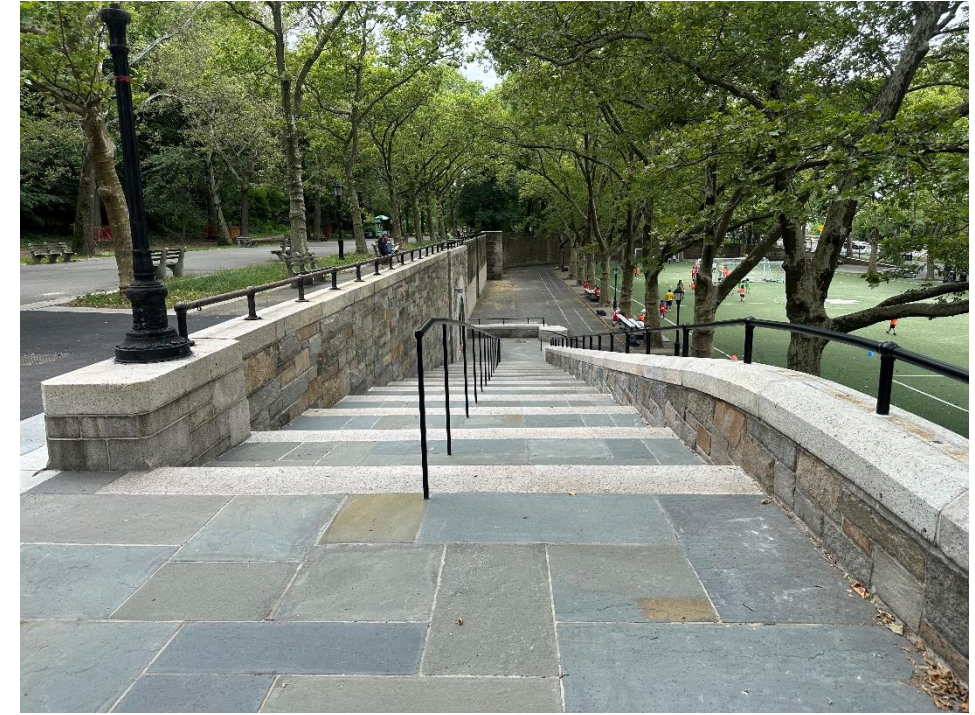
Handrail and guardrail – 102nd Street Staircase

Note: Proposed handrail and guardrail are as per the recent installation at 102nd Street, Riverside Park

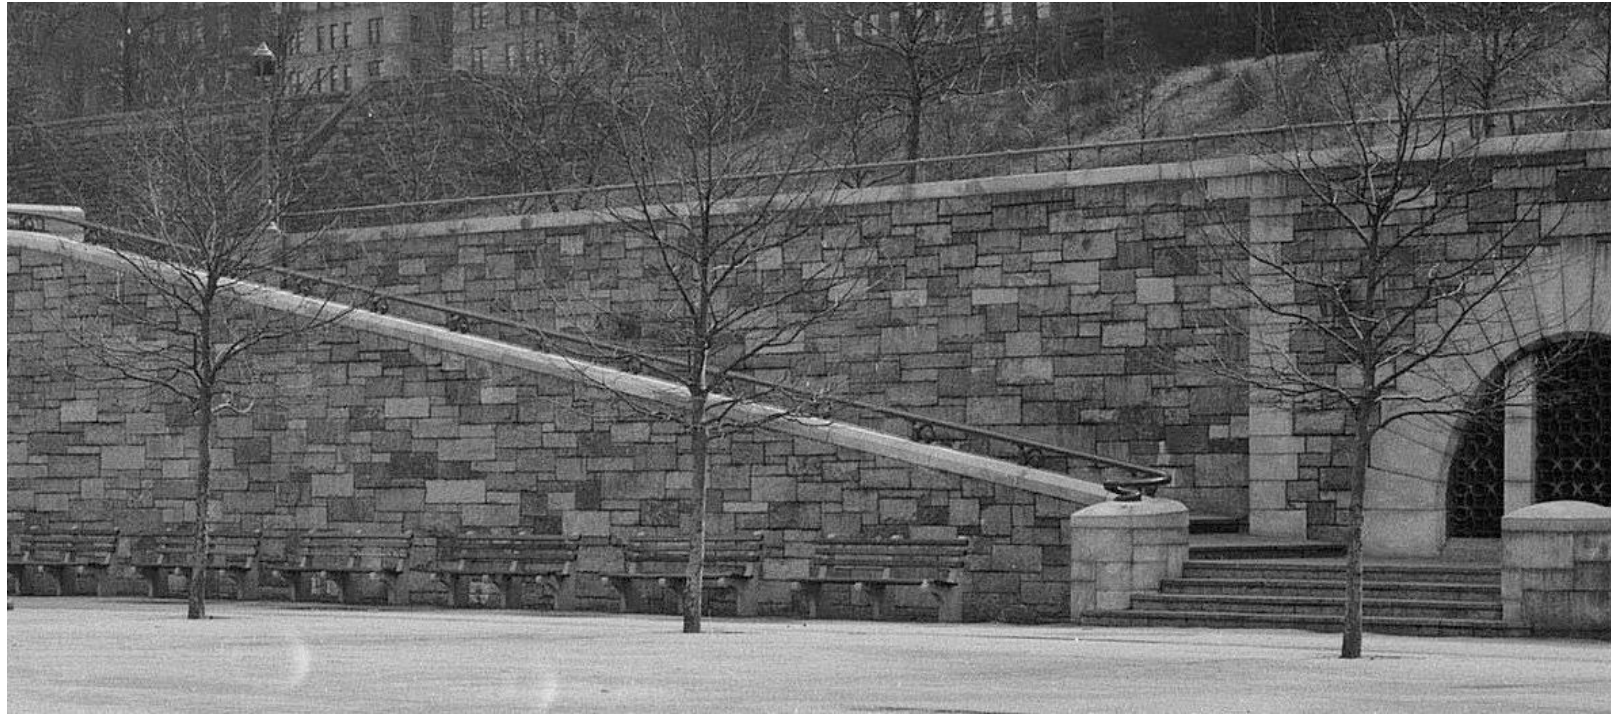
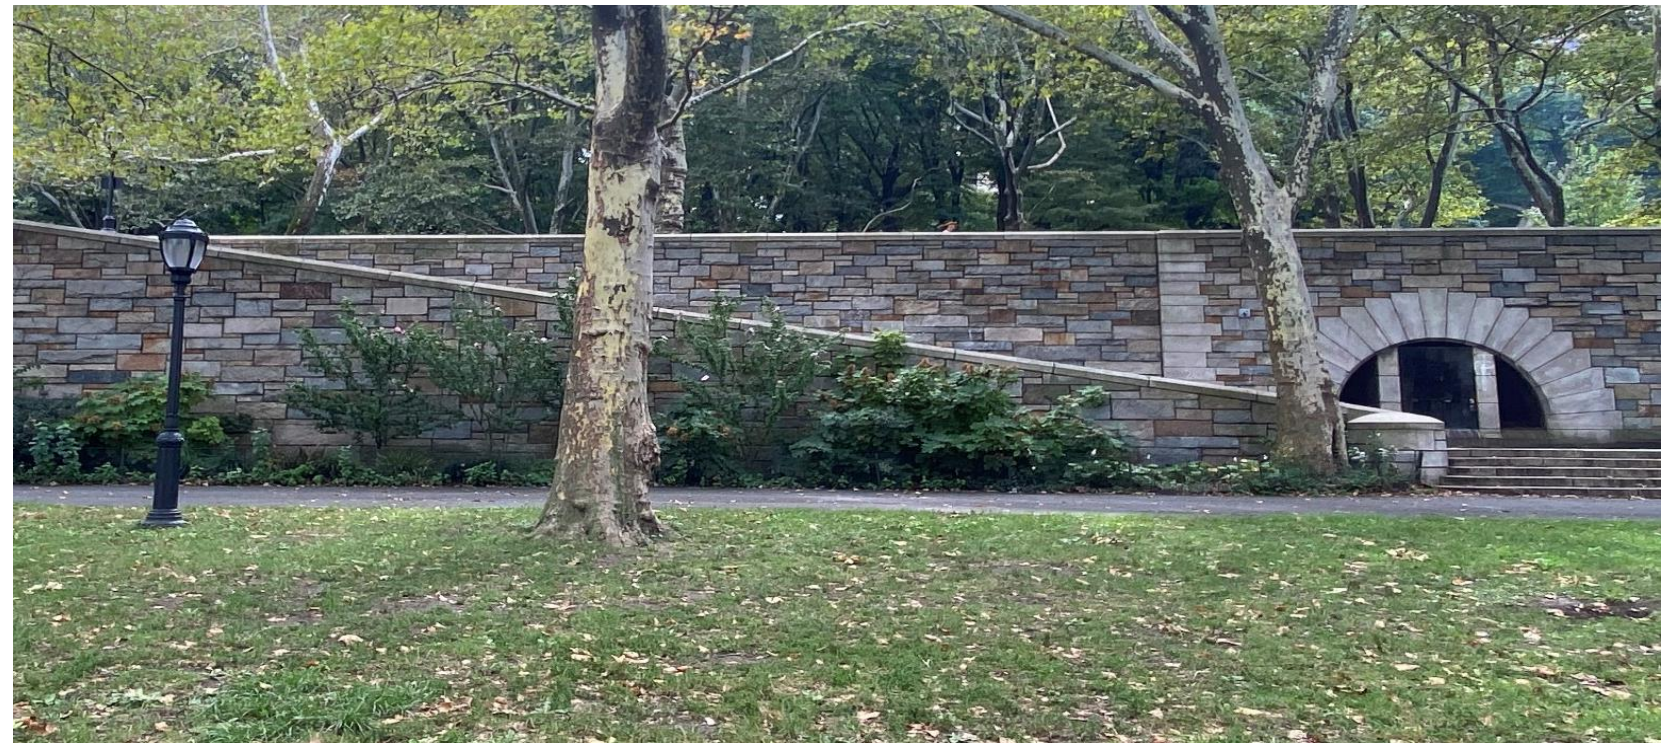
Riverside Park | Decorative Bronze Guardrail ca. 1943 and current condition

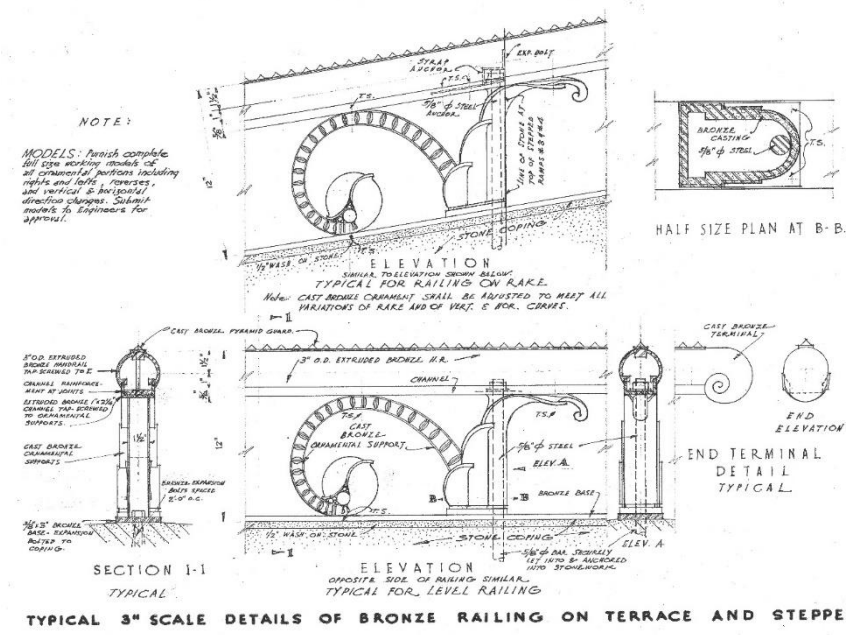
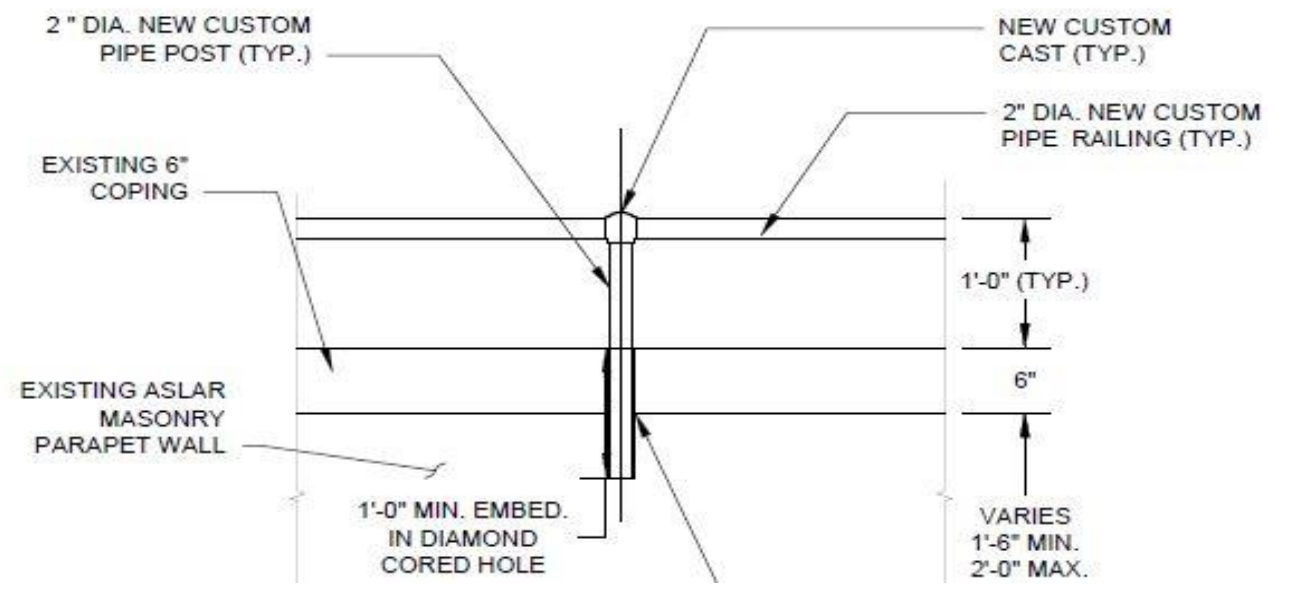
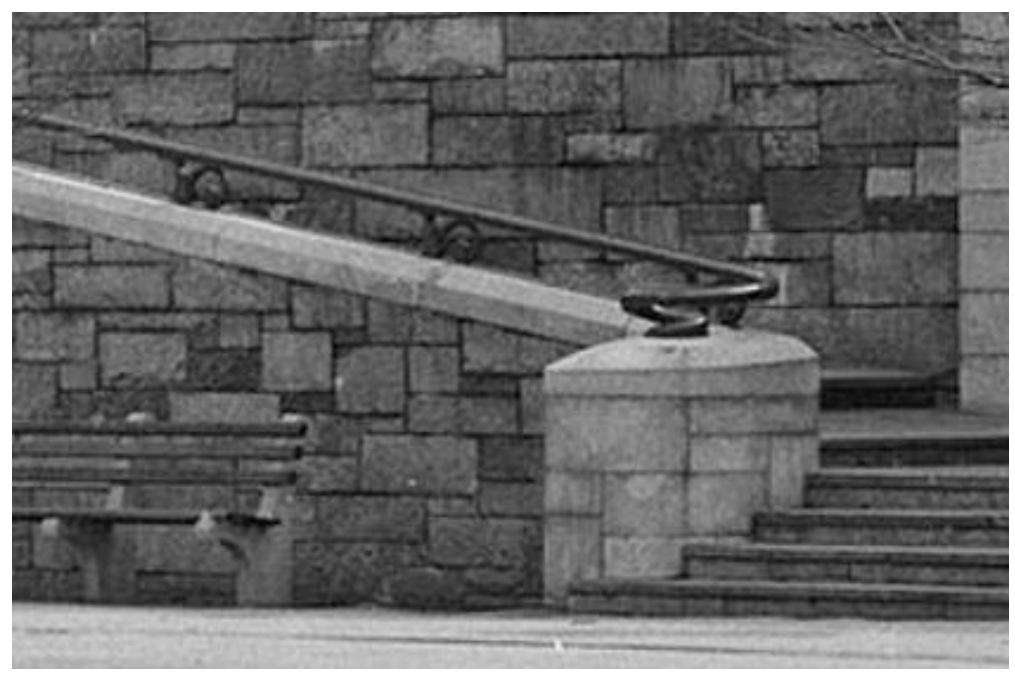
Decorative Bronze Guardrail ca. 1943

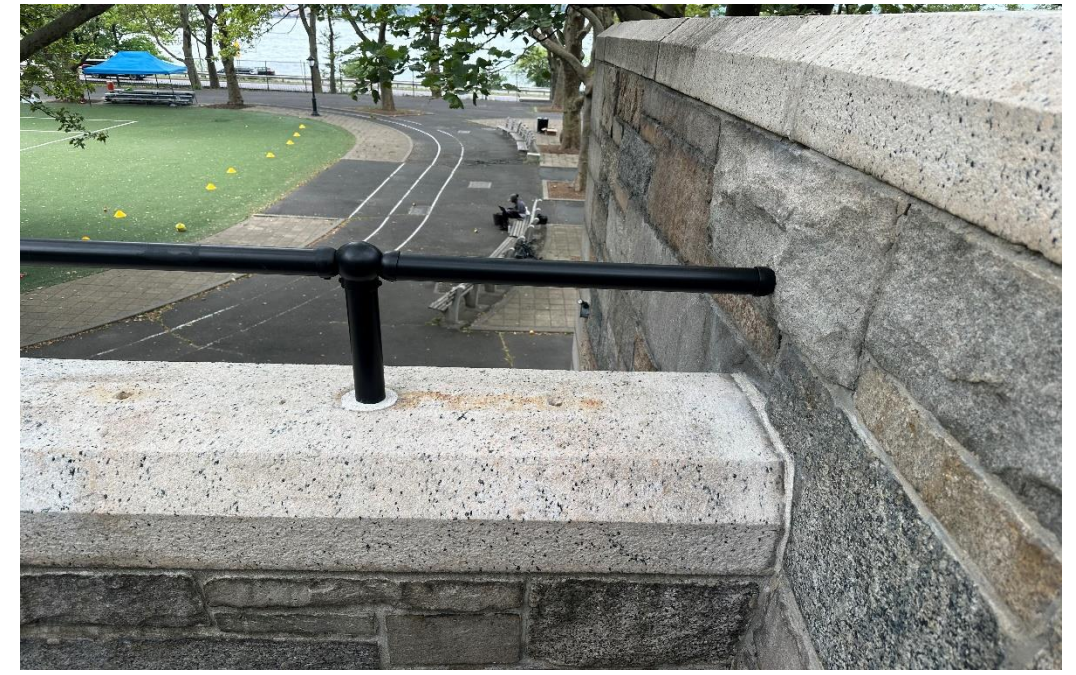
Guardrail recently installed at identical stair at 102nd Street

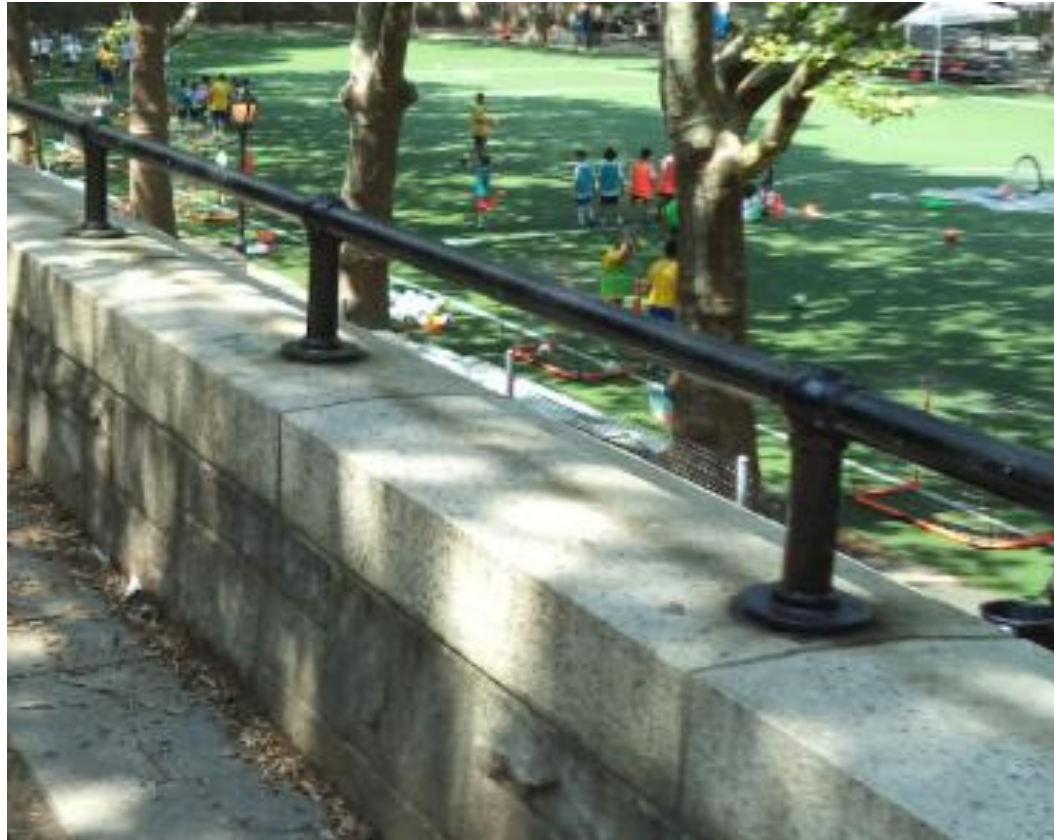
Existing Historic Guardrail on the retaining wall at 102nd Street

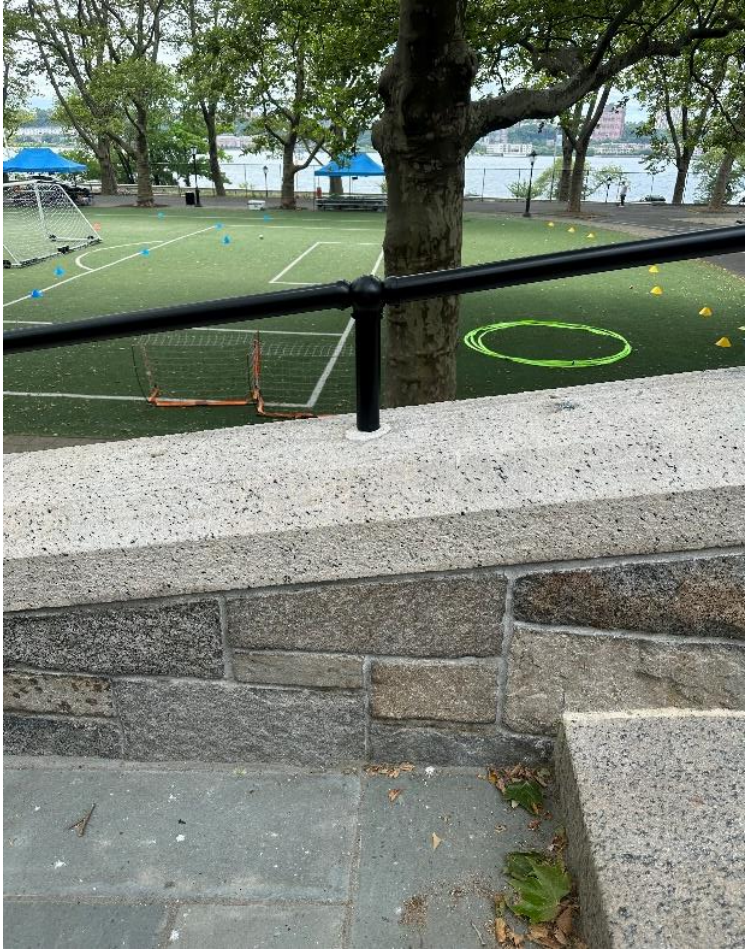
New Custom Guardrail replicates the guardrail at the adjacent retaining wall

Note: Proposed Guardrail as installed at 102nd Street Staircase, completed, June 21, 2023.
