222 West 79 Street, Manhattan

Upper West Side

Store Front Sign and Penthouse Enlargement

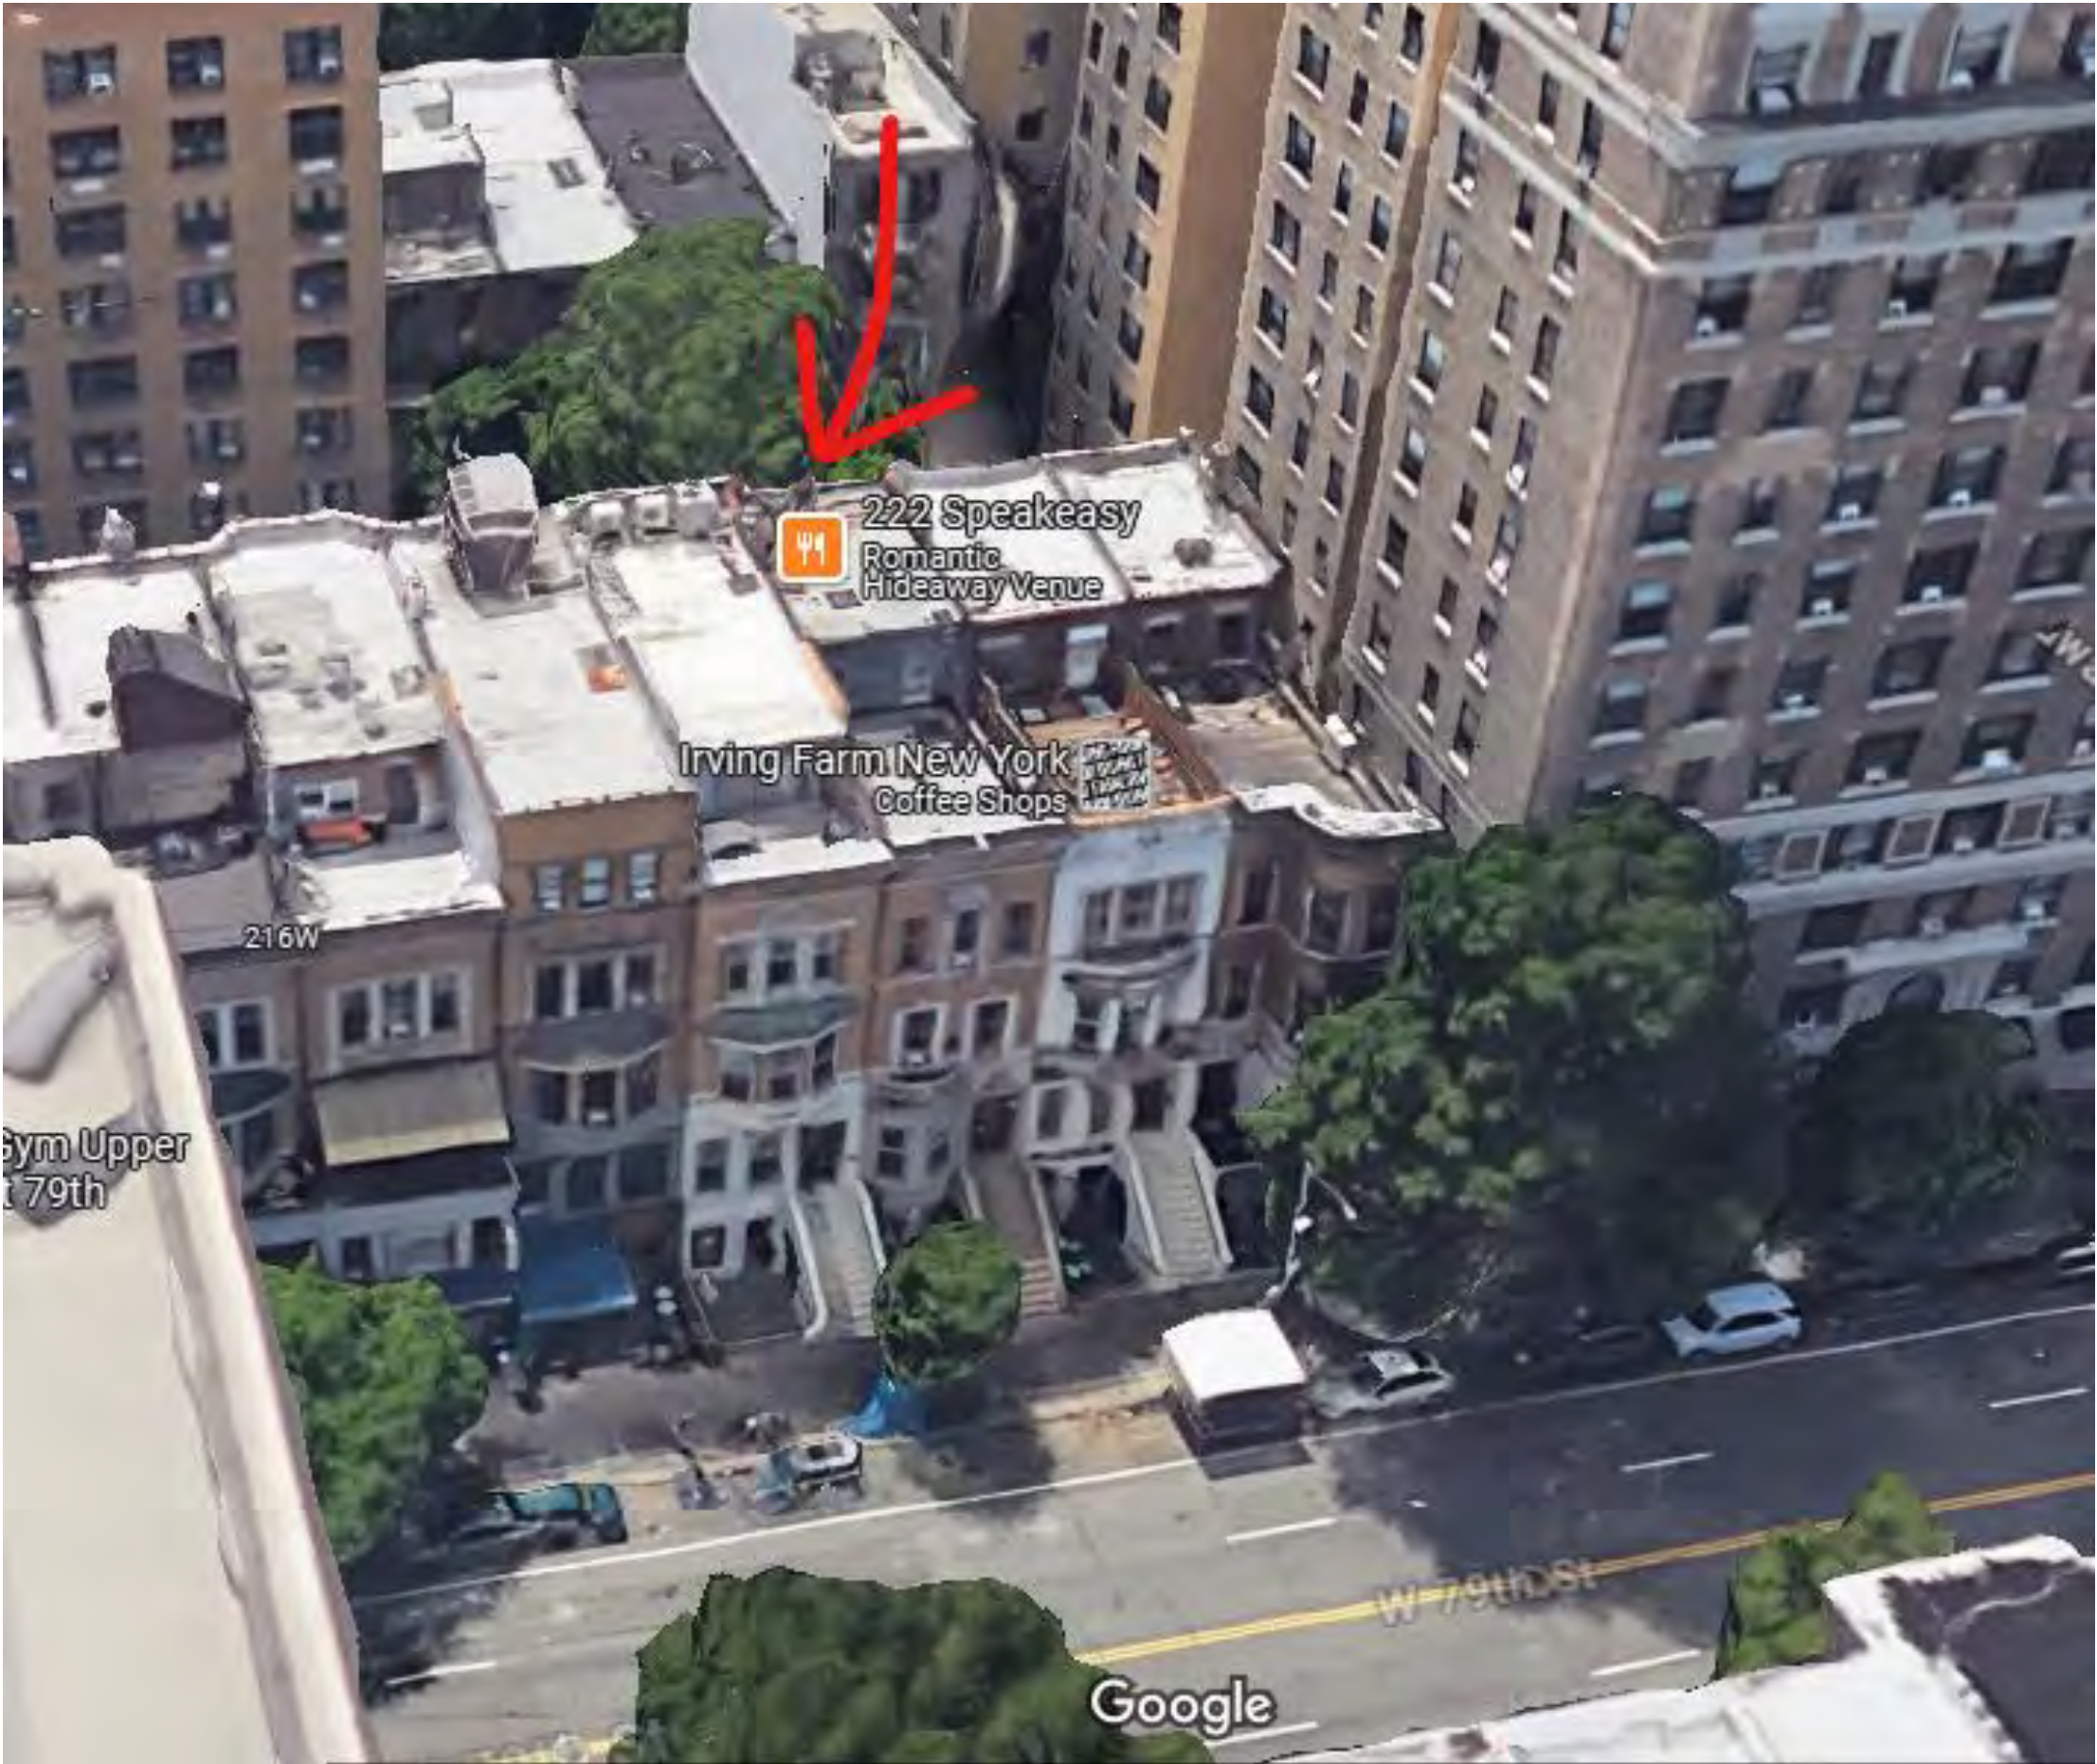
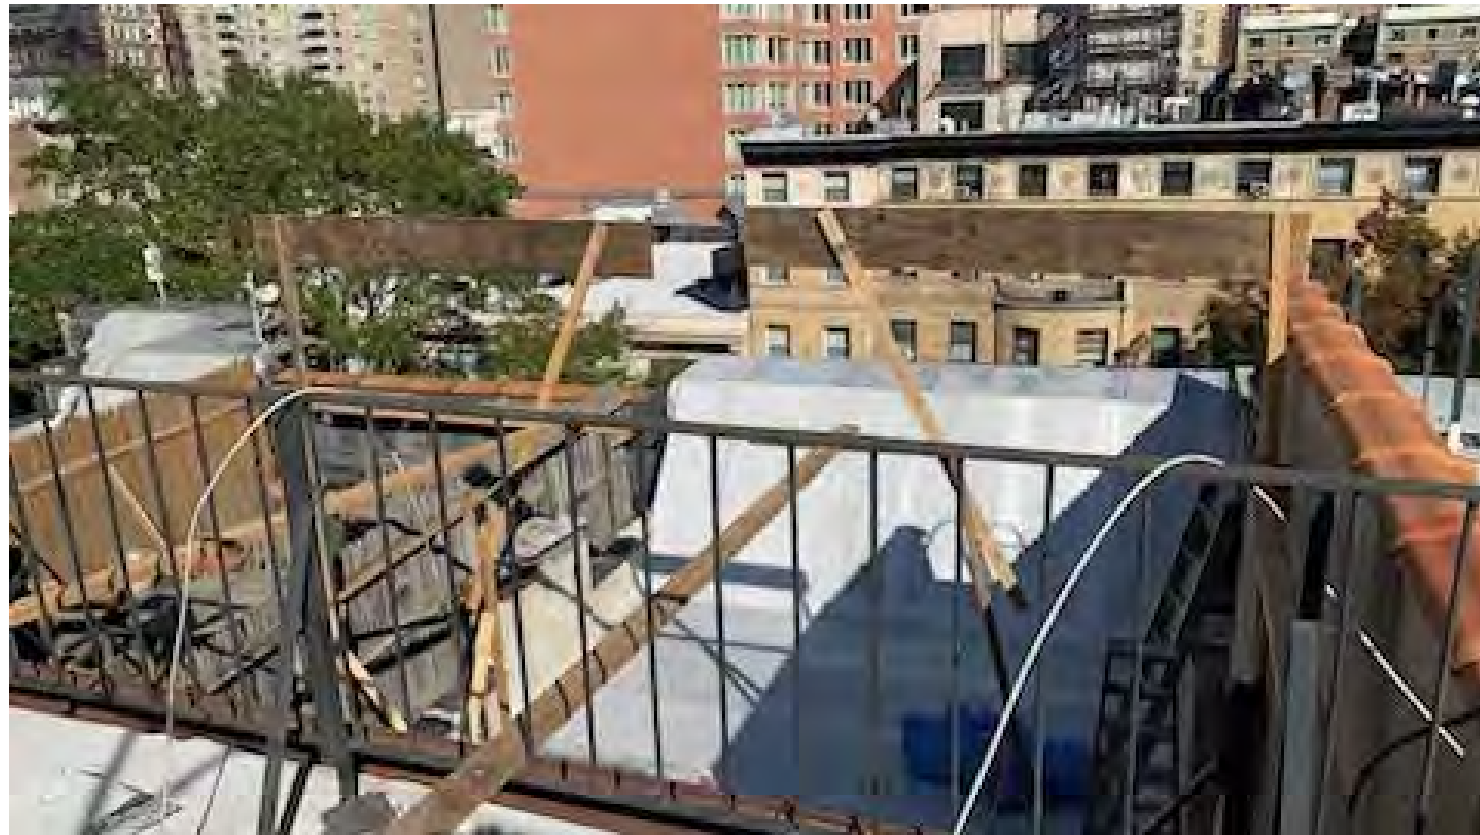
Mock-up of elevator bulkhead (reviewed at staff level)

Mock-up of proposed occupiable addition (including guardrail)

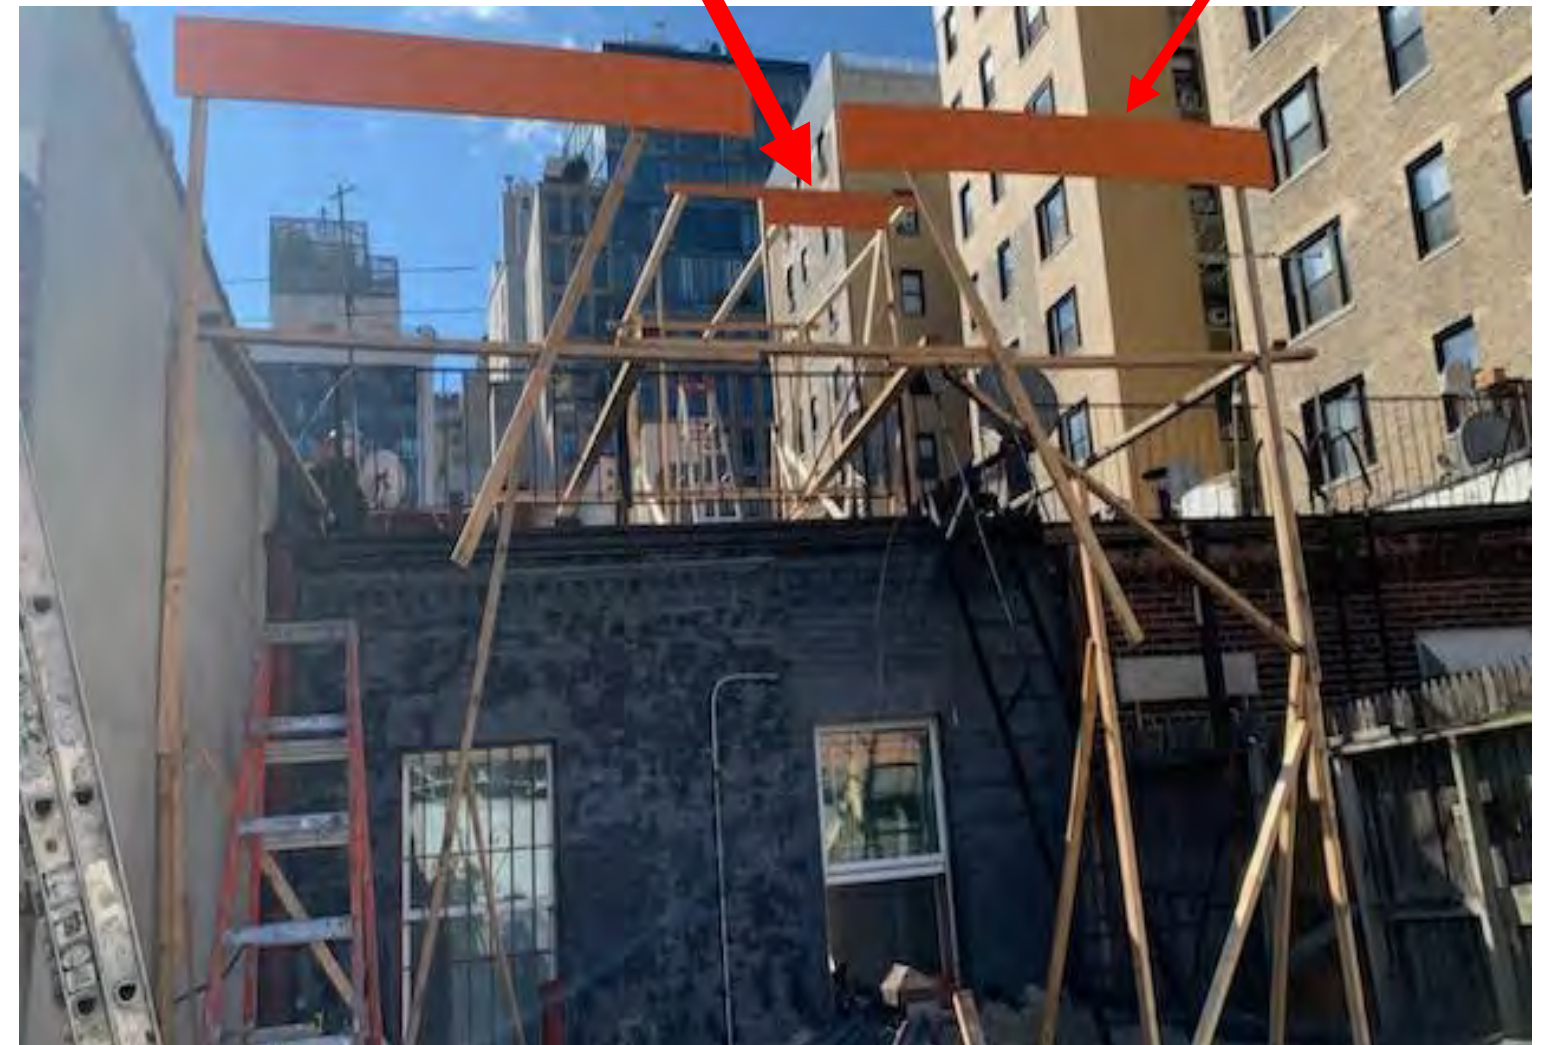
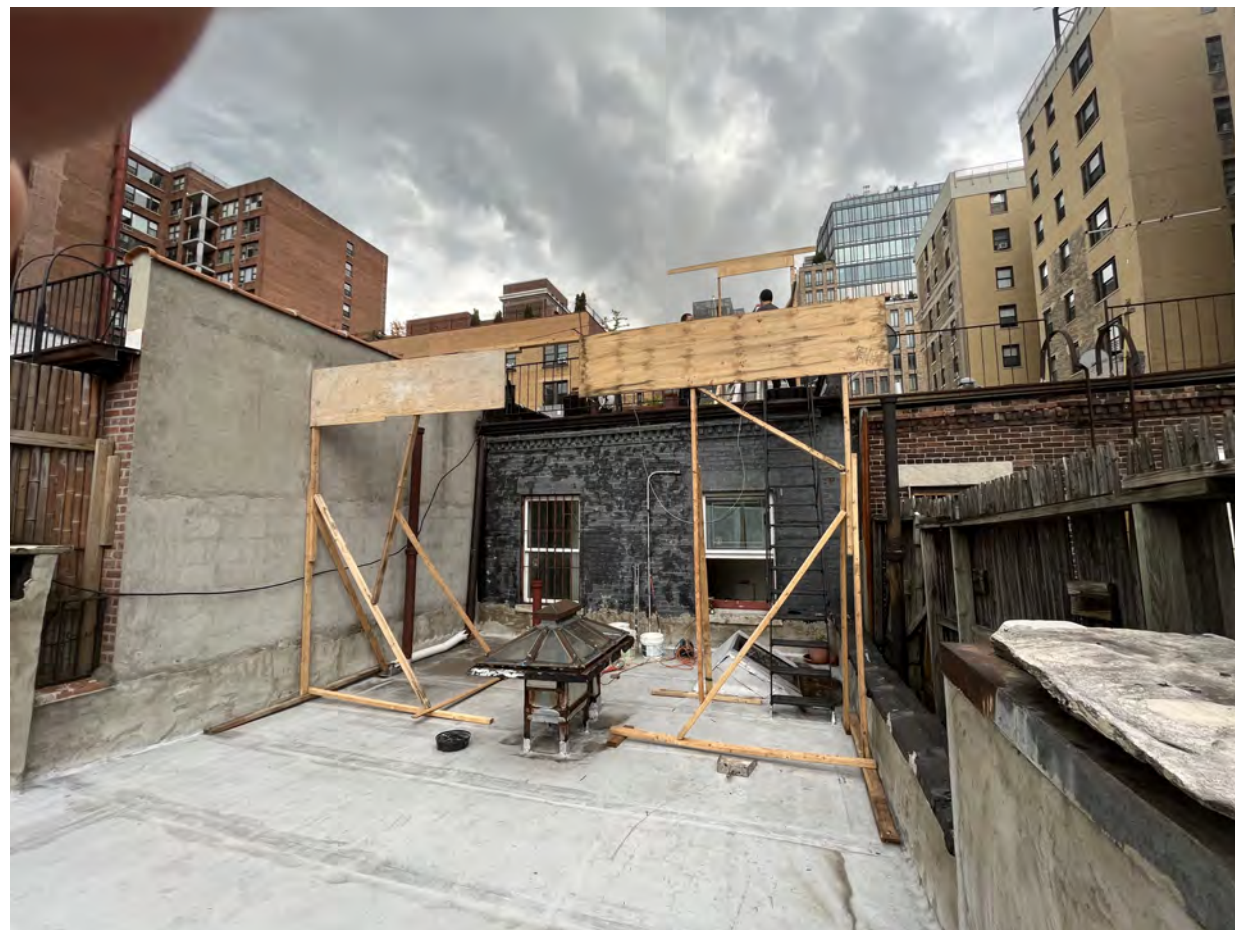
Pictures of the existing conditions at the roof and showing a tall cornice parapet at the front and additions at adjacent rooftops (note: lower left photo is a previous mock-up)

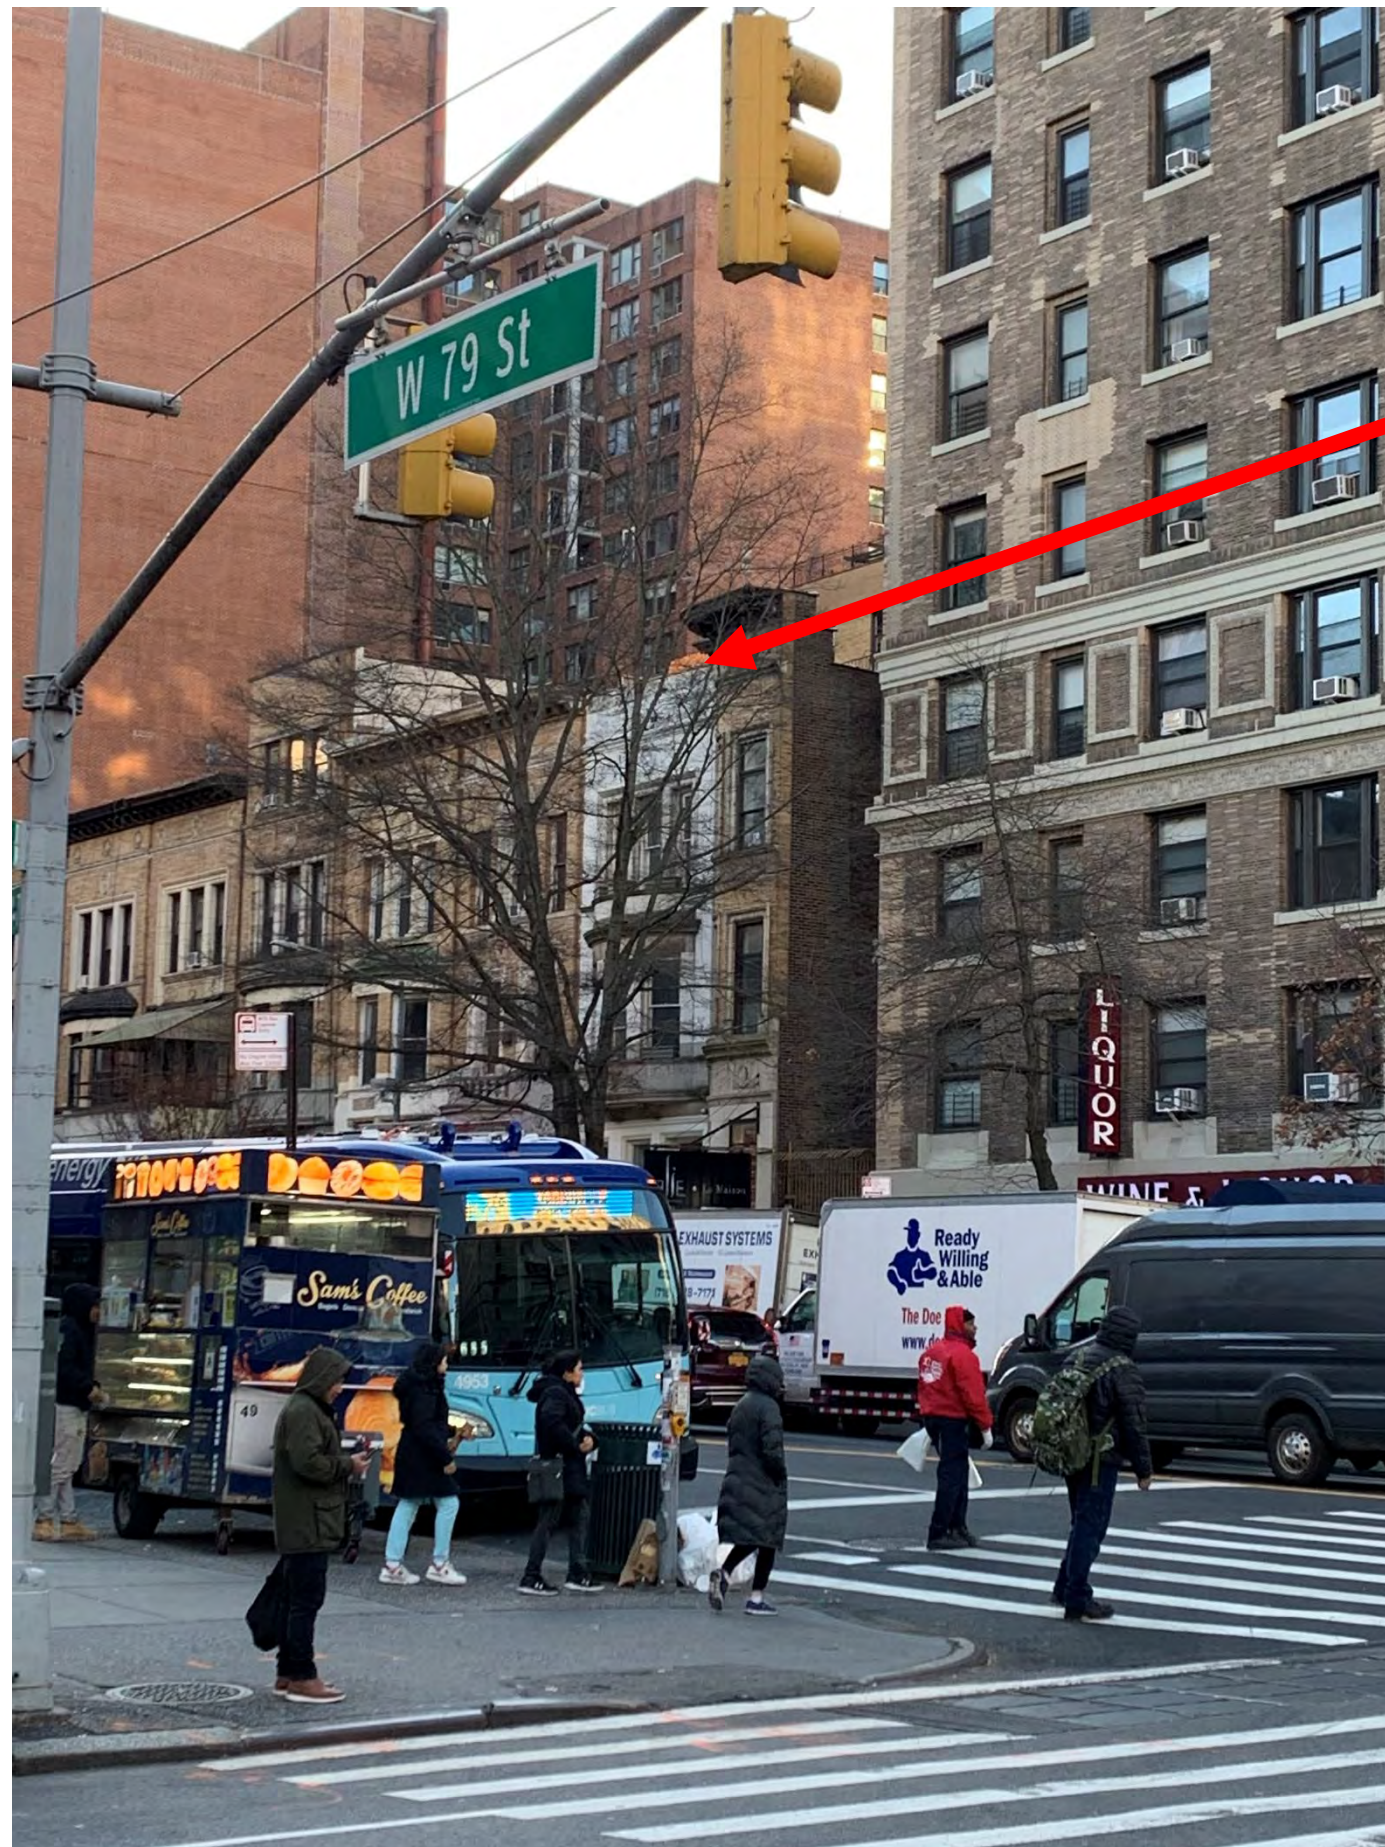
View 3

- Minimal visibility of guardrail at front of penthouse.
- Current photo contains bright orange mockup. Actual rail will be cable rail with steel gray color

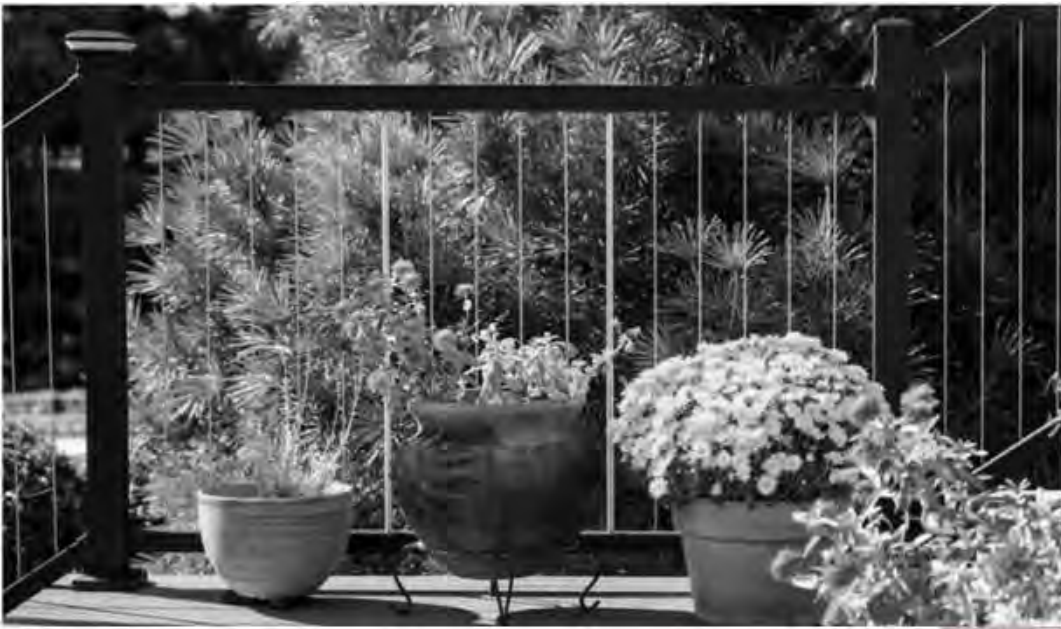
Photo of actual railing proposed

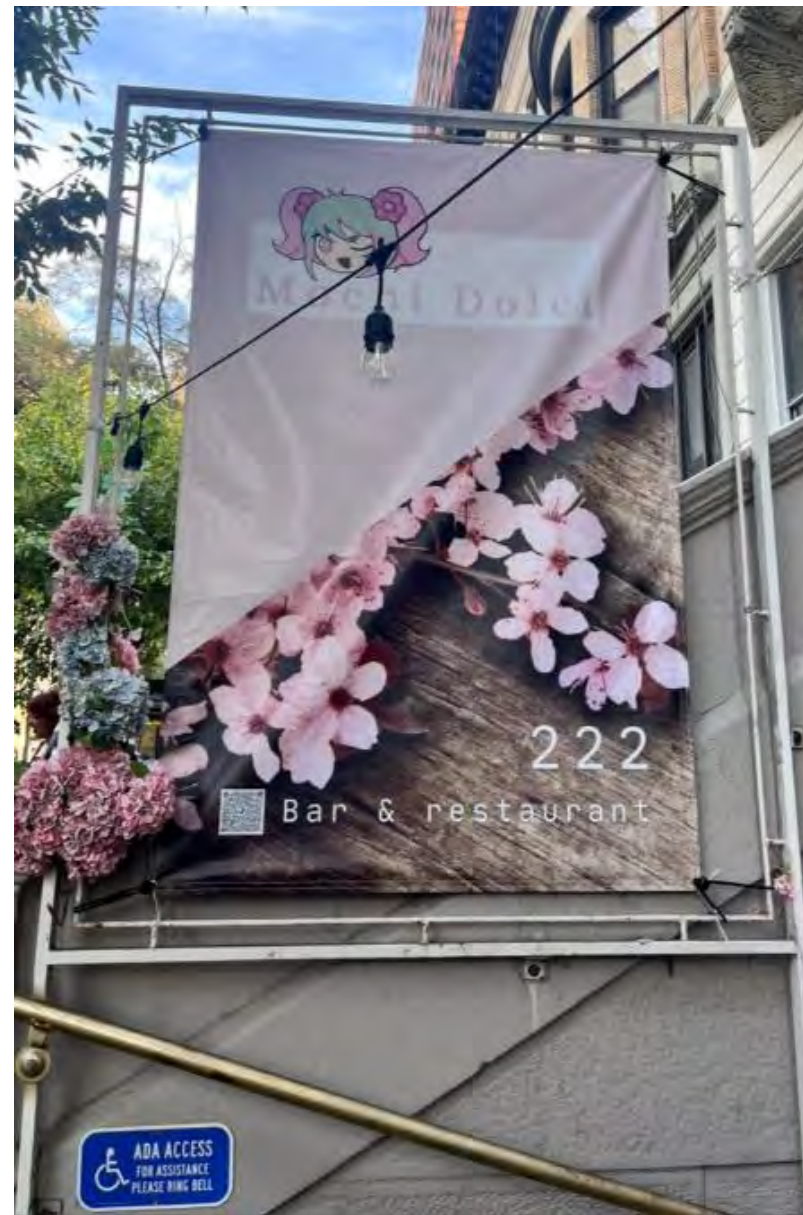
Current Sign by Current Owner

The current sign is temporary. We propose to install a similar sign that will expand into the inner frame. The proposed sign will also be accented with florals similar to what is seen in the bottom left corner of the current sign.

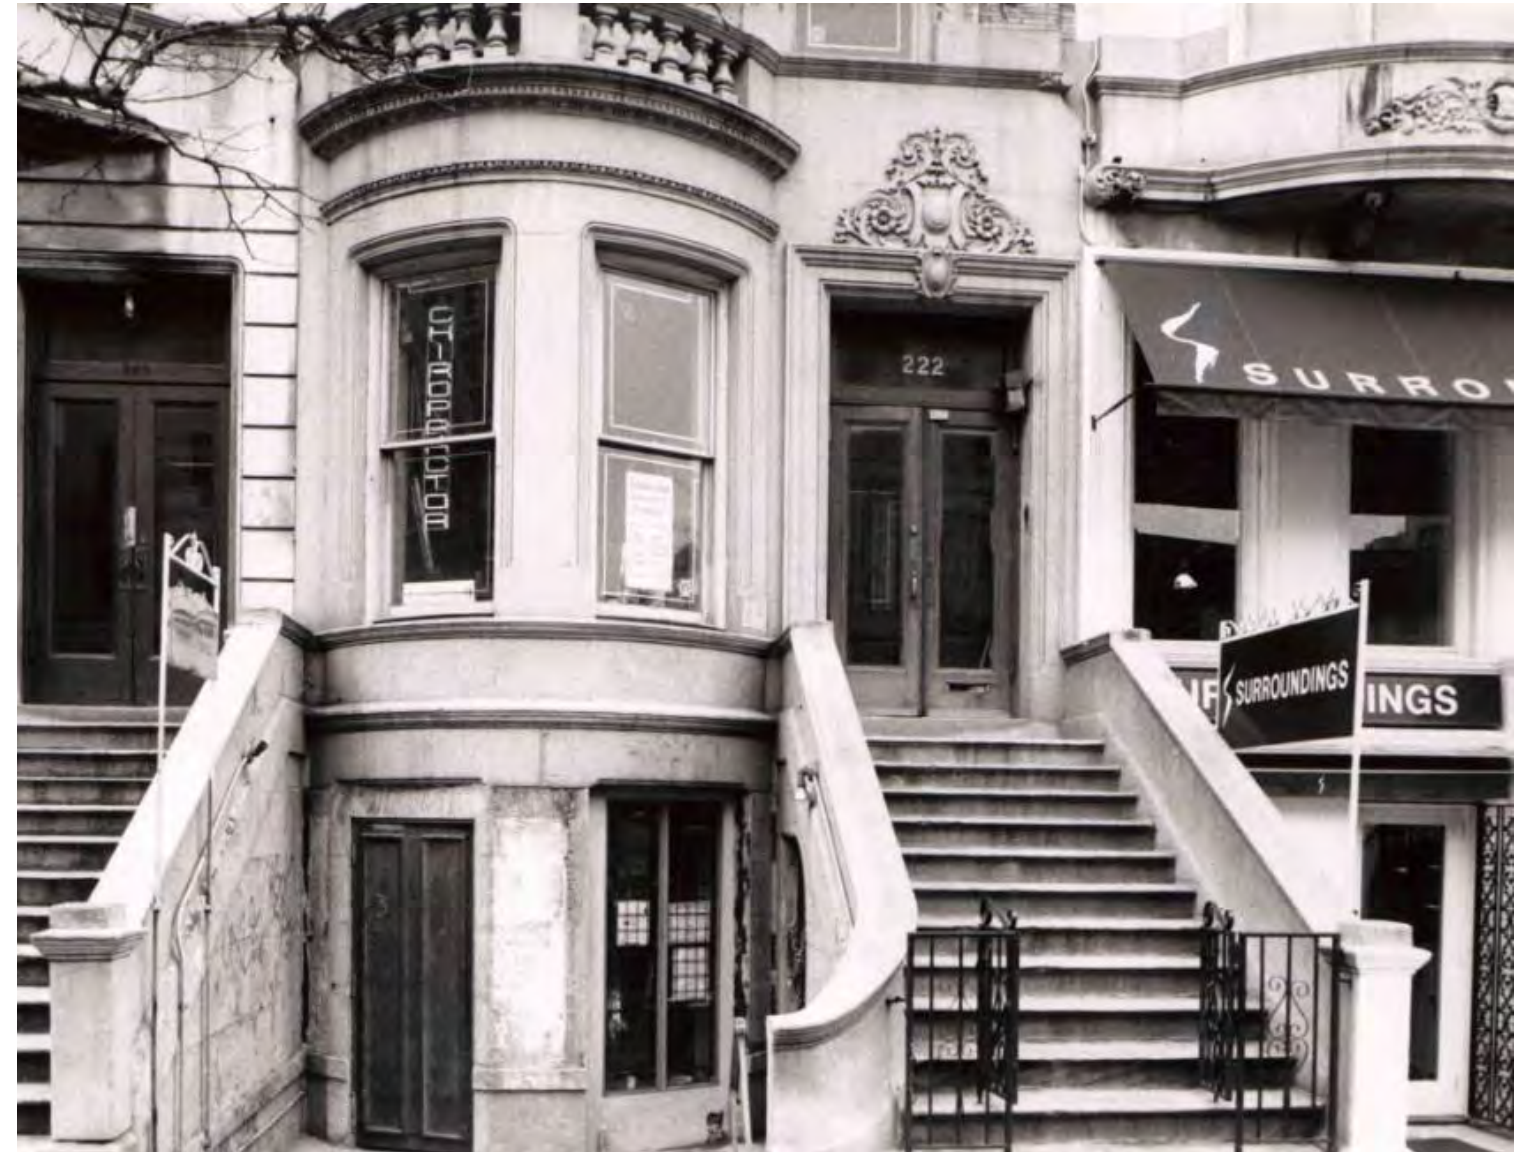
Designation Photo – had a frame and small sign mounted to side of stoop. Since then, the frame was replaced and sign was enlarged

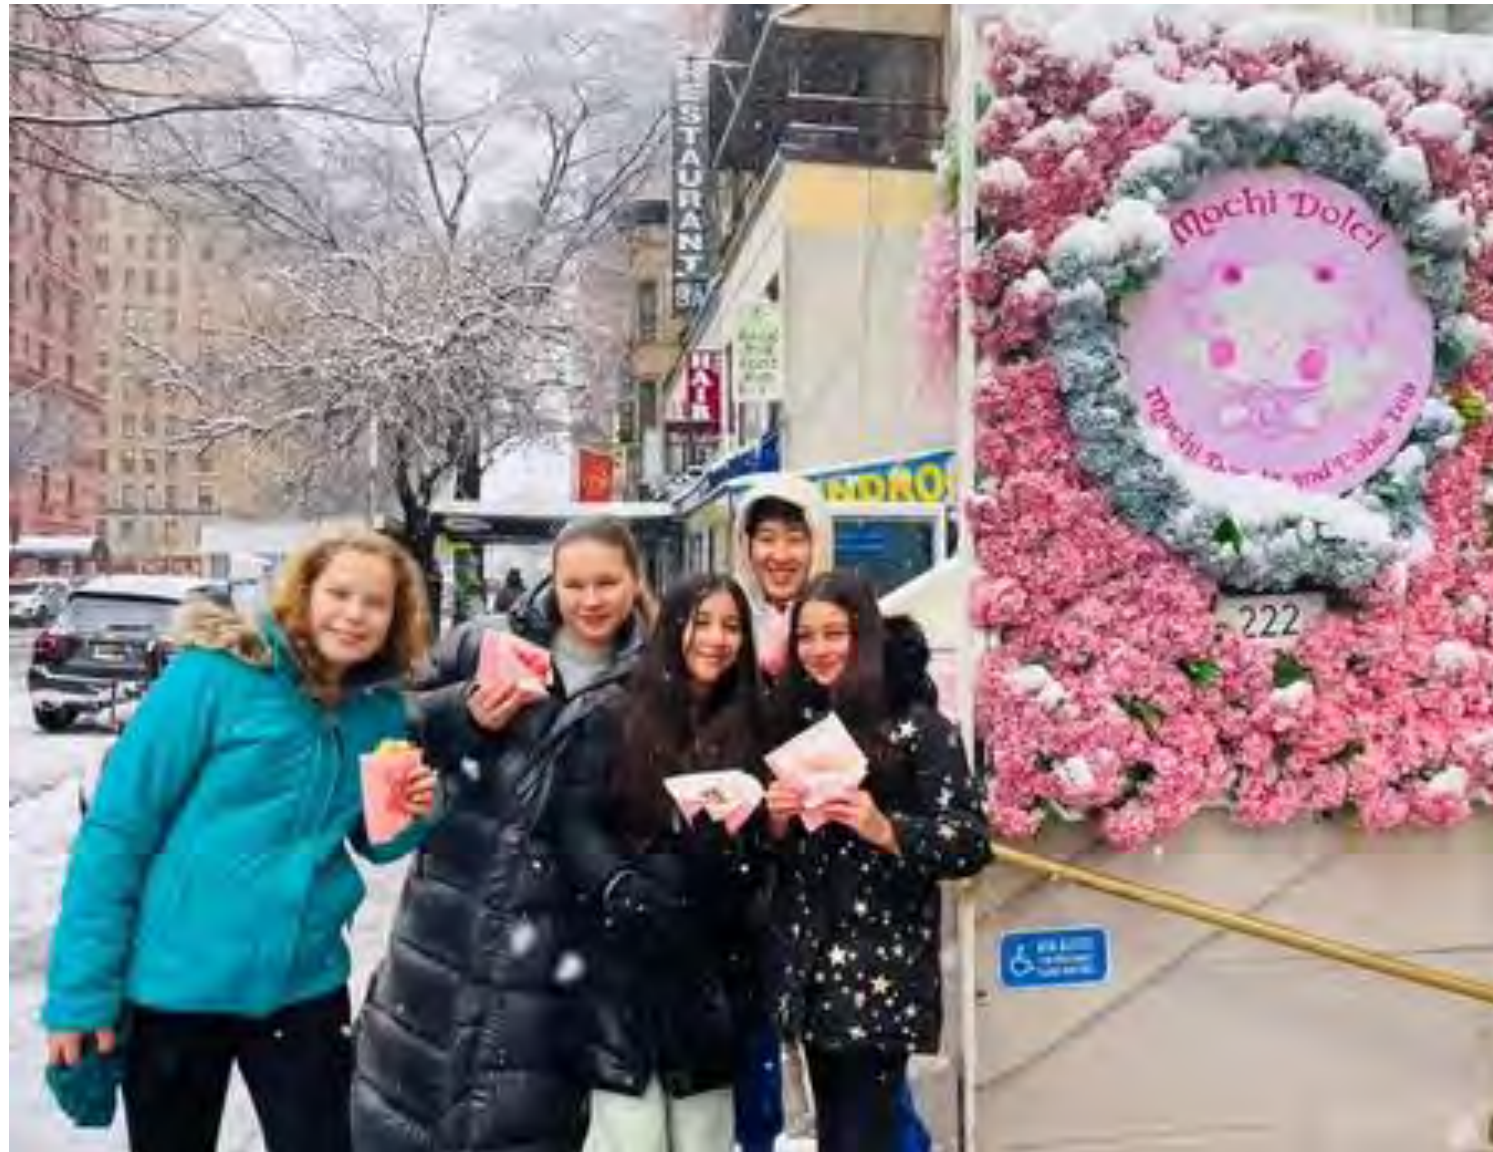
Previous Sign with Floral Accents – Winter Scene – The proposed sign will have a traditional canvas/vinyl weatherproof material on the inner frame, with floral accents around the perimeter.
