The Children's Museum of Manhattan

361 Central Park West

Special Windows Conditions Assessment
6 December 2019

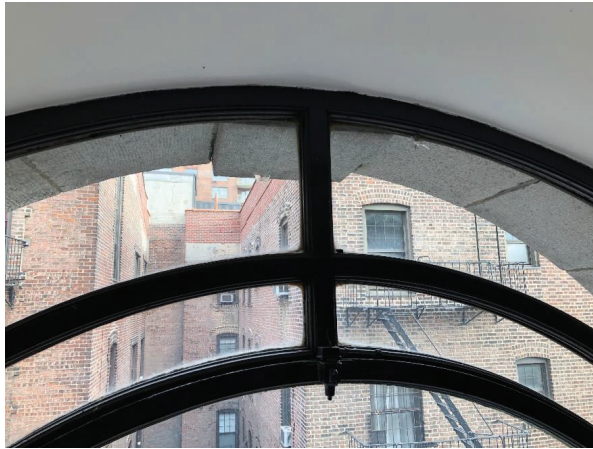
Picture 1

WINDOW REF #: **18** (picture # 1)
 SIZE: 7'-6 3/8"
 LOCATION: North Façade, Second floor
 OPERATION: Pivots
 QTY OF LITES : (16) lites of clear glass
 CONDITIONS ASSESSMENT: Frame is in relatively good condition
 The window was sealed
 No gaskets round oculus perimeter.
 Exterior glass sealant in dry conditions
 Interior finish shows some damage of water infiltration
 Interior finish was redone

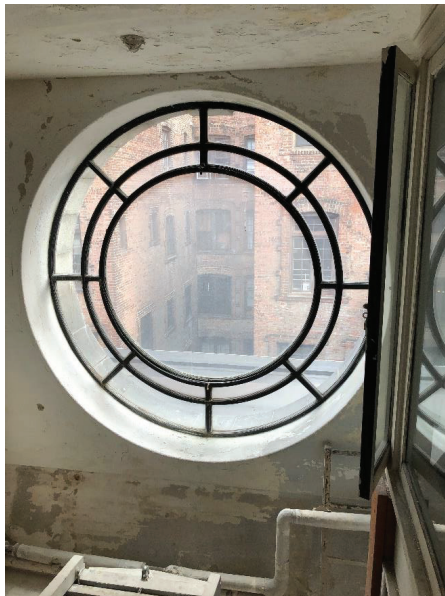
Picture 7

WINDOW REF #: **19** (picture # 7)
 SIZE: 7'-6 3/8"
 LOCATION: North Façade, Second floor
 OPERATION: Pivots
 QTY OF LITES : (16) lites of clear glass
 CONDITIONS ASSESSMENT: Frame is in relatively fair condition
 Access was limited at the time of survey
 Operable frame is not latched, same command that window 18
 Cannot be locked (closed)
 Do to interior astragal been damage at pivot (PICTURE 8)

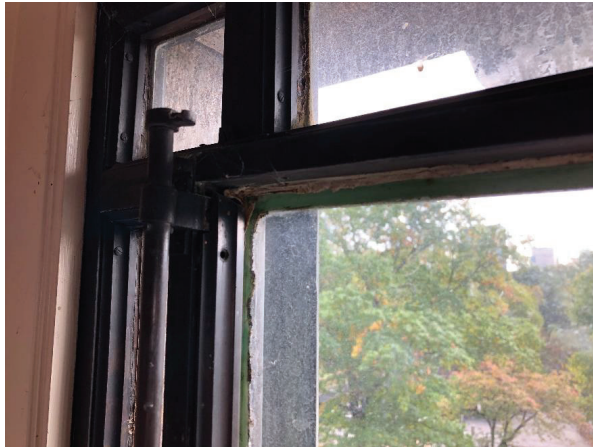
Picture 23

WINDOW REF #:	16 (picture # 23)
SIZE:	4'-6" x 2'-6"
LOCATION:	East facade, second floor
OPERATION:	Casement
QTY OF LITES :	(11) glass lites, clear
CONDITIONS ASSESSMENT:	Frame is in relatively poor condition Cremone mechanism in good conditions but latch is not.(PICTURE 23) Hinges are broken. (PICTURE 24) Missing screws Operable panel cannot be fully closed No apparent cracks Glass sealant is very dry

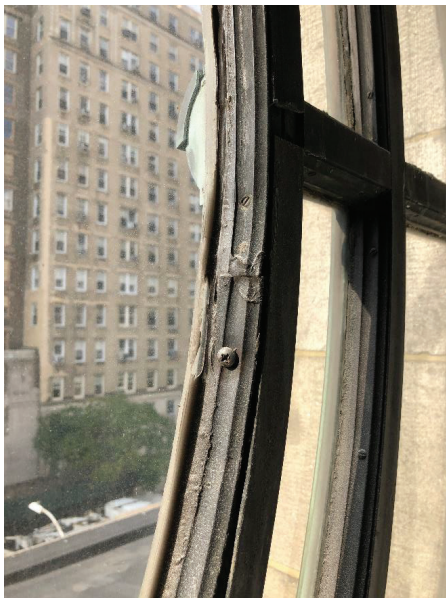
Picture 26

WINDOW REF #:	3 (picture #28)
SIZE:	7'-6 3/8"
LOCATION:	South façade, second floor
OPERATION:	Pivoting panel
QTY OF LITES :	(16) lites of clear glass
CONDITIONS ASSESSMENT:	Window is generally in a fair condition Center glass panel was changed and sealed improperly (picture 26) Operable panel swing improperly Frame is cracked (picture 25) Corrosion development in the outside (picture 27)
WINDOW REF #:	4 (pictures 36-37)
SIZE:	4'-11 7/8"x 2'
LOCATION:	South façade, first floor
OPERATION:	Single casement
QTY OF LITES :	(11) lites including (10) stained glass and (1) textured clear glass at center
CONDITIONS ASSESSMENT:	Window is generally in a fair condition Pivoting panel was made fixed Latch at bottom no longer functional No apparent cracks in frame Some joins seems to give a little and open up Frame shown signs of corrosion at the bottom. Hinge show sign of fatigue of the astragal

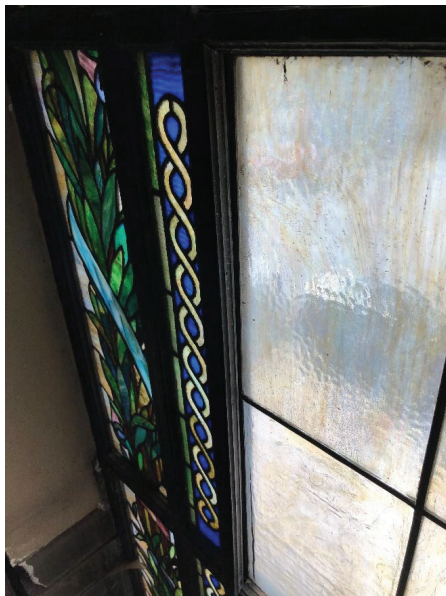
Picture 41

WINDOW REF #: 6 (picture 61)
 SIZE: 23'-3 5/8" X 7'-6"
 LOCATION: South façade, first floor
 OPERATION: (2) pivot panels
 QTY OF LITES : (60) lites of stained glass
 CONDITIONS ASSESSMENT: Window is generally in a poor condition
 window operates but does not close properly
 Latch is broken.
 Missing glass top (picture 41)
 Window is subject to deflection
 Operable window was silicone to prevent leaks (picture 43)
 Mullions are cracked at several locations. (picture 44,45,46)

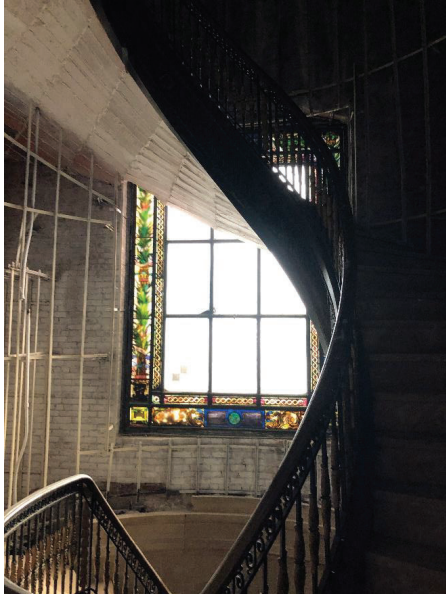
Picture 49

WINDOW REF #: 8 (picture # 49)
 SIZE: 11'-1"x 7'-9 5/8"
 LOCATION: East façade, first floor
 OPERATION: Pivoting window
 QTY OF LITES : (33) lites of stained and textured glass
 CONDITIONS ASSESSMENT: Window is generally in a poor condition
 Window is not operable.
 Latch is broken
 Operable window was sealed at a later date
 Missing glass stop
 Open mitered joints at several locations.
 Window is subject to deflection

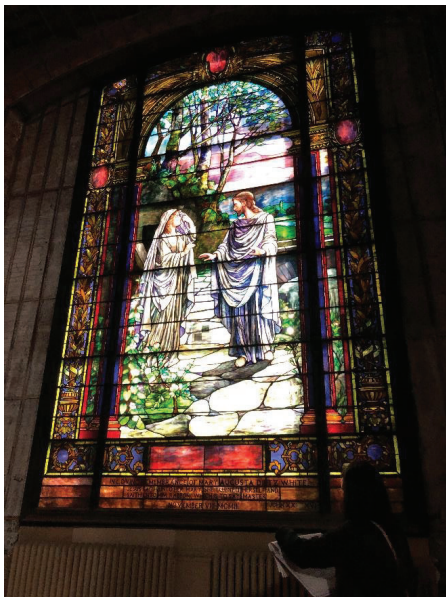
Picture 51

WINDOW REF #:	9 (picture # 51)
SIZE:	19'-4 1/4"x11'-6 3/4"
LOCATION:	East - first floor
OPERATION:	Fixed
QTY OF LITES :	(3) large stained glass panels with divisions
CONDITIONS ASSESSMENT:	Window is generally in a fair condition Include details that are unique to these windows due to size. Glass-stop on the bottom is pushed out by some internal corrosion. (picture 52-53) Mitered joints up at several location creating excess of verdigris Header and exterior details cannot be review at this time
WINDOW REF #:	10 (picture # 54)
SIZE:	11'-1"x 7'-9 5/8"
LOCATION:	East - first floor
OPERATION:	Pivoting window
QTY OF LITES :	(33) lites of stained and textured glass
CONDITIONS ASSESSMENT:	Window is generally in a fair condition Operable window is not operable. Latch is broken Operable window was sealed Missing glass stop. Open mitered joints at several location Window is subject to deflection
WINDOW REF #:	11 (picture # 66)

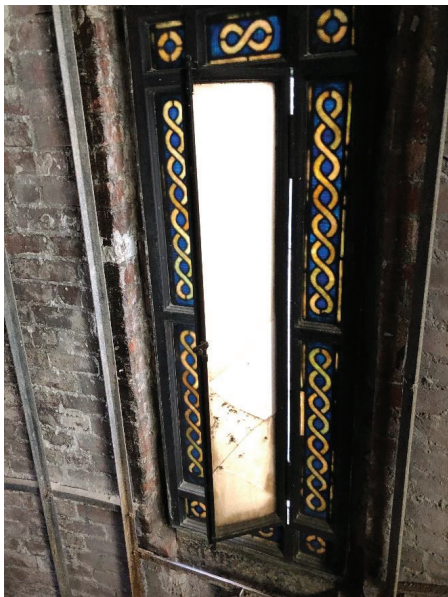
Picture 55

SIZE:	4'-11 7/8"x 2'
LOCATION:	East façade, first floor
OPERATION:	Fixed window
QTY OF LITES :	(11) lites, clear
CONDITIONS ASSESSMENT:	Frame is in relatively good conditions A second glass was installed on the inside Glass in center panel is broken. (picture 55)
WINDOW REF #:	12 (Picture # 56)
SIZE:	5'-2"x 2'-2"
LOCATION:	East façade, first floor
OPERATION:	Fixed window
QTY OF LITES :	(11) lites, clear
CONDITIONS ASSESSMENT:	Seems to be in a fair condition but no access (1) glass is broken

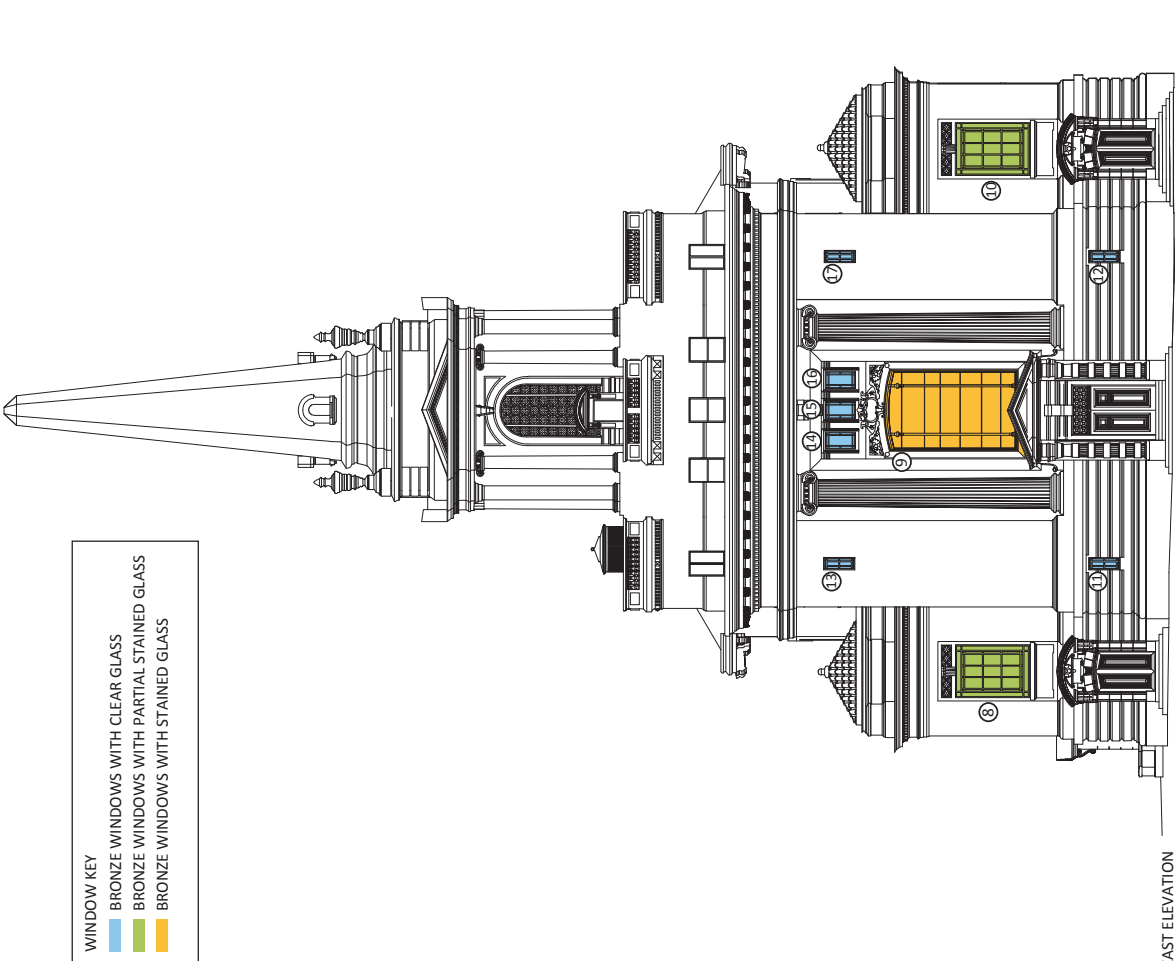
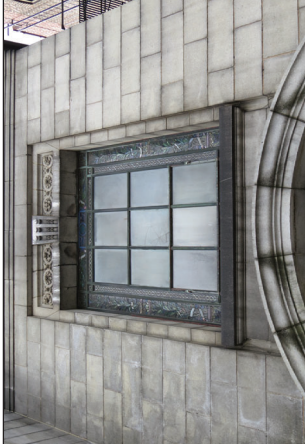
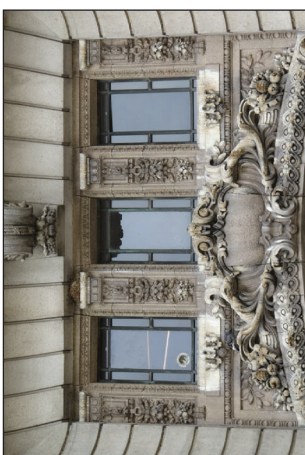
Typical window condition (window 10 shown)

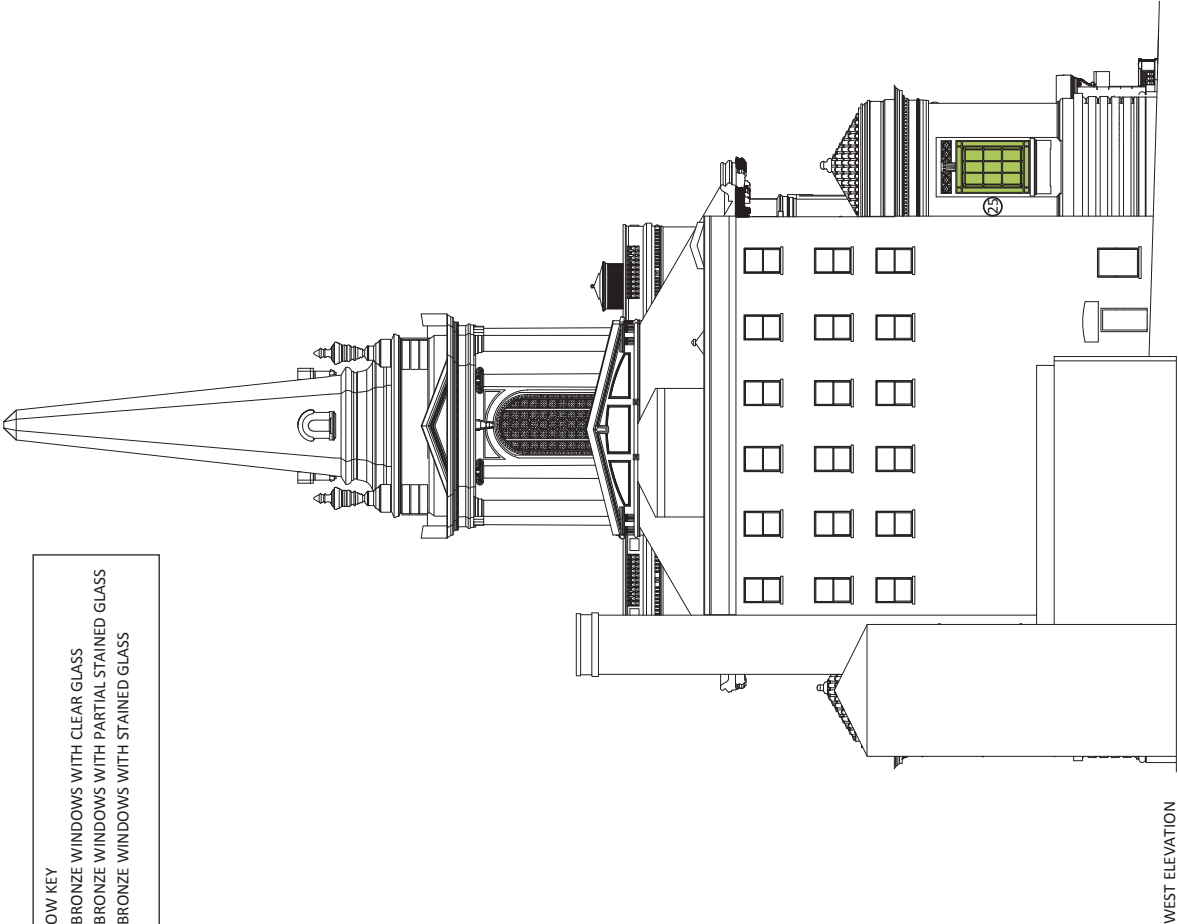
WEST ELEVATION

- **WINDOW 25 - BRONZE WITH STAINED GLASS AT PERIMETER ONLY:**
- The stained glass window is set in bronze frames and are held in place with bronze glazing stops. This West facing window has a center-pivot ventilating sash at the bottom and has protective glazing on the inside of the windows. The window is in poor condition. It is soiled, and dirt has built up in the space between the glass and the protective glazing. Some of the border panels are bowed outward, especially at the bottom. There is slight rusting observed on the bronze and oxidation on the patina.

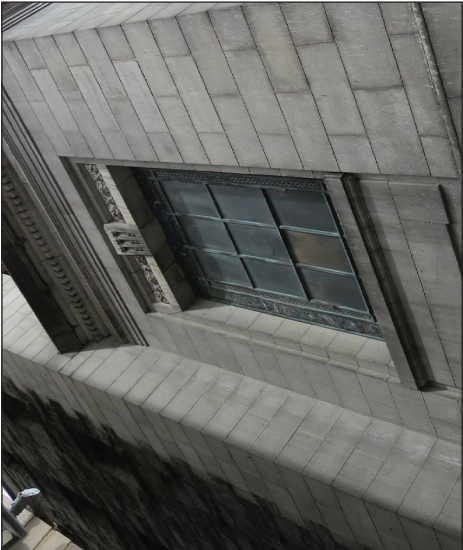
View of window 25

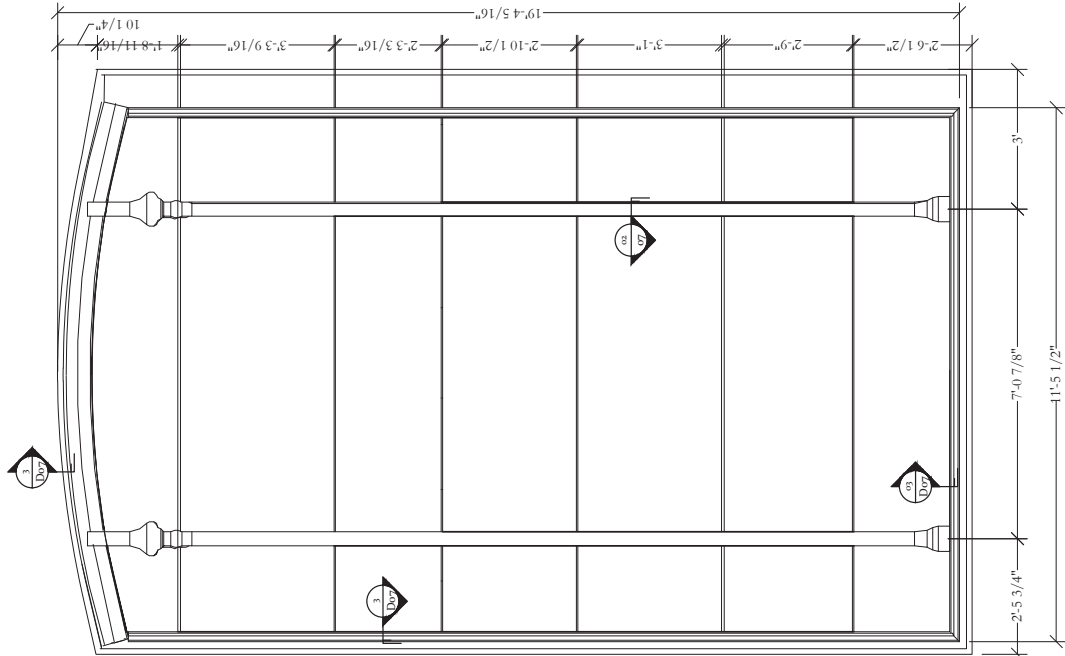
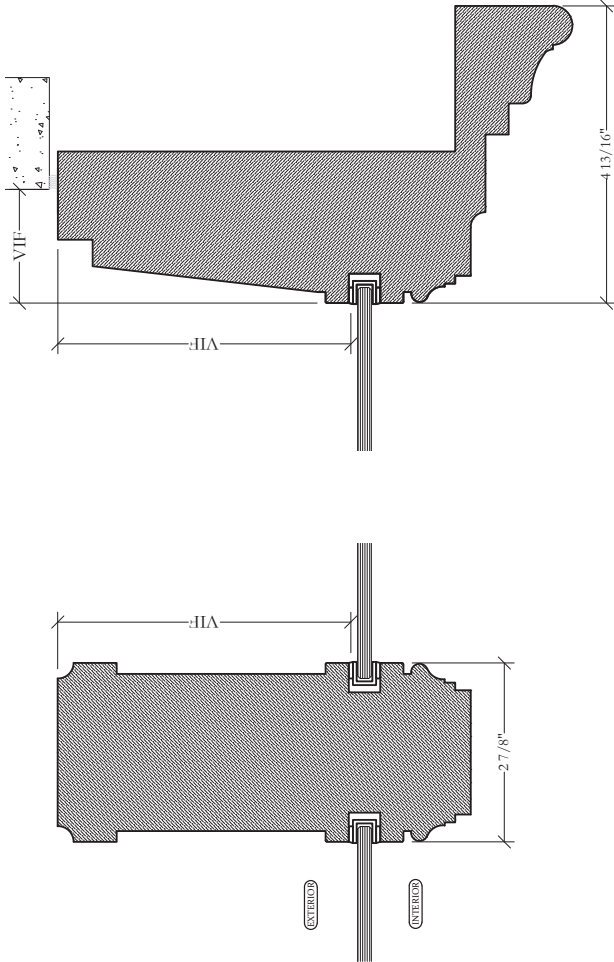
D07

NOTE: Exterior could not be surveyed. Requires manlift

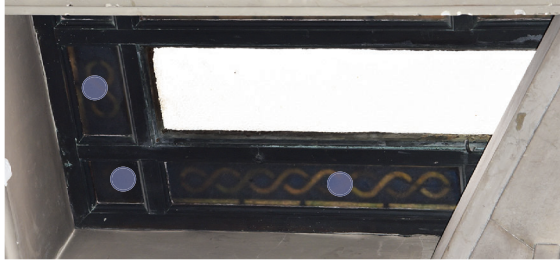
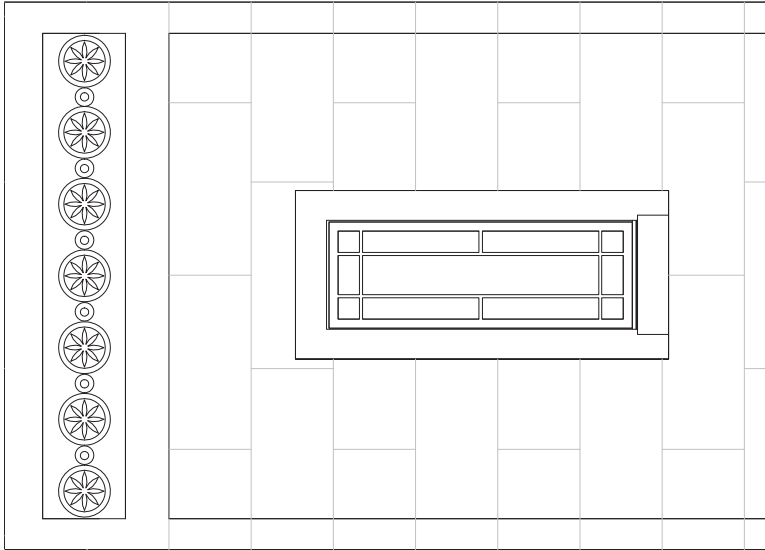
WINDOW 4 - BRONZE WITH STAINED GLASS AT PERIMETER ONLY

The window is in fair to good condition. There is minimal deflection in the panels. All of the original glass is present (see notes below). The interior plating has has solarized (turned a pinkish-purple color) due to an excess of manganese in the glass batch and exposure to ultra-violet radiation. There is an accretion of dirt and debris on the exterior and interior surfaces of the panels and trapped between the plates. This dirt is hygroscopic and is attracting water. There are condensation/leak trails on the interior surface and between the plates.

Area of severe dirt and debris accretions. This accretion is hygroscopic, attracting water. Standing water adversely affects the lead comes, the framing, and in the long term, contributes to the corrosion of the glass.

Area where the original glass is missing (interior plate) has been replaced with a poor color match.

Area of broken glass.

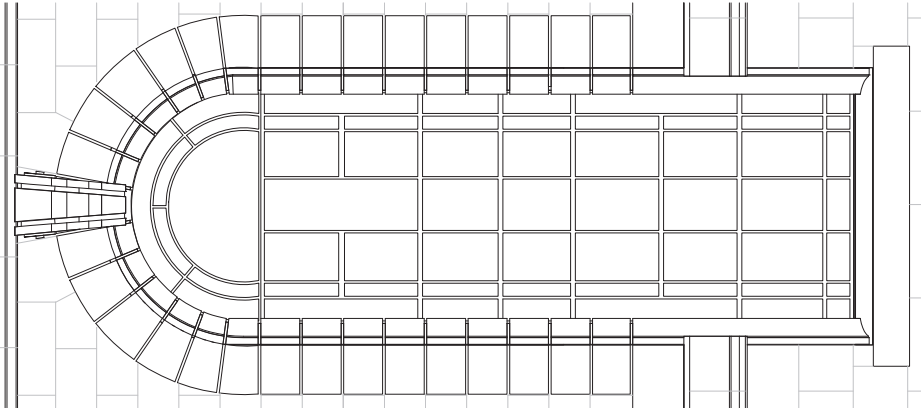
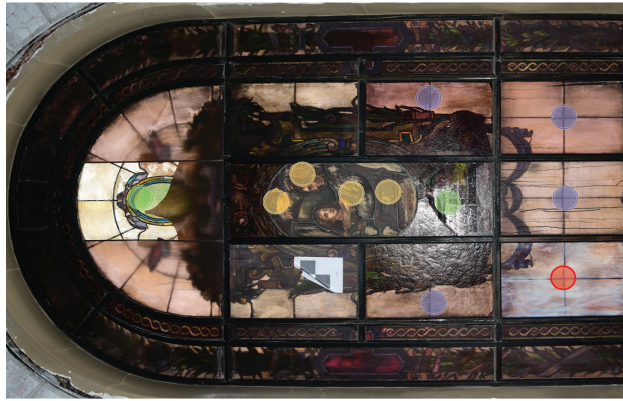
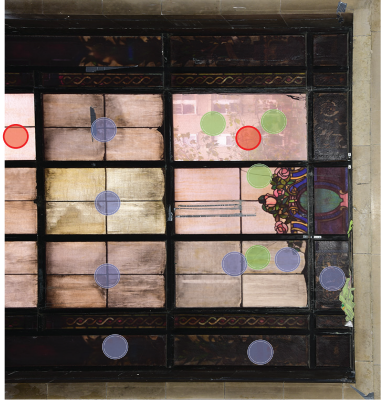
The window is in fair condition. There is minimal deflection in the panels. Most of the original glass is present (see notes below). The interior plating has has solarized (turned a pinkish-purple color) due to an excess of manganese in the glass batch and exposure to ultra-violet radiation. There is a great accretion of dirt and debris on the exterior and interior surfaces of the panels and trapped between the plates. This dirt is hygroscopic and is attracting water. There are condensation/leak trails on the interior surface and between the plates. There is broken glass and previous poor replacements.

- Area of severe dirt and debris accretions. This accretion is hygroscopic, attracting water. Standing water adversely affects the lead comes, the framing, and in the long term, contributes to the corrosion of the glass.
- Area where the original glass is missing (interior plate) has been replaced with a poor color match.
- Area of broken glass.
- Area of vitreous paint loss.

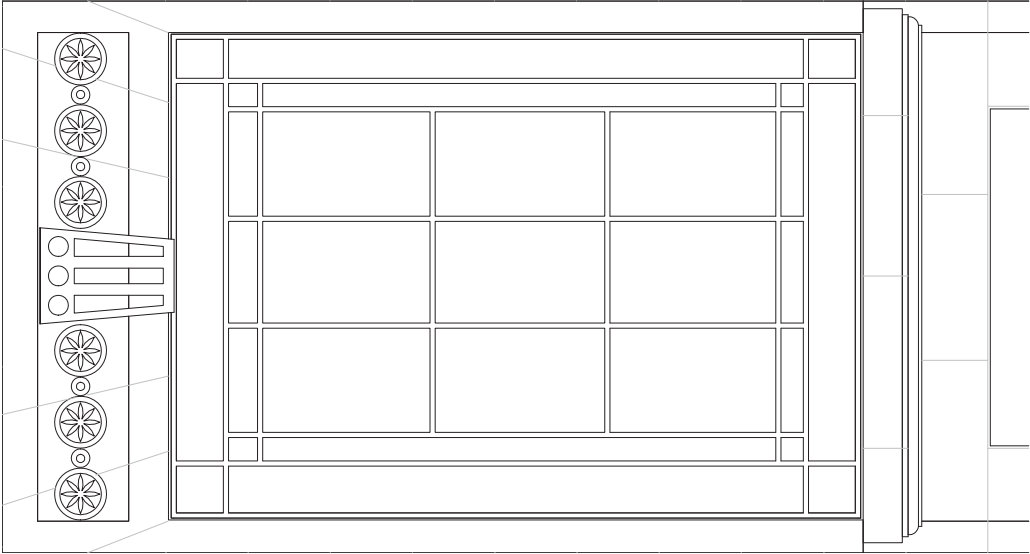
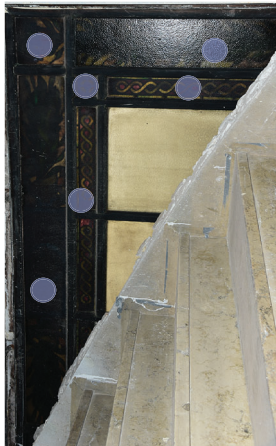
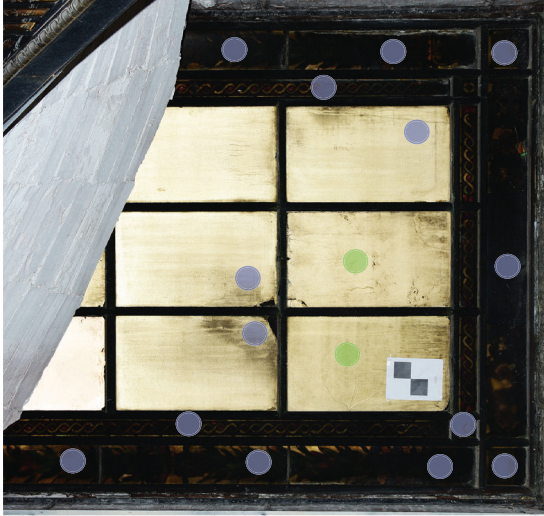
GENERAL CONDITION

The window is in fair condition. There is minimal deflection in the panels. All of the original glass is present, but some of it is broken. (see notes below). Some of the interior plating has has solarized (turned a pinkish-purple color) due to an excess of manganese in the glass batch and exposure to ultra-violet radiation. There is an accretion of dirt and debris on the exterior and interior surfaces of the panels and trapped between the plates. This dirt is hygroscopic and is attracting water. There are condensation/leak trails on the interior surface and between the plates.

CODE FOR DAMAGE

- Area of severe dirt and debris accretions. This accretion is hygroscopic, attracting water. Standing water adversely affects the lead comes, the framing, and in the long term, contributes to the corrosion of the glass.
- Area where the original glass is missing (interior plate) has been replaced with a poor color match.
- Area of broken glass.

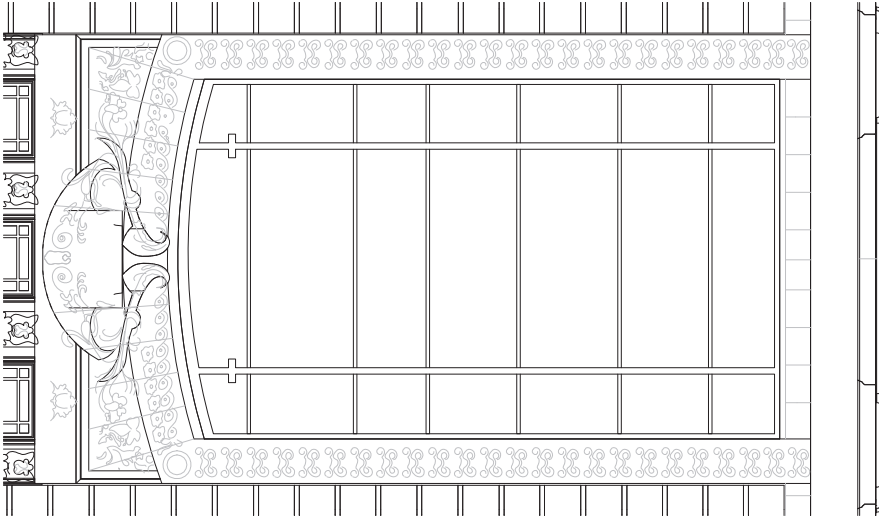
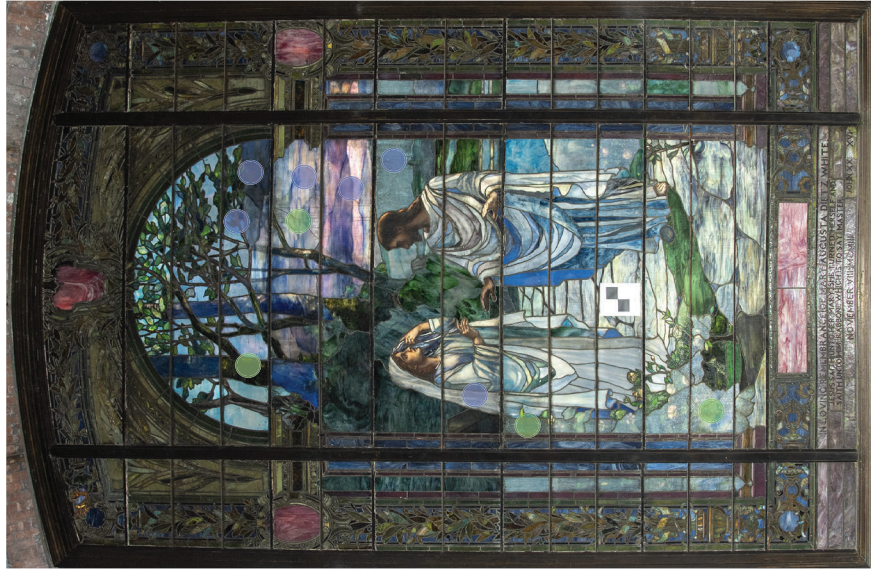
WINDOW 8 - BRONZE WITH STAINED GLASS AT PERIMETER ONLY

GENERAL CONDITION

The window is in fair to good condition. There is minimal deflection in the panels. Almost all of the original glass is present (see notes below). There is a great accretion of dirt and debris on the exterior and interior surfaces of the panels and trapped between the plates. This dirt is hygroscopic and is attracting water. There are condensation/leak trails on the interior surface and between the plates. There is broken glass and some previous poor replacements, but not many.

CODE FOR DAMAGE

- Area of severe dirt and debris accretions. This accretion is hygroscopic, attracting water. Standing water adversely affects the lead comes, the framing, and in the long term, contributes to the corrosion of the glass.
- Area where the original glass is missing (interior plate) has been replaced with a poor color match.
- Area of broken glass.

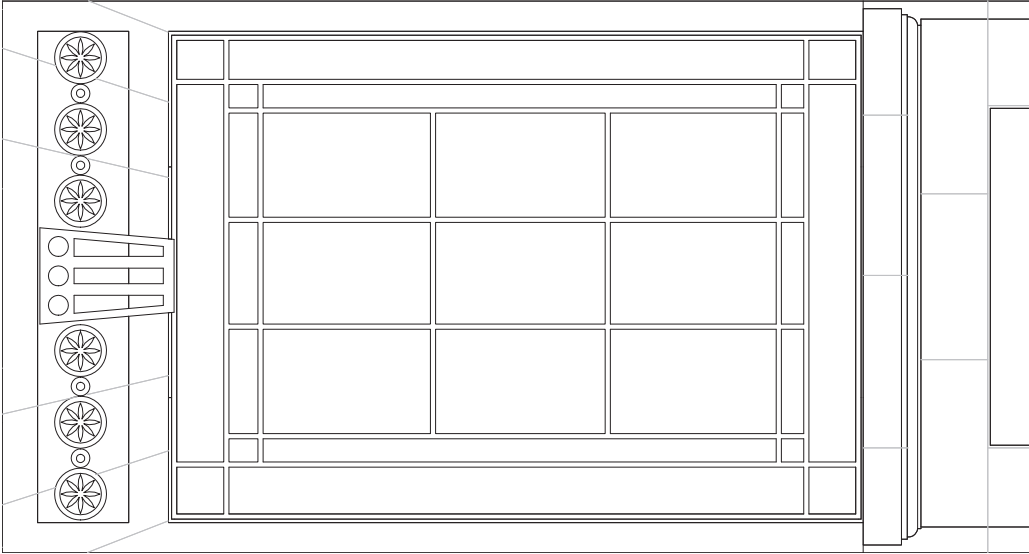
WINDOW 9 - BRONZE WITH STAINED GLASS

GENERAL CONDITION

The window is in fair condition. There is minimal deflection in the panels. All of the original glass is present, but some of it is broken. (see notes below). Some of the interior plating has has solarized (turned a pinkish-purple color) due to an excess of manganese in the glass batch and exposure to ultra-violet radiation. There is an accretion of dirt and debris on the exterior and interior surfaces of the panels and trapped between the plates. This dirt is hygroscopic and is attracting water. There are condensation/leak trails on the interior surface and between the plates.

Area of severe dirt and debris accretions. This accretion is hygroscopic, attracting water. Standing water adversely affects the lead comes, the framing, and in the long term, contributes to the corrosion of the glass.

Area where the original glass is missing (interior plate) has been replaced with a poor color match.

Area of broken glass.

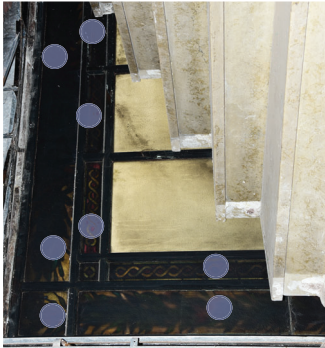
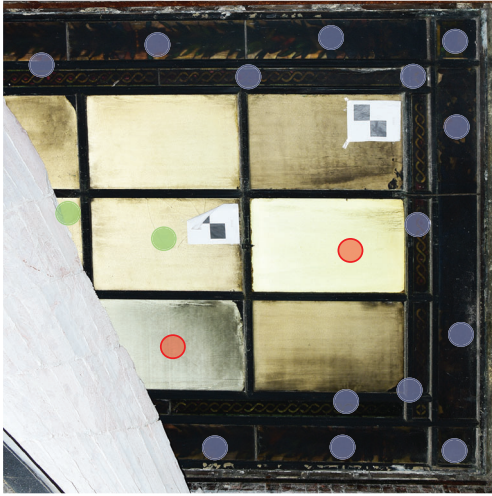
GENERAL CONDITION

The window is in fair to good condition. There is minimal deflection in the panels. All of the original glass is present (see notes below). The interior plating has has solarized (turned a pinkish-purple color) due to an excess of manganese in the glass batch and exposure to ultra-violet radiation. There is an accretion of dirt and debris on the exterior and interior surfaces of the panels and trapped between the plates. This dirt is hygroscopic and is attracting water. There are condensation/leak trails on the interior surface and between the plates.

CODE FOR DAMAGE

- Area of severe dirt and debris accretions. This accretion is hygroscopic, attracting water. Standing water adversely affects the lead comes, the framing, and in the long term, contributes to the corrosion of the glass.
- Area where the original glass is missing (interior plate) has been replaced with a poor color match.
- Area of broken glass.

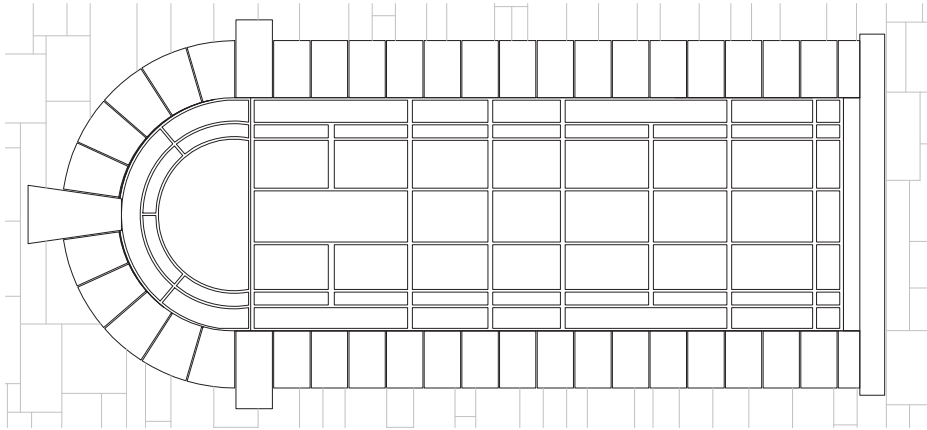
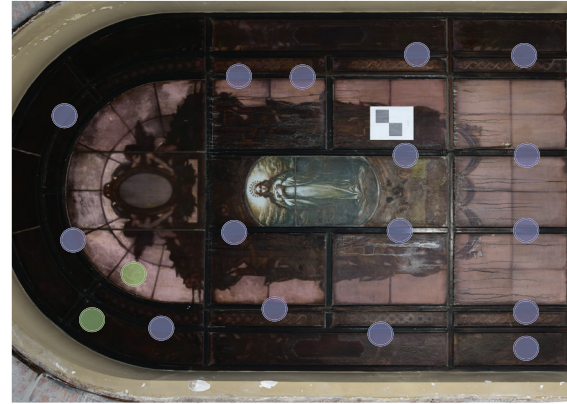
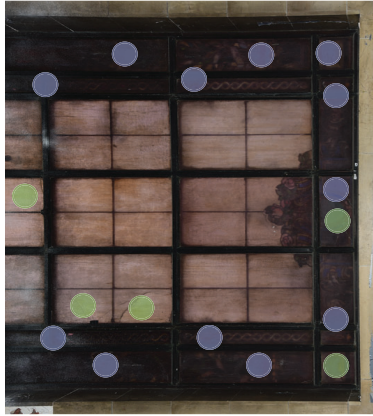
WINDOW 21 - BRONZE WITH STAINED GLASS AT PERIMETER ONLY

GENERAL CONDITION

The window is in fair to good condition with the exception of the dirt. There is minimal deflection in the panels. Most of the original glass is present (see notes below). The interior plating has has solarized (turned a pinkish-purple color) due to an excess of manganese in the glass batch and exposure to ultra-violet radiation. This is less than the South side due to the limited UV it has been exposed to. There is a great accretion of dirt and debris on the exterior and interior surfaces of the panels and trapped between the plates. This dirt is hygroscopic and is attracting water. There are condensation/leak trails on the interior surface and between the plates. There is broken glass and previous poor replacements.

Area of severe dirt and debris accretions. This accretion is hygroscopic, attracting water. Standing water adversely affects the lead comes, the framing, and in the long term, contributes to the corrosion of the glass.

Area where the original glass is missing (interior plate) has been replaced with a poor color match.

Area of broken glass.

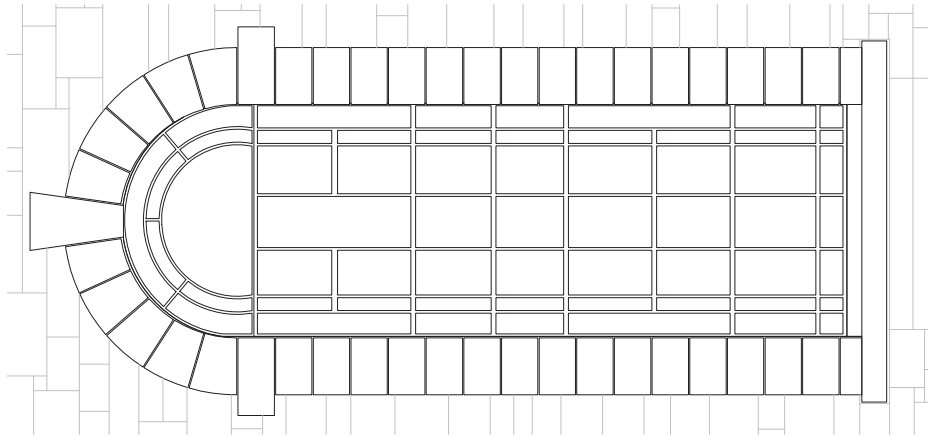
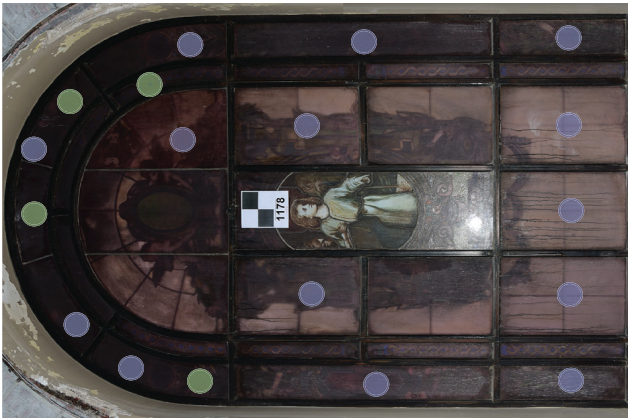
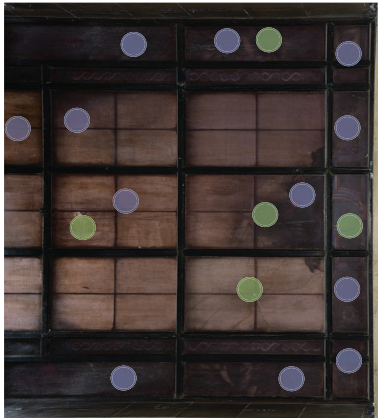
GENERAL CONDITION

The window is in fair to good condition with the exception of the dirt. There is minimal deflection in the panels. Most of the original glass is present (see notes below). The interior plating has has solatized (turned a pinkish-purple color) due to an excess of manganese in the glass batch and exposure to ultra-violet radiation. This is less than the South side due to the limited UV it has been exposed to. There is a great accretion of dirt and debris on the exterior and interior surfaces of the panels and trapped between the plates. This dirt is hygroscopic and is attracting water. There are condensation/leak trails on the interior surface and between the plates. There is broken glass and previous poor replacements.

CODE FOR DAMAGE

- Area of severe dirt and debris accretions. This accretion is hygroscopic, attracting water. Standing water adversely affects the lead comes, the framing, and in the long term, contributes to the corrosion of the glass.
- Area where the original glass is missing (interior plate) has been replaced with a poor color match.
- Area of broken glass.
- Area of paint loss.

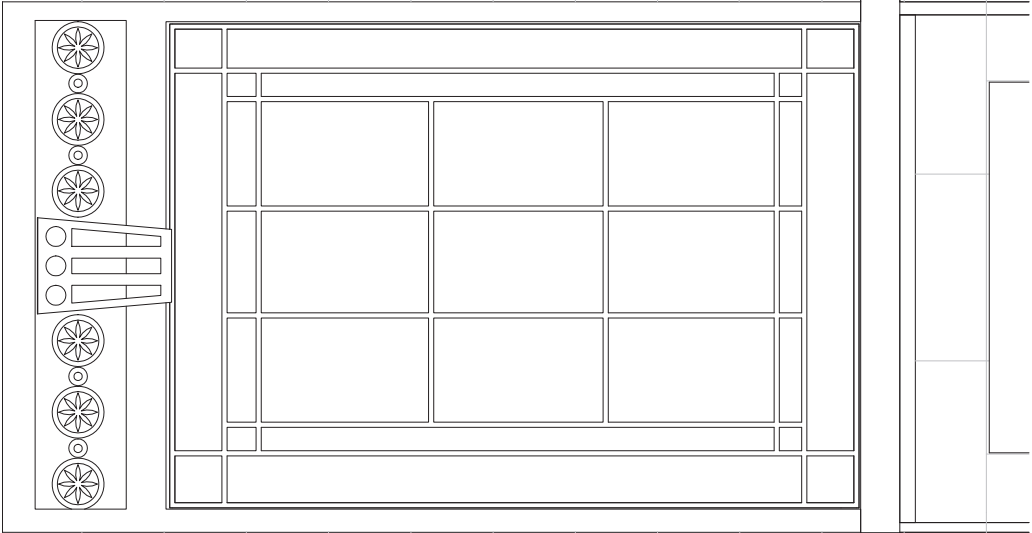
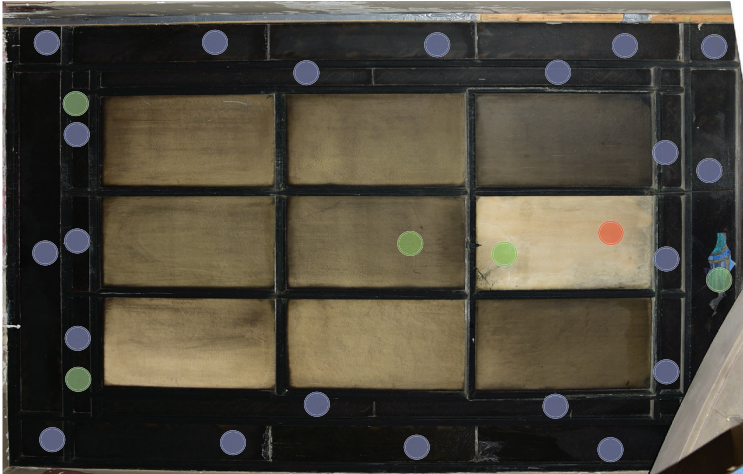
WINDOW 24 - BRONZE WITH STAINED GLASS

GENERAL CONDITION

The window is in fair to good condition. There is minimal deflection in the panels. All of the original glass is present, but some of it is broken. (see notes below). Some of the interior plating has has solarized (turned a pinkish-purple color) due to an excess of manganese in the glass batch and exposure to ultra-violet radiation. There is an accretion of dirt and debris on the exterior and interior surfaces of the panels and trapped between the plates. This dirt is hygroscopic and is attracting water. There are condensation/leak trails on the interior surface and between the plates.

CODE FOR DAMAGE

- Area of severe dirt and debris accretions. This accretion is hygroscopic, attracting water. Standing water adversely affects the lead comes, the framing, and in the long term, contributes to the corrosion of the glass.
- Area where the original glass is missing (interior plate) has been replaced with a poor color match.
- Area of broken glass.
