# **MONITORING REPORT**

# West Park Presbyterian Church

Stained Glass Condition Survey November 2022

## Preliminary Budget With Options Revised April 10, 2023

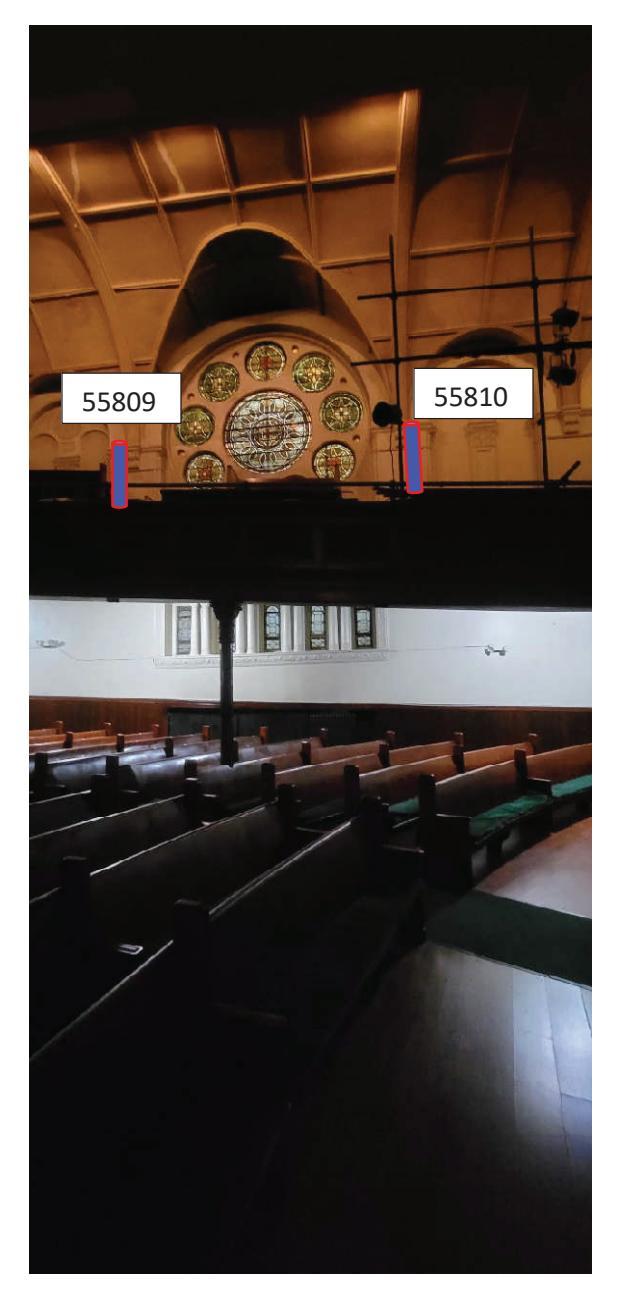
Interior of North Wall

<u>Tilt Beam 55809 Location</u> – Installed along the interior of the north (rear) wall facing the interior of the building. The beam is to the east (left) of the circular stained-glass window

<u>Tilt Beam 55810 Location</u> – Installed along the interior of the north (rear) wall facing the interior of the building. The beam is to the west (right) of the circular stained-glass window

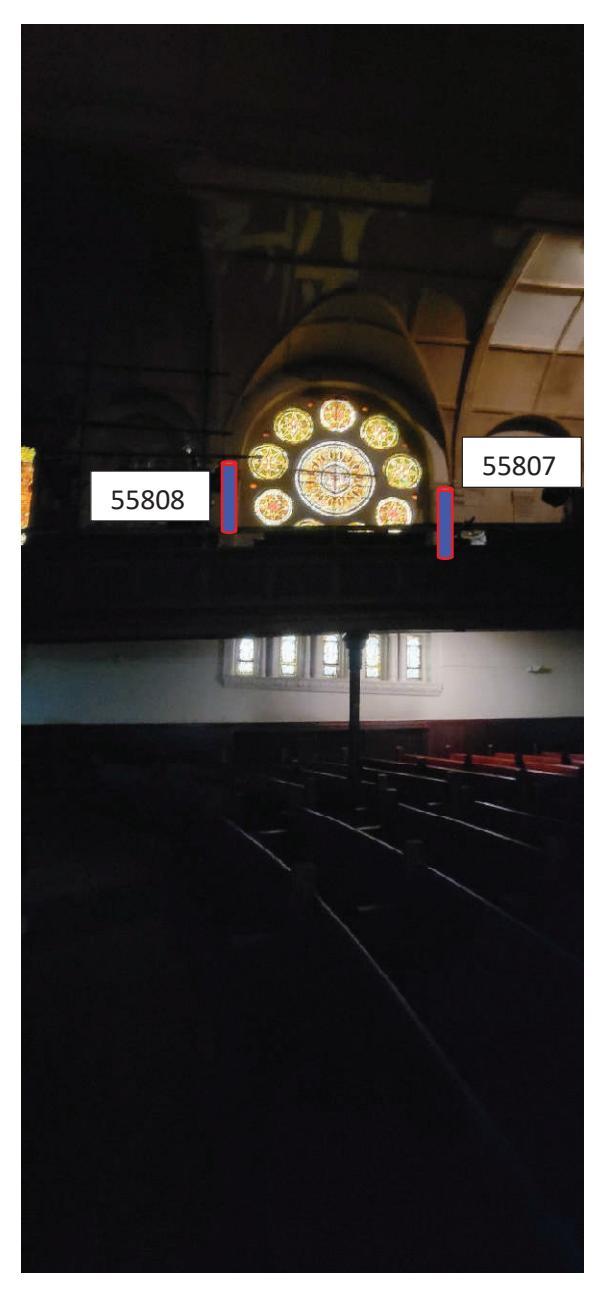
Interior of South Wall

<u>Tilt Beam 55807 Location</u> – Installed along the interior of the south wall (along West 86<sup>th</sup> St.) facing the interior of the building. The beam is to the west (right) of the circular stained-glass window

<u>Tilt Beam 55808 Location</u> – Installed along the interior of the south wall (along West 86<sup>th</sup> St.) facing the interior of the building. The beam is to the east (left) of the circular stained-glass window

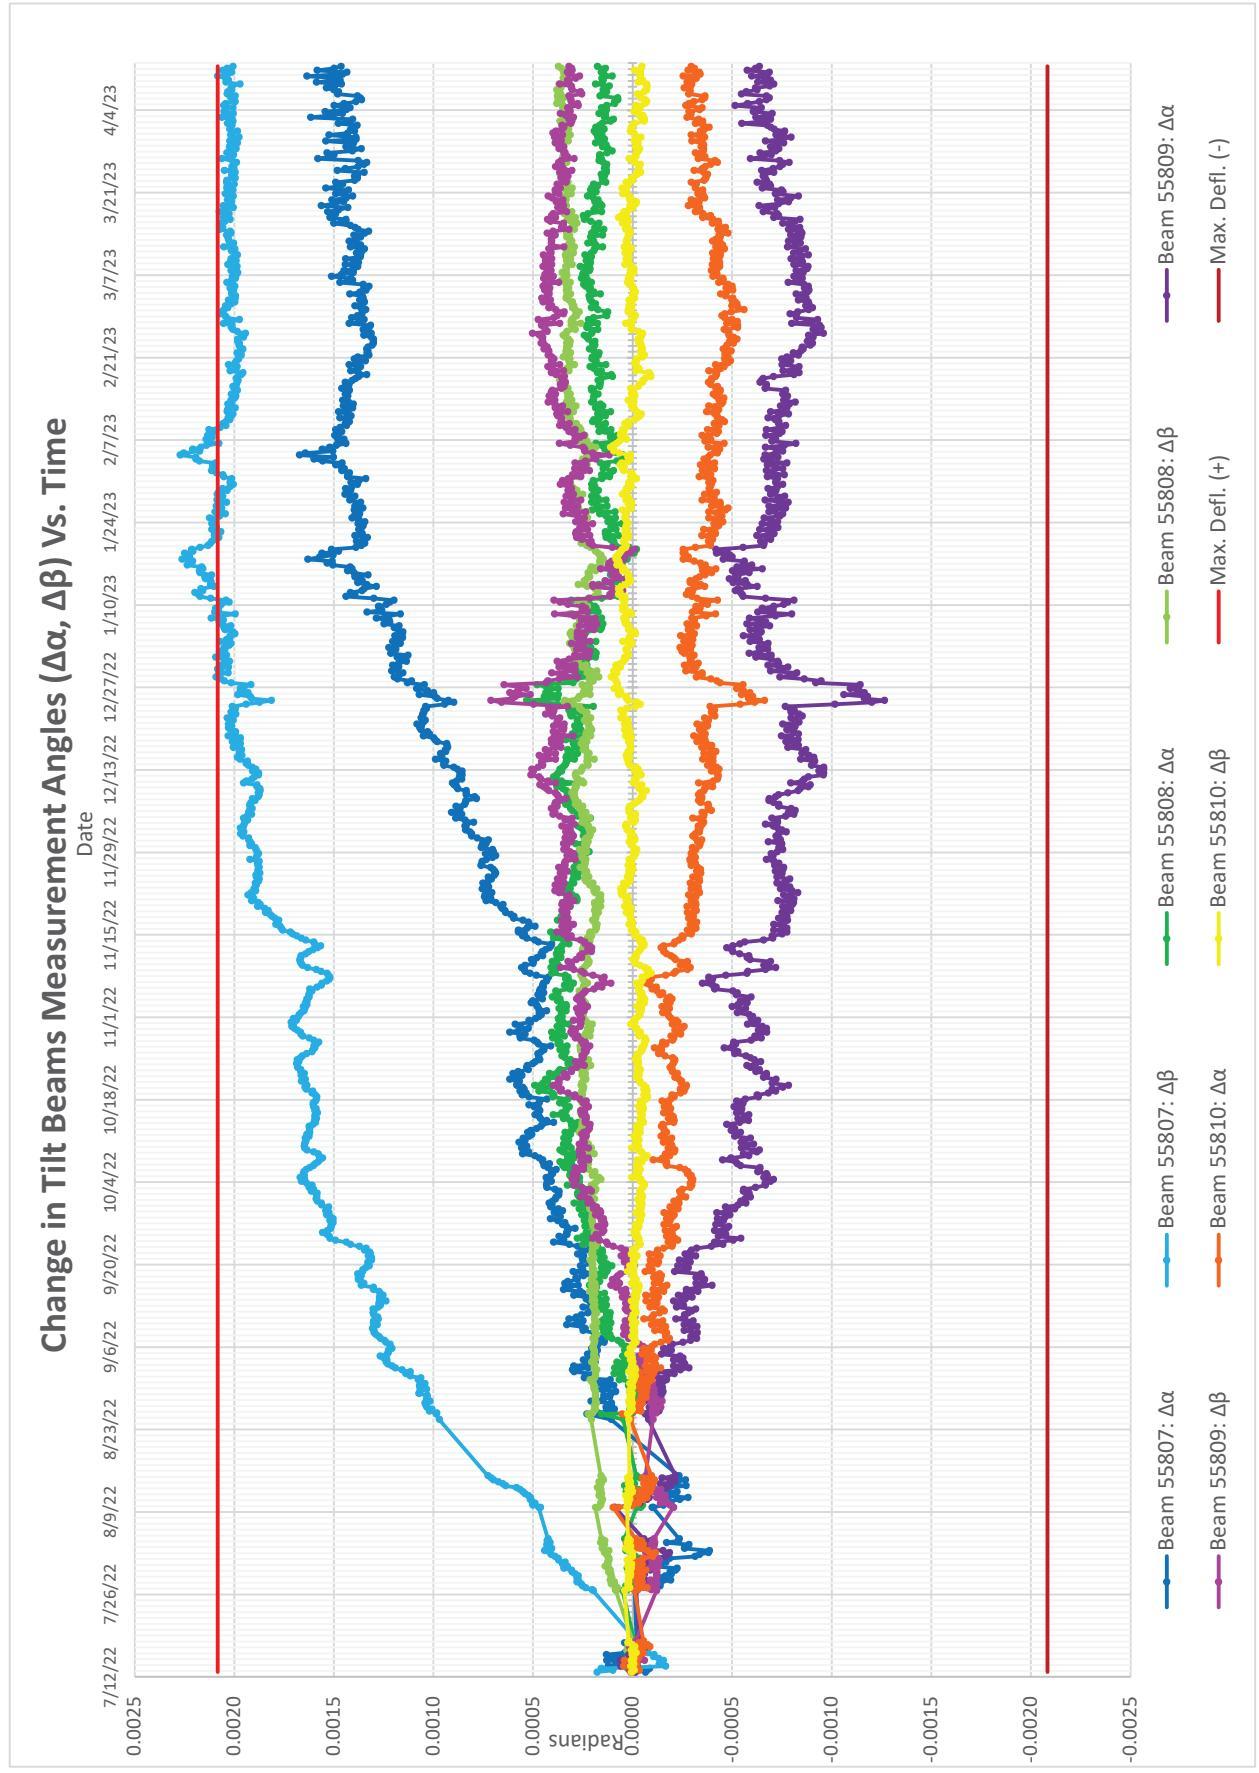
# Appendix II.A Tilt Beam #1 EB55807

Based on data and analysis through the date of this report, threshold value of Beam 55807 has exceeded above-referenced threshold of 0.0021 radians in  $\Delta\beta$ . Review of any bracing implementation and structural conditions should be performed.

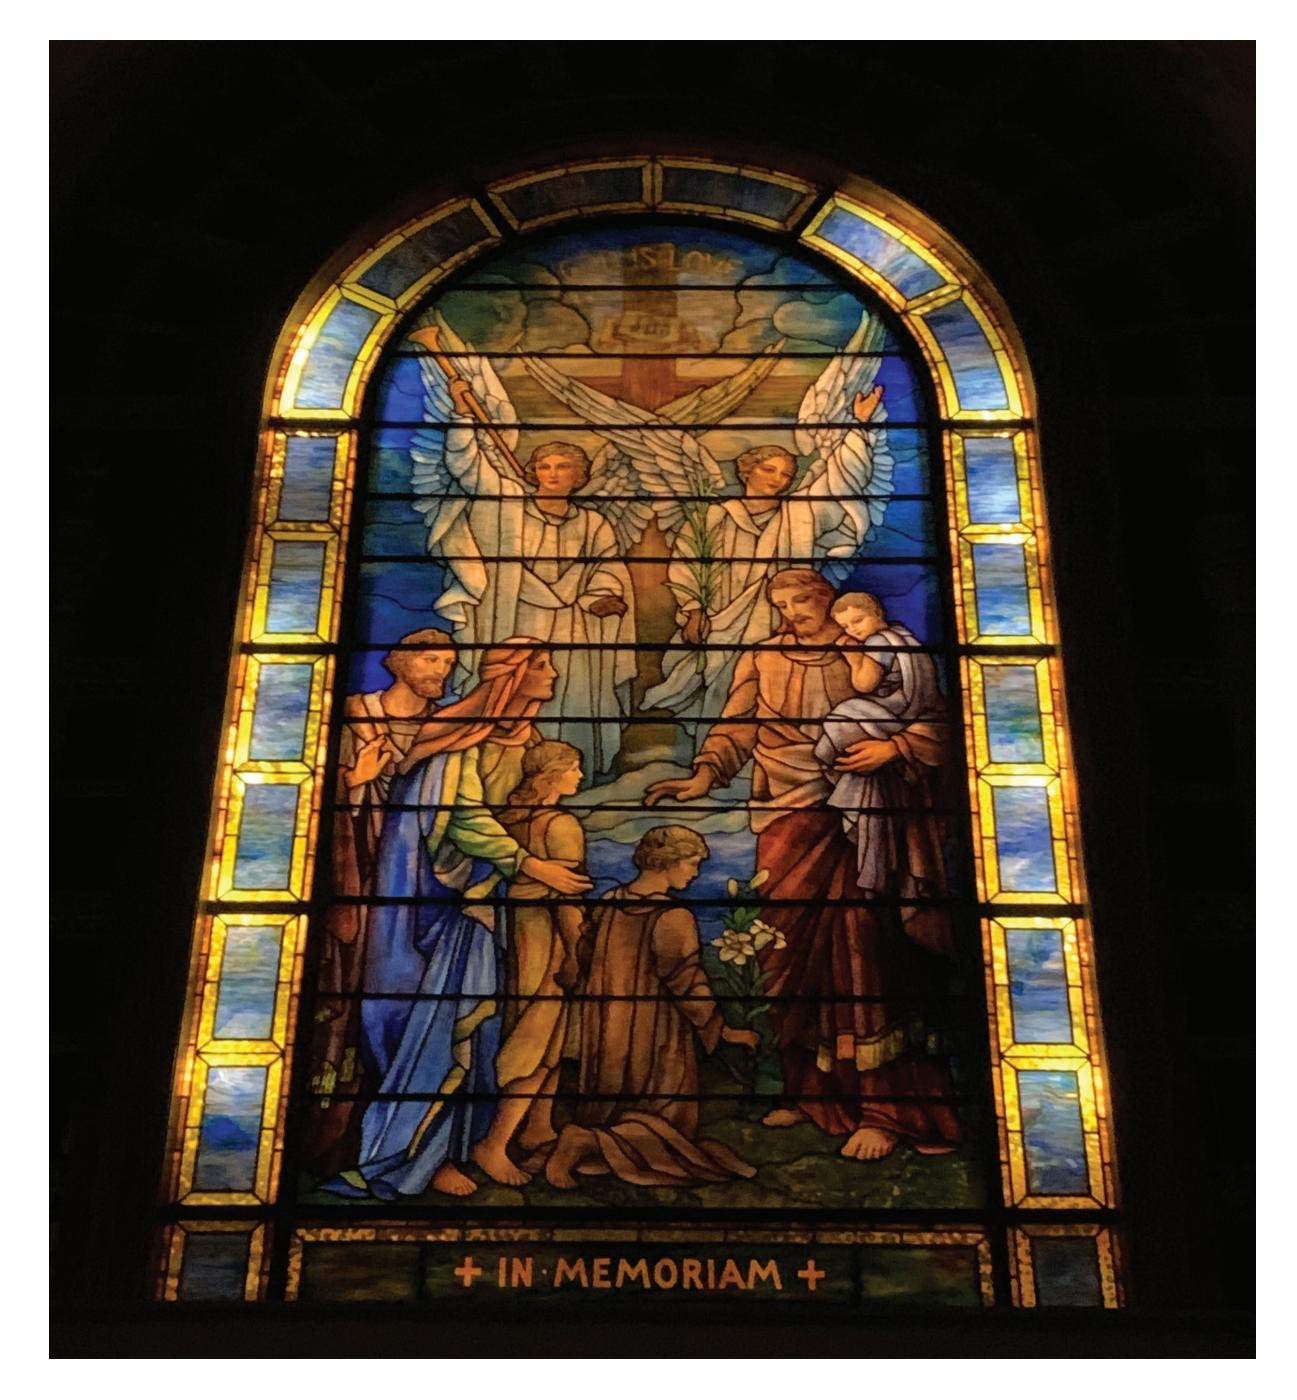
The War Memorial Window, depicting Christ Blessing the Children, was executed by Tiffany Studios in 1929. The window is dedicated to the sons of the church who sacrificed their lives in WWI (New York Times [27 May 1929, p. 25]).

The window was viewed from the back only. It is heavily plated and has a steel subframe to support it. The exterior side of the window did not show bowing or breakage. An up-close inspection of the window is needed.

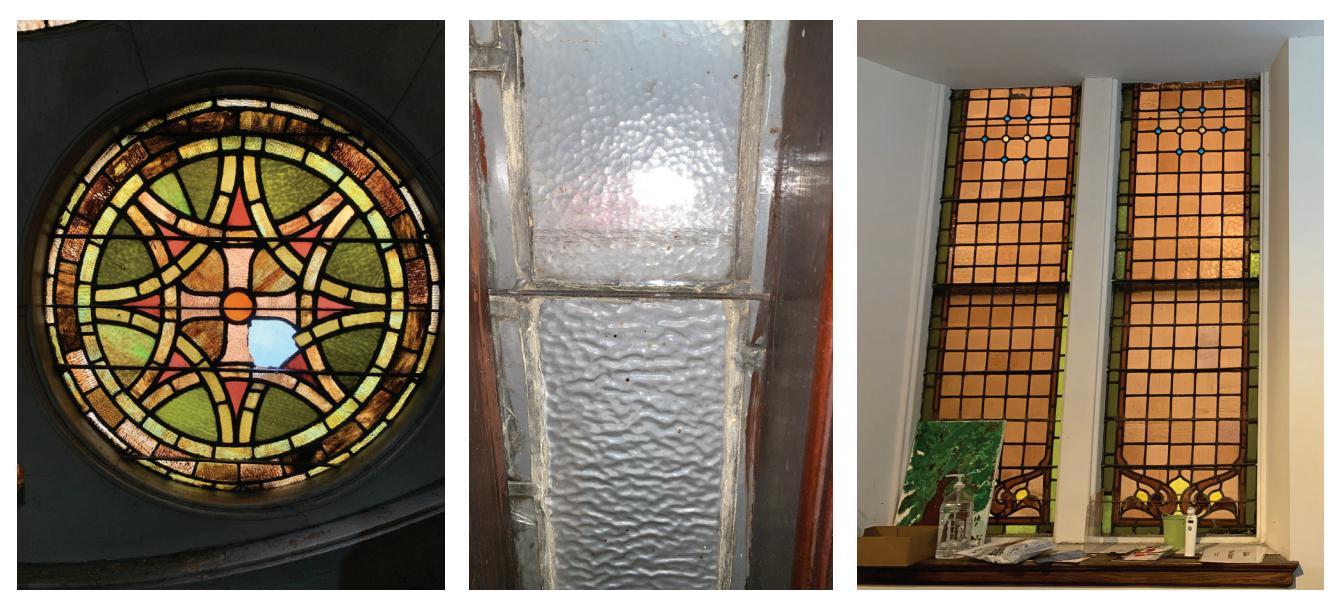
The windows at West Park Presbyterian Church and Parish House use various colors of opalescent (left), cathedral (center) and antique glasses (right). The clouded exterior Lexan coverings create a semi-opaque appearance, even in the transparent glasses. All of the windows were made with lead matrices.

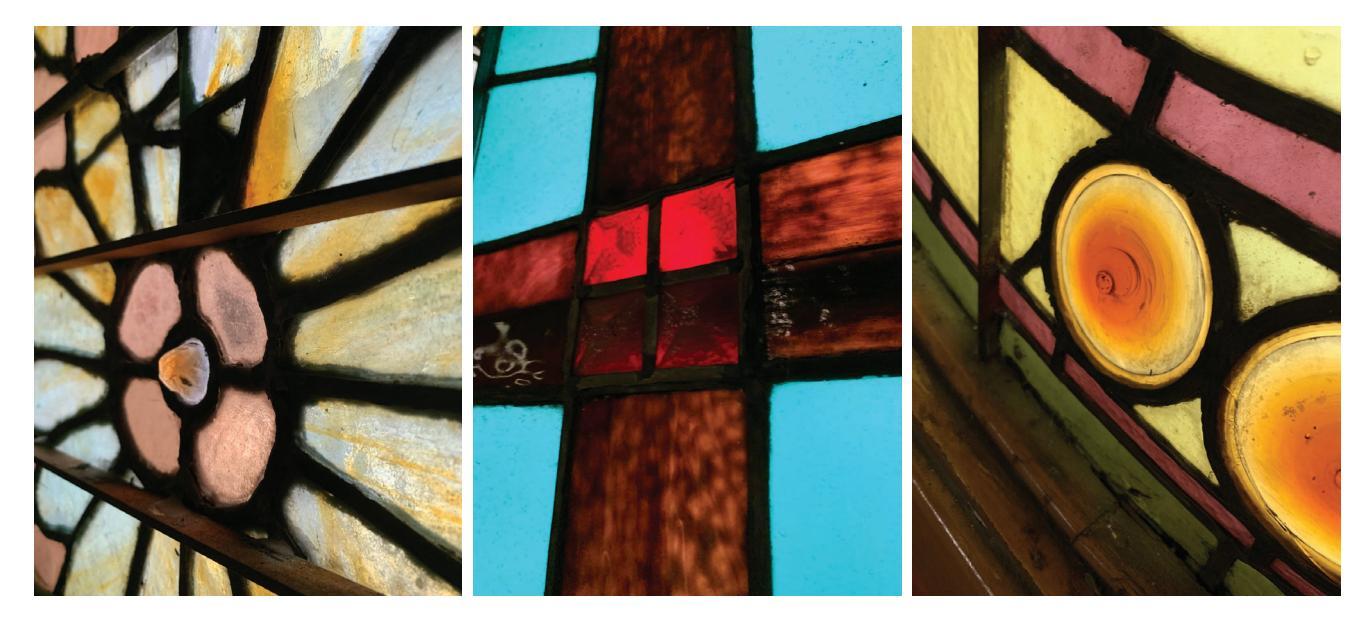
Detail from windows S9, PHS 9, and PHS 10. The window scheme uses chipped jewels in the sanctuary (left), cast jewels (center), and spun roundels (right) in the Parish House. Jewels and roundels were often seen in 19th-century windows and were a notable inclusion. They were more expensive than glass.

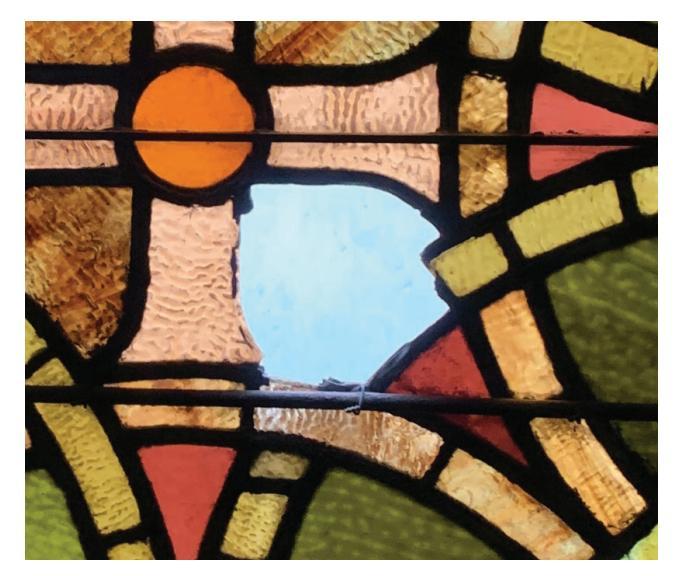
Detail from window S 12 where a piece of glass and the surrounding matrix have been lost. The pieces are unstable.

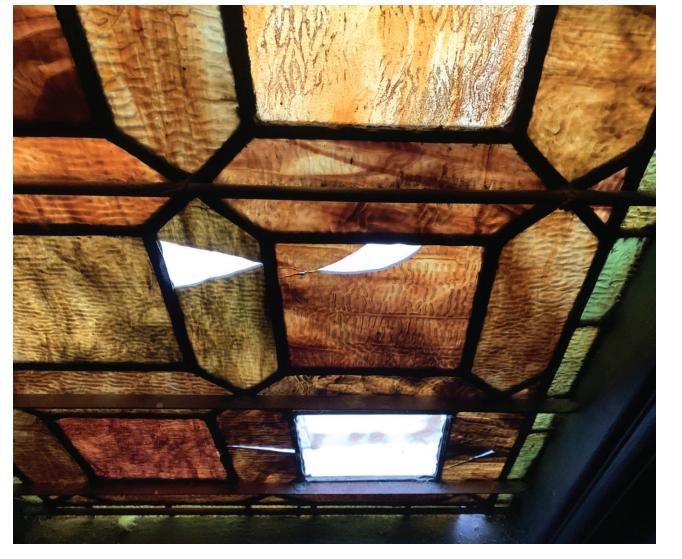
Detail illustrating several lost and unstable glass pieces in window S 13.

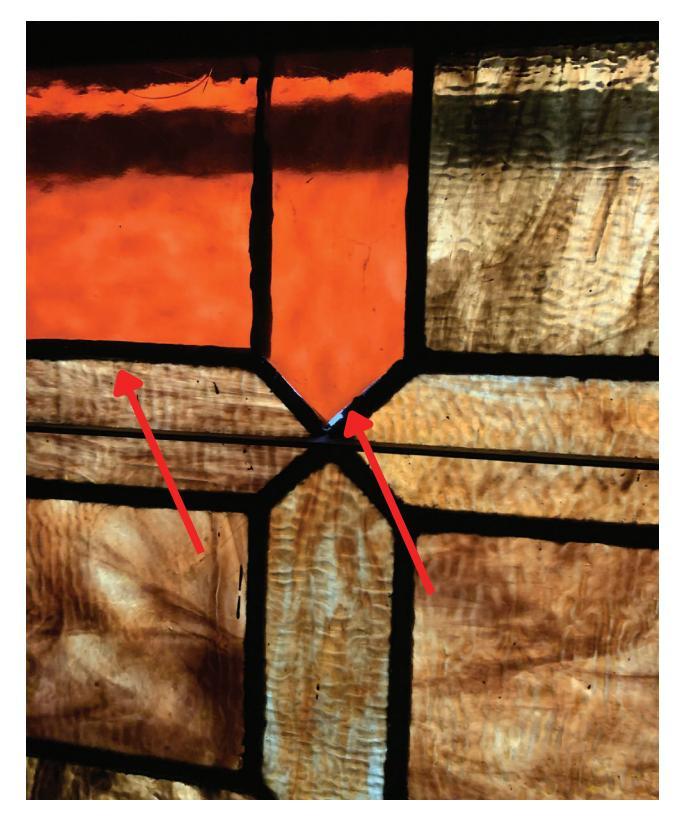
Detail of a poor repair in window S 13. The replacement glass is not a good match to the surrounding material.

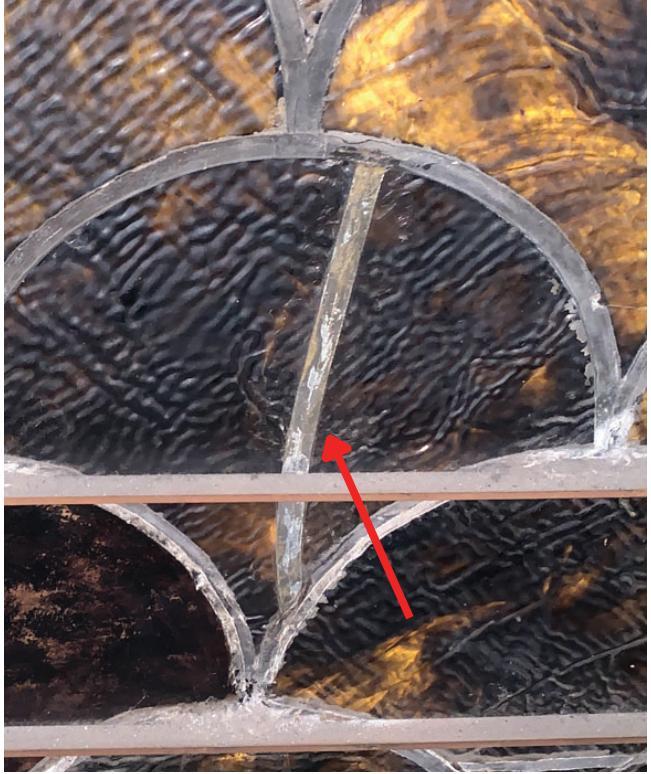
Detail of typical strap lead in window W 15. Strap leads are not true repairs, they merely cover the break.

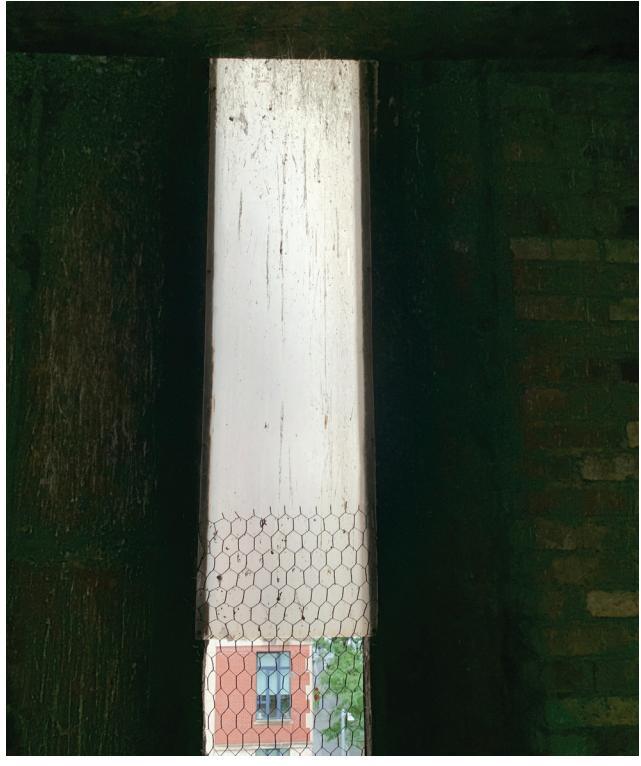
An opening with missing leaded glass that has been secured with plastic and chicken wire. This is not weather tight, and water is infiltrating the tower.

<u>IMMEDIATE PRIORITY</u>: The tower windows are in the worst condition and are of concern. The tower windows should be removed immediately, and the window openings closed with a weatherproof board-up until the leaded glass can be restored and returned to the building. There are large portions of missing glass, and the remaining glass is not secure. Missing areas have been covered with either plastic or chicken wire, which allows water infiltration. The tower has missing window stools, and the wood frames are shored with lumber angled against the interior wood tower. The tower is covered in guano, and there are the remains of dead birds. PPE, including respirators, should be utilized inside the tower.

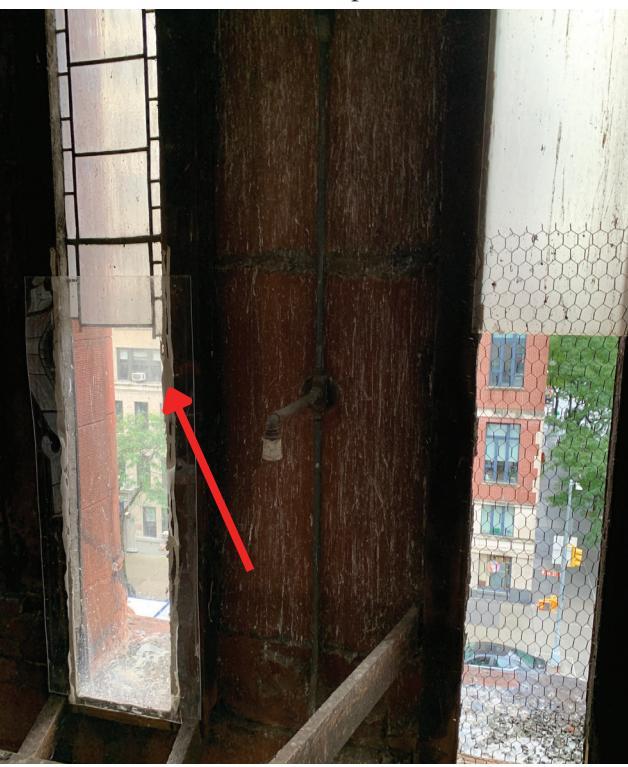
This remaining panel in danger of falling out. There is nothing supporting it from the bottom.

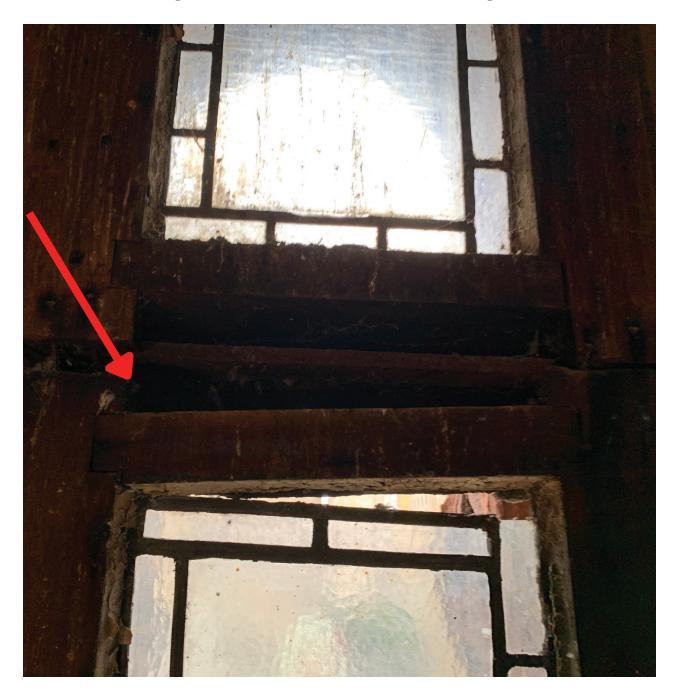
Detail of frame slippage. The top of the frame is no longer holding in the window.

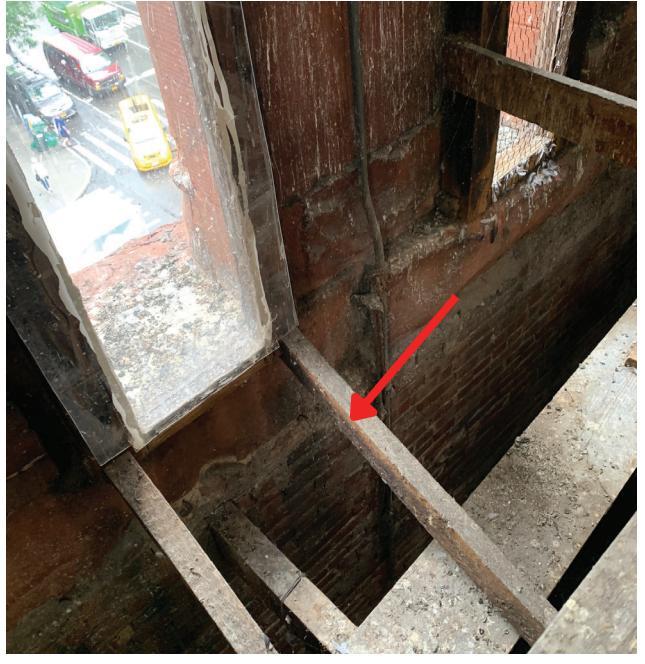
The frame appears to be shored by 2x2 lumber. The stone stool has been lost on the interior. The window frame is in danger of falling out of the setting.

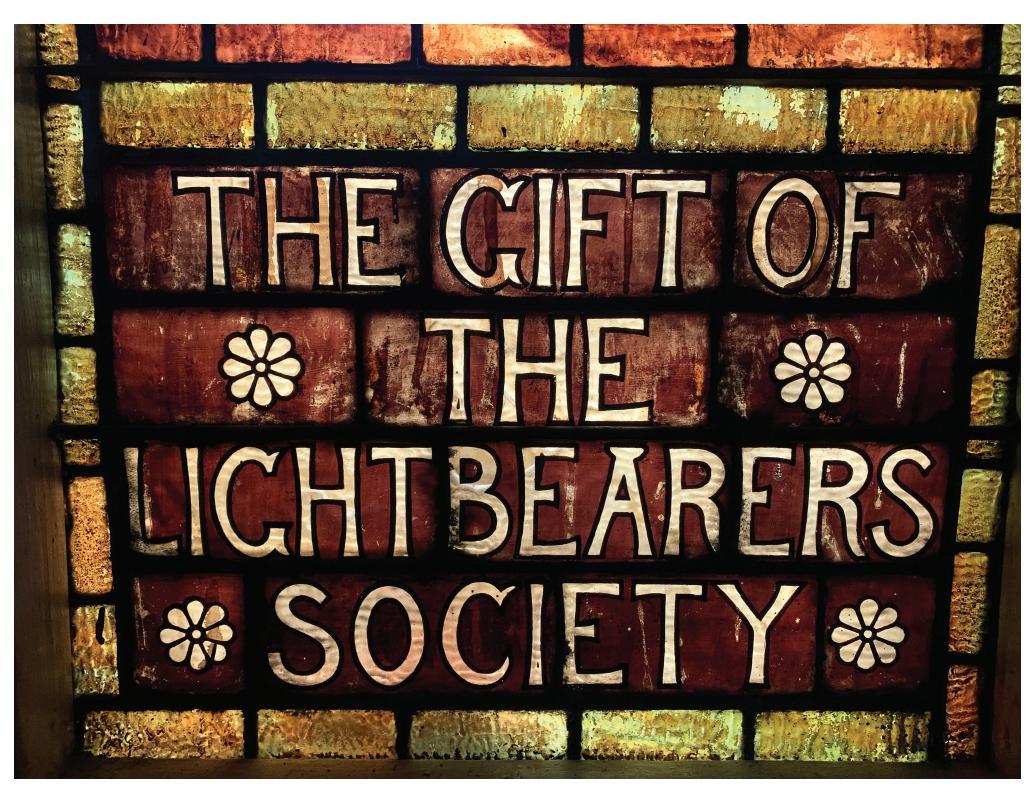
Detail from window S 11. The grisaille (glass paint) shows scratch marks and speckled losses. Cold paint (unfired paint) was applied to the inscription pieces, likely to camouflage the failures of the glass paint. The glass paint should be assumed fragile and handled with care until further testing is conducted.

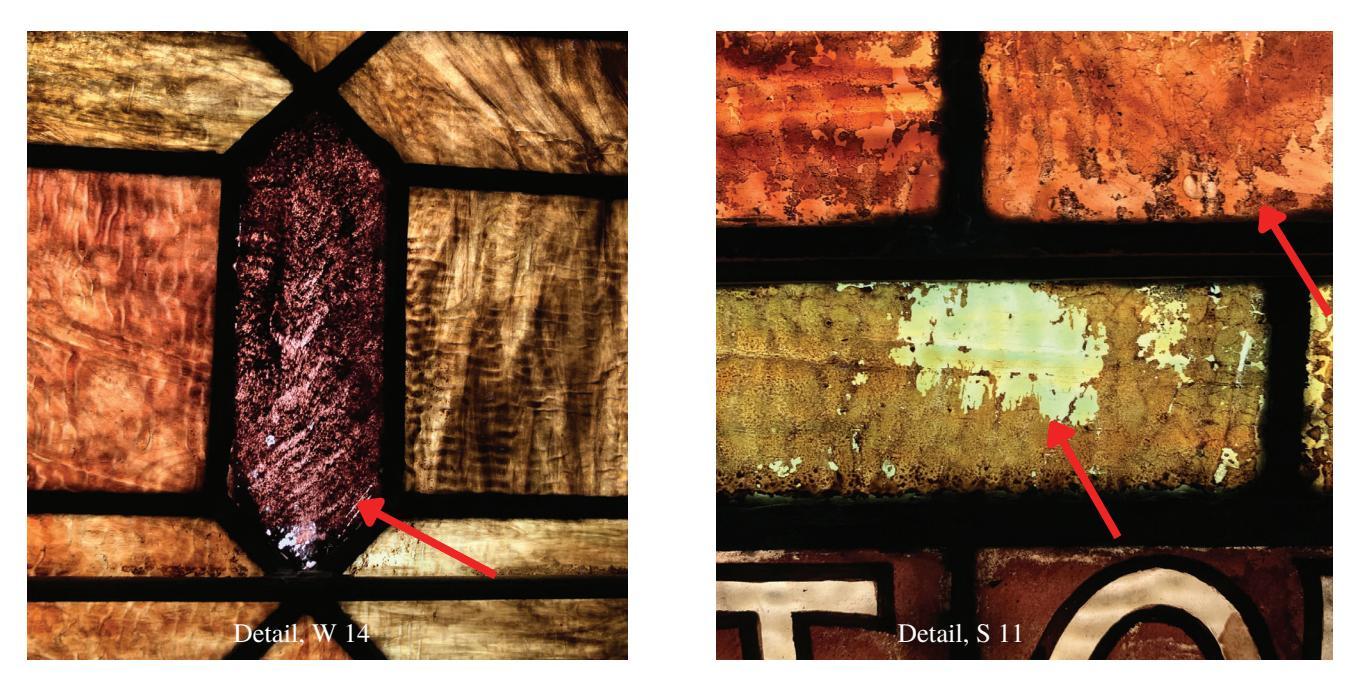
Nearly all of the sanctuary windows have been treated with cold paint. It was likely used as a darkening agent to mask bright light and to darken the extensive replacement pieces to blend in with the historic glass. Cold paint, like all material, degrades over time. The cold paint is patchy and has been affected by age and condensation.

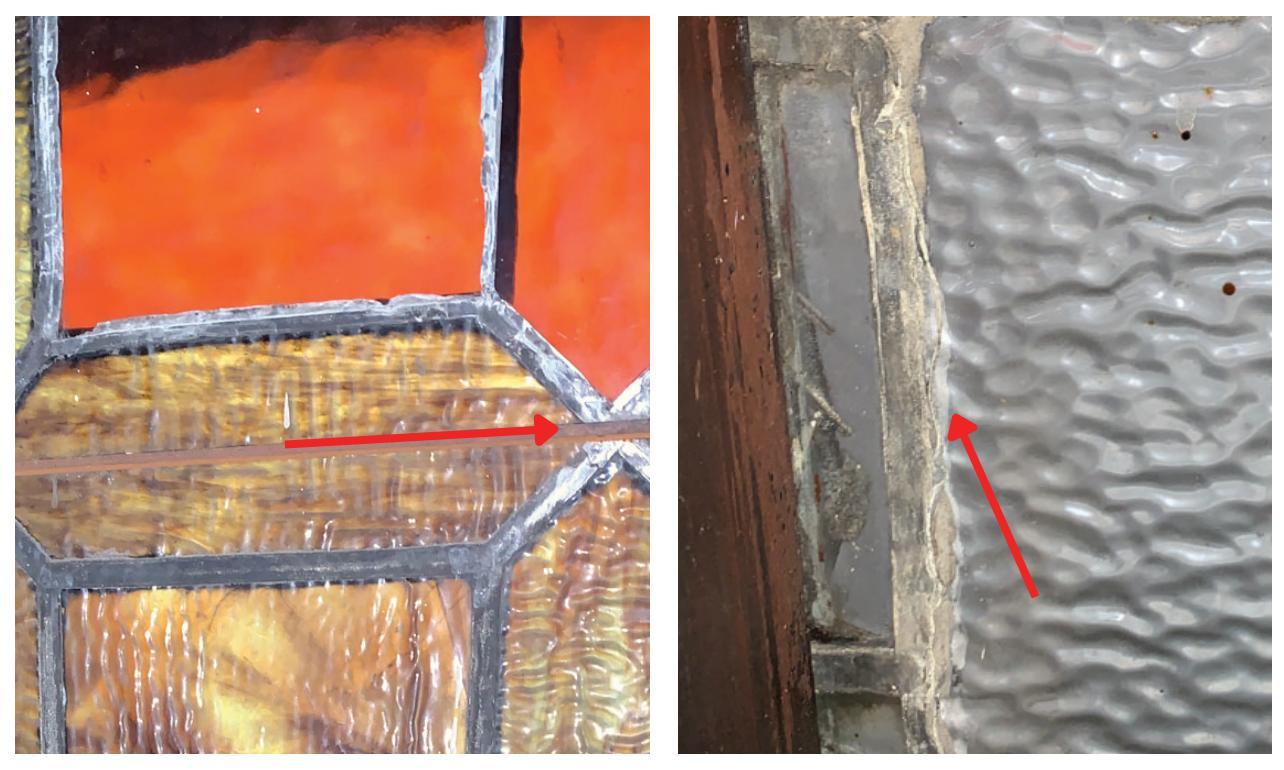
Details of windows S 13 (left) and W 11 (right) showing lead carbonate, a white powdery substance, on the interior lead matrix. Lead carbonate is a by-product of advanced oxidation. It can become friable and should be considered dangerous. The lead has become brittle and is breaking in areas. This condition occurs in 40% of the interiors of the windows.

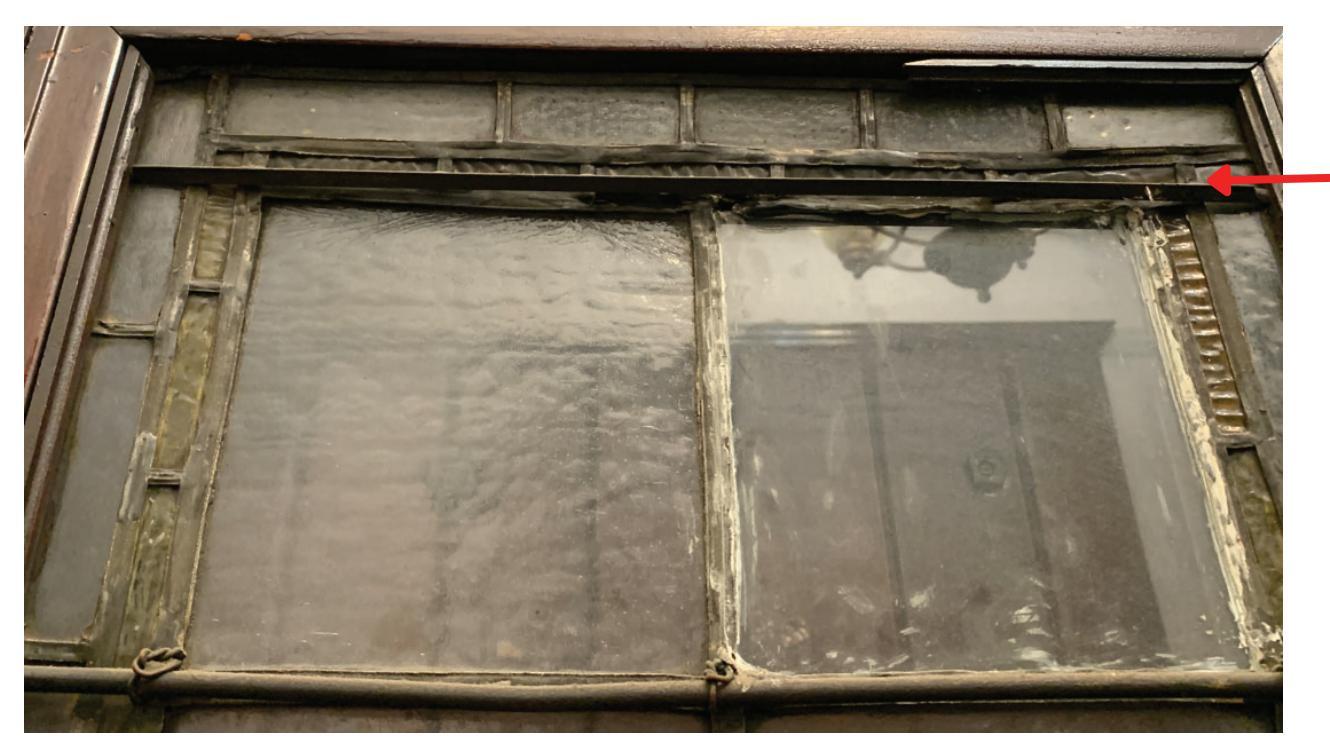
Details of window W 10. Note the lead carbonate, brittle lead came and bowing of the matrix.

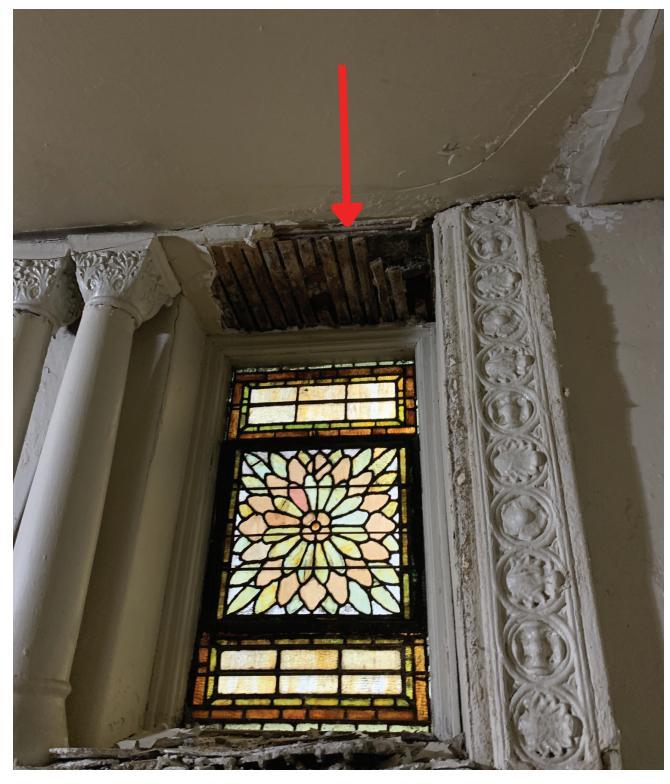
Detail of lost, cracked and damaged plaster in window  $$\rm N$$  1.

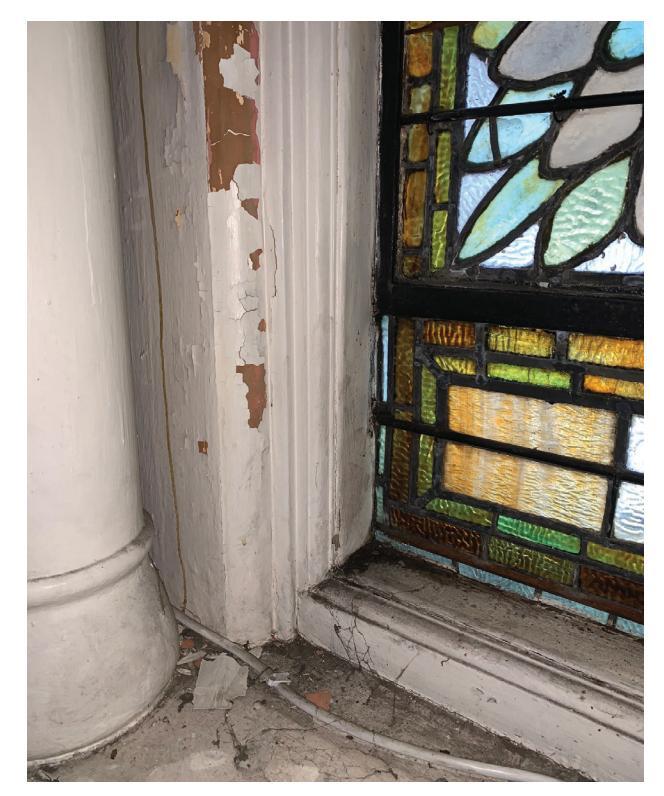
Detail of window S 9 showing chipping interior paint which is typical across the building.

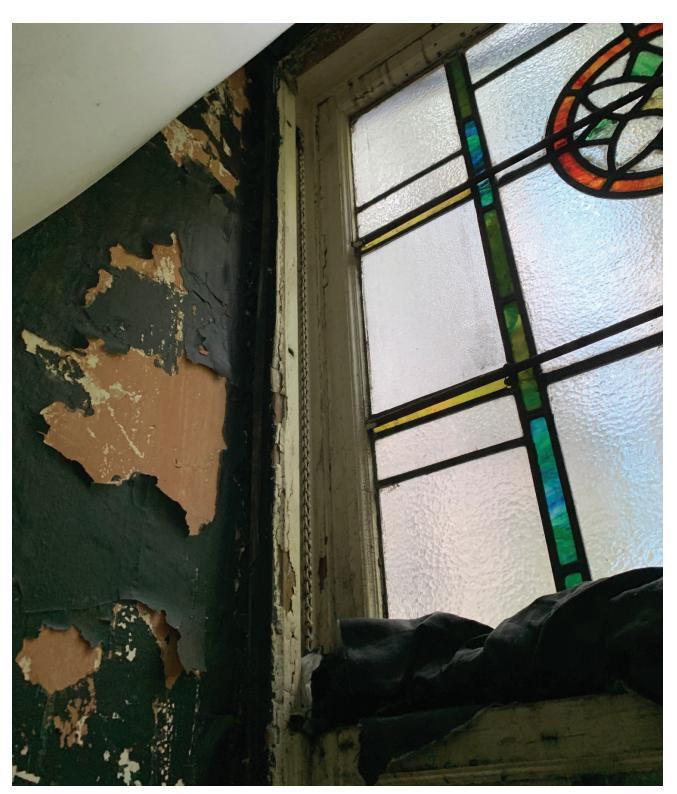
Detail of PHN (Register 1) showing watermarks on the interior of the sash and chipping paint.

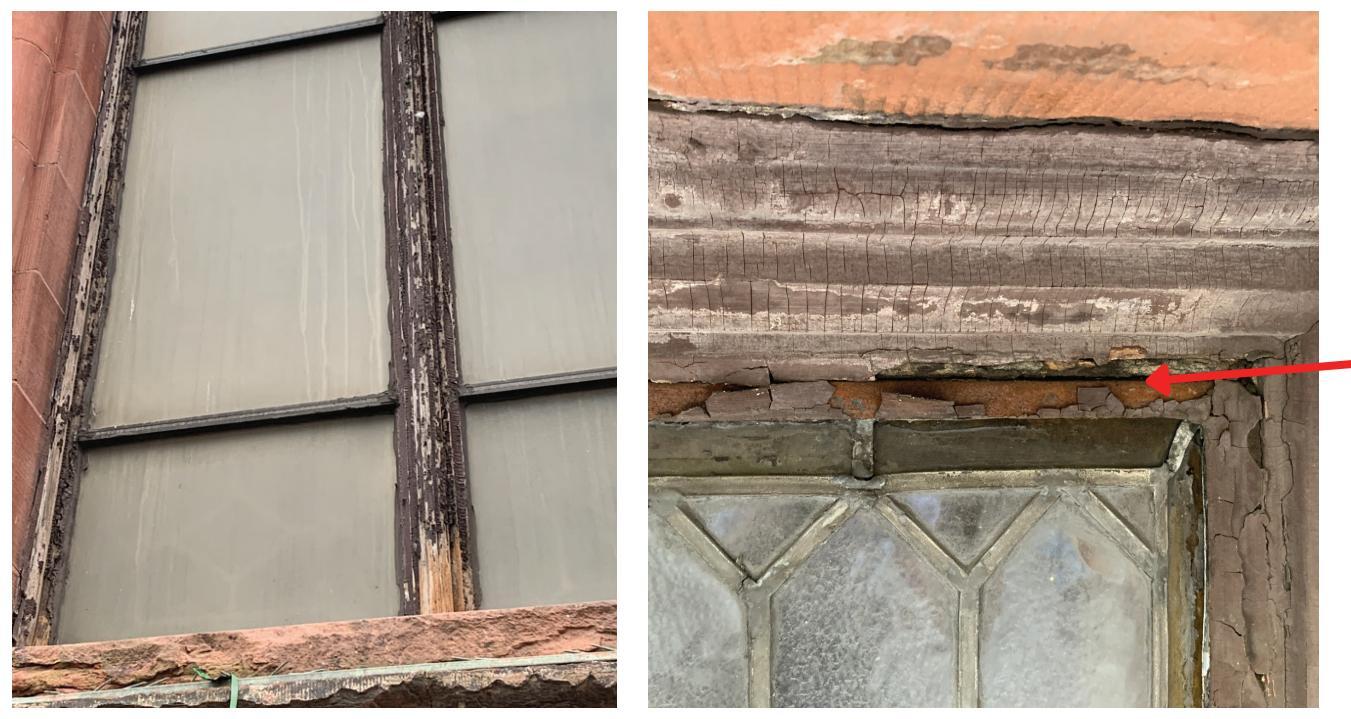
Details illustrating typical exterior wood and steel conditions. The paint has chipped away exposing bare wood and steel. The steel ventilators have rusted.

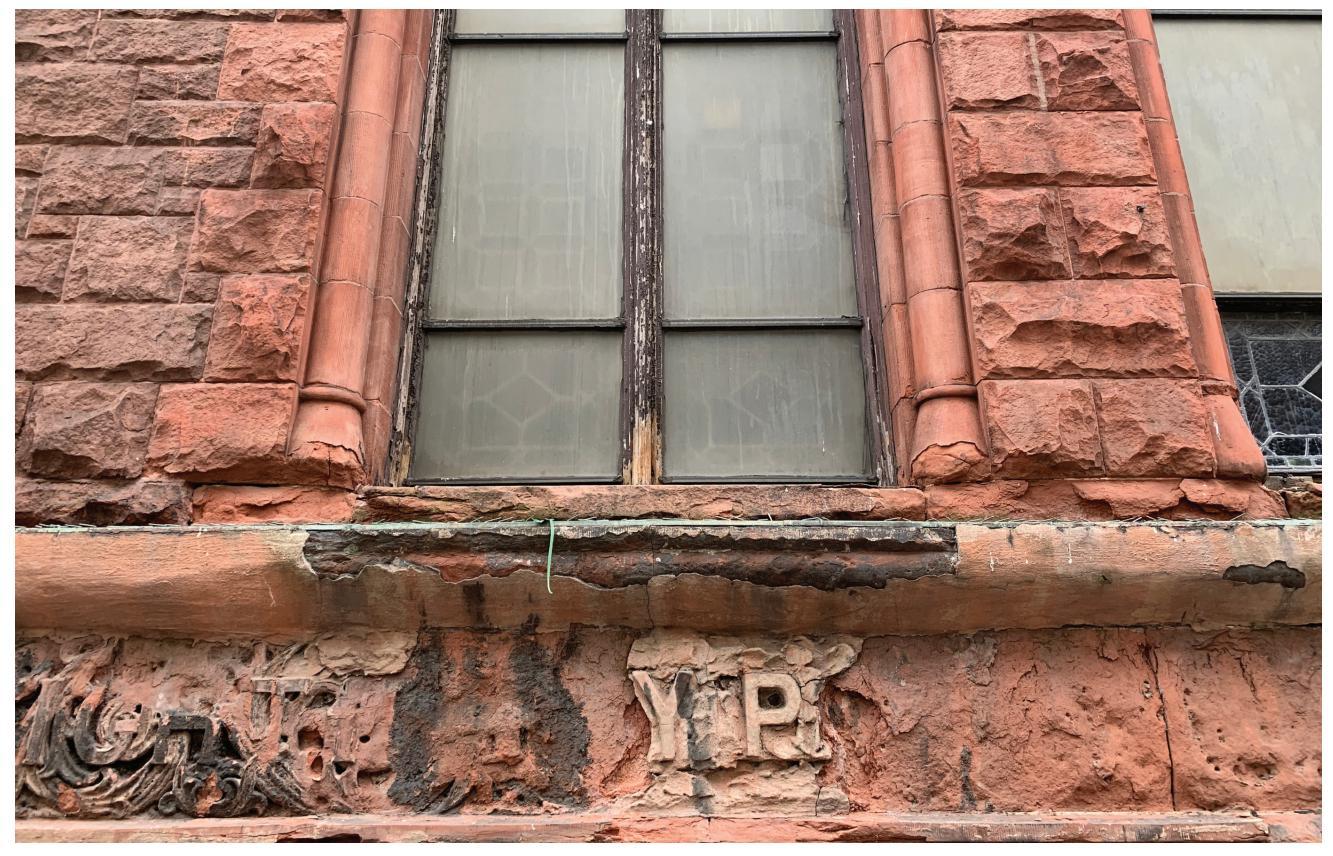
Stone spalling and delamination on the exterior of the West facade. The window sills have eroded.

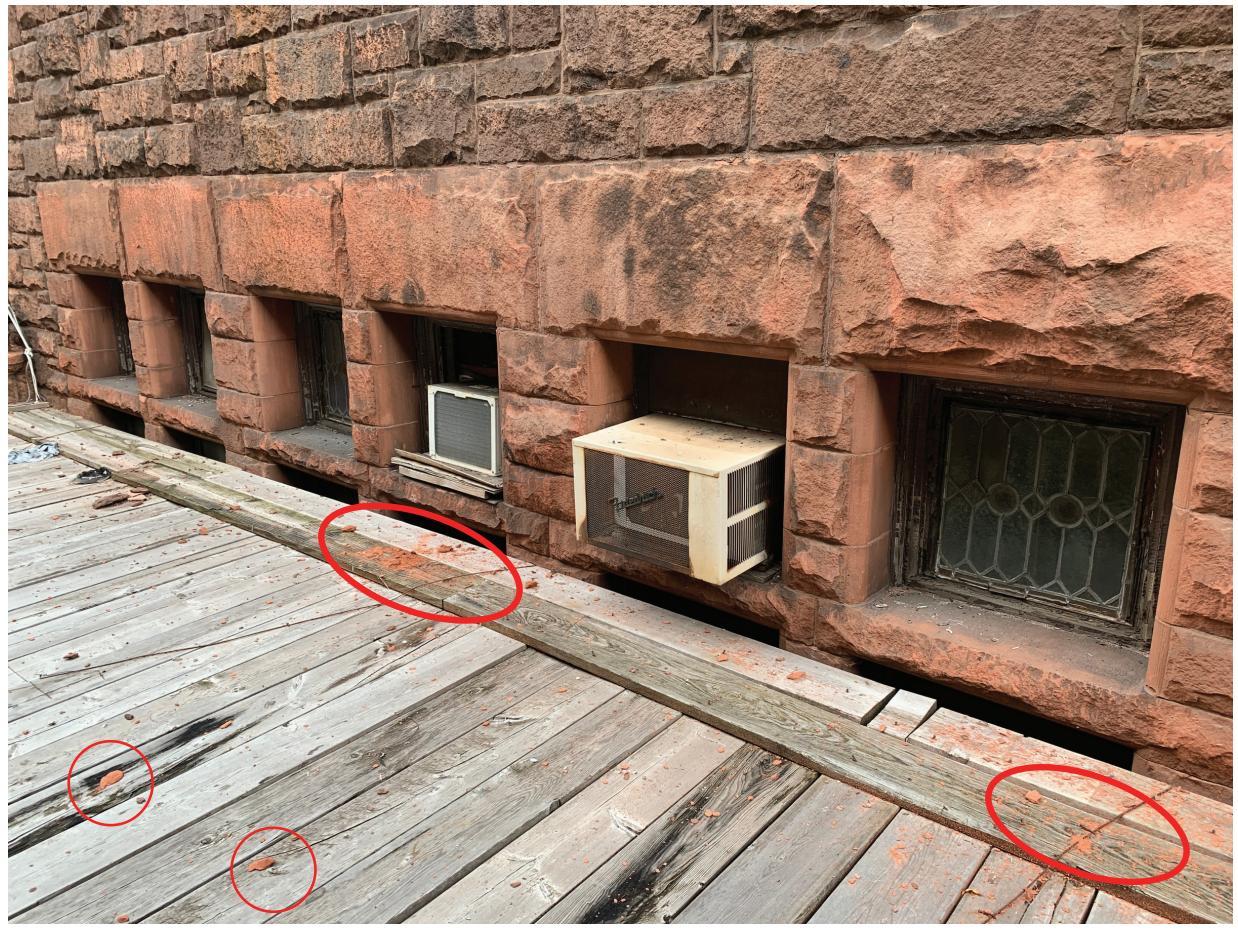
Many panels have been removed to accommodate air condition units across the building. Note the pieces of stone which have fallen on the sidewalk bridge.

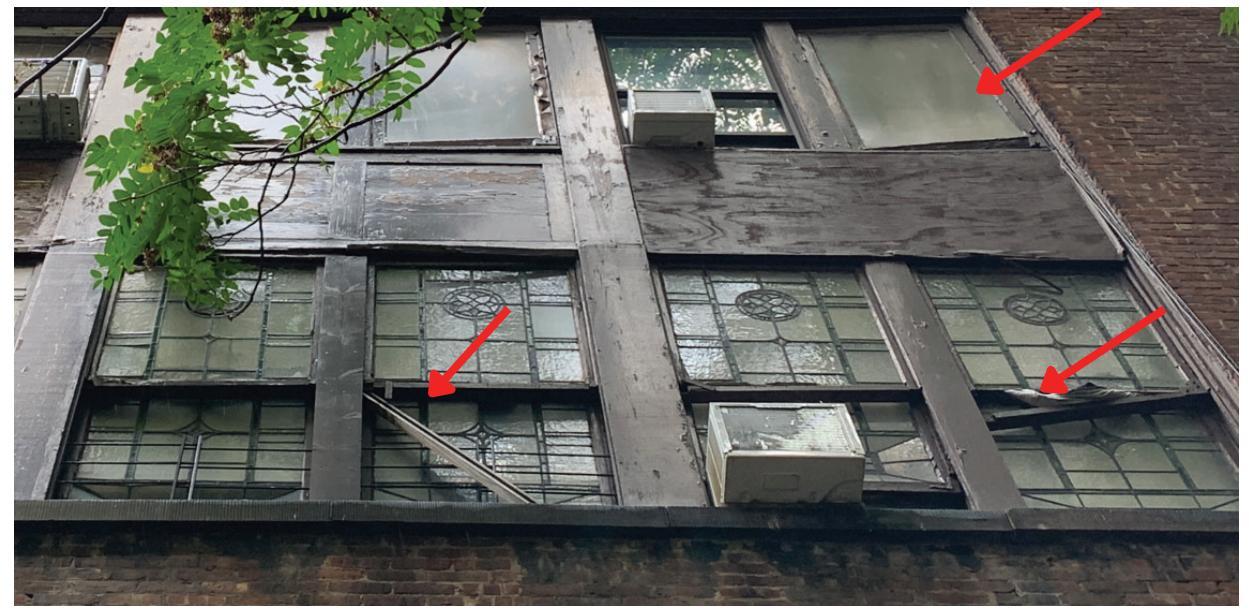
Pieces of the wood sashes and Lexan framing are in danger of falling on the northern side of the parish house. The caulk adhering the Lexan has failed and the Lexan is unstable.

<u>Finding</u>: The method of attachment of the Lexan has failed. The current condition of the caulk cannot be counted upon to remain intact. A caulk-only attachment is no longer considered best practice.
