Testimony of LANDMARK WEST! Certificate of Appropriateness Committee Before the Landmarks Preservation Commission 45 West 81st Street February 14, 2023

The Certificate of Appropriateness Committee wishes to comment on 45 West 81st Street, a neo-Moorish style apartment hotel building with Spanish Renaissance style elements designed by Sugarman & Hess and built in 1922 from within the Upper West Side/Central Park West Historic District. The application is to construct a rooftop addition.

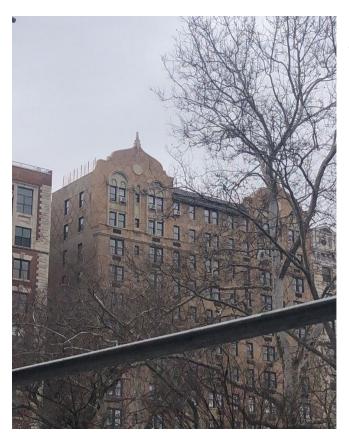
View from Columbus Avenue showing visibility impacts on the decorative arch.

The LANDMARK WEST! Certificate of Appropriateness Committee would ask that the applicant consider setting the addition back further and pull it in equally at both sides to lessen its proximity to the front facade and its visibility.

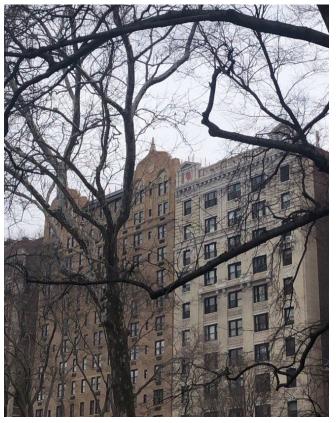
View from 81st Street, Rose Center for Earth and Space showing considerable visibility of the side of the addition closest to the edge of the main building.
