B'NAI JESHURUN COMMUNITY HOUSE FIRE-RATED AND LOT-LINE WINDOW REPLACEMENT

REVISION#2 September 12th, 2022

Re: **DOCKET: #LPC-22-07597
WOOD WINDOW RESTORATION AND FIRE-RATED WINDOW REPLACEMENT
270 WEST 89TH STREET
MANHATTAN, NEW YORK 10024
BLOCK: 1236 LOT: 58**

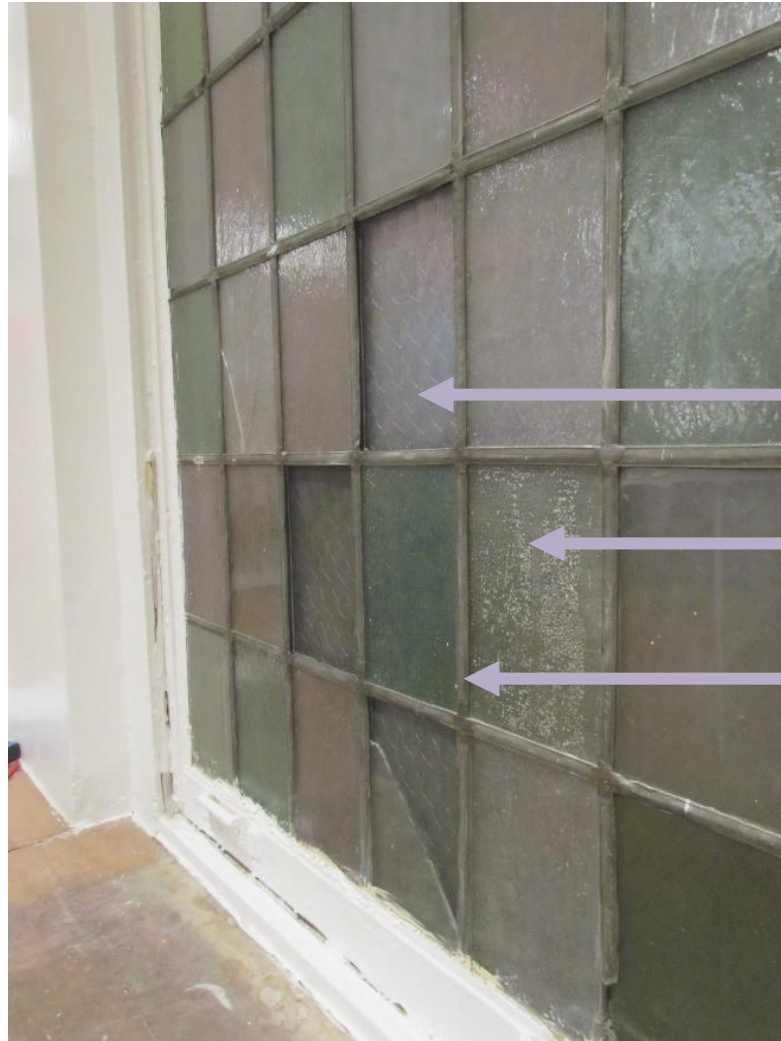
EXISTING FIRE-RATED WINDOW – INTERIOR PHOTO

PARTS OF MODIFIED SASH:

1. FIRE-RATED WIRED GLASS (BEHIND)

2. COLORED GLASS LITES

3. LEAD CAMING

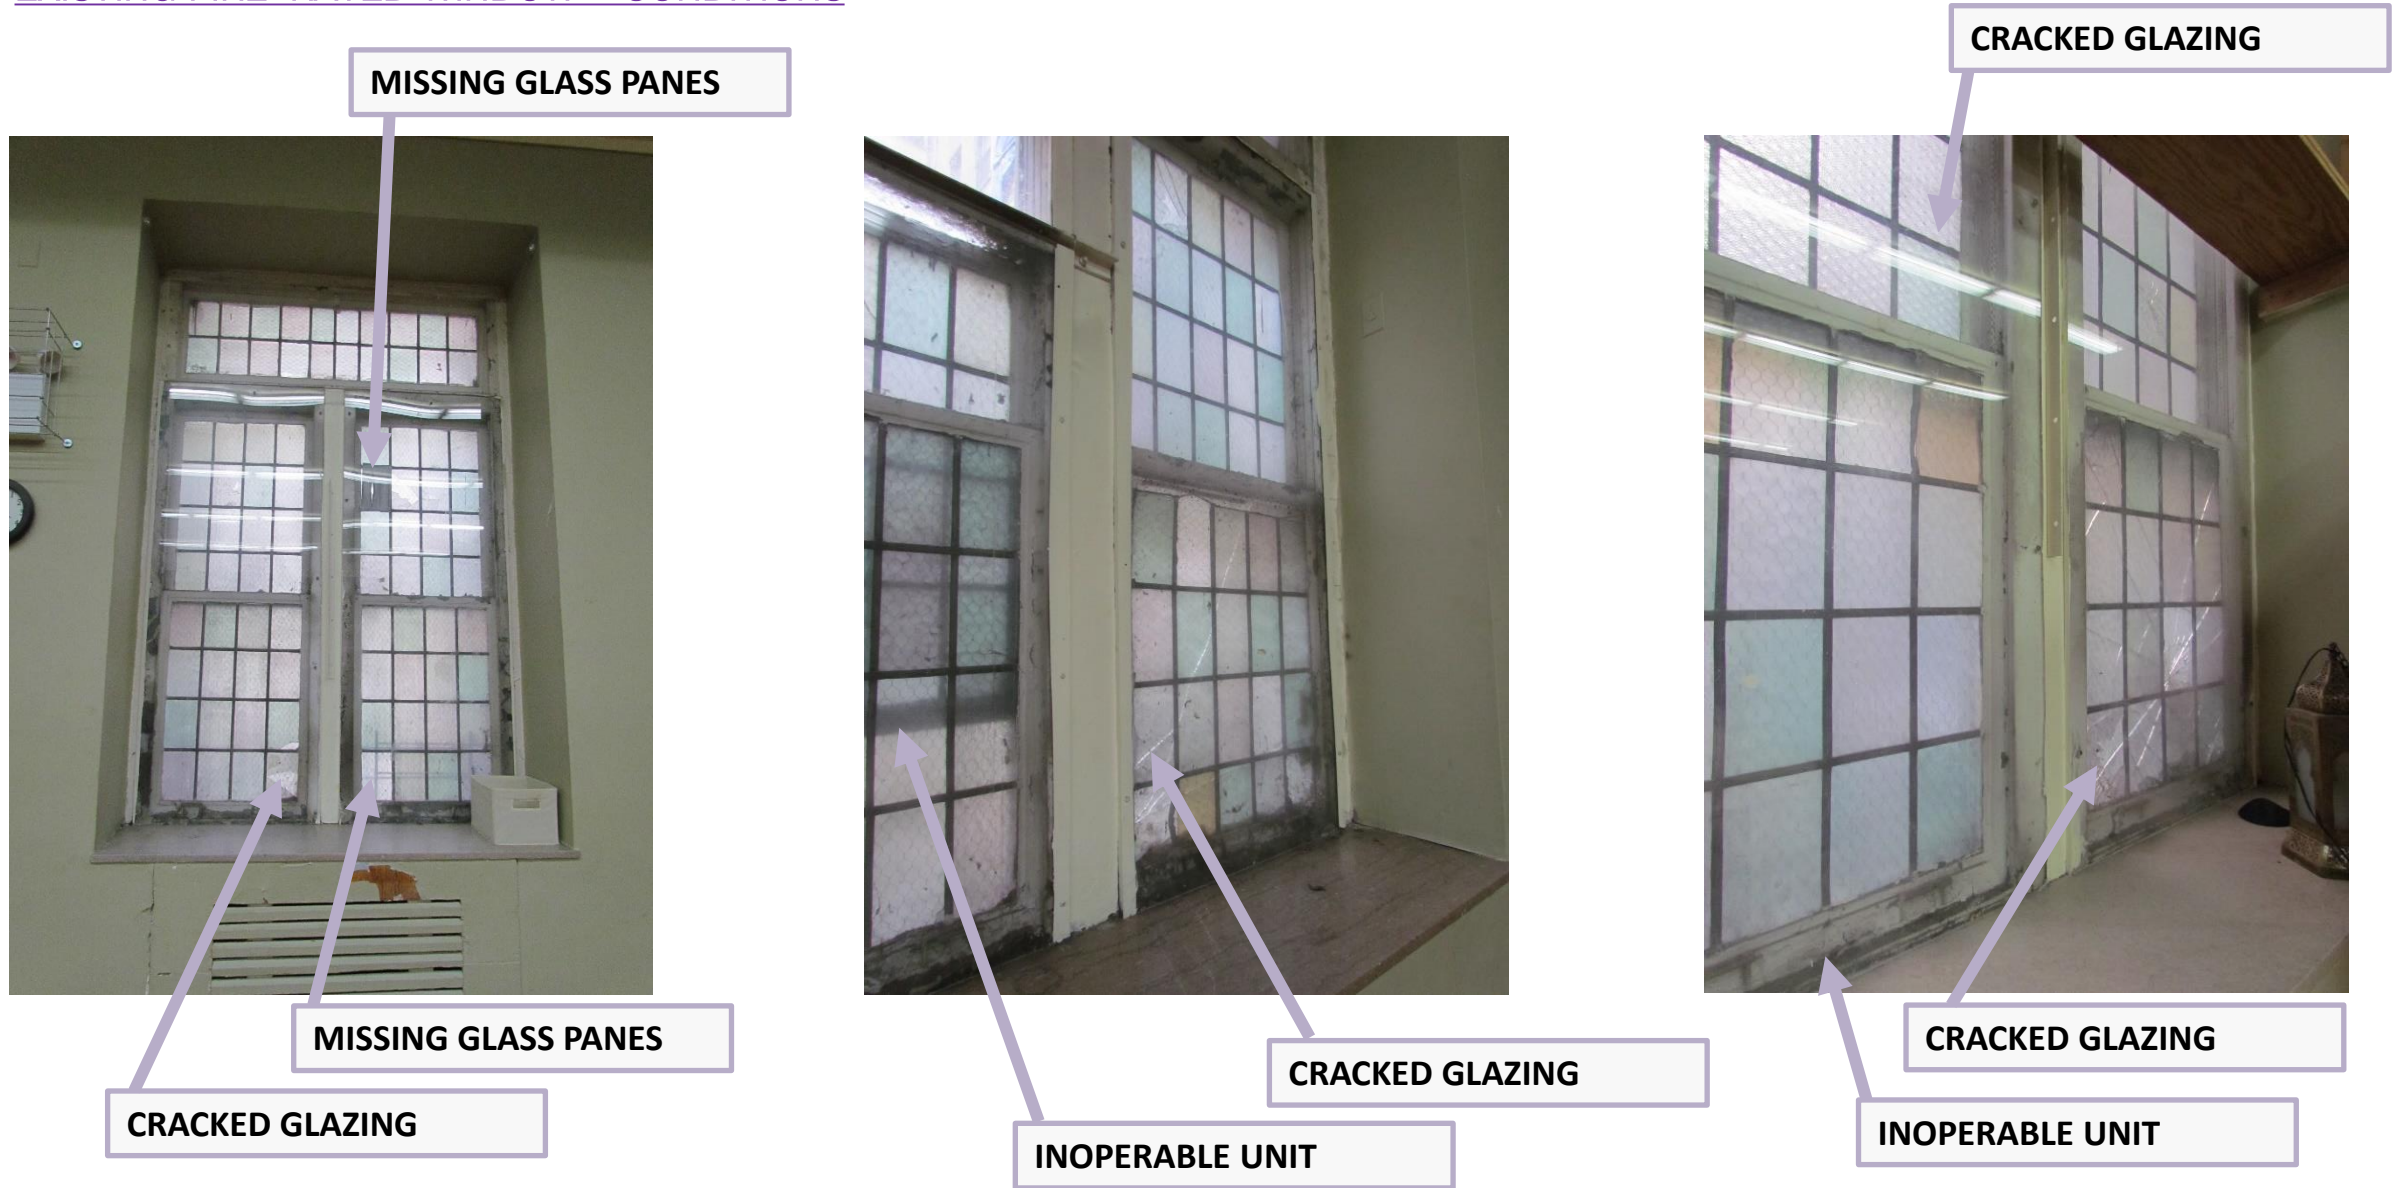
EXISTING FIRE-RATED WINDOW – CONDITIONS

CRACKED GLAZING

INOPERABLE UNIT

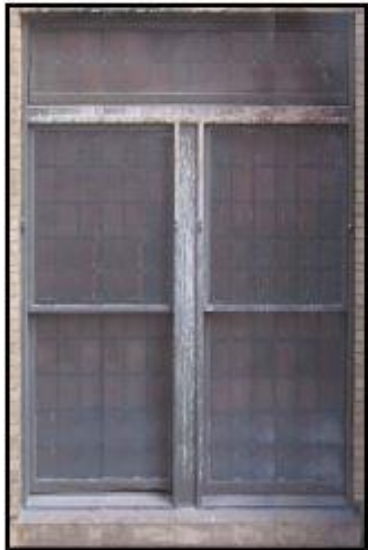
EXISTING FIRE-RATED DOUBLE WINDOW ELEVATION

GLASS LOSS CALCULATION - E2
EXISTING: 35.5 SF
PROPOSED: 38.6 SF
GLASS GAINED: +9.1%

NOTE: WINDOW E2 IS LOCATED IN MEETING ROOM. GLAZING TO RECEIVE PRINTED MUNTIN PATTERN TO MATCH PROPORTION & PATTERN OF EXISTING CAMING.

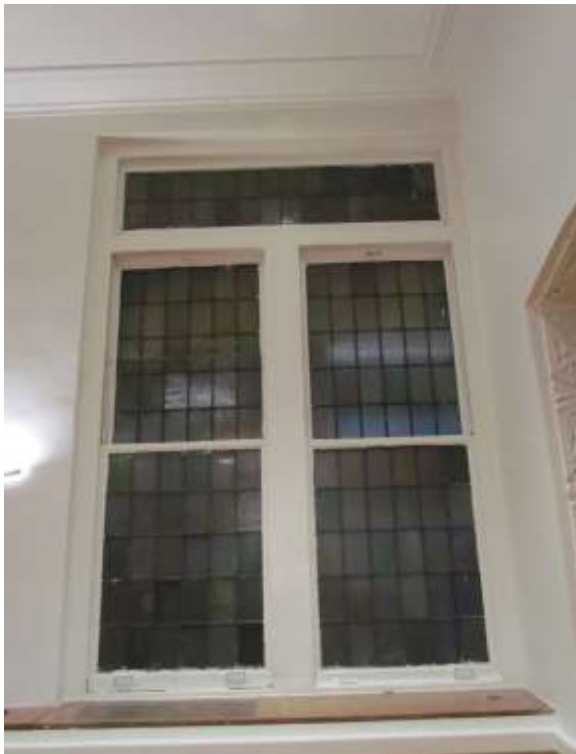
Photo 32:

ST1 existing conditions, interior.

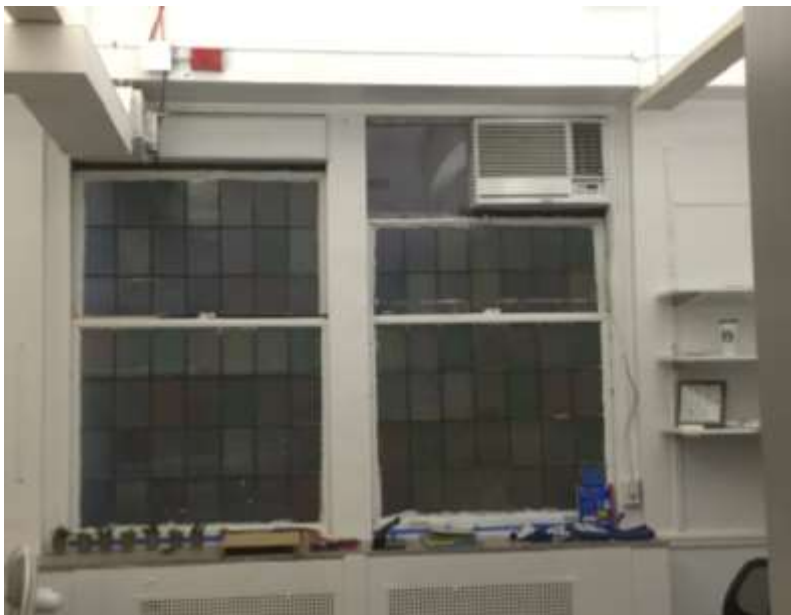
Photo 37:

ST3 existing conditions, interior.

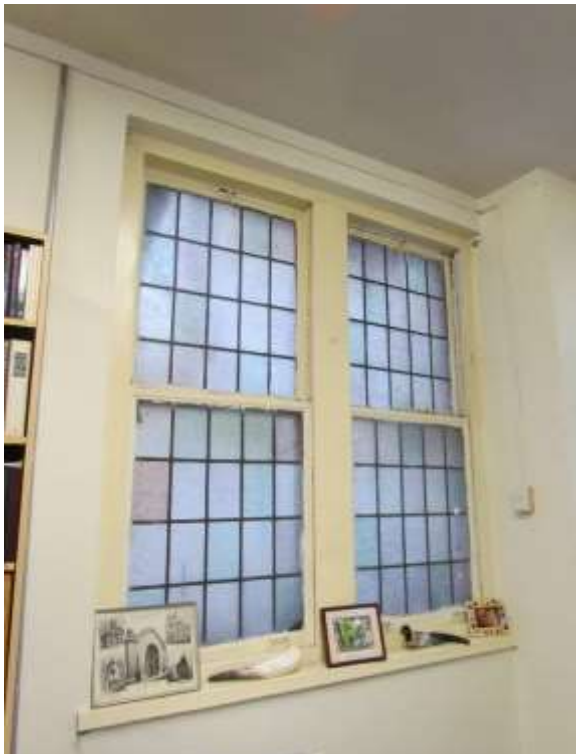
Photo 41:

ST4 existing conditions, interior.

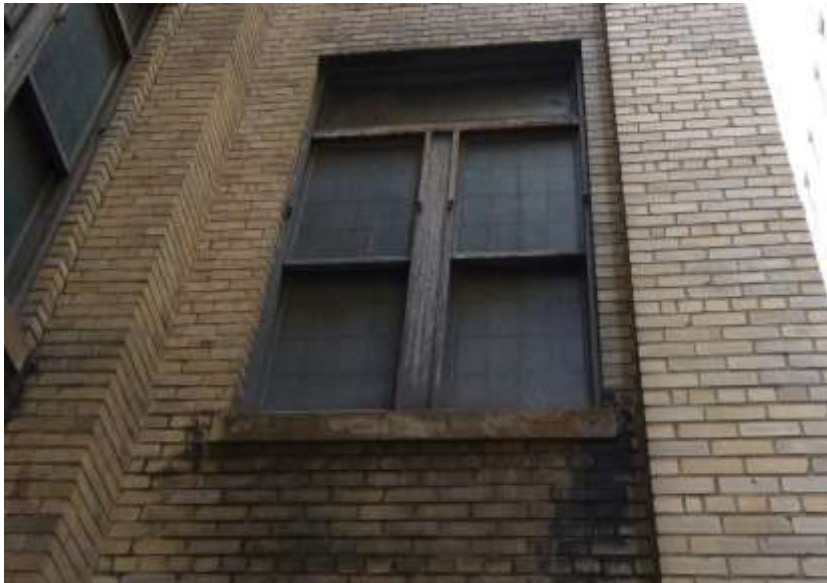
Photo 44:

ST6-1 existing conditions, exterior.

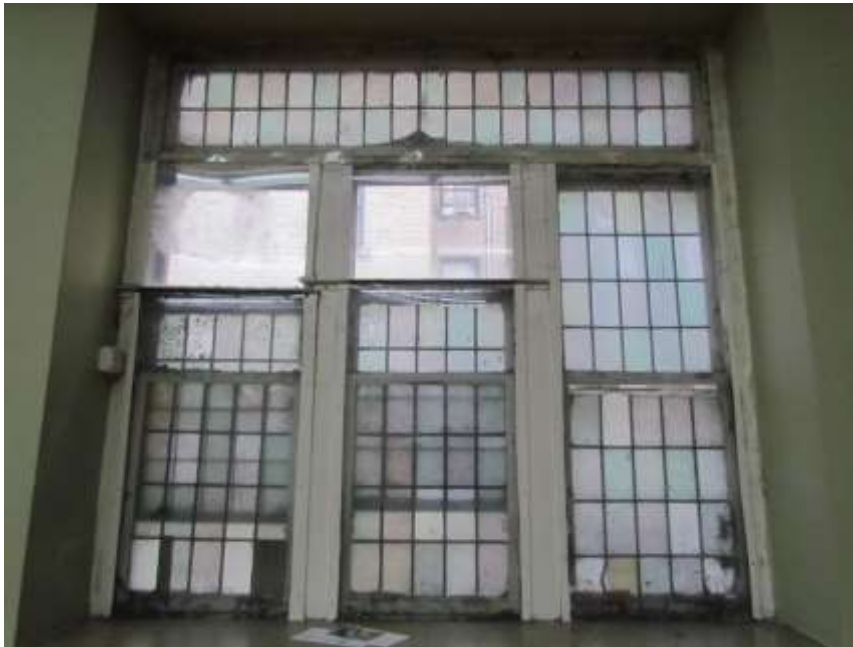
Photo 48:

ST7-1 existing conditions, interior:
Replacement sashes installed.

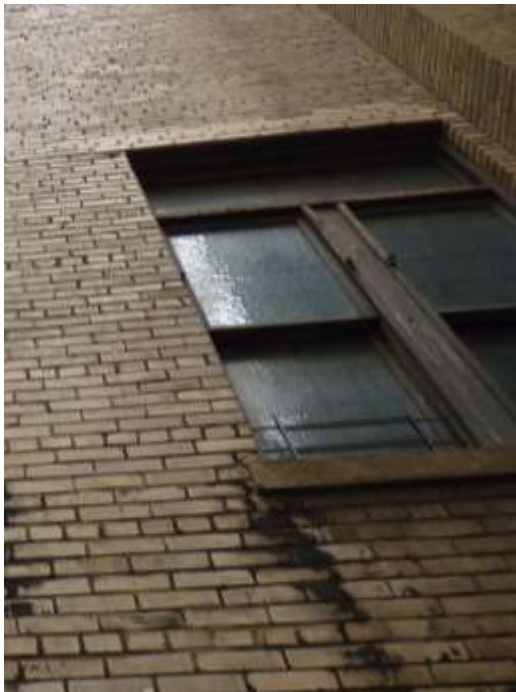
Photo 51:

ST8-1 existing conditions, exterior.

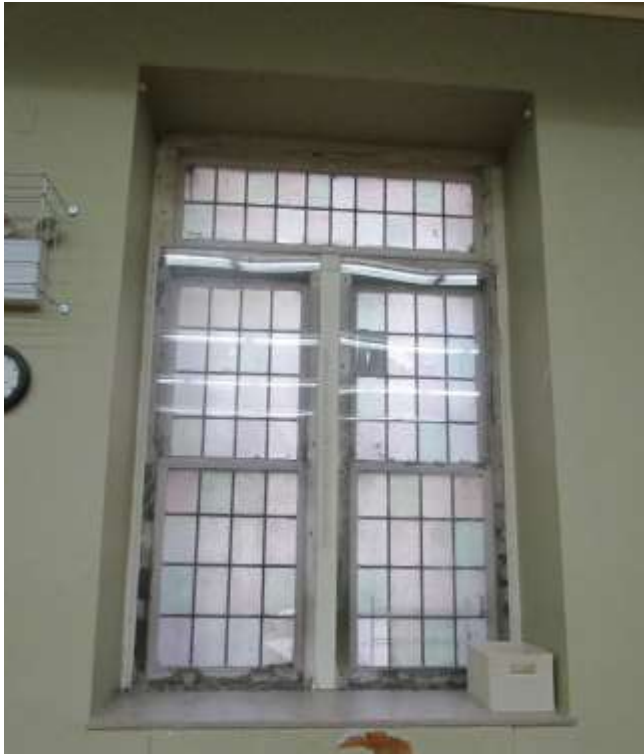
Photo 52:

ST8-1 existing conditions, interior.

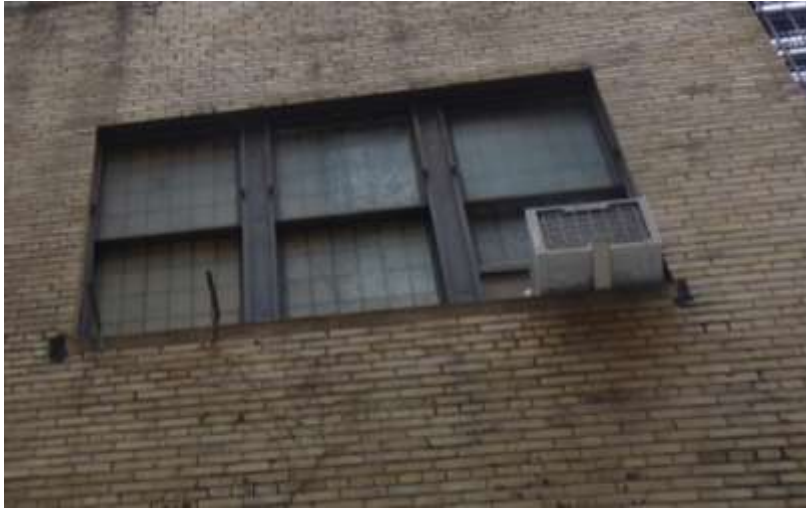
Photo 63:

ST28 existing conditions, exterior.

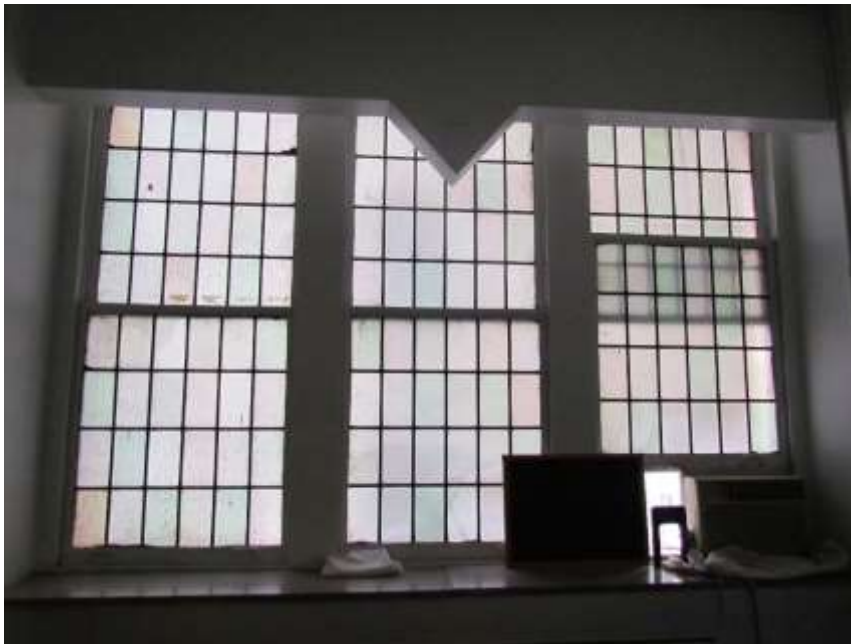
Photo 64:

ST28 existing conditions, interior.

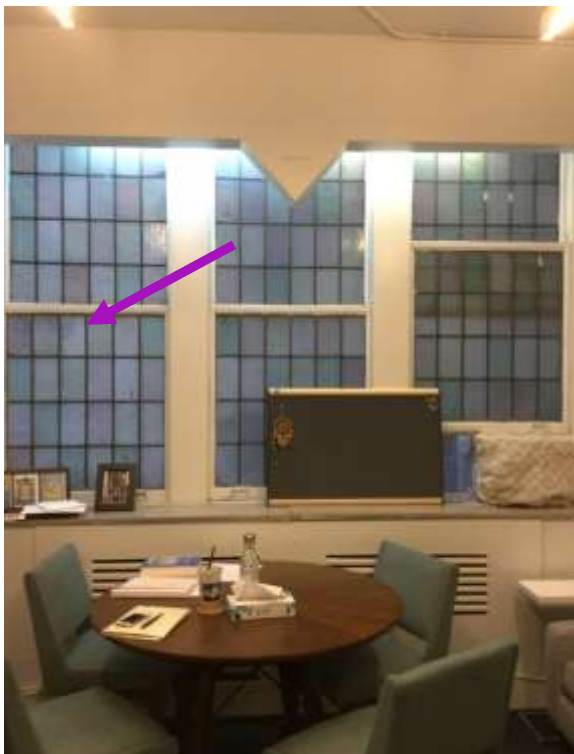
Photo 66:

ST27-4 existing conditions, interior:
Deteriorated frames and sashes,
cracked and broken colored glass
lites.

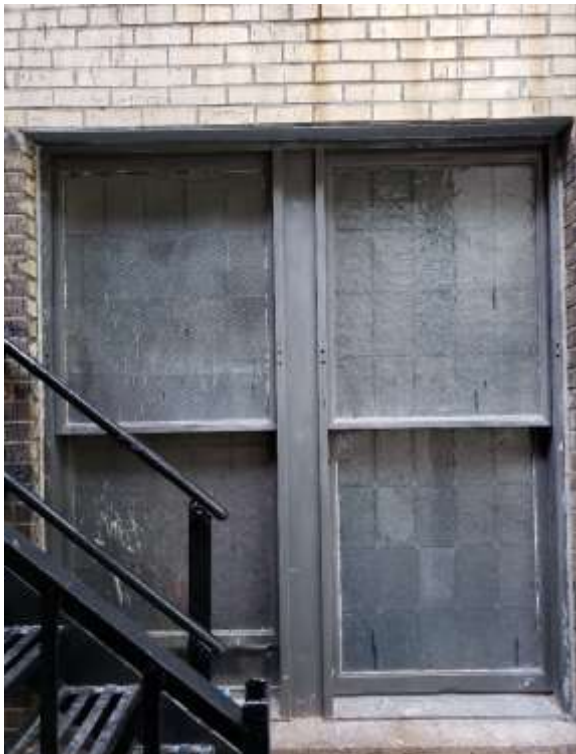
Photo 77:

SC1 existing conditions, exterior.

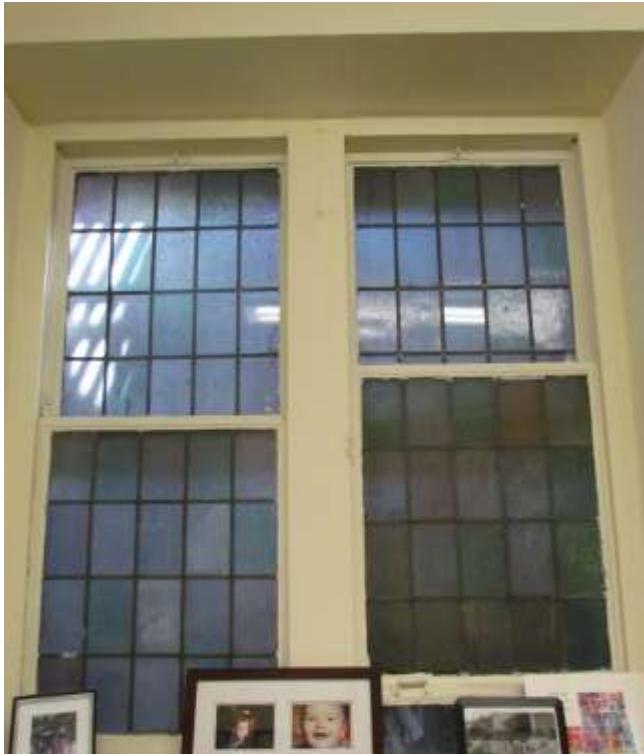
Photo 78:

SC1 existing conditions, interior.
