Façade Reconstruction 231 & 233 West 74th Streets

This presentation seeks to demonstrate that the deterioration of the primary (south) facades of the above buildings is so advanced that restoration work is not be possible to perform safely or effectively. MVN therefore seeks permission from LPC to perform reconstruction of the primary facades using salvaged original masonry brick and stone units to the greatest extent possible, and new materials to match the existing, where existing materials are not able to be salvaged.

MVN Architect LLC
Public Hearing 10/3/2022

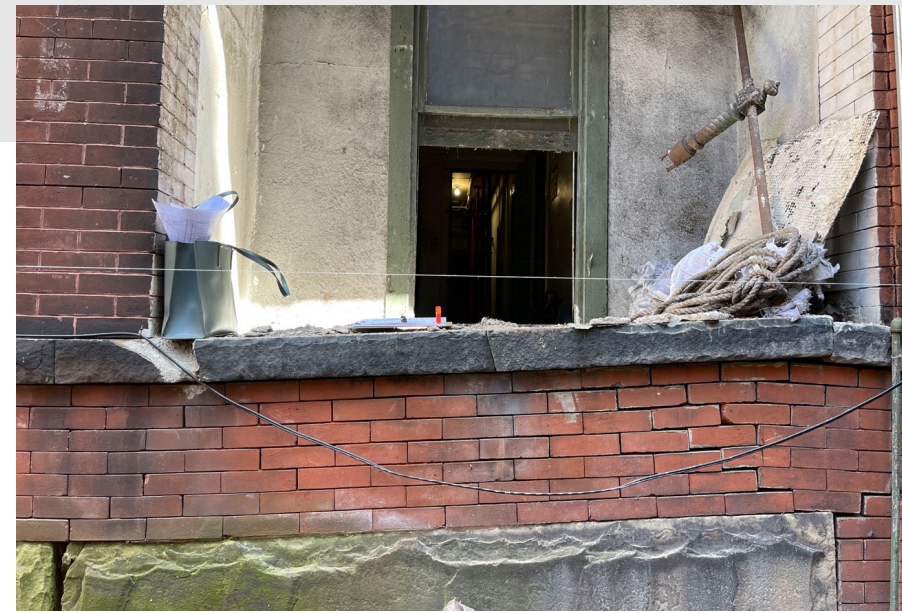
Existing Displacement & Deterioration

231 West 75th Street (Bay window segment coming apart at corner and cracked vertically from settlement.)

Photo taken 2022

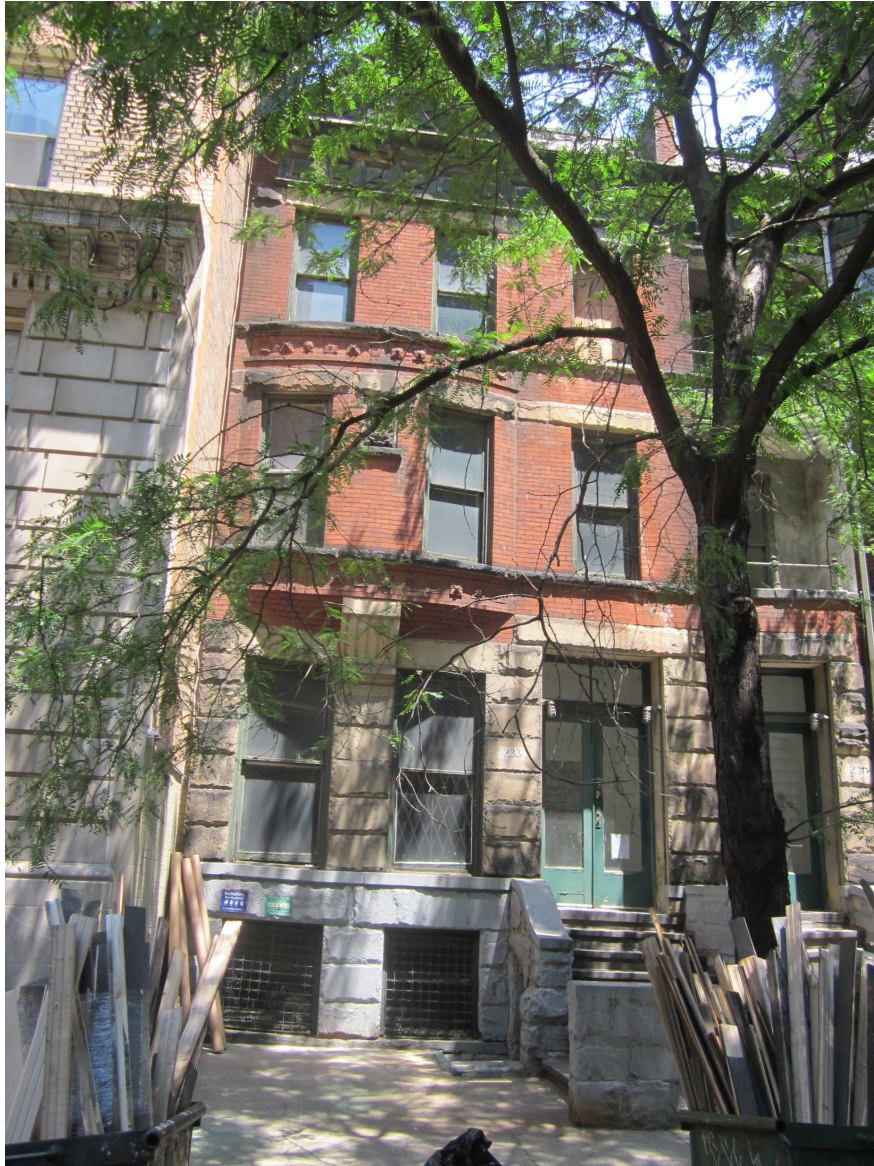
233 West 75th Street – Photo taken 2012

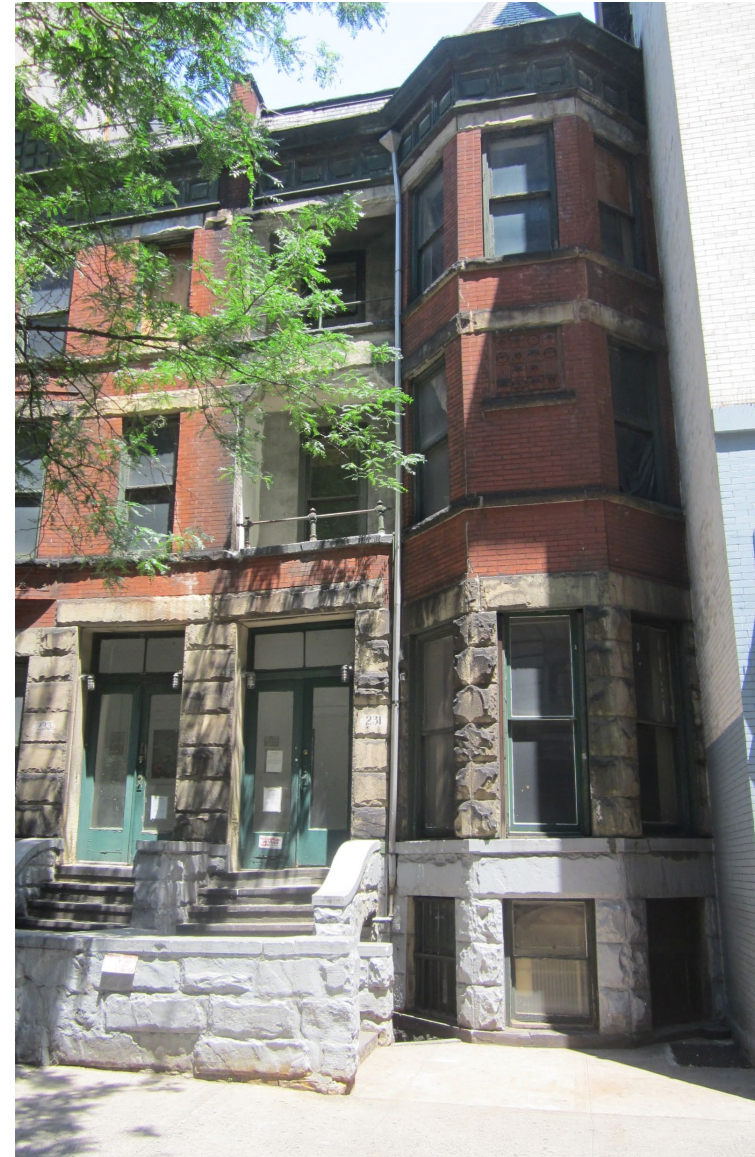
231 West 75th Street – Photo taken 2012

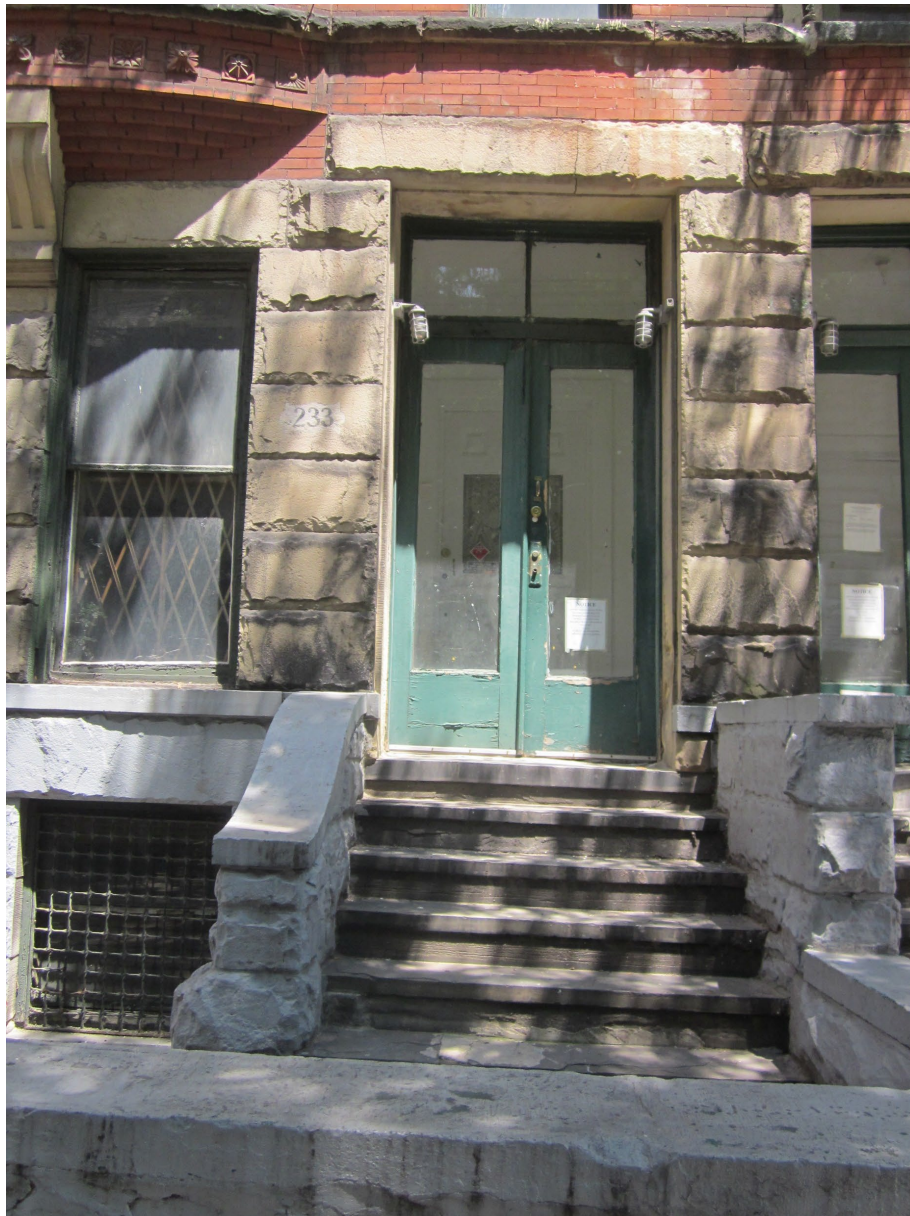
233 West 75th Street – Photo taken 2012

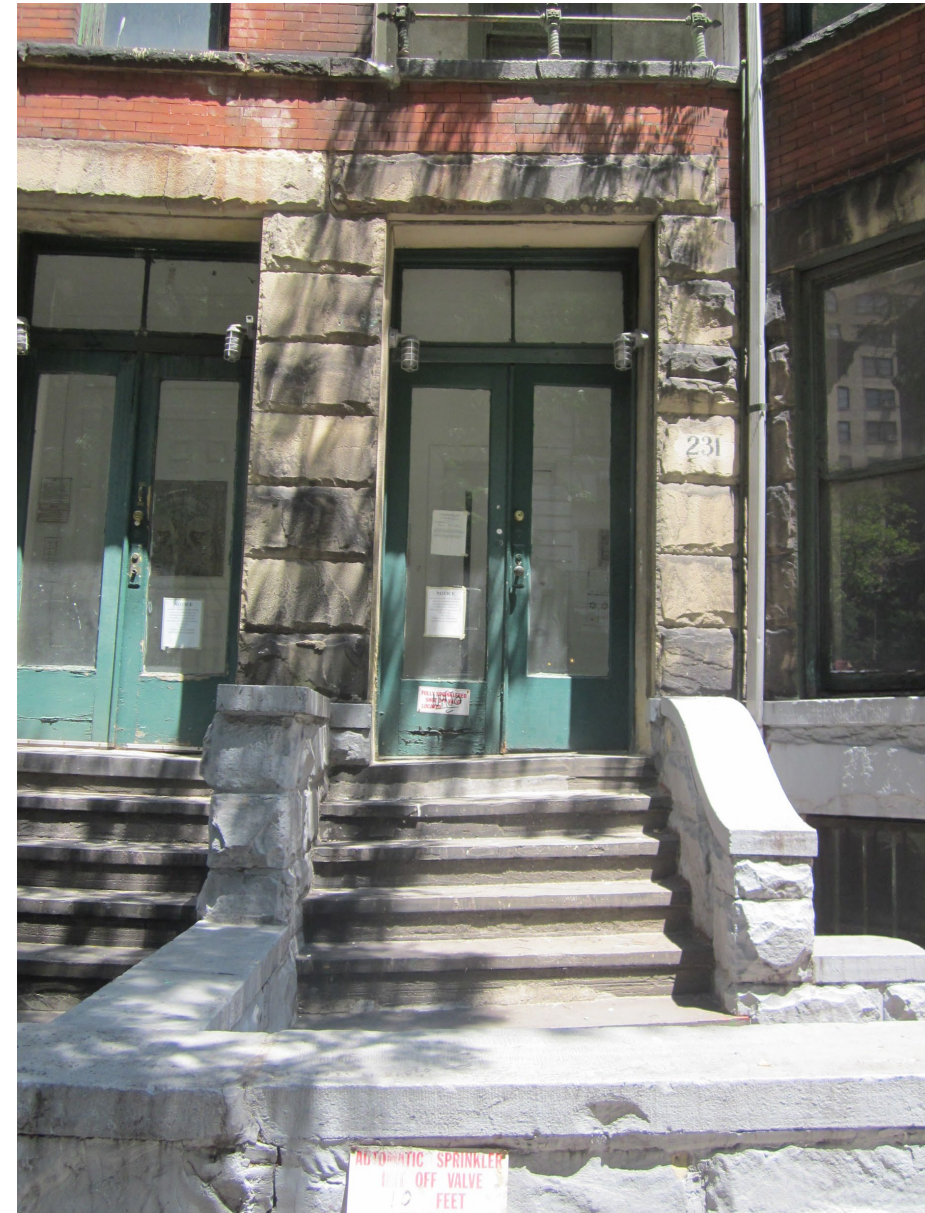
231 West 75th Street – Photo taken 2012
